DRAFT BAYJI WHITE PHOSPORUS INCIDENT INVESTIGATION REPORT

COALITION MUNITIONS CLEARANCE (CMC)
NAD BAYJI, IRAQ
Conducted March 07-08, 2008
Issued March 09, 2008

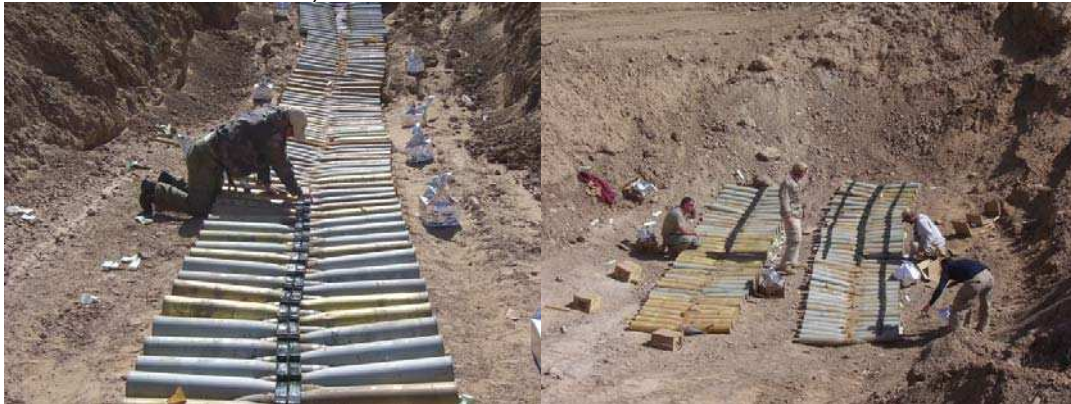
1040- Demo Team start setting up the shots. There are 5 shots consisting of 124 rounds of Armor Piercing (AP) rounds and one shot of 59 High Explosive (HE) and High Explosive Anti-Tank (HEAT) Rounds. Additionally (1) one 105MM White Phosphorus (WP) Projectile that was found outside of Demo Pit 1 and tied into Shot 1 for disposal. (Disposal of WP round briefed at Demolition Safety Brief, but hazards of WP not briefed)

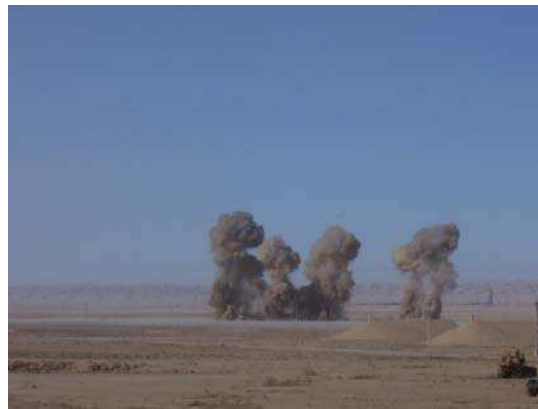
1511- The disposal shots are initiated via the remote firing devise. Initially the UXOSO has questions if all 6 shots detonated (see attached log book entry). SUXOS John Carter broadcast over the radio that there will be a 1 hour wait time observed due to the possible misfire. Sean Fry a TT UXO Tech II located at an opposite Observation Point 19 calls back over the radio to state all 6 shots detonated and that he has photographic evidence of the fact. So a 5 minute wait time is observed.

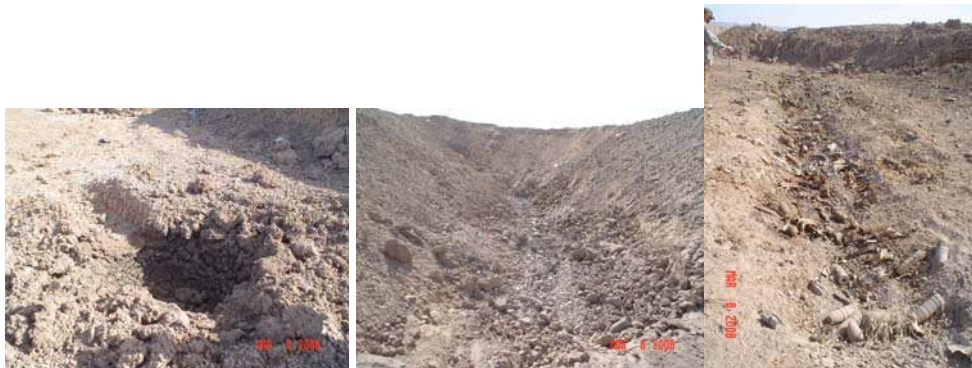
1518- SUXOS and Demolition Supervisor return to the demolition pits to verify that all shots had detonated. The Demo Supervisor checks demo pits 6, 5, & 4 located on the north side of the range. The SUXOS checks demo pits 1, 2, & 3 located on the south side of the range. Additionally SUXOS checks the shot hole location for the single 105 MM White Phosphorus Projectile that was tied into shot number 1.

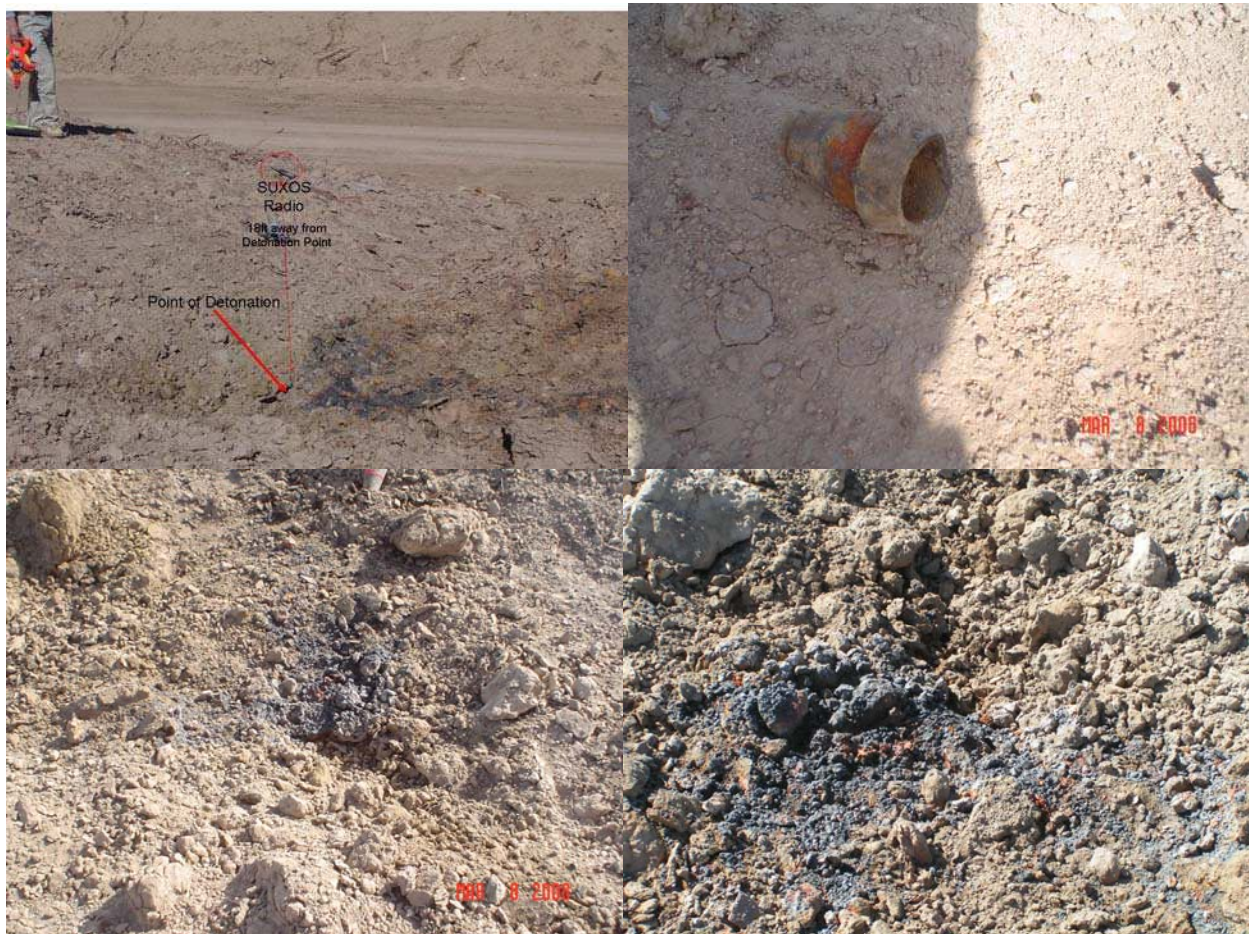
1530- Unintentional Detonation is heard and observed. Demo Supervisor sees SUXOS stumbling with his hands on his face and declares an emergency by stating “Emergency, Emergency, Emergency” over the radio then proceeds to the SUXOS to render assistance. The Medic and one UXO Tech proceed to the demolition range to render aid. Demolition Supervisor broadcasts to the medic that he is walking the SUXOS to the vehicle. Medic arrived on scene and proceeded to administer first aid.

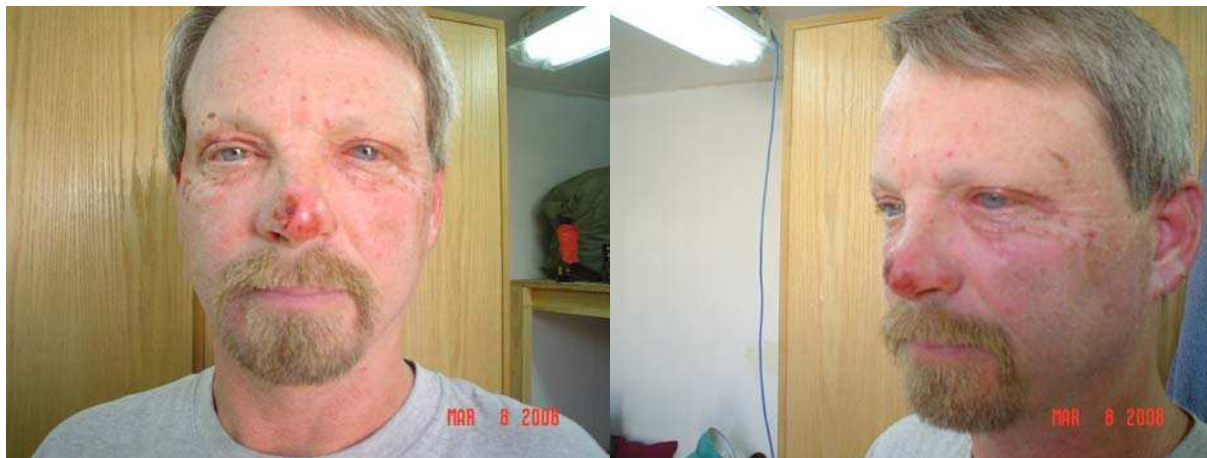
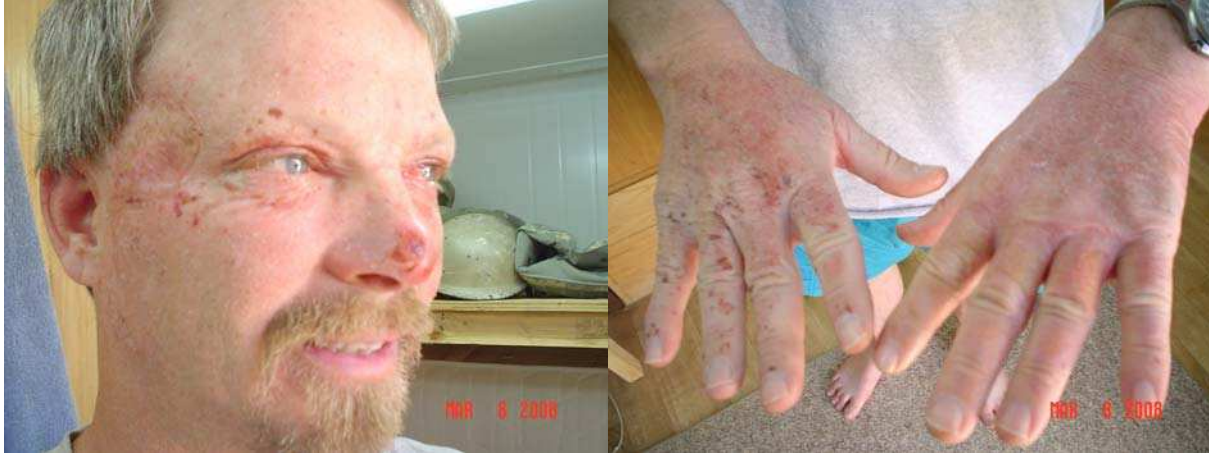
As a result of the detonation of the 105MM white phosphorus projectile John Carter received white phosphorus flash burns to both hands and eyes, a corneal laceration to the left eye and foreign body in the anterior cornea of the right eye. John states that he was wearing protective eye wear but not wearing gloves. The following is a summary of the treatment received;
