Final Report on the Investigation of the Macondo Well Blowout

**Deepwater Horizon Study Group
March 1, 2011**

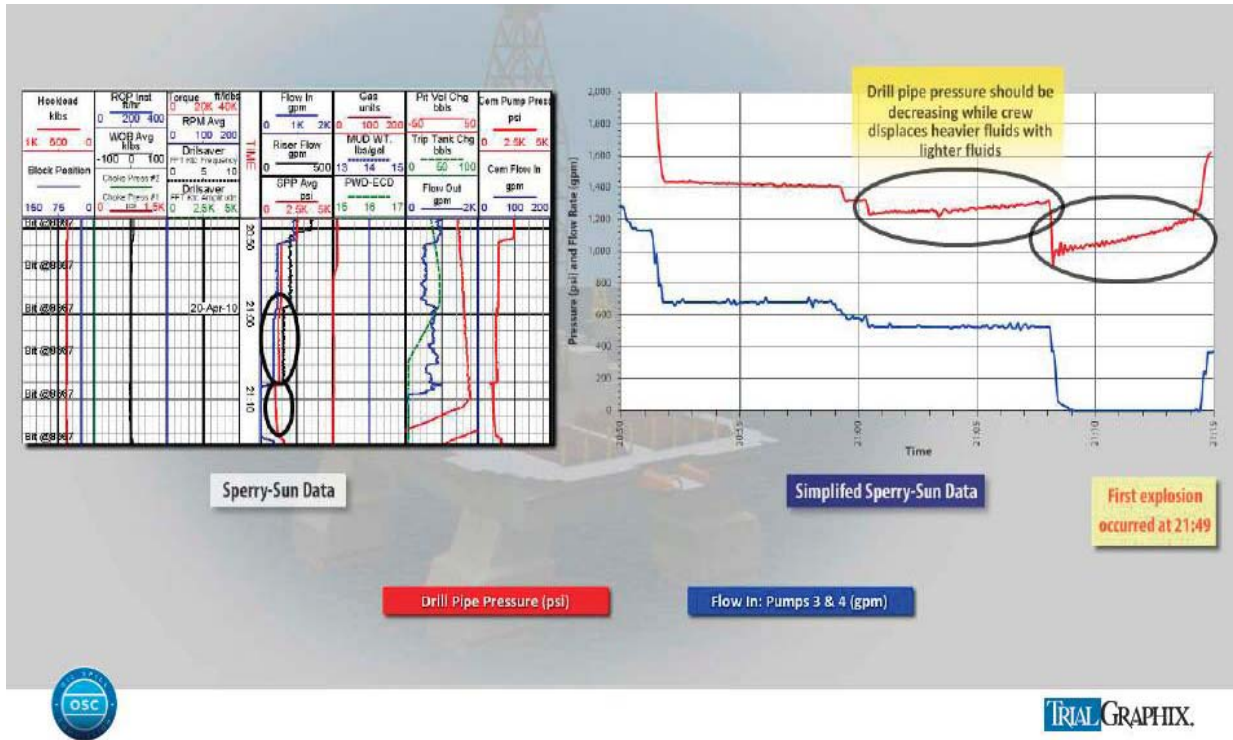
April 20, 9:00 p.m. – Shortly after 9:00 p.m. pressure on the drill pipe increased from 1,250 psi to 1,350 psi. The drill pipe pressure should have decreased due to the removal of the heavier mud (14.7 ppg) and its replacement with the lighter weight seawater (8.6 ppg). This abnormality could have been detected from monitoring the drill pipe pressure data, and could have been the first clear indication of the flow of hydrocarbons into the well, visible to the crew.⁹⁸ Spacer fluid was then observed at the surface.

Figure 1.22 – Drill pipe pressure showing pressure increase.¹⁰⁰

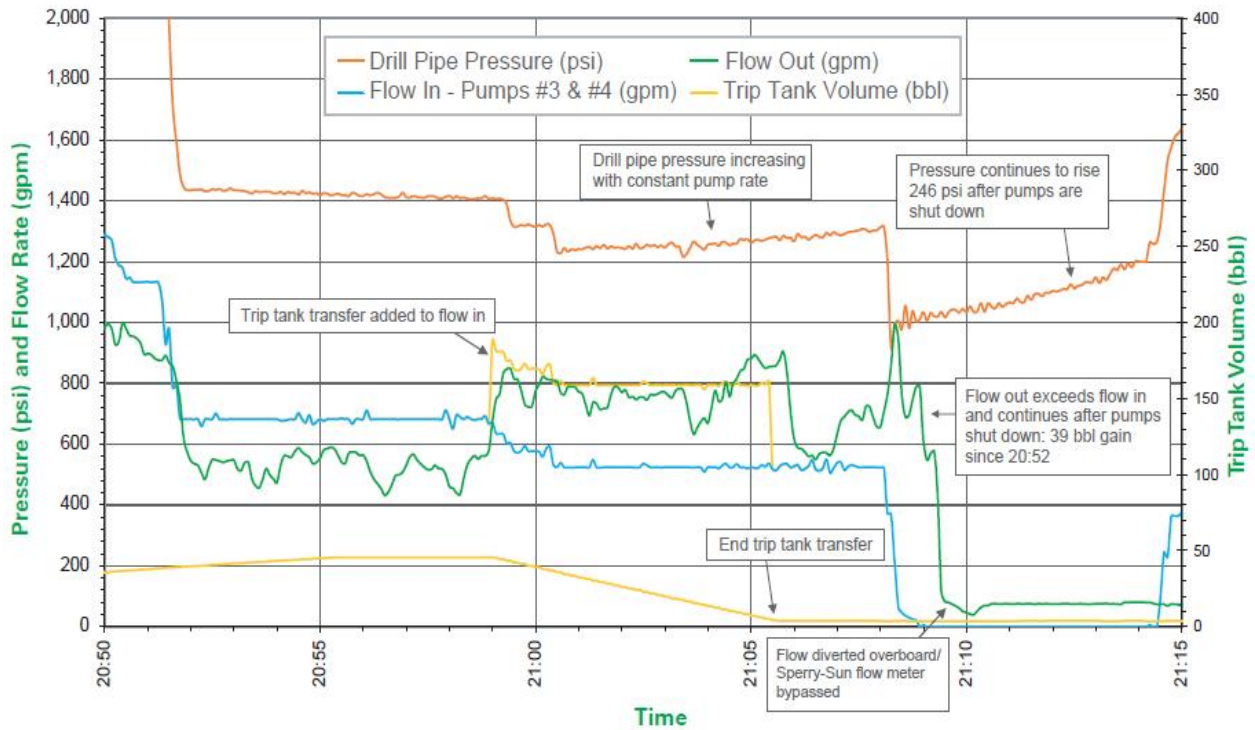
Figure 1.23 – Flow indication graph showing anomalies (real-time data).¹⁰¹

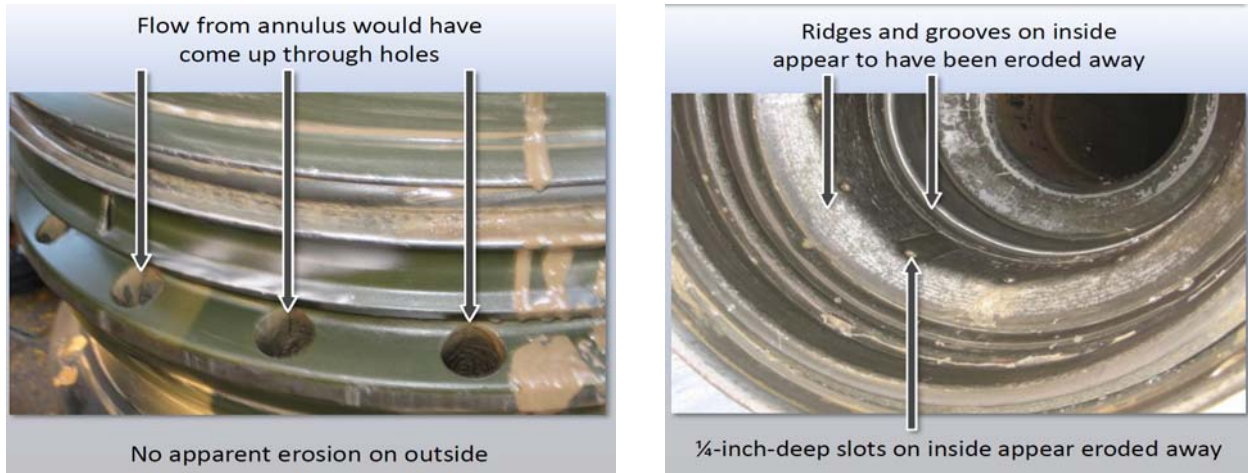
Figure 2.3 – Photographs of exterior (left) and interior (right) of 9⁷/₈ in Hangar Seal Assembly.¹⁹

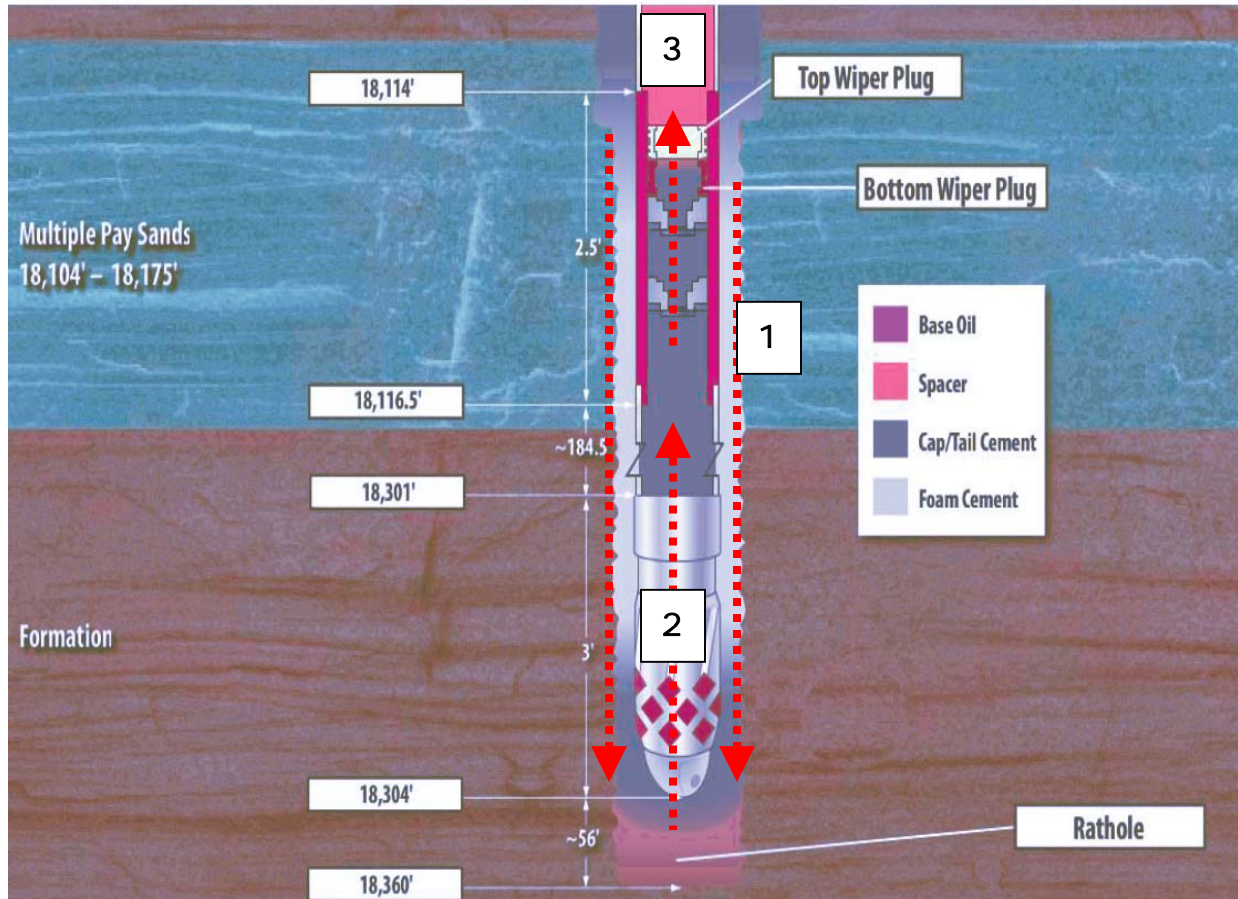
Figure 2.4 – Shoe Track hydrocarbon penetration paths.²⁴

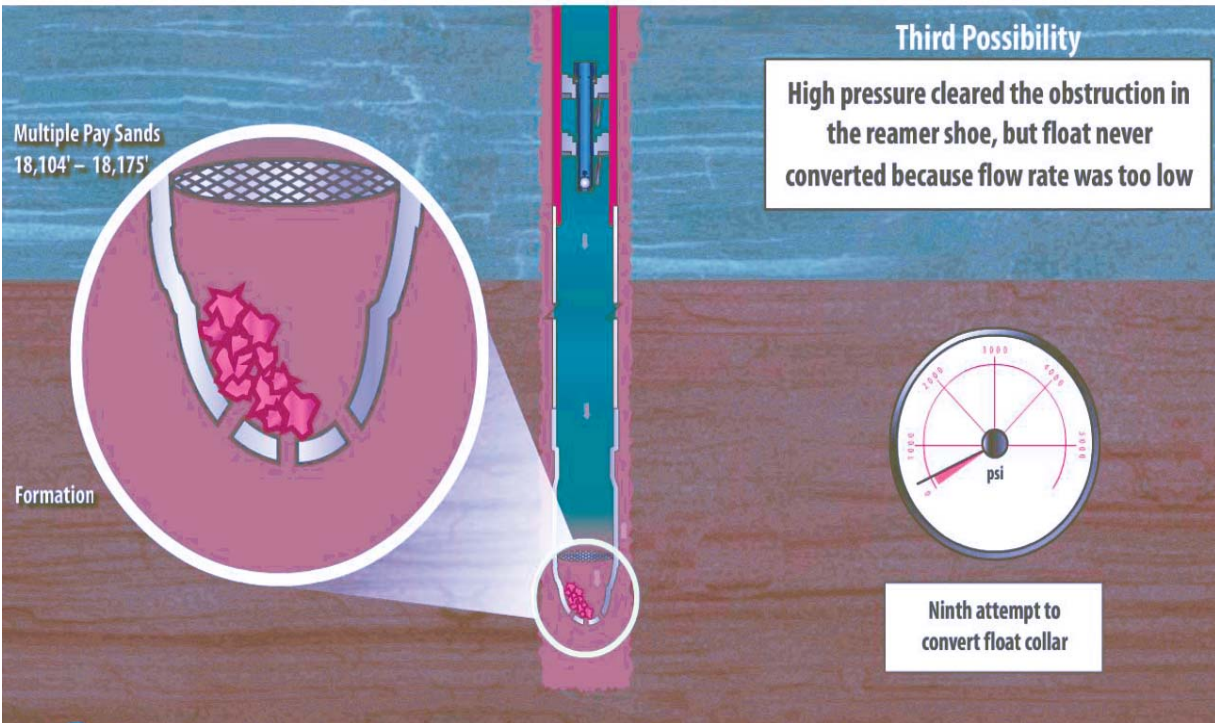
As summarized in Chapter 1, it took nine tries to convert the float collar. There were anomalous flow-pressure conditions during and following the conversion attempts. Analysis of the available information indicates it is plausible that the float collar failed to convert (Figure 2.6). In this condition, hydrocarbons would be able to migrate through the flow tube and open back-flow valves and into the open well bore above. The BP investigations identified three failure modes for the double-valve float collar in the shoe track: 1) it was damaged by the high load conditions required to establish circulation, 2) it failed to convert due to insufficient flow rate, and 3) the check valves failed to seal. The BP analyses were not able to determine which of these failure modes occurred. Similar conclusions were reached by the National Commission. Consequently, as for the annulus and shoe track cement barriers, there are multiple plausible failure modes that can explain how hydrocarbons were able to breach the float collar assembly.

Figure 2.6 – Float collar conversion failure.²⁶

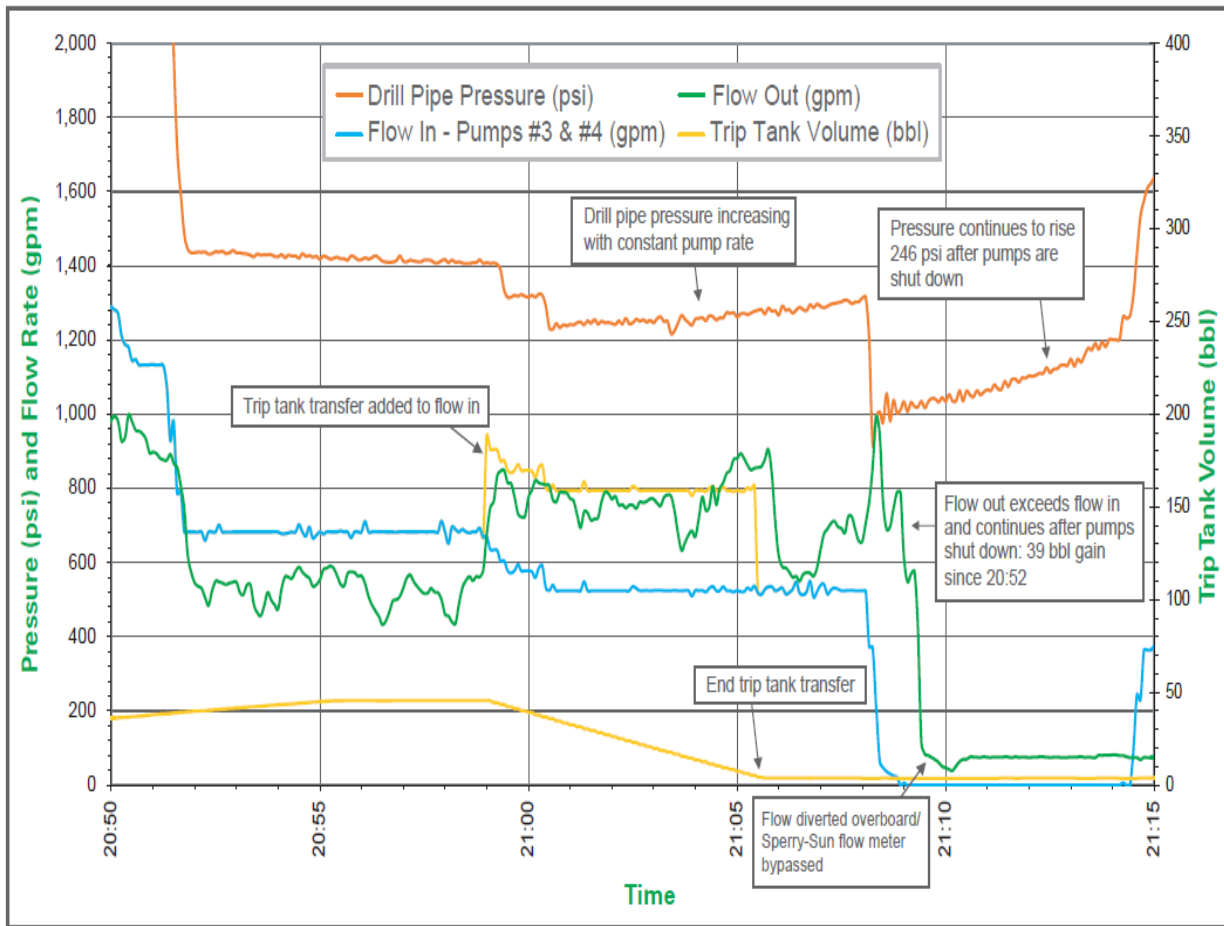
Figure 2.8 – Real-Time data (April 20, 2010) during last portion of mud transfer operations.³⁵

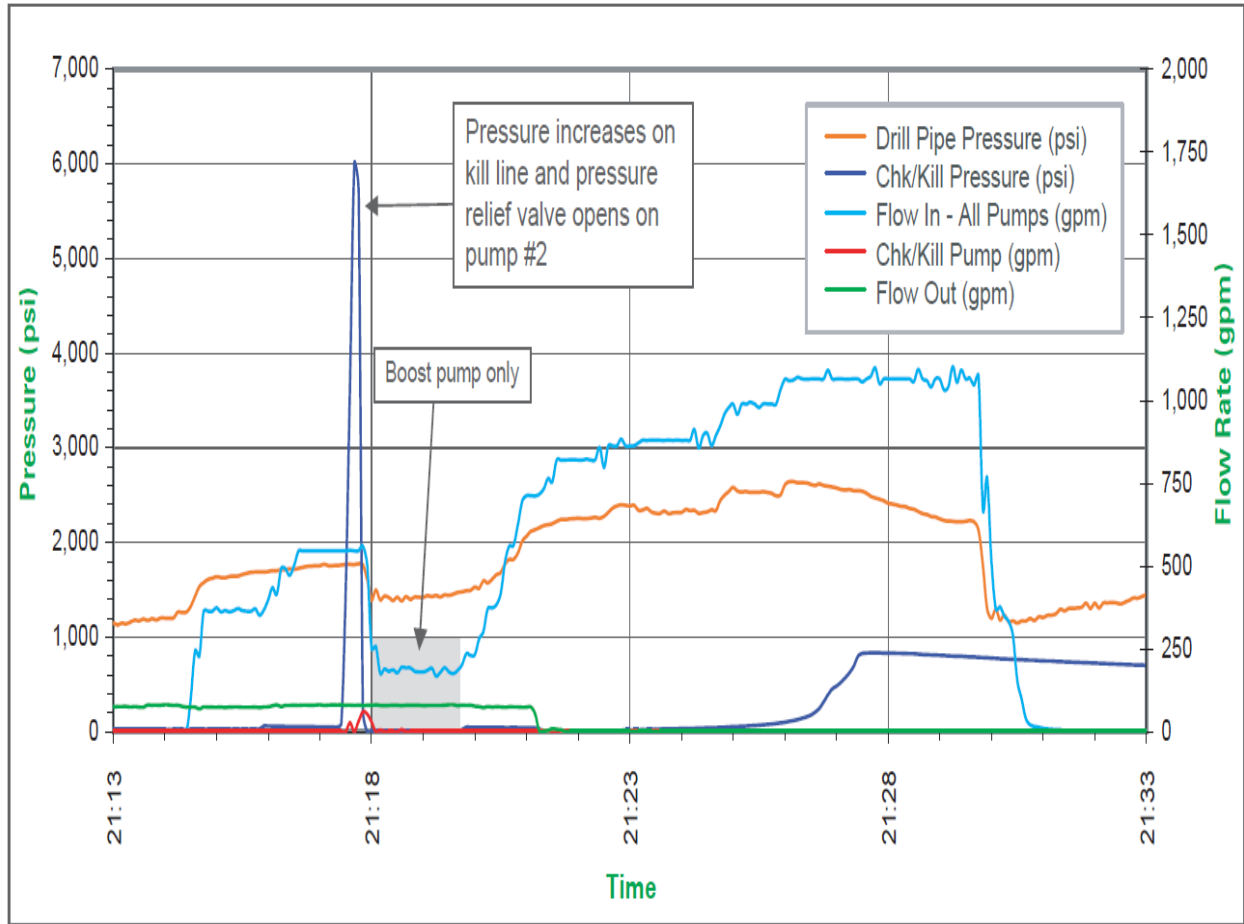
Figure 2.9 – Real-Time data (April 20, 2010) during overboard discharge operations.³⁷

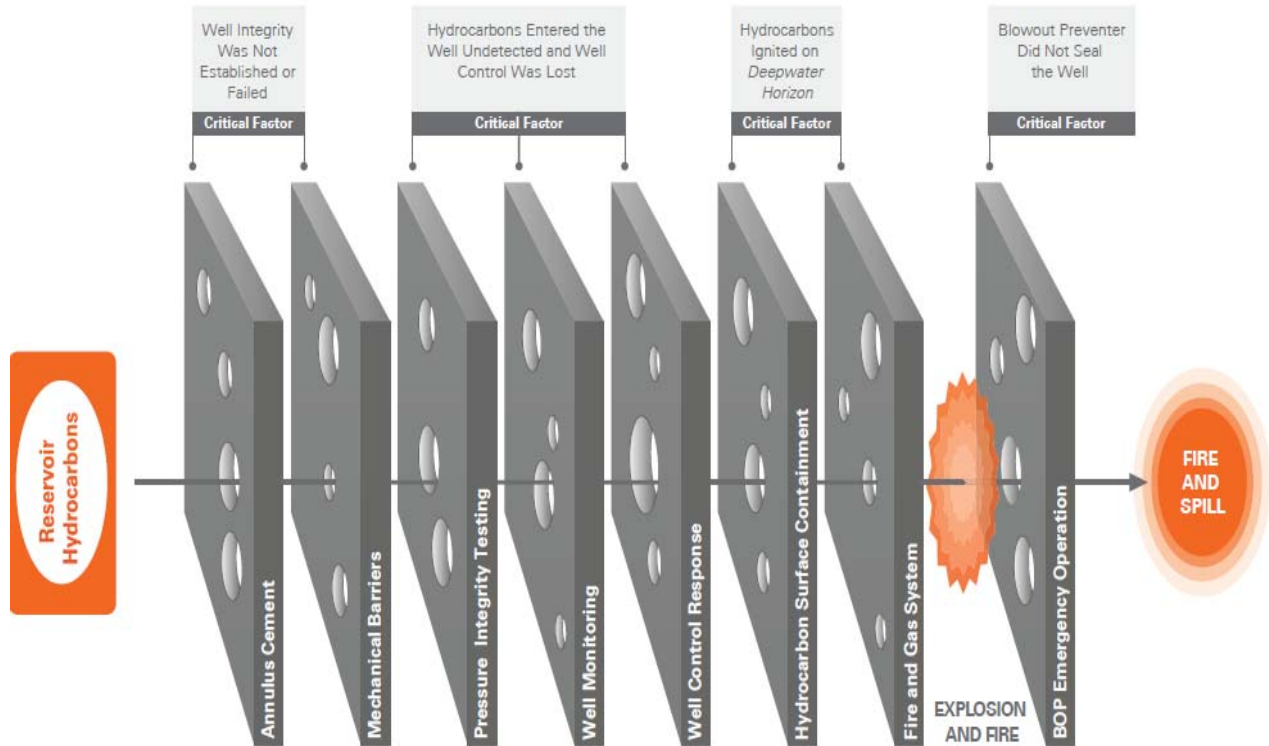
Figure 3.2 – BP’s analysis of defensive barrier penetration leading to the Macondo blowout.⁷
