Macondo Well
Deepwater Horizon
Blowout

LESSONS FOR IMPROVING
OFFSHORE DRILLING SAFETY

Committee on the Analysis of Causes of the
Deepwater Horizon Explosion, Fire, and Oil Spill to
Identify Measures to Prevent Similar Accidents in the Future

NATIONAL ACADEMY OF ENGINEERING AND
NATIONAL RESEARCH COUNCIL
OF THE NATIONAL ACADEMIES

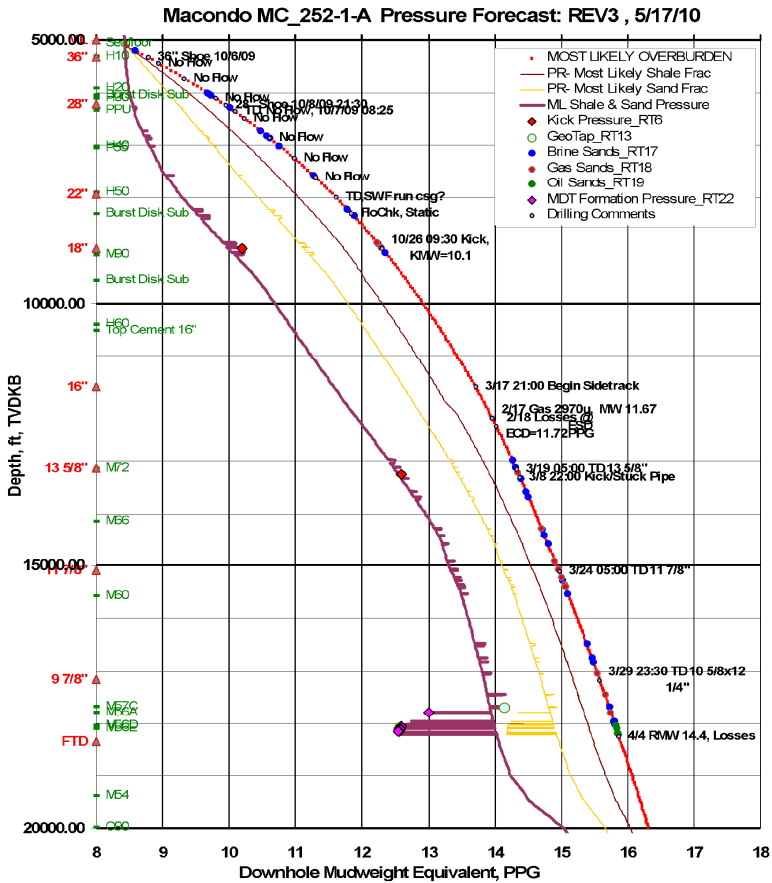
2. In the course of drilling at 13,250 feet, a kick occurred, and the lower annular blowout preventer (BOP) was closed in response. During well control operations, the drill string became stuck and was severed at 12,147 feet. The drill string and hole below 12,147 feet were abandoned, and subsequent well drilling deviated slightly to go around the abandoned materials left in the original hole. The $13\frac{5}{8}$ -inch liner was run at 13,145 feet, which was shallower than planned, to allow the well to be drilled safely past the higher-pressure reservoir that had been encountered. The $11\frac{7}{8}$ -inch liner was used at 15,103 feet to seal the reservoir and allow for the use of higher mud weights than had been anticipated. Mud weight was to be kept between the curves for pore pressure and fracture pressure, as shown in Figure 2-3.

FIGURE 2-3 The four curves (moving from right to left) represent overburden stress, fracture gradients in the shale and sands, and pressure in the Macondo well. Depth and diameter values on the y-axis correspond to the final well bore architecture shown in Figure 2-2. The equivalent mud weight (EMW), expressed in pounds per gallon (ppg), must be higher than the pore pressure to avoid flow from the well and lower than the fracture gradient to prevent accidental hydraulic fracturing. Note the small separation between the values at depths below 18,000 feet. Source: BP unpublished report, July 26, 2010.³ Reprinted with permission, BP.

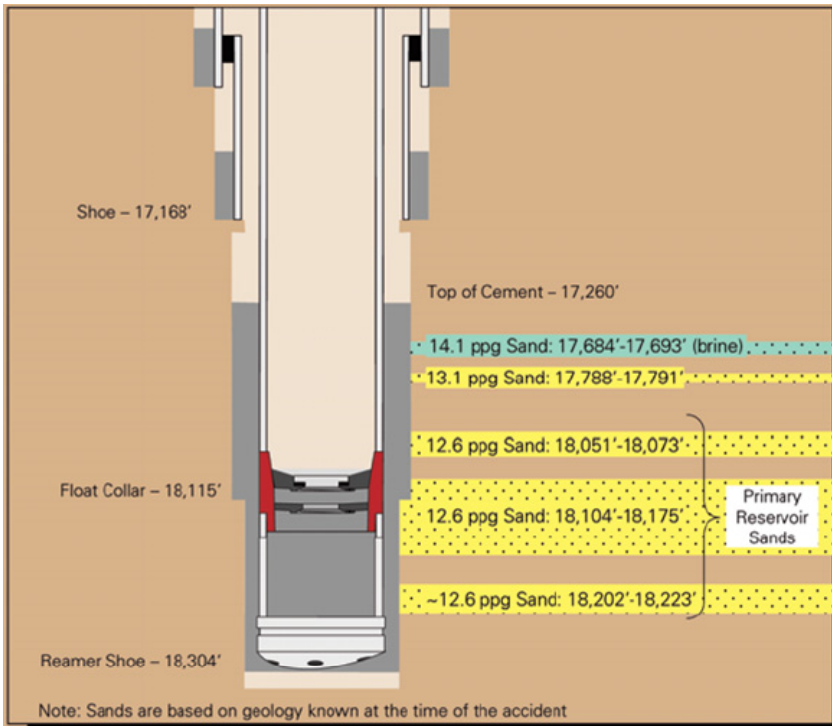
tion report, the well analysis indicated that there were in fact several reservoirs open in the wellbore with decreasing pore pressure with depth, as shown in Figure 2-4. The hydrocarbon reservoirs had pore pressures equivalent to a range of 12.6 to 13.1 ppg. A reservoir containing salt water that had a pore pressure equivalent to 14.1 ppg was also exposed in the wellbore. As discussed below, the difference between the mud weight needed to prevent flow of salt water and the mud weight above which reservoir fracture could occur was only 0.2 ppg. Recent reports in the press have indicated that a thin gas sand was present above the salt water bearing zone shown in Figure 2-4 and have questioned the possible contribution of this sand to the blowout. The committee has seen no evidence indicating that flow occurred upwards in the annulus between the production casing and the reservoirs (see discussion below). Also, the presence of the high-pressure salt water sand created the same completion problem referenced above as would have been created by the presence of a high-pressure gas sand. Therefore, the presence or absence of the gas sand is expected to have had no material effect on the cause of the blowout.

FIGURE 2-4 Variation of pore pressure in the open hole section of the Macondo well expressed in pounds per gallon. Source: BP 2010, p. 54. Reprinted with permission; copyright 2010, BP.

To continue drilling to the planned final depth of 19,650 feet, the reservoirs that had been discovered with decreasing pore and fracture pressures with depth (Figure 2-4) were to be sealed with the 9 $\frac{7}{8}$ - × 7-inch combination casing string and cement. However, because the hole diameter that could be drilled below the 7-inch casing was considered too small to be practical, the well was terminated at 18,360 feet.

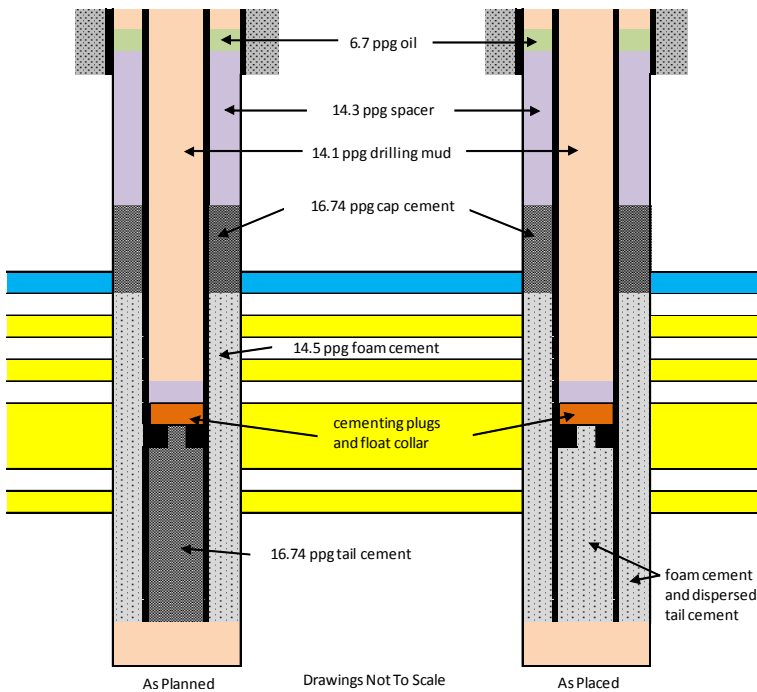
FIGURE 2-5 Planned cement location and likely cement location after pumping. Source: Committee.

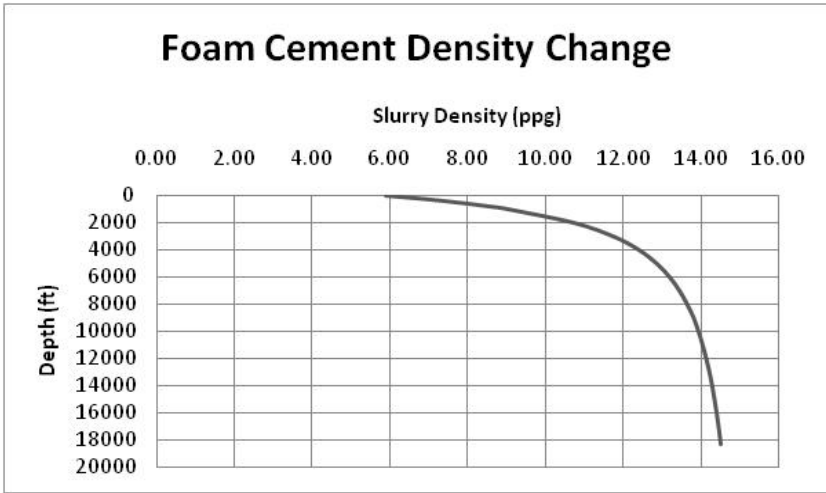
FIGURE 2-6 Calculated foam density versus depth during pumping. Source: Committee.

Once mixed, the foam was immediately pumped into the well, where pressure and temperature increased with depth, changing the foam quality and slurry density all the while. The shear associated with fluid movement down the inside of the pipe would act to break up large bubbles, which immediately reform as smaller bubbles so long as agitation is taking place.

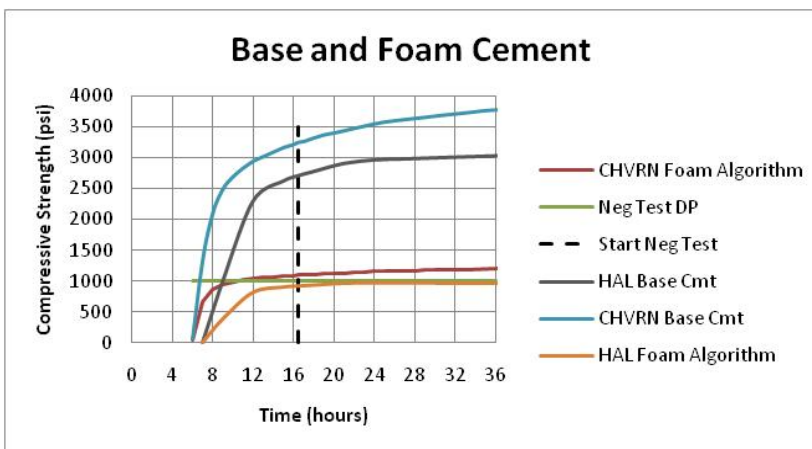
FIGURE 2-7 Uncontaminated cement compressive strength tests (DP = differential pressure). Source: Committee.

The curves for the two foamed cements are not from direct measurement but assume that the foamed cement compressive strength is reduced according to the foam protocol used in the Chevron test software (by a factor of approximately 35 percent).

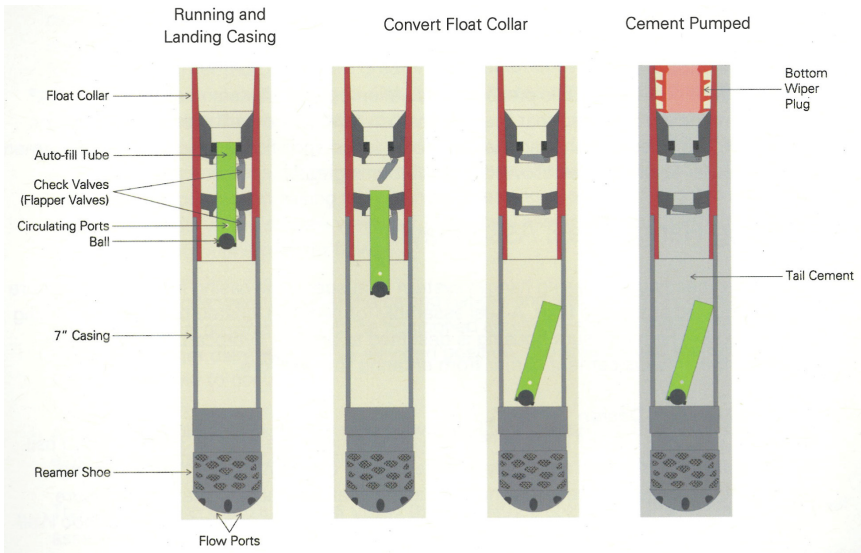
FIGURE 2-8 Float collar with flapper valves and differential fill tube. Source: BP 2010, p. 71. Reprinted with permission; copyright 2010, BP.

Once the casing was in place in the Macondo well, initial circulation could not be established until 3,142 psi of pump pressure was applied. This suggests that the shoe track was plugged with foreign material when it was run into the well. The practice of allowing mud to fill the casing by flowing up through the differential fill tube is a time-saving step that would not be needed if the casing were filled with mud from the top as it is run, a much slower process but one that reduces the possibility of debris entering the casing.

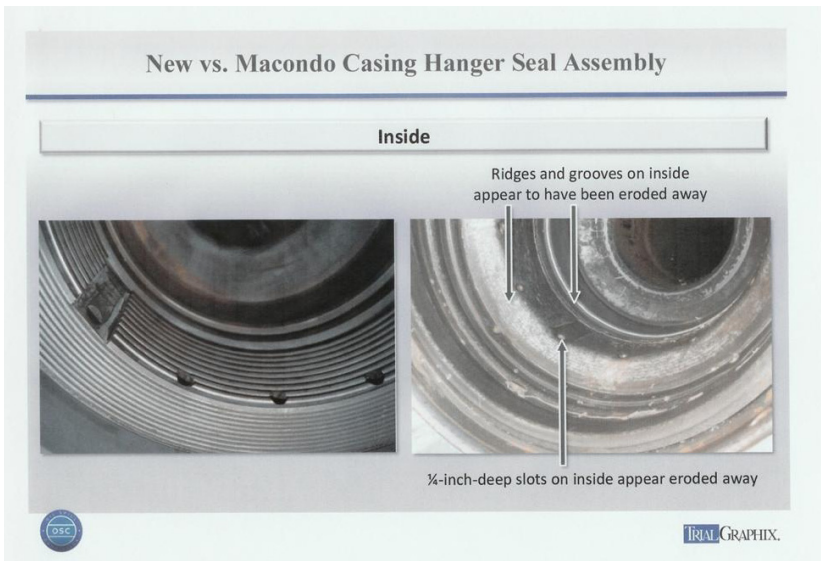
FIGURE 2-9 View inside casing hanger. Source: Presidential Commission 2010, Slide 118.

This type of circulation was not done completely at the Macondo well to reduce the possibility of exceeding the fracture pressure because of unforeseen pressure surges. This decision by BP also cut down on the time spent circulating. Failure to perform the minimum circulation could leave debris inside the casing or annulus that may plug it. Any hydrocarbons in the annulus may result in a well control problem.

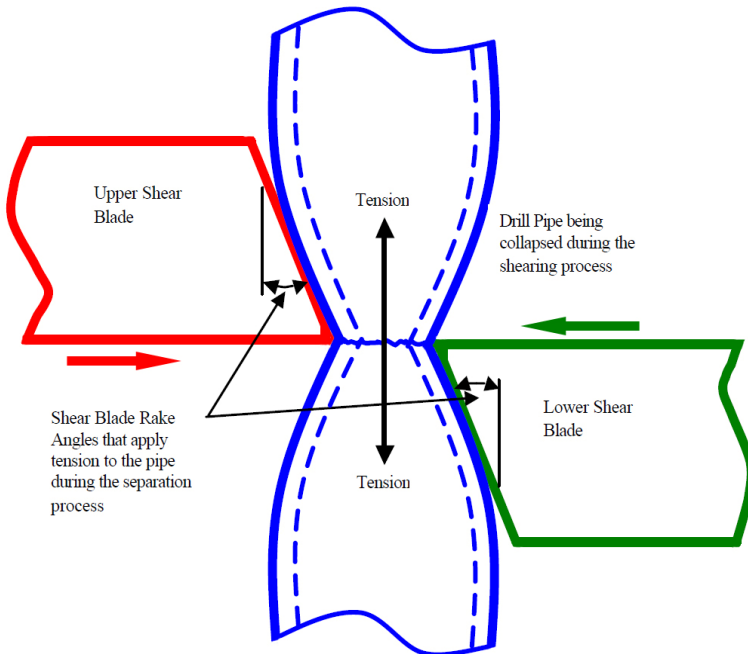
FIGURE 3-3 Upper and lower shear blades crushing the drill pipe and beginning the shearing (or breaking) operation. Source: West Engineering Services, Inc. 2004, p. 2-2. Reprinted with permission; copyright 2004, West Engineering Services, Inc.

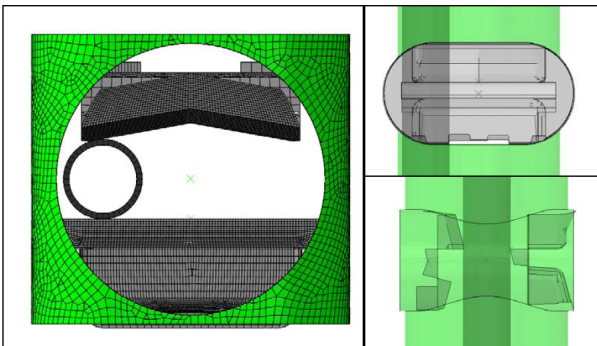
FIGURE 3-5 Finite element analysis model of BSR blade surfaces and off-center drill pipe. Source: DNV 2011b, p. 15. Reprinted with permission; copyright 2011, DNV.

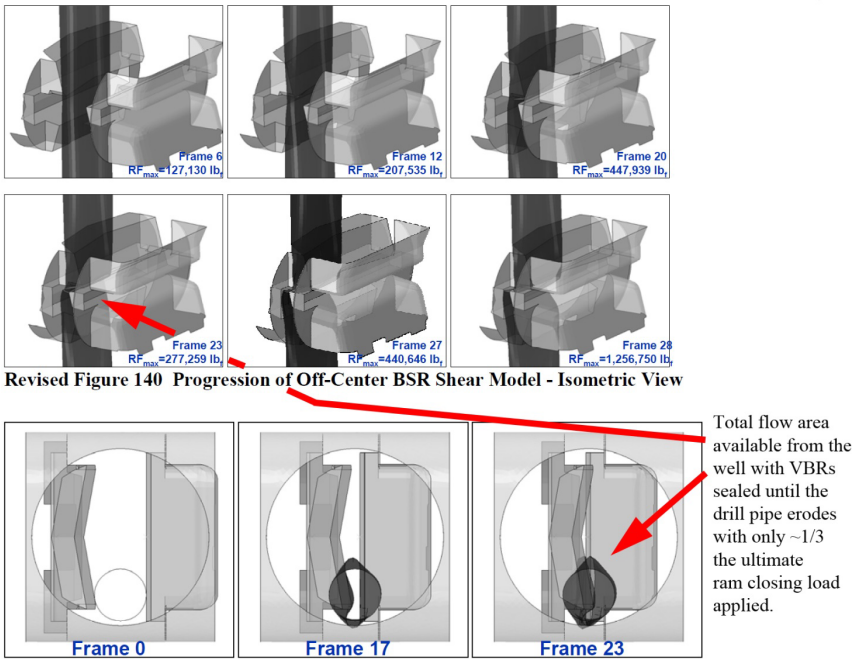
FIGURE 3-6 Progression of off-center BSR shear model, isometric view (*top*) and top view showing deformation of drill pipe outside of shearing blade surfaces (*bottom*). Source: DNV 2011b, p. 17. Reprinted with permission; copyright 2011, DNV.
