Historic Floors

Their Care and Conservation

— JANE FAWCETT —

*Published in association
with ICOMOS UK
(International Council on
Monuments and Sites)*

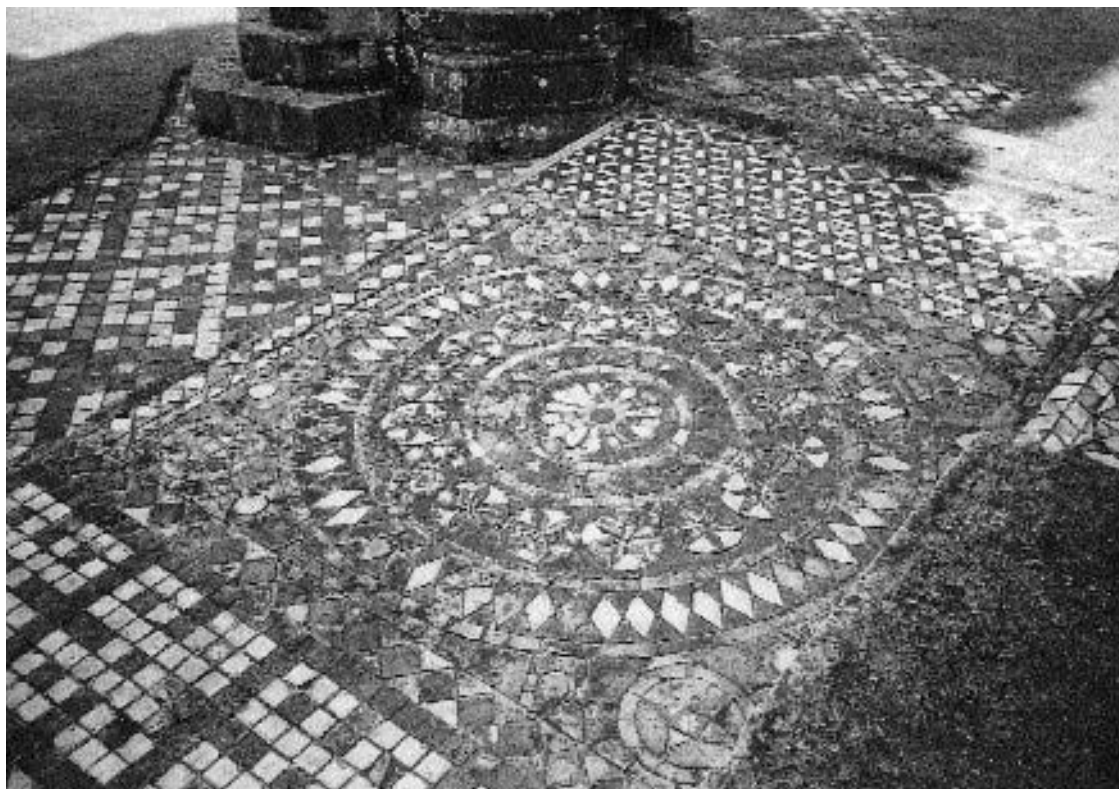
Figure 1.1 Byland Abbey, Yorkshire. Thirteenth-century *opus sectile* tile mosaics containing 900 tesserae, south transept chapel (Photograph, Jane Fawcett)

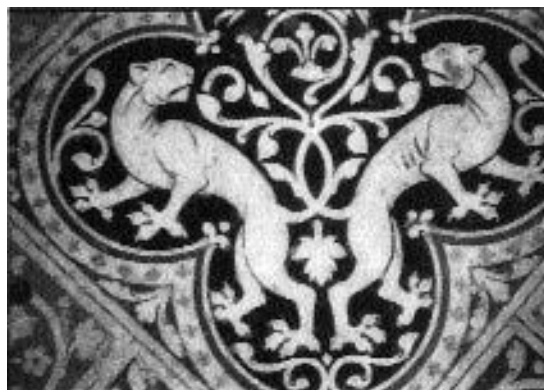
Figure 1.5 Sainte Chapelle, Paris. Nineteenth-century copy of thirteenth-century tile (Photograph, Dombau Archiv, Cologne)

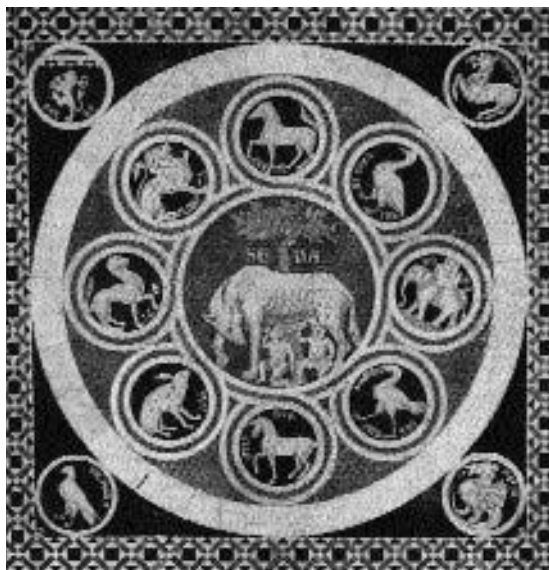
Figure 1.11 Siena Cathedral, Tuscany, Italy. 1284–1296, by Giovanni Pisano has one of the richest Renaissance floors in Italy, constructed between 1349 and 1547. Artists include Pinturiccio and Beccafumi. Subjects range from biblical to allegorical themes. Some sgraffito panels. Above, Romulus and Remus, restored by Leopold Maccari in the nineteenth century (Photograph, Dombau archiv, Cologne)

Santa Maria della Salute, Venice, by Longhena, 1630–1687, has a fine marble perspective pavement under the dome (see Plate 15). Siena Cathedral, Tuscany, 1284–1296, by Giovanni Pisano, has some of the finest Renaissance floors in Italy, by artists including Pinturiccio and Beccafumi. It was constructed between 1349 and 1547 (see Figure 1.11).

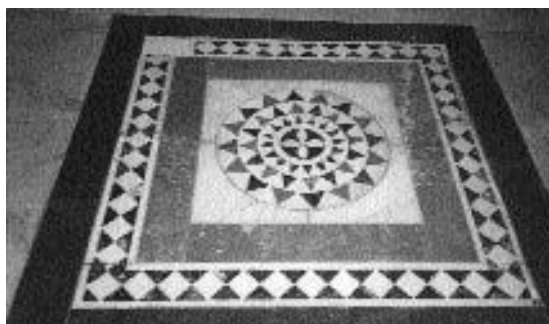
Figure 1.12 Lucca Cathedral, Tuscany, Italy. Fifteenth-century marble pavement (Photograph, Jane Fawcett)

Another fine marble pavement of the fifteenth century can be found in Lucca Cathedral, Tuscany (see Figure 1.12). It contains panels of geometric patterns, including fictive cubes.

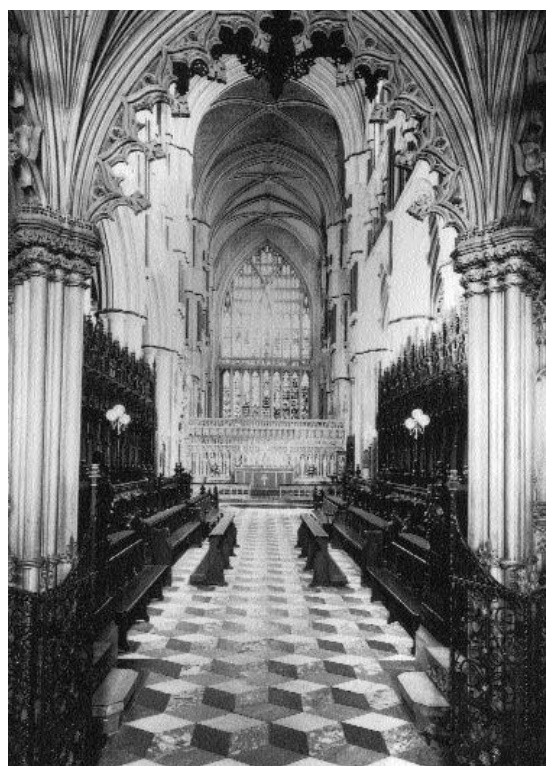
Figure 1.17 Beverley Minster Choir showing Nicholas Hawksmoor's fine pavement of 1716–1720 (Photograph, Pitkin Guides)

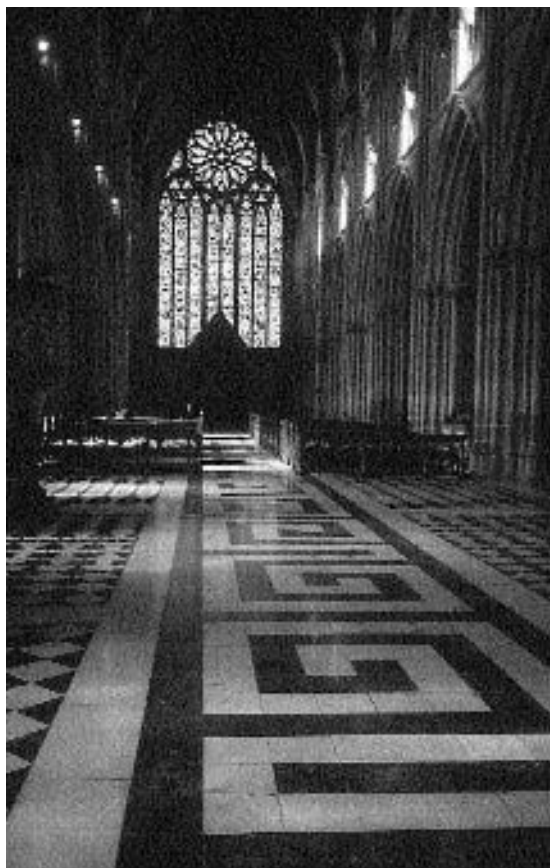
Figure 1.18 Worcester Cathedral, Hereford and Worcester. Marble pavement, c.1874, designed by Sir George Gilbert Scott. (Photograph, Jane Fawcett)

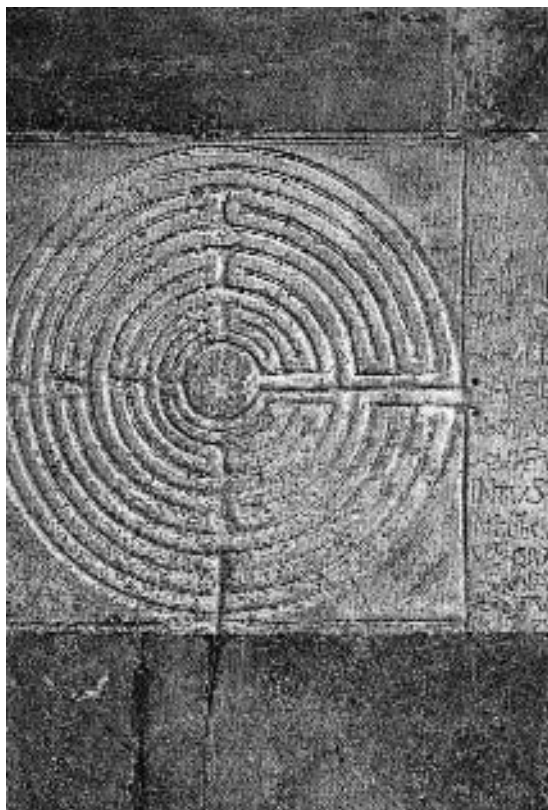
Figure 1.19a Hall of San Martino, the Roman labyrinth, Lucca, Italy

To the Greco-Roman world the labyrinth represented the unrolling of life towards the final exit into the kingdom of death. This pagan symbol was adapted by Christianity, to represent the course of life leading to paradise. The history of the labyrinth is obscure, and it is not known how the Cretan legend from Knossos became adapted to Christian use. It was first recorded on a Cretan coin of 67 BC. An ancient slate tablet found at Pylos, Greece, was engraved with a similar design. A labyrinth was found in the ruins of Pompeii, with an inscription in Latin. There are several at the Roman site of Italica, near Seville, and one on the Roman pavement at Cormerod, Switzerland. At Lucca, in Tuscany, the Hall of San Martino contains a remarkably intact Roman carving of a labyrinth (Figure 1.19a).

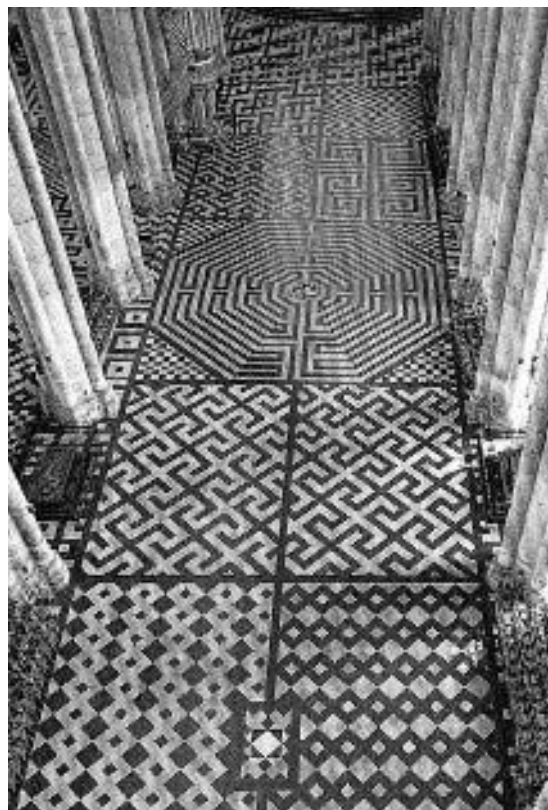
Figure 1.19b Amiens Cathedral, Northern France. Fine marble geometric pavement, containing a representation of a labyrinth, destroyed in 1820 and reinstated in 1894 (By kind permission of the Direction Régionale des Affaires Culturelles de Picardie)

In France, the cathedrals of Sens, Arras, Reims and Auxerre had stone labyrinths in the nave of similar date and design to Chartres. They were destroyed during the Revolution. In 1820 the octagonal labyrinth in the nave at Amiens was destroyed, but reinstated in 1894 (Figure 1.19b). The octagonal labyrinth at Reims, destroyed in 1778, was reinstated more recently (Villette, 1984). All were intended, as with the Cosmati pavements, to lead the eye towards the high altar.

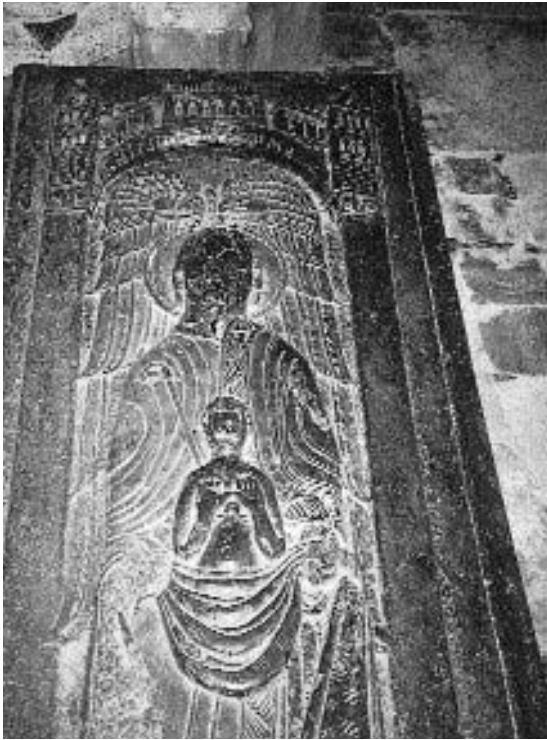
Figure 1.20 Ely Cathedral, Cambridgeshire. North choir aisle. Tournai marble slab. Possibly Bishop Nigellus, d.1169 (Photograph, Jane Fawcett)

The ancestry of ledger stones can be traced back to the late eleventh century, when carved stone coffin lids were sunk into the floor. These were simply decorated with a foliate cross, with a sword for a man at arms, an anvil for a blacksmith or a sickle for a farmer. During the twelfth century incised coffin shaped slabs in Tournai or Purbeck marble developed, and a few have survived. One of the earliest Tournai slabs is to Bishop Nigellus, d.1169, at Ely Cathedral. An angel is depicted carrying his soul to heaven (Figure 1.20).

The north choir aisle contains the Tournai marble tomb slab, possibly to Bishop Nigellus, 1169, one of the first effigial tomb slabs in Britain (Figure 1.20), and many ancient paving slabs and ledger stones. The south choir aisle has a particularly fine sequence of indents and brasses, recently surveyed by the Monumental Brass Society, and an immense black armorial ledger to Bishop Petrus. Brasses to Bishop Goodrich, d.1554, and Dean Humphrey Tyndall, d.1614, are protected by rails. Both ledgers and indents are deteriorating. The paving to both choir aisles has recently been repointed and some badly worn York stone has been replaced.

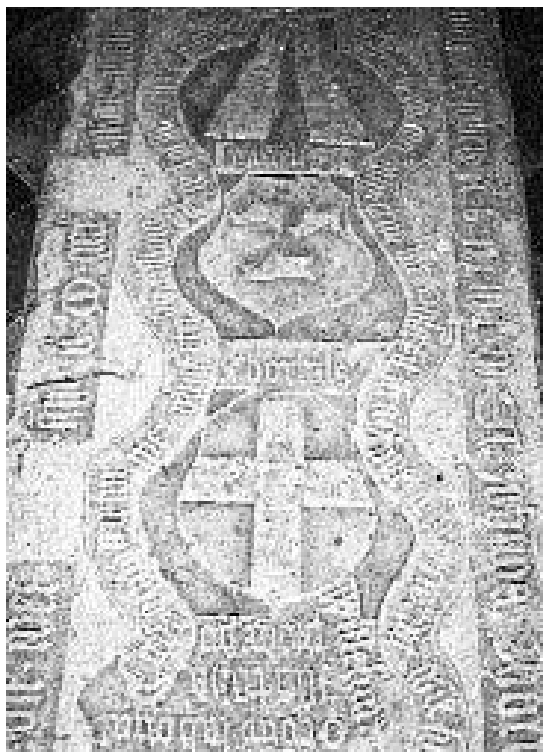
Figure 1.24 Kilkeny Cathedral, Ireland. Ledger stone to James Purcell, d.1552, and Johanna Shortals. Black letter inscription. Sixteenth century (Photograph, Jane Fawcett)

Kilkenny Cathedral, Ireland, contains the most important collection of medieval floor monuments in the country (Figure 1.24). A number of them are inscribed with the tools of the trades of the deceased. These include Donatus Brin, a carpenter, showing adzes, an auger and carpenter's square, William

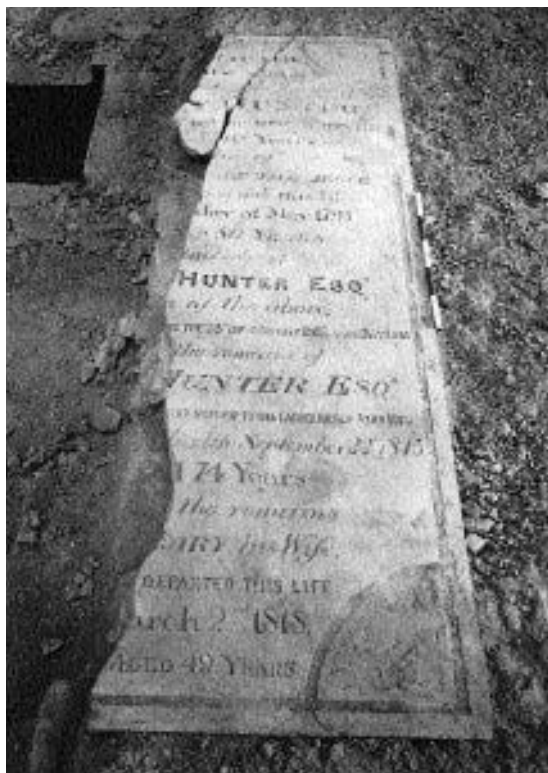
Figure 1.25 Pershore Abbey, Hereford and Worcester. Ledger stone, damaged during replacement of steps in c.1860 and uncovered during excavations, 1995–1996 (Photograph, Kevin Blockley)

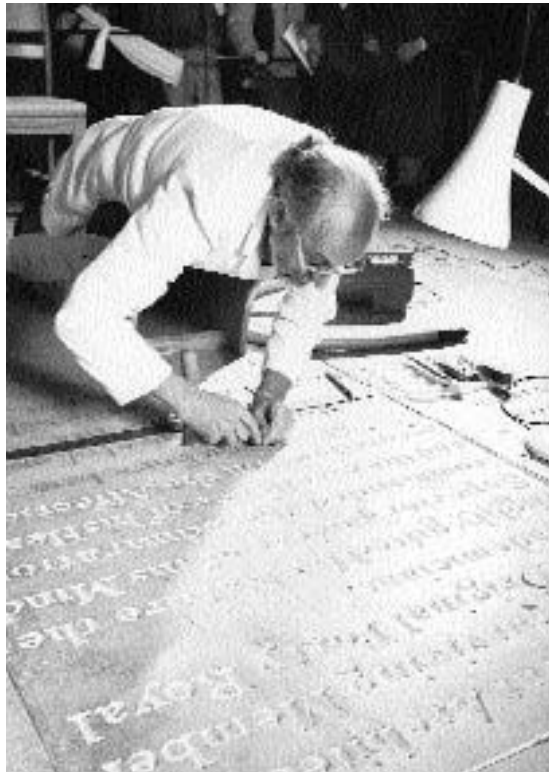
Figure 1.28 St Paul's Cathedral, London. 1675–1711. Sir Christopher Wren. Crypt. Tony Webb, Master Carver re-entering inscription to George Dance, d.1825, on worn ledger stone, in 1995 (Photograph Philip Way)

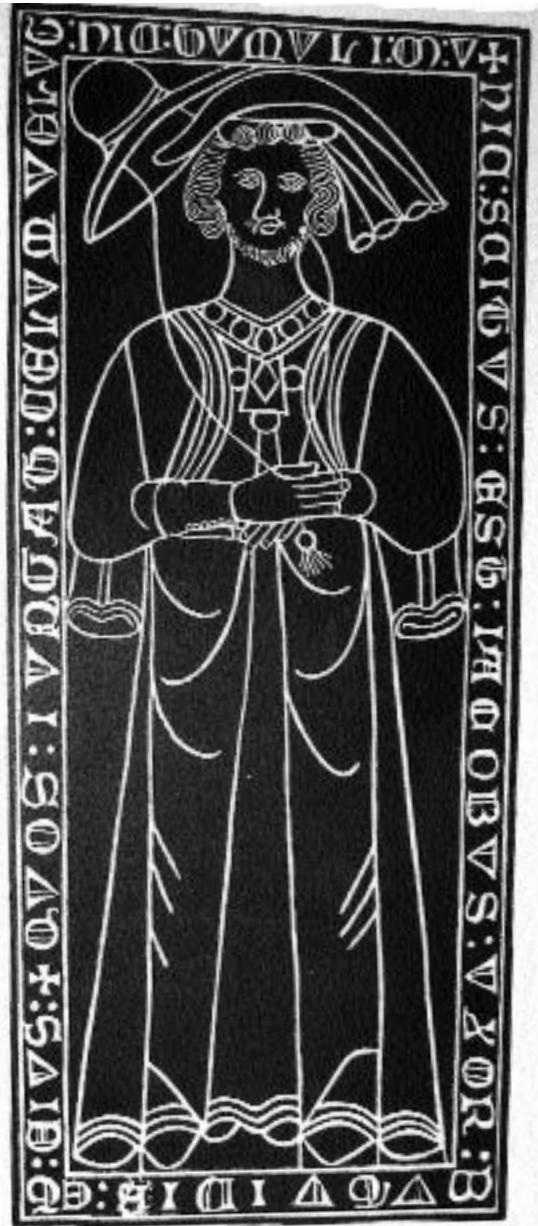
Figure 1.30a Stenkyrka, Gotland, Sweden. Incised slab to Jacobus et Butuidus d.c.1500. The slab proved too short, so the hat was placed in the corner. Stenkyrka, or stone church, c.1030, was the oldest of ninety-three churches on Gotland, all in use in 1891 (From *Incised Slabs on the Continent of Europe*, 1891, by Rev. Greeny. Published privately. Reproduced by courtesy of Society of Antiquaries, London)

On the Continent, there is a rich heritage of ledger stones, effigial slabs and incised slabs, with many regional variations. Ledgers in France, Holland and Belgium resemble those in the UK. In Italy, Germany and Austria, however, ledgers often contain a lifesize effigy in high relief. The inscribed ledger slabs recorded by the Reverend Creeny in 1891 document a remarkably wide range of styles, but many have now disappeared (Figures 1.30a and b).

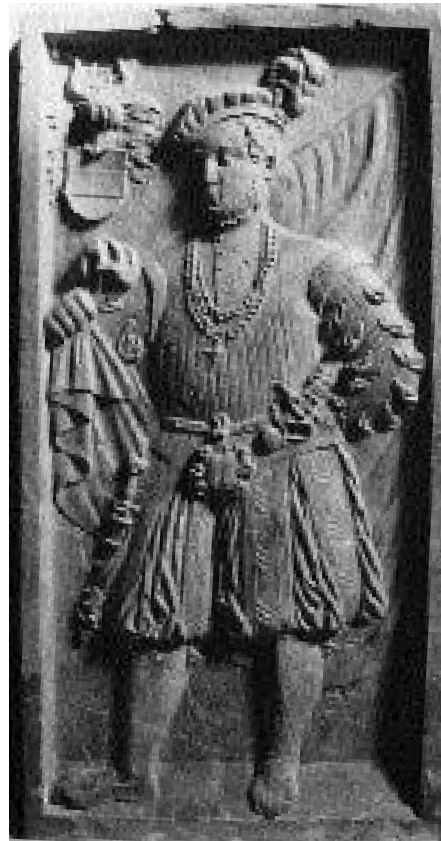
Figure 1.30b St Stefan's Cathedral, Vienna. Fifteenth-century relief in the north choir aisles, taken from the Old Churchyard (Photograph, Jane Fawcett)

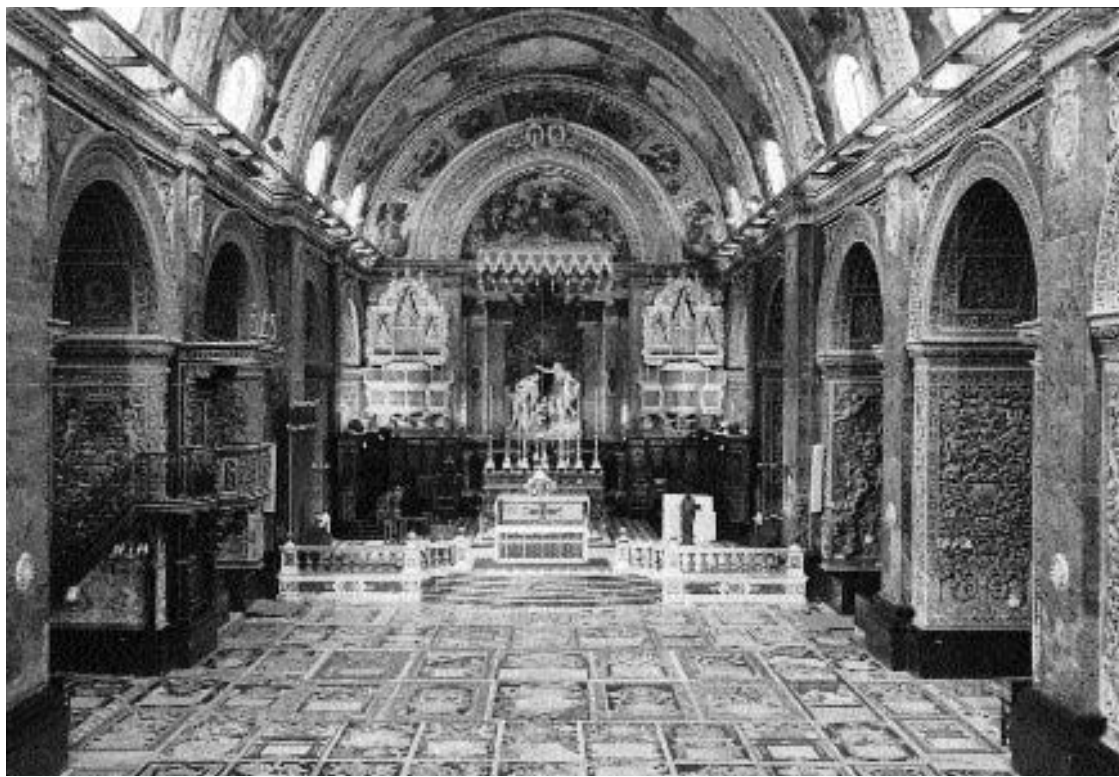
Figure 1.31 St John's Cathedral, Valetta, Malta. Floor entirely covered with ledger stones in coloured marble, mostly dating from the seventeenth century, many to Grand Masters of the Order of the Knights of St John. These fine ledgers are being damaged by stiletto heels, and a conservation programme is in progress (Photograph, Mario Mintoff, Photocity, Valletta)

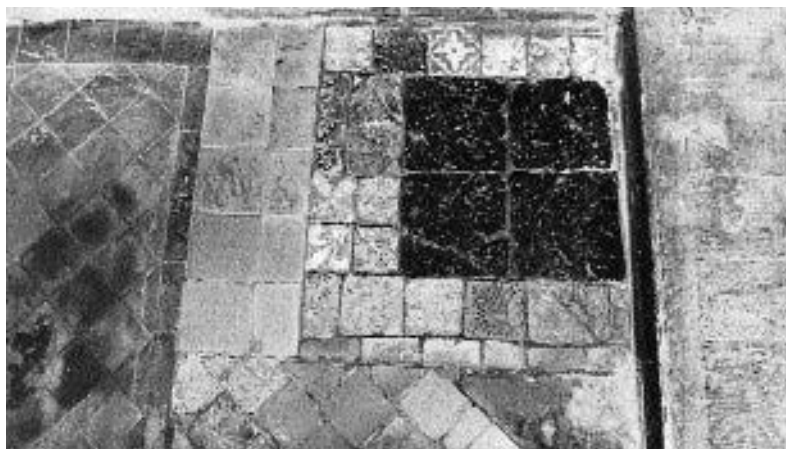
Figure 2.1 Lichfield Cathedral. Scott's 'museum' of tiles on the floor of the Consistory Court, 1861. Various thirteenth- and fourteenth-century designs surround four pieces of cannel coal which had been used for black and white paving in the choir in the late seventeenth century (Photograph, Warwick Rodwell)

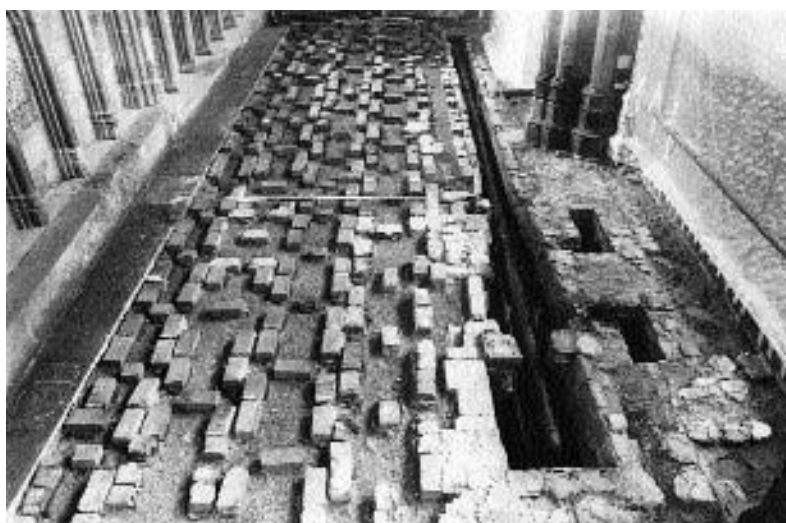
Figure 2.2 Lichfield Cathedral. Unusual brick sub-structure to support Scott's limestone paving of 1860 in the north choir aisle (Photograph, Warwick Rodwell)

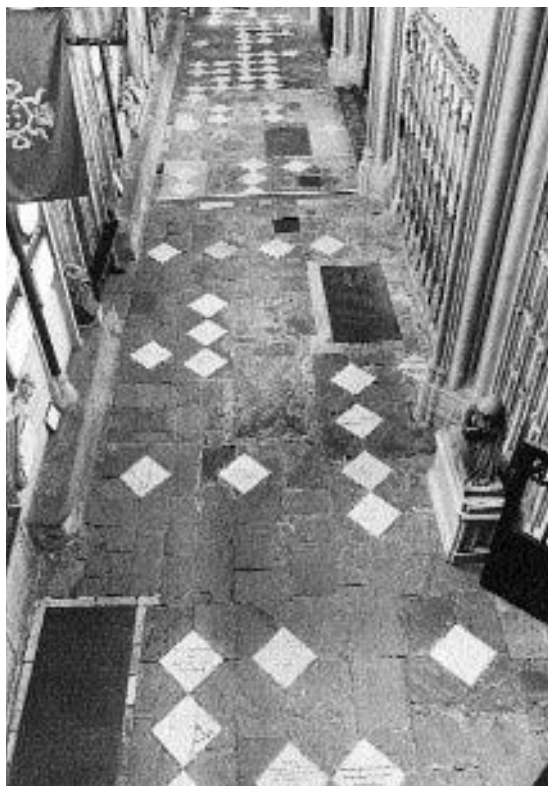
Figure 2.4 Bristol Cathedral. View of South Choir aisle floor looking west, with bay 5 in the foreground (Photograph, Warwick Rodwell)

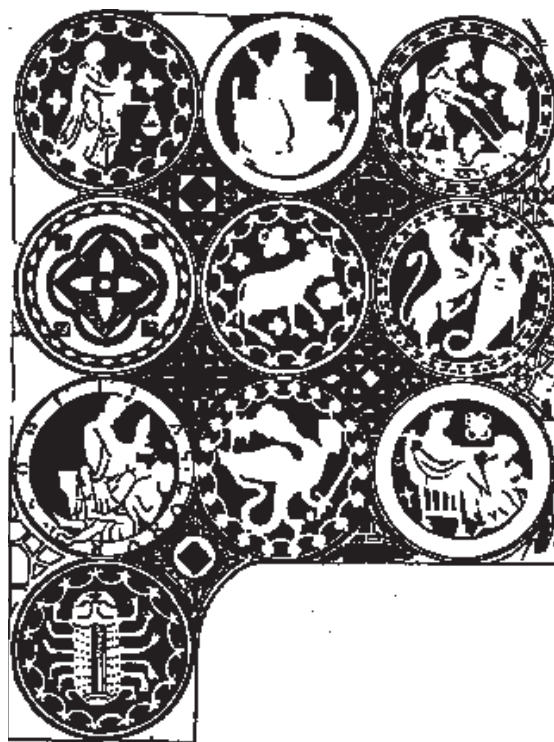
Figure 3.2 Canterbury Cathedral. Roundels from the *Opus Alexandrinum* pavement. The drawing shows the amount of wear on the tile, and was made in c. 1858.

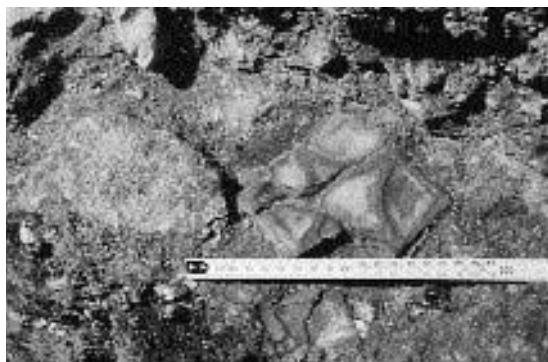
Figure 4.1 Late Anglo-Saxon relief-decorated floor tile, in a layer of Norman demolition rubble (Photograph, Canterbury Archaeological Trust)

No floors were located inside the Anglo-Saxon cathedral, although occasional finds recovered from the backfill of the 1787 grave-clearance pits provided information on the possible floors. Numerous fragments of *opus signinum* (mortar with crushed brick and tile added) were located. Some of these may have come from the underlying Romano-British buildings (one of which was located beneath the cathedral), but other pieces may have come from floors inside the Anglo-Saxon cathedral. An example of in situ Anglo-Saxon *opus signinum* was found lining the base and walls of a small Anglo-Saxon mausoleum, to the south of the Anglo-Saxon cathedral. Similar floors have been recorded in other Anglo-Saxon churches, for example the churches of St Peter & St Paul, at St Augustine's Abbey, Canterbury (Saunders, 1978, pp. 44–9), Reculver (Dowker, 1878), and Glastonbury (Radford, 1981, p. 117). A further important find was that of Late Anglo-Saxon relief-decorated floor tiles, two of which were located (one in a demolition layer of the Anglo-Saxon cathedral, the other in a 1787 clearance layer). The complete example, measuring 0.1 m², can be used to establish the design of the floor (Figure 4.1). Both tiles are heavily worn, suggesting they had been sited in prominent locations.

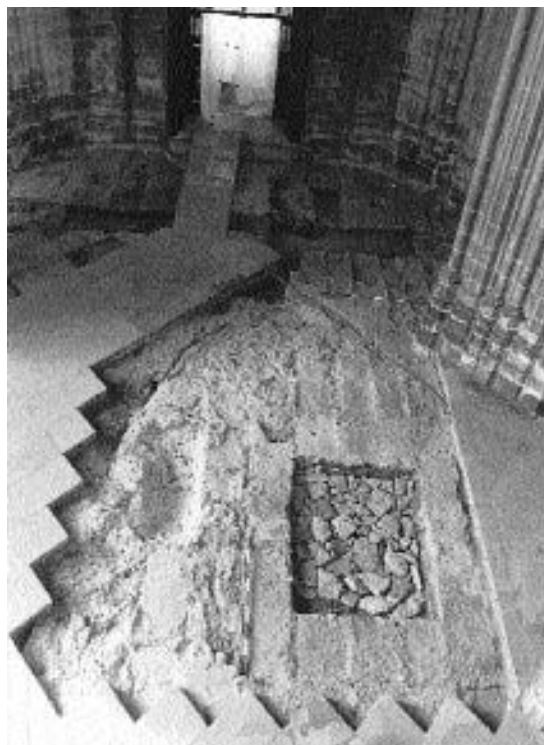
Figure 4.2 Norman floor-bedding mortar at the west end of the nave. Note the broken Norman floor slabs in the backfilled grave (removed during the 1787 reflooring), and the pattern of the 1787 floor slabs (scales 2 m) (Photograph, Canterbury Archaeological Trust)

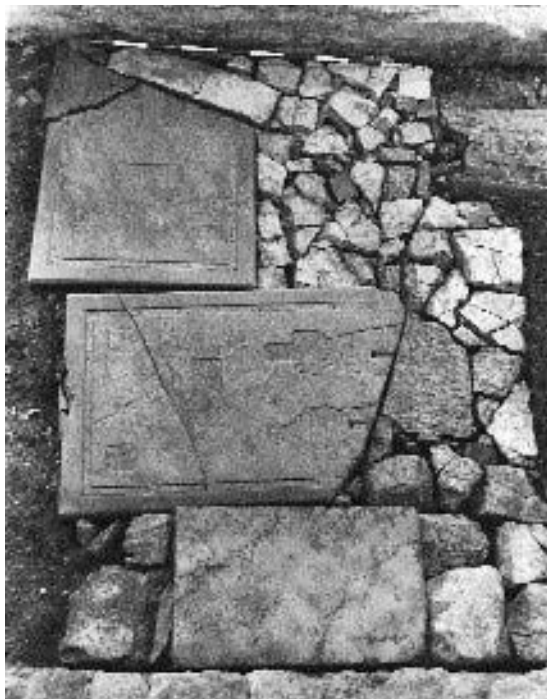
Figure 4.3 1787 backfill of cleared graves, showing ledger slab of Sir William Lovelace, and a complete Norman floor slab (foreground) (scale 2 m) (Photograph, Canterbury Archaeological Trust)

Although it is thought that this regular insertion of graves related largely to the pattern of the Norman floor slabs, many of the burials would have had a ledger or indent laid over them. A plan of the nave floor was drawn by White shortly before the 1787 reflooring, recording eighty-seven burials. Of these fifty-two have a name recorded on the plan, and a further thirteen are identified by means of a key; the latter were largely medieval stones with indents for brasses. It is evident, therefore, that this plan does not record all of the burials, but out of twenty-seven brick-lined and vaulted graves, twelve can be identified on the plan, and a further seven of those on the key identified. The clearance of the burials in 1787 had been thorough and the ledgers and indents broken up and used as hard-core in the backfill of the graves. One of the stones with indents for brass was retrieved in the excavation, broken into four pieces (Figure 4.3). This can be identified with certainty by comparison with burial number 8 on White's plan as the burial of Sir William Lovelace (d.1577). This shows the accuracy of the 1787 plan, particularly since all of the brasses had

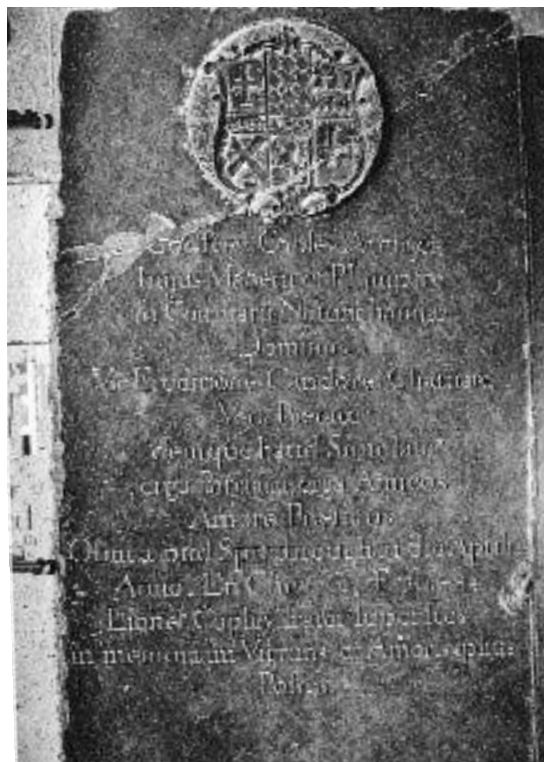
Figure 8.1 Floor slab commemorating Godfrey Copley Armiger d.1761, in chancel floor of St Mary's Church, Sprotborough, S. Yorkshire. Lit by electronic flash from the right of camera. Note use of graduated scale outside subject area (Photograph, RCHME Crown Copyright, 1995)

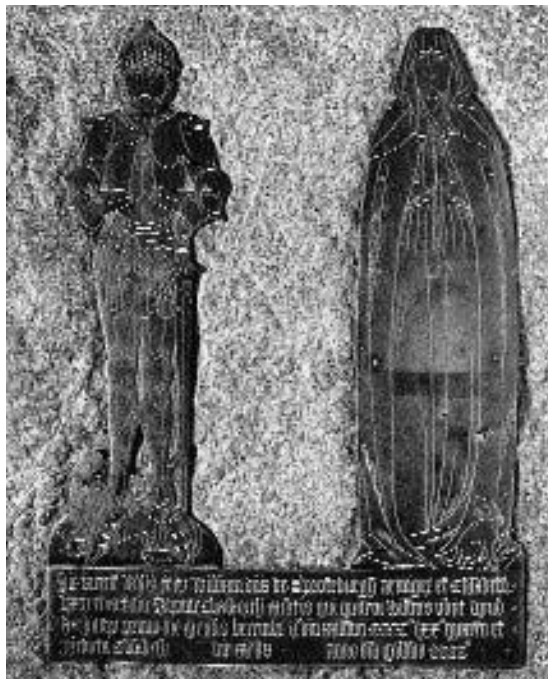
Figure 8.3 Fourteenth-century floor brass to William Fitzwilliam d.1474, set in the chancel floor of St Mary's Church, Sprotborough, S. Yorkshire (RCHME Crown Copyright, 1995)

To record inscribed and structural details, it is necessary to create the illusion of three dimensions in a two-dimensional photograph. To do this, the subject has to be lit in such a way as to give the impression of 'depth' by the use of shadows. Lighting the subject from the camera position will result in flat and featureless photographs. The light source has to be off-camera, and at around 45° to the subject, normally coming from the side. This will produce a clear and crisp photograph, as illustrated in Figures 8.3 and 8.4.

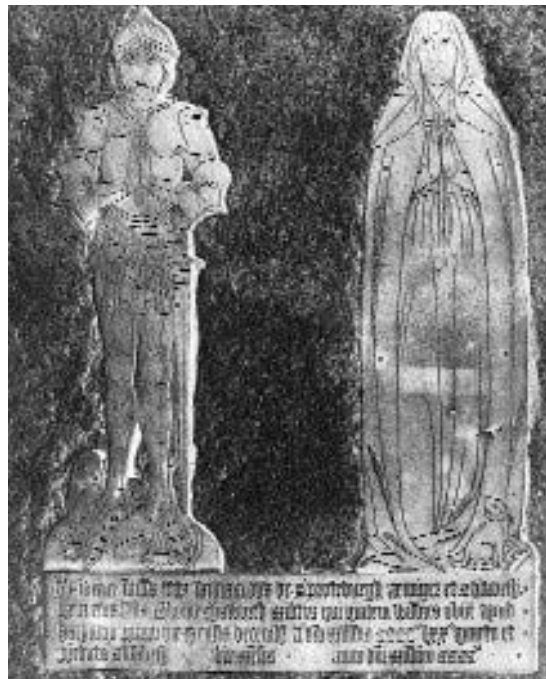
Figure 8.4 As Figure 8.3, but a negative image (RCHME Crown Copyright, 1995)

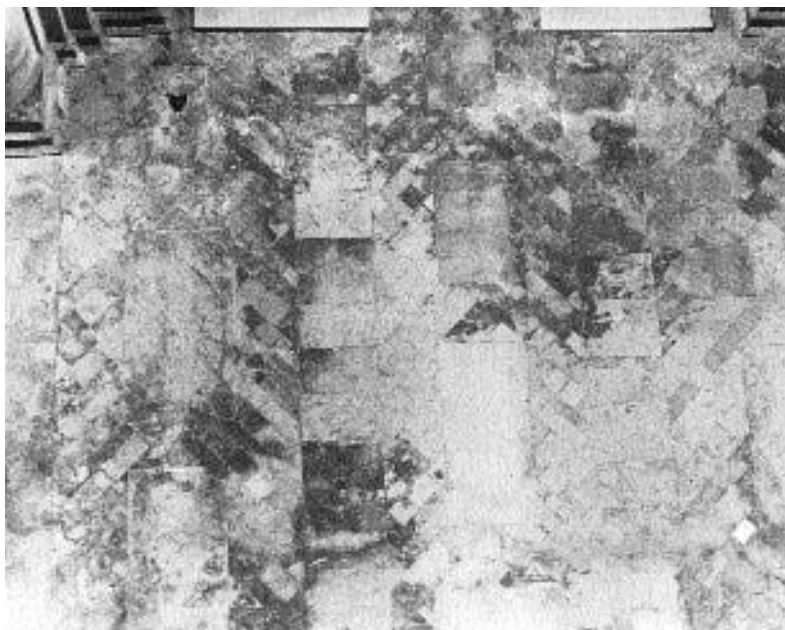
Figure 9.1 The floor of the central crossing at Southwell Minster, Nottinghamshire, taken from the eastern tower clerestory stage: as it appears to the naked eye (Photograph, Dr C.J. Brooke)

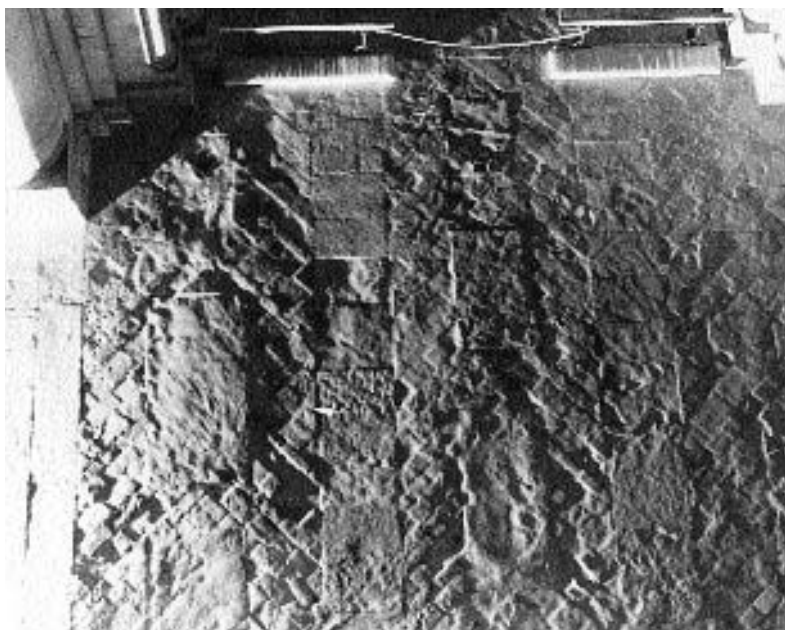
Figure 9.2 The central crossing floor illuminated by CEI, rendering the surface profile more clearly visible and showing the extent of damage and wear (Photograph, Dr C.J. Brooke)

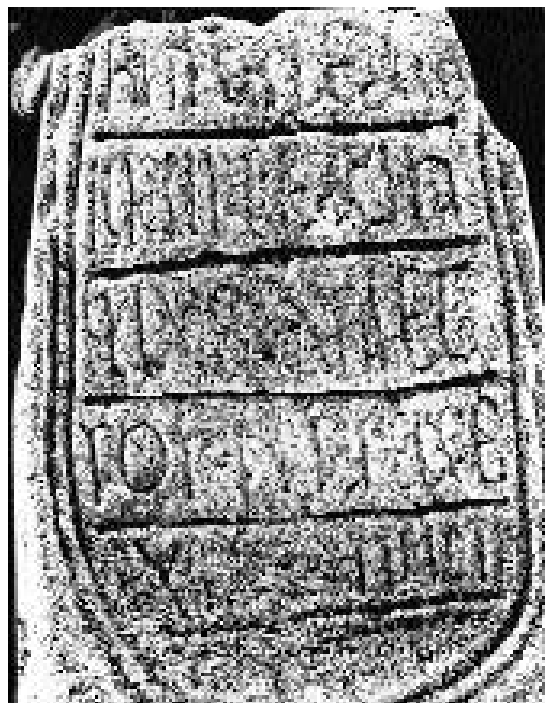
Figure 9.5 Beckermeth cross face using MASS imagery to produce an enhanced image of the inscription (Photograph, Dr C.J. Brooke)

more clearly discerning incised inscriptions and decorative carving. It is based upon the use of extreme angled illumination, but instead of using just one angle MASS employs multiple angles of incident radiation within the same image.

Figure 9.4 shows one of the pre-Conquest carved crosses at St Bridget's Church, Beckermeth, Cumbria, as seen by the naked eye. The inscription is heavily worn and partly covered by lichen and moss growth. Figure 9.5 shows the inscribed face using MASS to reveal the majority of elements present in the inscription.

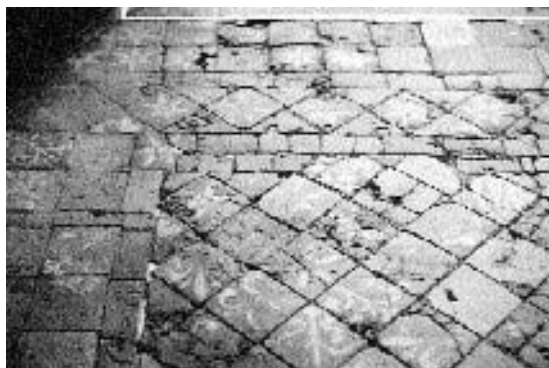
Figure 12.1 Tiles in the central vessel of the retrochoir before cleaning and conservation (Photograph, Cliveden Conservation Workshop Ltd)

vessel which contains the largest areas of *in situ* tiles in the floor (Figure 12.1). It was considered that the red mastic – such it was assumed to be – posed a threat to the survival of the floor because of the preferential drying, and salt crystallization it was felt it would promote. Several areas of inserted modern tiles (dating from the eighteenth century and later) in the floor in these areas were already showing signs of decay as a result of such preferential crystallization. It was considered that the removal of this material ought to be an essential part of the repair programme.

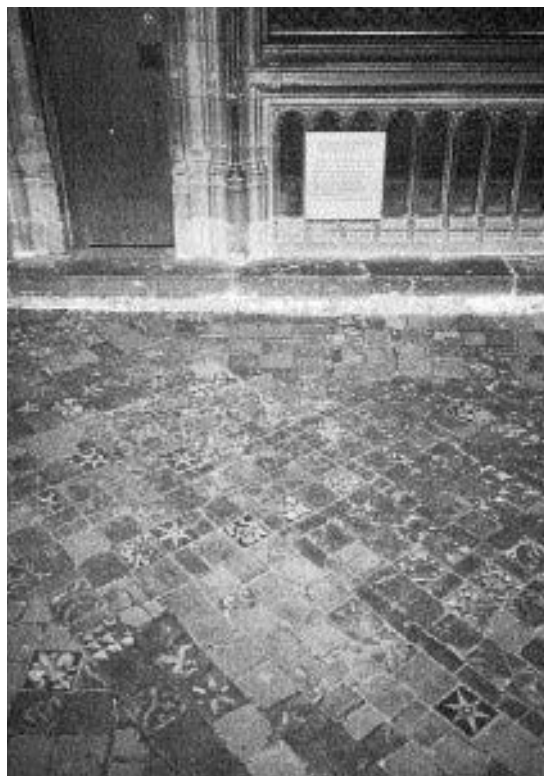
Figure 12.2 Conserved tiles, many of which are in situ, completed in the first stage of work. Isolated replica tiles are visible (Photograph, Peter Bird)

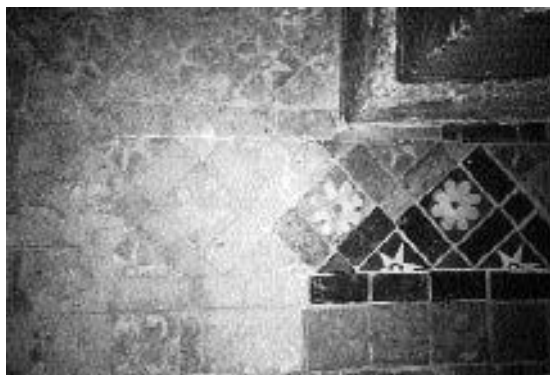
Figure 12.3 Contrasting areas of conserved tiles and replicas and tiles awaiting cleaning (Photograph, Peter Bird)

the possible contrast with the surrounding work (Figure 12.3). This was felt philosophically to be more acceptable, since they would represent honest repair in material as near as possible to the original work, and that they should be allowed to wear naturally – adopting much the same philosophy as that being applied in the stonework repair in progress at the same time on the West Front.

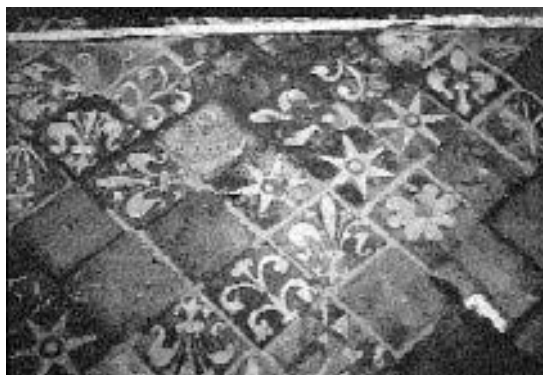
Figure 12.4 Completed mortar repairs and pointing conservation (Photograph, Cliveden Conservation Workshop Ltd)

Vanessa Simeoni, the lead conservator, and her colleagues in saving and repairing quite severely damaged tiles, that it proved necessary to use many fewer replicas in the repair than had originally been expected; in the central vessel, where most of the in situ tiles remain, no replicas were used at all, and the largest area of replicas, as had originally been hoped, was confined to the restoration of the carpet pattern in the north aisle (Figure 12.4).

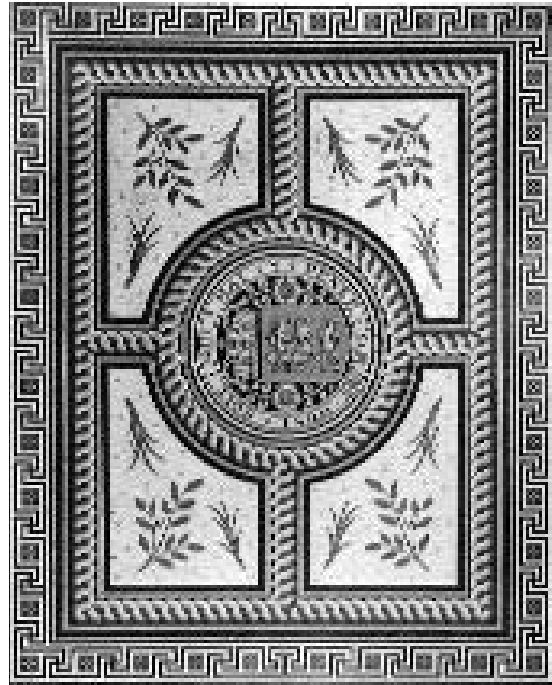
Figure 14.3 The Foreign Office, London, 1861. Sir George Gilbert Scott. Grand Staircase. Detail of encaustic tile floor panel in staircase hall. Minton (Photograph, National Monuments Record)

Digby Wyatt collaborated with Gilbert Scott over the designs for the encaustic tiles in the Foreign Office (see Figures 14.2, 14.3 and Plate 41) and the India Office. Wyatt also developed an interest in Moorish tiles and his Moorish majolica tiles were displayed in the Great Exhibition of 1862. He also advised Henry Cole on the tiles used extensively at the South Kensington Museum (the Victoria and Albert Museum). The tiles in the Central Refreshment Room, 1868–1870, were by Maws, those on the remarkable ceramic staircase

Tiles also provided a cheap and colourful flooring for many public buildings. Scott's lavish pavements for the Foreign Office and India Office add an important dimension to the interiors. The staircase hall for the opulent Ambassador's Staircase, for which Clayton and Bell supplied the mural decoration, is paved with mosaic tiles in a plaited design with a central roundel, inscribed with Queen Victoria's coat of arms (see Figures 14.2 and

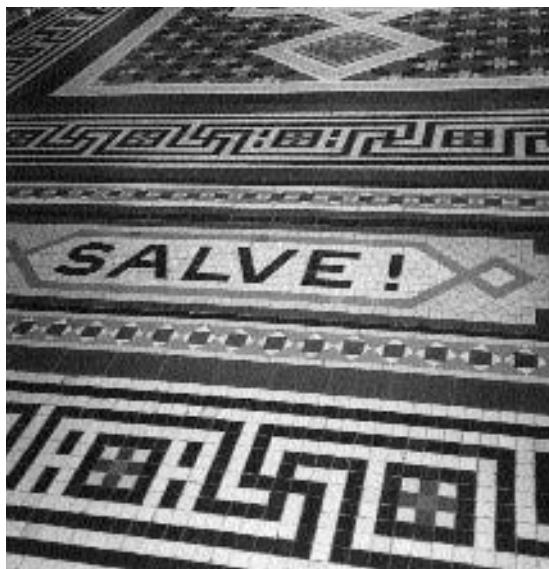
Figure 14.4 Wimpole Hall, Cambridgeshire, c.1793, Soane, and c.1840, Kendall. Encaustic tiled pavement. Entrance hall, c.1840. Kendall (Photograph, Jane Fawcett)

The fashion for tiled entrance halls grew rapidly during the mid-nineteenth century, and many leading country house architects employed Mintons or Maws. At Wimpole Hall, Cambridgeshire, H.E. Kendall remodelled the seventeenth-century entrance hall for the 4th Earl of Hardwicke, in the 1840s. The encaustic tiled floor incorporates the Hardwicke motto and monogram and the welcome, *Salve* (Figure 14.4). A key fret border completes the scheme. The entrance hall at Somerleyton Hall, Suffolk, designed by John Thomas for Sir Morgan Peto, the contractor in 1844–1851, was also tiled. Even more exotic, grandiose, and out of its period, was the 3rd Marquis of Bute's Cardiff Castle, remodelled by the neo-medievalist William Burges from 1865. Tiles were used in many of the rooms. In the summer smoking room, a map of the ancient world is surrounded by circles of ships and whales on the floor. The walls are decorated with painted tile patterns, and with the signs of the zodiac.

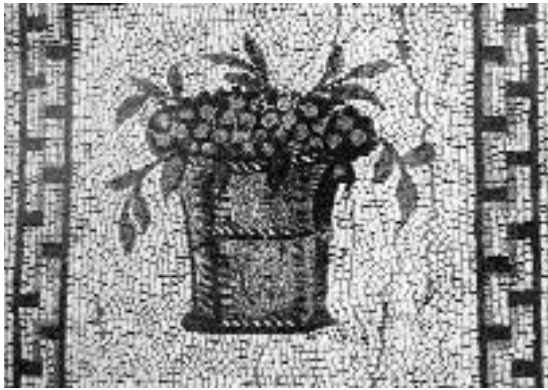
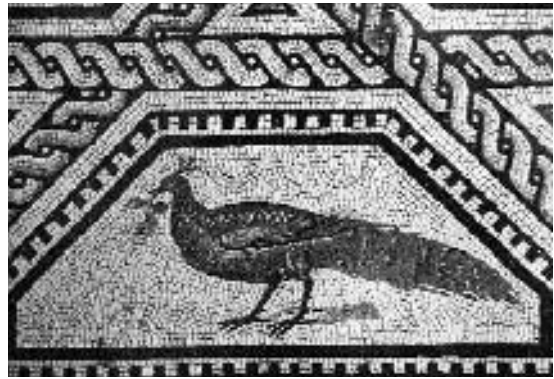
Figure 14.5 Cologne, Germany. Second century AD. Roman villa. Dionysius mosaic floors. Details. (a) Basket of plants (b) Peacock (Photographs, by kind permission of Römisch-Germanisches Museum der Stadt, Greven Bechthold, Cologne)

In Cologne, Germany, the superb Roman Dionysian floor mosaic, once in a house of twenty rooms lying to the south of the cathedral, was excavated in 1941. After deterioration, owing to rising damp, the whole floor was rolled up and removed, new foundations were provided, and the mosaic reinstated on its original site (Figure 14.5). Spain is also rich in Roman mosaics. Cordoba, Merida, and Italo, near Seville, all have good Roman mosaic pavements.

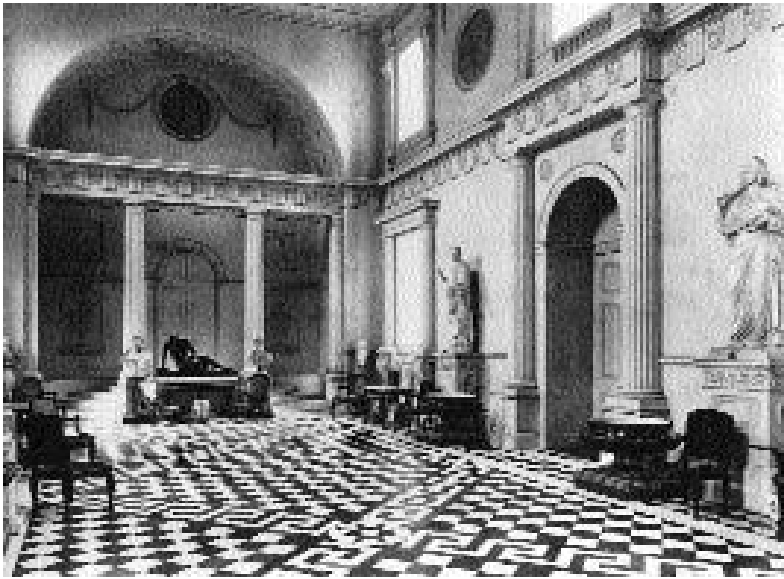
Figure 14.10 Syon House, Isleworth, 1761. Robert Adam. The Great Hall. A superb Neo-classical interior, leading to Adam's ante-room with its magnificent coloured scagliola pavement (Photograph, National Monuments Record)

Robert Adam, inspired by the magnificent pavements of Rome, designed interiors, in which the floors were an essential component of an integrated architectural composition. Two of his finest rooms are at Syon House, Isleworth, designed in 1761. The chaste black and white chequered marble floor of the great hall (see Figure 14.10) has bands of key-fret, corresponding with the ceiling panels, while the alcove has a coffered ceiling reflected in a radiating floor pattern. The ante-room has, to complement its superbly rich Neo-classical interior, a scagliola floor, the design derived from Serlio's *Book IV, Folio 68*. It consists of octagons and circles embellished with floral motifs in red, yellow, blue, green, brown and red. The floor we see today was relaid in 1831–1832, replicating the original design, for £900 (Gilbert *et al.*, 1987).

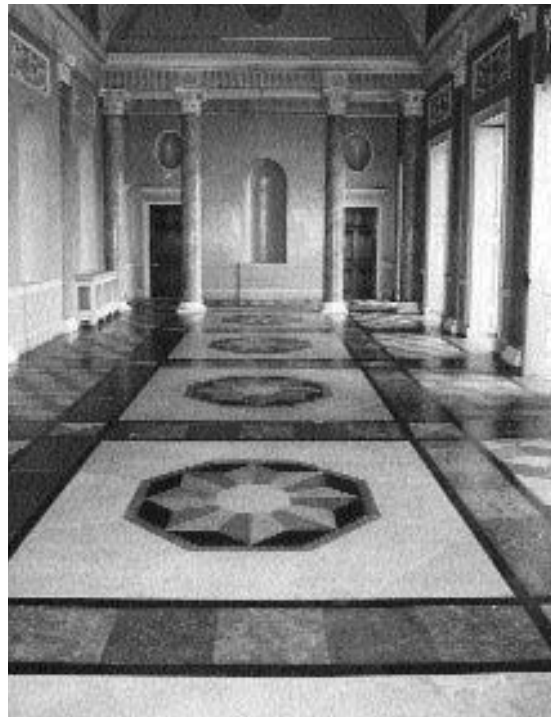
Figure 14.11 Heveningham Hall, Suffolk, Sir Robert Taylor 1787. James Wyatt. Entrance hall, 1784. Fine marble floor, combining fictive cube design and geometric elements (Photograph, Christopher Hanson-Smith)

James Wyatt designed a superb floor for the entrance hall at Heveningham, Suffolk, completed in 1784 (Figure 14.11). The central section of red and black marble on a stone base is composed of circular motifs, contrasted with fictive cube panels.

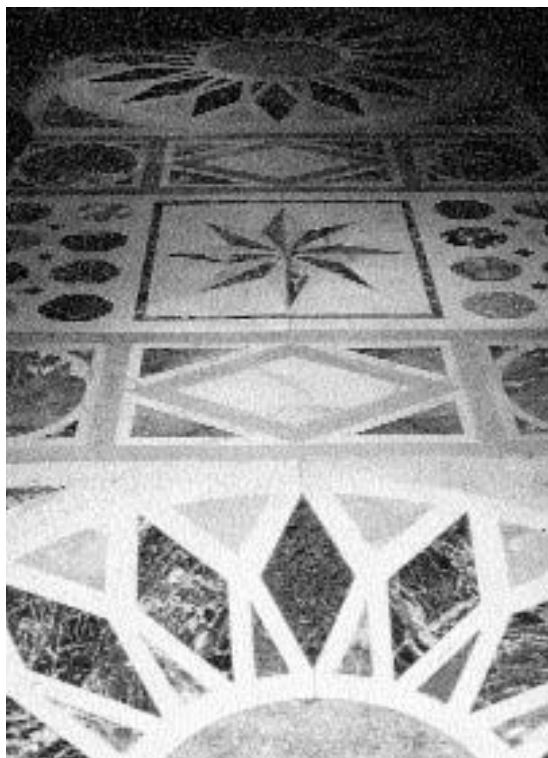
Figure 14.12 Chatsworth, Derbyshire. North corridor, 1841. Sir Jeffrey Wyattville. Marble floor by Leonardi, a Roman craftsman, working on the Forum (Photograph, Jane Fawcett)

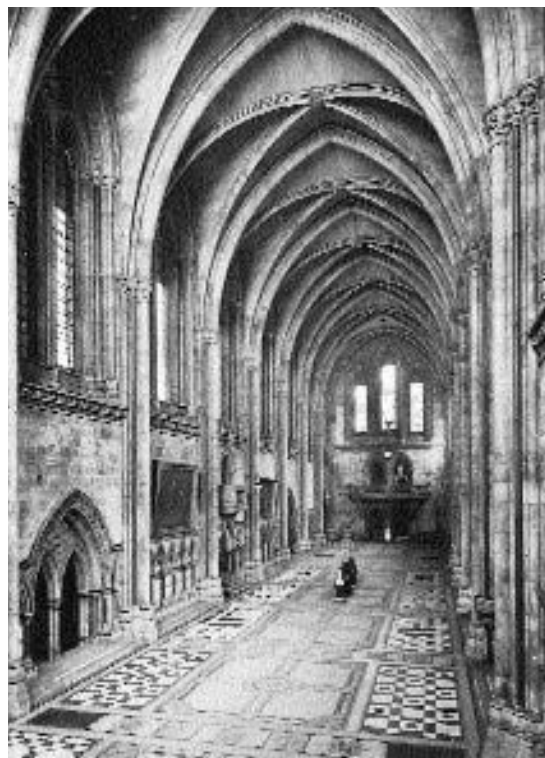
Figure 14.13 The Royal Courts of Justice, London, 1874. G.E. Street. The great hall, decorative pavement (Photograph, National Monuments Record)

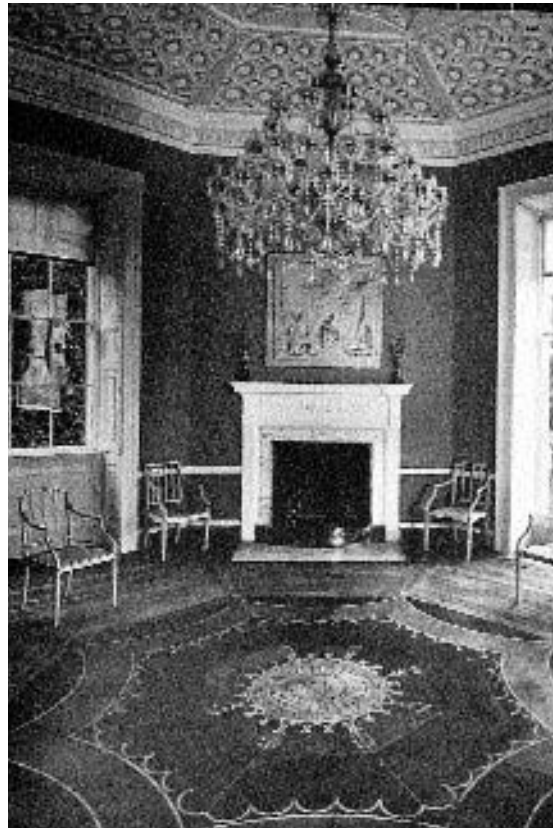
Figure 14.18 Mount Stewart House, Co. Down, Northern Ireland, 1782–1785. James (Athenian) Stuart. Temple of the Winds. Marquetry floor (Photograph, Jane Fawcett)

George Dance designed inlaid Neo-classical floors at Cranbury Park, Hampshire, c.1780, and for the music room at Mount Stewart, Co. Down, 1782–85 (see Plate 52). The delicate inlaid floor in the Temple of the Winds, 1782–1783, by Athenian Stuart (see Figure 14.18), combines mahogany, American walnut, sycamore and bog oak, to create a subtle octagonal design to enhance this charming room, with views over Strangford Lough. The Casino at Marino, Dublin, by William Chambers, also contains fine marquetry floors, recently restored (see Figure 14.19). The library floor at Sledmere, Yorkshire, originally

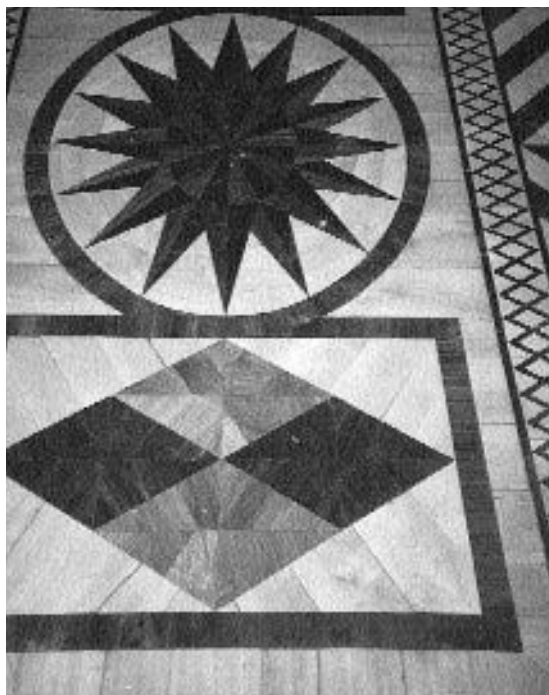
Figure 14.19 Casino, Marino, Dublin, Ireland, 1758–1776. Sir William Chambers. Marquetry floor, restored in the 1980s (Photograph, Jane Fawcett)
