Historic Floors

Their Care and Conservation

— JANE FAWCETT —

*Published in association
with ICOMOS UK
(International Council on
Monuments and Sites)*

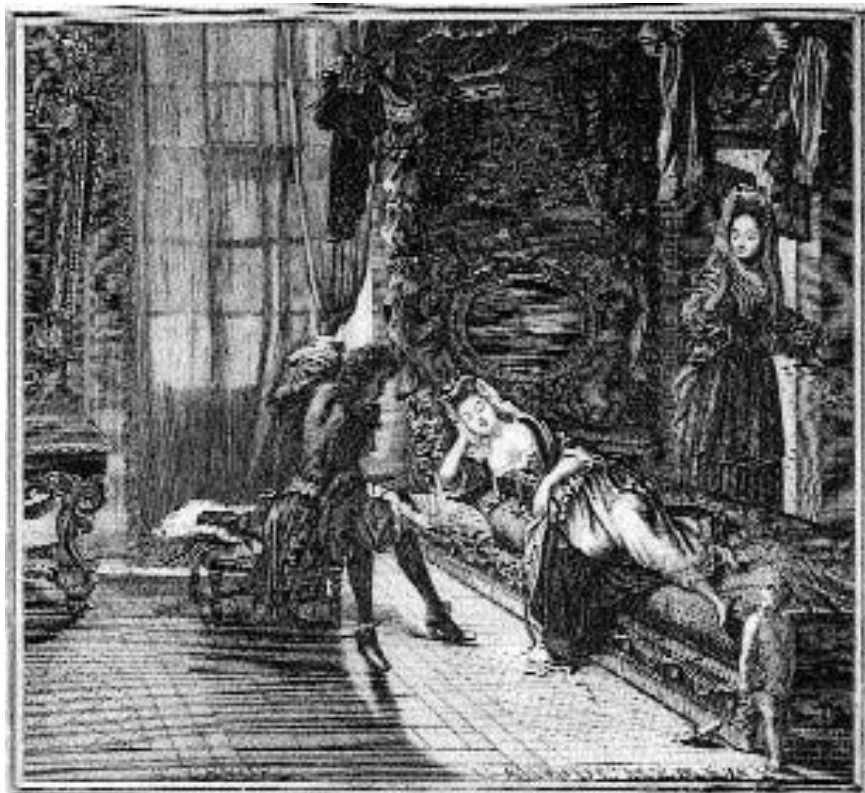
Figure 16.1 A French Bedchamber of the 1680s, engraving by J.D. de St Jean (Bibliothèque Nationale, Paris). The parquet floor is identical in pattern to the floors of the Queen's Apartment laid by Henry Harlow in 1673 (Copyright, Bibliothèque Nationale)

Queen Henrietta Maria, in her apartment at Somerset House in 1661–1662. The style originated in late fifteenth-century Italy, but came to England via France (where it had been in use since at least the 1620s), and Holland.⁶ Its pattern, of alternating criss-cross and diagonal motifs within square fields, is very similar to the floor depicted in a 1680s French engraving (Figure 16.1), and similar flooring of 1656–1657 is still in situ at the Hôtel Lauzun, Paris.⁷ Both French and Dutch craftsmen are recorded in the Lauderdale accounts (e.g. 'Hendrick Mommers the Dutch Joyner') but this floor is known to have been

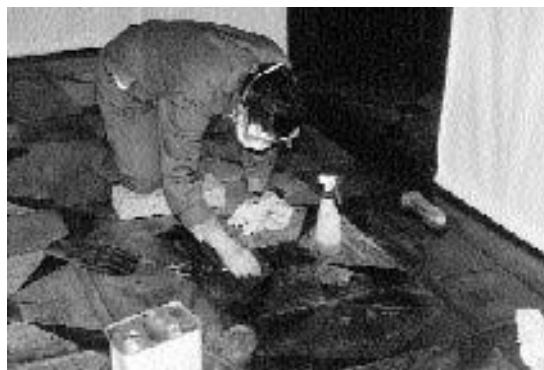
Figure 16.2 The Marble Dining Room: cleaning the marquetry floor of c.1744 in about 1992 (Photograph, F.R. Latham)

floor inlaid with squares, diamonds and lozenges of walnut, cedar, ebony, rosewood and poplar,¹² is entirely in sympathy with the oak carved panelling of the 1670s, and this suggests a consciously antiquarian approach by the 4th Earl. Much darkened by dirt and numerous thick layers of polish, the floor has been greatly improved by Mr John Hart's recent repair and restoration (Figure 16.2). Originally, the decorative woods were glued onto oak or deal support panels three feet square which were tongue and grooved together. The panels are fixed to the joists at the corners by screws and nails – there is no cross-flooring to support the panels as in the seventeenth-century floors upstairs. They are therefore more prone to damage, but the floor has survived remarkably well, apart from the usual lifting and separation of the marquetry. This has now been fixed in place, with larger gaps filled with slivers of stained balsa wood, thus allowing lateral movement.

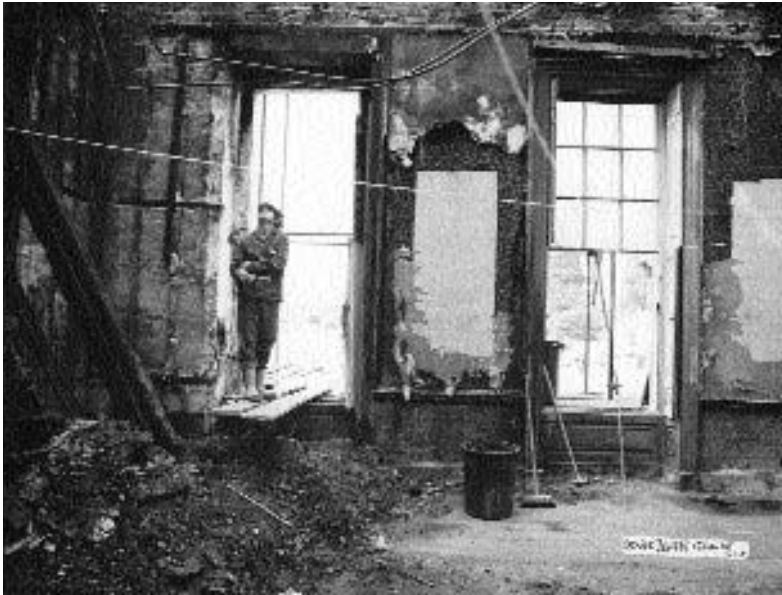
Figure 17.1 Uppark. Ash and debris being removed from the Red Drawing Room, revealing the floorboards intact (Photograph, The National Trust)

At ground-floor level the floorboards were, in the main, plain oak boards of roughly the same dimensions. Two rooms, on the east flank, had softwood floors of presumably nineteenth-century origin. Despite the apparent intensity of the blaze, all of these timber floors at ground-floor level, with the exception of one destroyed by falling masonry, survived with remarkably little damage. It became evident, as the salvage operation progressed, that the blanket of ash and debris from above, made soggy by firefighting water, had effectively insulated the surface of the floors (Figure 17.1).

The bulky debris and ash was carefully removed, with the ash being then sieved for recovery of usable remnants. This exposed the floors where each board was first numbered and recorded before being lifted and transferred to an environmentally controlled store nearby. It was discovered, during this operation, that each board was fixed to its neighbour by means of irregularly sized and spaced hand-made dowels, and fixed to the joist

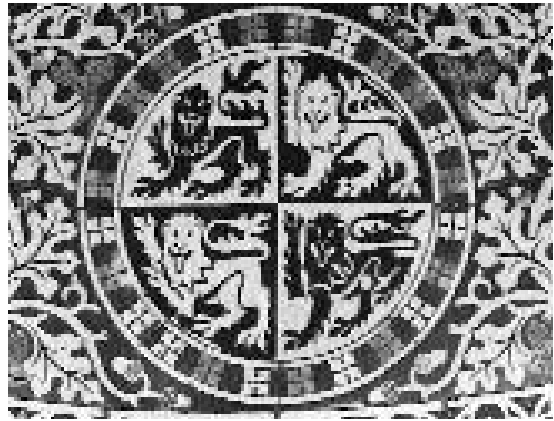
Figure 18.2b Tiles from Central Lobby, Palace of Westminster (Photograph, George Garbutt)

So far as the tiles themselves are concerned, the majority were designed by Pugin. Except for the large tiles used in the Peers' Lobby which are about twelve inches (305 mm) square, and the centre of Central Lobby which is composed of concentric rings and some circular tiles (Figures 18.2a and 18.2b), most of the tiles are six inches (152 mm) square.

Normally the original tiles are one inch (25 mm) thick and consist of a top and bottom layer of fine clay separated by a rougher mix of red grog. The undersides are impressed with holes to assist drying out and keying and the words, MINTON & Co PATENT STOKE ON TRENT, and a number, thought to identify the person who made them. No date stamp has been found on any of the tiles lifted so far.

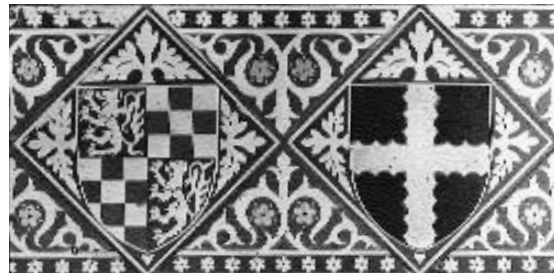
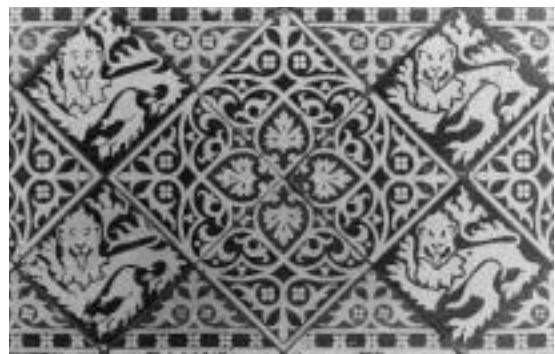
Figure 18.3 Tiles from St Stephen's Hall, Palace of Westminster (Photographs, George Garbutt)

Tile patterns include gothic lettering, heraldic lions, shields, and foliated designs some of which can stand alone whilst others are combined in sets to produce a complete pattern. Some patterns are produced in different colour combinations. The coats of arms on the tiles in St Stephen's Hall include those of knights who fought at the battle of Crecy (Figure 18.3).

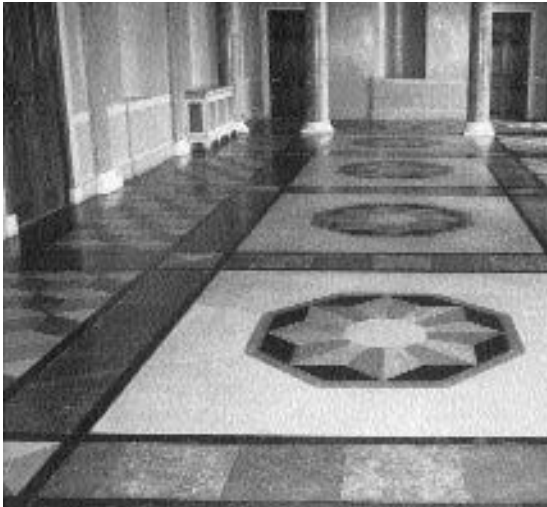
Figure 20.4 The front Hall, designed by James Wyatt, of Heveningham Hall, the Palladian mansion in Suffolk. The fine, inlaid stone floor deserves the most careful conservation. (Photograph, Christopher Hanson-Smith)

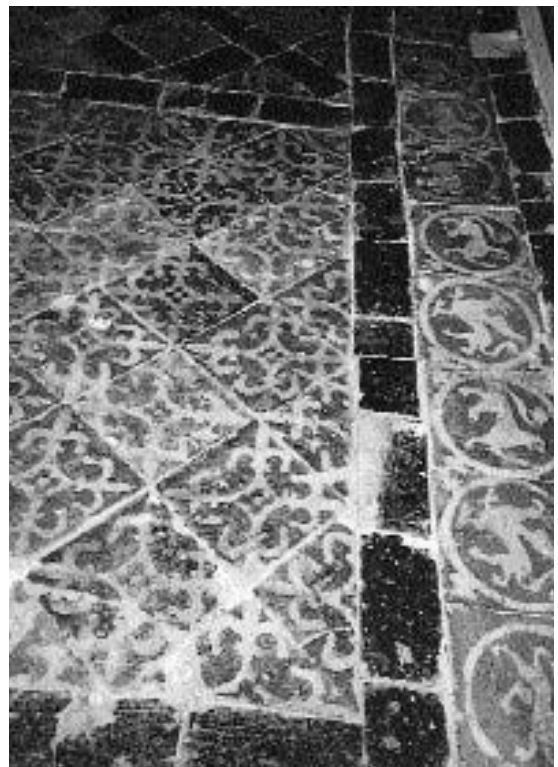
Plate 3 Salisbury Cathedral. Muniment room. Thirteenth-century tiled pavement detail – see page 6 (Photograph, Jane Fawcett)

The octagonal inlaid tiled floor in the muniment room of c.1260 is one of the best-preserved medieval pavements in Europe (see p.6 and Plate 3). The tile carpet is composed of Wessex tiles, in parallel strips radiating from the central piers. The individual tile designs include lions, griffins, birds and fleurs-de-lys, comprising altogether fifteen different designs. The protective wooden floor was temporarily removed in 1995 for recording and repairs. There is also a group of re-set medieval tiles, possibly from the original chapter house floor, flanking the old altar position in the chapel at the east end of the north presbytery aisle.

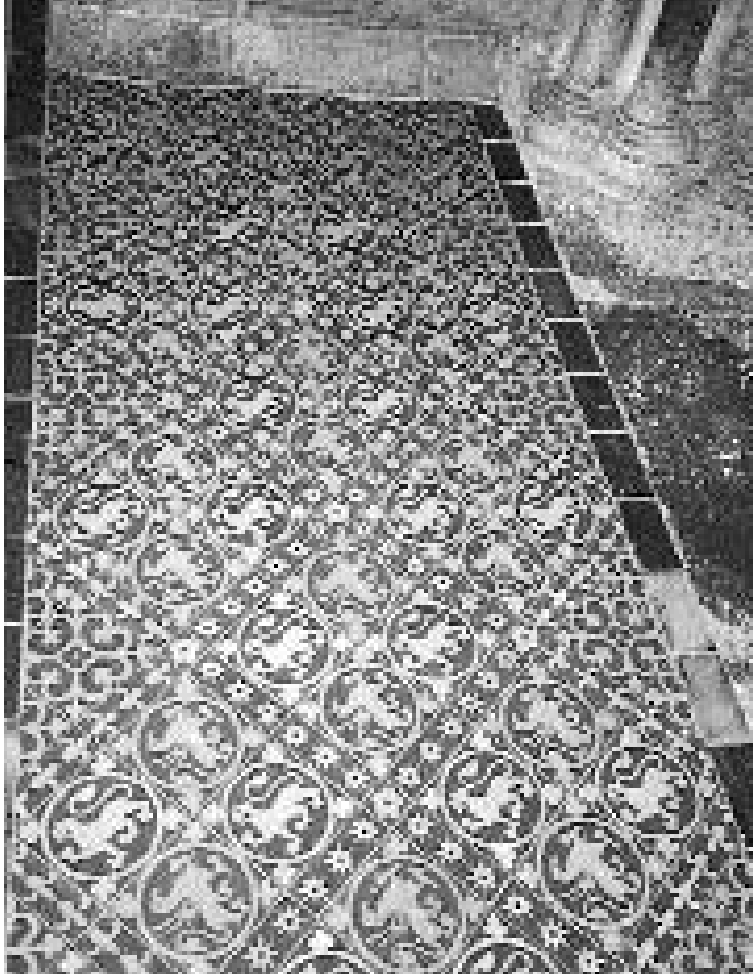
Plate 4 *Salisbury Cathedral Chapter House. Encaustic tiles by Godwin, laid c.1856 during restoration by Henry Clutton and William Burges, replicating thirteenth-century tiles, recorded by Henry Shaw in 1858. Note similarities with thirteenth-century muniment room tiles – see page 6 (Photograph, Jane Fawcett)*

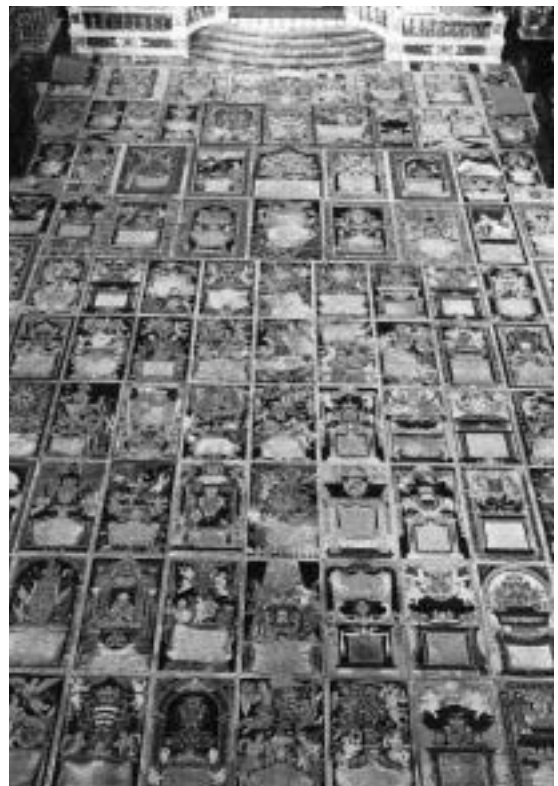
Plate 16 *St John's Cathedral, Valetta, Malta. Ledger stones – see page 31 (Photograph, Mario Mintoff, Photocity, Valetta)*

The beautiful Cosmatesque pavement in the chancel designed by Gilbert Scott in 1871 contains roundels of seated virtues. It is reputedly inspired by designs in the Cathedral of St John, Valetta, Malta (see Figure 1.31 and Plate 16).

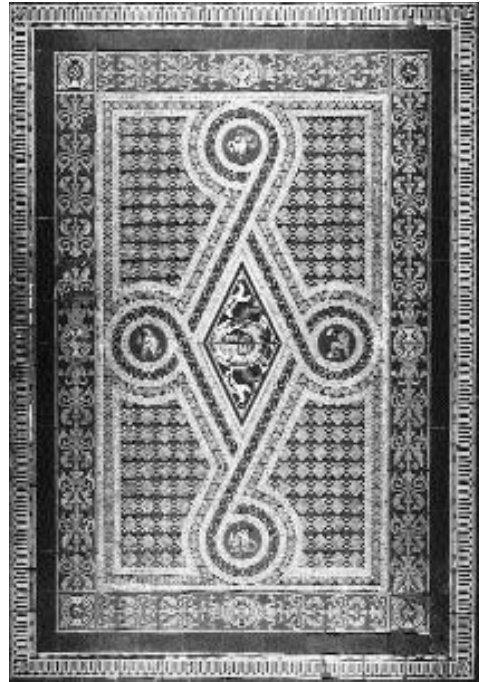
Plate 35 Osborne, Isle of Wight. Encaustic tiles by Minton, detail – see page 132 (Photograph, English Heritage)

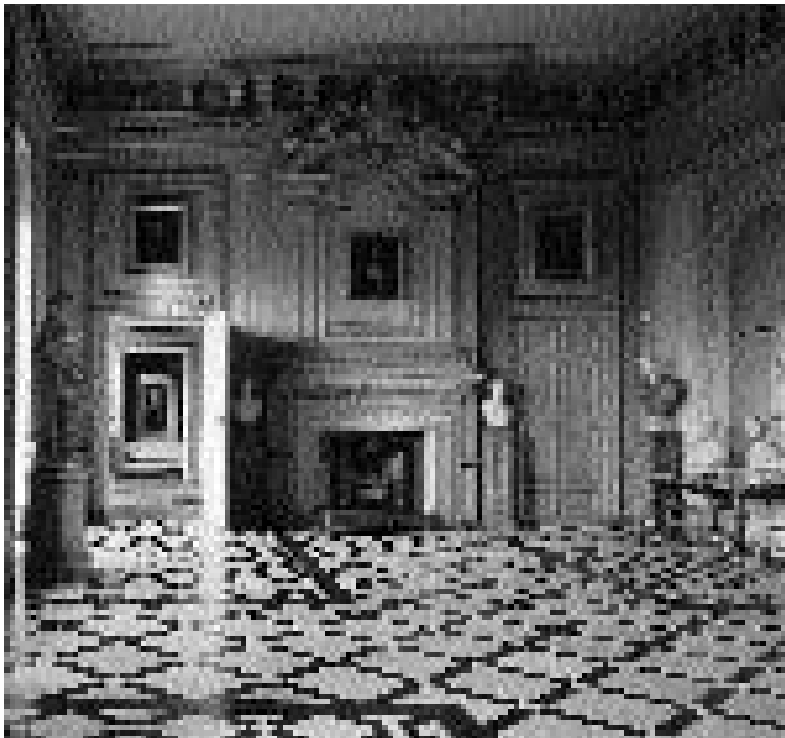
Plate 47 *Petworth House, West Sussex, 1688. Daniel Marot. The marble hall. Laid in 1692 by James Sayers, mason – see page 145 (Photograph, National Trust Photographic Library, Andreas von Einsiedel)*

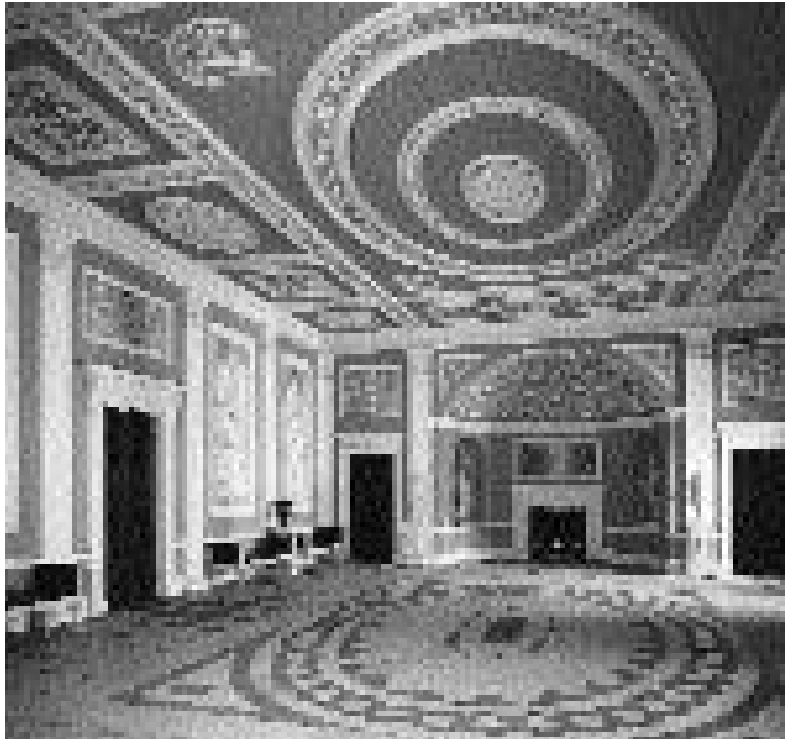
Plate 48 Osterley Park, Middlesex, 1767. Robert Adam. Entrance hall. The stone floor reflects the ceiling design – see page 147 (Photograph, National Trust Photographic Library, Oliver Brown)

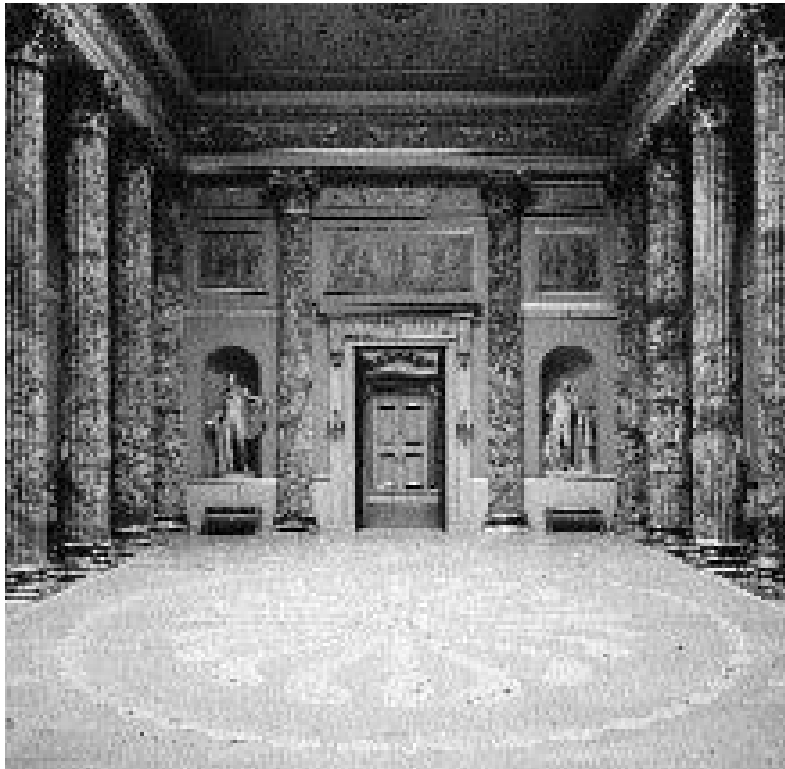
Plate 49 Kedleston Hall, Derbyshire, c.1760. Robert Adam. The marble hall, constructed from Derbyshire alabaster. An integrated architectural interior dominated by giant Corinthian columns – see page 147 (Photograph, National Trust Photographic Library, Andrew Haslam)

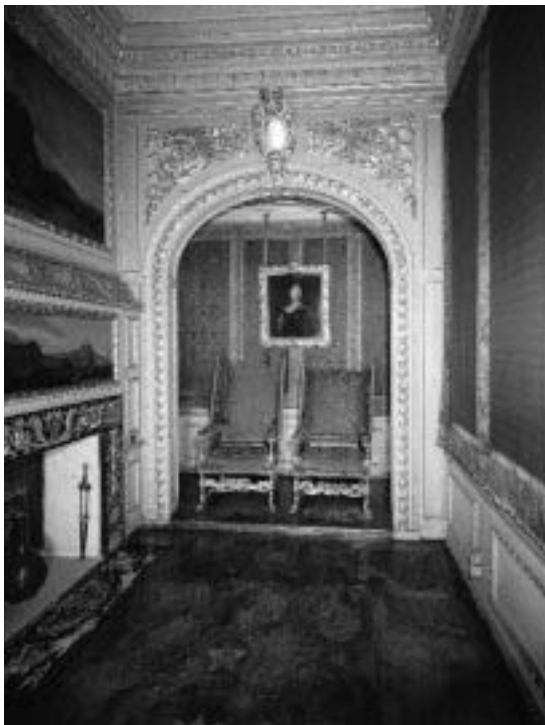
Plate 66 *Ham House. The marquetry of the Queen's Closet floor, looking towards the dais – see page 175 (Photograph, courtesy of the Trustees of the Victoria & Albert Museum)*

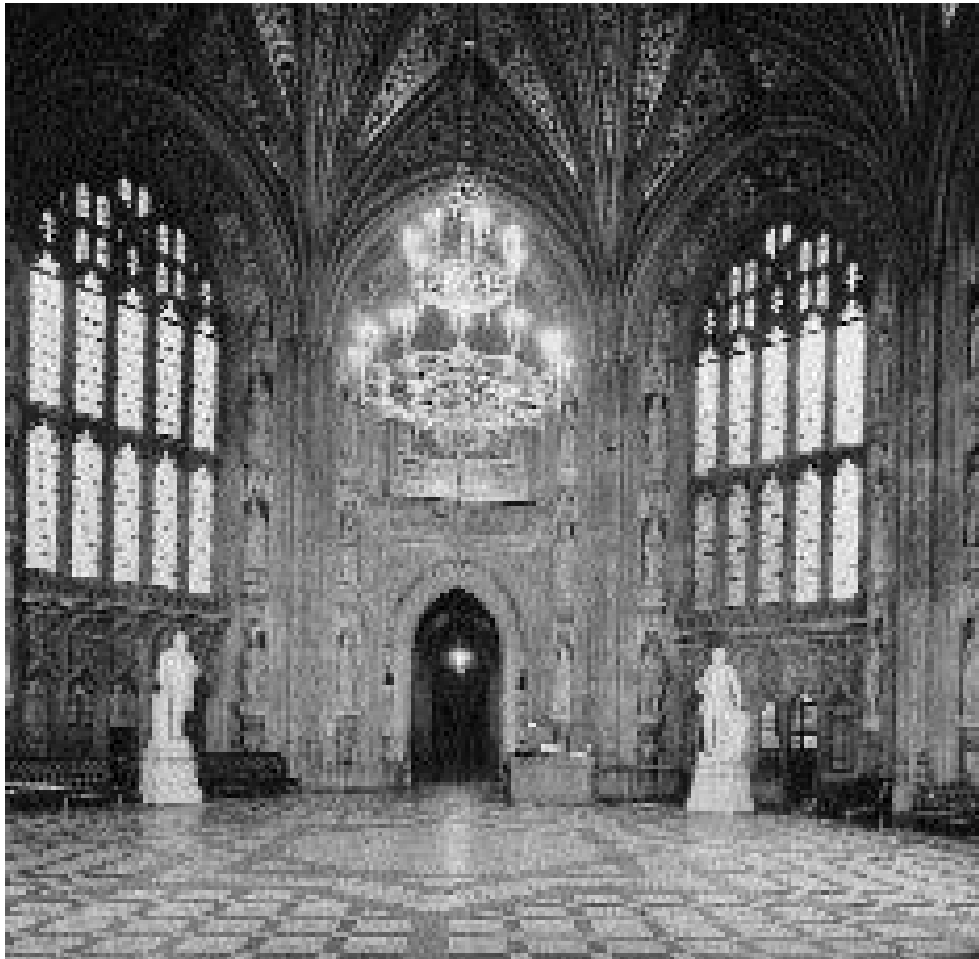
Plate 69 *Central Lobby, Palace of Westminster. Tiles by Minton – see page 187 (Photograph, George Garbutt)*

The earliest example is in the Peers' Lobby (Figures 18.1a and 18.1b). It was laid in 1847 and by early 1852 the Central Lobby (see Plate 69) and St Stephen's Hall were completed and in use. According to Benjamin Ferrey's *Recollections of Augustus N. Welby Pugin* published in 1861, Pugin wrote to Herbert Minton in January 1852 saying 'I declare your St Stephen's tiles the very finest done in the

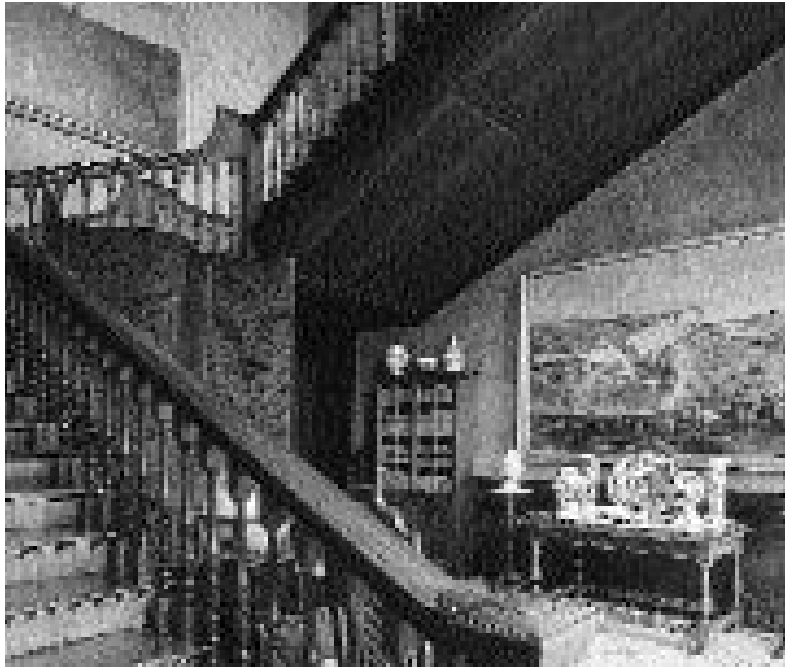
Plate 73 At Dyrham Park, near Bath, this main staircase cannot bear the weight of the constant flow of visitors. The treads and the landing also show damage from sharp heels. Now closed to the public – see page 198 (Photograph, National Trust)

When fashion dictated that women should wear stiletto heels the damage these lethal shoes did to floor surfaces was immediately apparent. It is calculated that the average sharp heel with a tip one-sixteenth of an inch square exerts a concentrated pressure of 960 lbs. Two heels resting on a few square inches of floor can therefore exert nearly a ton of pressure between them, causing irreversible damage to wooden floors in particular. This is well illustrated at Dyrham Park in Avon where stair treads and the landing floor have been seriously scarred and pitted (see Plate 73). No
