Conservation of Historic Buildings

*Conservation
of Historic Buildings*
Third edition

Bernard M. Feilden

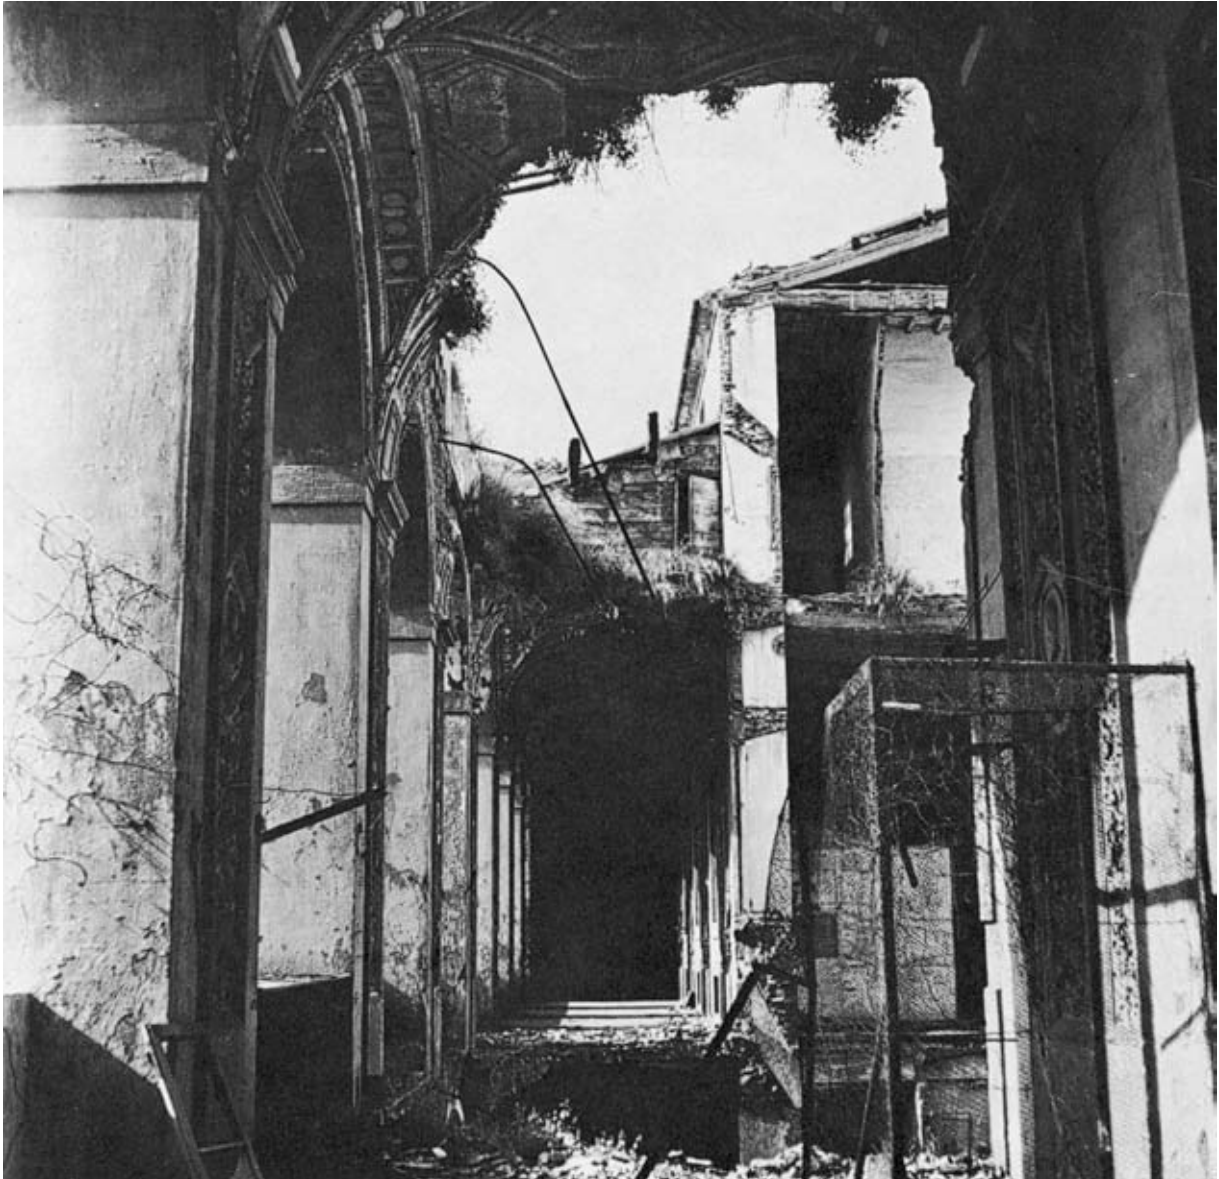
Frontispiece Ospizio di San Michele, Rome, Italy, before conservation

This state of affairs was due to lack of maintenance resulting from planning blight. The rainwater outlets were allowed to become blocked, so the gutters overflowed causing rot in the ends of the main beams which in due course collapsed taking the roof structure with them

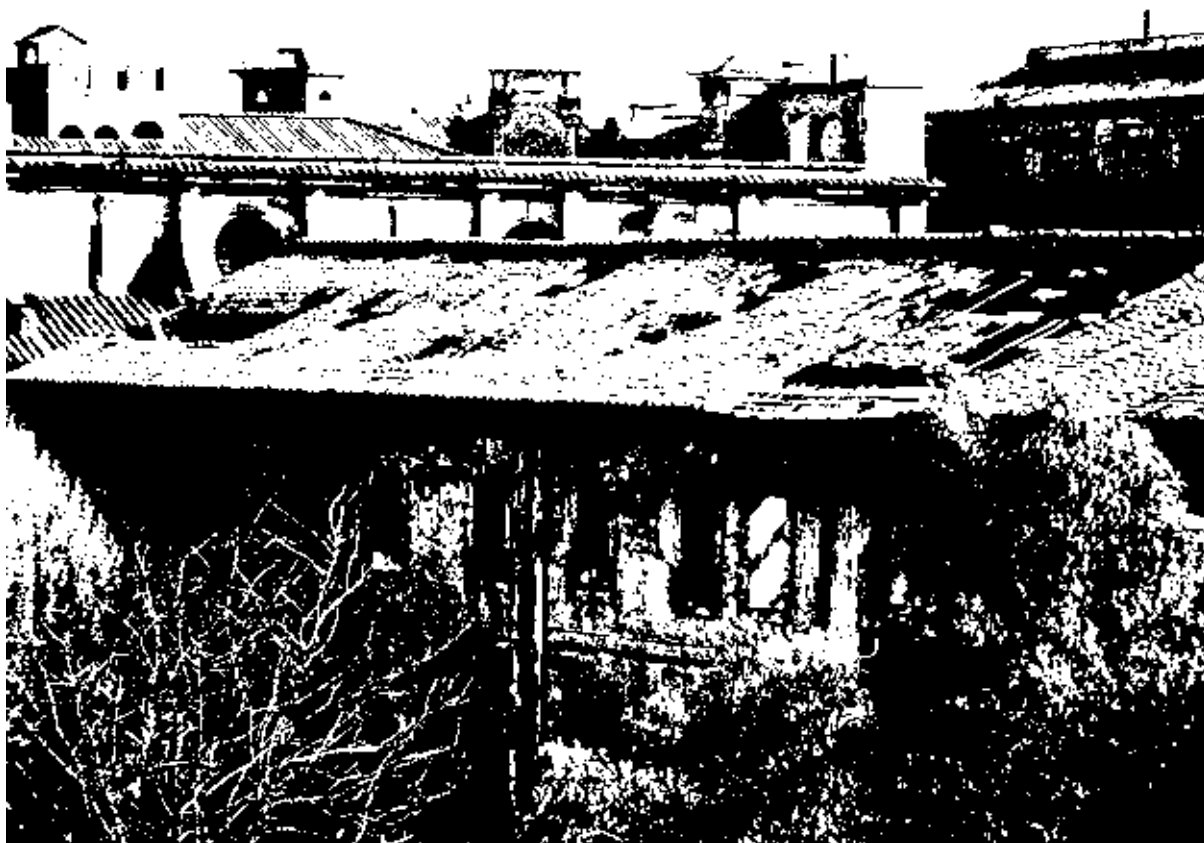
Figure 1.2 Trastevere, Rome, Italy

A sound structure has been neglected. The results are visible; a system of regular inspections and conservation planning could prevent this sad state of affairs

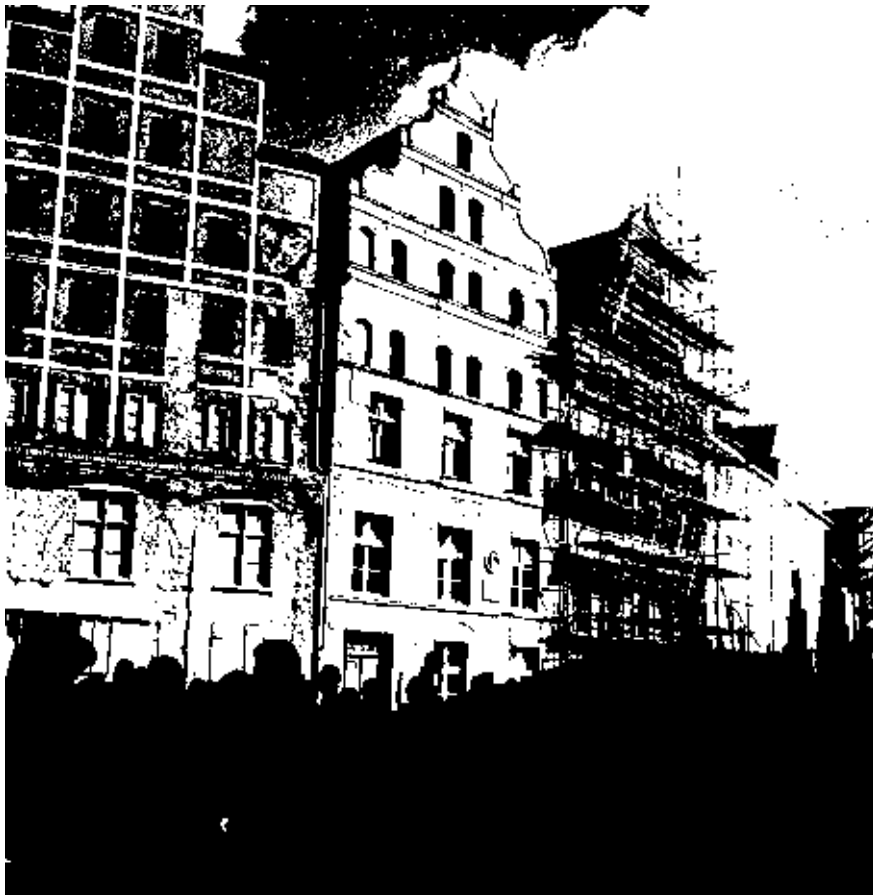
Figure 1.4 Merchants' houses, Stralsund, Germany

Decay has gone so far that only the facade can be preserved and the interior has to be rebuilt. Taking the city as a whole, this may be justified. However, there is a danger of deception when only townscape values are considered

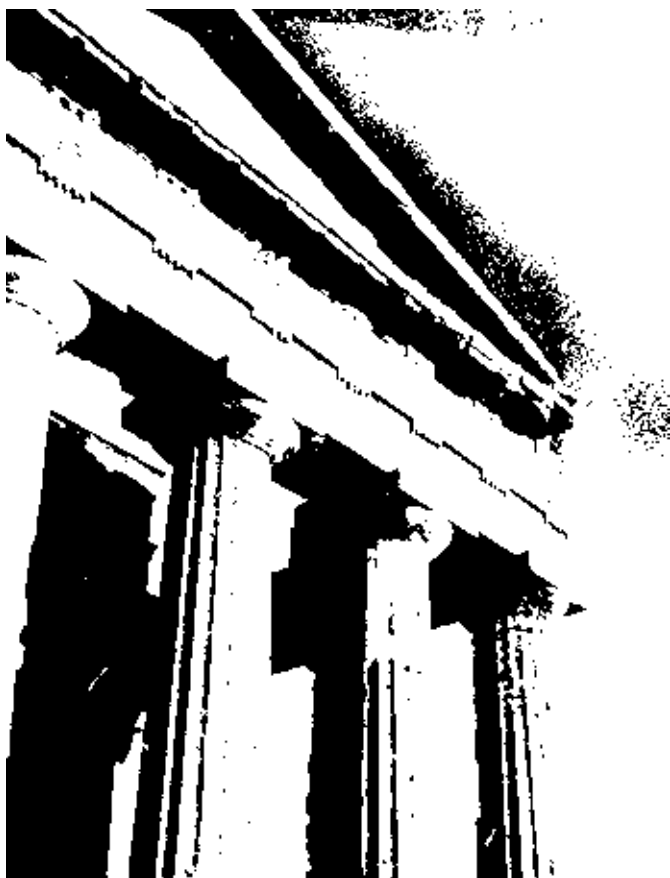
Figure 1.6 Doric temple, Silene, Sicily, Italy

Anastylosis can recreate the glories of the past, making the architectural values of space and mass more easily understood. Sometimes this is done at the expense of archaeological and documentary values. In this case the effect is spoiled by a plaster patch on one of the columns

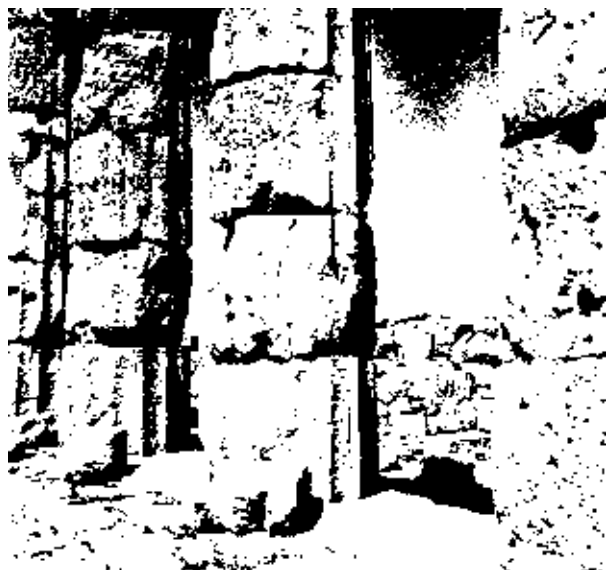
Figure 1.7 Doric temple, Silene, Sicily, Italy

The column drums have been re-erected. Problems arise, however, as the stones have weathered differently while lying on the ground for centuries and it is this factor that gives the columns a rather strange appearance

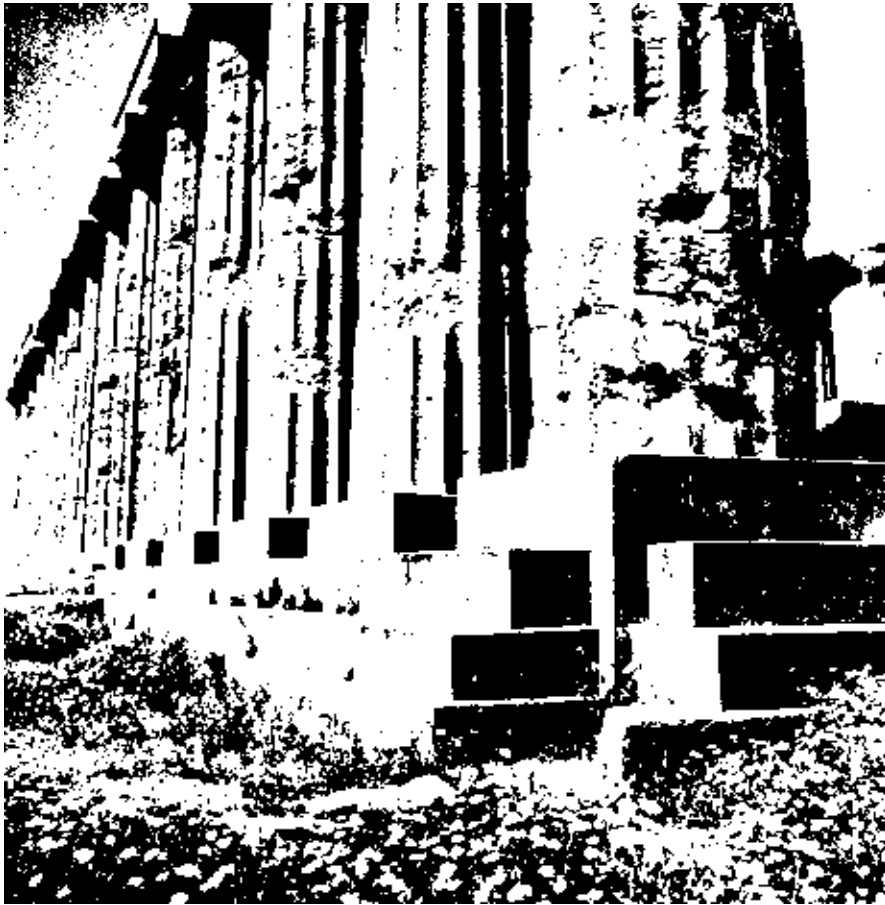
Figure 1.8 Doric temple, Silene, Sicily, Italy

Forming individual bases for the first six columns destroys the original design in an arbitrary manner. Anastylis should at least be correct

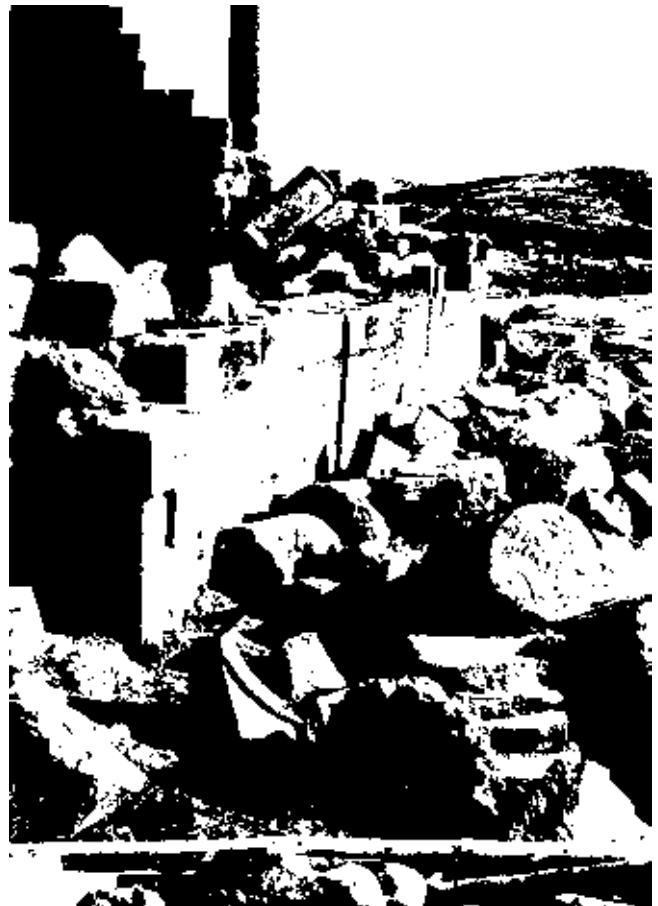
Figure 1.11 Temple of Zeus, Jerash, Jordan

The fallen stones give archaeological evidence sufficient to make a model to demonstrate the original design

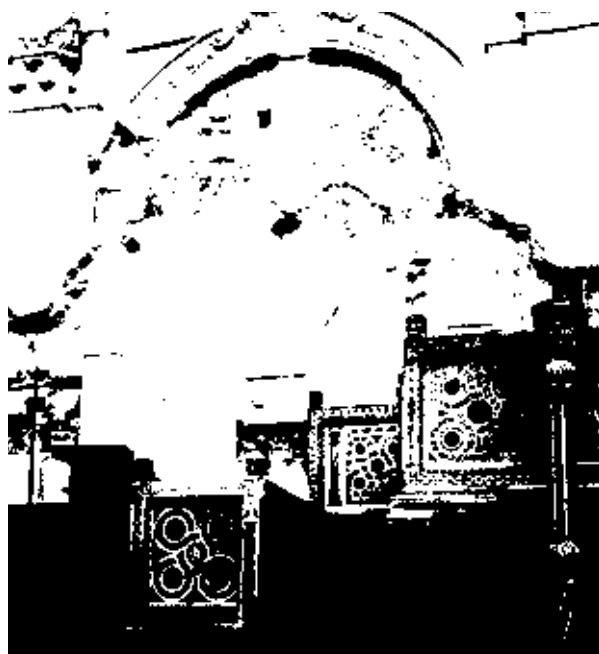
Figure 1.12 Salerno Cathedral, Italy

Contrary to the Venice Charter, the baroque work has been unpicked to satisfy archaeological curiosity and expose early Christian arcading. How will the situation be resolved? Will the baroque be reinstated for the benefit of the whole or will the earlier period take precedence. It is vital to decide on a clear presentation policy in conservation

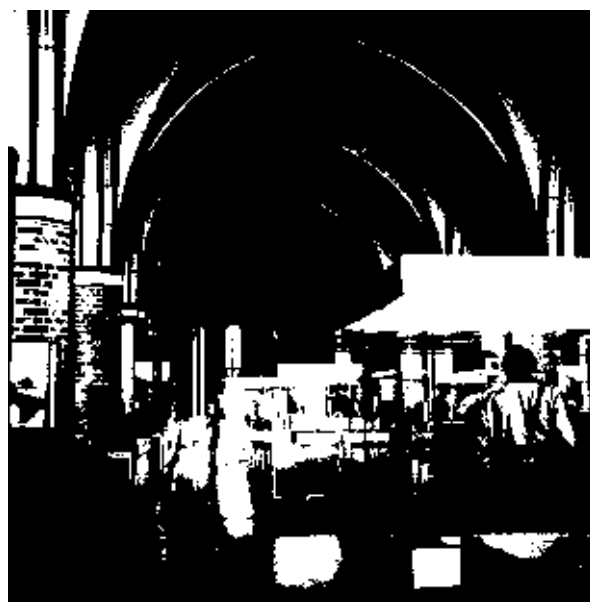
Figure 1.17 Church, Stralsund, Germany

This church has been turned into a maritime museum. The fabric is preserved and new spatial values created by insertion of a mezzanine floor. An interesting case of re-evaluation and adaptive use of an historic building, but purists might object

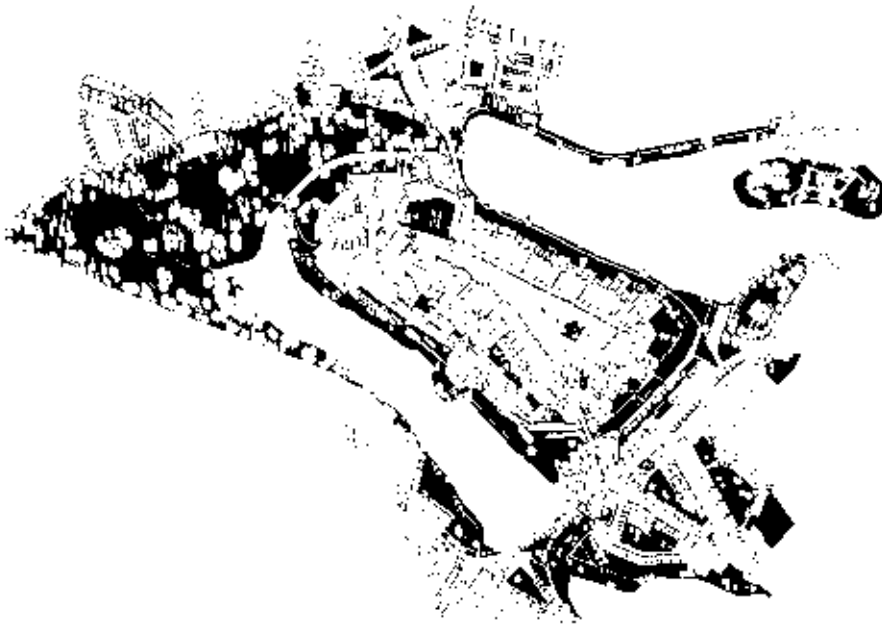
Figure 1.18 Telc, Czechoslovakia
(Courtesy: V. Uher and Statni Ustav pro Rekonstrukce Pamatkovych mest a Objektj v Praze)

A typological and volumetric study of the town in axionometric projection

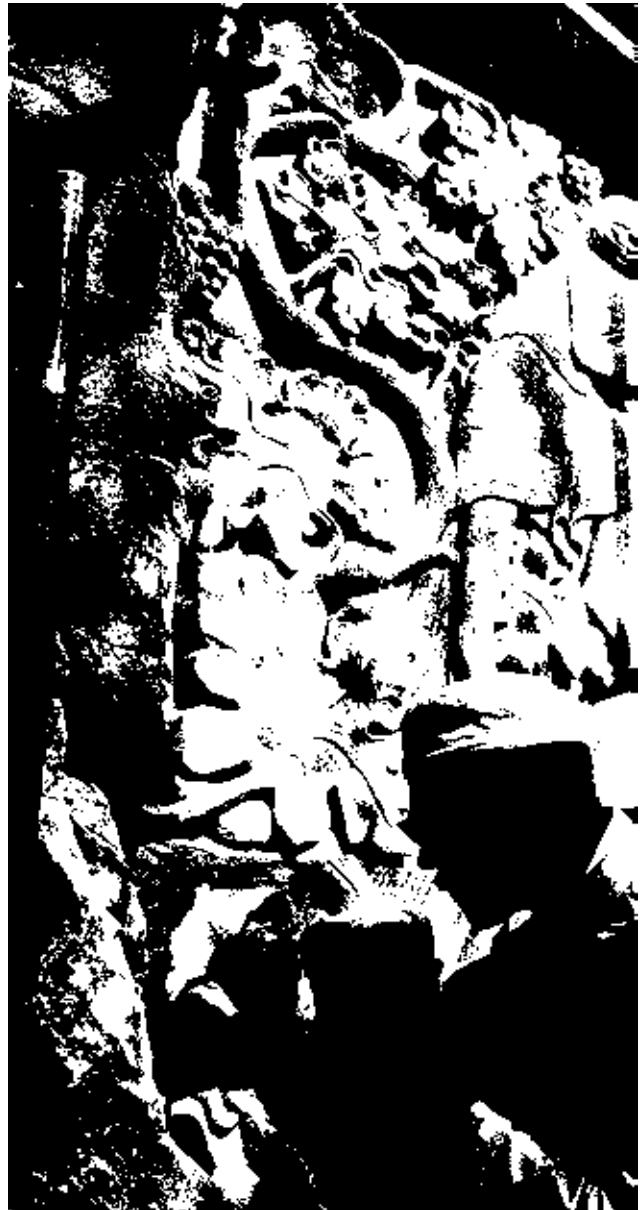
Figure 1.22 Ethelbert Gateway, Norwich, England

The stone was so decayed that most of the evidence had disappeared. Research showed that an etching by J.S. Cotman, made in 1820, was a reliable basis for a reproduction by the sculptor

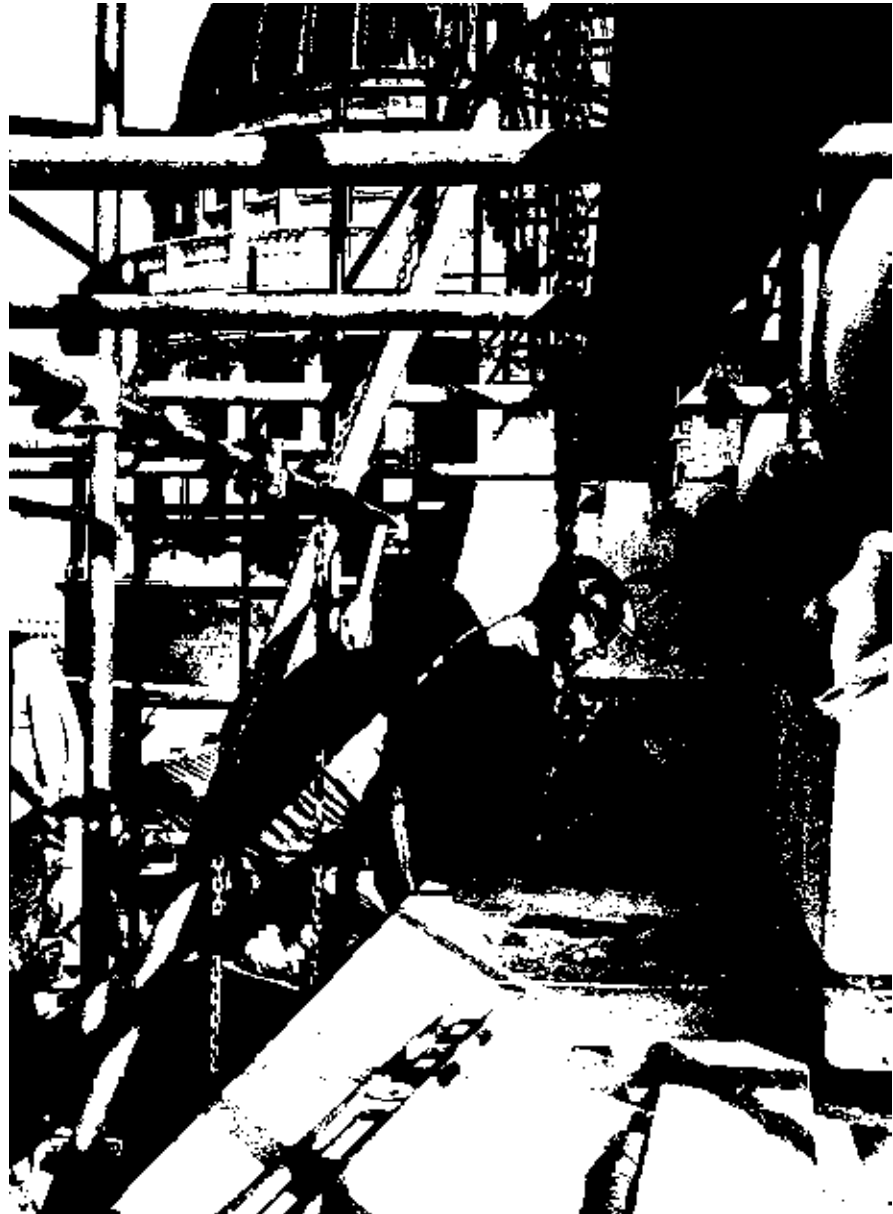
(Courtesy: Feilden & Mawson)

The cornices of St Paul's protect all the other masonry and so are the first line of defense against the effects of atmospheric pollution which is dissolved in rain water or condensation. After over 250 years many stones were defective and had to be replaced. A large stone has been lifted 50 m (164 ft) and is then carefully lowered into place, then grouted and pointed and protected with lead. Handling such heavy stones weighing up to a ton needs great skill, the prerogative of the mason, and also strong scaffolding

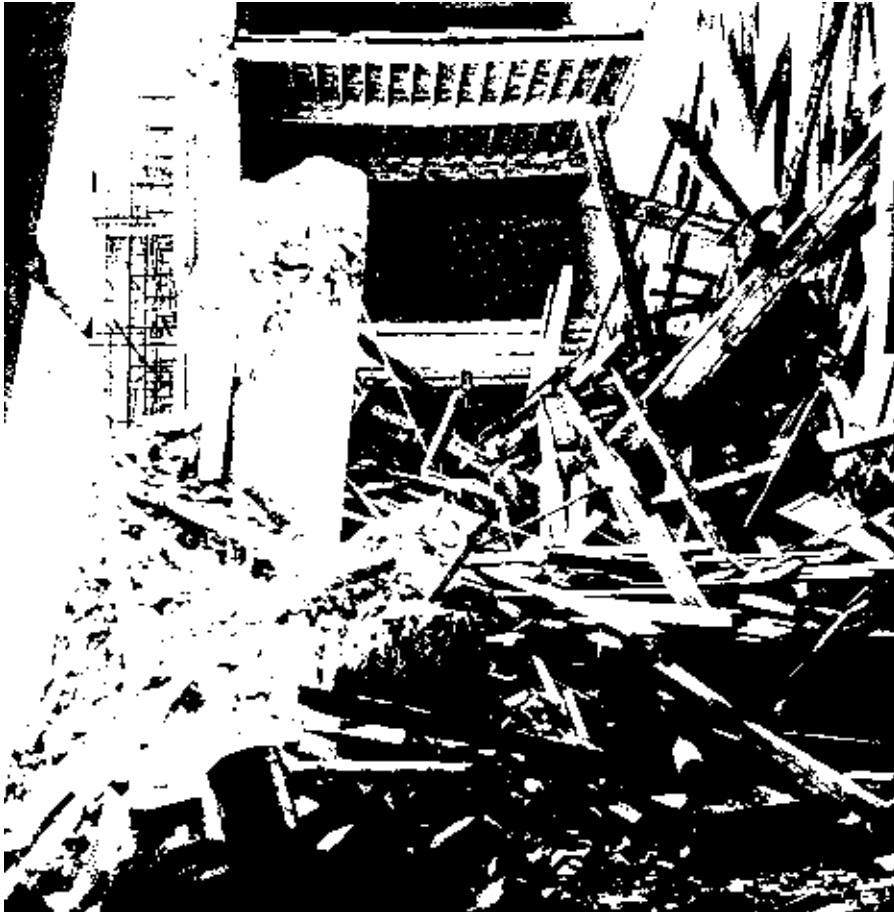
Figure 2.1 Ospizio di San Michele, Rome, Italy

This section collapsed less than 24 hours after it was declared unsafe by the author on 31 March, 1977. The basic cause was bad workmanship. The evidence of imminent collapse was a new bulge in the wall between two windows. The pattern of collapse tells much about the condition of the structure

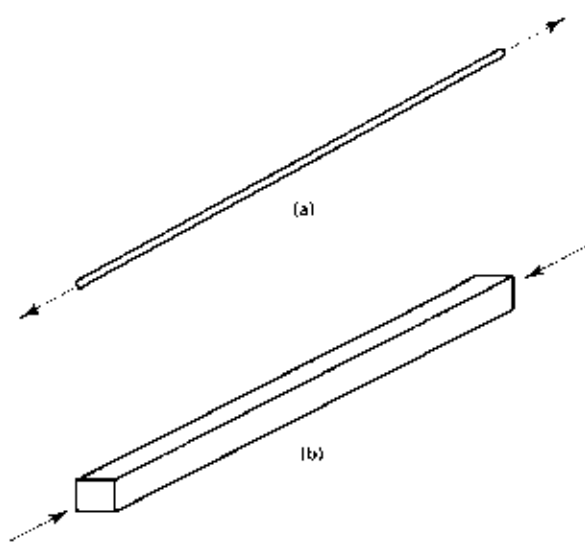
Figure 2.2 Types of loadings—(a) tension and (b) compression

Arrows indicate the direction of the applied force. Dotted lines indicate tension or pulling apart. Solid lines indicate compression or pushing together. Tension requires positive joints

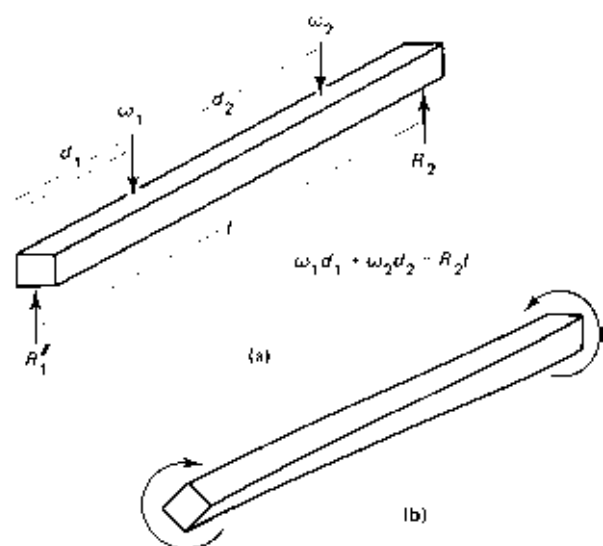
Figure 2.3 Types of loadings—(a) bending and (b) twisting

In bending, applied loads some distance from the end of a beam cause equal and opposite couples in their own plane. Twisting is caused by equal and opposite couples

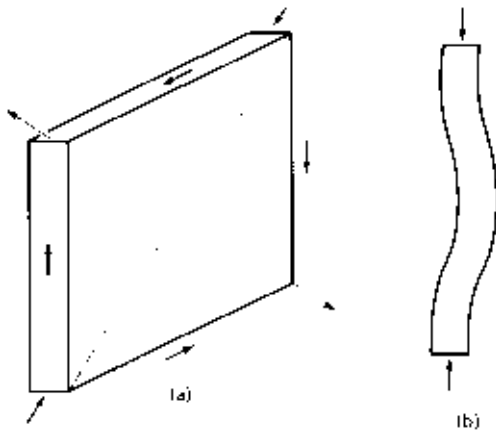
Figure 2.4 Types of loadings—(a) shear and (b) buckling
(Based on R.J. Mainstone)

In shear, one part tends to slip over the other along the shear line (shown dotted). Buckling is a sign of overloading in members that are not sufficiently stiff

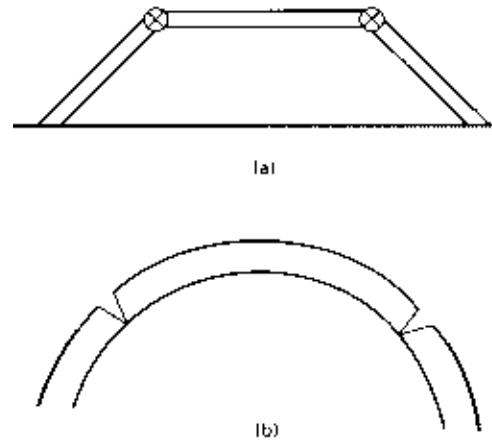
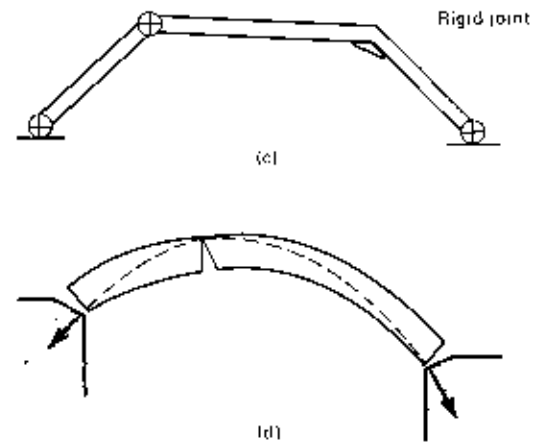
Figure 2.6 Examples of stable structures
(Based on R.J. Mainstone)

- (a) Two-hinge frame with ends fixed
- (b) Cracked arch with firm abutments and two fractures at quarter-span
- (c) A three-hinge frame
- (d) A deformed arch having three cracks with one abutment that has settled. Note that the line of thrust must go through the hinges

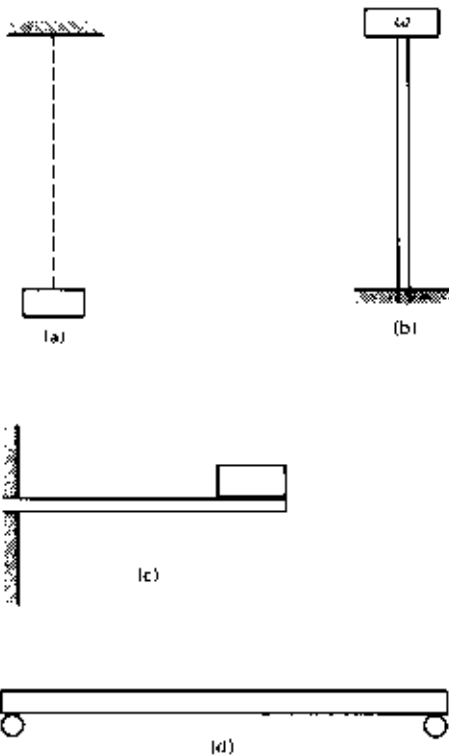
Figure 2.5 Determinate types of stability
(Based on R.J. Mainstone)

- (a) Suspension
- (b) End fixity
- (c) Cantilever
- (d) Beam on two supports

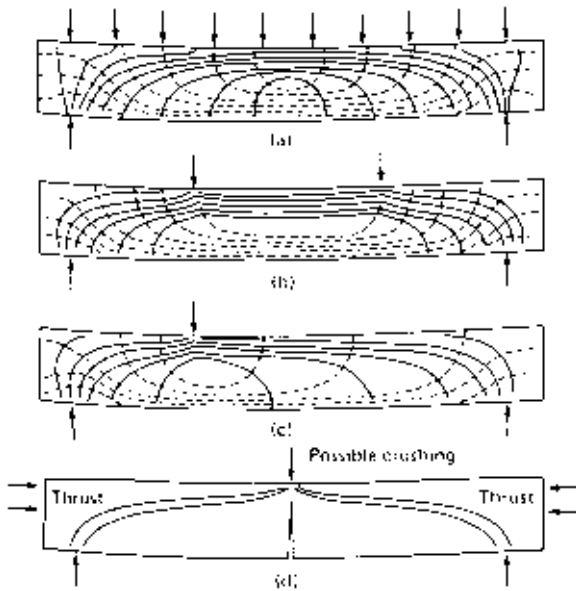
Figure 2.7 Isostatics of a beam
(Courtesy: R.J. Mainstone)

Isostatics are contour lines of tension (shown dotted) and compression (shown solid). The closeness of the contours indicates the intensity of stress. Where lines cross, shear occurs. It can be seen that tension is greatest in the bottom and compression in the top of the beam at mid-span. Shear is greatest at the ends.

- (a) Uniformly distributed loading
- (b) Two-point loads
- (c) One-point load
- (d) One-point load with crack

The occurrence of the cracks causes the beam to become an arch, only dealing with compressive stresses. Lateral thrusts are now required to retain it in position. Local crushing may occur

The calculation of stresses in complex indeterminate structures is an extremely difficult task. The master builders of the Middle Ages and the architects of the Renaissance had only practical and empirical, not theoretical, knowledge of the forces involved in their buildings; but a cathedral which survives several hundreds of years is clearly the work of a good builder. The typical Romanesque and Renaissance structure is 'cavernous', i.e. a mass, as it were, hollowed out. Its aim was to disperse forces as much as possible. Walls were pierced to admit light only with caution, and vaulting and domes were designed so as to disperse rather than concentrate forces. The Gothic system conversely was to concentrate forces into frames of stone, and a cathedral was required to be as tall and light as possible. Viollet-le-Duc says that 'from the moment that the flying buttress was clearly expressed in the building the structure of the (Gothic) cathedral developed'. Isostatic diagrams help one to visualize stress distributions (see *Figures 2.7* and *2.8*).

Just as a beam conceals within itself the action of an arch, so slabs contain the actions of shells and membranes. The directions of principal stresses, as shown earlier in *Figure 2.7*, of compression (thick lines) and tension (dotted lines) are known as isostatics. These give a picture of typical situations that will enable visible evidence to be understood and interpreted. A simply supported beam (free to rotate about the supports at its ends and to expand or contract longitudinally) is an element acting in bending, compression and in shear. In carrying any particular sets of loads, *a*, *b* and *c*, it is equivalent to a family of arches (compression) associated with an orthogonal family of catenaries (tension). These internal arches and catenaries adjust themselves within the beam to each change in the loads. When the beam cracks due to weakness in tension, as often happens with stone, the situation changes and the beam then acts mainly as an arch and produces outward thrusts. The beam may also fail in shear and for this reason, in the Near East and Italy, masonry flat arches were often built with joggled joints, to give greater earthquake resistance.

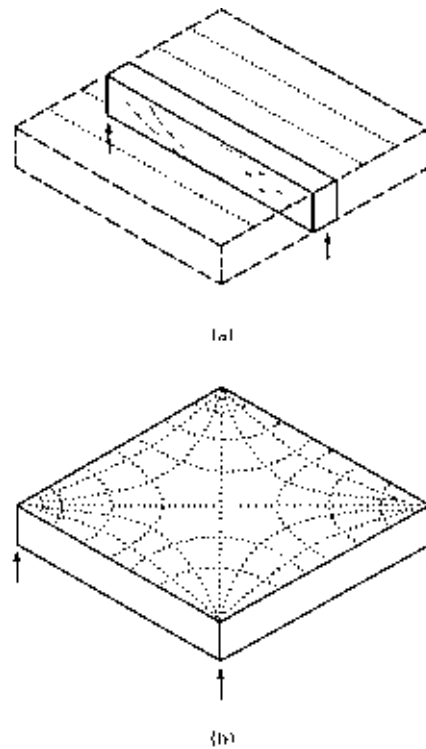
Figure 2.8 Isostatics of a slab
(Courtesy: R.J. Mainstone)

- (a) *A slab reinforced in one direction may be considered as a series of parallel beams*
- (b) *A slab reinforced in two directions set on four supports. For simplicity, only tensile stresses are shown, but compressive stresses are equal and opposite. The stress pattern is remarkably like the pattern made by the ribs of a Gothic vault which, by using arched forms, removes the need for positive joints having tensile resistance but which generates outward thrusts*

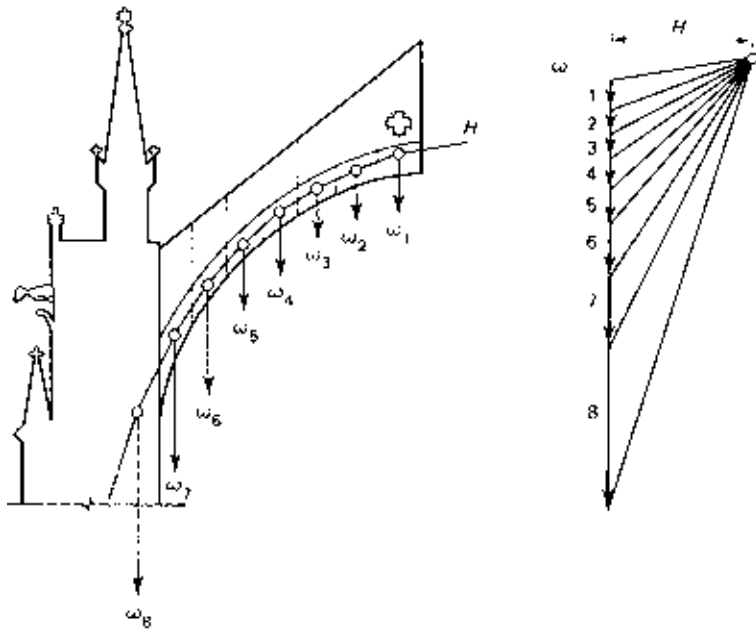
Figure 2.9 Graphical analysis of forces in a Gothic flying buttress
(Courtesy: Ove Arup & Partners)

The horizontal thrust must be known and the weights of each section calculated. The line of thrust can then be drawn from the diagram on the right. If the line comes outside the masonry, tension is indicated and this may lead to collapse

The outward horizontal stresses resisted by the flying buttresses may be as low as 10.30 kN/m² (1.5 lbf/in²) on single-arch buttresses and as high as 150 kN/m² (22 lbf/in²) on double-arch buttresses such as those at Notre Dame in Paris. The horizontal stress is caused by thrust from the roof and vault structures and by wind loading, which is variable. Flying buttresses have minimum and maximum horizontal loads imposed upon them, depending upon the direction and intensity of the wind, but function as long as the lines of thrust are within the masonry arch. A graphical method of analysis is shown in *Figure 2.9*.

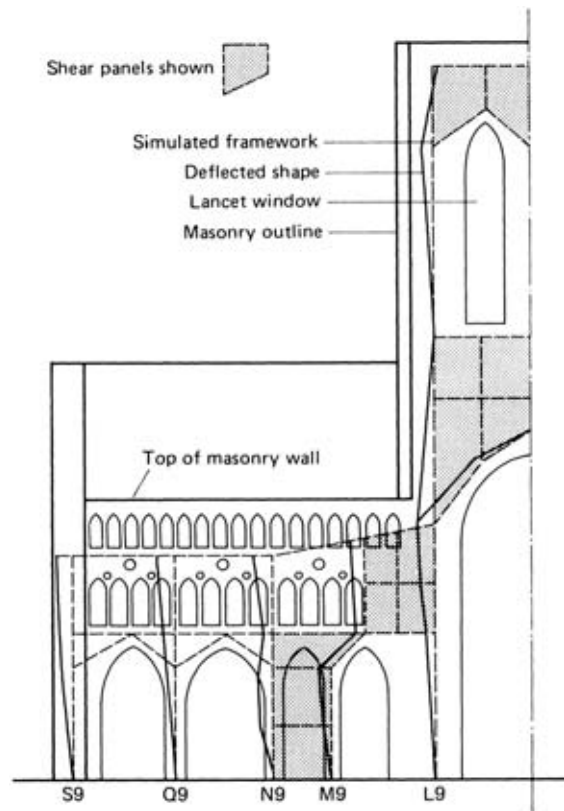
Figure 2.10 Shear panel computer analysis of York Minster's central tower

Calculated deflections of the central tower and transept due to gravity loads acting on an uncracked simulated structure were found by computer analysis

Ove Arup and Partners used a shear panel convention to simulate the structure of the central tower of York Minster, and by this means were able to calculate the loads of the lines of thrust with the help of a computer (*Figure 2.10*). The lines of thrust showed eccentric loading on the foundations; this was one of the main causes of subsidence and associated danger to the superstructure. Likewise, calculations showed an eccentric line of thrust at the east end which had to be rectified by insertion of new foundations. The choir piers at York, which are of solid ashlar construction, were not rebuilt but only refaced after the fire of 1829; the central tower pier has an eleventh century rubble core with thirteenth century additions, all encased in a ring of rubble masonry, with a thin skin of fine ashlar executed in three or four phases in the fifteenth century and damaged by fire in 1829 and 1840. With such variables it is difficult to calculate the actual loadings on the masonry, for who can tell how much load is taken on the core with up to 70% mortar content and on the outer casing with about 3% mortar content? However, the average loadings are 3900 kN/m² (36 tonf/ft²) in these main piers. In the arcade piers of the nave and choir they are 4200 kN/m² (39 tonf/ft²) and in the piers under the western towers they are 6000 kN/m² (56 tonf/ft²). Similar loadings occur at Milan Cathedral. Salisbury is reported to have a loading of 4800 kN/m² (45 tonf/ft²) under the central tower and spire, whereas loads at Beauvais of 1300 kN/m² (12 tonf/ft²) in the 6 m² (65 ft²) piers and at Norwich Cathedral of 1400 kN/m² (13 tonf/ft²) in the main tower pier are not quite so heavy. It may be helpful to keep in mind the figures for these loadings when making a visual inspection.

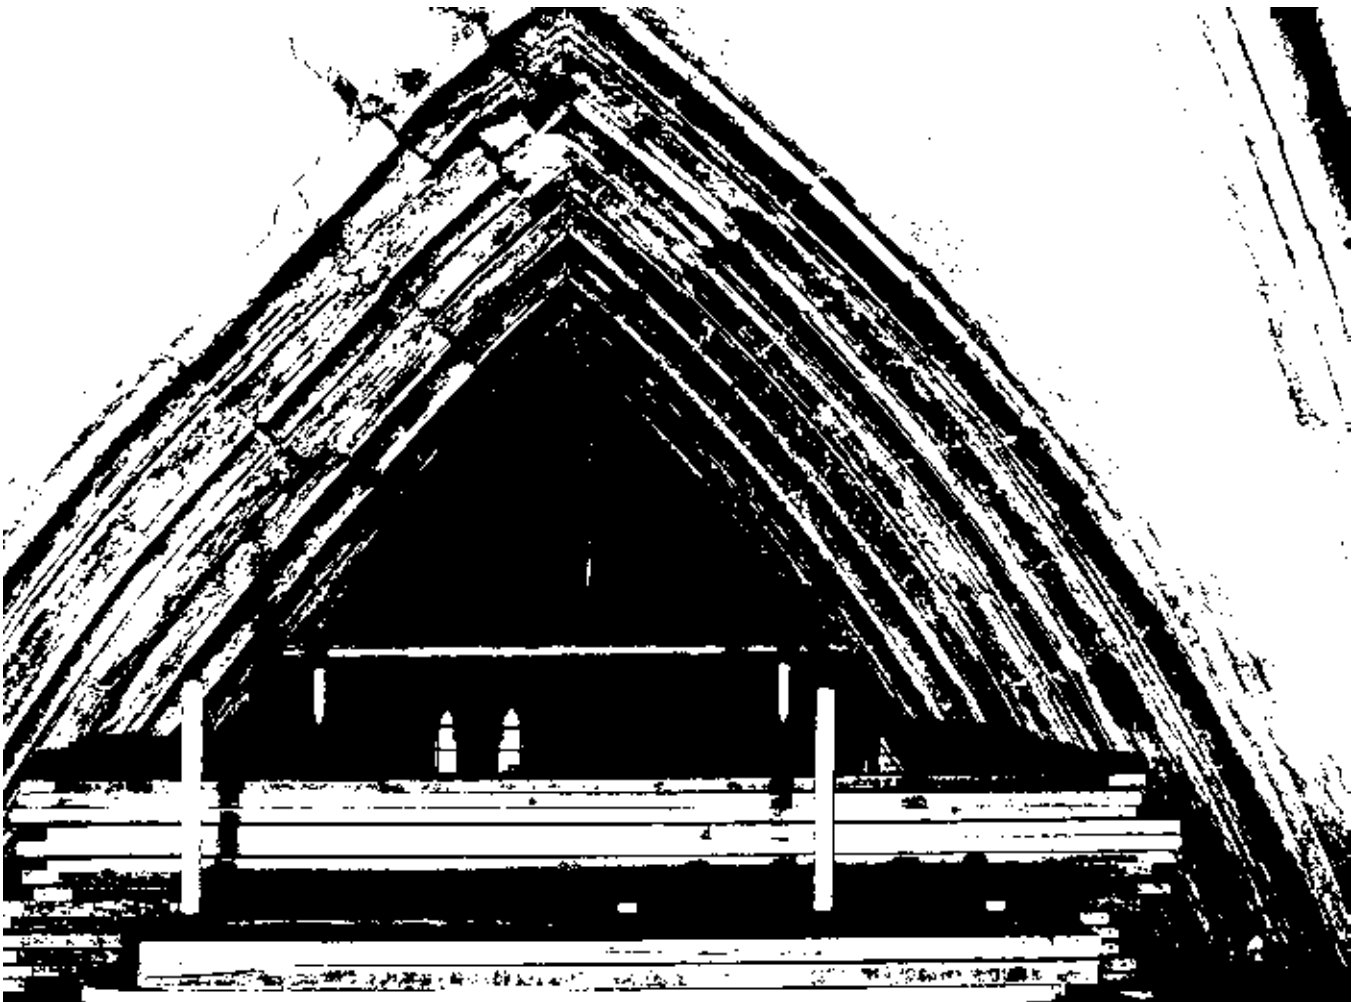
Figure 3.1 Transept arcade arch, York Minster, England
(Courtesy: Shepherd Construction Ltd, York)

The thirteenth century arch has been severely damaged by the settlement of the central tower. The top part had to be rebuilt, which work revealed an earlier eleventh century window opening

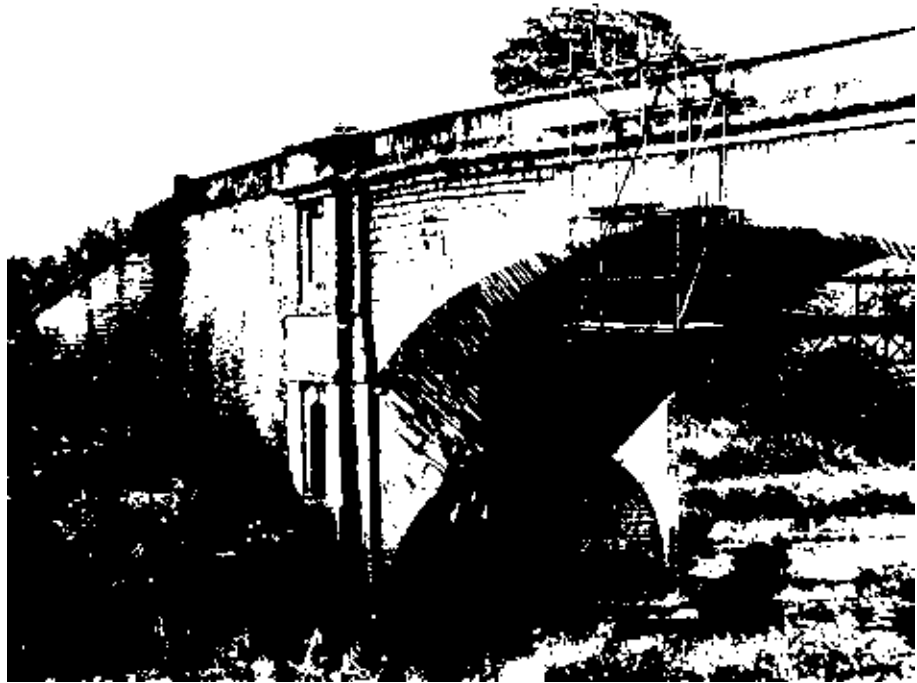
Figure 3.4 Over Bridge, Gloucester, England

Because there were cracks at the quarter-span and the bridge sagged at its apex, where there was also a horizontal crack, the road authorities had signed a contract to blow up this magnificent bridge of 45.5 m (150 ft) built by William Telford. Due to early settlement of the east abutment the bridge had in fact 'binged' at the quarter-spans. Examination of the abutments showed that they were still perfectly sound. The authorities were persuaded to keep the bridge as an ancient monument

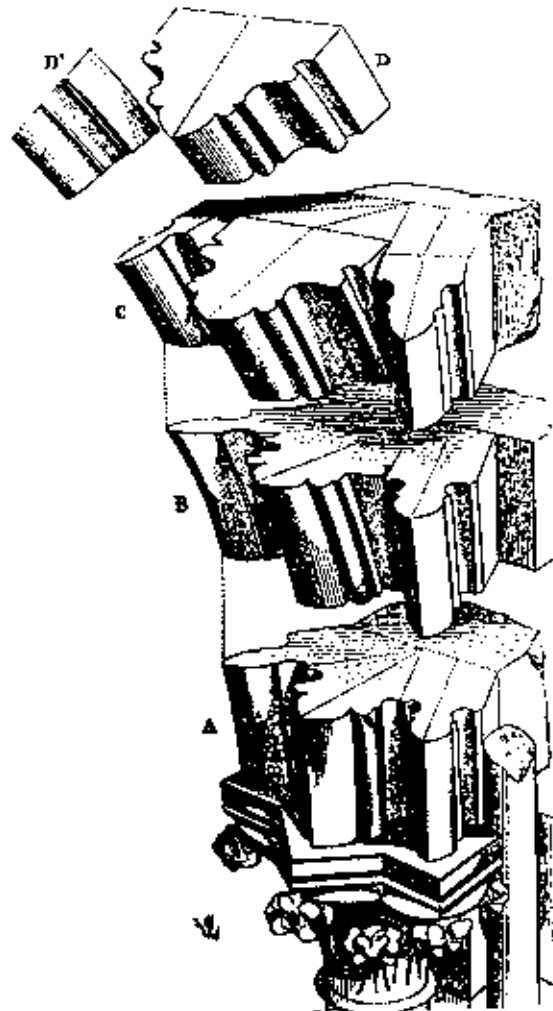
Figure 3.7 A 'tas de charge'

The setting out of such stones needs a master in solid geometry and was done full size on a tracing floor making templates for each stone. Note that stones A, B and C are bonded integrally into the outer wall

planning; and thirdly, they reduced the need for centring. After the stone facing had been placed, vaults were frequently thickened with a backing of brick or lime concrete, in which case the rib lost its structural function and in time might fall away from the vault. Loose ribs are met fairly frequently in Gothic construction. On the other hand, if thin, the vault itself might fall, leaving only the diagonal ribs and transverse arches standing. The care with which the masonry of vaults was designed is shown in *Figures 3.7 and 3.8*, taken from Viollet-le-Duc's book on construction.

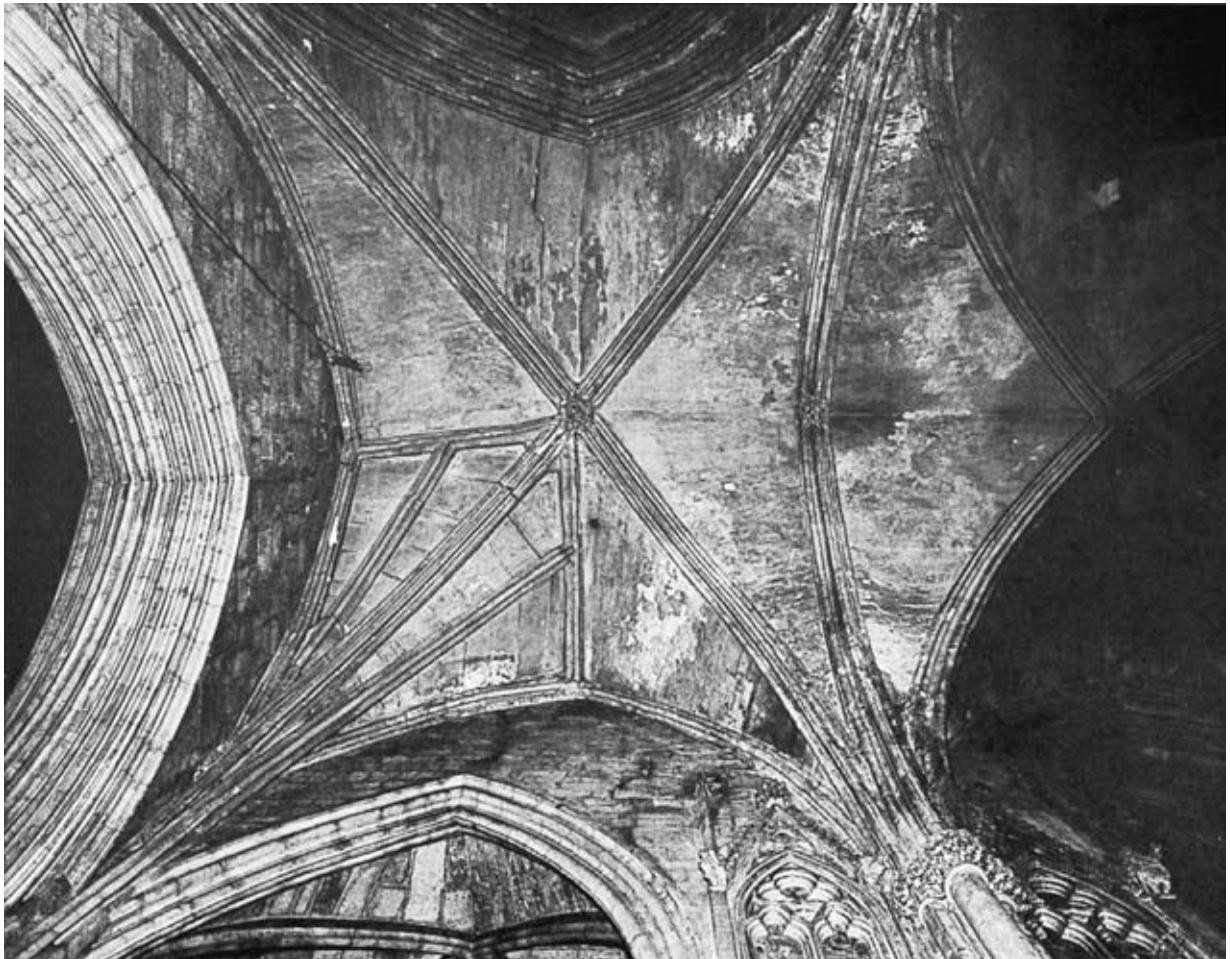
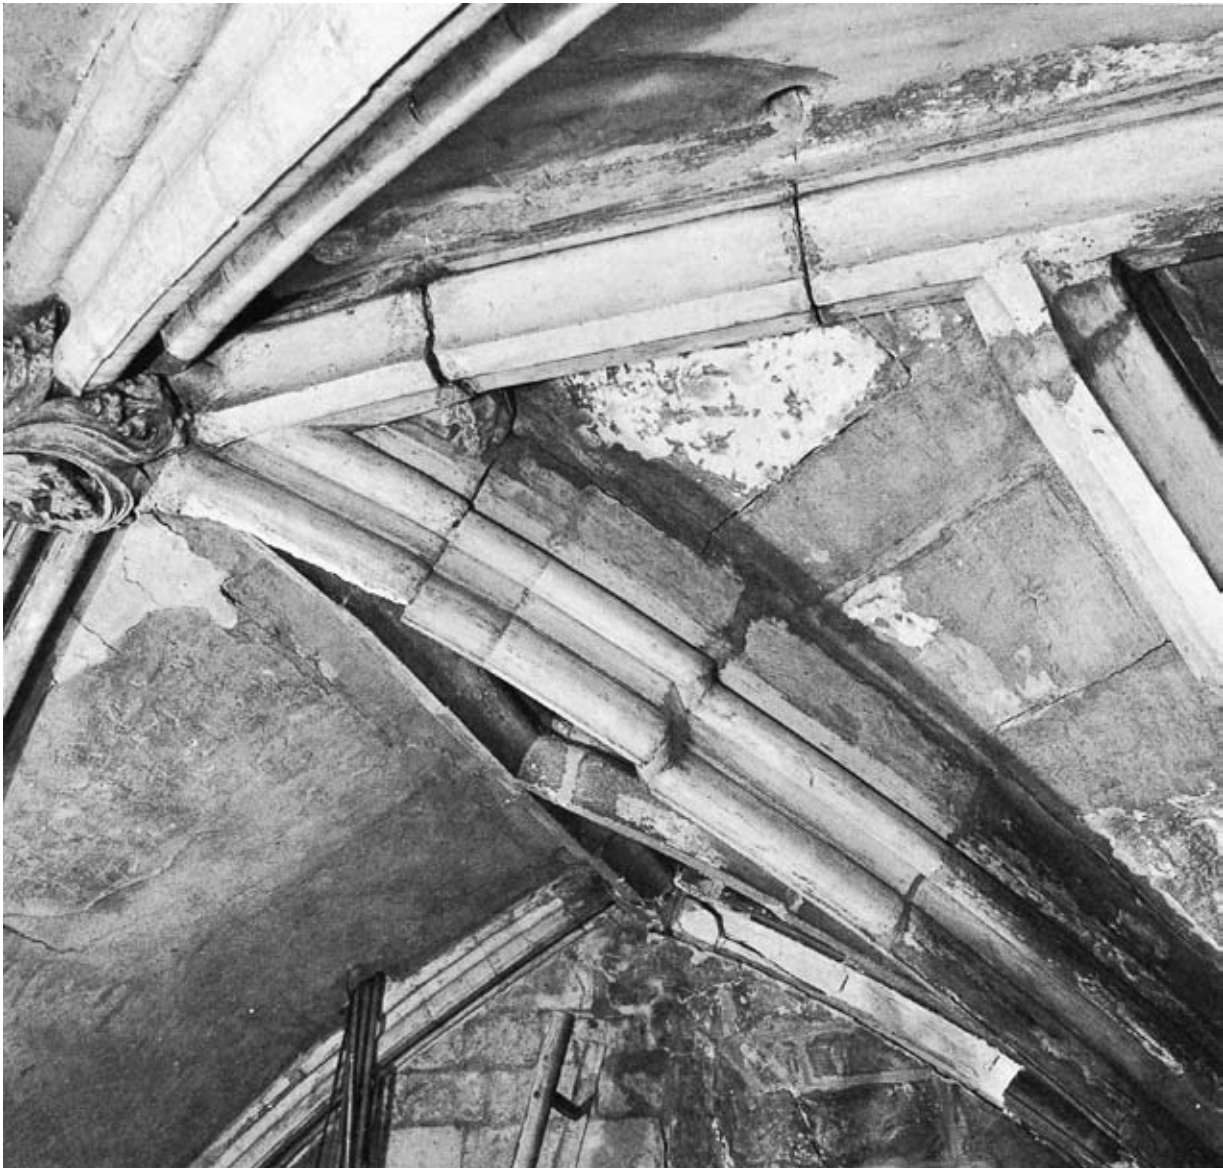
Figure 3.10 North nave aisle vault, York Minster, England
(Courtesy: Shepherd Building Group Ltd)

A general view of the vault adjacent to the north-east pier of the central tower. Severe defects, resulting from the settlement of the tower, can be seen in the ribs and panels

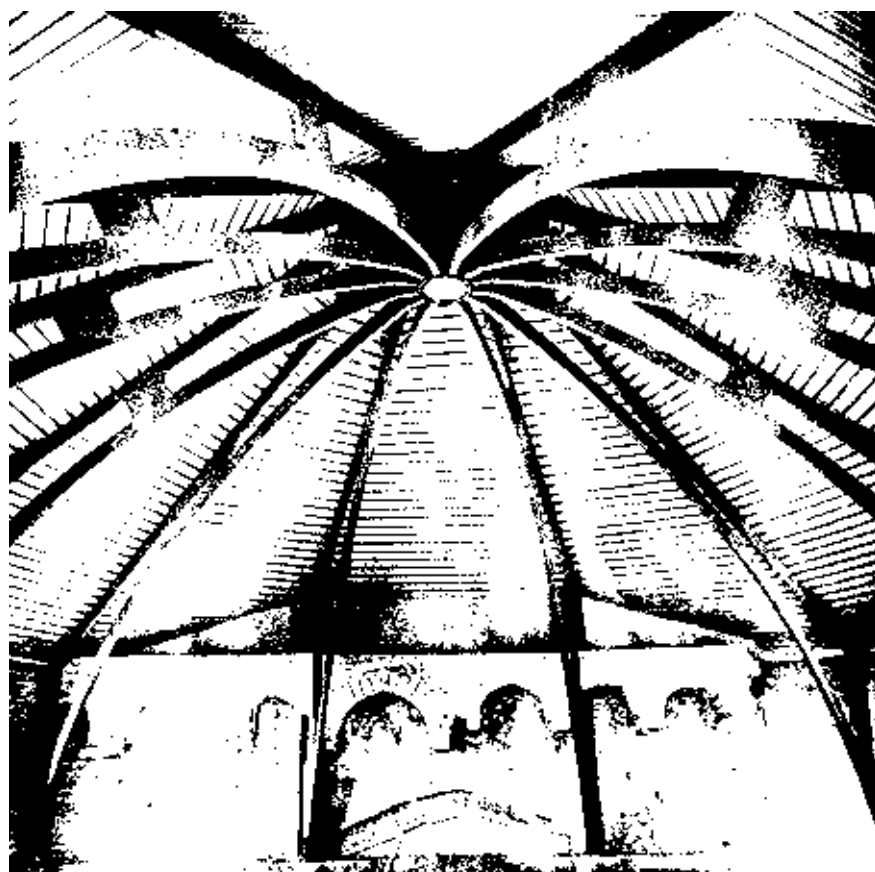
Figure 3.12 Vault over choir of Naples Cathedral, Italy
(Courtesy: R. di Stephano)

After wartime bomb damage, the roofs had to be reconstructed. An elegant arched ribbed dome in welded steel was devised to support the metal deck on which the roof tiles rest
