Conservation of Historic Buildings

*Conservation
of Historic Buildings*
Third edition

Bernard M. Feilden

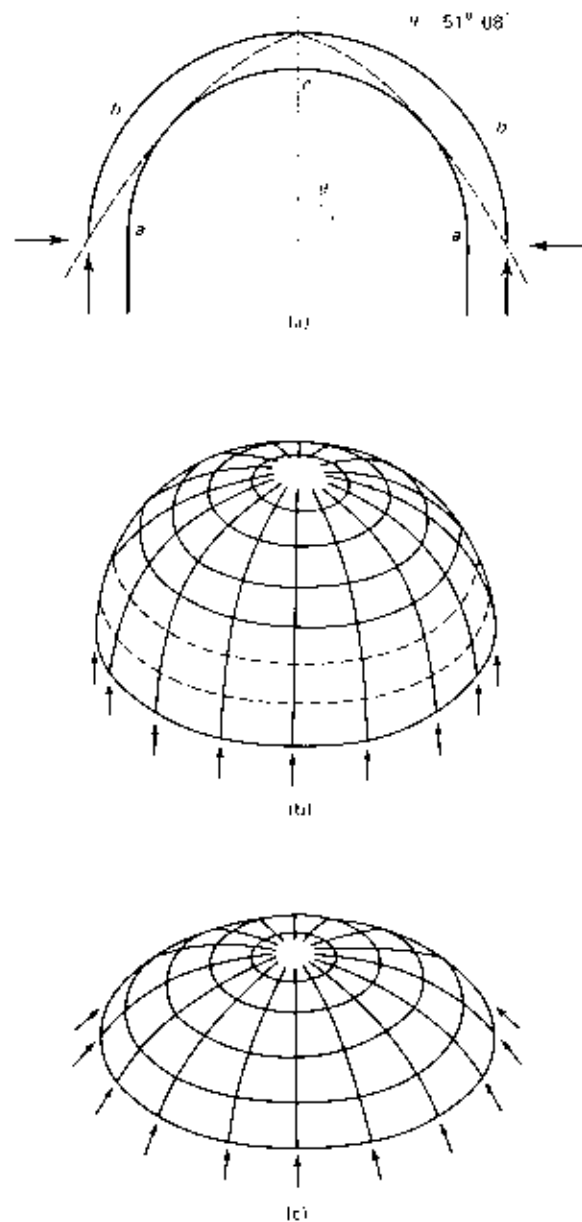
Figure 3.13 Spherical domes
(Courtesy: Allen Lane and Penguin Books)

- (a) Geometry of a hemispherical dome. Early domes were thick because the action of tension in the lower part at below θ° was not fully appreciated. Tension rings were inserted in the lower parts
- (b) The isostatic diagram shows the zone where tension occurs
- (c) In flat domes with no part below θ° no tension occurs, but much greater thrusts are imposed on the abutments

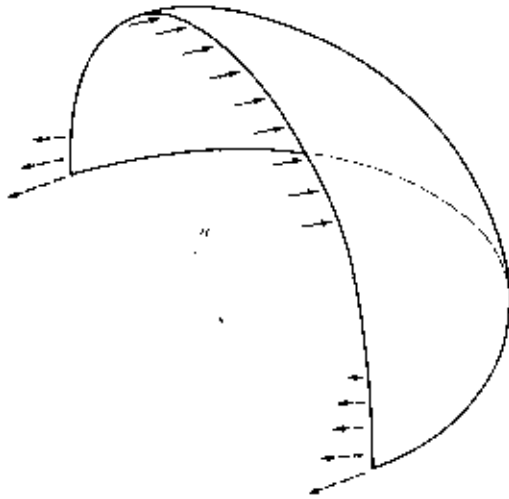
Figure 3.14 Actions of hemidomes

A half-dome may be considered exerting compressive pressure in the upper part and tension in the lower part when an element in the whole structure

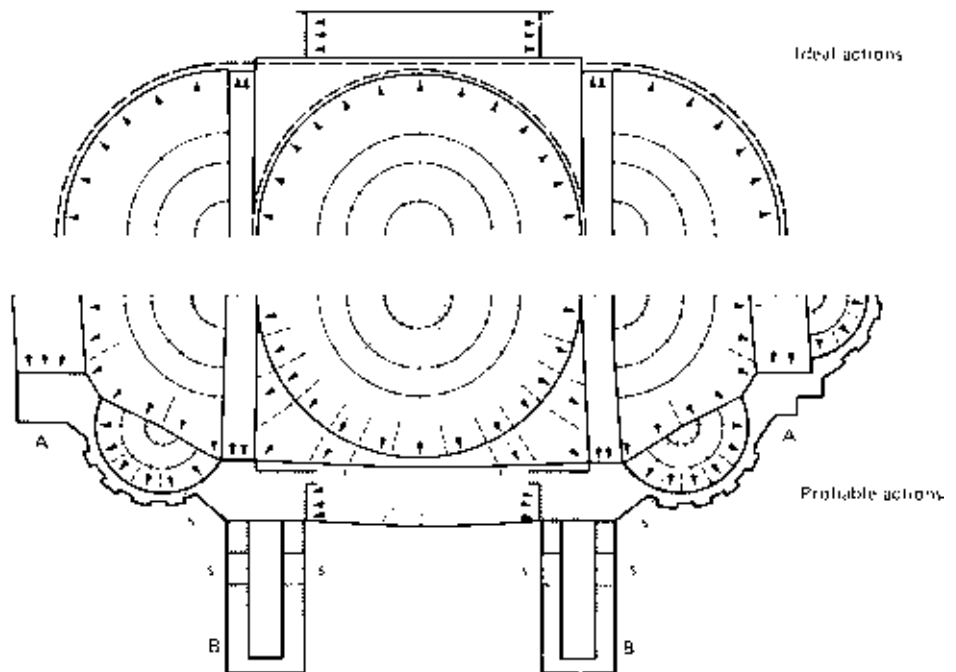
Figure 3.15 St Sophia, Istanbul, Turkey: part plans of the superstructure

Above—the dome and semidomes and main north arch shown with their outward thrusting actions contained, ideally, by cramped string-courses at the springing levels acting as continuous ties. Below—the probable actual behaviour with associated tensile cracking, shear failures and major deformations. Light continuous lines show the directions of the principal compressions (thrusts), heavy broken lines indicate ties, light broken lines indicate tensile cracking, and s—s denotes the approximate location of a shear failure. For simplicity, no account is taken of the window openings in the dome and semidomes, and the exedrae semidomes are omitted from the upper drawing, but the representation of the probable actual behaviour does take into account the progressive nature of the deformations as construction proceeded

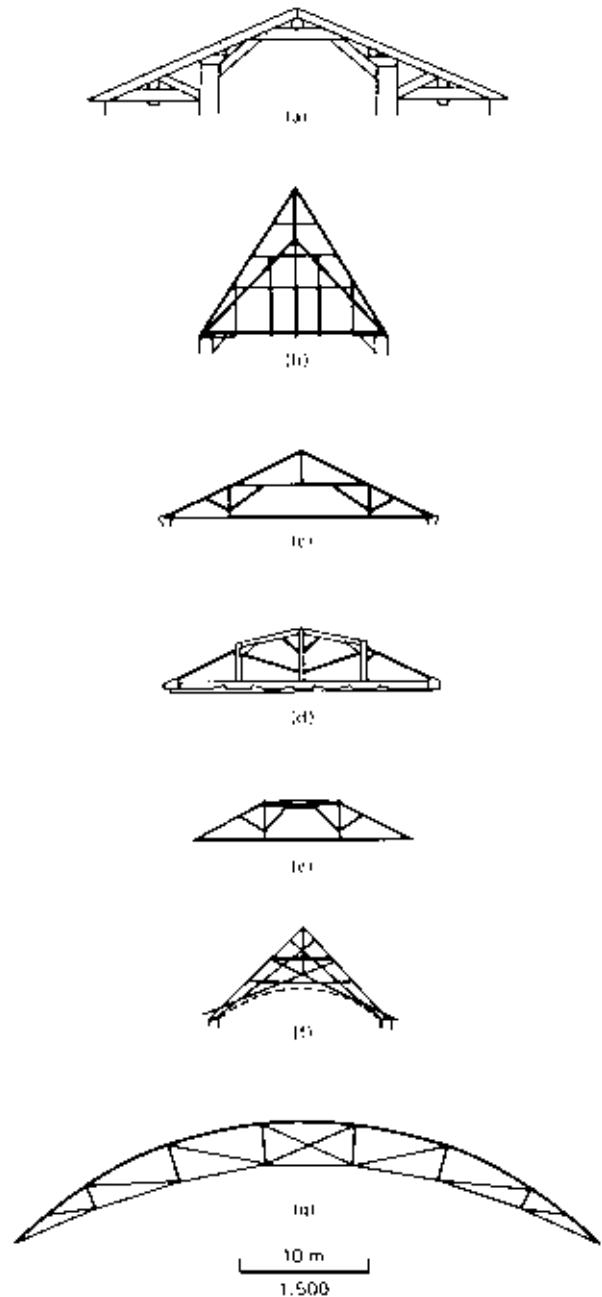
Figure 4.1 Roof trusses from the second to the nineteenth century

- (a) *Pantheon, Rome, Italy—second century*
- (b) *Notre Dame, Paris—thirteenth century*
- (c) *Theatro Olimpico, Vicenza, Italy—sixteenth century*
- (d) *Sheldonian Theatre, Oxford, England—seventeenth century*
- (e) *Royal Hospital, Greenwich, England—eighteenth century*
- (f) *Church at Steinbach, Federal German Republic—eighteenth century*
- (g) *Lime Street Station, Liverpool, England—mid-nineteenth century*

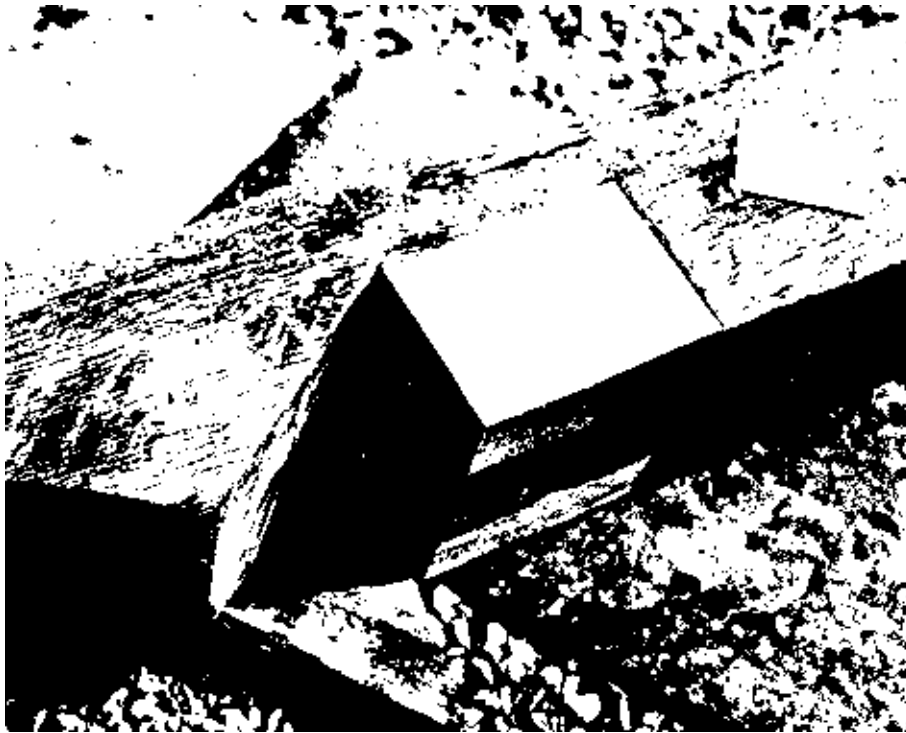
Figure 4.4 Baguley Hall, Manchester, England

Roof timber repairs. A roof rafter having the minimum amount of new oak inserted in order to make good a tenon joint. Dismantling is necessary for this work, but by restoring the joints the structural integrity of the building is maintained

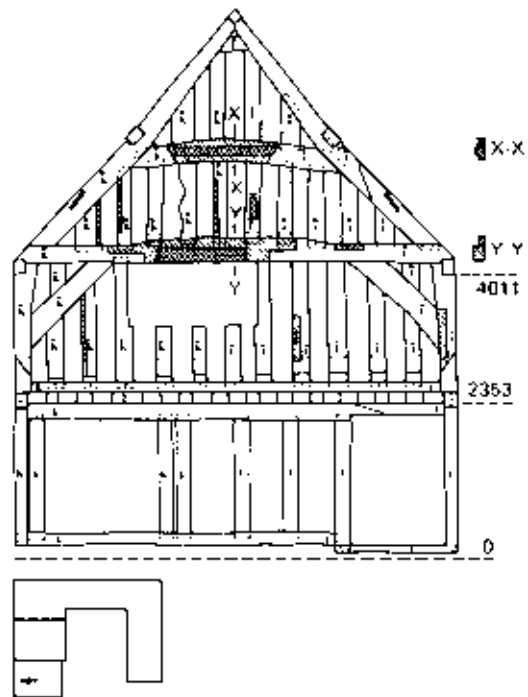
Figure 4.5 Chester House, Knowle, Warwickshire, England

Drawing to be read in conjunction with the timber repair schedule for Truss 1, opposite (Architect: F.W. Charles)

Timber repair schedule—Truss 1 (see Figure 4.5)

Dimensions are given gross, allowing for tenons and cutting to waste after checking dimensions on job. Mortices in members are not generally noted—refer to drawings. New timber only is given

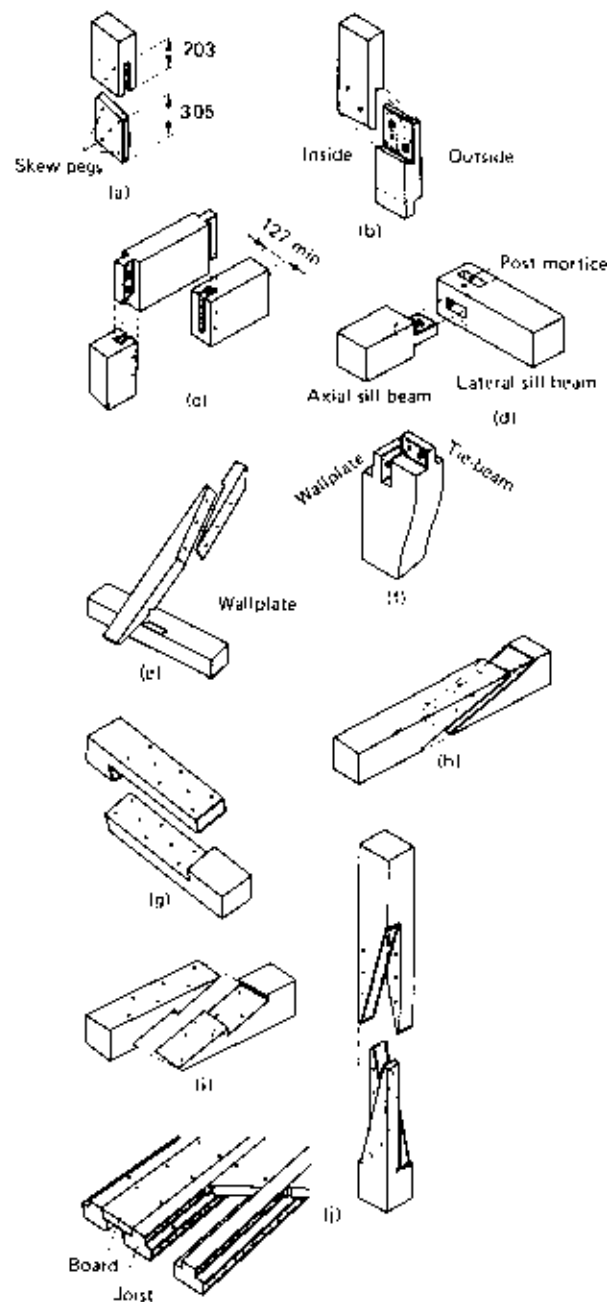
Figure 4.6 Chester House, Knowle, Warwickshire, England
(Courtesy: *Architects' Journal* and F.W. Charles)

Timber carpentry joint details used by the architect in repair work:

- (a) Slip or fish tenon for studs, rods, etc.
- (b) Repair joint for studs only
- (c) Dovetailed tenon inset for collar or tie-beam
- (d) Sill beam joint
- (e) Face-splayed scarf for rafters
- (f) Post head—wallplate and tie-beam joint
- (g) Edge-halved scarf—vertical, horizontal or inclined member, minimum length: $\text{depth} \times 3$
- (h) Scarf for repairing horizontal members, minimum length: $\text{depth} \times 2$
- (i) Tabled scarf—beams and joists with both end fixed skew-pegged, minimum length: $\text{depth} \times 2.5$
- (j) Scissor scarf for repairing posts, minimum length: $\text{depth} \times 2.5$

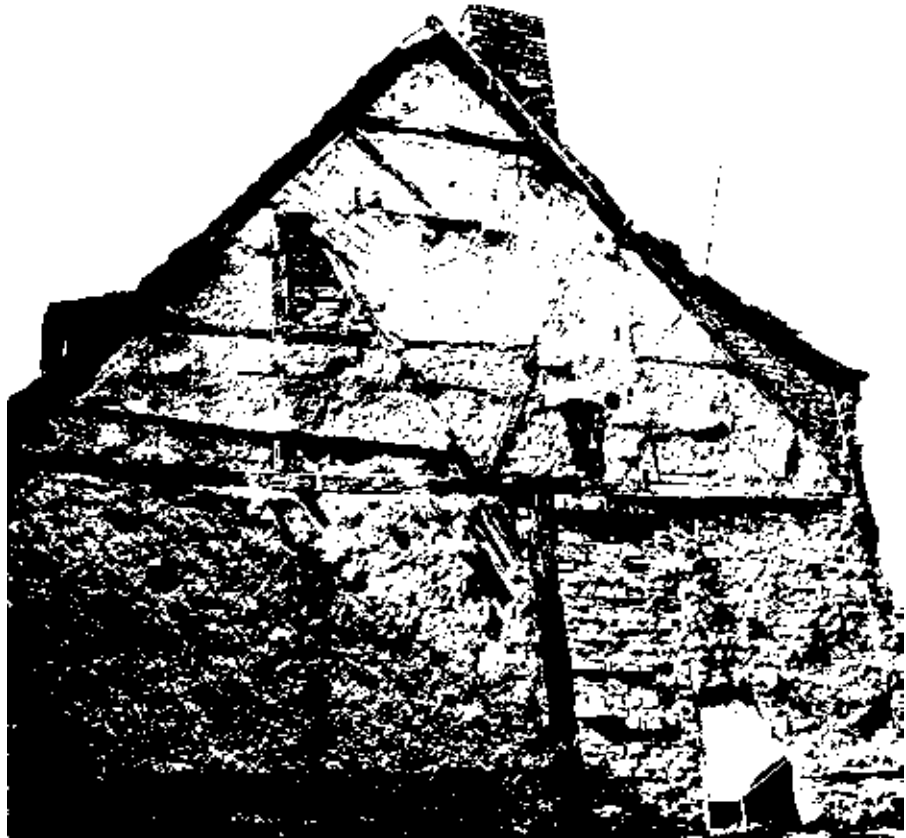
Figure 4.7 Gable of house in Weimar, Germany

Timber framing and various types of infill including brick and wattle and daub used in a typical mediaeval house

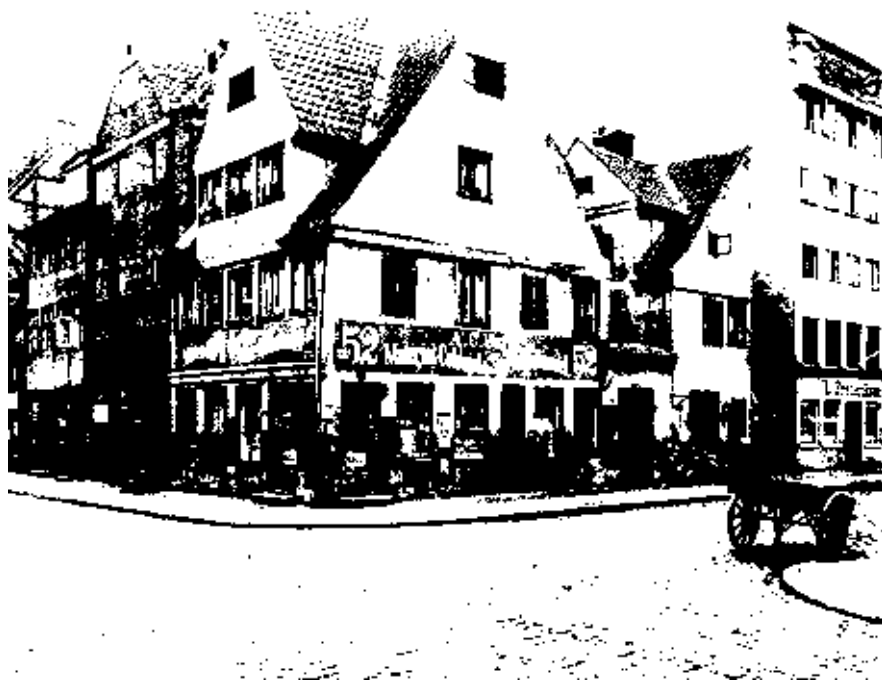
Figure 4.8 Three houses, Christianshavn, Copenhagen, Denmark

Although condemned in 1960, these mid-eighteenth century timber-framed houses were economically conserved in 1975. Roofs had to be reconstructed and windows to a great extent renewed, and external plaster had to be removed and renewed

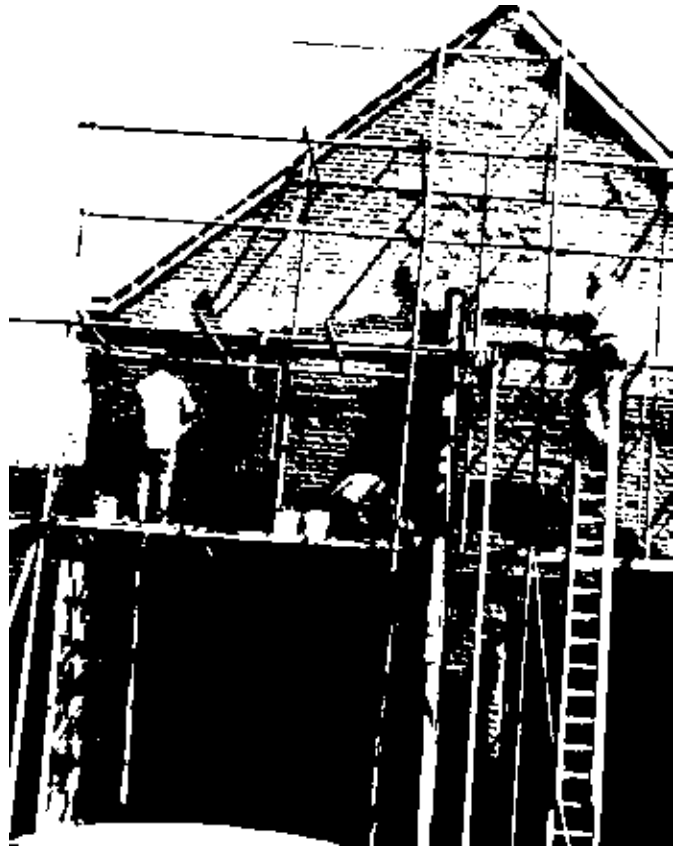
Figure 5.4 Barn gable, Oxnead Hall, Norfolk, England

The gable was leaning outwards and the central pier had settled somewhat after a builder had formed two large garage doors

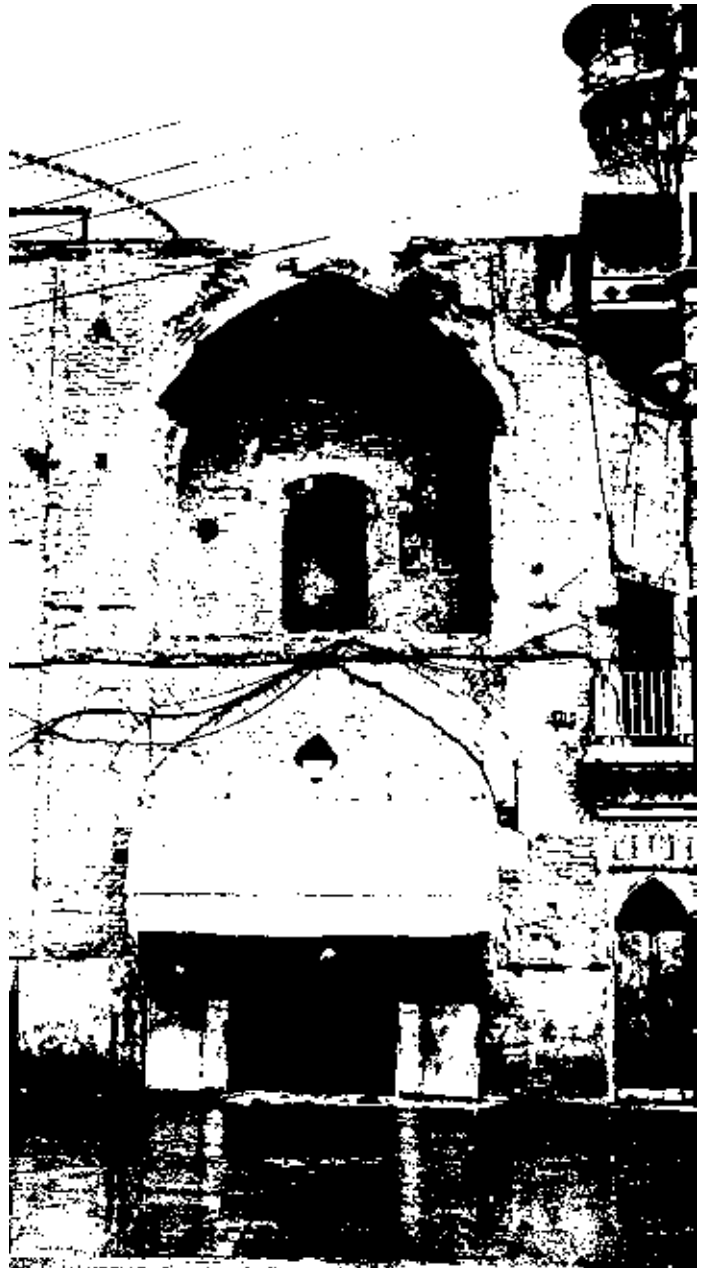
Figure 5.6 The Holy Shrine of Al Abbas, Kerbala, Iraq

The tiles have been stripped off and the parapet removed. Distress in the brick arch is due to two causes: first, pumping of ground water which is removing silt, especially from the corners; secondly, the thermal expansion of the new reinforced concrete porch which expands and contracts quite violently each day with the extremes of temperature. Unfortunately there is no expansion joint between the concrete porch and the wall, so the weak brick arch suffers

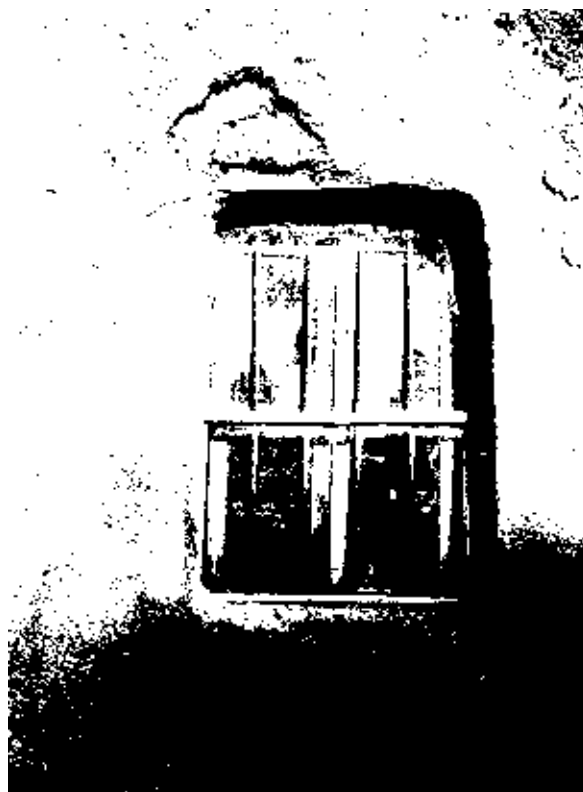
Figure 5.8 Mud plaster wall, Mosul, Iraq

Mud plaster showing the amount of chaff used as bonder

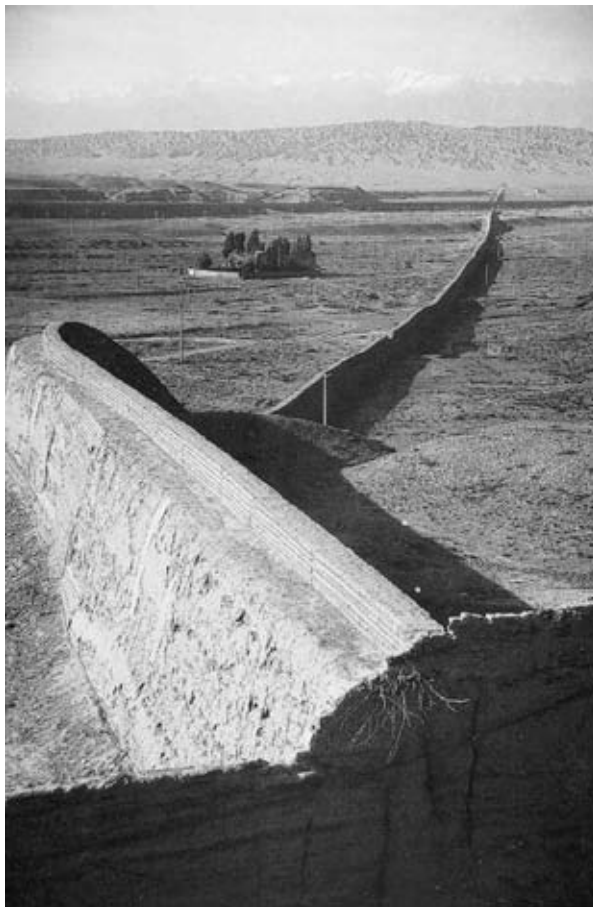
Figure 5.9 The Great Wall of China—the western end at Giau Guan. Famed as man's largest historic construction, the Wall is an earth structure throughout its length, although stone-faced at its eastern end (Courtesy John Warren)

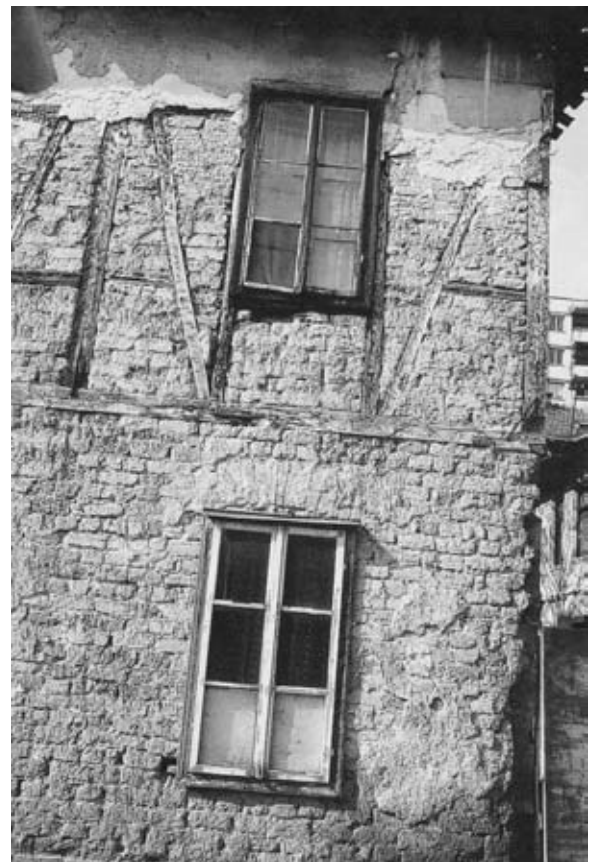
Figure 5.10 Earth construction typical of Europe, the Balkans, through mountainous Turkey, Mesopotamia and the Caucasus to the Himalayas. Here earth block is used in the understorey with a light timber framing above filled with similar block. An outer skin of rendering—stripped from this example—may be used externally

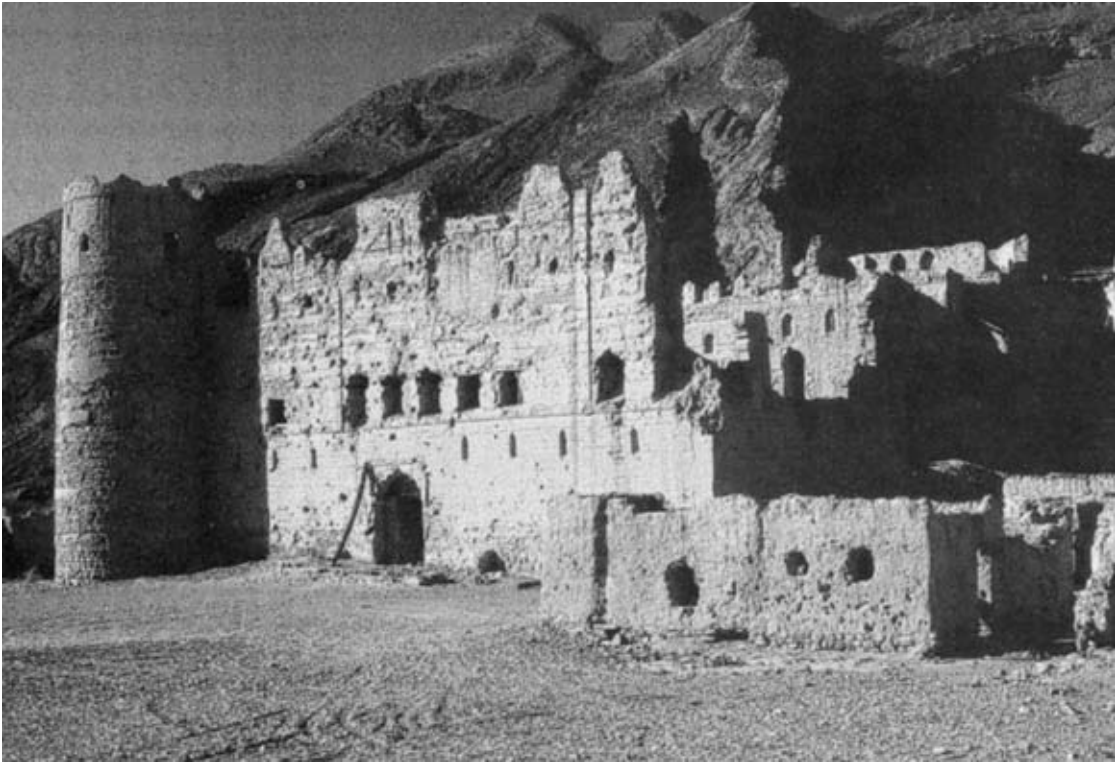
Figure 5.11 A palace at Birket Muz, Oman, rendered uninhabitable by air attack, demonstrating how man is one of the most potent forces of destruction (Courtesy John Warren)

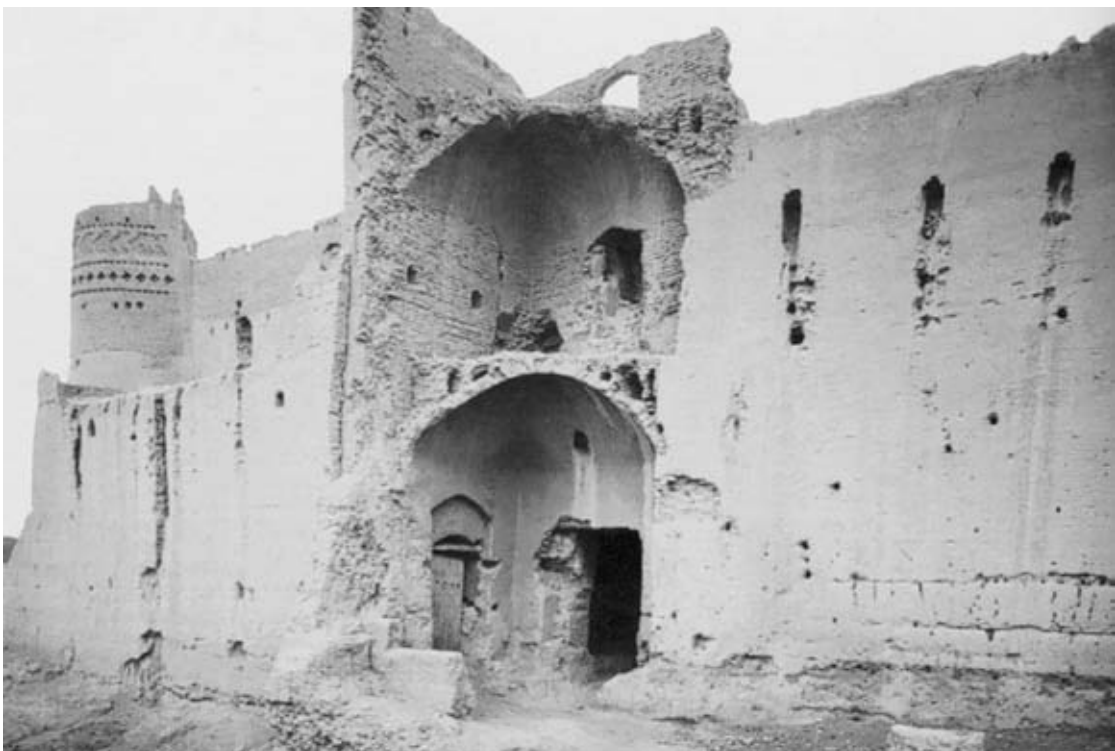
Figure 5.12 Iran: medieval castle at Faraj. The collapse of a double-chambered tower demonstrates the slender cross-sections achievable with the use of squinches and secondary vaulting in the haunches of vaults. These techniques are apparent from the early Middle Ages and precede the structural magic of Persian brickwork (Courtesy John Warren)

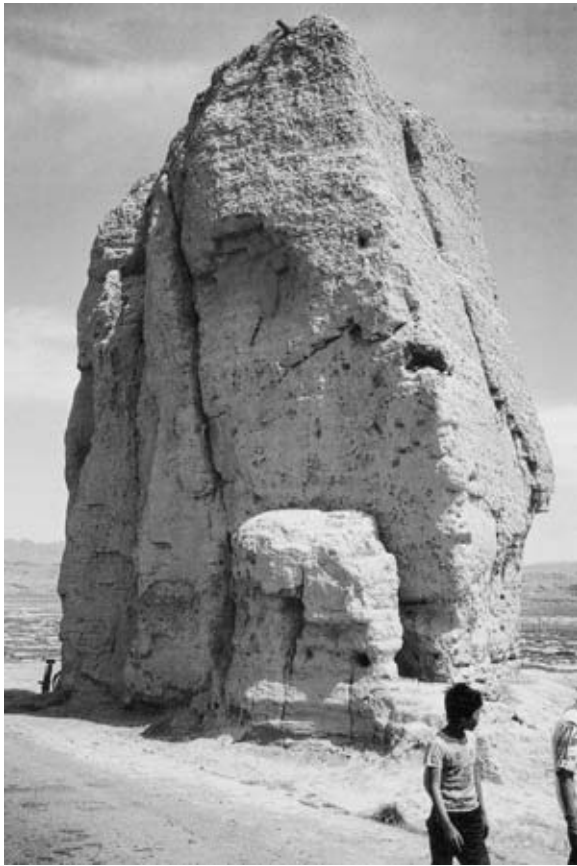
Figure 5.13 A tower, now an isolated fragment of the Great Wall of China, displaying vertical fissuring which causes the loss of segments in vertical slices. The loss of lateral restraint in the lowest zones effectively ‘unloads’ the compression previously applied to the bottom strata by the mass of superimposed earth. The lateral stress-release causes the peripheral mass to form shear cracks parallel to the external surface. This phenomenon is unique to earths, among building materials, due to its compressibility and low shear strength (Courtesy John Warren)

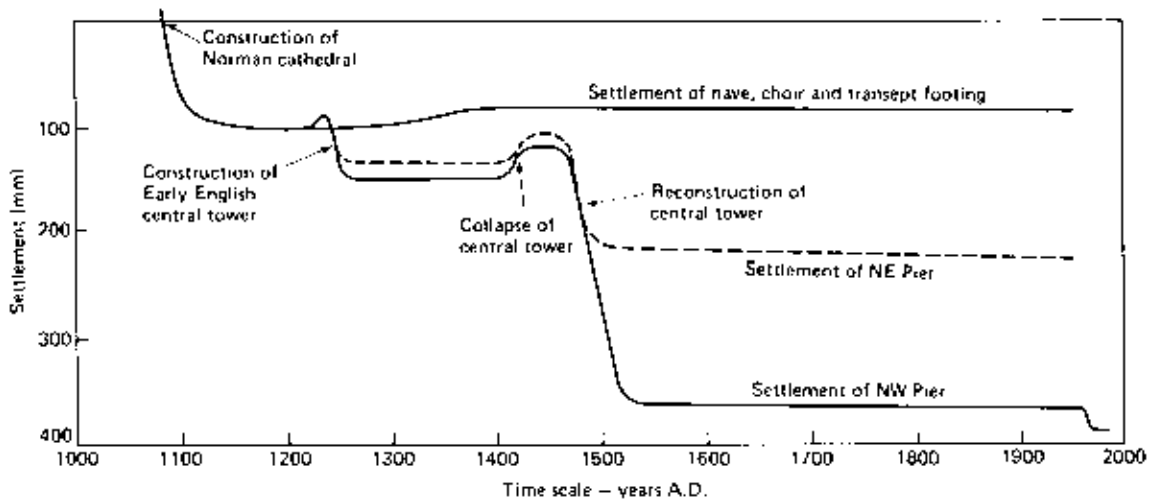
Figure 6.1 Hypothetical reconstruction of settlements since A.D. 1080, central tower, York Minster, England
(Courtesy: Ove Arup & Partners)

Such a diagram combines history and soil mechanics and introduces the fourth dimension of time into structural engineering. After being in unstable equilibrium for nearly four centuries, the foundations of the central tower began to settle again due to lowering of a perched water table

With an architecture of thrust and counterthrust, loads are concentrated on to piers and buttresses enabling the windows to be large, and this means that not only are differential settlements likely unless the original foundations took this into account, but also that they can within reason be accommodated. These settlements may be aggravated by inconsistencies of the bearing capacity of the soil under the foundations which turn straightforward overall settlement into differential settlement, causing distortion and cracking of the superstructure. Very high loadings, up to 800 kN/m² (7 tonf/ft²) have been applied to foundation soils, and loads of 4000 kN/m² (35 tonf/ft²) are not unusual in piers. The ultimate stress of the soil had in fact been reached under the central tower of York Minster before the 1967–72 restoration, so there was a danger of the soil shearing.

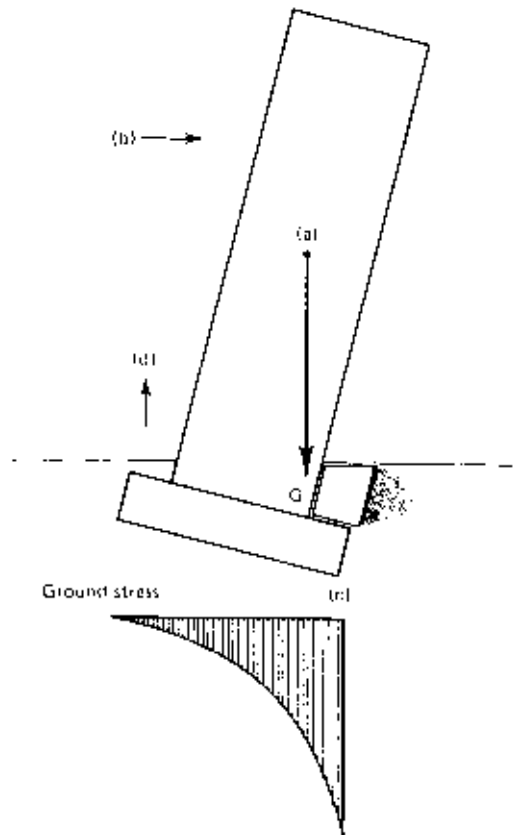
Figure 6.2 Extreme settlement of a tower

- (a) The weight acts through the centre of gravity
- (b) Wind forces add to the turning movement
- (c) The pressure on the toe of the foundation increases rapidly as the tower leans
- (d) There is a danger of uplift

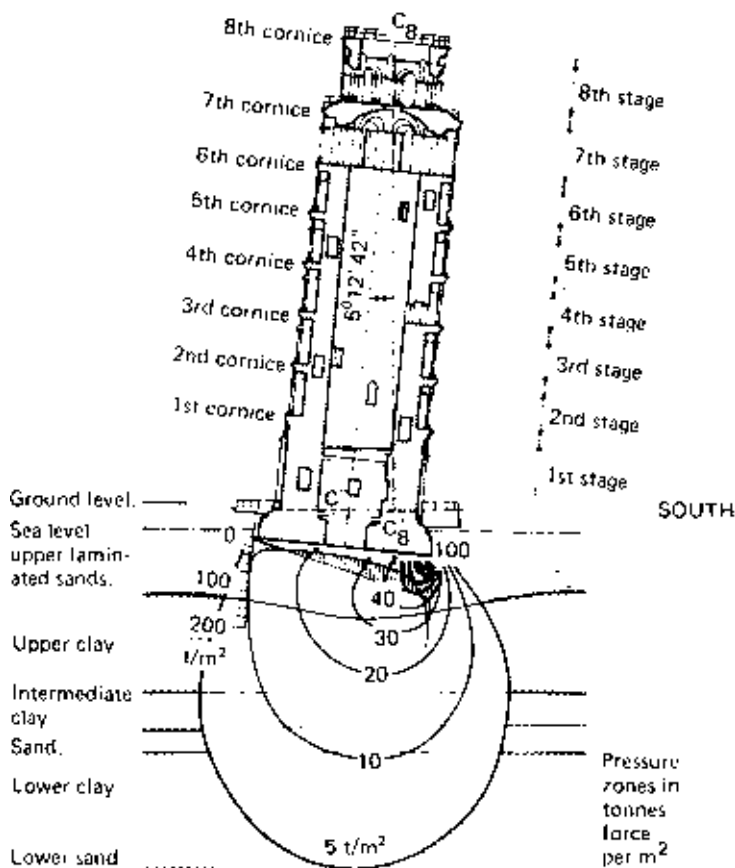
Figure 6.3 Leaning Tower of Pisa, Italy
(Courtesy: *Bollettino Ingegneri*)

Section showing pressure zones (in tonnes-force per m^2) and levels of recent sands and clays which have been compressed by the weight of the tower which is approximately 12 000 t (11 810 ton). The inclination of the tower has been monitored accurately. The tower was closed to tourists because of concern over the condition of its masonry. Ground water levels have been controlled with beneficial results. In 1992 there were proposals to maintain equilibrium by placing lead weights on the north side. In 2001, the tower was reopened to tourists, after its inclination to the south had been reduced by about 50 cm (20 inches), by extracting soil under the foundations on the north side. This simple solution to a complex problem meets all the desirable theoretical criteria, and in itself is reversible.

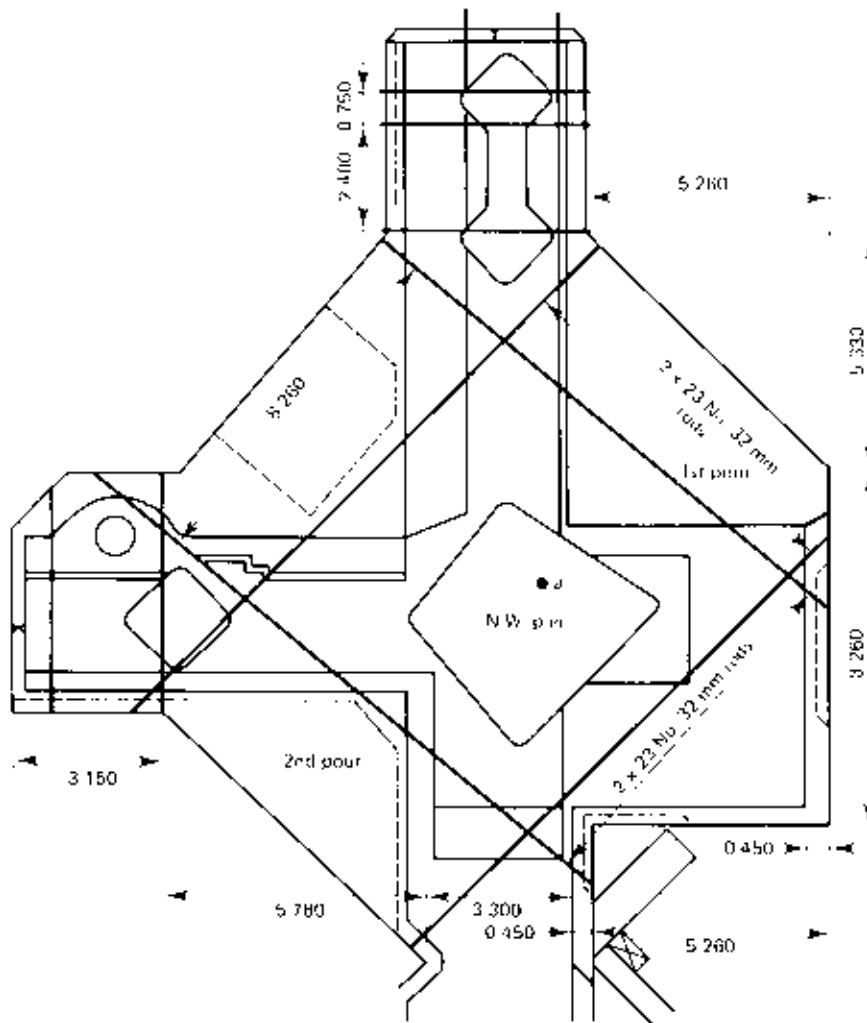
Figure 6.4 Central tower foundations, York Minster, England
(Courtesy: Ove Arup & Partners)

Plan of north-west pier foundations showing stainless steel post-tensioned layout. The project was to enlarge the area of foundations making them symmetrical about the line of thrust a, so avoiding eccentric loads and dangerous pressures on the soil

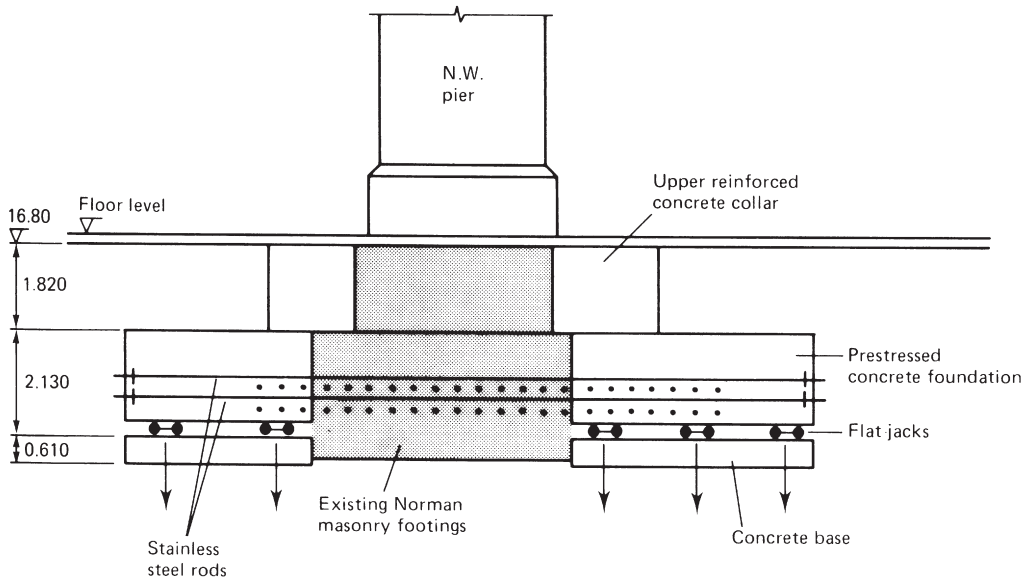
Figure 6.5 Central tower foundations, York Minster, England

Section through north-west pier foundation. The existing masonry was contained with the new concrete. The flat-jacks were slowly inflated to prestress the soil and equalize loads carried by old and new work

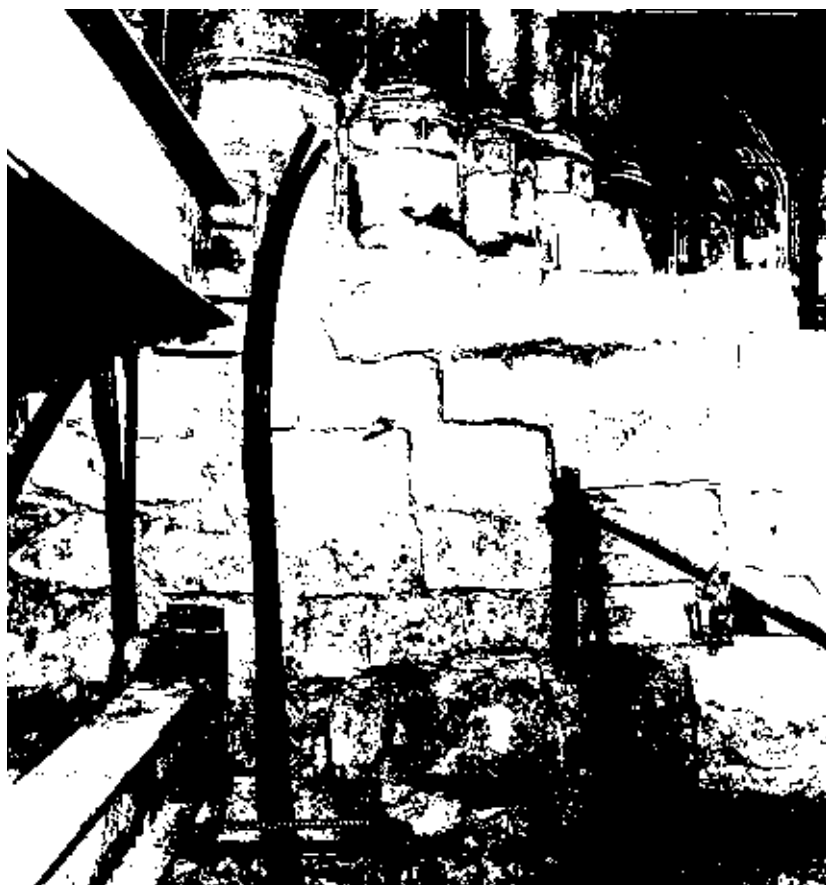
Figure 6.7 North-east pier foundation, central tower, York Minster, England
(Courtesy: Shepherd Building Group Ltd)

Similar shear cracks were found on the west side. The strength of the horizontal strutting should be noted, with the screws and plates for applying pressure to contain the masonry. The polythene pipes are for injection of liquid grout

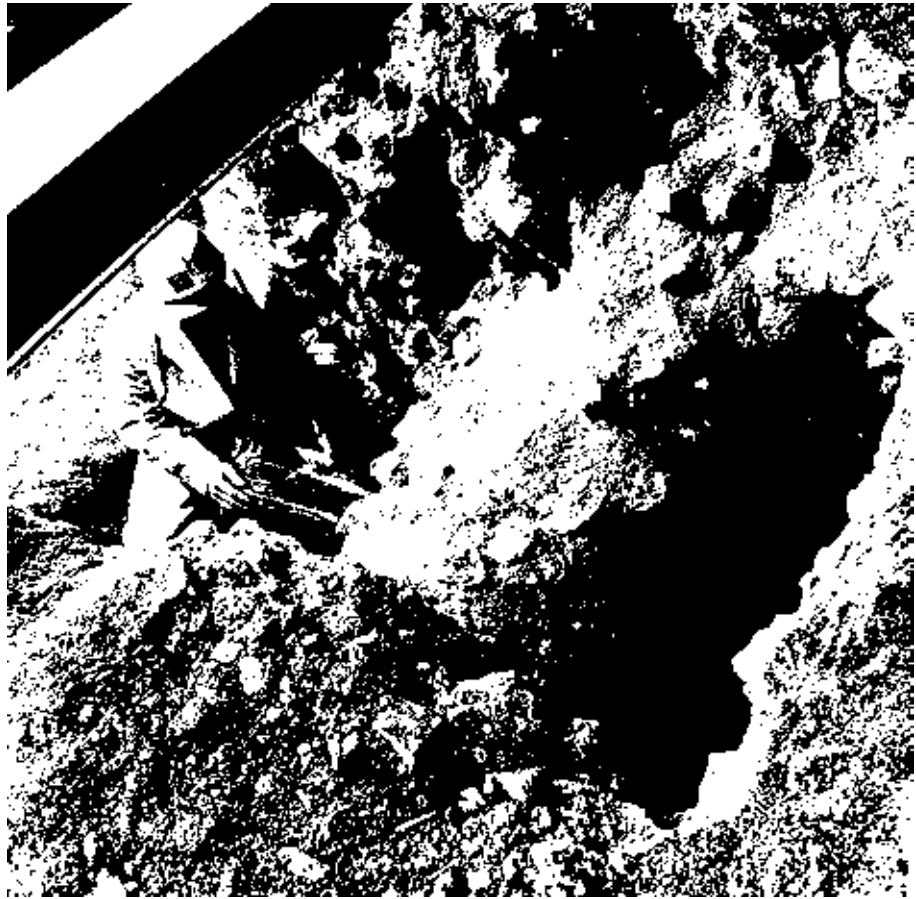
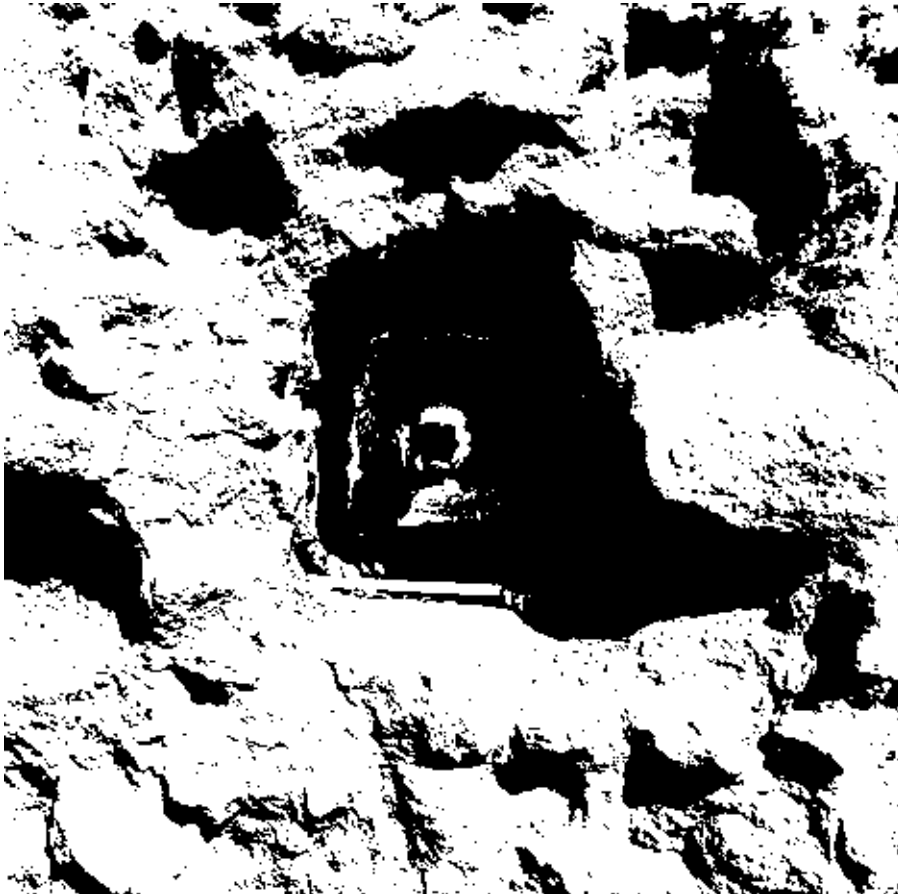
Figure 6.9 Investigation of foundations, York Minster, England
(Courtesy: Shepherd Building Group Ltd)

It was found that the Normans had used a grillage of oak beams to reinforce their foundations and that by and large this grillage, a fragment of which can be seen being held, had rotted away leaving voids

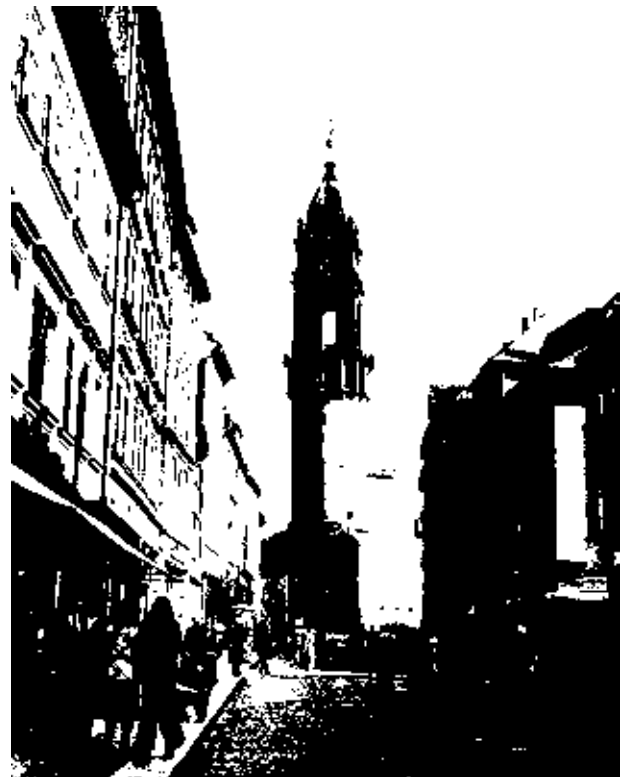
Figure 6.12 Tower, Bautzen, Germany
(Courtesy: Ing. W. Preiss)

The tower was underpinned by W. Preiss of Dresden and the sequence of the operation was carefully worked out in 14 stages. The inclination of the tower was recorded and had increased by 21 mm (0.8 in) in three years. During the works this rate was somewhat exceeded, but on completion there was evidence of less inclination and a cessation of movement

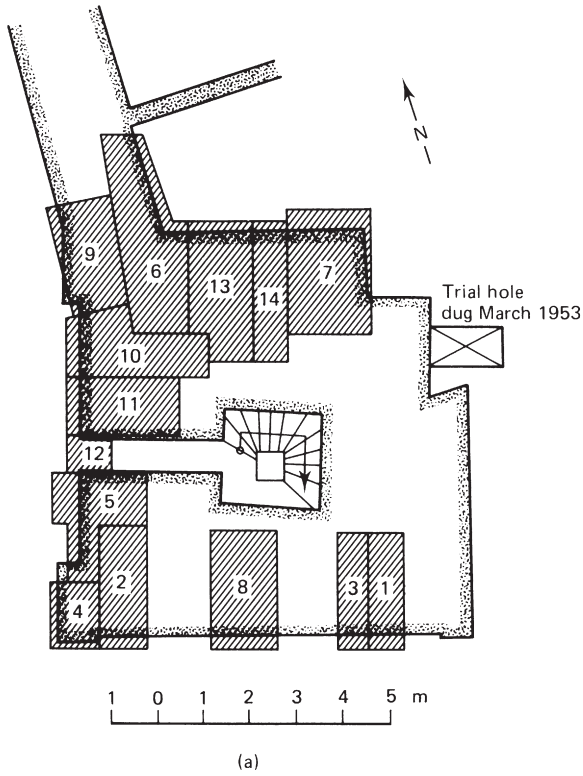
(a) Plan showing sequence of underpinning

1 14 Order of underpinning operation

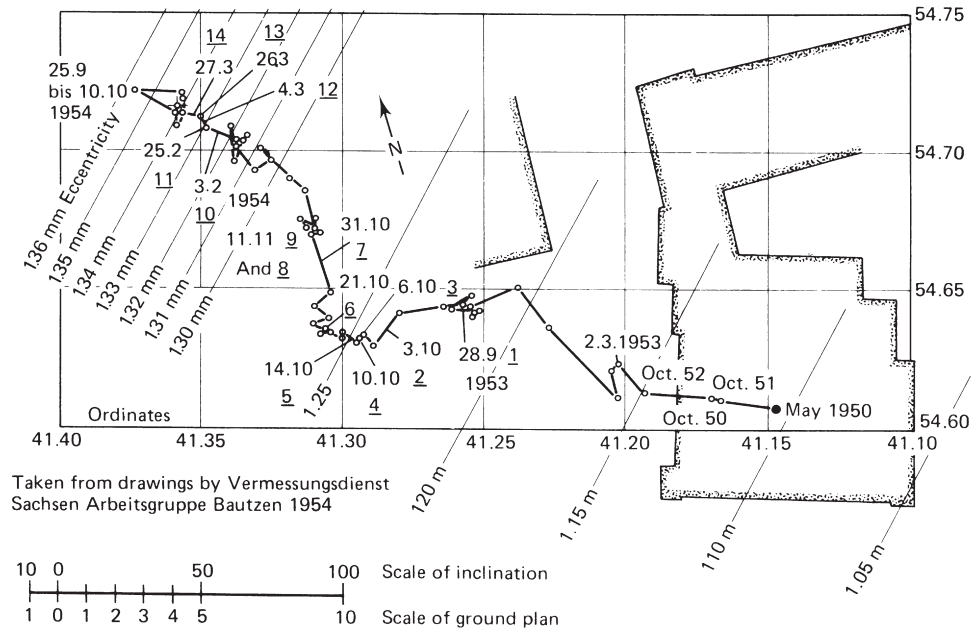
(b) Record of movement of tower from May 1950 to October 1954

Taken from drawings by Vermessungsdienst
Sachsen Arbeitsgruppe Bautzen 1954

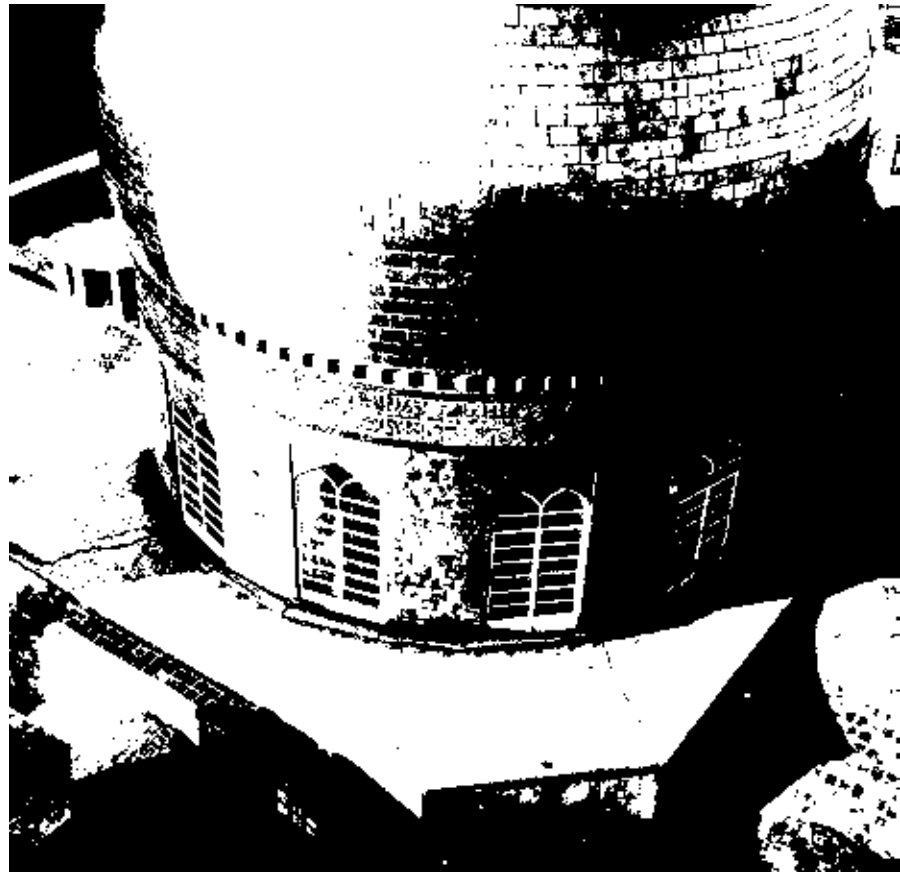
Figure 7.4 Palazzo at Fianello, Lazio, Italy

Thermal cracking in new cement mortar rendering around base of dome due to large daily changes in temperature and use of an inflexible material

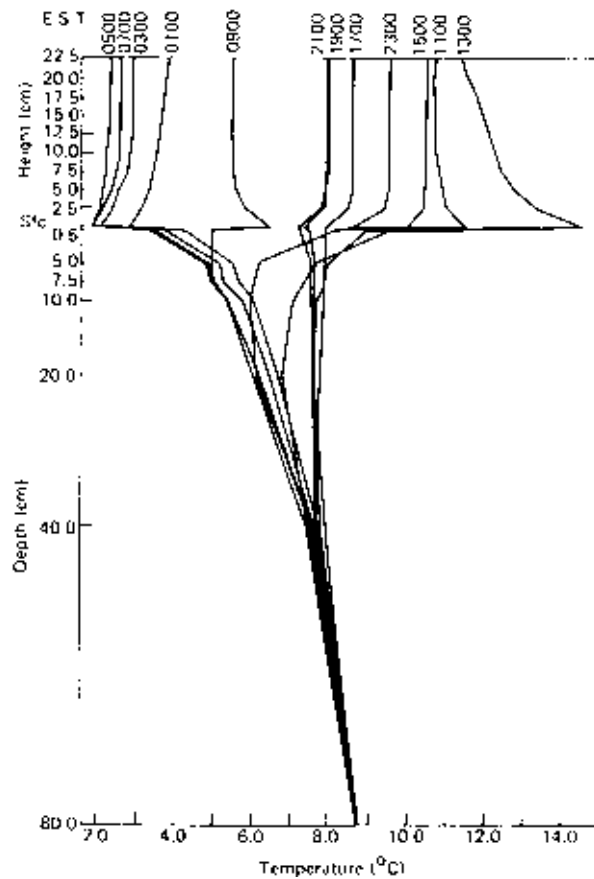
Figure 7.6 Profiles of air and soil temperatures at Seabrook, N.J., USA

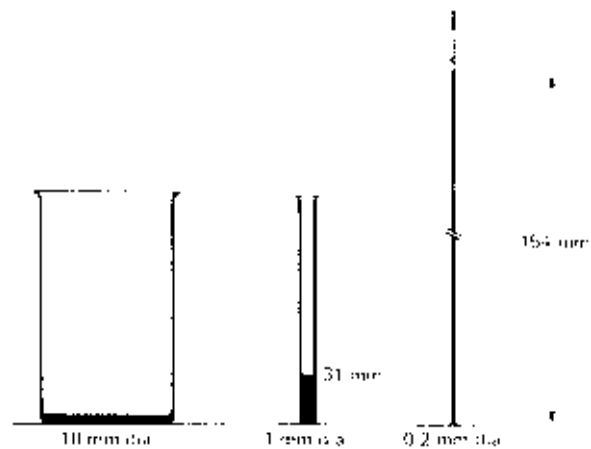
I. Title

363.69

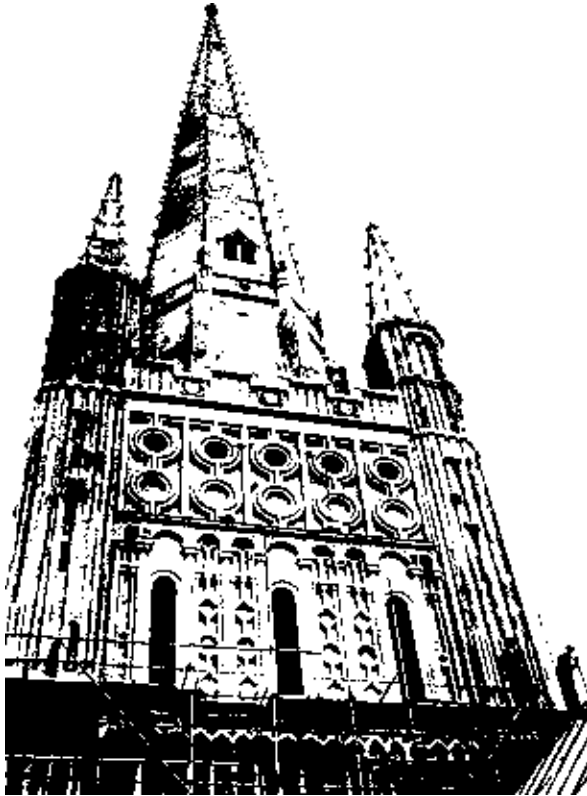
Man-made causes of decay need careful assessment, as they are in general the by-product of the industrial productivity that brings us wealth and enables us to press the claims of conservation. They are serious and can only be reduced by forethought and international co-operation. Neglect and ignorance are possibly the major causes of destruction by man, coupled with vandalism and fires, which

are largely dealt with in Chapter 17. It should be noted that the incidence of arson is increasing, putting historic buildings at even greater risk.
