Conservation of Historic Buildings

*Conservation
of Historic Buildings*
Third edition

Bernard M. Feilden

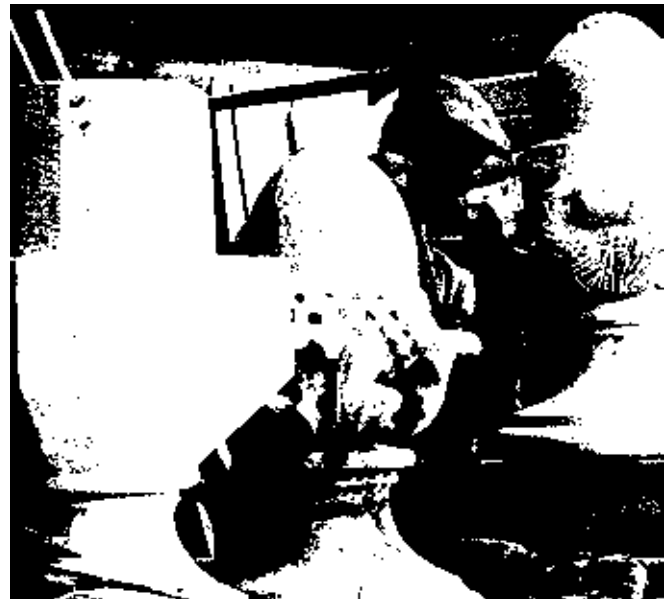
Figure 7.31 Carved ornament, St Paul's Cathedral, London, England

The central acorn feature was fractured and eroded by wind and pollution. Note the reduction of size in comparison with the replacement which is shown in two stages: the rough work prepared by the mason for the carver, and the process of carving

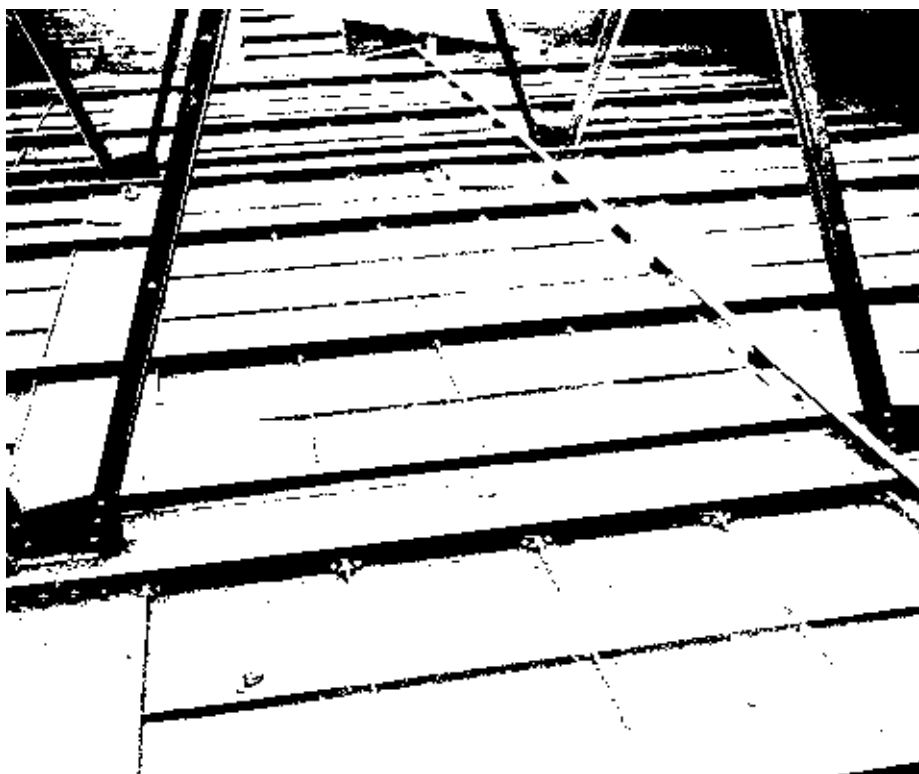
Figure 7.32 Dust deposit, Cairo Museum, Cairo, Egypt

Dust is one of the most difficult environmental hazards to combat as it gets into all unsealed spaces. Here it lies thickly on a roof light

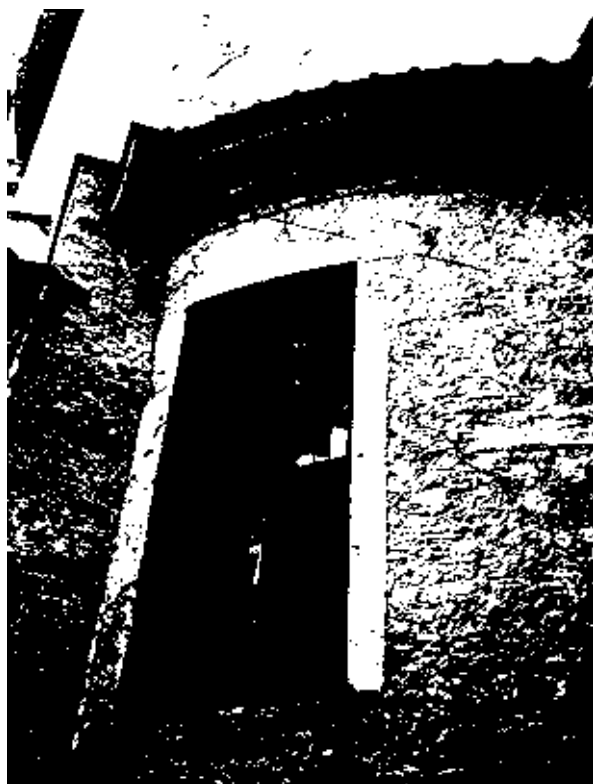
Figure 7.33 Church, Scarperia, Italy

Damage by landslide. This Renaissance church was built on a geological fault. It is also vulnerable to earthquakes

An interesting example of a natural disaster is the Sun Temple at Chauvim Huamtar in Peru, initiated in 1600 B.C. and covered by a landslide of liquid mud in A.D. 1540. Only now is the temple being excavated and consolidated. A case of land movement due to a geological fault is that of the Iron Bridge, in England, at the village of the same name, which was being crushed by a closing of the river Severn's banks. Insertion of a massive concrete strut under the river bed has prevented this. At Scarperia, in northern Tuscany, the mediaeval castle and a Renaissance church are badly cracked due to land-slipping along a geological fault.

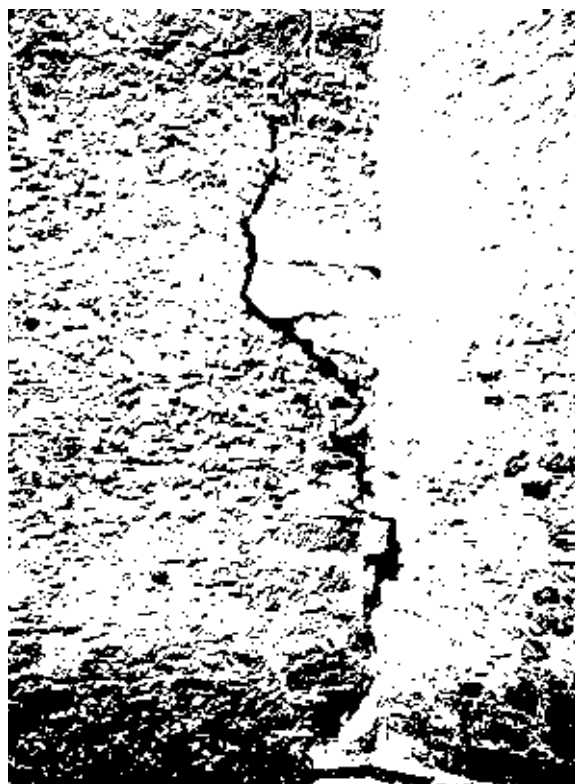
Figure 7.34 Church, Scarperia, Italy

Details of cracking. Repairs always fail if the cause is not diagnosed: in this case a geological fault leading to a landslide

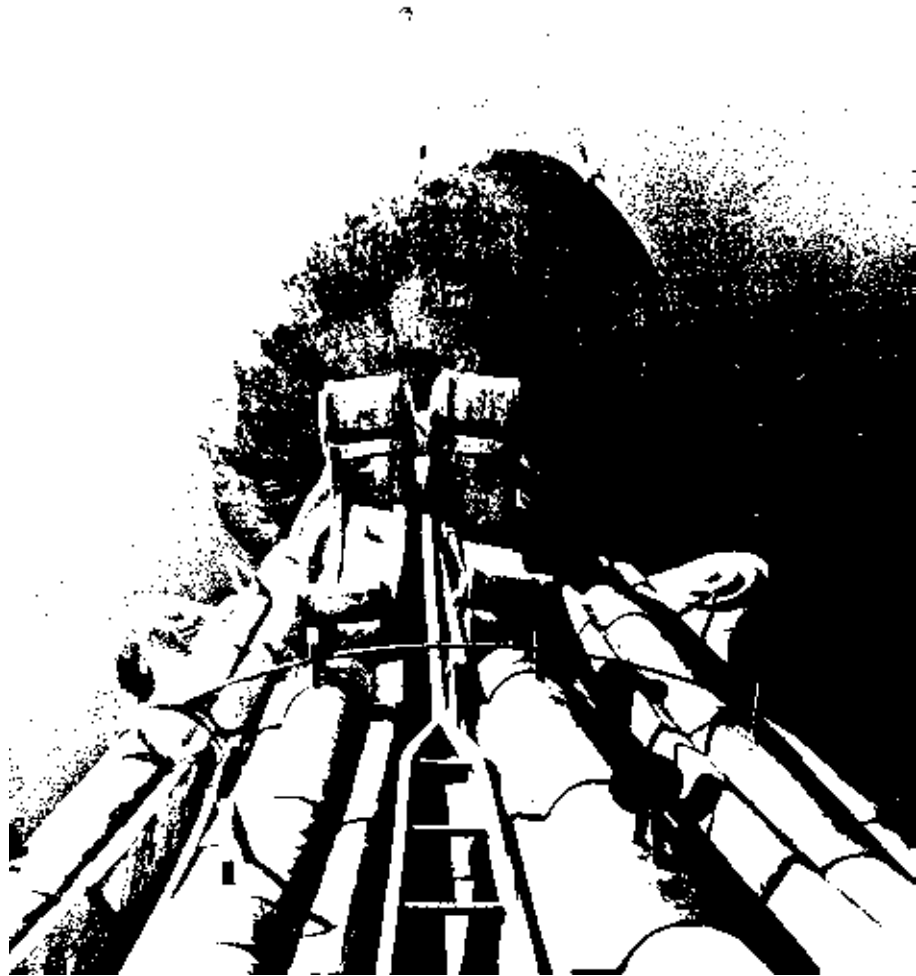
Figure 7.37 Lightning conductors, St Peter's, Rome, Italy

This massive building, with walls 13 m (43 ft) thick and superbly built with good travertine, need only fear earthquakes and lightning. The ball is bronze gilded and well protected against strikes

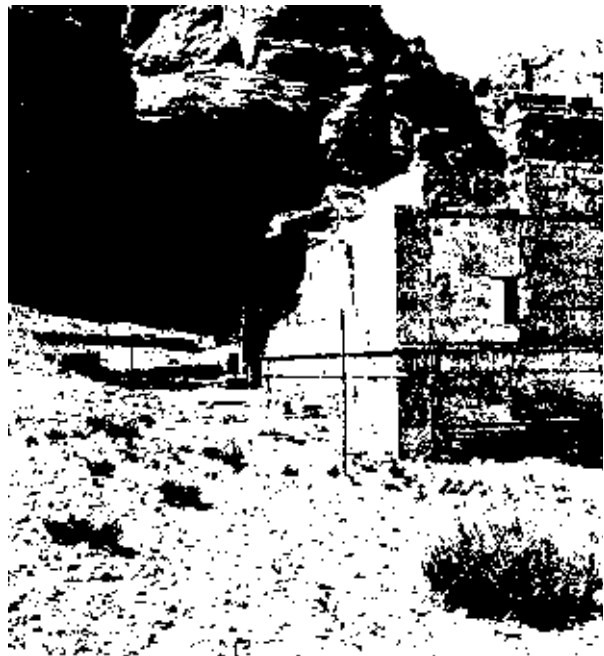
Figure 8.1 Quasr el Bint, Jordan

This remarkable second century A.D. building was given tensile reinforcement against earthquakes by insertion of lacing bands of timber—most of which eventually rotted. However, it proved effective in preserving the outer walls while the roof collapsed

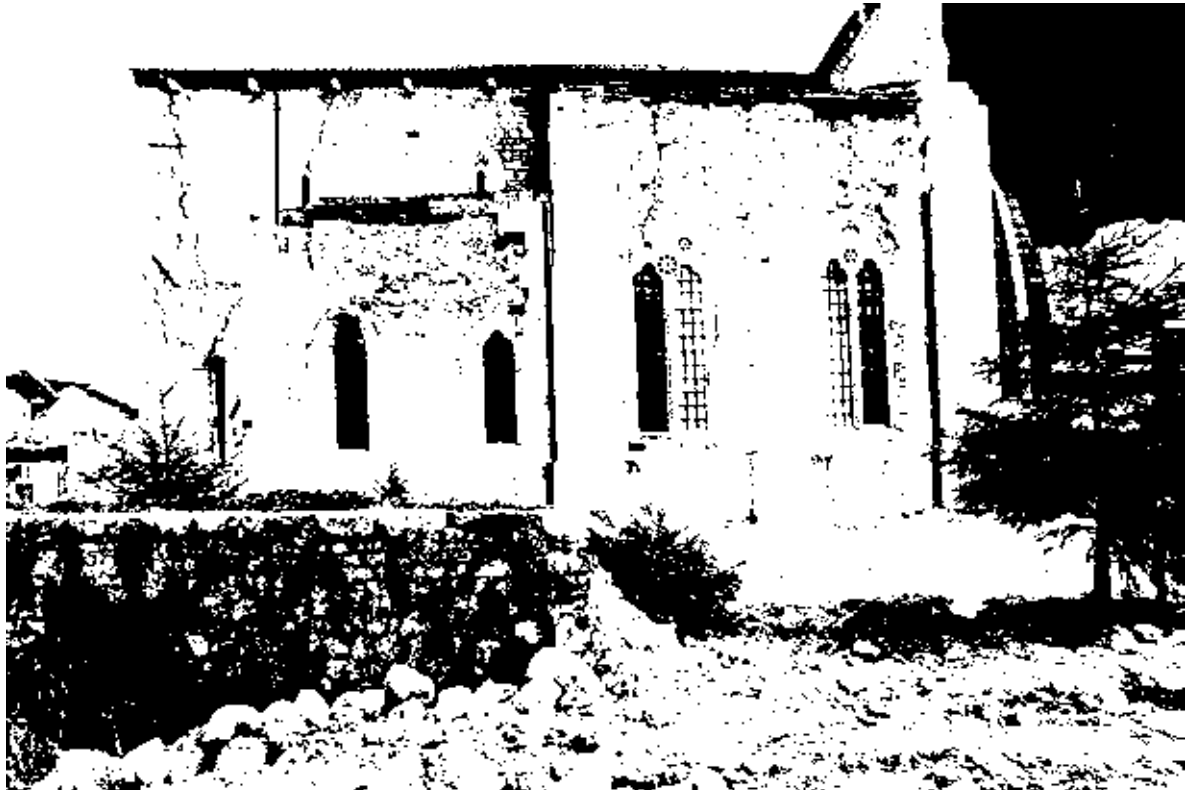
Figure 8.3 Friuli, Italy
(Courtesy: Architect G. Tampone)
Earthquake damage

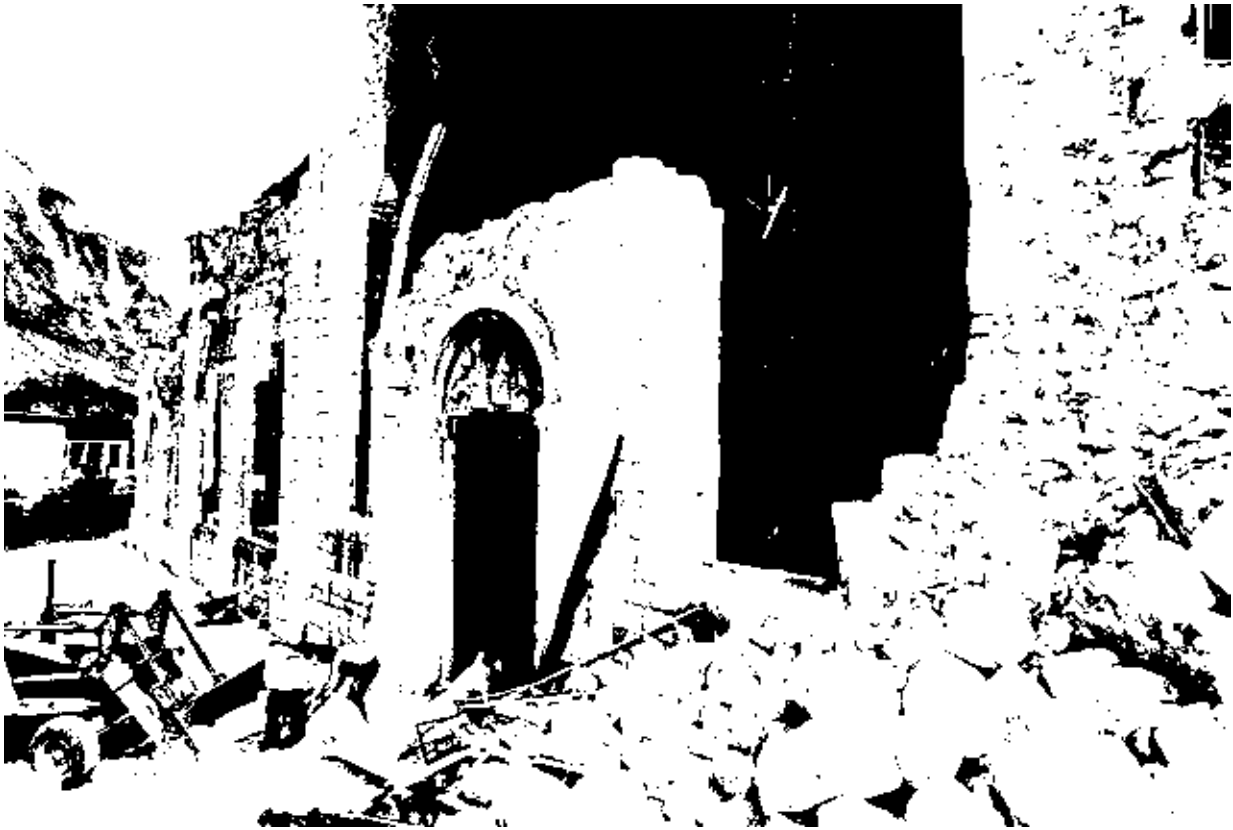
Figure 8.4 Friuli, Italy
(Courtesy: Architect G. Tampone)
Earthquake damage

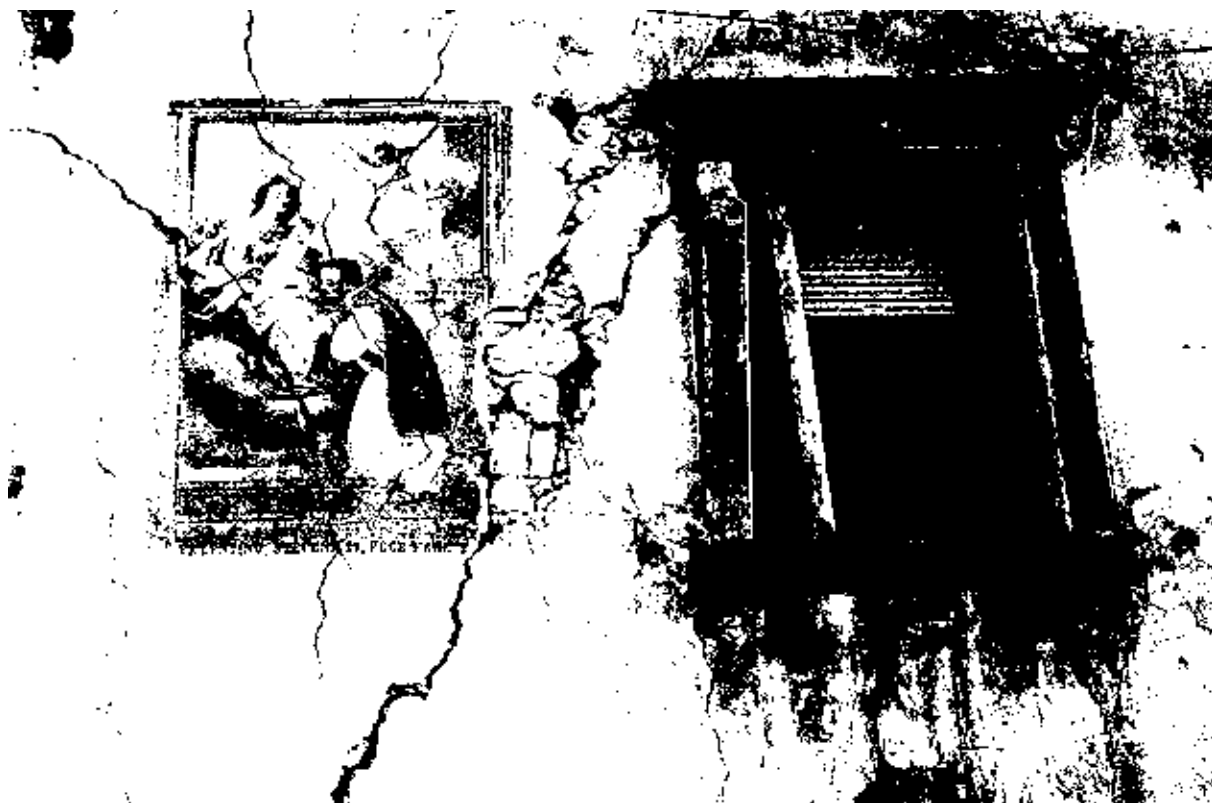
Figure 8.5 Ospedelletto di Germona, Friuli, Italy
(Courtesy: C. Silver)

Private house with fresco on the facade. Attempts to save this structure were abandoned due to the severe earthquake damage. Collapse was judged to be imminent and conditions too dangerous to permit detachment of this fresco, which was a nineteenth century copy of a seventeenth century original. The house was demolished

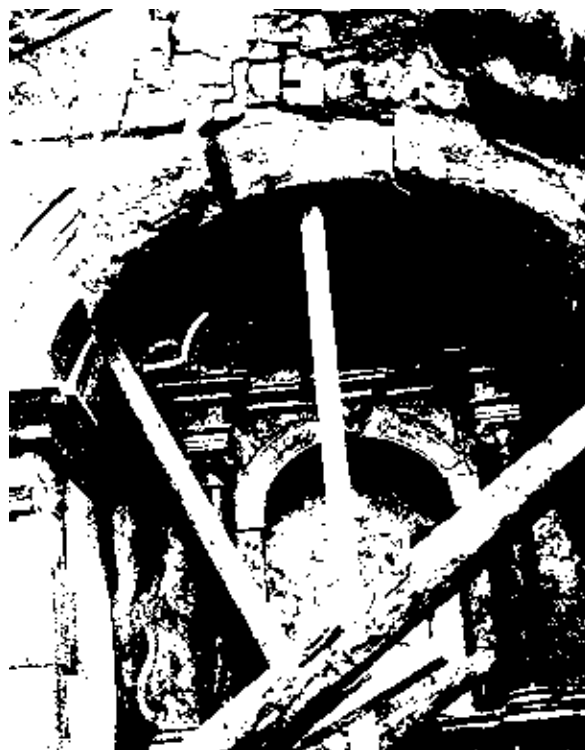
Figure 8.6 S. Stefano, Antegna, Friuli, Italy
(Courtesy: C. Silver)

Nineteenth century plaster hides the fine Lombard (c. A.D. 700) bas-reliefs and the frescoes. The keystone of the arch of the presbytery has been temporarily propped to prevent immediate collapse

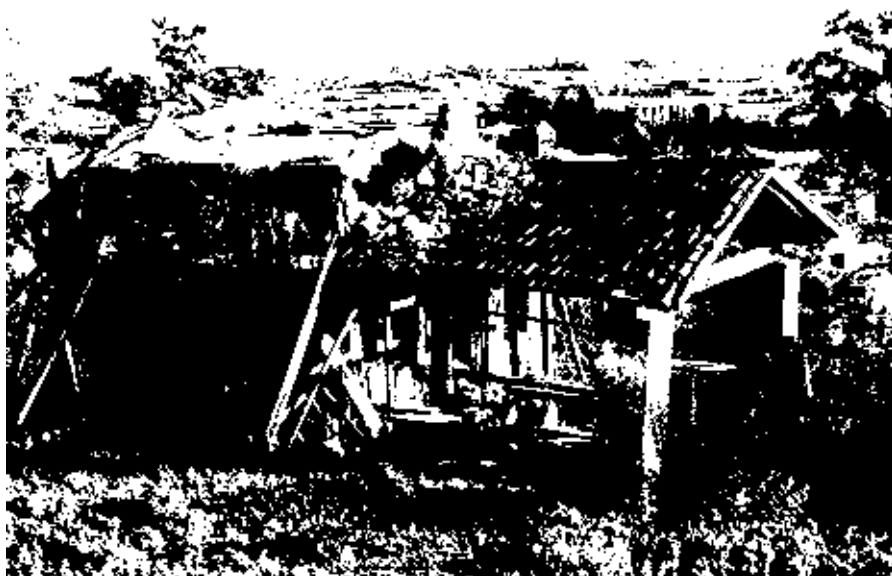
Figure 8.7 S. Stefano, Antegna, Friuli, Italy
(Courtesy: C. Silver)

The interior of this small church contains important cycles of superimposed frescoes dating from the twelfth, fourteenth and fifteenth centuries under nineteenth century plaster. The altar in the presbytery was found to be constructed from important Lombard bas-reliefs, also covered by nineteenth century plaster. Friuli has the highest level of rainfall in Italy. Therefore, the church has been covered with plastic sheeting to protect the cultural property inside. The proppings of wood proved insufficient; thus two steel cables were locked about the exterior walls

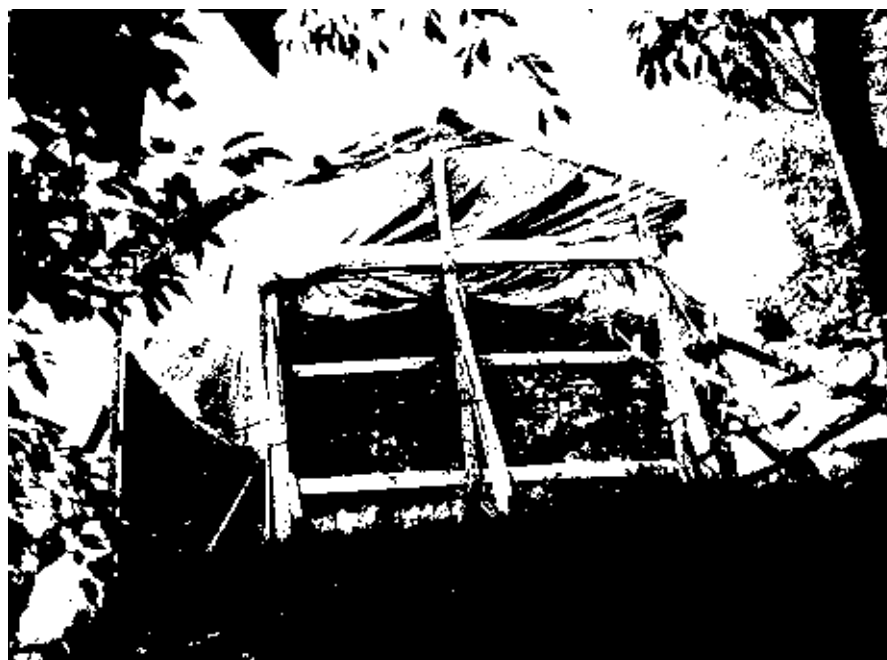
Figure 8.8 S. Stefano, Antegna, Friuli, Italy
(Courtesy: C. Silver)

Presbytery from outside. Note plastic-sheet waterproofing and two steel cables that encircle the exterior walls

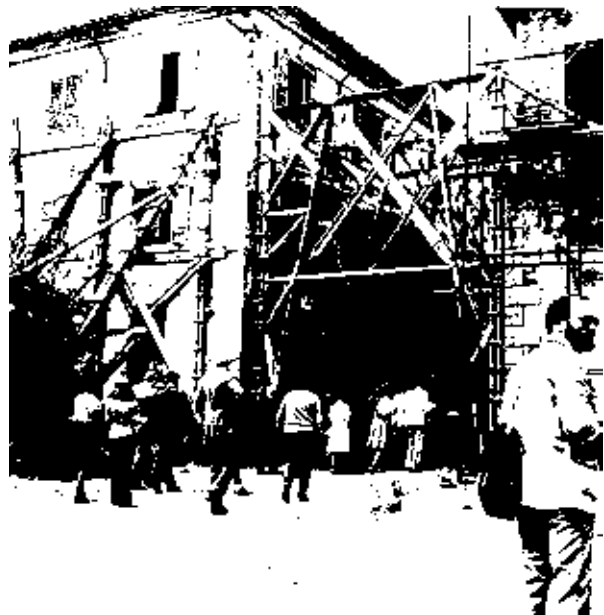
Figure 8.9 Tuscania, Lazio, Italy

Emergency shoring after an earthquake is vital, as often the greater damage is caused by a second shock two or three months later. In this case, after some years the shoring has rotted where in contact with the ground. It often takes 10 years to rectify earthquake damage, so shoring should be rot-proof

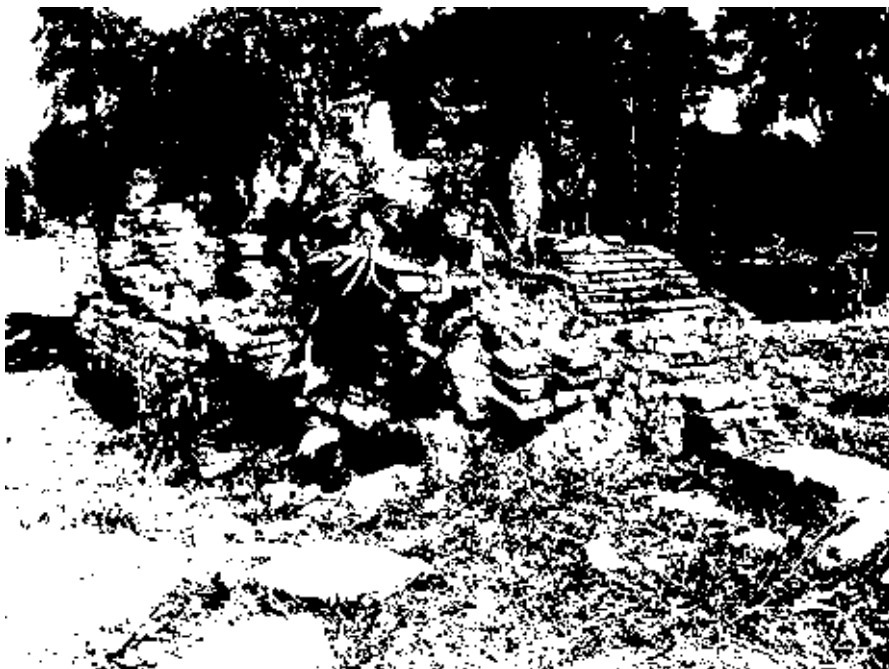
Figure 9.1 A ruined temple at Sukothai, Thailand

Unrestricted plant growth poses great problems to archaeologists and conservators. Taking into account the climatic conditions, which favour rampant plant growth, in practice this ruined temple can only be dismantled and reconstructed

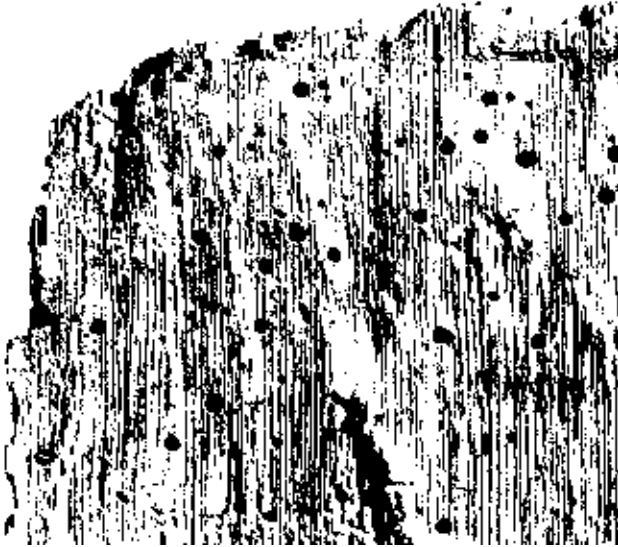
Figure 10.1 Boreholes of the common furniture and deathwatch beetles

The boreholes of the common furniture beetle, Anobium punctatum, are about 1.5 mm (0.06 in) in diameter, while those of the deathwatch beetle, Xestobium rufovillosum, are about 3 mm (0.12 in) in diameter. However, in the tropics each species may be larger

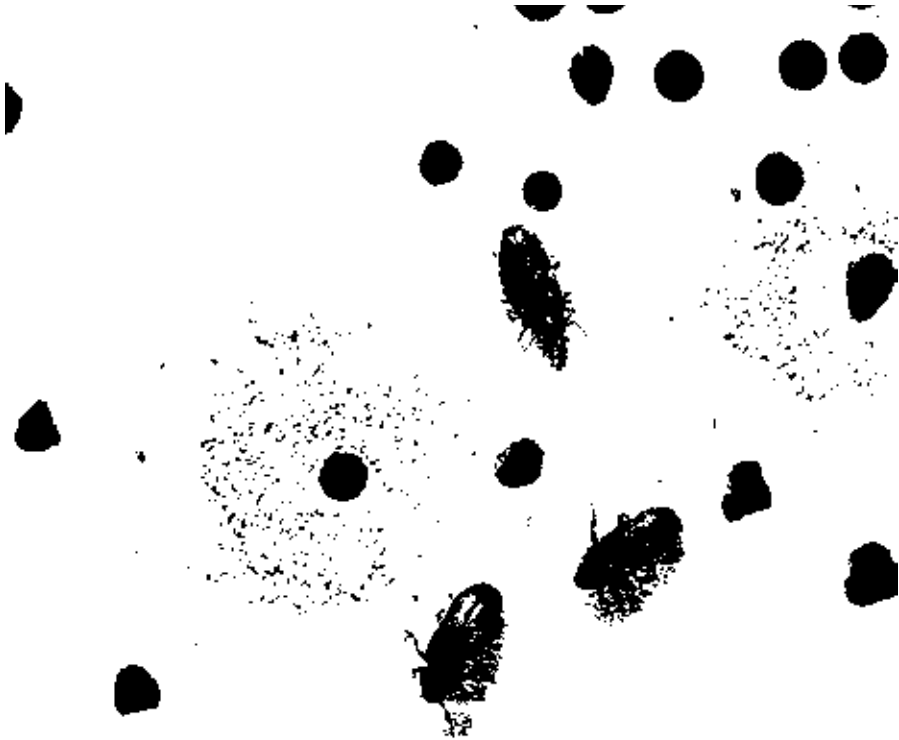
Figure 10.2 Boreholes, frass and adults of the common furniture beetle

Boreholes, frass pellets and adults of the common furniture beetle, Anobium punctatum, are visible. This insect has worldwide distribution

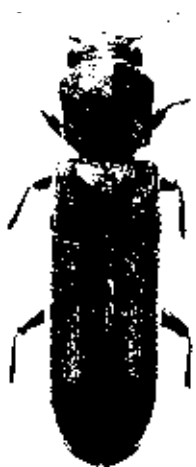
Figure 10.5 Powder post beetle, *Lyctus*
(Courtesy: Department of the Environment,
Building Research Establishment)

'Lyctus' forms circular holes 1.5 mm (0.06 in) in diameter, with copious fine powdered frass

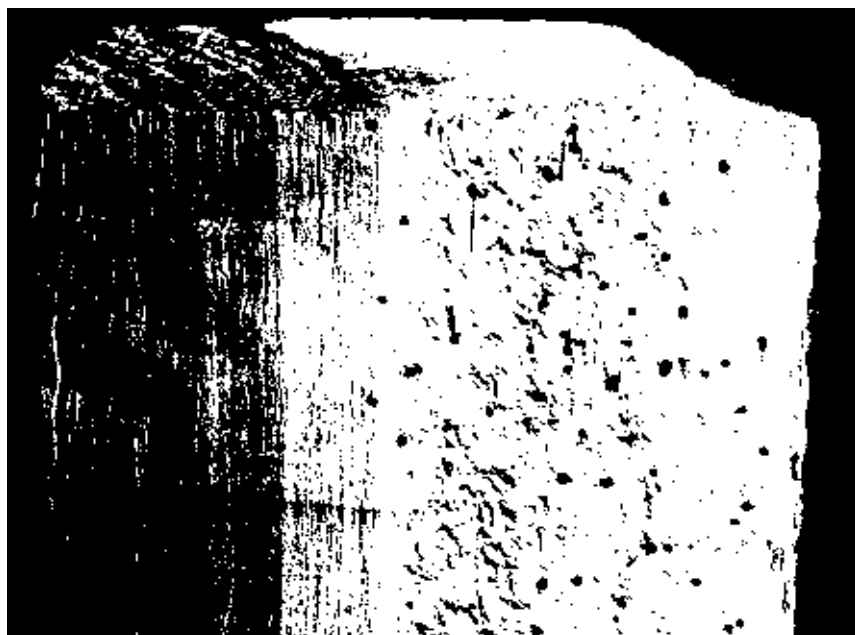
Figure 10.6 Boreholes of the powder post beetle, *Lyctus*
(Courtesy: Department of the Environment, Building Research Establishment)

This beetle confines its activities to sapwood of hardwoods where sugar content is high, so is unlikely to cause structural damage

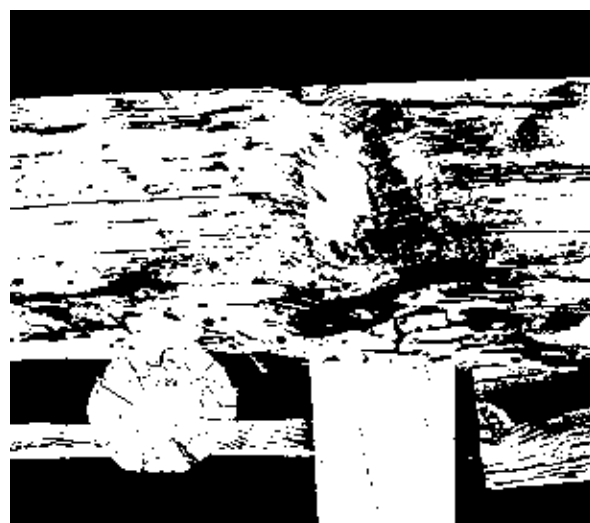
Figure 10.8 Balcony of house in Trudos Mountains, Cyprus

*The destruction of structural timber at joints is by the house longhorn beetle, *Hylotrupes bajulus* in all probability. Note the crushing of the affected timber*

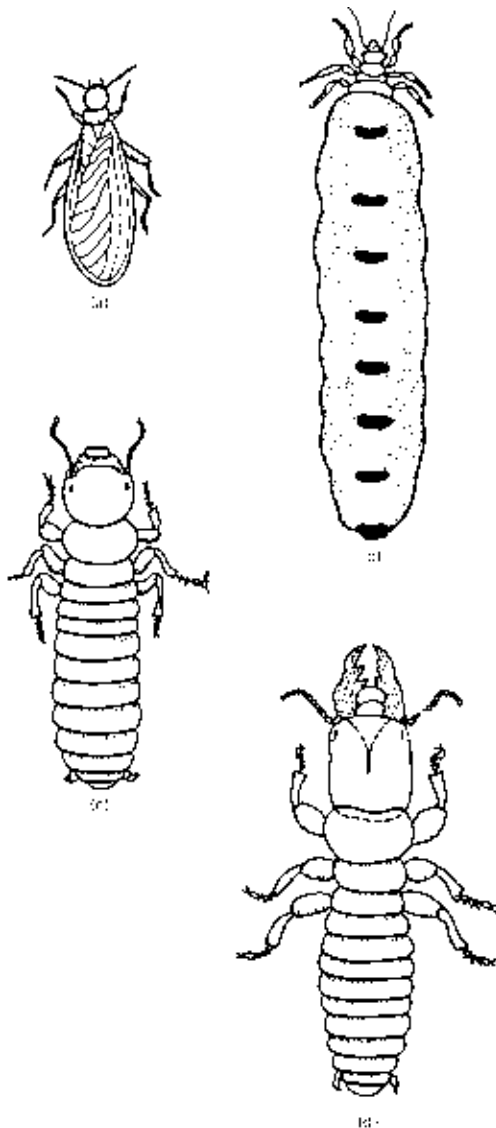
Figure 10.9 Typical termites
(Courtesy: O.P. Agrawal)

- (a) King
- (b) Queen
- (c) Worker
- (d) Soldier

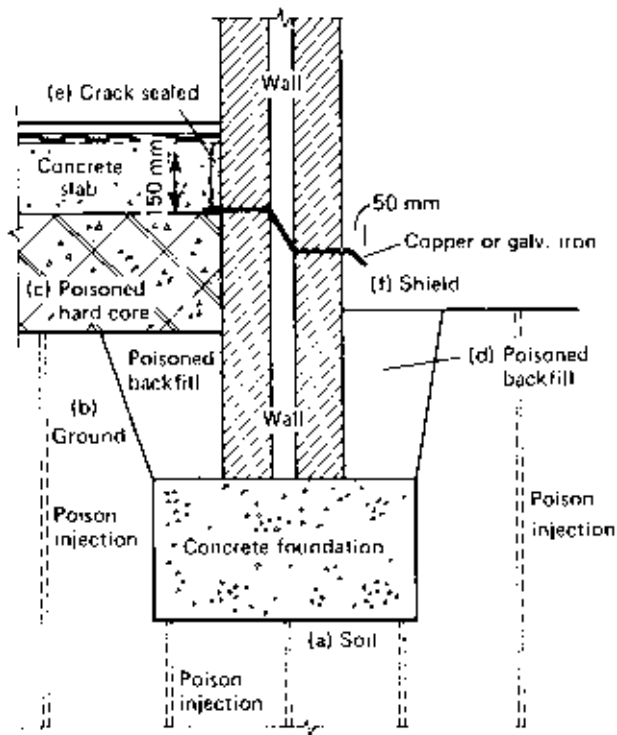
Figure 10.12 Precautions against subterranean termites

- (a) Soil poisoned under foundations
- (b) Holes at 300 mm (12 in) poisoned
- (c) Hardcore poisoned
- (d) Poisoned backfill
- (e) Coal tar or poisoned mortar seal in crack
- (f) Metal termite shield protects 50 mm (2 in)

In existing buildings a precaution against ground termites is for foundations to be exposed and the earth poisoned as it is replaced. In the bottom of this trench and elsewhere, holes can be drilled at 300 mm (12 in) centres and poisoned. Any soil at the foot of the cross-walls should also be poisoned so as to prevent termites climbing up the walls. Soil poisoning is only the first line of defence against ground termite attack and may become ineffective after some years. The most commonly used soil

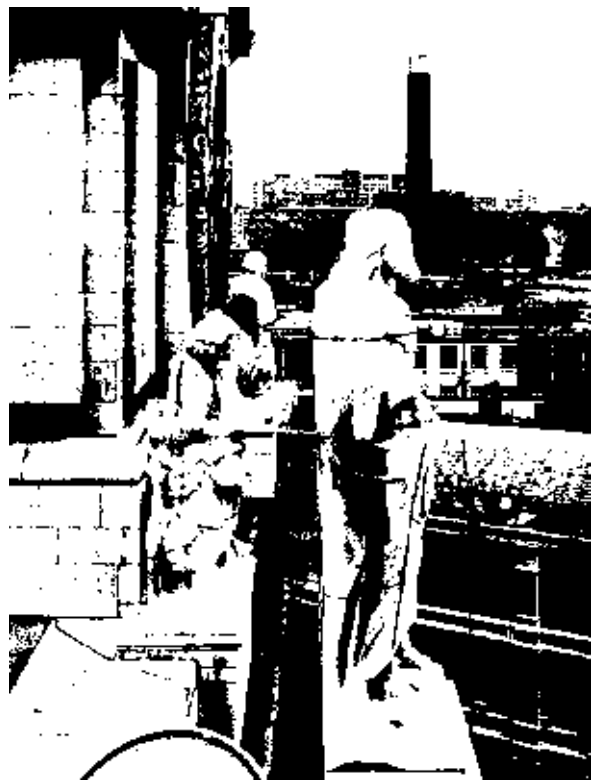
Figure 11.1 Bankside Power Station from St Paul's Cathedral, London, England
(Courtesy: Feilden & Mawson)

Electricity generating stations produce about one-quarter of the atmospheric pollution in Britain. Bankside Power Station, built shortly after World War II, has undoubtedly caused damage to St Paul's Cathedral and should never have been sited so close to a national monument. Expensive plant was installed to reduce the emissions of sulphur dioxide and it was claimed that 98% had been eliminated. The post-Wren statuary by Thomas Bird (fl. 1710) in the foreground has suffered severe damage and should be moved inside before it becomes meaningless. Bankside has now been converted into the Tate Modern Gallery – a good example of adaptive reuse

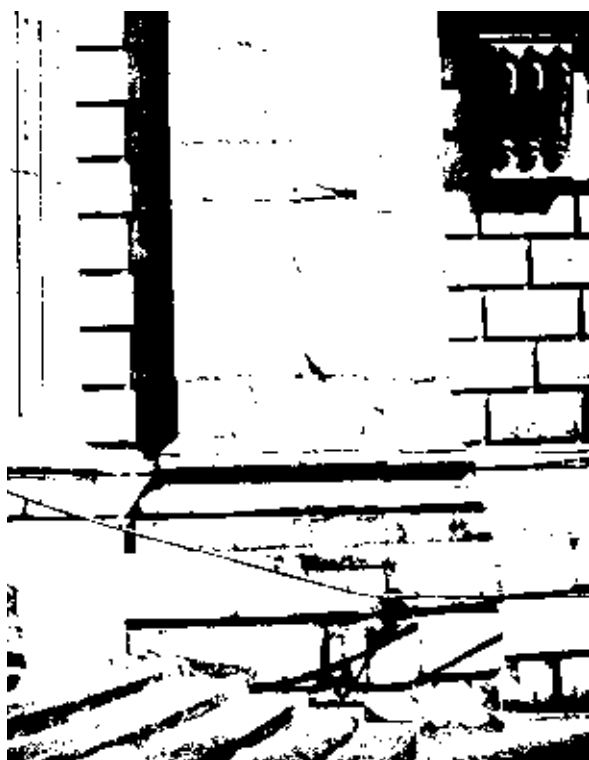
Figure 11.2 St Paul's Cathedral, London, England, south portico

Cracking and splitting of the masonry is caused by the compaction of the rubber core due to vibration throwing greater loads on the outer casing of asblar. A traffic count showed sufficient vehicle units to halve the life of St Paul's Cathedral. The City of London co-operated by keeping the road surface smooth and now heavy vehicles have been banned, an important factor in preventive conservation

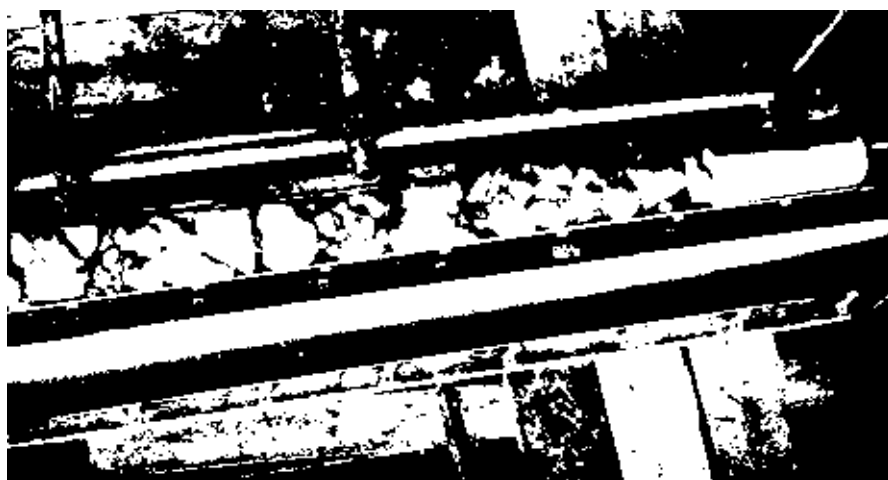
Figure 11.4 St Paul's Cathedral, London, England, base of south-west tower

The internal condition of the masonry can be judged from this core sample. The outer ashlar is backed by rubble set in lime mortar which has broken up and become severely fissured. Traffic vibration causes and accelerates this type of internal decay, which can only be rectified by grouting with epoxy resins

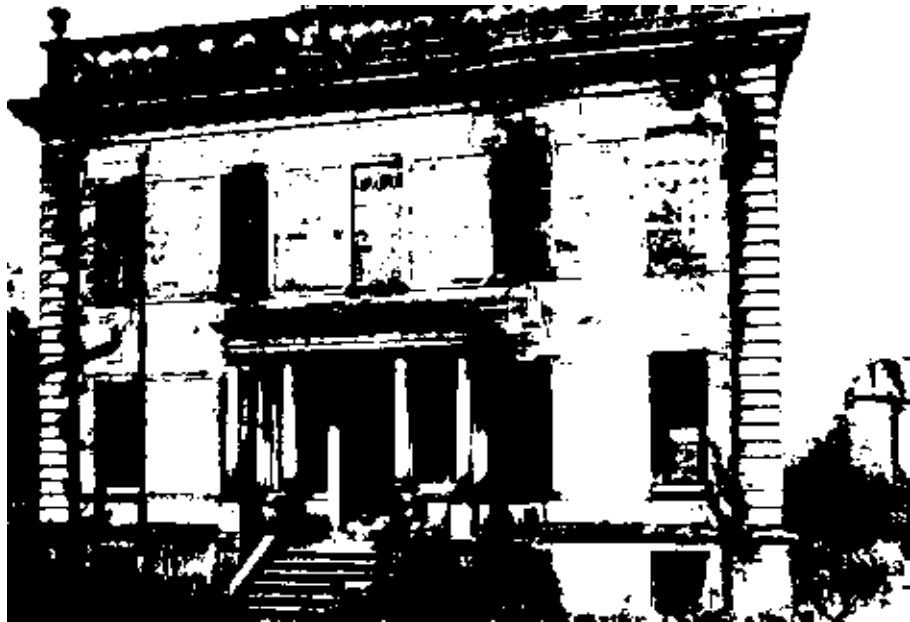
Figure 11.6 Mavis Bank, Midlothian, Scotland

Mining subsidence caused these severe settlements which led to the house being abandoned, so making it vulnerable to vandalism and finally fire. Yet it is not beyond redemption

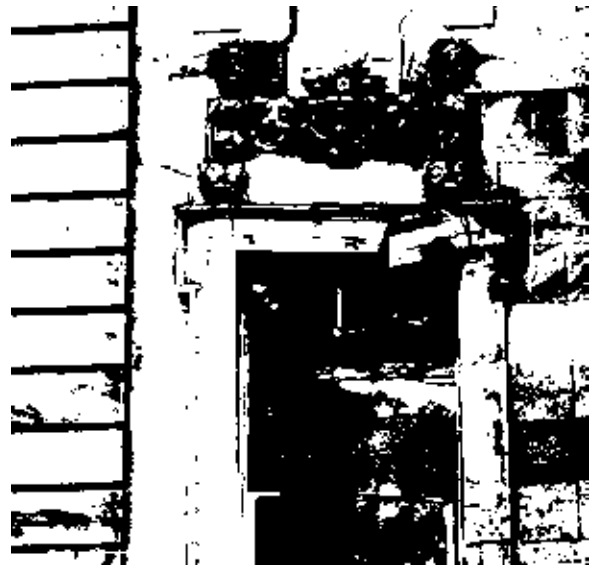
Figure 11.7 Mavis Bank, Midlothian, Scotland

A detail of damage caused by mining subsidence, neglect and fire

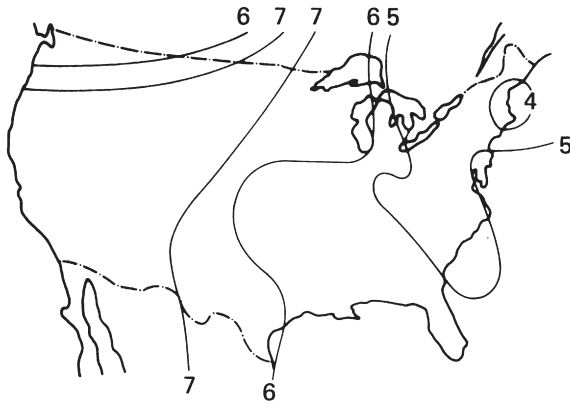
Figure 11.9 The acidity of rain falling in the USA in 1966

pH 7 is neutral, while below this figure rain is acid. One digit down on this scale represents a ten-fold increase in acidity; thus pH 4 is 10 times as acid as pH 5 and 100 times more acid than pH 6. Damage to limestone masonry also increases with ascending intensity according to the amount of pollution

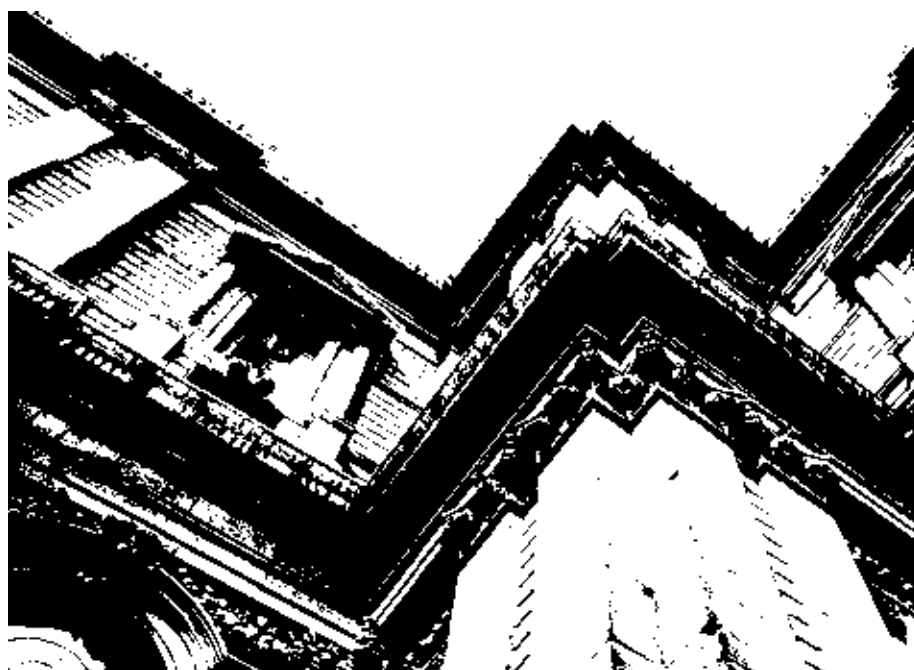
Figure 11.11 St Paul's Cathedral, London, England, cornices

The projecting cornices protect the ashlar walls, but acid-laden rain finds out any weakness of detail, especially where condensation and rain water drips. The projecting cyma recta top moulding and fascia is badly eroded and grooved by rain water

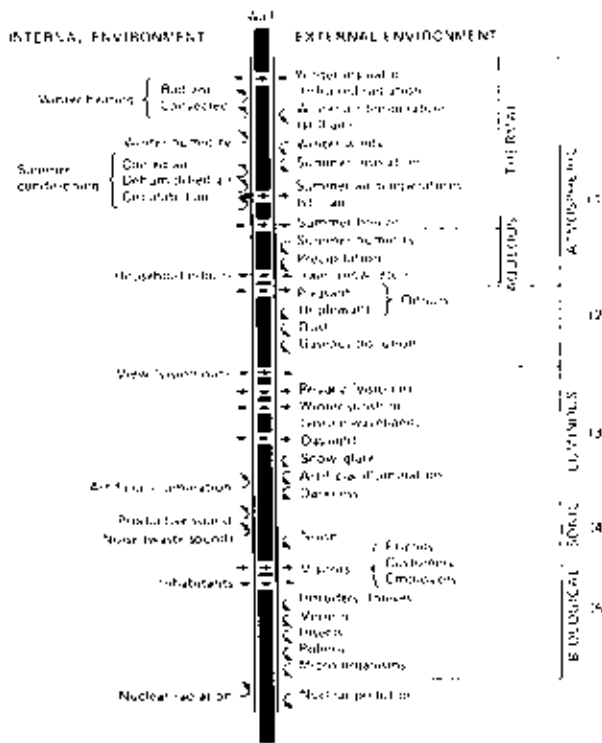
Figure 12.2 Diagrammatic function of a wall (Courtesy: J. Marston Fitch, with comments by the author)

Lightweight construction

- (1) Tendency to overheat and trap infra-red rays
 - Poor insulation value, high heating costs, cold radiation discomfort
 - Condensation of cold surfaces often in hidden places
 - Solar overheating compensated for by costly mechanical cooling plant.
 - High overall running costs
- (2) Resistant to atmospheric pollution
- (3) Lack of privacy
 - Too much daylight
 - Too much snow glare
- (4) Glare from over-large windows without gradation of light
- (4) Difficult to absorb sounds
 - Difficult to keep out noises
- (5) Easily vandalized or broken; difficult to repair, with long delay for deliveries
 - Vermin, if established, difficult to remove
 - Generally resistant to micro-organisms unless framed in timber, then very vulnerable

- (1) Absorbs heat by day; releases by night—thermal flywheel effect
 - Good insulation, low heating costs, warm walls
 - Absorbs and transmits molecular moisture outwards
 - Balances day and night temperatures and gives pleasant dynamic change
 - Thermal storage reduces winter heating costs
- (2) Some materials vulnerable to pollution
- (3) Good privacy
 - Daylight controlled
 - Snow glare a pleasant variation of climate
 - Light gently modulated, giving pleasant internal luminosity by reflection
- (4) Easy to absorb sounds
 - Easy to keep out noises
- (5) Easily protected; relatively robust and easy to repair
 - Vermin easily dealt with
 - Vulnerable to some micro-organisms if badly maintained

In *Figure 12.2* the complicated functions of the external membrane, including windows, of a building are examined. From the environmental point of view, it can be concluded that good insulation, high thermal mass and permeability to moisture are

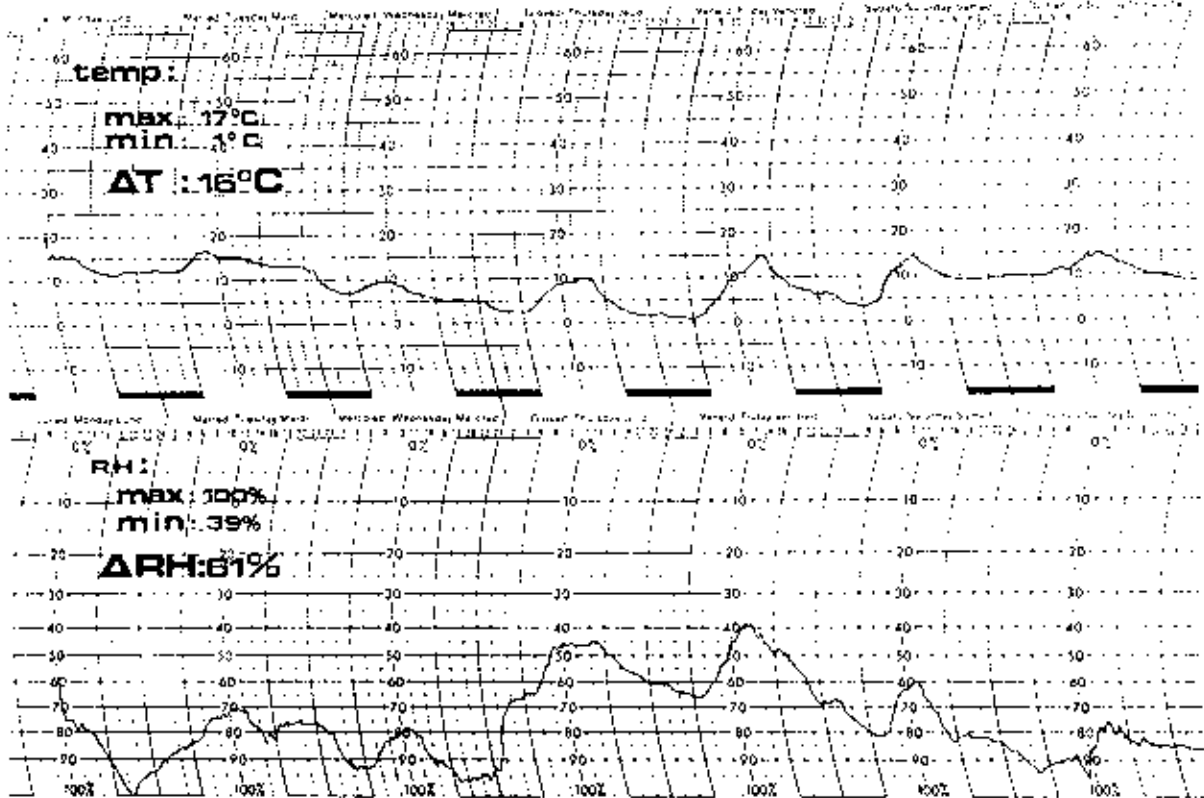
Figure 12.4 External environment, Ospizio di San Michele, Rome, Italy (Courtesy: ICCROM)

Outside temperatures in March vary over 16°C, from 1°C to 17°C, in one week with 14°C change on Friday. External relative humidity varies by 61°C with 50% change on Thursday and 25% change on Friday

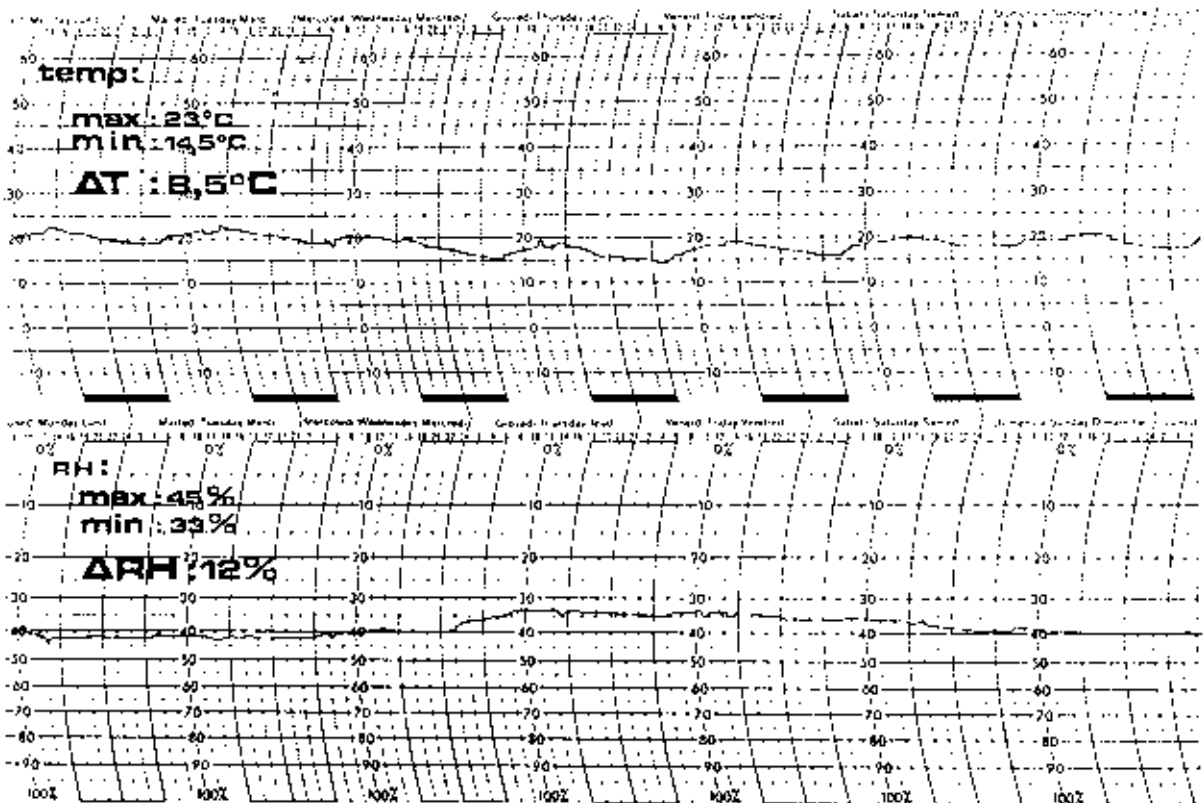
Figure 12.5 Internal environment, Ospizio di San Michele, Rome Italy (Courtesy: ICCROM)

Inside temperatures vary by 8.5°C, about half the outside temperatures, even though there is no heating, as the heavy walls give up heat. The greatest change occurs on Friday. Relative humidity changes by a maximum of 12%, the maximum change being on Thursday, about 7%, i.e. just over one-quarter of the external change

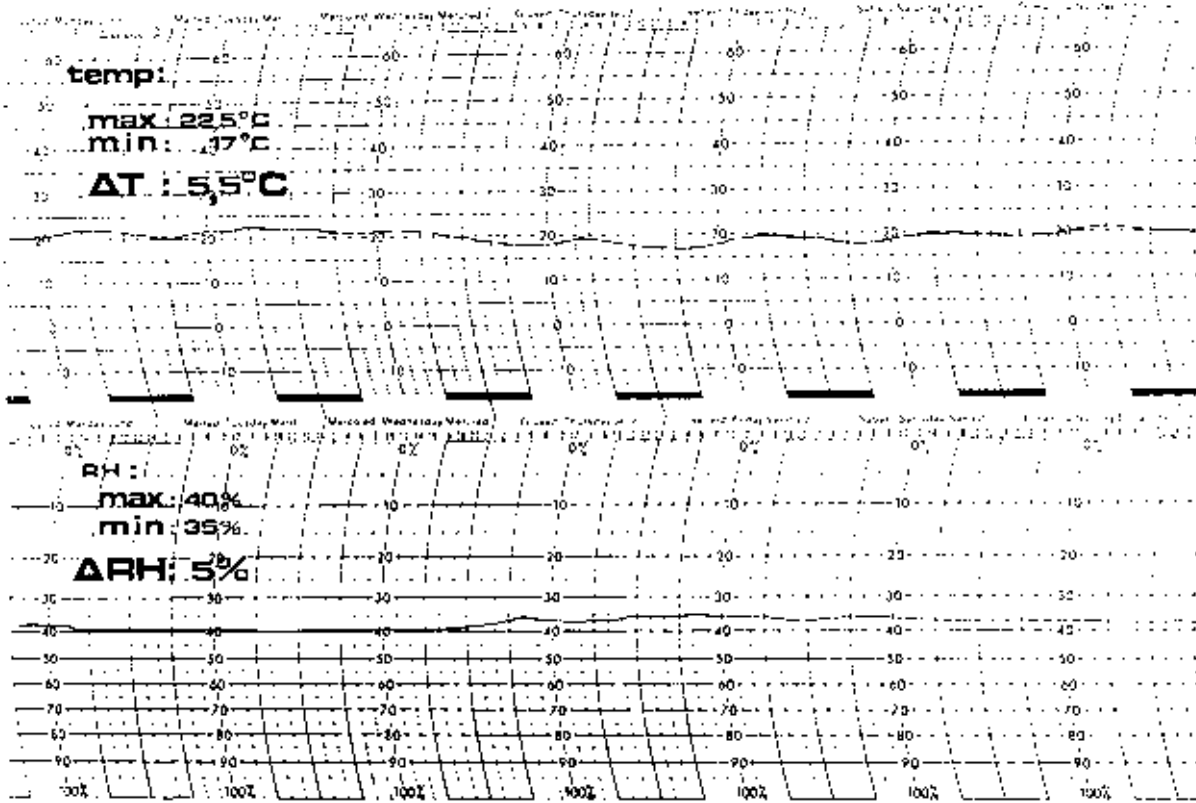
TEMPERATURES AND RELATIVE HUMIDITIES COMPARED FOR UNSEALED AND SEALED SHOWCASES AT THE SAME TIME
AS FIGURE 12.5

Figure 12.6 Environment inside an unsealed showcase, Ospizio di San Michele, Rome, Italy (Courtesy: ICCROM)

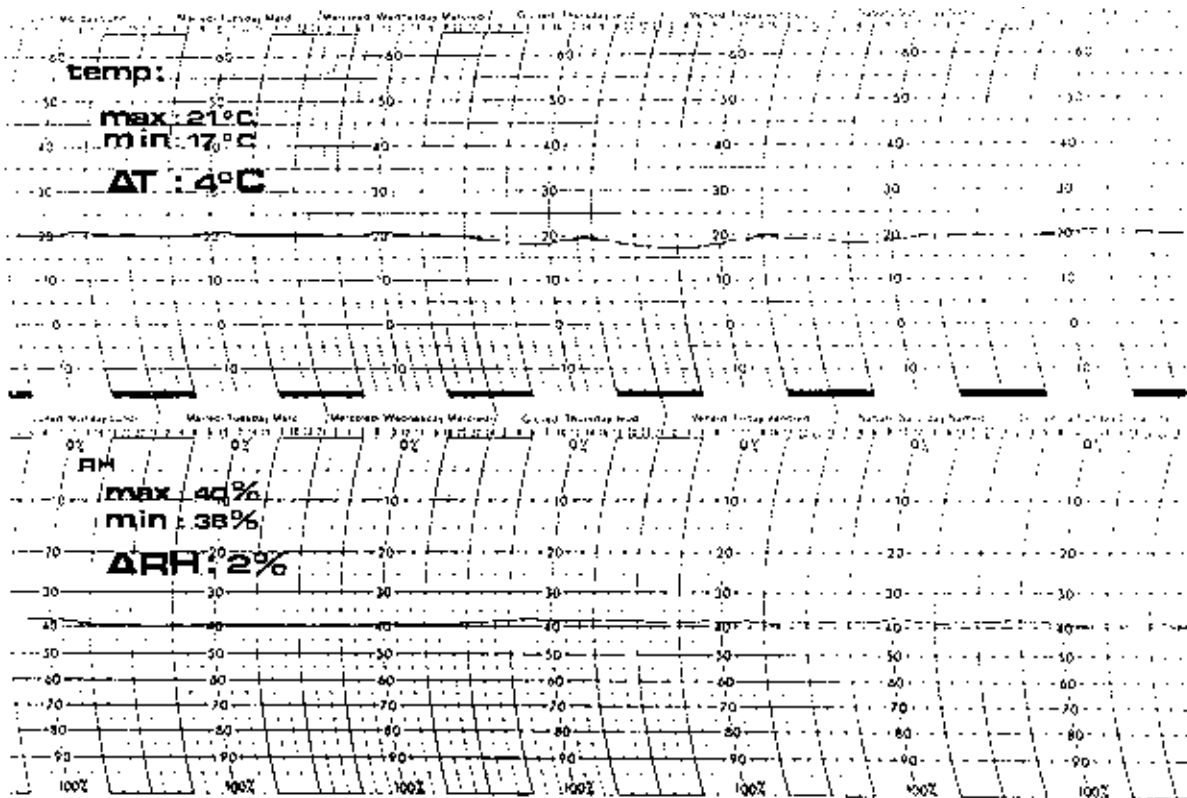
Figure 12.7 Environment in a sealed showcase with buffer material, Ospizio di San Michele, Rome, Italy (Courtesy: ICCROM)
