Conservation of Historic Buildings

*Conservation
of Historic Buildings*
Third edition

Bernard M. Feilden

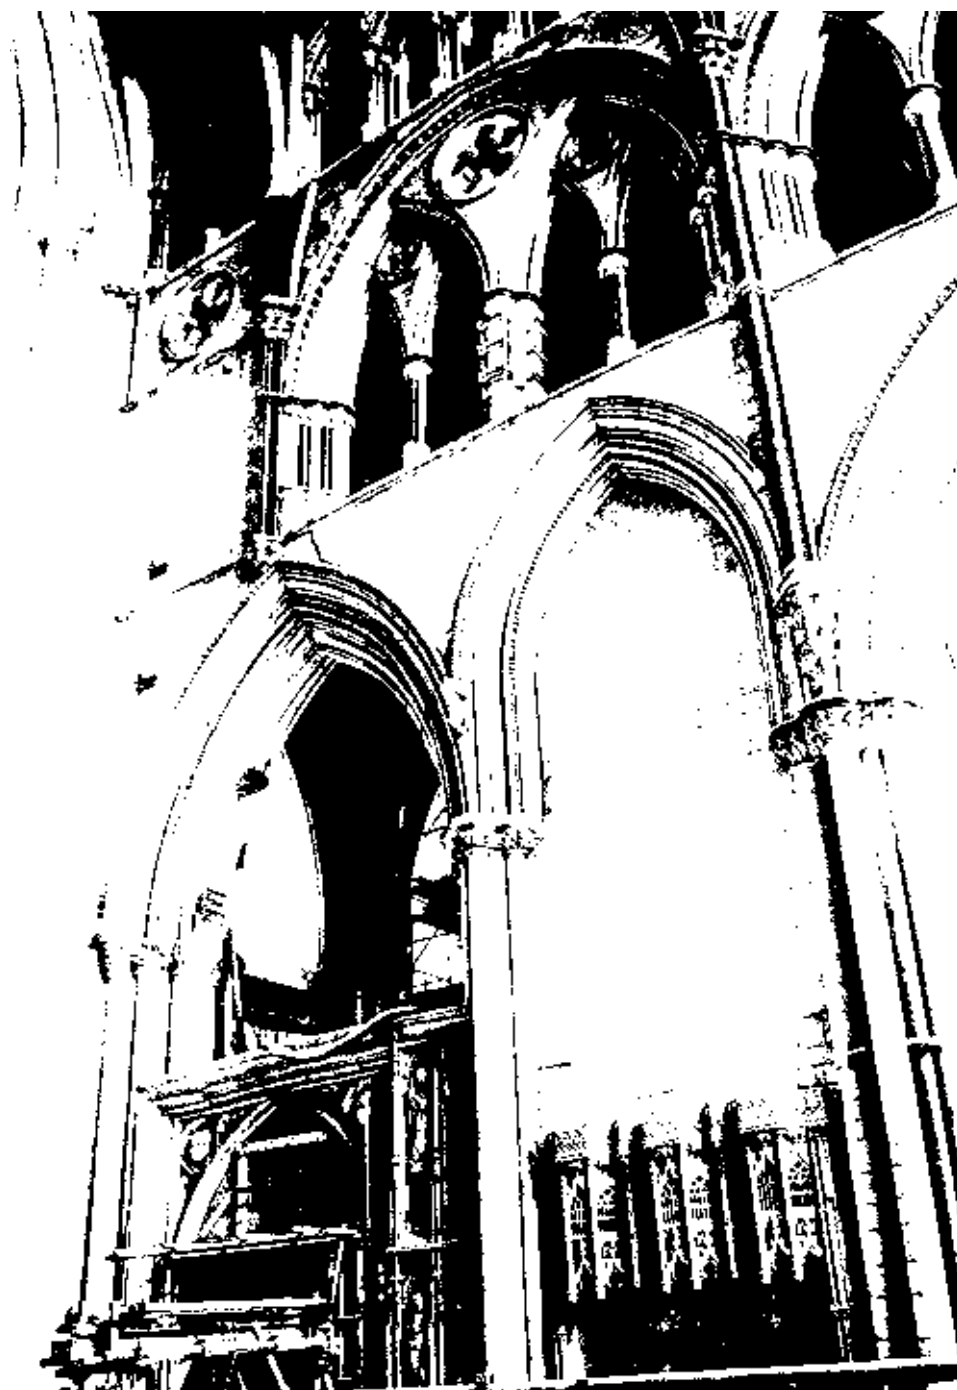
Figure 14.3 South transept, east arcade, and tower abutment, York Minster, England

Cracks and distortions are related to the settlement of the tower. The narrow arch was filled in the eighteenth century to improve its stability, but masonry and piers have cracked. When making repairs to the vertical crack (in the flat panel below the roundel), an eleventh century shaft was discovered and left exposed

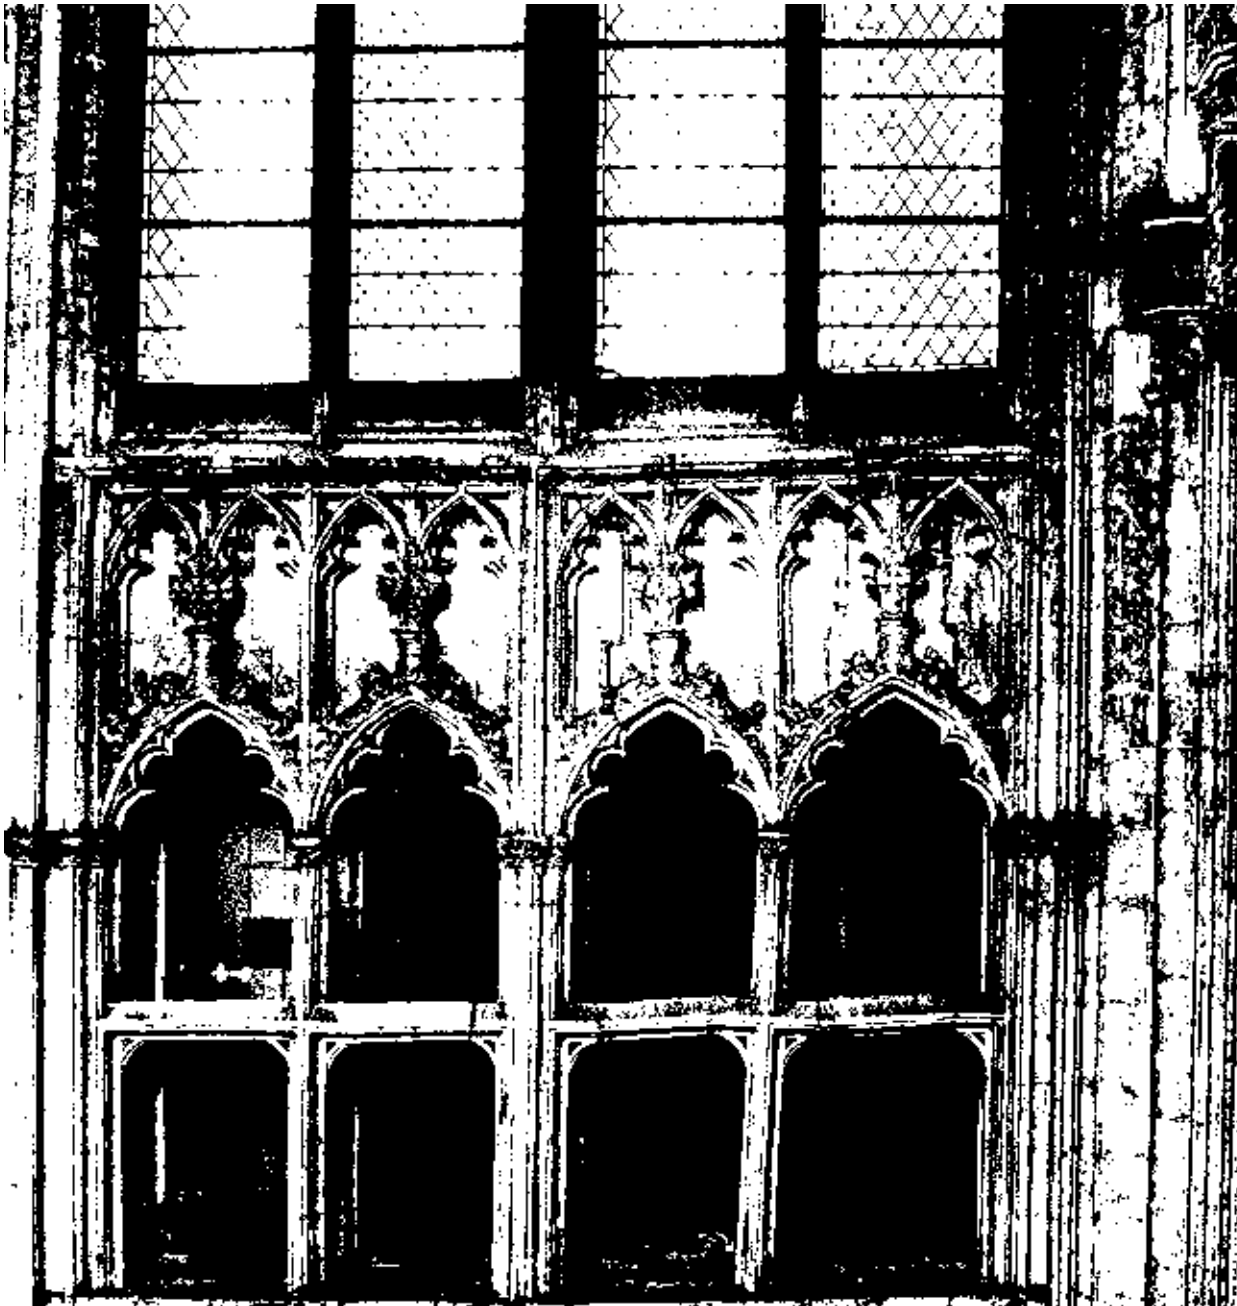
Figure 14.6 Choir, north arcade, east end, York Minster, England
(Courtesy: Shepherd Building Group Ltd)

The foundations supporting the pier and shafts on the left-hand side (west) have settled considerably more than the east wall, causing distortions and distress in the masonry. The east end has rotated outwards, causing the vertical elements to lean. The cracks had been mortared over but had reopened

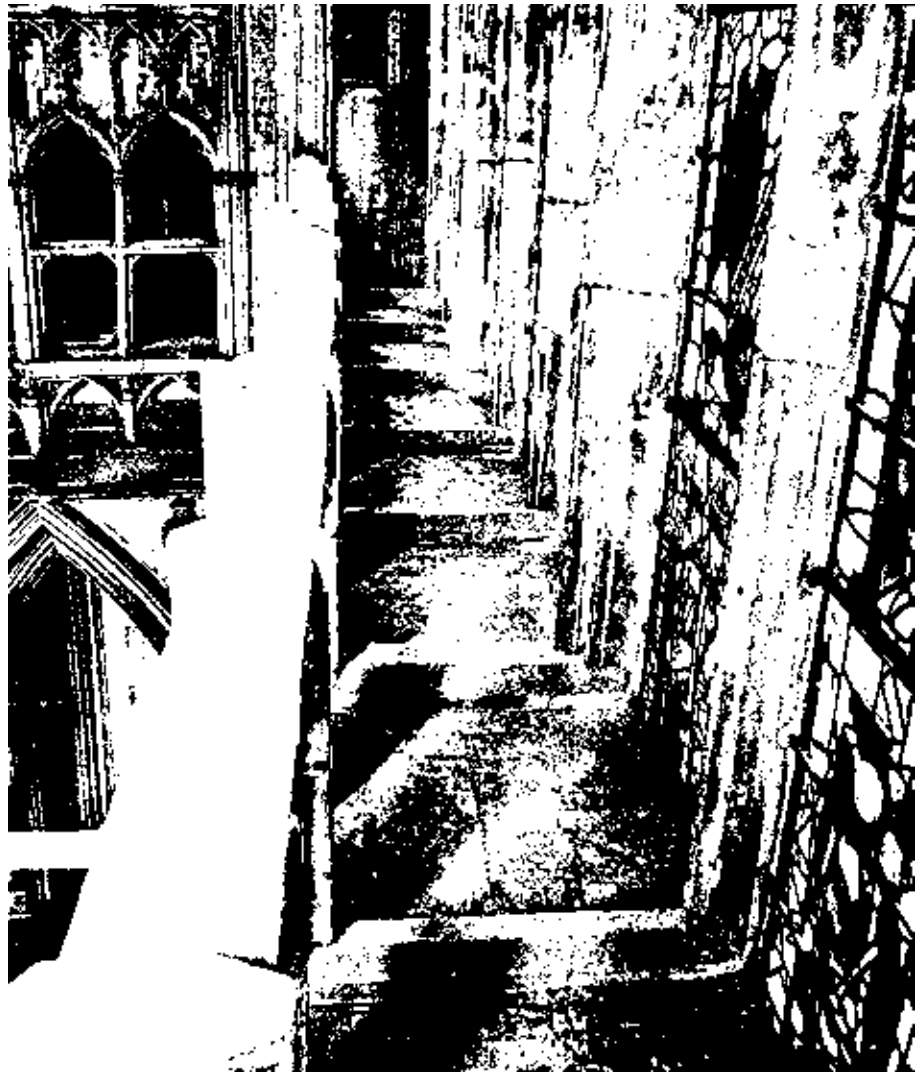
Figure 14.7 Gallery, east window, York Minster, England
(Courtesy: Shepherd Building Group Ltd)

The gallery is bowing some 150 mm (6 in) and the window above about 225 mm (9 in). With the very slender structure there was a danger of over-stressing

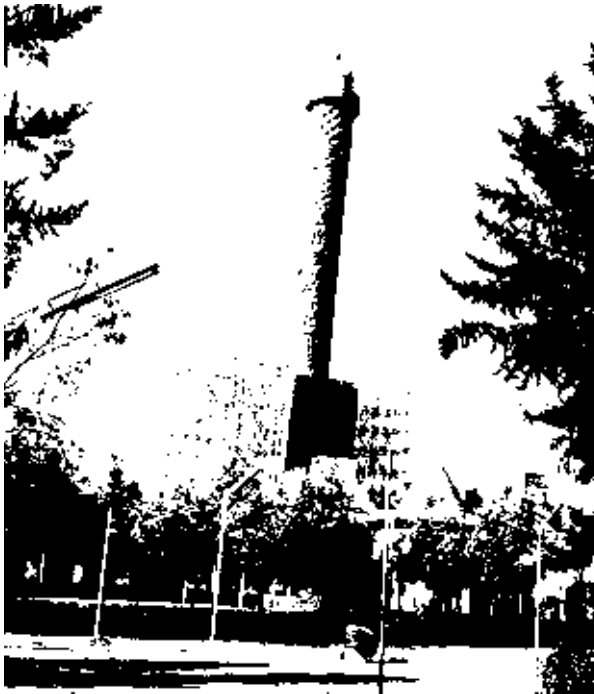
Figure 14.9 Al Hadba Minaret, Mosul, Iraq

Like many chimneys this minaret leans, bending its back to the prevailing wind. Wind vibrations have caused loose mortar to drop and cause bulges in the decorative outer casing. There is a shear crack where the flexible tower joins a stiff base

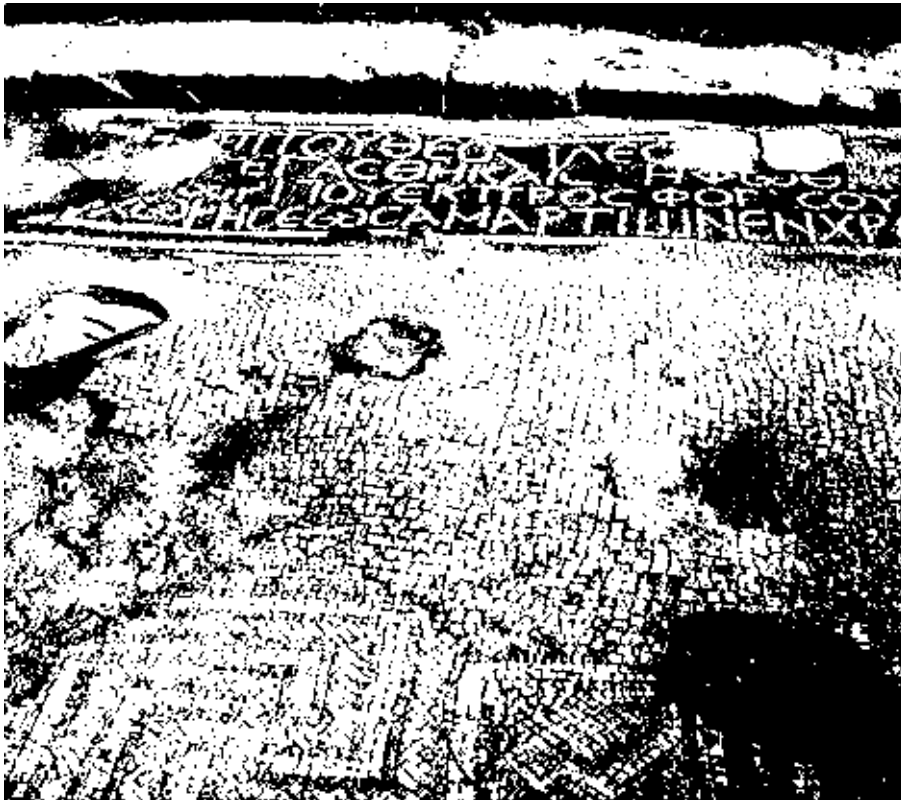
Figure 14.10 Mosaics at Jerash, Jordan

Rain penetration causes water erosion which causes soil to leach away forming a depression that collects rain, so accelerating the process. Patching with Portland cement mortar is no answer to the complicated problem of conservation and presentation

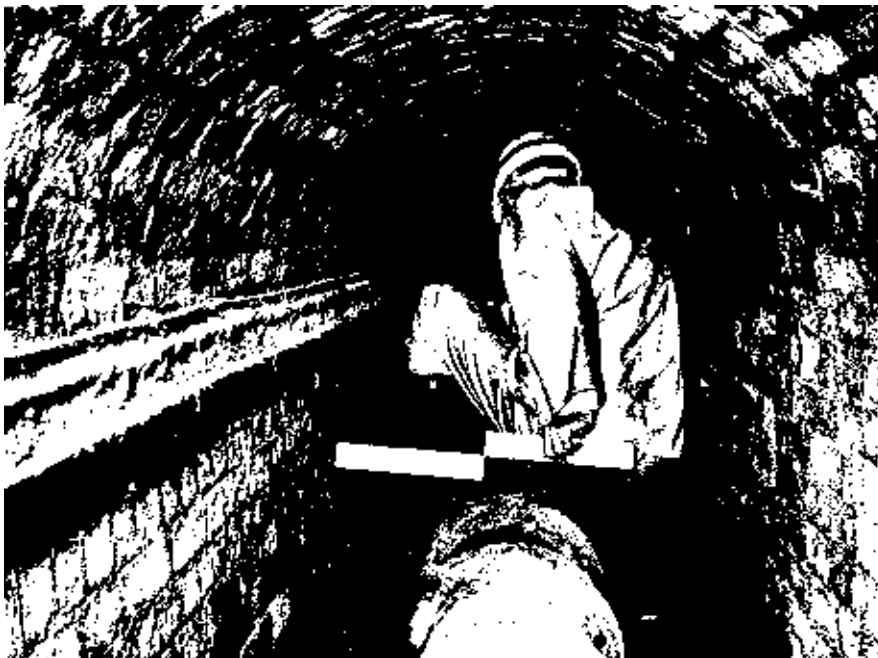
Figure 14.11 Original rainwater disposal system, St Paul's Cathedral, London, England

A view along the north branch before cleaning out took place. The drain was found to be blocked, causing storm water to flood over the sensitive foundations of the north-west tower. After cleaning out, the movements of the tower ceased, at least for the time being

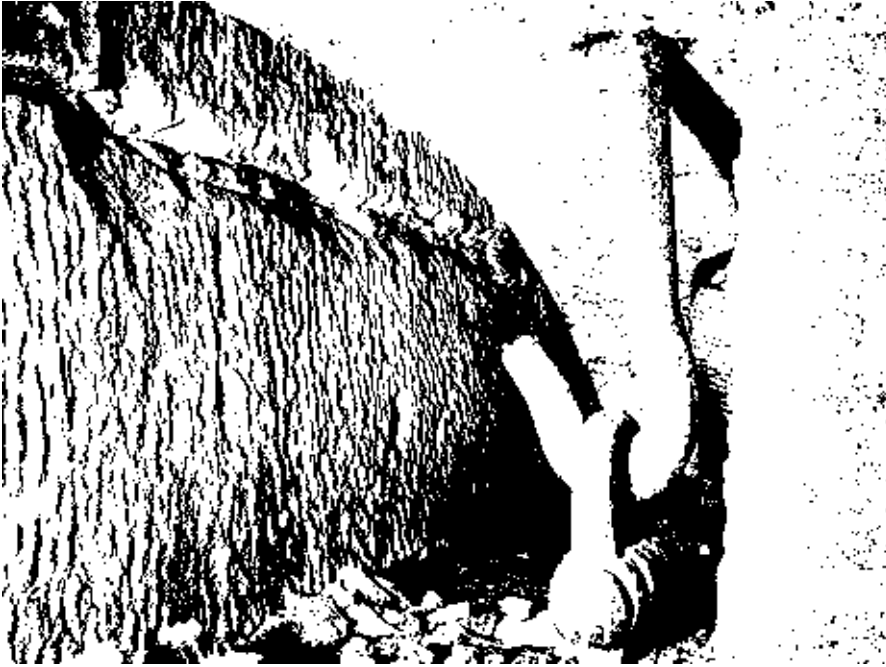
Figure 14.12 West porch, St Paul's Cathedral, London, England

A view inside the jack-arch on the middle cornice of the west front porch shows the Lewis bolt which appears to be in good condition: it was not known that the lintel was held up by the Lewis bolt until it was opened up

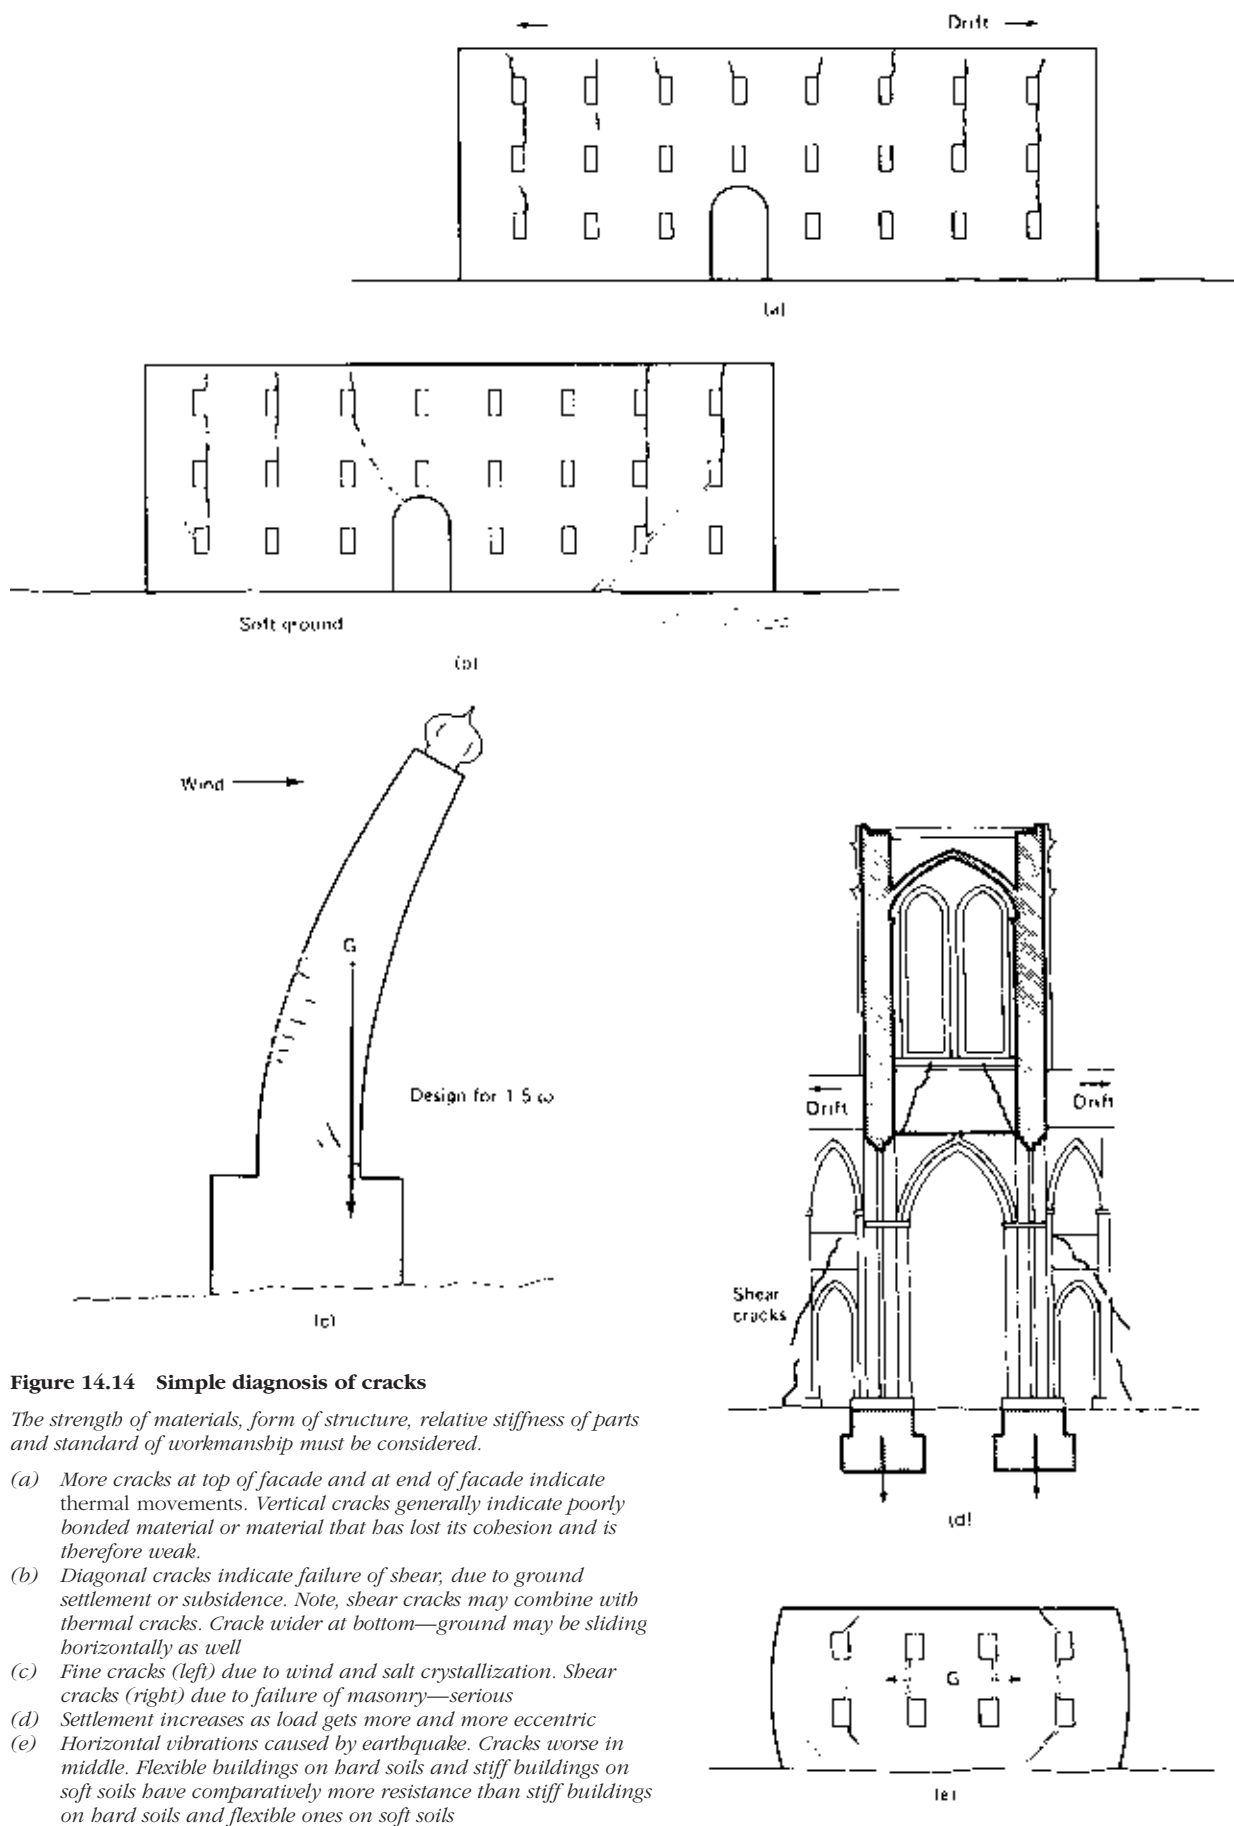
Figure 14.14 Simple diagnosis of cracks

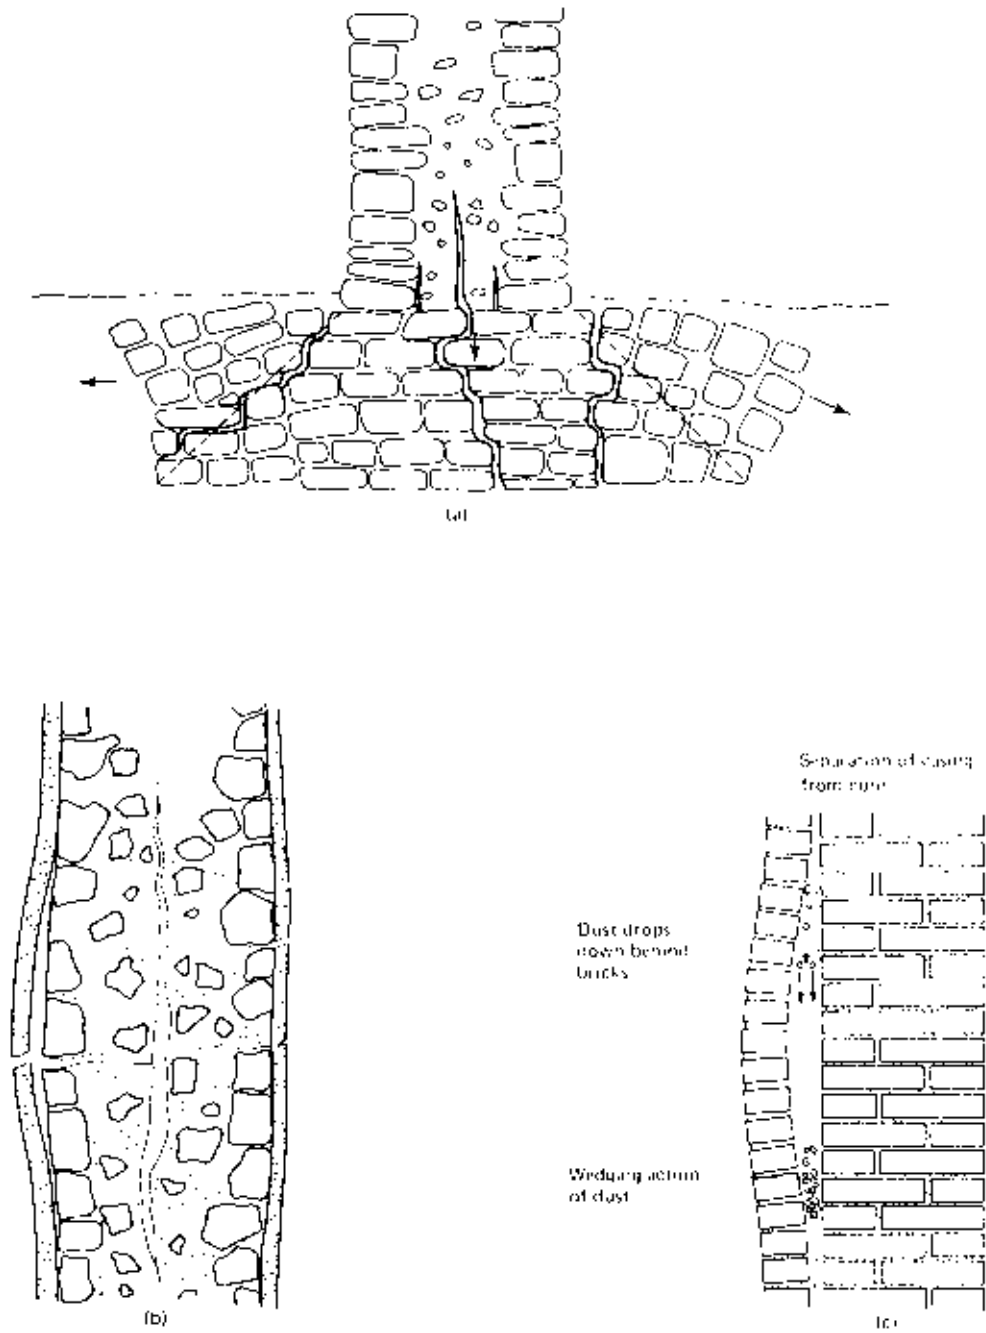
Figure 14.15 Failures of walls and piers

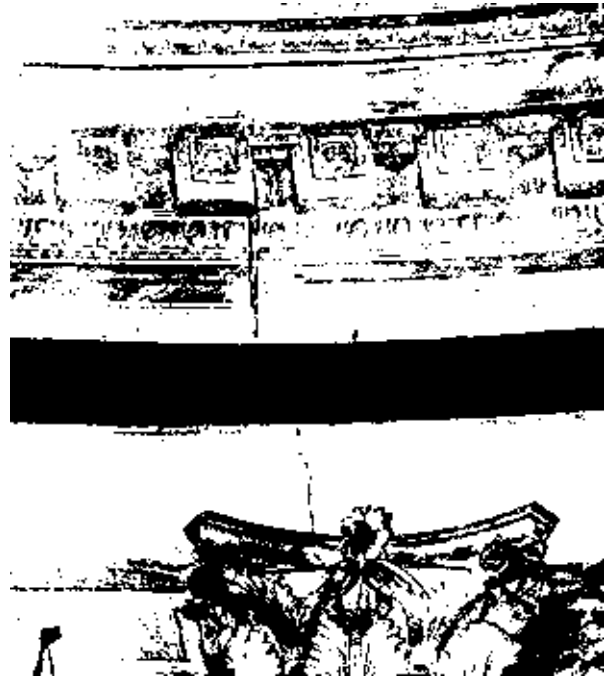
Figure 14.16 Pantheon, Rome, Italy

A detail of a structural crack, probably due to thermal movement. One of only a few deformations visible in this well-maintained monument

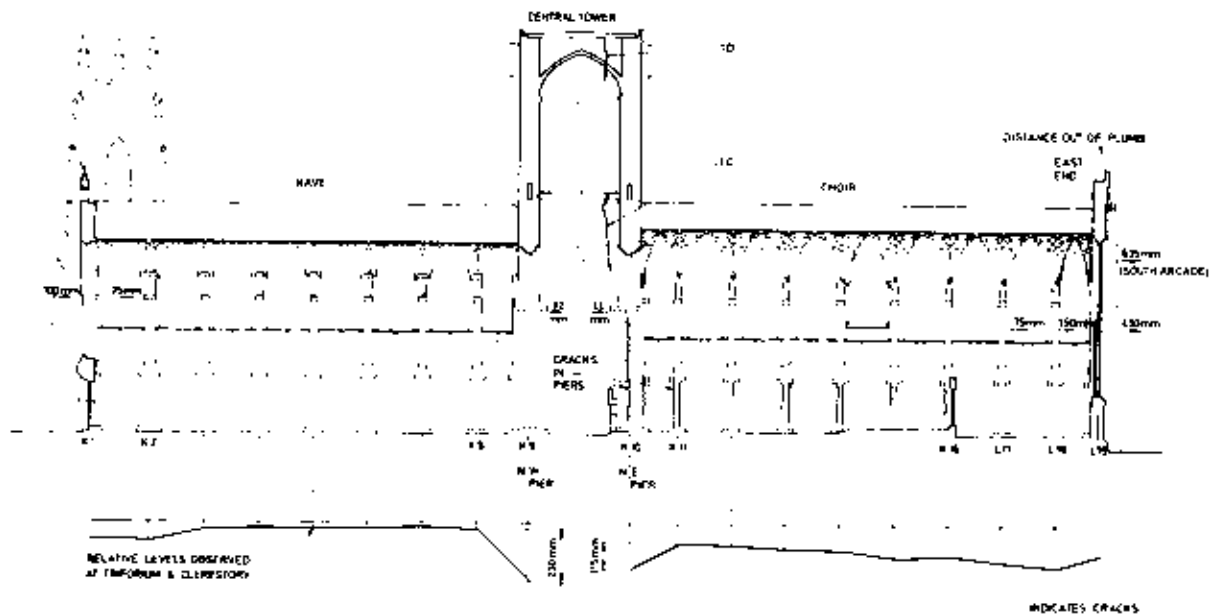
Figure 15.1 York Minster, England, long section
(Courtesy: Ove Arup & Partners)

A simplified drawing to 1/200 scale (now reduced) of a section through nave and choir showing settlements, deformations and some cracks

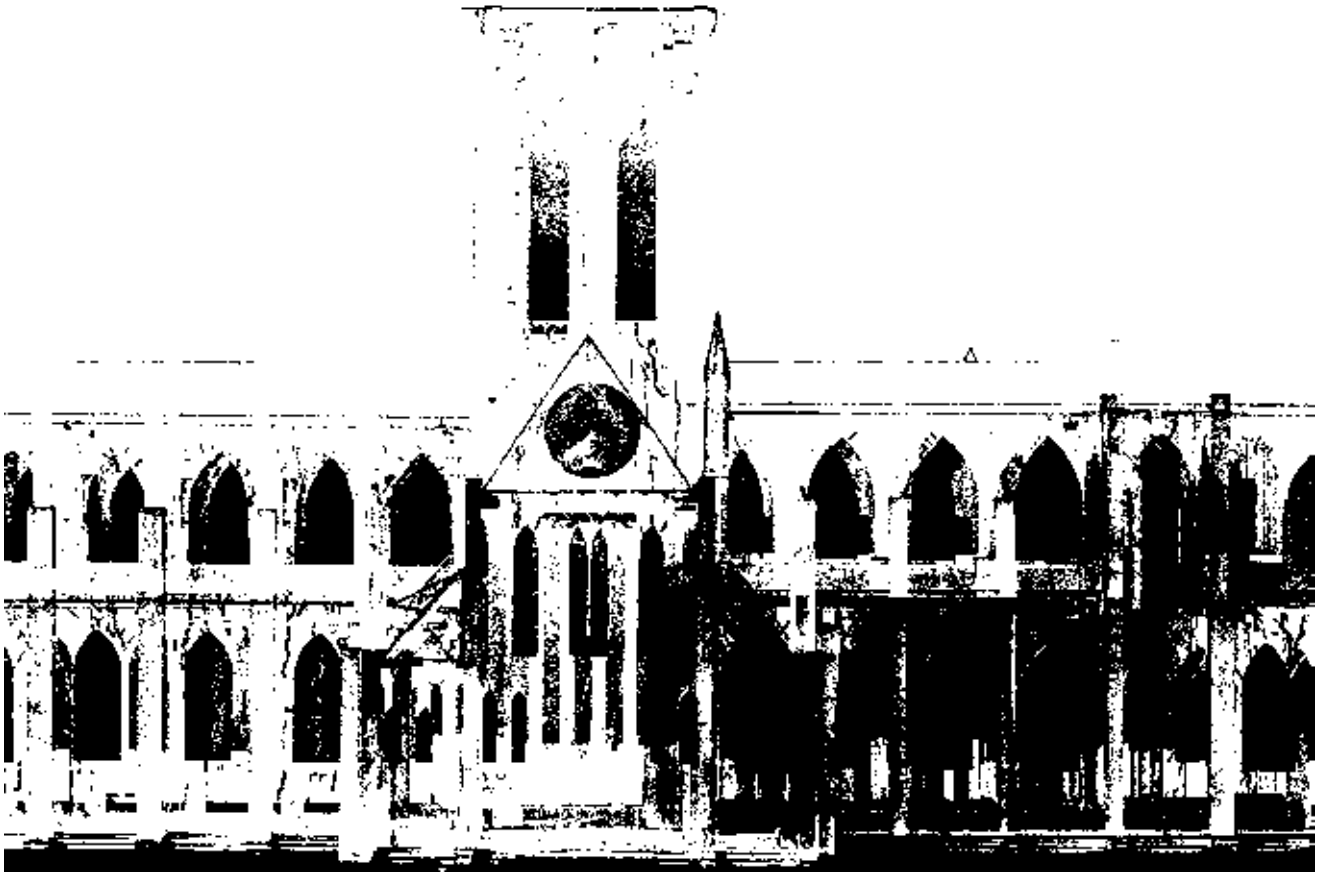
Figure 15.2 Perspex model of York Minster, England
(Courtesy: Feilden & Mawson)

After a visual inspection with a written report, the information was consolidated into drawings and finally a perspex model was made which enabled a three-dimensional simultaneous assessment of the complicated syndrome of cracking and deformation to be carried out, together with an analysis of the structural actions of the building as a whole

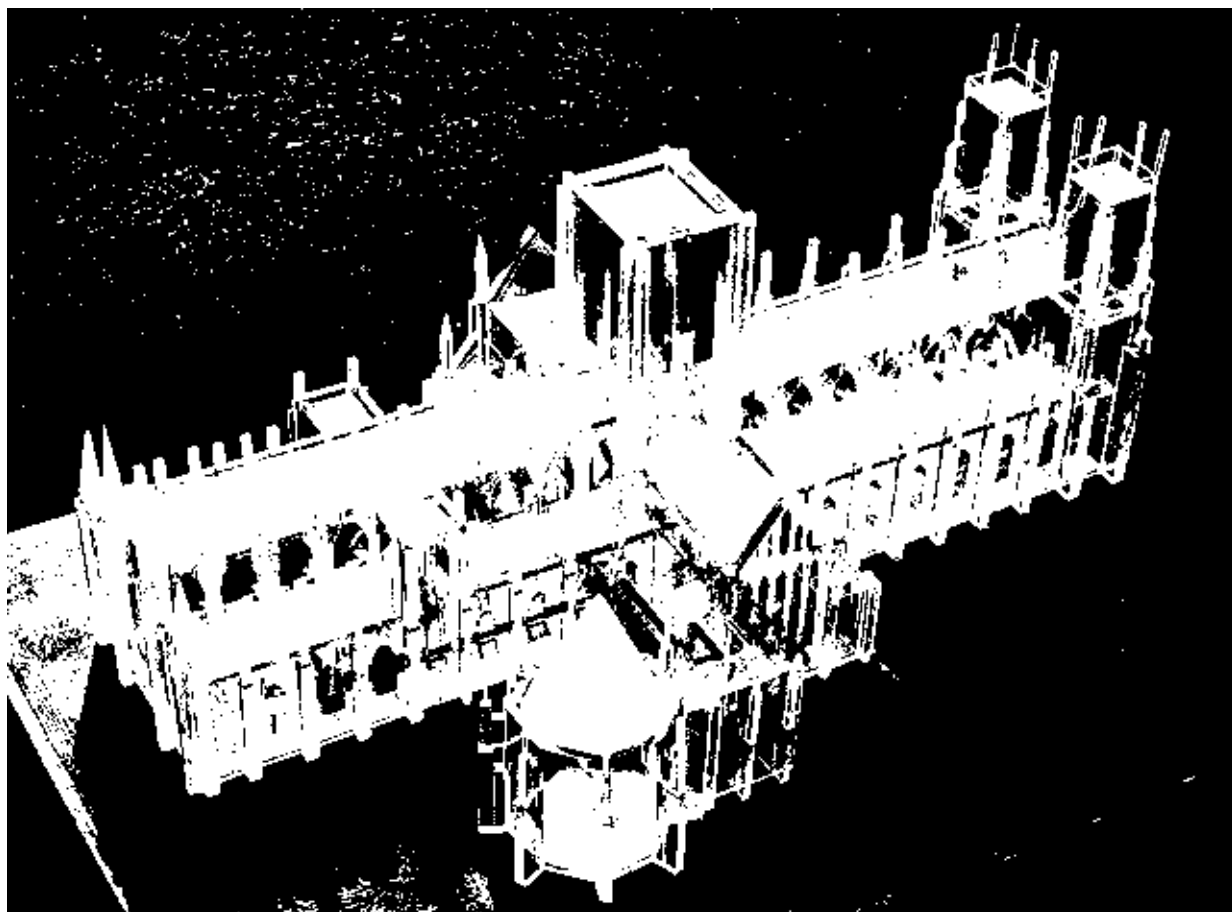
Figure 15.3 Perspex model of York Minster, England
(Courtesy: Feilden & Mawson)

Using this model enabled information on at least 16 drawings to be absorbed and co-ordinated simultaneously

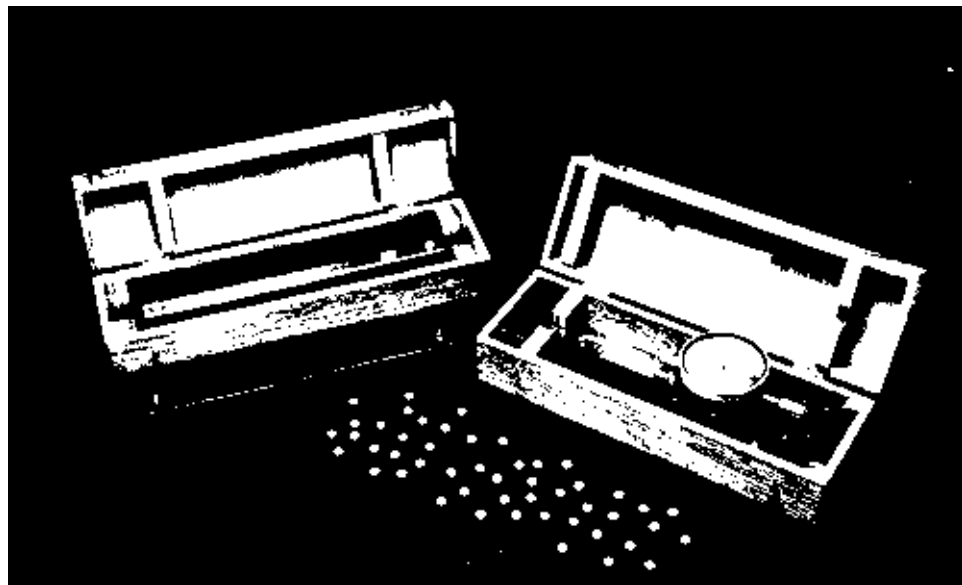
Figure 15.5 Demec mechanical strain gauge
(Courtesy: Ove Arup & Partners)

The standard 200 mm (8 in) gauge is most useful for historic buildings because the stainless steel locating centres can be glued to the surface of the fabric using a locating jig. The extra width of the gauge allows it to span multiple cracks. In practice, it is sometimes difficult to find a firm fixing. Movements in two directions can be plotted

The measuring points, a fixed and movable cone, are placed into the locating centres which are glued either side of the crack using a jig to place them sufficiently accurately. Patterns of measurement record that:

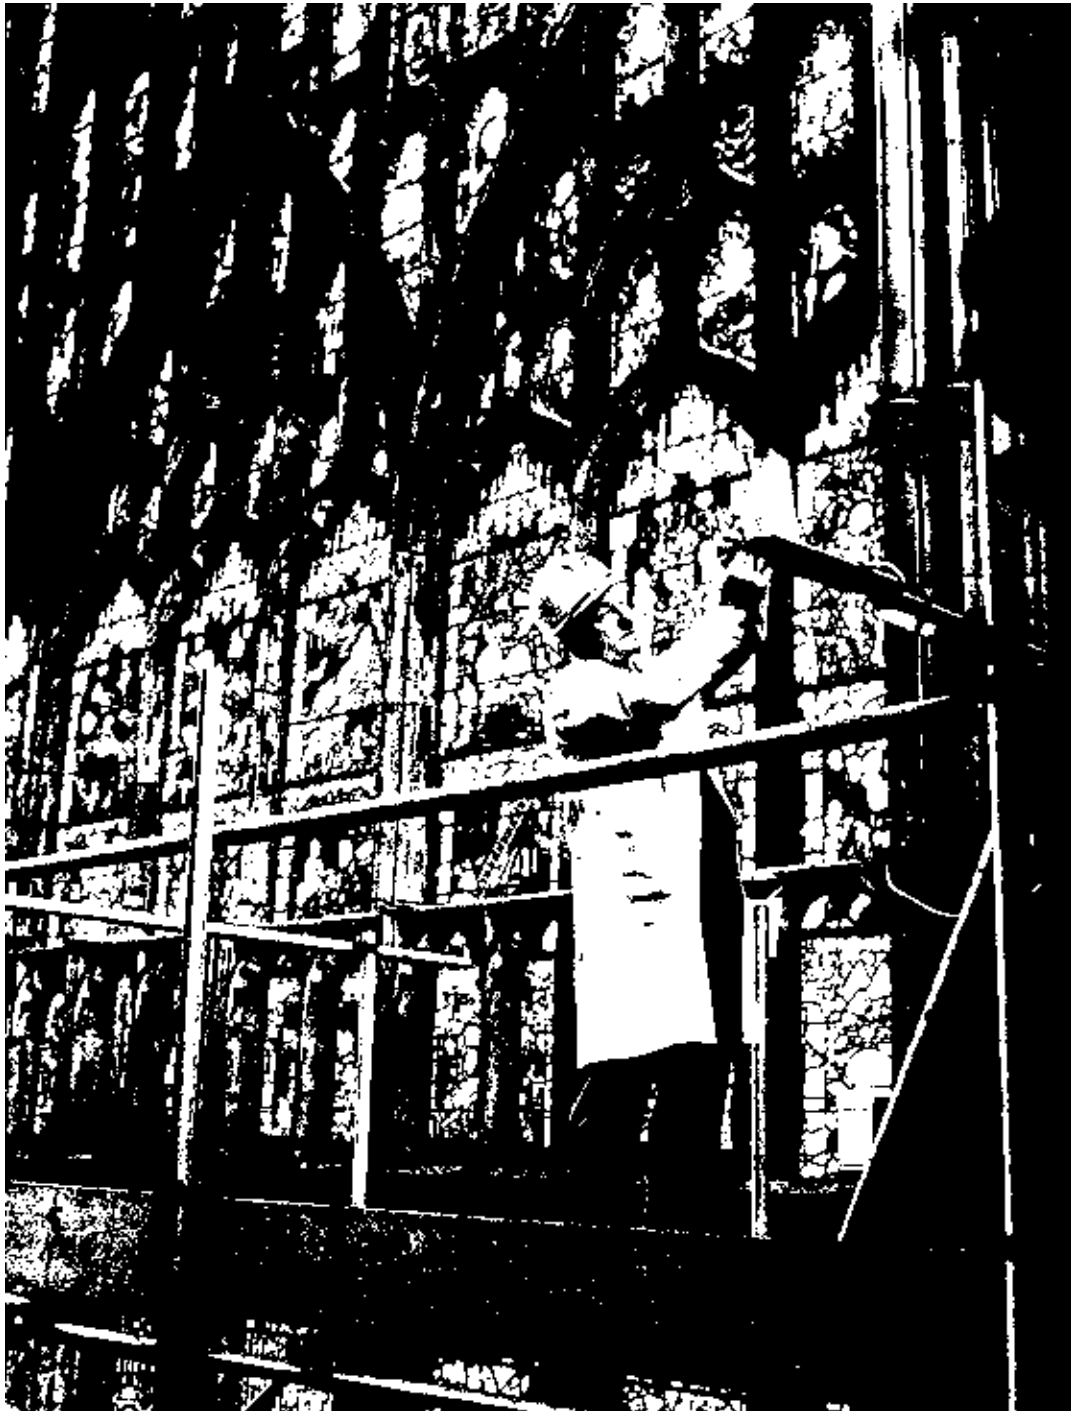
Figure 15.8 Optical plumb bob, York Minster, England
(Courtesy: Shepherd Building Group Ltd)

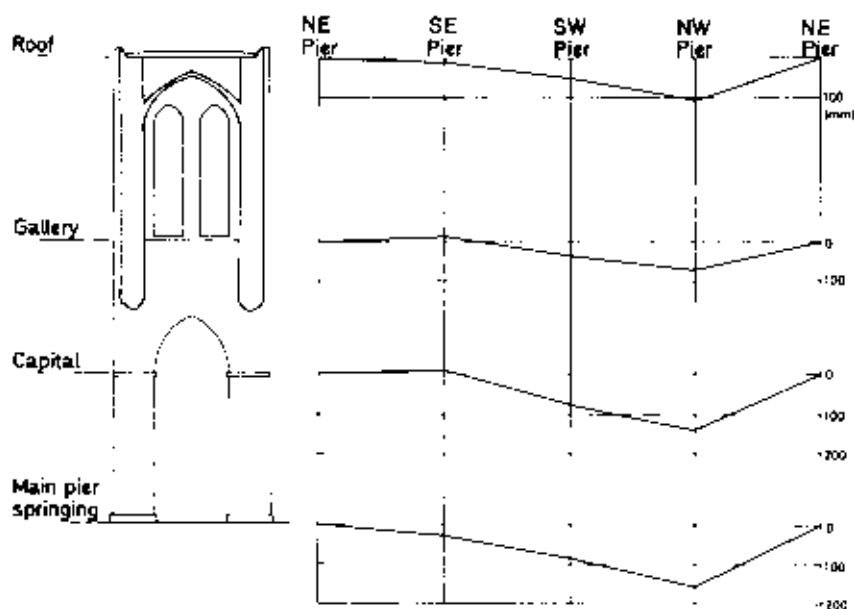
Figure 15.9 York Minster, England, central tower
(Courtesy: Ove Arup & Partners)

A simplified drawing to show the differential levels of the four corners of the central tower measured at different heights. These measurements were used to test assumptions made in the calculations

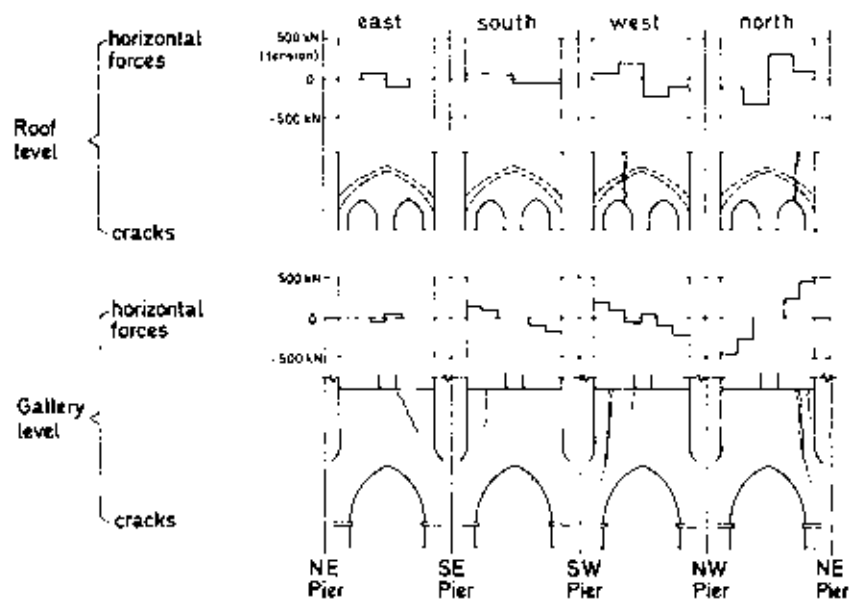
Figure 15.10 York Minster, England, central tower
(Courtesy: Ove Arup & Partners)

An exploded diagram showing observed cracks and the horizontal forces calculated assuming the differential settlement shown above

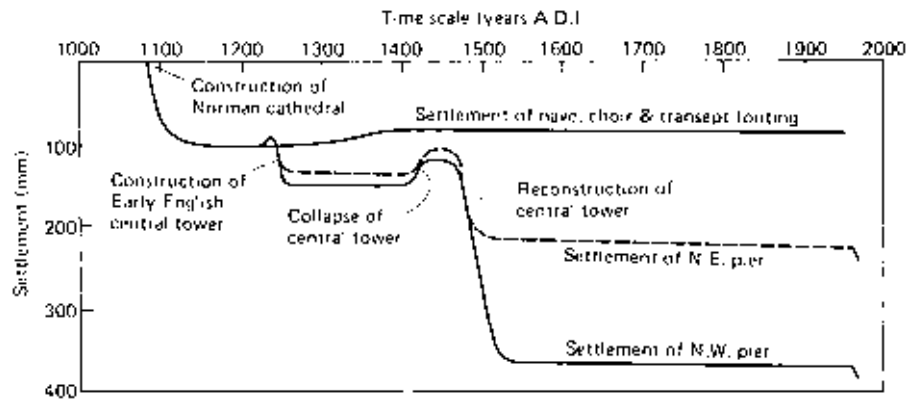
Figure 15.11 Settlements, York Minster, England

A hypothetical reconstruction of settlements since the building of the Norman cathedral in 1080. This diagram is most useful in visualization of the structural history of a building which had reached a crisis due to the foundation, long overloaded, having become sensitive to small environmental changes such as lowering of the water table

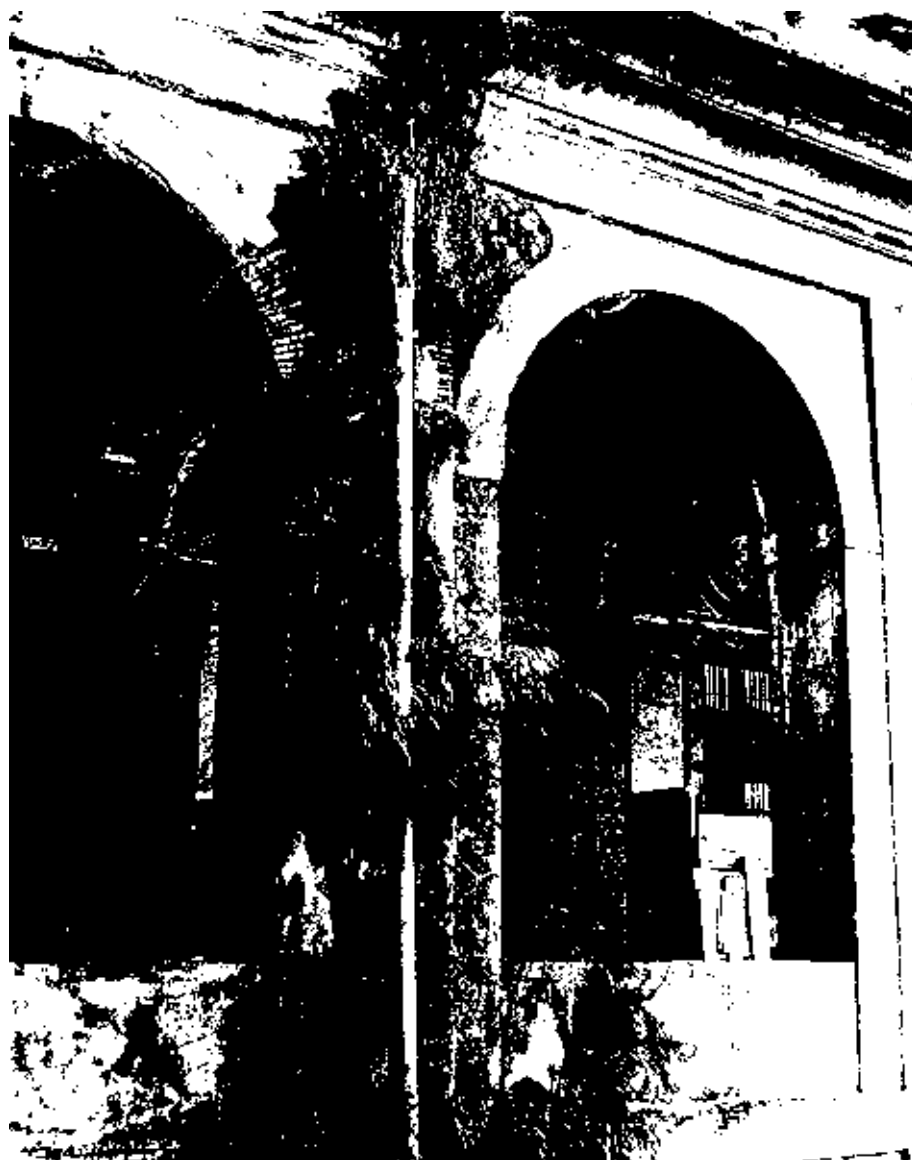
Figure 16.1 Ospizio di San Michele, Rome, Italy

As a new use for this building had not been decided, it was neglected for a few years. Blocked rainwater gutters and downpipes initiated decay which led to some parts of the building collapsing

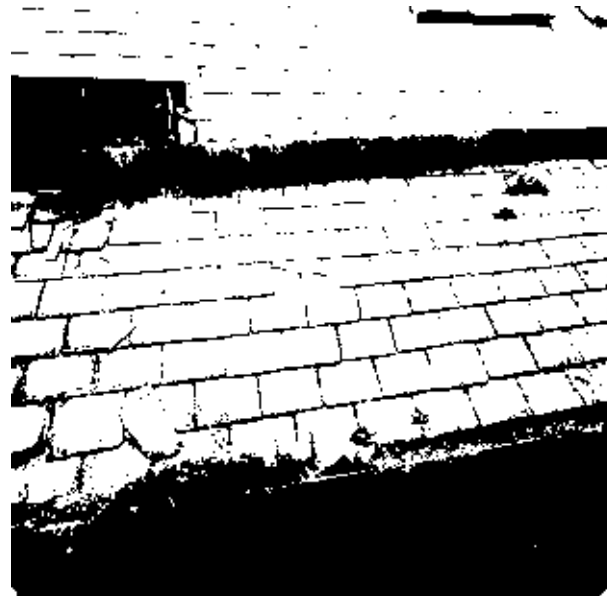
Figure 16.2 Pears Almshouses, Peterborough, England
(Courtesy: Feilden & Mawson)

The slate roof has missing, broken and slipped slates and gutters blocked by debris and grasses, but the roof only needs small repairs, for it is basically sound if work is done in time

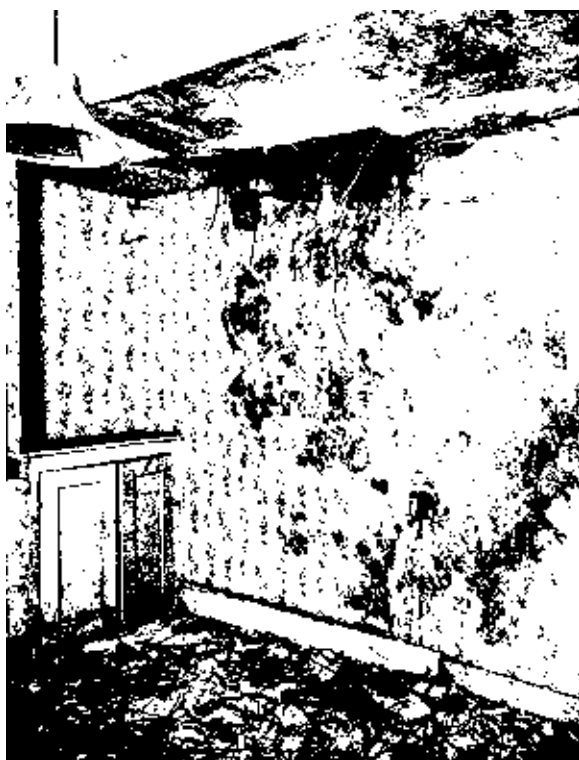
Figure 16.4 Living room, Pears Almshouses, Peterborough, England

Local water penetration from the faulty roof has caused reed lathing to rot and the plaster to fall, besides staining the walls. Reed lath was frequently used in East Anglian plasterwork until the end of the nineteenth century

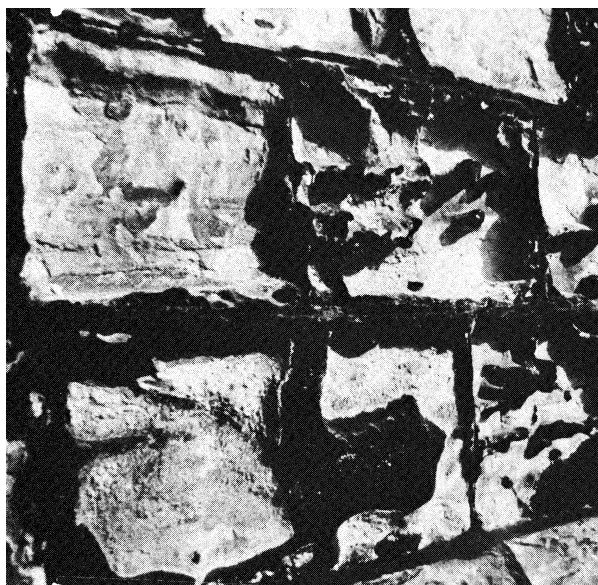
Figure 16.7 St William's College, York, England

The hard cement pointing stands proud, while the decay of the softer permeable stone has been accelerated. An example of wrong maintenance

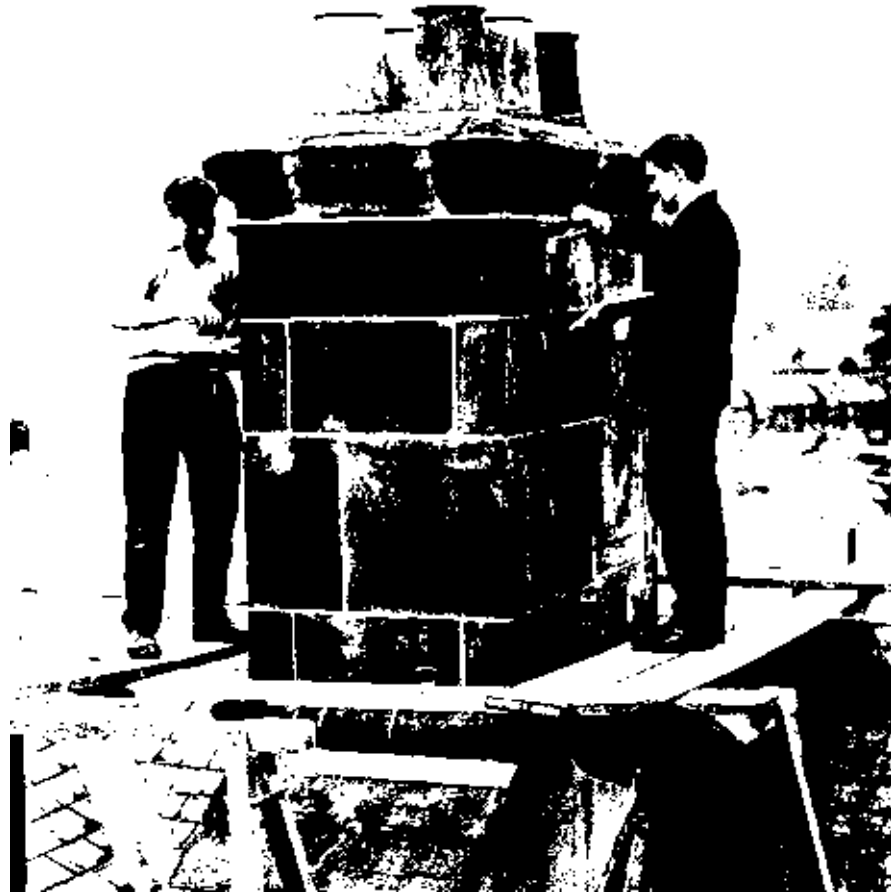
Figure 16.10 Kedelston Hall, Derbyshire, England
(Courtesy: D.W. Insall)

Fundamentally, mortar joints in stone should be close in colour to the stone, but should not be made black to match the soot. After re-pointing sandstone the mortar shows up lightly for a few years, but will then darken and harmonize naturally. The colour, thickness and surface texture of pointing are vital to the appearance of a building

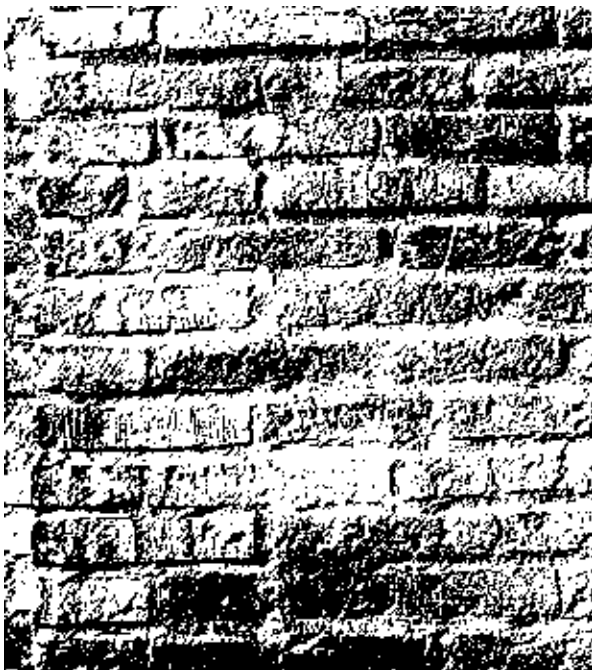
Figure 16.11 Bridge, Isphahan, Iran

Maintenance of the bridge includes renewal of brickwork and pointing. A skilled eye can detect a slight colour and texture change in the brick and a slight change in the mortar

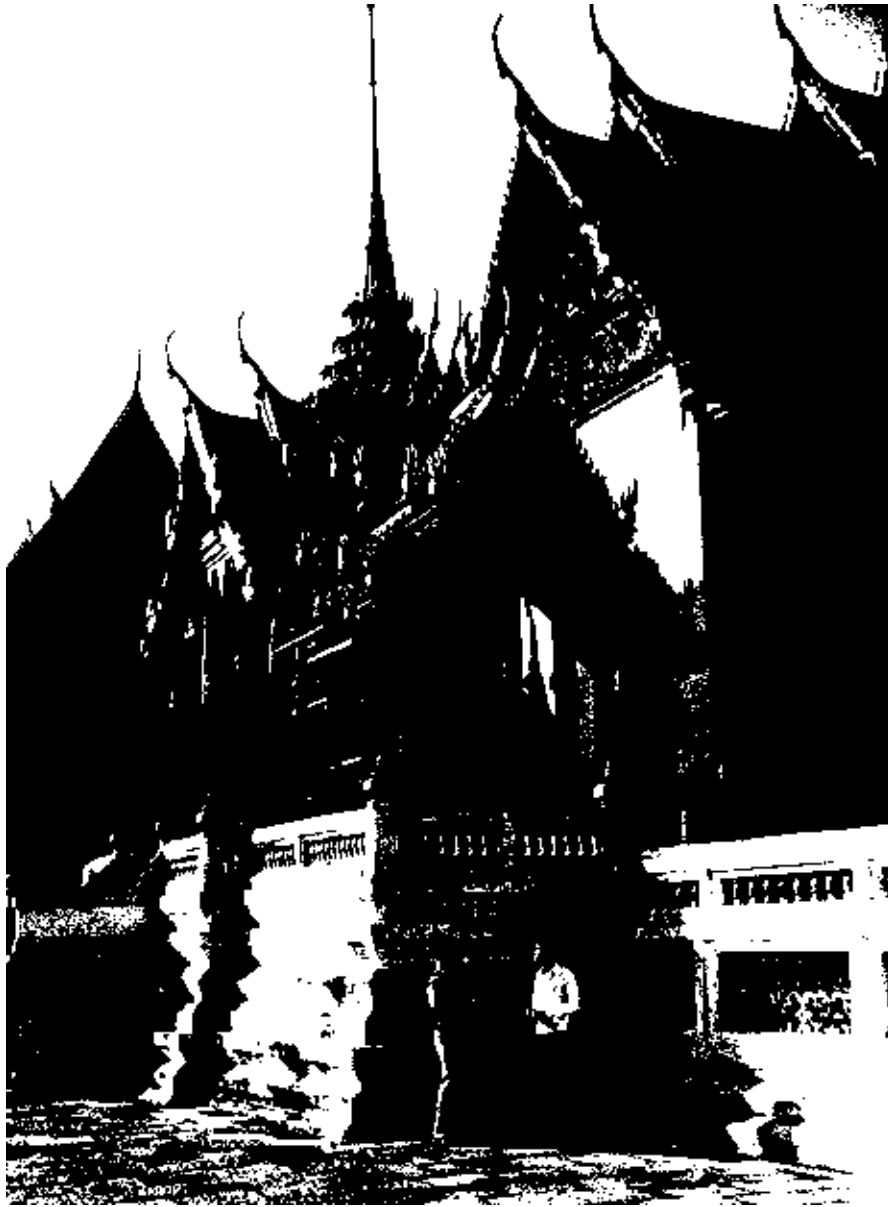
Figure 16.13 The Royal Palace, Bangkok, Thailand

Even the ridge pieces of the roof can be attacked by termites. Externally they are protected by thick black natural resin lacquerwork and by pieces of embedded coloured glass which are difficult to reproduce
