Conservation of Historic Buildings

*Conservation
of Historic Buildings*
Third edition

Bernard M. Feilden

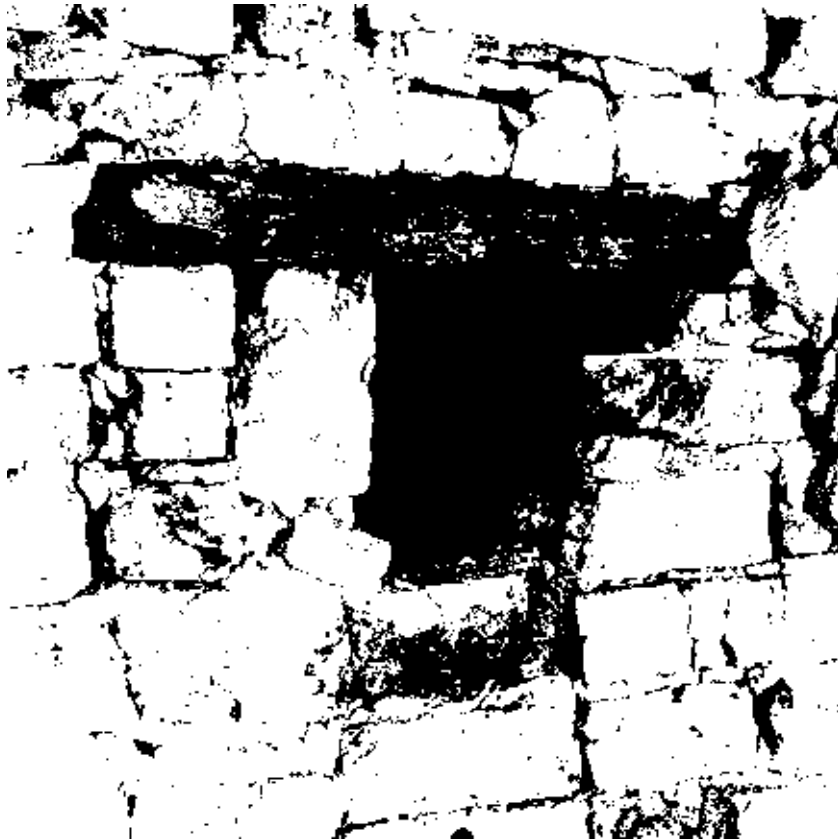
Figure 16.15 National Museum, Bangkok, Thailand

The cause of distress was found to be that termites had completely eaten away the timber post supporting the roof which was encased by the non-structural brickwork

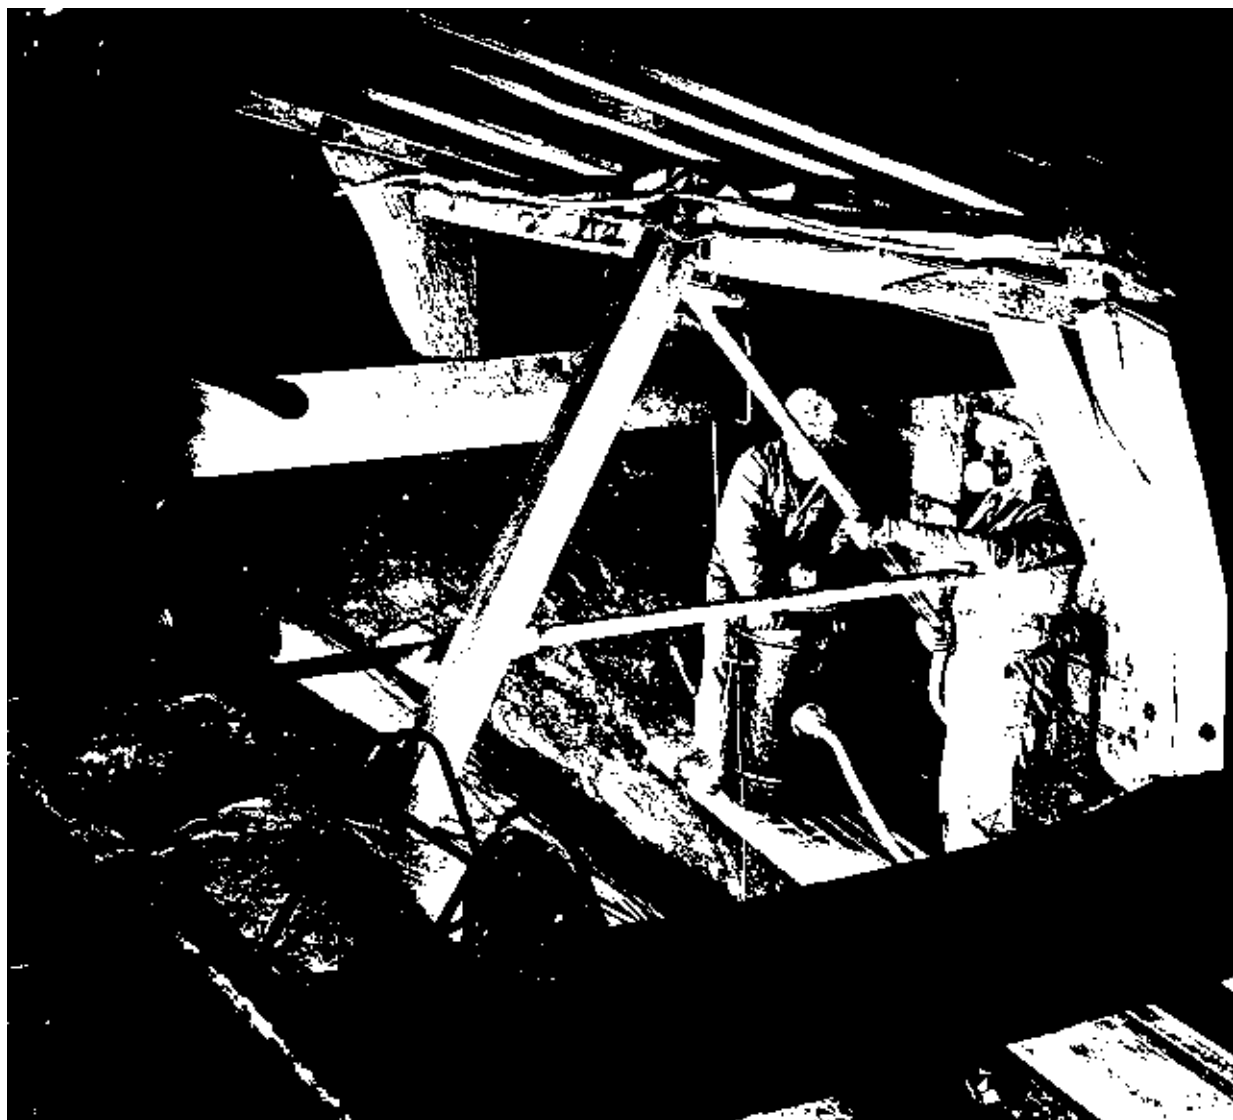
Figure 16.16 Roof spaces, north aisle, York Minster, England
(Courtesy: Shepherd Building Group Ltd)

Before application of preservatives, all accumulations of the rubbish of ages was removed and the roof areas were vacuum cleaned as part of a programme of good housekeeping

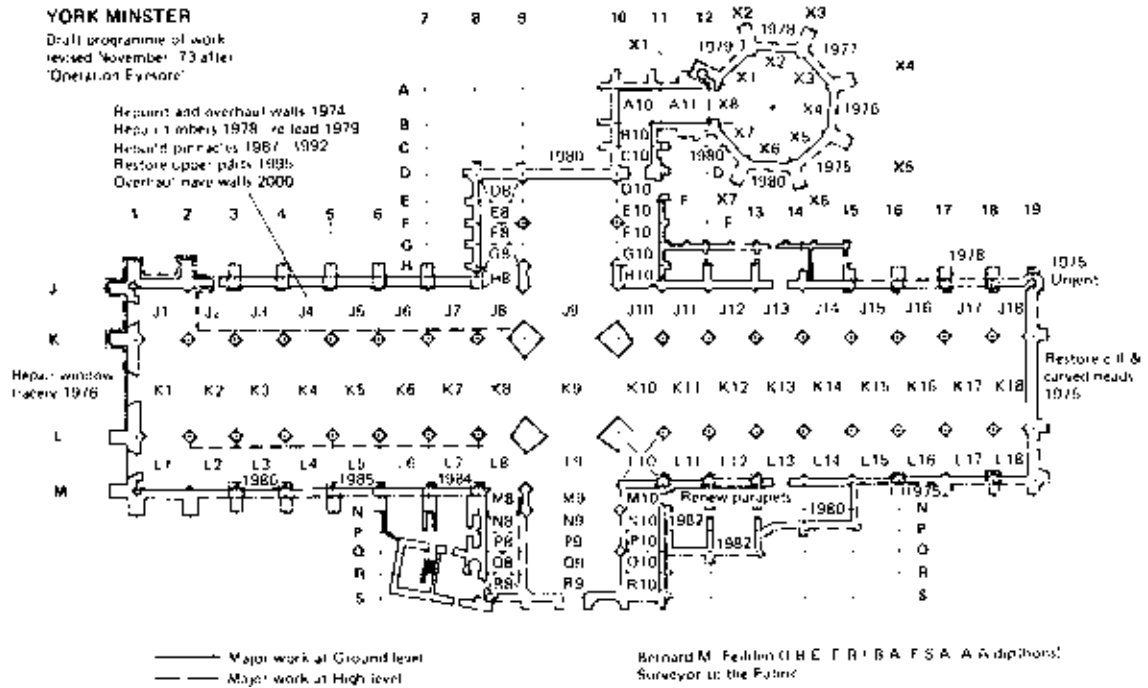
Figure 16.17 The rolling programme of preventive maintenance for York Minster, England

This programme was based on two quinquennial inspections; it should be revised and updated after each regular inspection

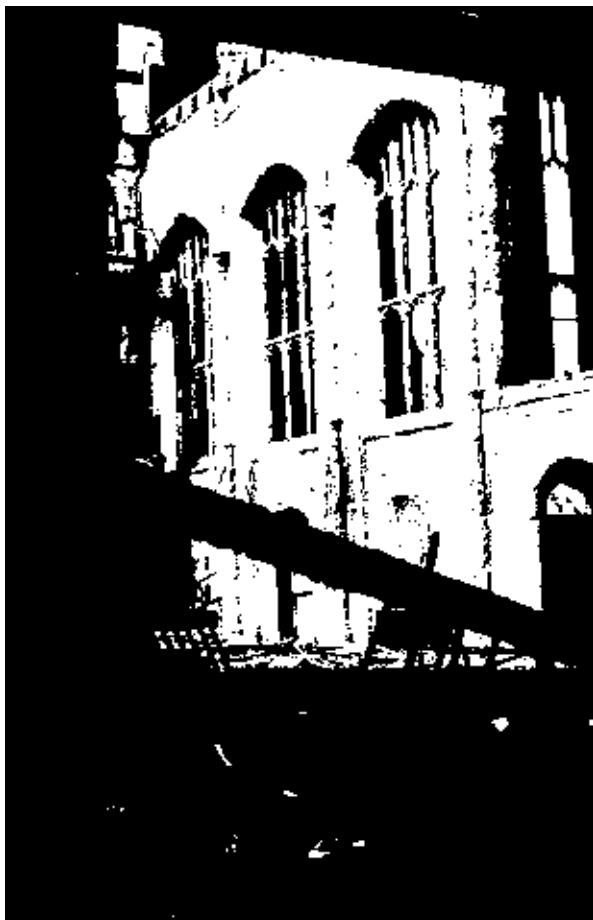
Figure 17.2 Bedford School, Bedford, England
(Courtesy: Bedfordshire Times Press)

The burnt-out remains, with stone dressings spalled by the heat and all combustible material consumed except for a few charred beams. The cause of the fire was arson

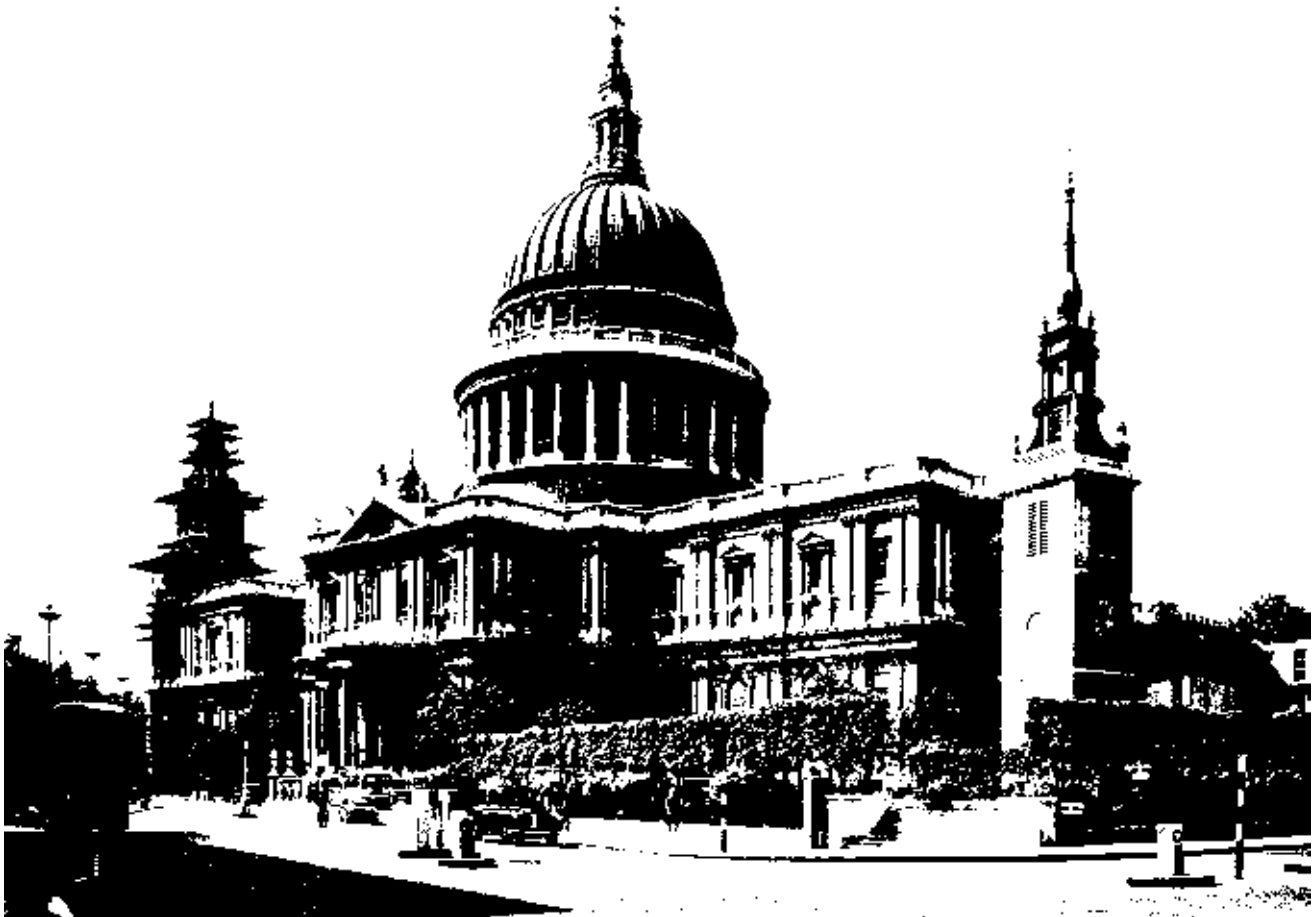
Figure 17.3 St Paul's Cathedral, London, England
(Courtesy: Feilden & Mawson)

The dome, one of the most perfect, is a major fire hazard due to the amount of timber used (fire load) and its inaccessibility to normal fire-fighting equipment. A lift was installed against the south-west corner to enable four firemen, in full equipment, to be taken up the first 30 m (100 ft). A second lift to the base of the dome has been planned. Repairs to the south-west tower are in progress

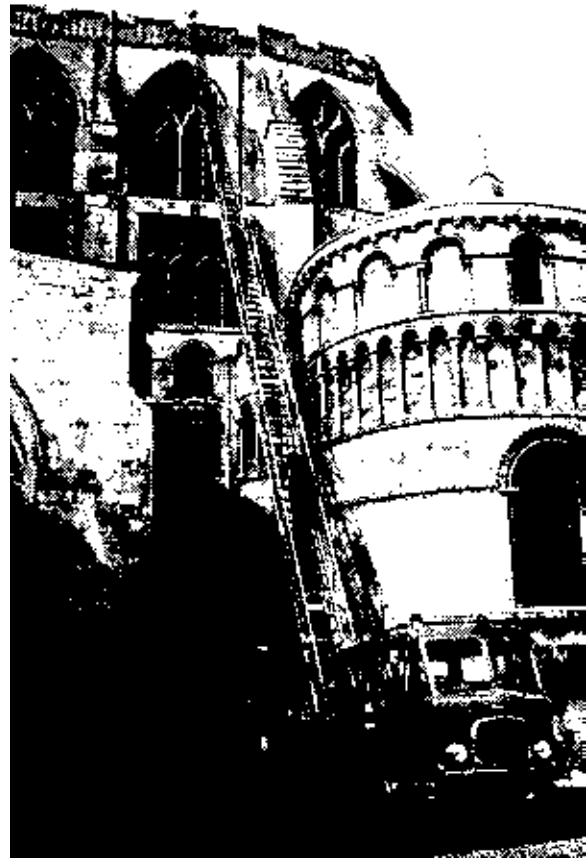
17.5 Norwich Cathedral, Norwich, England

At Norwich Cathedral, fire-fighting drill is practised regularly. A hard standing has been formed so that the heavy fire tender can put its 30 m (100 ft) ladder into position. Rehearsals take place every six months, so that every fireman knows his way in an emergency

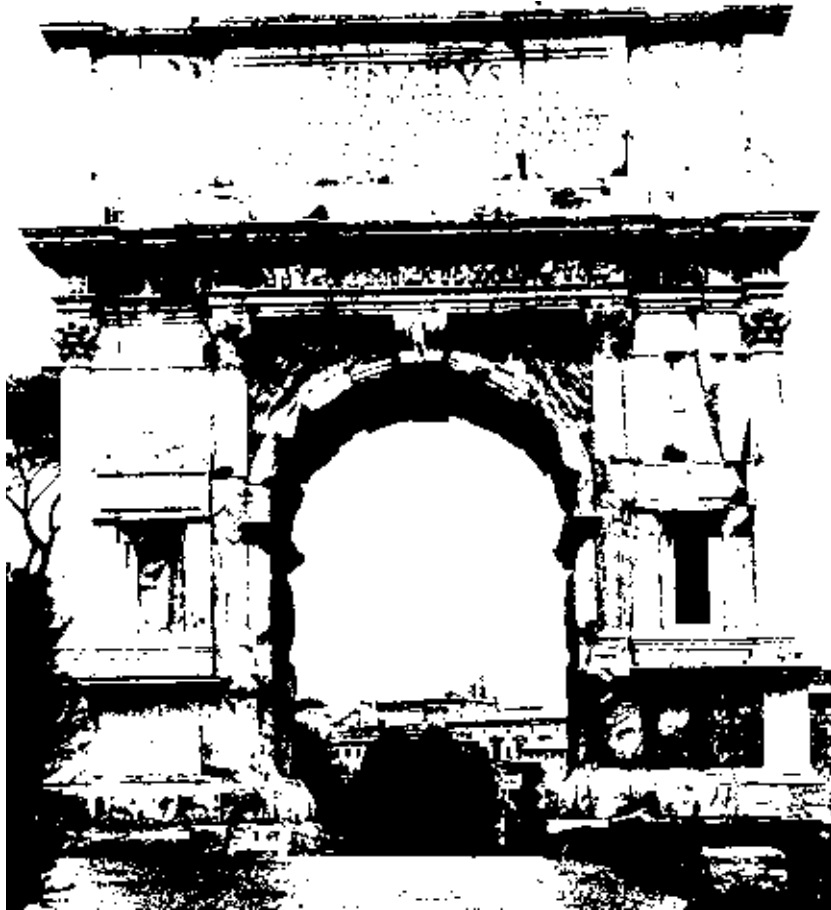
Figure 18.3 Arch of Titus, Rome, Italy

This is considered a good reconstruction by Italian experts because it makes the message clear and the missing pieces (lacunae) are restored using a slightly different stone and having less detailed carving so that the intelligent observer can distinguish between original work and that which has been added, but at a distance the unity of the whole monument is not disrupted

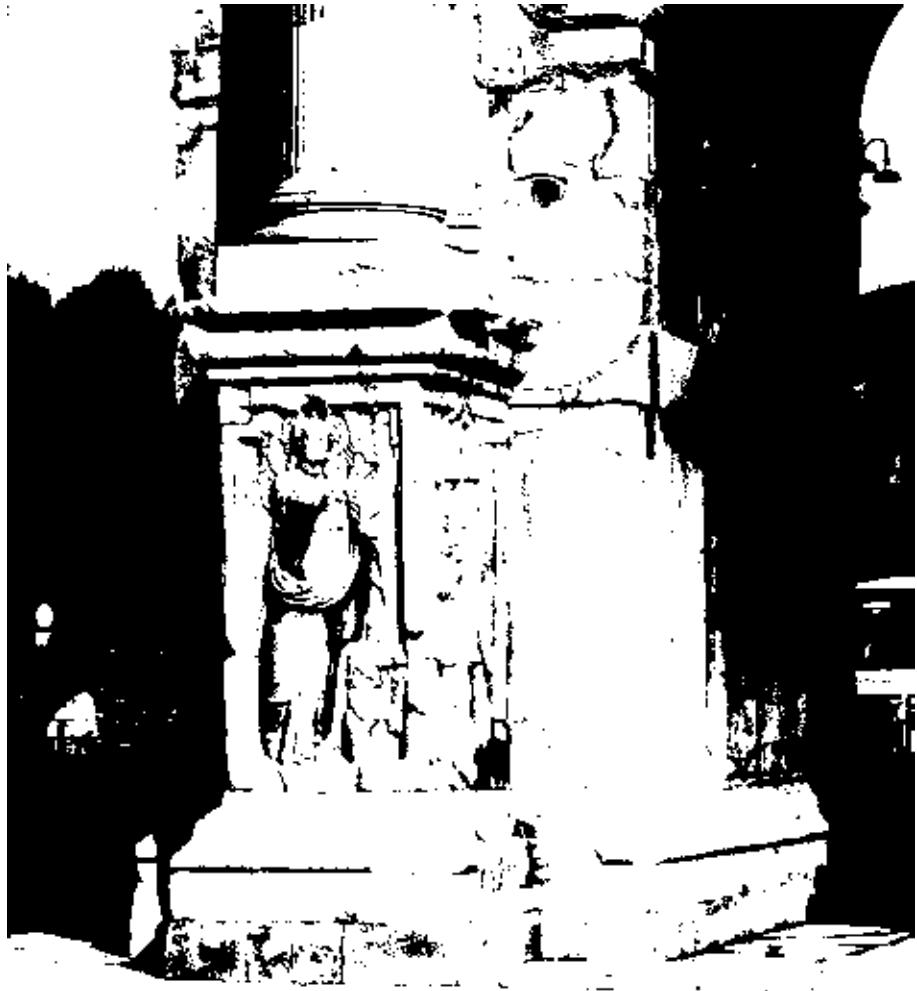
Figure 18.5 Arch of Constantine, Rome, Italy

This monument was made up of pieces from several sources so perhaps it never had great artistic unity; however, the treatment of lacunae has not improved its presentation

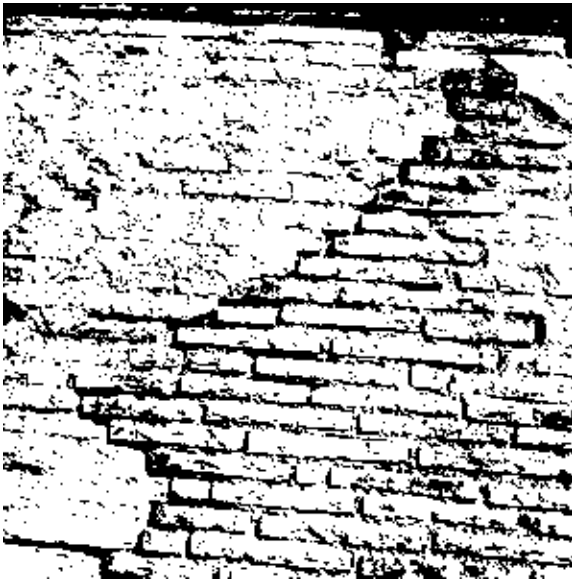
Figure 18.7 The Pantheon, Rome, Italy (detail of brickwork on the drum)

The lacunae are too dark and textured so come forward visually and thus are unsatisfactory. Note the marvellous durability and texture of the second century brickwork with wide joints made of slaked lime and pozzuolana. Age gives material a patina that cannot be reproduced

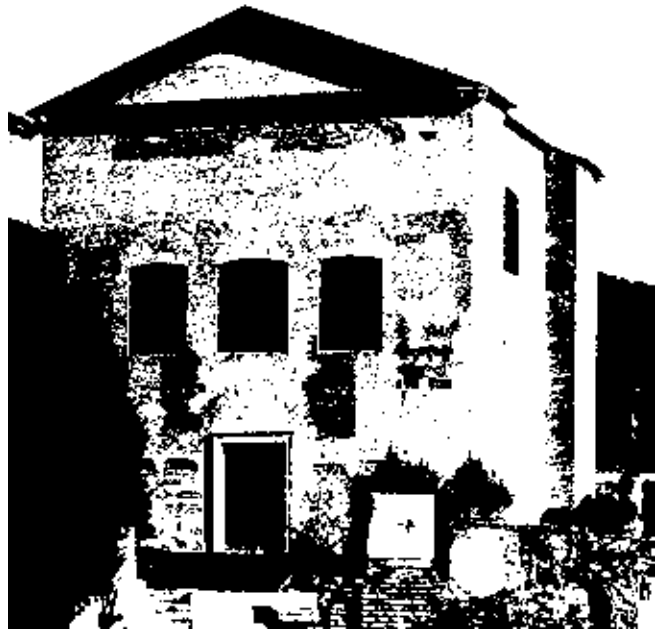
Figure 18.9 The Curia, Rome, Italy

The Curia was reconstructed under Mussolini, and it is difficult to determine what was original. Its scale and bulk are much too domineering with regard to excavations in the Forum and the hard outlines make it difficult to think that this building was contemporaneous with the ruins

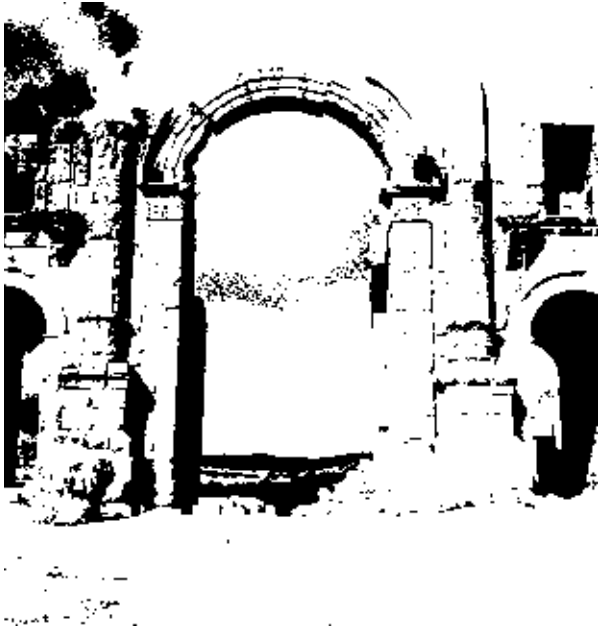
Figure 18.12 South Triumphal Arch, Jerash, Jordan

The South Triumphal Arch was reconstructed leaving a rather hard outline on the right-hand side. The distant skyline must be considered as part of the monument as new buildings out of scale could destroy the message of a walled city, which should not have buildings outside its perimeter

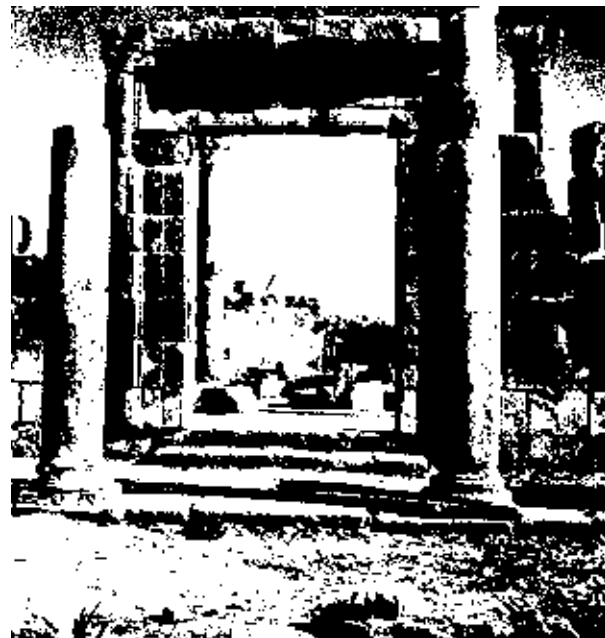
Figure 18.14 Doorway to Byzantine Cathedral, Jerash, Jordan

This doorway and several columns were re-erected thereby giving the visitor a better chance to visualize the volume and architectural character of the building. Unfortunately, Portland cement was used for the work, giving the joints an unpleasant texture

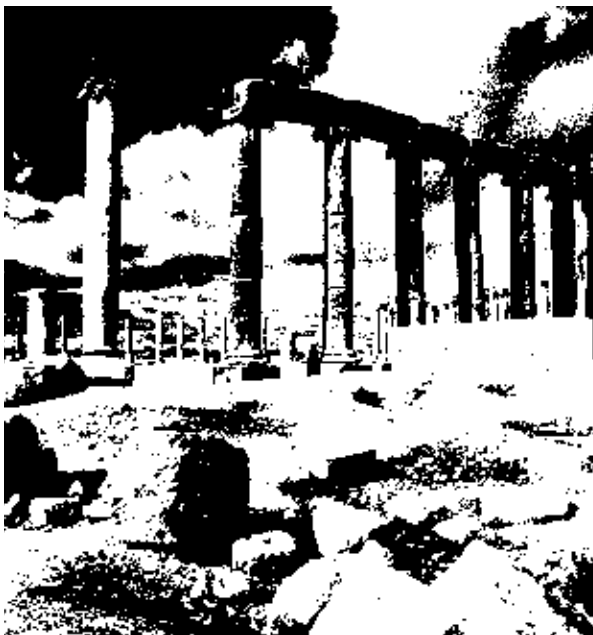
Figure 18.13 The Festival Area, Jerash, Jordan

The colonnade is nearly all the result of anastylosis which helps the visitor visualize the space, but this policy should not be carried to extremes as it can give the impression of being a film set where everything is false. A spare concrete lintel still lies on the right-hand side

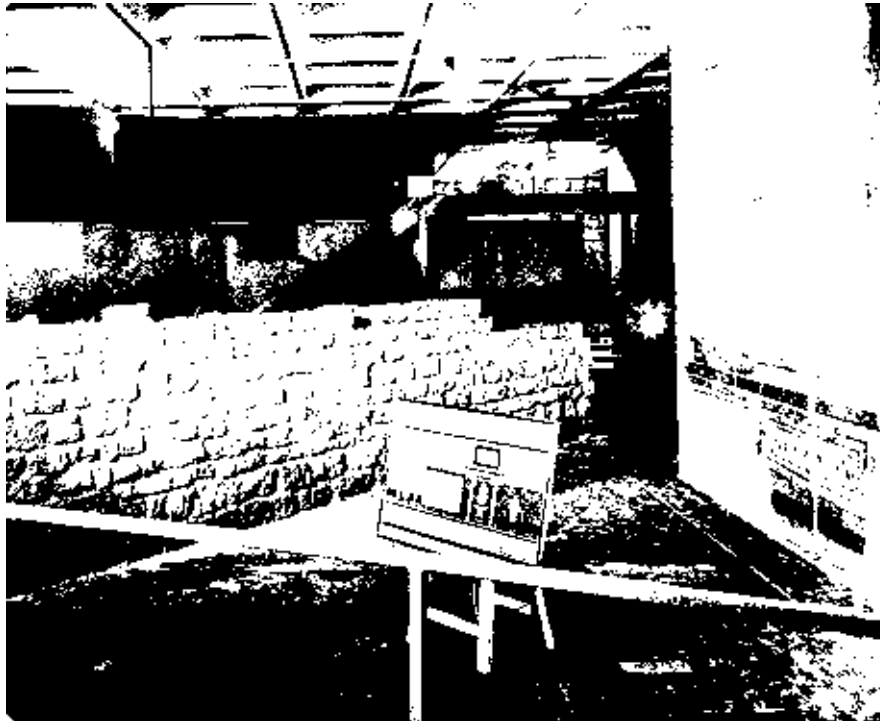
Figure 18.15 Undercroft, York Minster, England
(Courtesy: Shepherd Building Group Ltd)

To help interpret the messages of the site of York Minster a second century Roman wall which was found during the excavations for new foundations was left in position. It was waterproofed by injection. Fragments of plaster found in the mud were put together in three years of patient work and then displayed, as shown on the right, together with a drawing showing the probable scheme of decoration

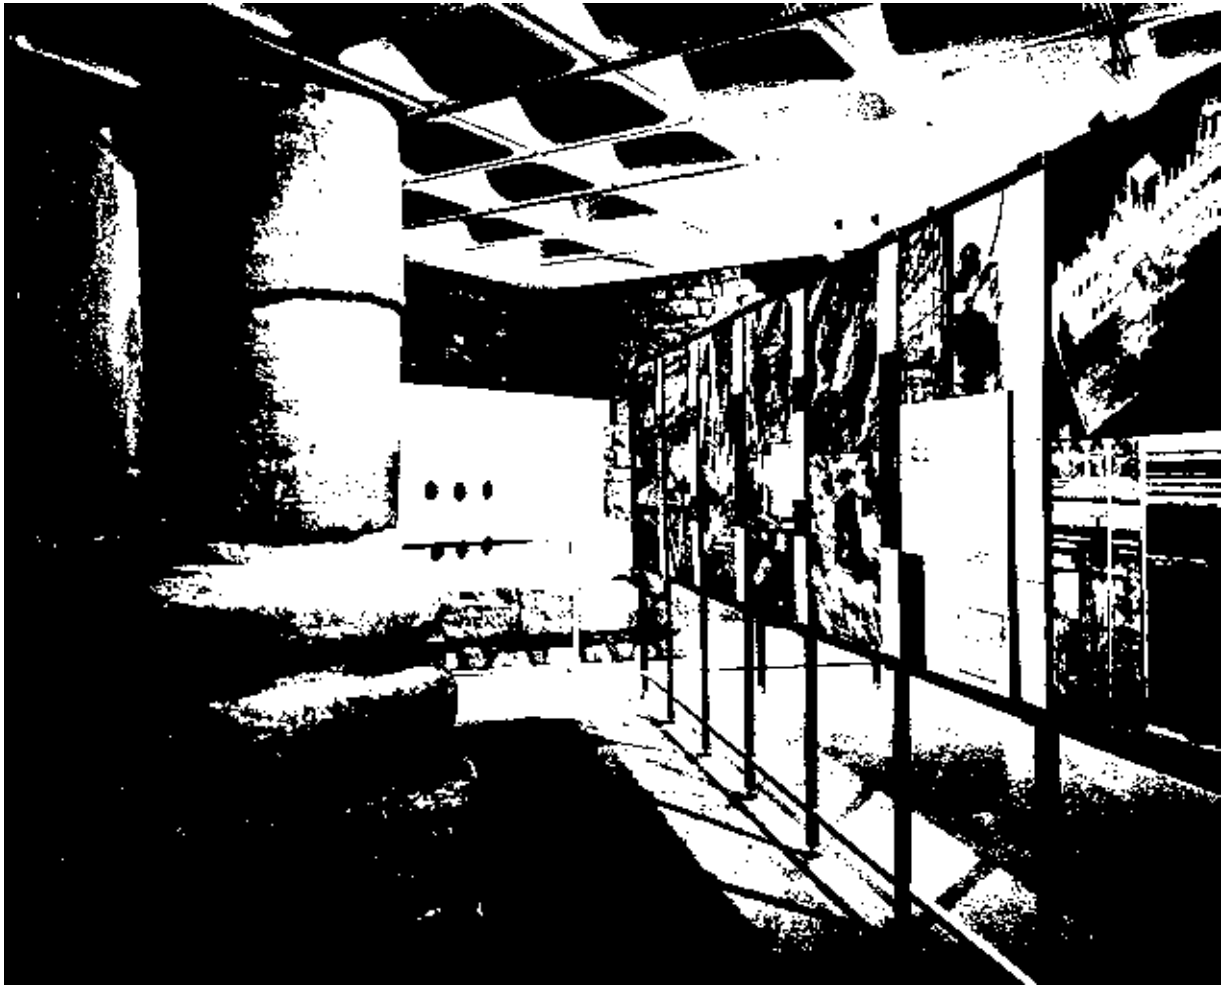
Figure 18.17 Undercroft, York Minster, England
(Courtesy: Shepherd Building Group Ltd)

The interpretation was arranged in historical sequence ending up with an exhibition of the work involved in consolidating the fabric between 1967 and 1972. Although the Roman column in the foreground did not conform to the historic sequence of the display, it was re-erected in its original position to show the Roman phase of use of the Minster site

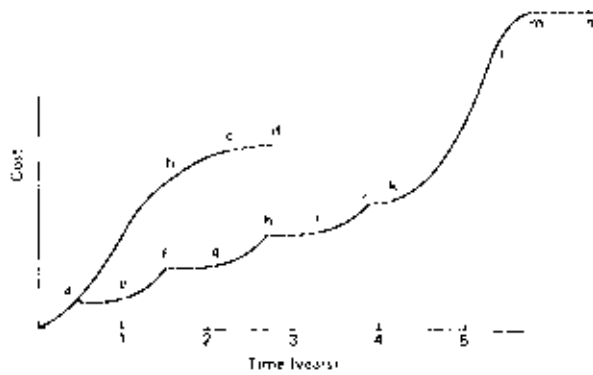
Figure 19.1 Two methods of financing a conservation contract: method A (top curve), budget for whole cost; method B (bottom curve), annual budget increments

Method A: a, slow start; a–b, major tasks and steady progress; b–c, slower progress due to detailed finishes and skilled work, d, furnishing and balancing of mechanical services

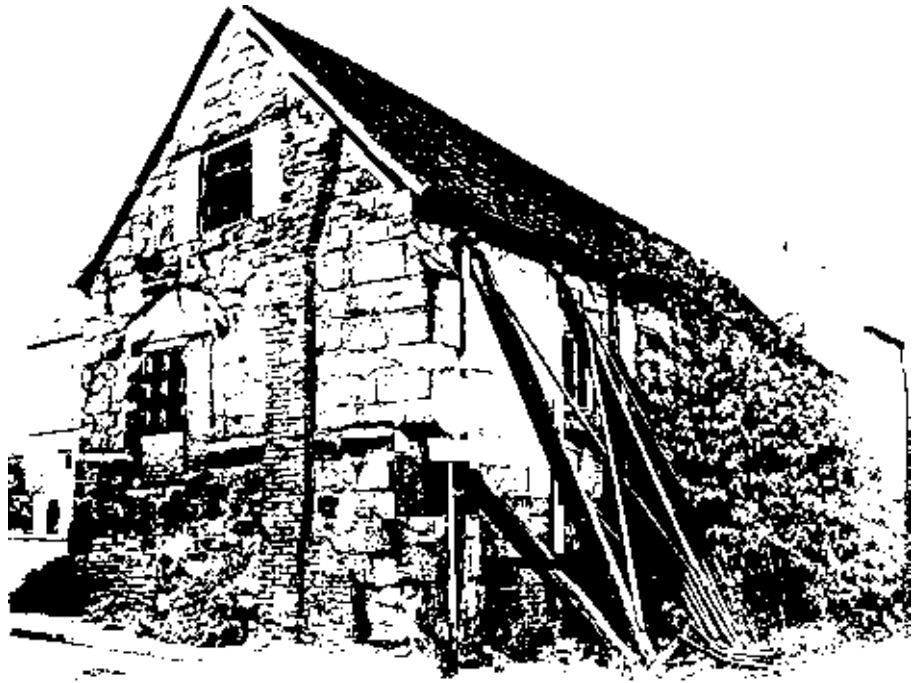
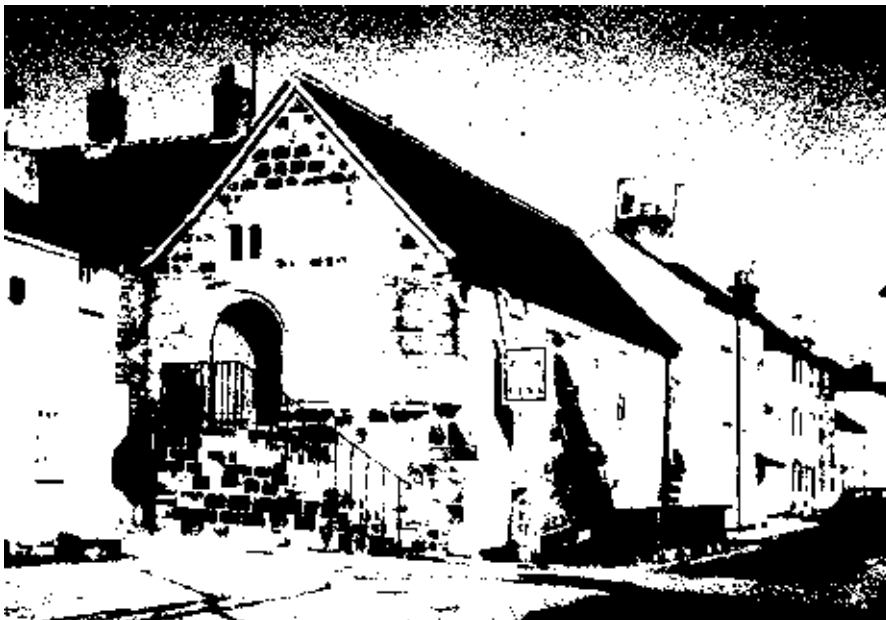
Figure 20.17 Darley Abbey, Derby, Derbyshire
(Architects: Wood Newton Partnership, Ripley)
(Courtesy: Civic Trust, London)

Before restoration—This is the last remaining structure from the Augustinian Abbey of St Mary of Darley, outside Derby. It may have been the Guest House of the Abbey, but for almost 50 years since the 1930s its future was in doubt and, in consequence, its condition worsened. Its front wall, which had to be shored up, was as much as 500 mm (20 in) out of true and the building was given up by most as being beyond economic repair.

After restoration—The building was saved through the imagination and courage of new owners who have given it a new lease of life by restoring it and converting it into a public house, not so far removed from its original use. Secondhand materials have been used wherever possible; where new were necessary they have been selected to match or be in character with the mediaeval structure

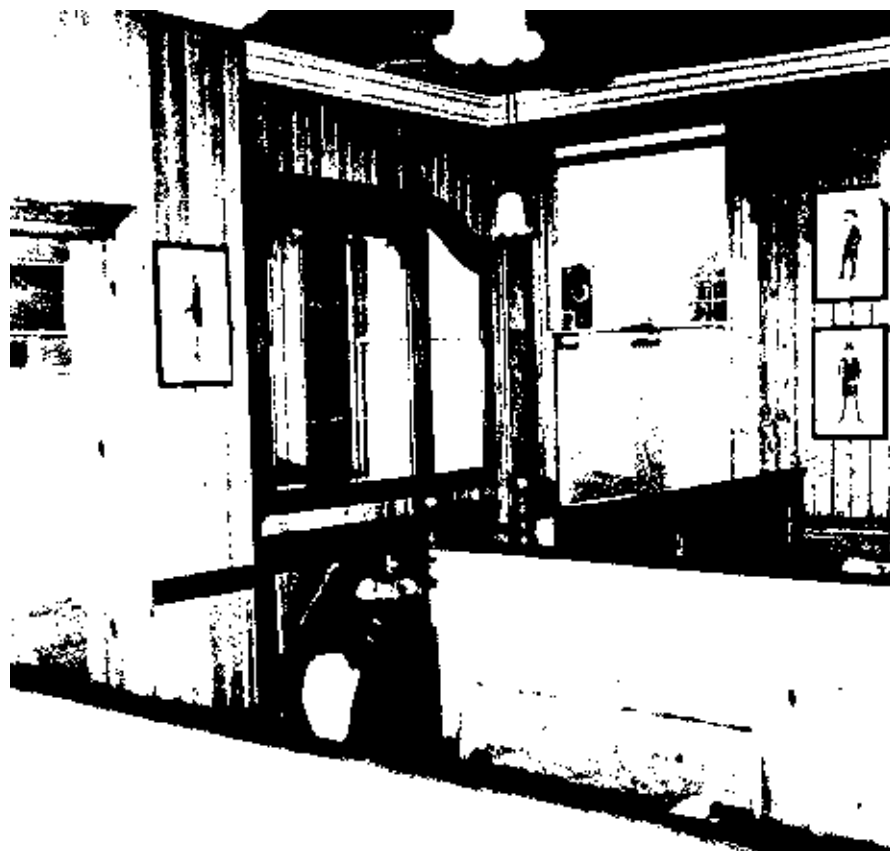
After restoration—As many of the original fixtures as was possible were retained and refurbished for re-use in such a way as to retain also the character of a City lunch house

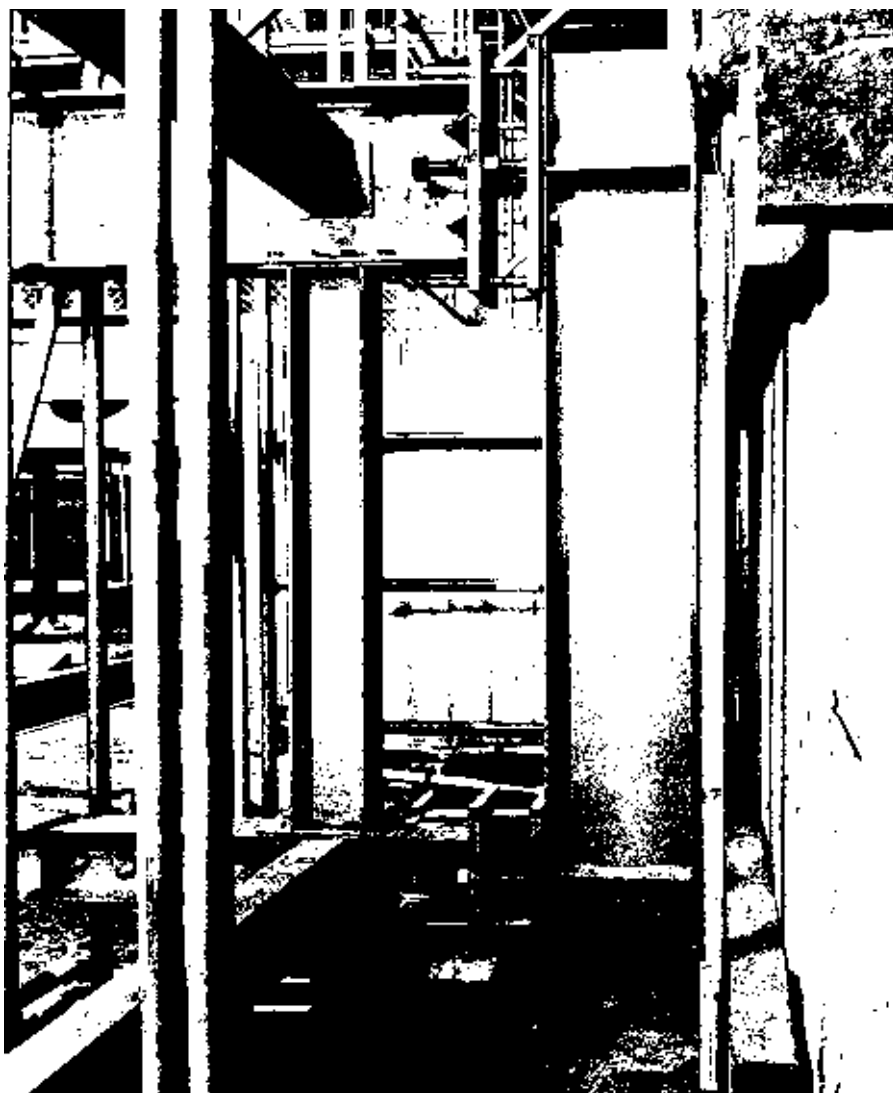
Figure 21.1 Excavations, York Minster, England

Planking and strutting should follow excavation immediately. This was of heavy steel designed to resist outward thrusts from the heavily loaded masonry and support a temporary floor above. The detail shows the special high tensile steel bolts used to tighten up the strutting. The planking is 50 mm (2 in) thick and with the benefit of experience should have been treated with a timber preservative, as some of it had to remain in position over three years in damp and poorly ventilated positions, and later became affected by dry rot and had to be renewed

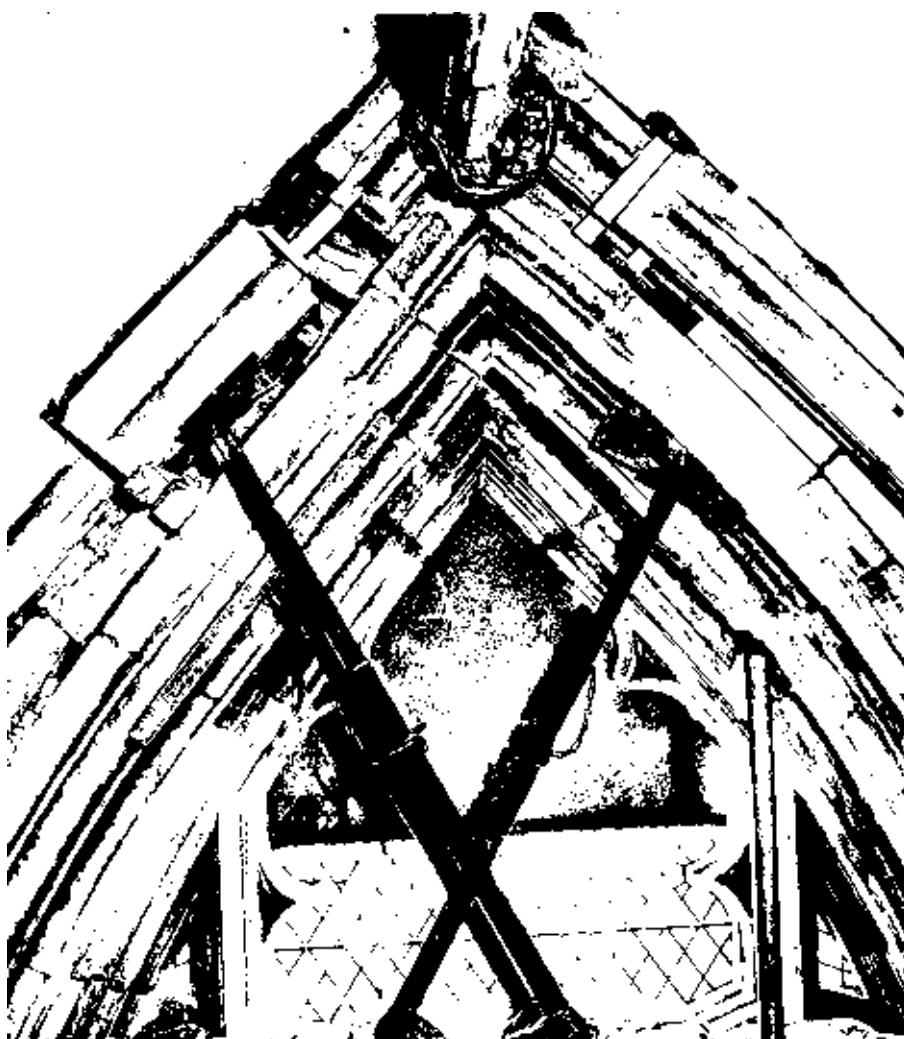
Strutting was erected in order to repair an arch. Screw-type struts and wedges hold masonry in position while it is repaired. Such work needs final grouting to consolidate any voids

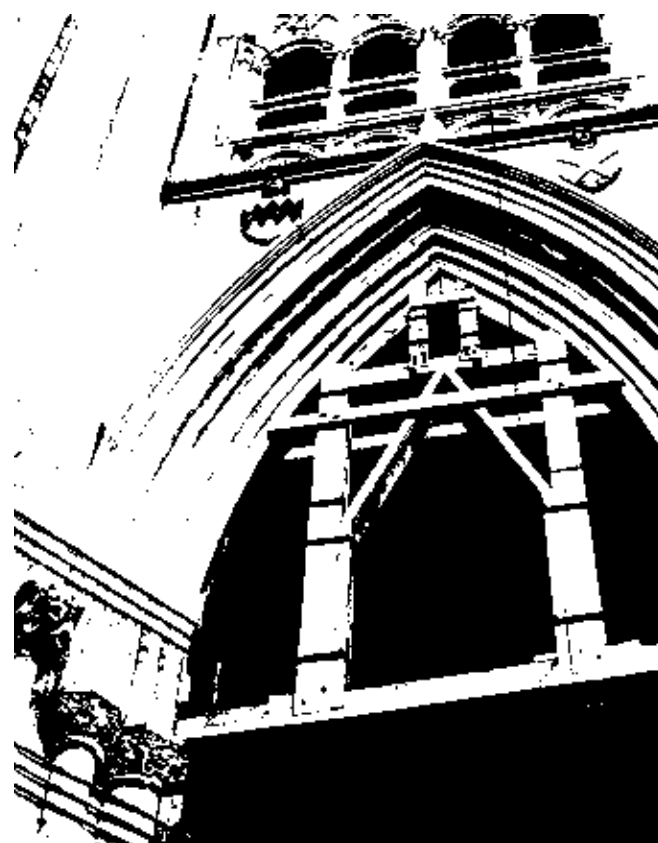
Figure 21.3 Shoring, choir, north arcade, York Minster, England

Timber shoring was erected in order to repair a defective arch in the York Minster choir. See also on left side, triple 25 mm (1 in) dia. high tensile steel ties inserted as a safety measure to strengthen the main piers during consolidation of foundations

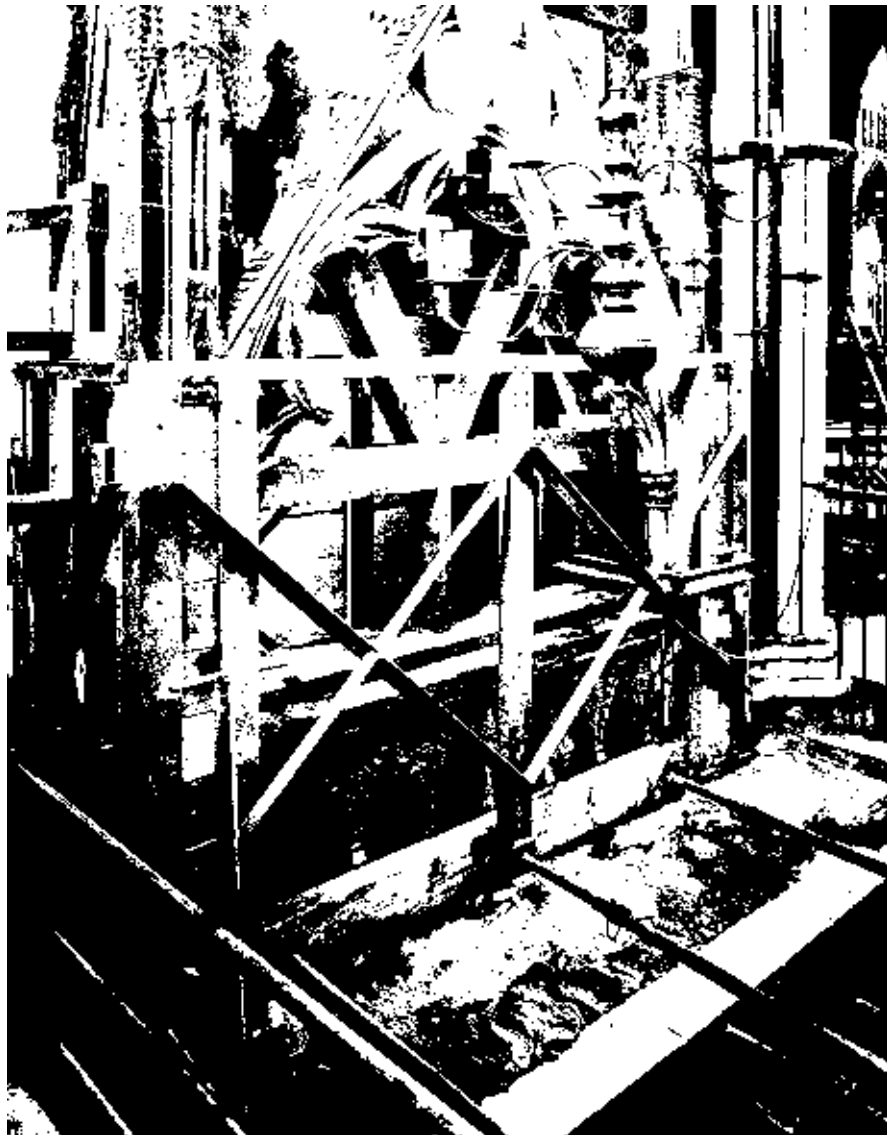
Figure 21.4 Cradling, north transept, York Minster, England
(Courtesy: Shepherd Building Group Ltd)

A timber and steel cradling was put up in order to hold a thirteenth century archbishop's table tomb and canopy in position while the space below was excavated for foundation works

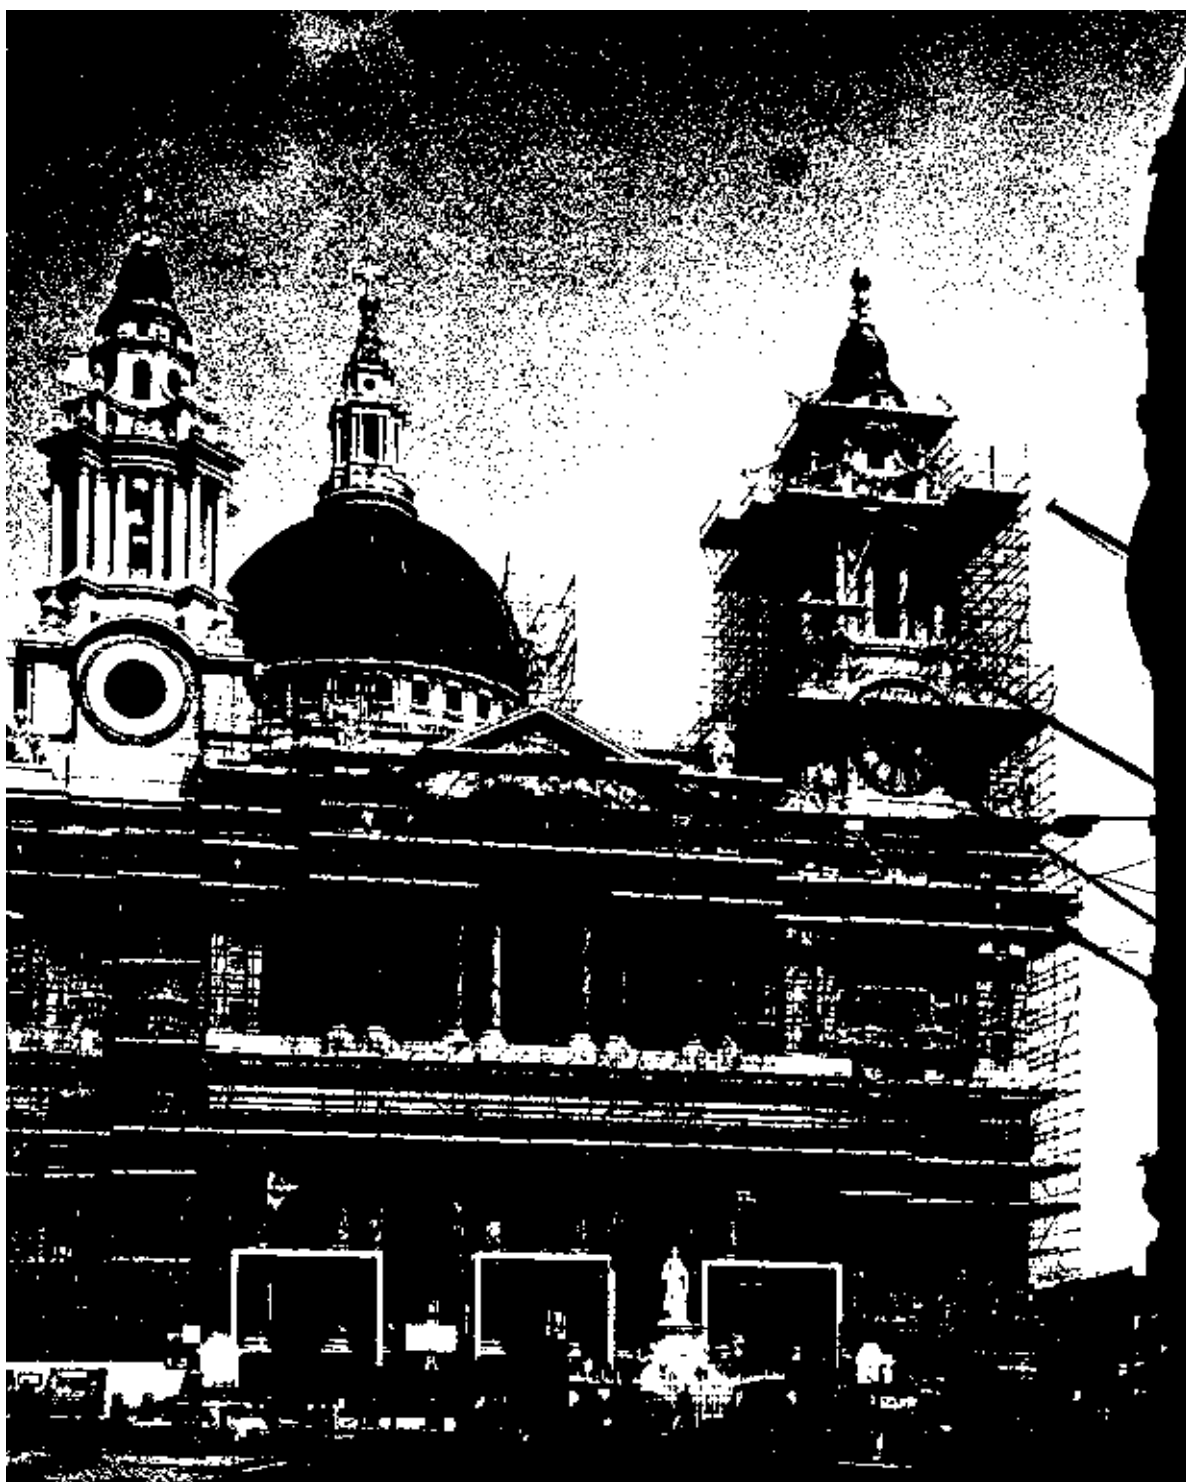
Figure 21.5 Scaffolding, west front, St Paul's Cathedral, London, England

This external scaffolding was put up to effect heavy masonry repairs, so the verticals are just over 1 m (3.3 ft) apart. The diagonal bracing gives stiffness and wherever work is in progress there are scaffold boards and toe-boards. The doorways used by the public are well protected. As such work is likely to take several years it is generally most economical to buy the scaffolding outright, together with an electric hoist in view of the bulk of the work being at heights greater than 25 m (80 ft)

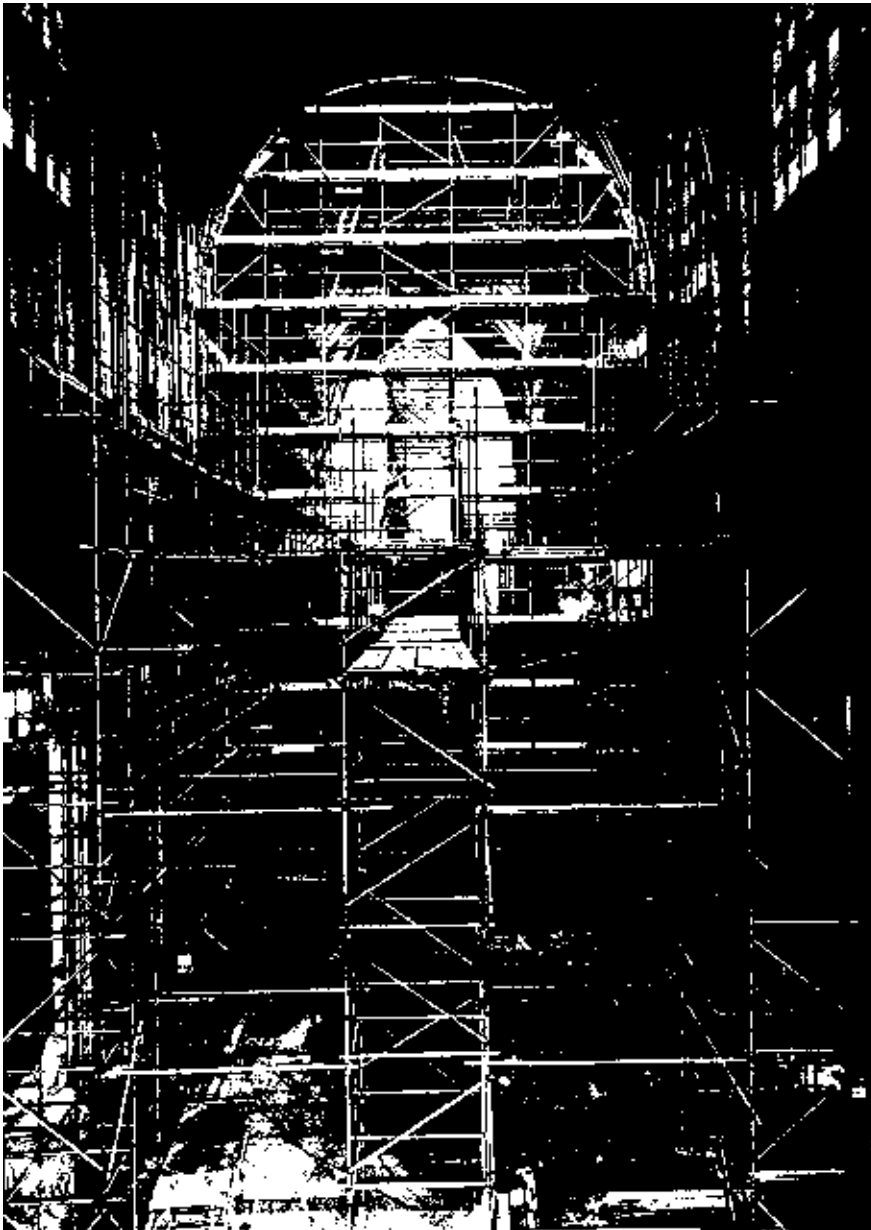
Figure 21.6 Scaffolding, nave, York Minster, England
(Courtesy: Shepherd Building Group Ltd)

The scaffold itself is designed for economy, using a central and two side towers linked and braced together. The scaffolding is being moved horizontally from east to west two bays at a time, since a 'rolling programme' is far more efficient than an 'up-and-down programme'. The amount of work in erecting and dismantling scaffolding should not be under-estimated, as in fact one is building a temporary building within a building to gain access to all surfaces. Note the system of bracing which is essential for stability and the toe-boards for safety. Verticals are nearly 2 m (7 ft) apart because this is a light-duty scaffold. The cleaning has exposed local faults which have to be corrected by the masons, while quite serious defects, which had been kept under observation during the consolidation of the foundations, were rectified in the bays immediately adjacent to the central tower

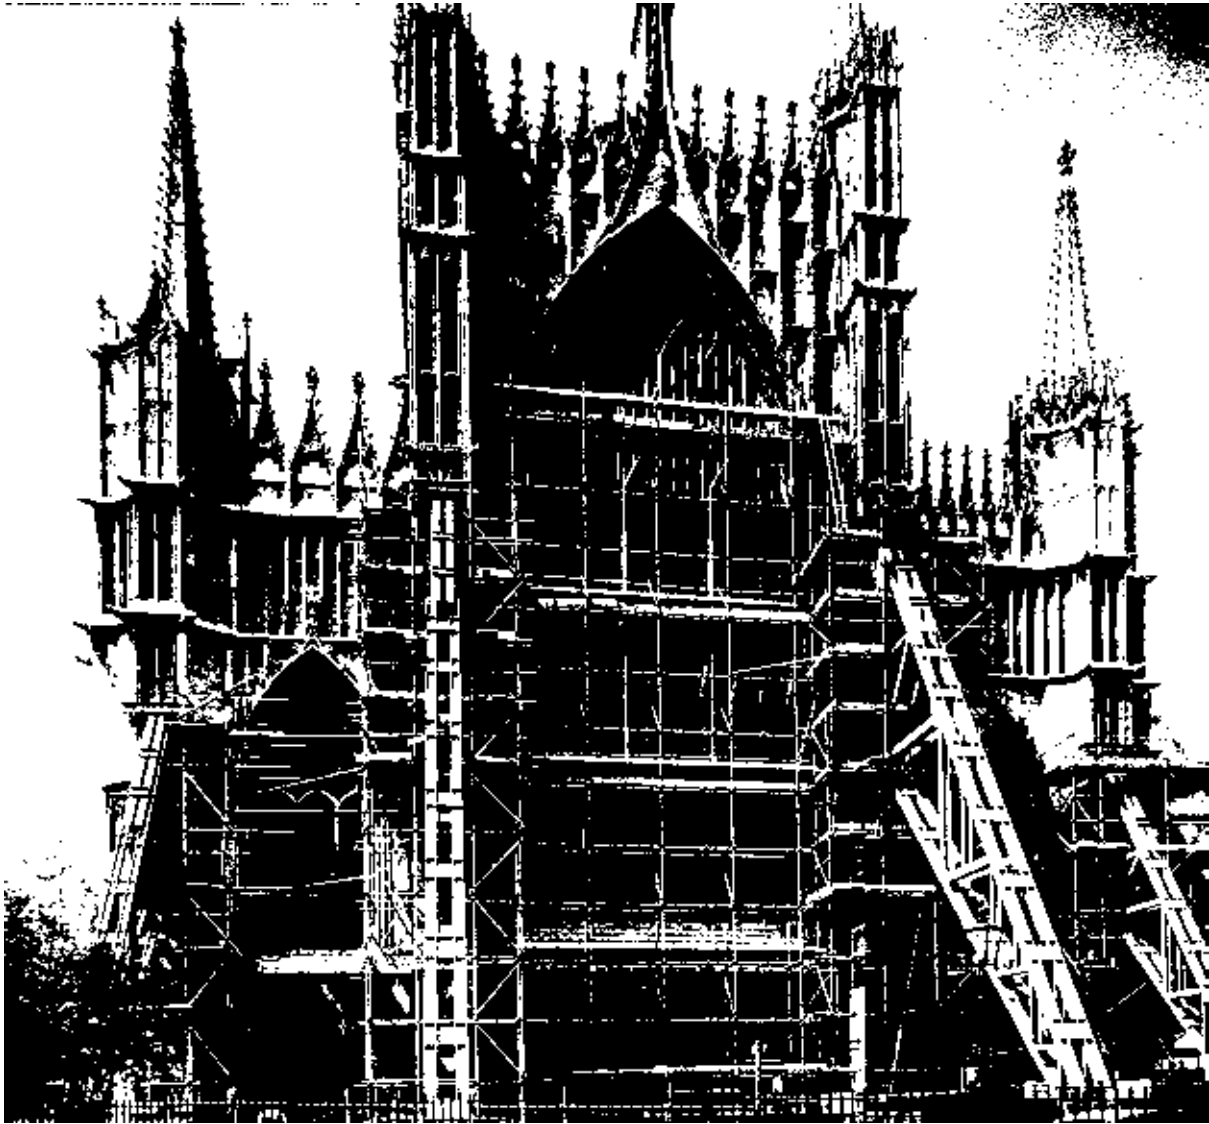
Figure 21.7 Shoring, east end, York Minster, England
(Courtesy: Shepherd Building Group Ltd)

Raking shores support the wall which is leaning outwards and near collapse. Flying shores act as horizontal struts between the raking shores. The whole wall had to be kept intact in order to avoid damage to the famous early fifteenth century Alpha and Omega window which is as large as a tennis court

The raking shoring required massive foundations and the base-plate rested on four Freyssinet flat hydraulic jacks which were attached to a constant pressure system. The jacks compensated for settlement of the foundation and thermal movements in the long steel shores, and resisted the thrust of the cathedral while allowing it to settle
