Conservation of Historic Buildings

*Conservation
of Historic Buildings*
Third edition

Bernard M. Feilden

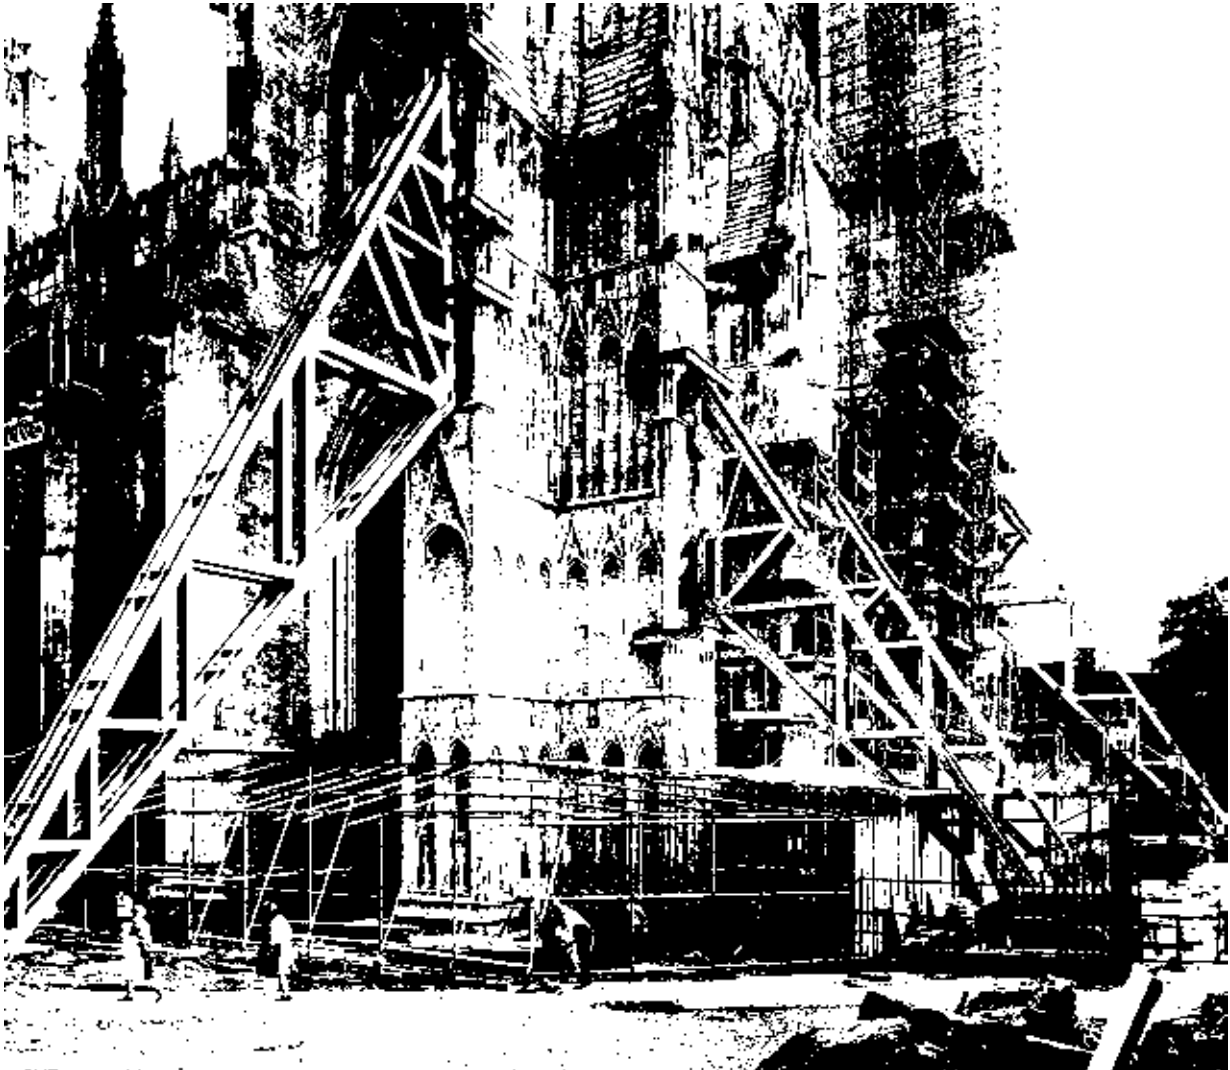
Figure 21.10 Enlarged foundations, central tower, York Minster, England
(Courtesy: Shepherd Building Group Ltd)

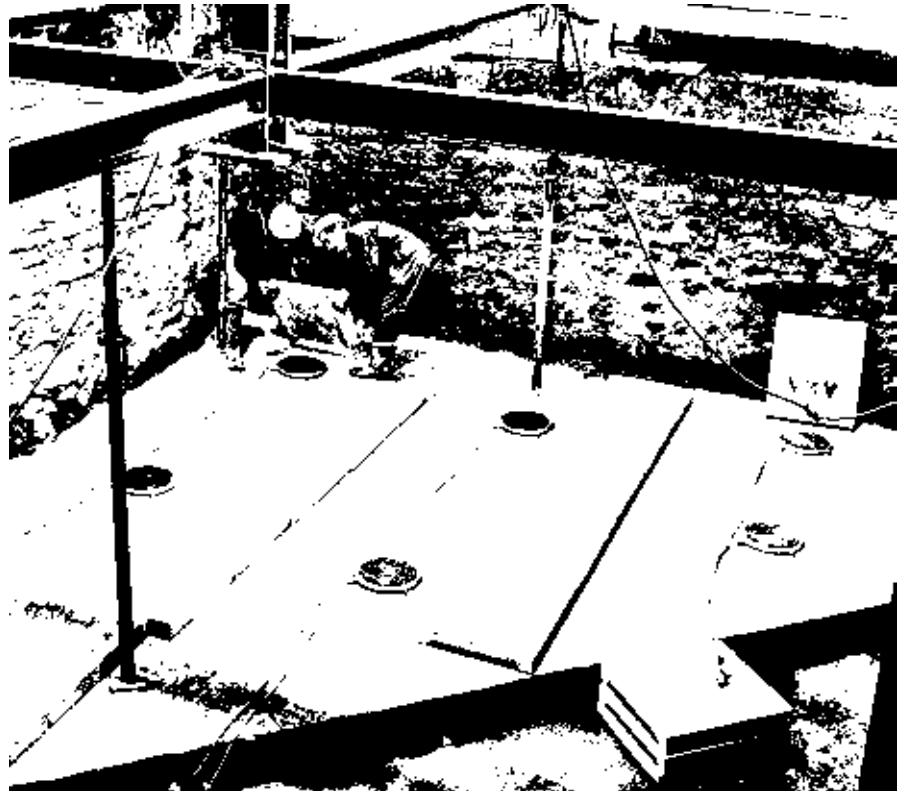
Hydraulic cells or flat-jacks were laid on a large independent pressure pad of concrete and covered with precast slabs. A separate foundation is to be laid above and linked to the existing masonry with post-tensioned stainless steel ties

Another use of flat-jacks was in the foundations to the central piers of York Minster. These were designed in two horizontal layers with flat-jacks between them (about 400 in all), each connected to

an individual inlet with associated pressure gauge. It was planned that when the jacks were inflated the lower layer of the foundations would be pressed into the clay and take up half the overall load, leaving the original foundations with the balance of the load. By measuring the pressure on each plate individually, the loads could be calculated, and if settlements were unequal the necessary adjustments could be made, for the pressures can be adjusted separately by individual piping which is also a precaution against a failure of the jack. In the case above, about 7 out of the 400 jacks failed but there were sufficient reserves. Schemes similar in principle but on a smaller scale have been carried out at St John's, Ousebridge, York, and in the cloisters of Norwich Cathedral. In both these cases, flat-jacks were used on extensions to the buttress foundations in order to ensure proper loading of the additional new supporting areas.

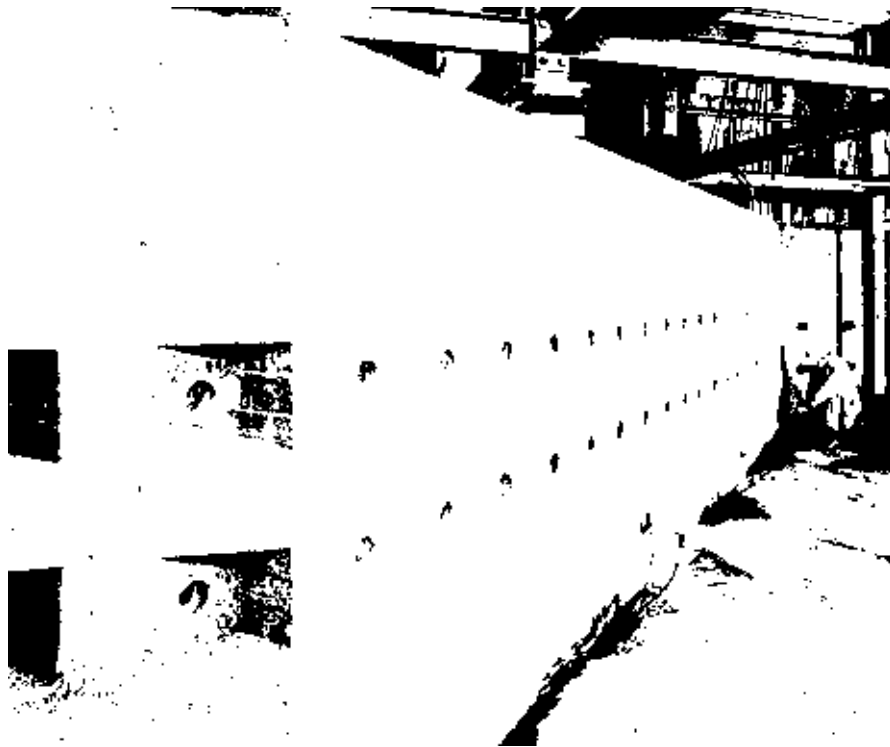
Figure 21.11 Enlarged foundations, central tower, York Minster, England
(Courtesy: Shepherd Building Group Ltd)

The foundations proper have been cast, leaving ducts for the steel reinforcement on one side and the pipes to the hydraulic cells which will be inflated in due course

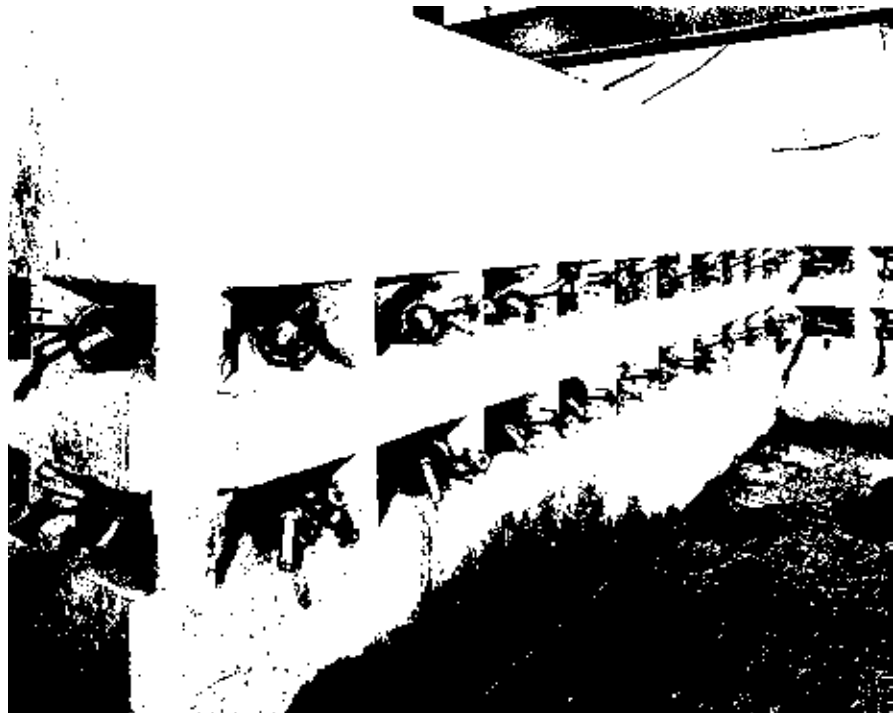
Figure 21.12 Enlarged foundations, central tower, York Minster, England
(Courtesy: Shepherd Building Group Ltd)

After drilling through 15 m (50 ft) of concrete, stone, mortar and wood the hole is lined temporarily with a pipe to prevent local collapse and the tensile stainless steel bars inserted. These were then stretched and given a final tensioning after two months and then grouted. The probes are all ready to receive the liquid grout injection

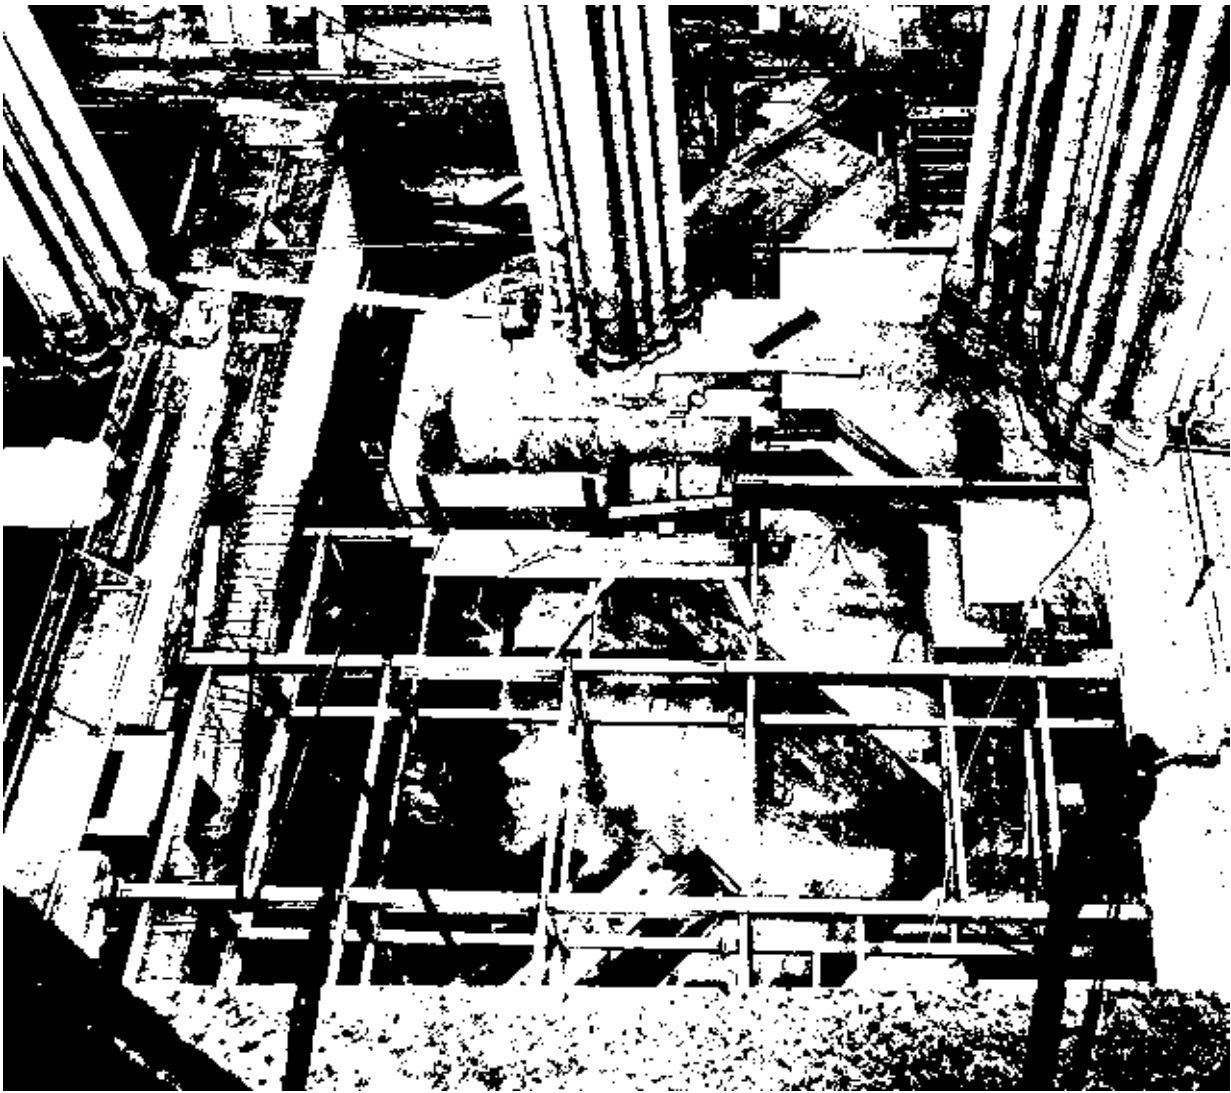
Figure 21.13 Enlarged foundations, central tower, York Minster, England
(Courtesy: Shepherd Building Group Ltd)

View showing the enlarged foundations and one of the massive piers of the central tower, each of which takes 4064 t (4000 ton) or more, now linked to the adjacent nave pier. As the temporary planking and strutting and floor supports are stripped away the enlarged 16 m (52 ft) square foundations show. They have been designed to eliminate eccentric loadings which gave ground pressures of 8 t/ft² (7.9 ton/ft²) which was equal to the ultimate stress of the soil. New loadings were all brought up to 3 t/ft² (2.95 ton/ft²) under the direction of Ove Arup & Partners, the consulting engineers and authors of this elegant design

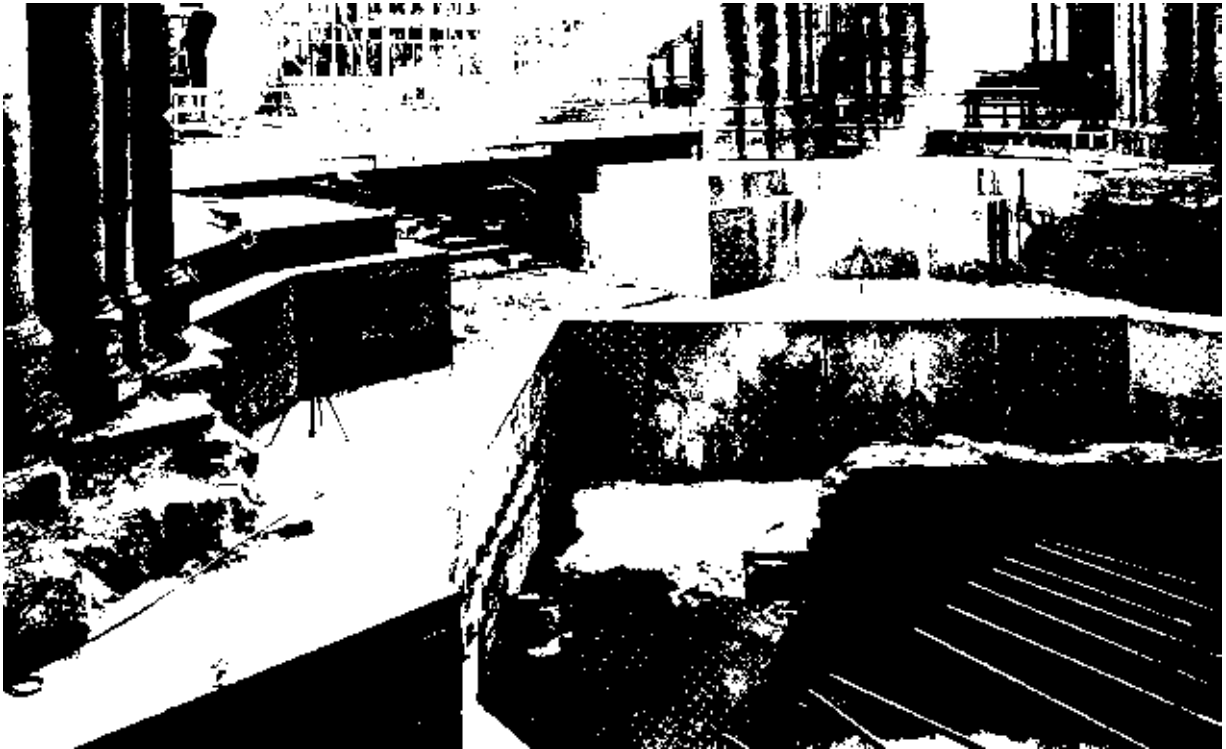
Figure 21.14 Enlarged foundations, central tower, York Minster, England
(Courtesy: Shepherd Building Group Ltd)

A general view showing the enlarged independent foundations of the central piers which are linked to adjacent nave, choir and transept aisle piers. The concrete rings to prevent bursting are above the new foundations proper. Measuring points are fixed on to each foundation, movements being checked each week. Prestressed stainless steel reinforcing rods were inserted diagonally under the main piers, 100 to each pier, in holes drilled through the original masonry

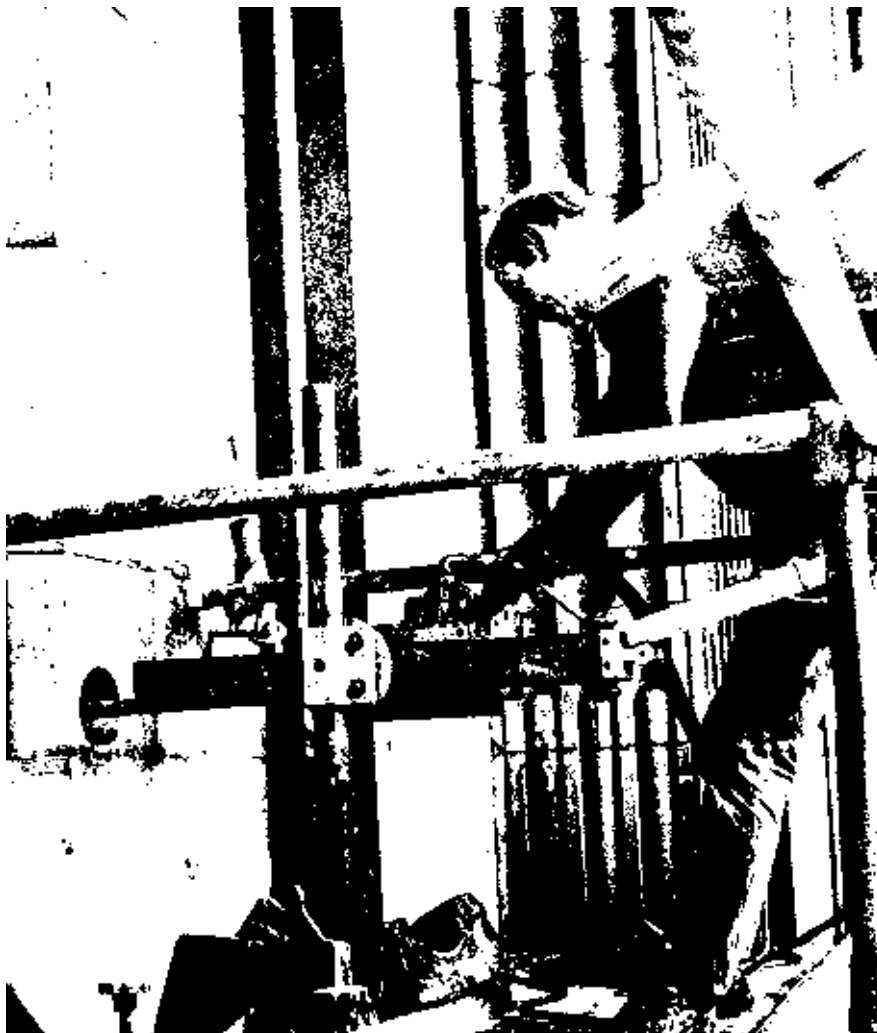
Figure 21.15 Investigation, St Paul's Cathedral, London, England
(Courtesy: Feilden & Mawson)

A core was cut with a diamond-toothed bit in order to investigate the condition of the wall. The sample obtained was much fragmented, indicating weakness of the structure. The core hole was used together with an adjustable sparge pipe to test water penetration in the masonry

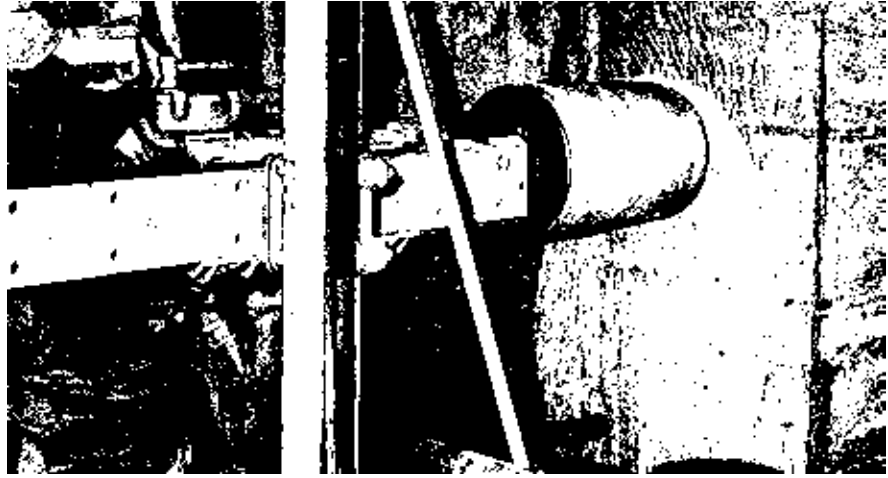
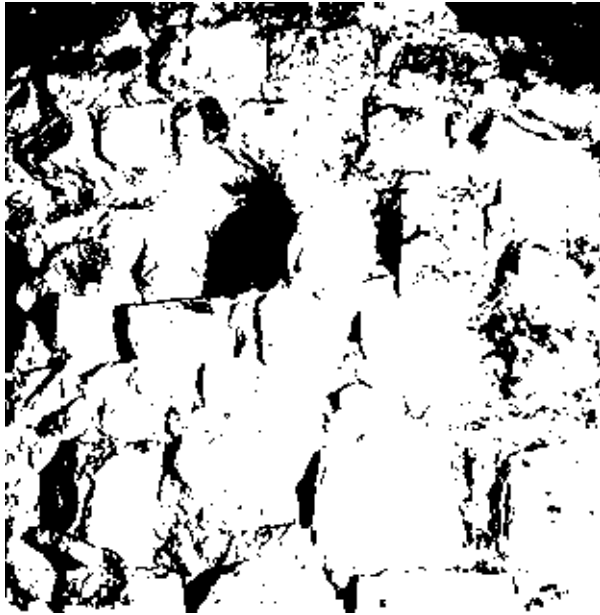
Figure 21.17 Coring, York Minster, England

This foundation was cored with a 230 mm (9 in) diamond auger to form a hole about 4 m (13 ft) long in order to insert a 200 mm × 100 mm (8 in × 4 in) galvanized steel grillage or needles to consolidate poor masonry

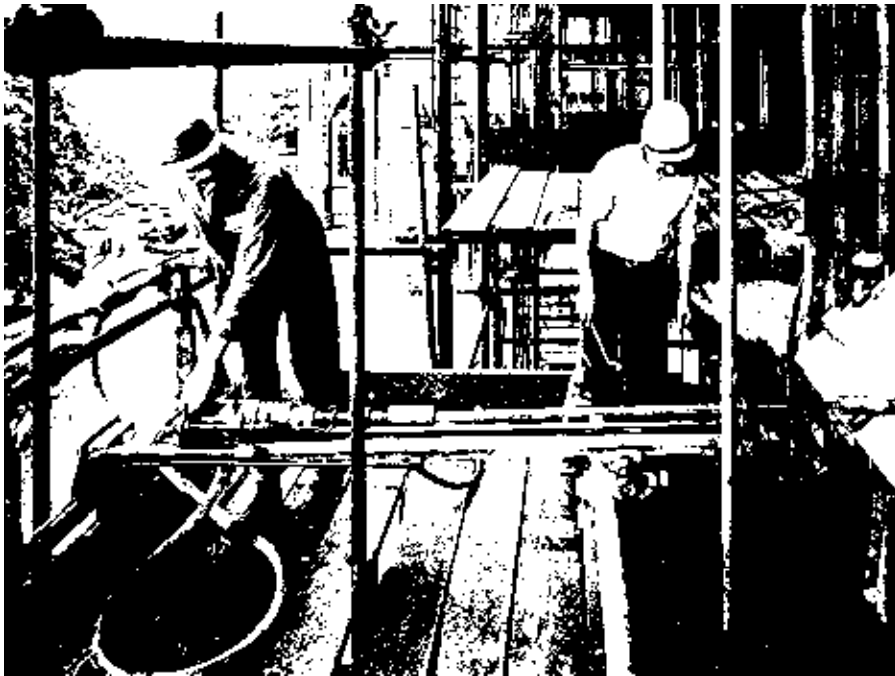
Figure 21.19 Drilling, York Minster, England
(Courtesy: Shepherd Building Group Ltd)

A compressed air drill being set up on a cradle prior to drilling probe holes for insertion of grout on the north-west tower north face. Note the firm rear anchorage to resist the thrust from the automatic screw feed of the drill and the adjustments to scaffold that are required. An electric hoist cage can be seen in the background. Such equipment is essential on large-scale operations with climbs of more than 15 m (50 ft) or for smaller jobs some 30 m (100 ft) height or more simply to save time and energy. Power supply for twin 10 h.p. electric motors is necessary

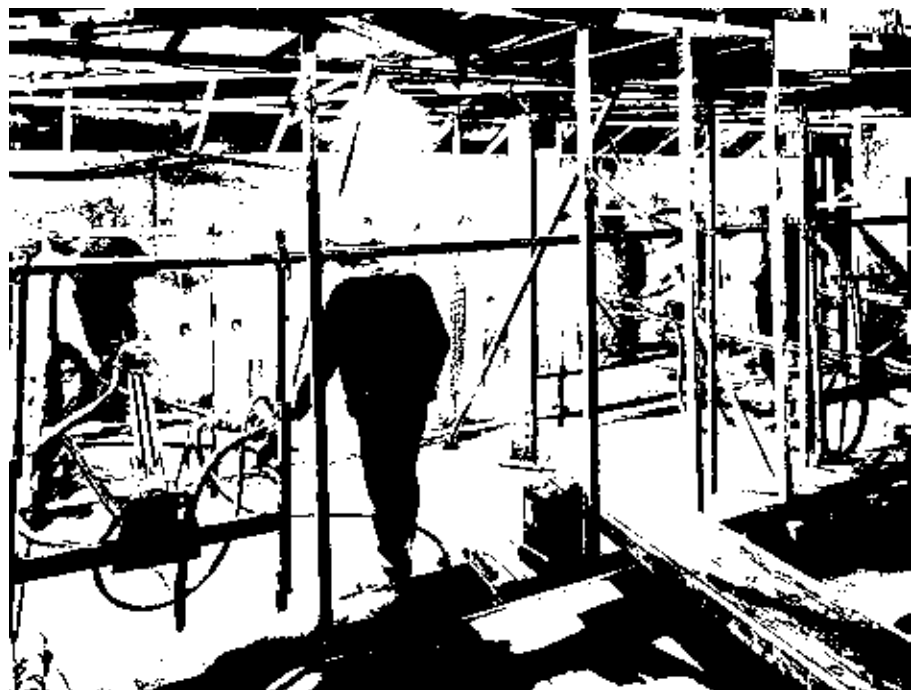
Figure 21.20 Drilling, York Minster, England
(Courtesy: Shepherd Building Group Ltd)

Accurate drilling horizontally through 15 m (49 ft) of concrete, mortar and stones of various size and condition, with timber baulks set in grout, was difficult. In any horizontal drilling operation it is difficult to keep direction, but much more so if the material is inconsistent. Note the wet conditions and the ear-muffs to protect against the intense and continuous noise

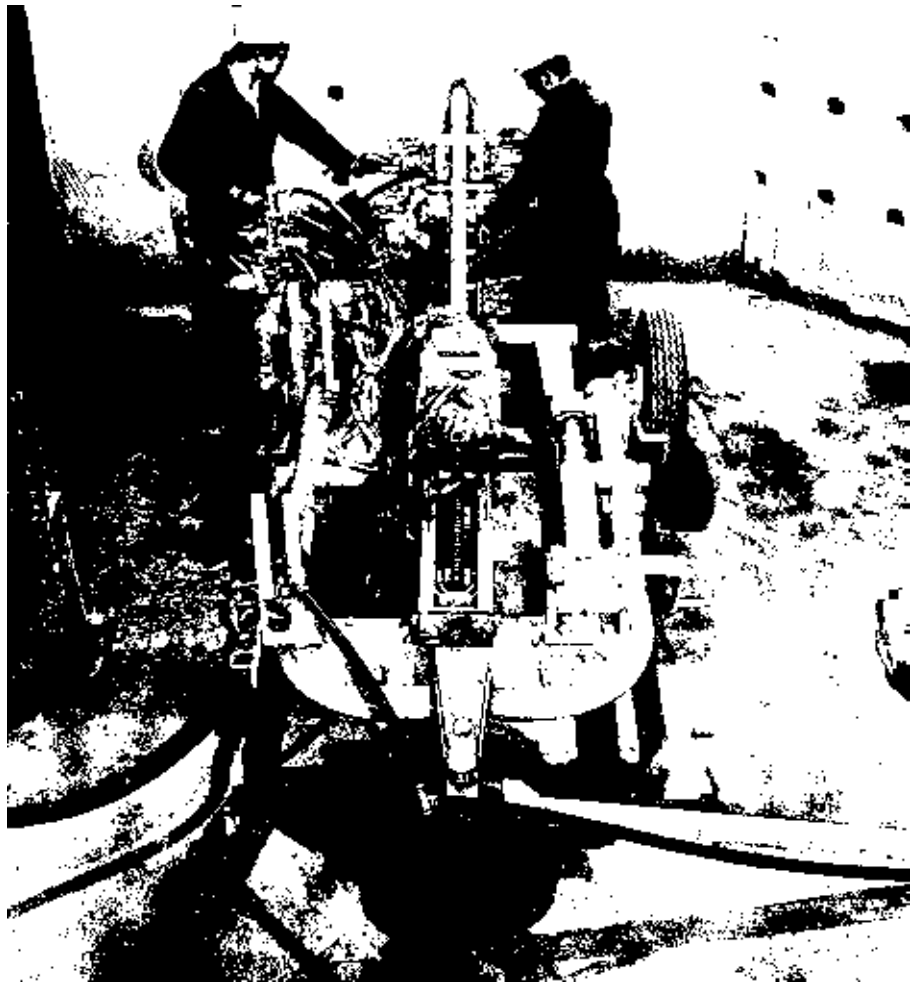
Figure 21.21 Drilling, York Minster, England
(Courtesy: Shepherd Building Group Ltd)

A more powerful drill set on a movable cradle which can be adjusted for height was obtained. It was found that a stiff rod helped preserve direction and for most purposes the 'down-the-hole' vole hammer was quickest and most accurate. Auger bits had to be used when embedded wood was met, and occasionally diamond studded bits were used. The operatives acquired a special expertise by continuous work in shifts over nearly three years. Often the holes would collapse, so these had to be lined with a 50 mm (2 in) diameter tube immediately after drilling. Later the steel could be inserted as shown and then the tube was extracted using hydraulic jacks. The drill inevitably breaks out through the concrete, so finished work was planned to cover this

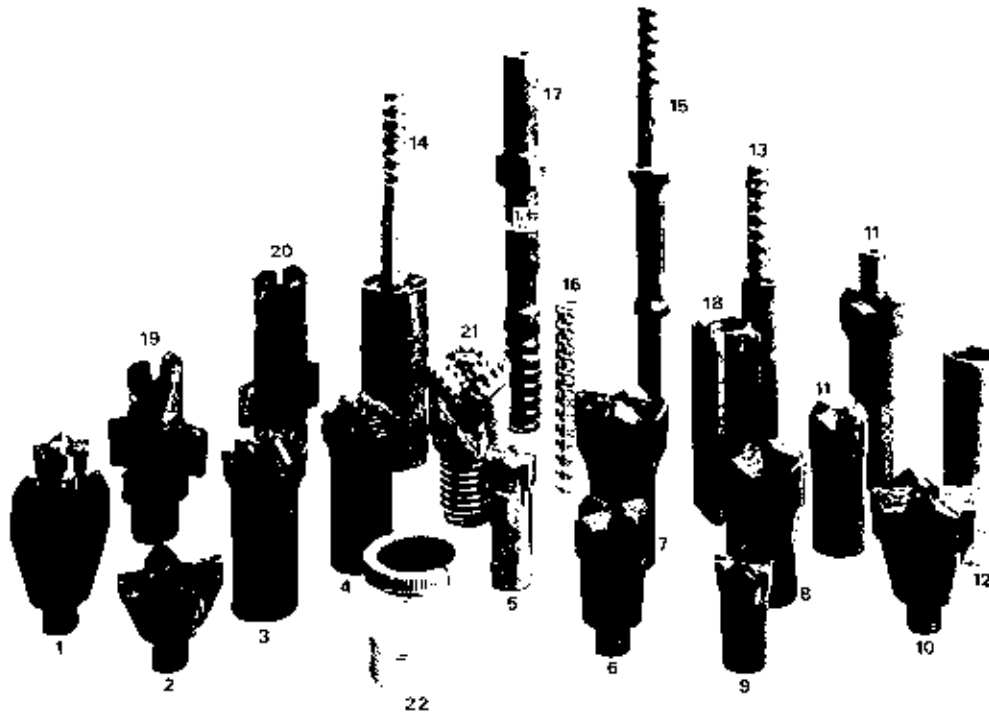
Figure 21.22 Drilling bits, York Minster, England
(Courtesy: Shepherd Building Group Ltd)

All the drill-head components and assemblies described are powered pneumatically for both rotary and rotary percussive drilling units. Advantages and disadvantages—high-speed rotary percussive is the most economical means of drilling; tungsten carbide tipped bits are much cheaper than diamond crowns. This type of drilling is fast, but demands a homogeneous mass, preferably of like material, to provide for accuracy in operations where long holes are required horizontally in masonry. Diamond core drilling is rather slower and thus more costly, but under adverse conditions in bad materials is more accurate in maintaining alignment

4 Standard button bit, 3 in diameter, for drilling in broken ground by rotary percussive means.

14 Purpose-made coupler for use with 1 in hex hollow drill steels, designed to provide accuracy when drilling through broken ground, using 3 in diameter retro cross-bits. This type of coupling assembly allows the drill cuttings to pass through internally in suspension and centralizes the drill steels at coupling points, ideal for drilling operations 50–70 ft horizontally.

21 Standard Trycon roller bit used for rotary drilling in broken ground of material that yields. This type of bit is employed with diamond tubes.

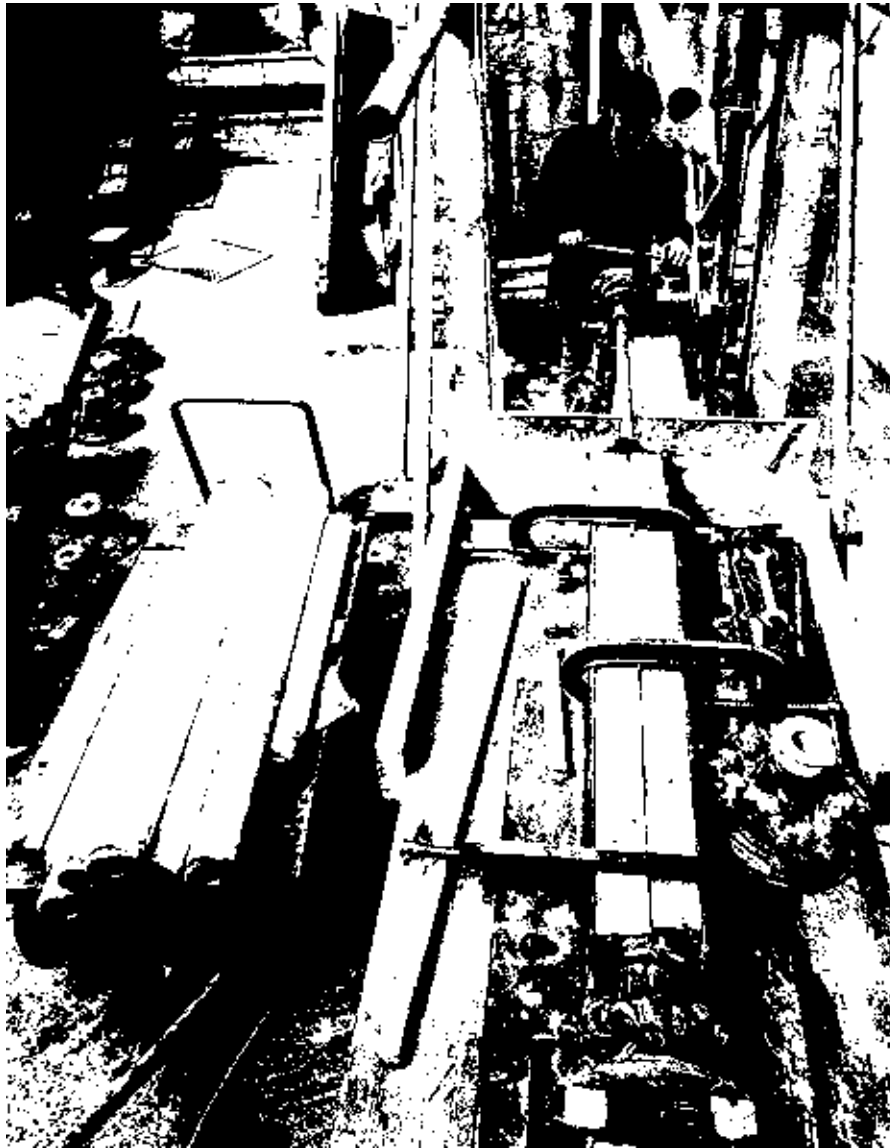
Figure 21.23 Drilling marble shafts, York Minster, England
(Courtesy: Shepherd Building Group Ltd)

The shafts were badly cracked, so they were put into splints and encased in plaster of Paris before being dismantled. Then a 40 mm (1.60 in) hole was drilled down the length of the shaft and capital. The shafts were re-erected, having been strengthened with 30 mm (1.25 in) stainless steel rods, and the cracks were repaired with epoxy resin

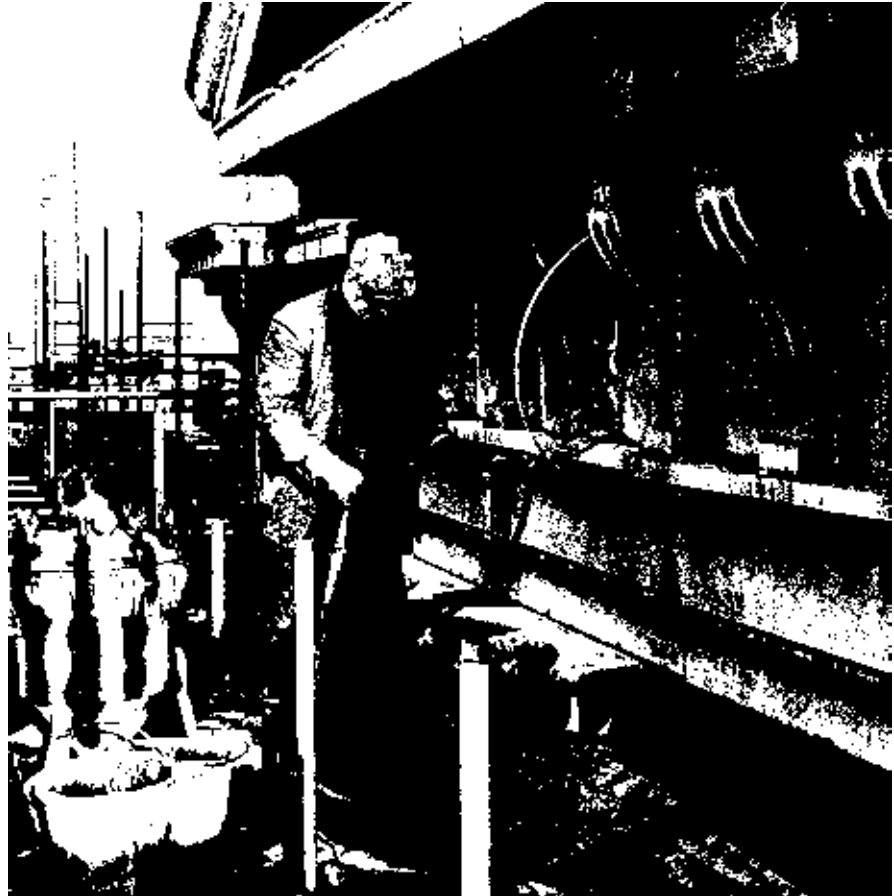
Figure 21.26 Grouting, central tower, Norwich Cathedral, England
(Courtesy: Feilden & Mawson)

Holes for the probes were drilled into the wide joints so that their position would not show after making good. During the work at 30 lbf/in², it was found that grout might spurt a considerable distance and so the protective drapes of polythene were necessary. All the piers of the tower with the arcades and walls above were consolidated by grout

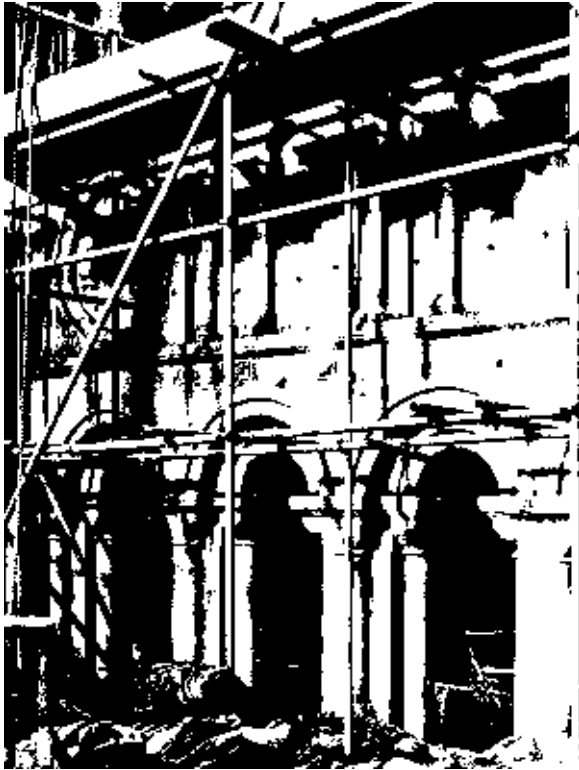
Figure 21.27 Grouting, central tower, Norwich Cathedral, England
(Courtesy: Feilden & Mawson)

The holes drilled ready for insertion of probes show clearly. Lime and fly-ash with a small amount of Portland cement was used as a mix and the amount injected into each hole was recorded. The cracked capitals in the arcade were grouted with epoxy resin which only had a short pot life of 30 minutes

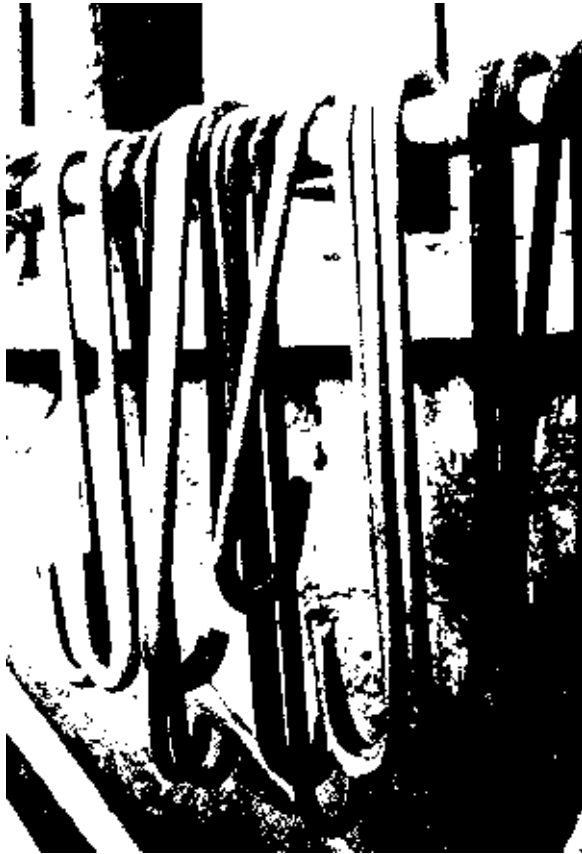
Figure 21.33 Reinforcement, central tower, Norwich Cathedral, England

Steel reinforcement for the tensioned ring beams galvanized after bending and cutting. This has to be inserted in short lengths; each piece of steel was hooked on to the next to provide a continuous chain of four 20 mm (0.75 in) bars. The different lengths enabled variations to be dealt with

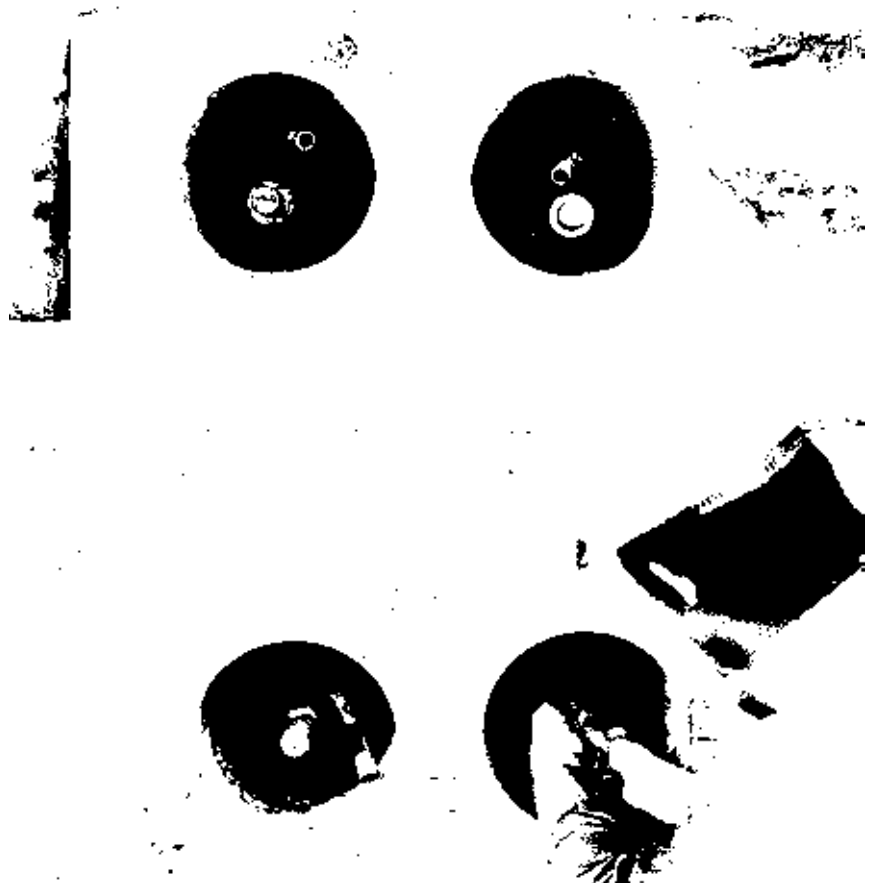
Figure 21.34 Reinforcement, north-west tower, York Minster, England

End anchorages of 150 mm (6 in) diameter stainless steel was used. Then the steel was pre-stressed using a hydraulic jack, allowed to stretch for two months and then given final tension. Grout was inserted through prepared probes

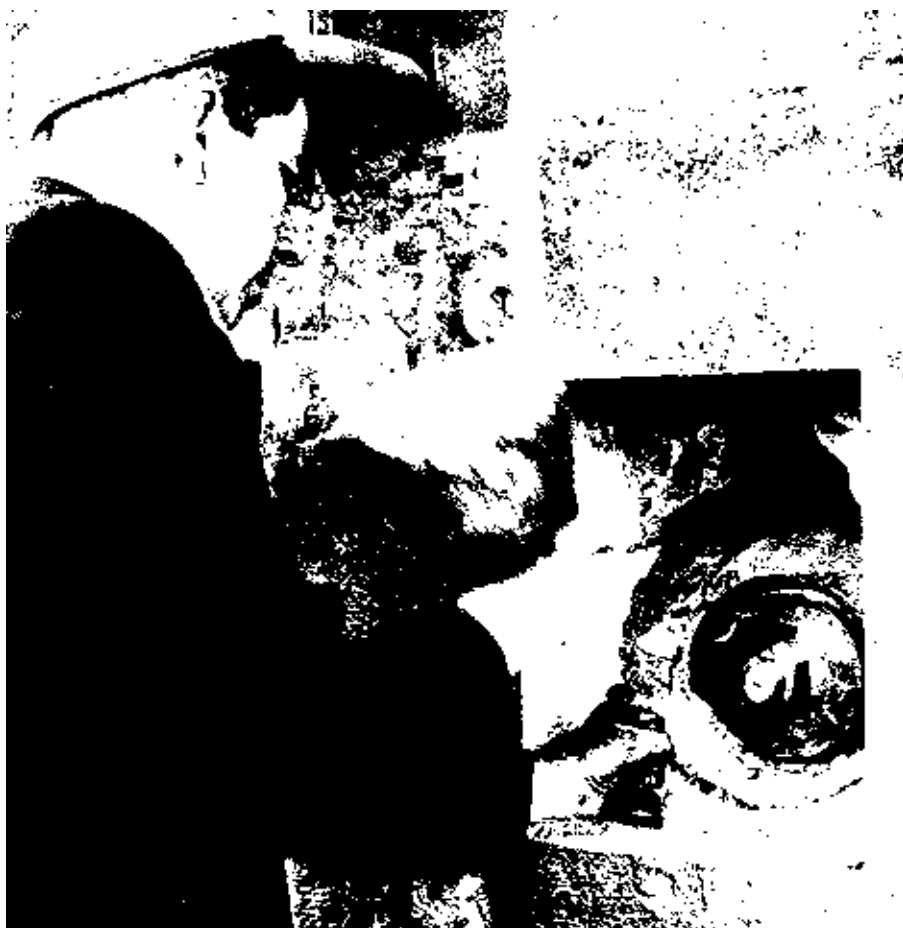
Figure 21.36 Making good, north-west tower, York Minster, England
(Courtesy: Shepherd Building Group Ltd)

The mason prepares to make good by cutting out a rectangular shape for the new stone. He should have been consulted about re-setting the piece cored out

Finally, the mason makes good by inserting new stone and grouting it into position

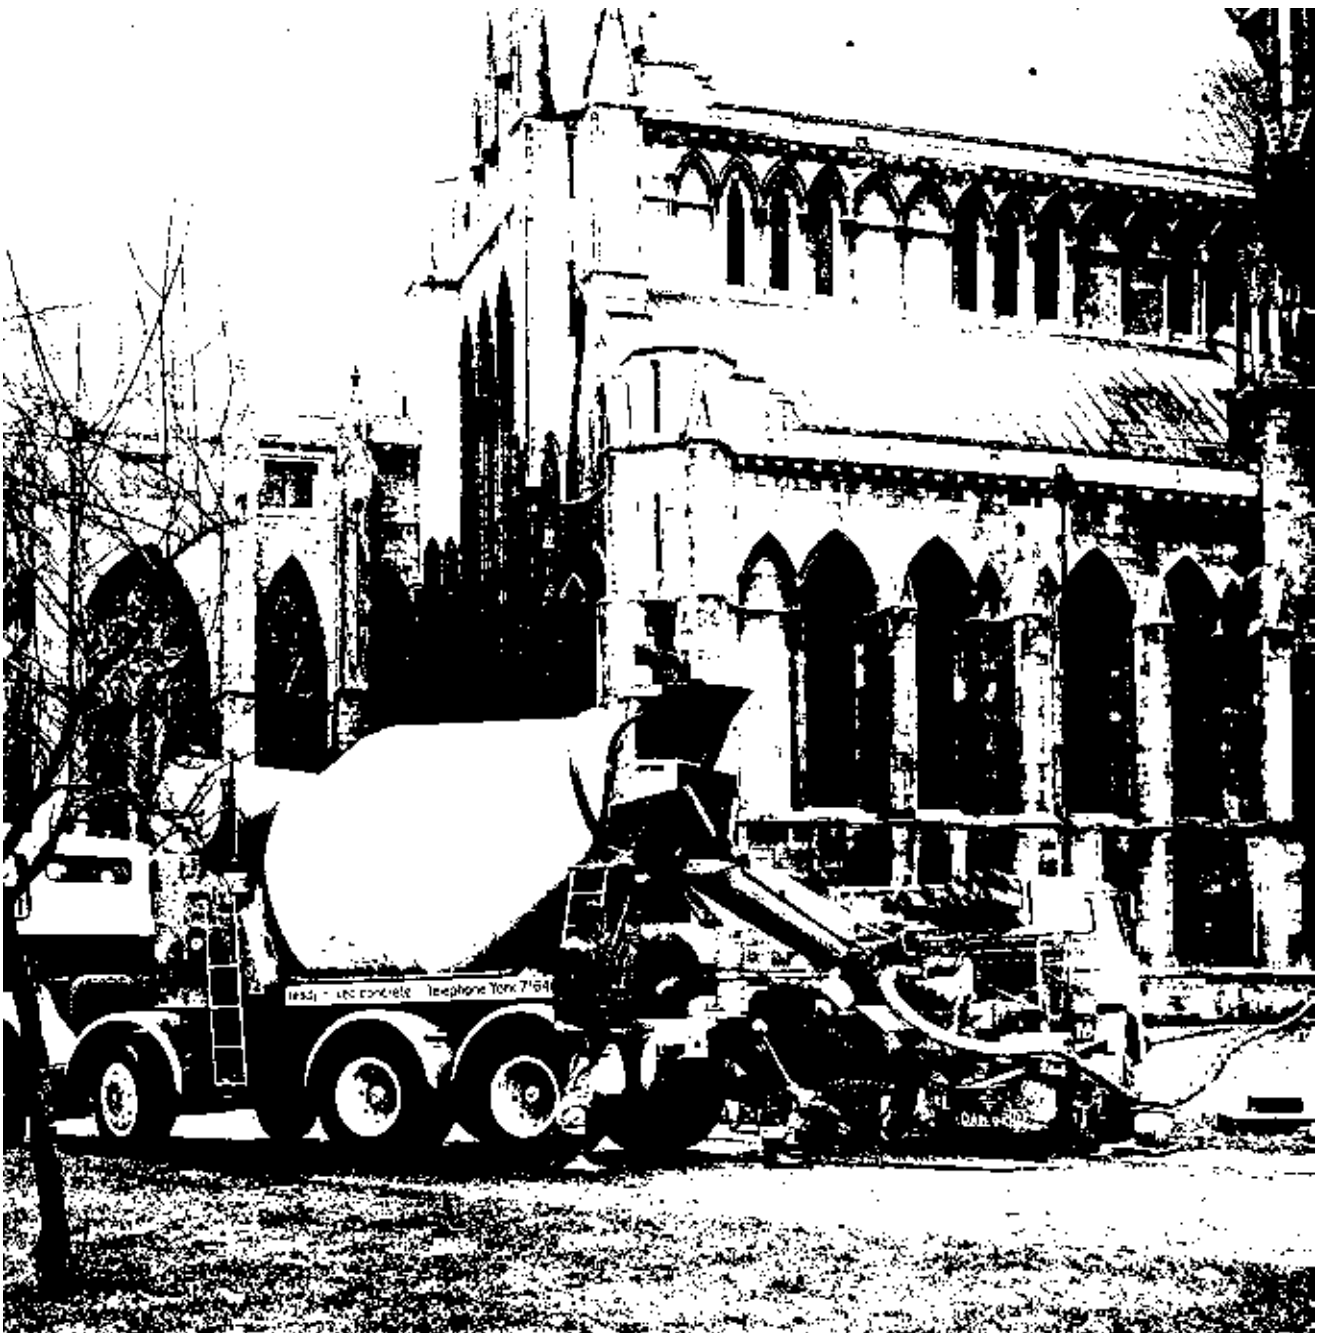
Figure 21.38 Pumping concrete, York Minster, England
(Courtesy: Shepherd Building Group Ltd)

Ready-mixed concrete deliveries can lessen labour costs and save space on a confined site, leaving it cleaner and reducing the noise nuisance from concrete mixers. In combination with a pump unit, concrete can be delivered wherever required by

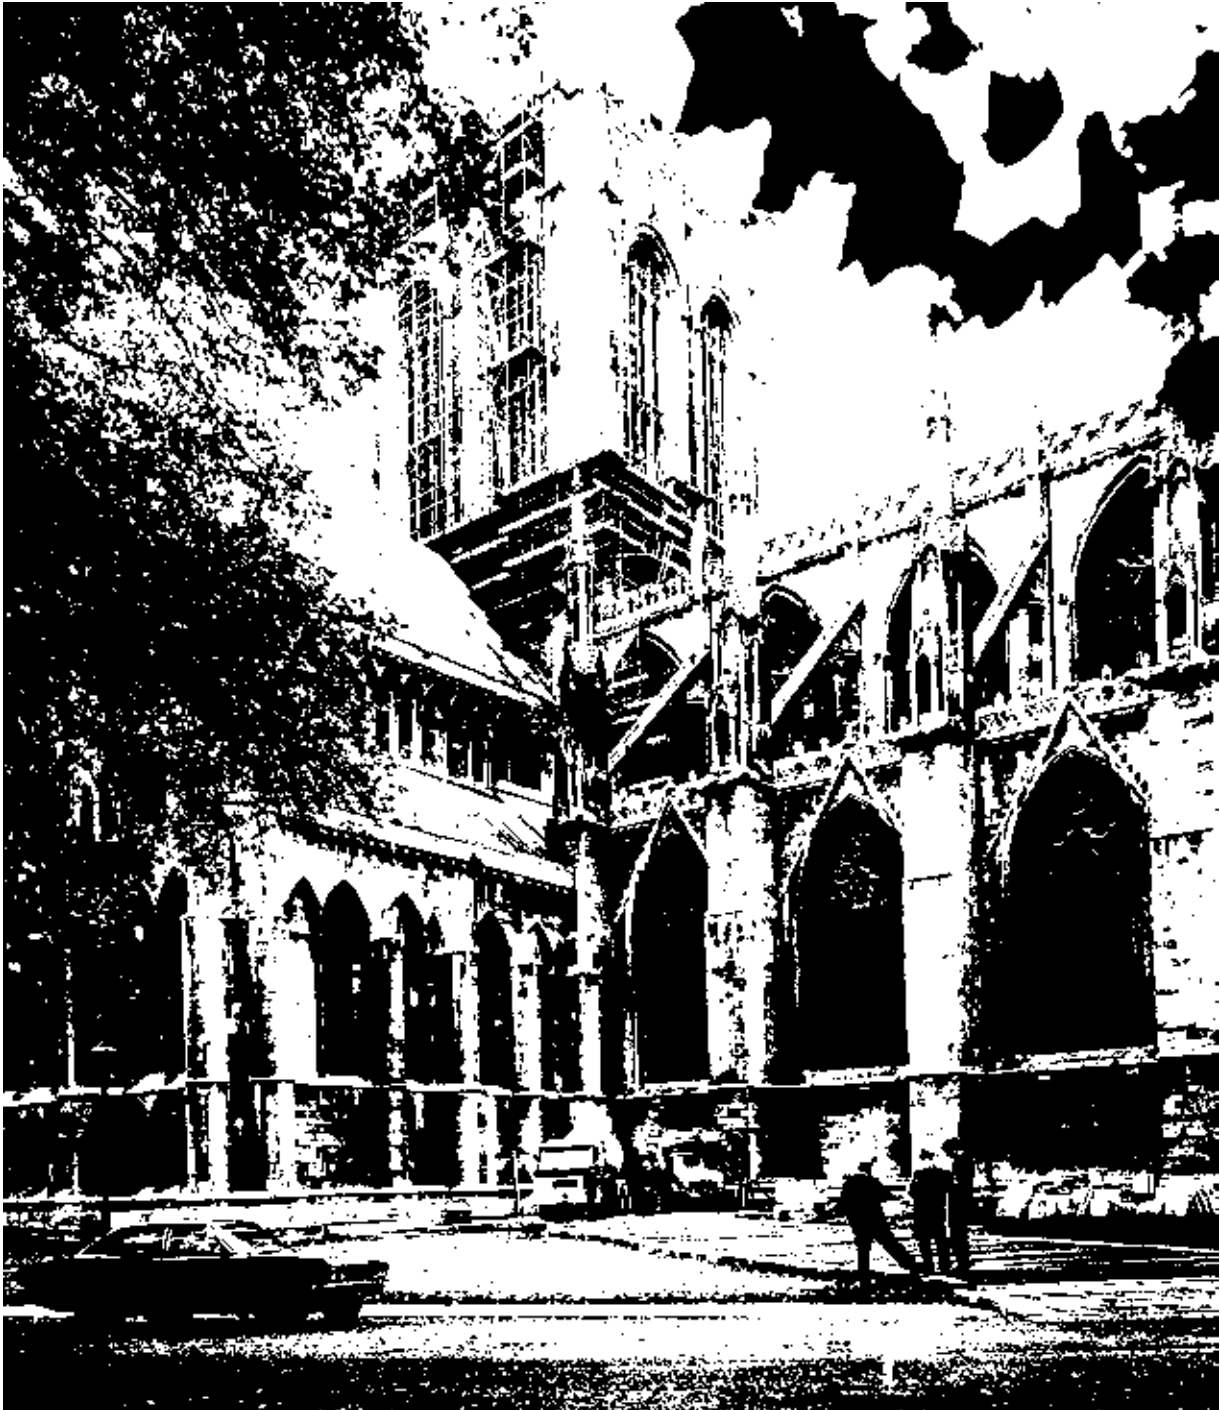
Figure 21.39 Pumping concrete, York Minster, England
(Courtesy: Shepherd Building Group Ltd)

Shepherd's Contracts Manager organized the pumping of some 80 m³ (105 yd³) of concrete to the top of the central tower, 63 m (207 ft) high. The work of laying this concrete took about five hours. Shepherd's were awarded a special Cembureau prize for this feat. In the conservation team the contribution of the contractor in using plant and equipment efficiently is vital to overall efficiency and economy of the project

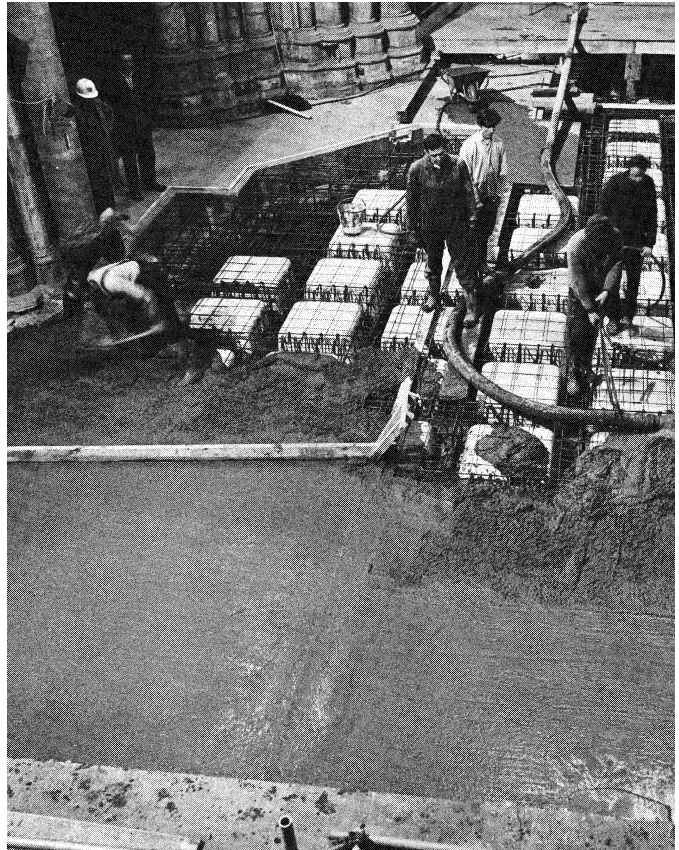
Figure 21.40 Pumping concrete, York Minster, England
(Courtesy: Shepherd Building Group Ltd)

After the enlargement of the foundations had been completed and the active settlement of the central tower stopped, it was possible to reinstate the floor which was of reinforced concrete laid over plastic coffer moulds. The concrete was pumped into position, vibrated and tamped to form a level and smooth finish

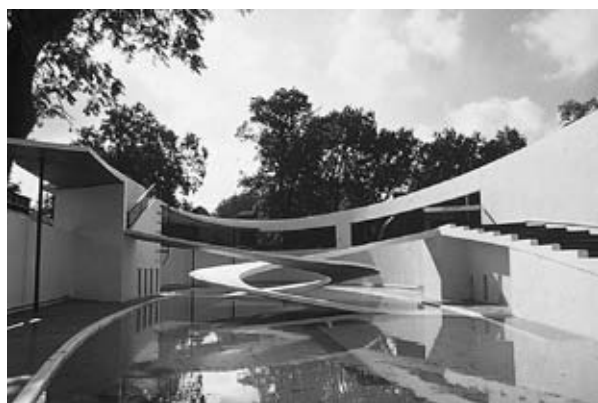
Figure 22.2 The Penguin Pool, London Zoo, England, 1934
(Photograph: John Allan, Avanti Architects, London)

Lubetkin & Tecton's celebrated Grade I listed icon has been restored by Avanti Architects, using modern concrete repair techniques

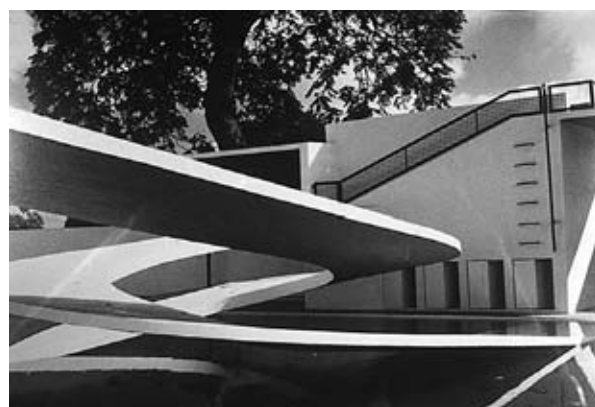
Figure 22.3 The Penguin Pool, London Zoo, England, 1934
(Photograph: John Allan, Avanti Architects, London)

The original blue colour of the ramp undersides was rediscovered and reinstated during the restoration project

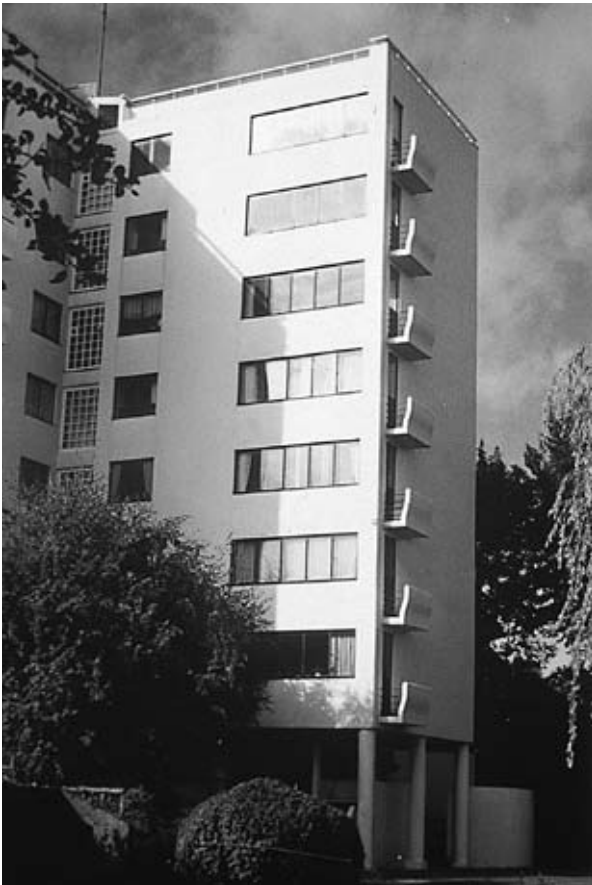
Figure 22.4 Highpoint, Highgate, London, England, 1935
(Photograph: John Allan, Avanti Architects, London)

The sustainability of this Grade I masterwork by Lubetkin & Tecton relies on conscientious maintenance and informed repair. The integrity of its facade is dependent upon the uniformity of fenestration, making care in any window replacement of crucial importance
