Conservation of Historic Buildings

*Conservation
of Historic Buildings*
Third edition

Bernard M. Feilden

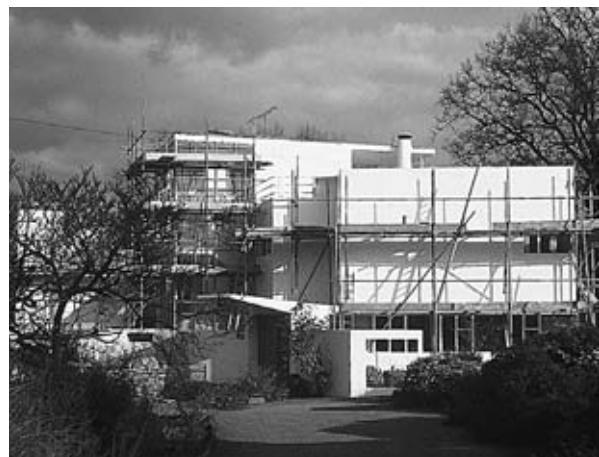
Figure 22.6 The White House, Haslemere, Surrey, England, 1932
(Photograph: John Allan, Avanti Architects, London)

This Grade II listed house by Amyas Connell, architect, undergoing facade and window restoration by Avanti Architects in the early 1990s*

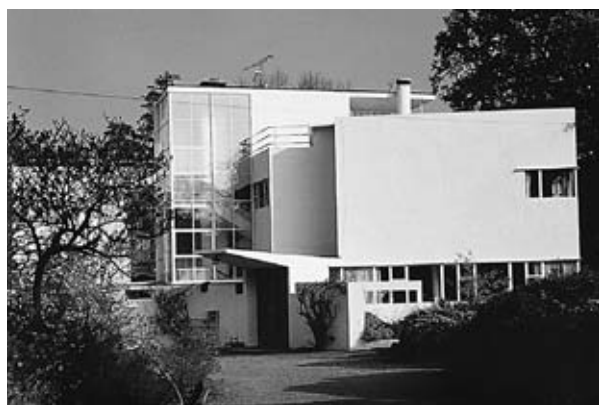
Figure 22.7 The White House, Haslemere, Surrey, England
(Photograph: John Allan, Avanti Architects, London)

View of the completed concrete restoration, which involved removal of previous deleterious overpainting, replacement of damaged fabric, and application of anti-carbonation vapour permeable fairing-coats

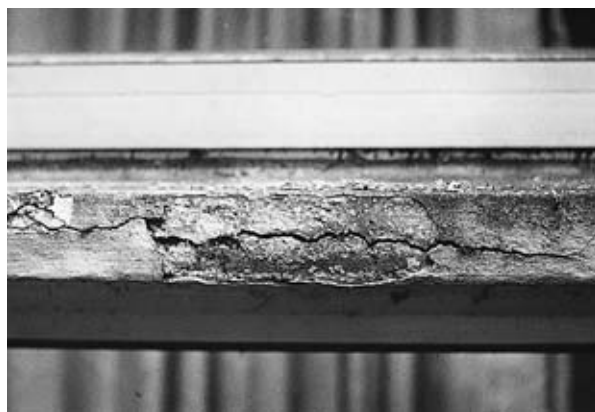
Figure 22.8 Concrete damage
(Photograph: John Allan, Avanti Architects, London)

Typical instance of an incipient spall, where corroded reinforcement in a slim section element has fractured the concrete casing. Displaced and damaged fragments of concrete and rebar must now be removed back to sound material in order to begin forming the repair

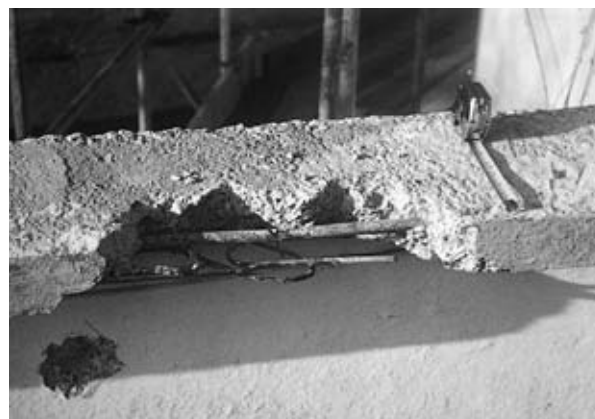
Figure 22.9 Concrete damage
(Photograph: John Allan, Avanti Architects, London)

A damaged coping section showing break-out of defective material prior to commencement of repair. This will require reinstatement of lost reinforcement and local recasting in matching formwork

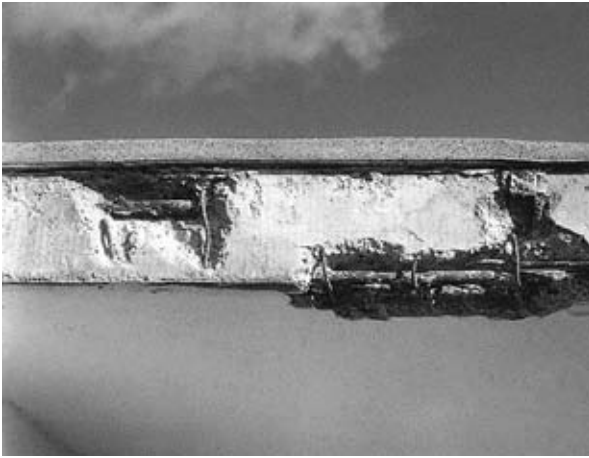
Figure 22.10 Concrete damage

Part of a damaged thin section canopy fascia, where spalled concrete has been removed to expose rebars and establish the repair site. The bars must be brought back to bright metal and primed for a bonding coat prior to packing replacement mortar and applying protective coatings

replacement. Rusted reinforcement is best cleaned by grit blasting. As soon as possible after cleaning, the prepared steel is primed in two coats, using an epoxy coating or polymer-modified cementitious slurry—the second coat being applied while the first is still tacky—and including a quartz sand blinding, to optimise keying of the ensuing repair.

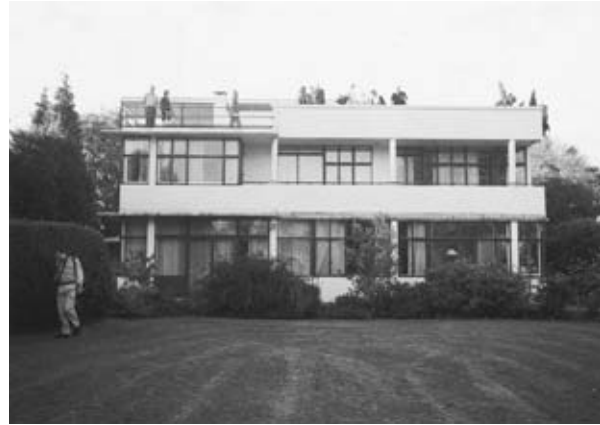
Figure 22.11 The Concrete House, The Ridgeway, Westbury-on-Trym, Bristol, England

Designed in the 1930s by Amyas Connell of Connell Ward and Lucas. This is one of the least altered examples of the vanguard of modern design in Britain. The construction is a reinforced concrete frame, infilled with concrete walls, finished internally with insulating board used as permanent shuttering

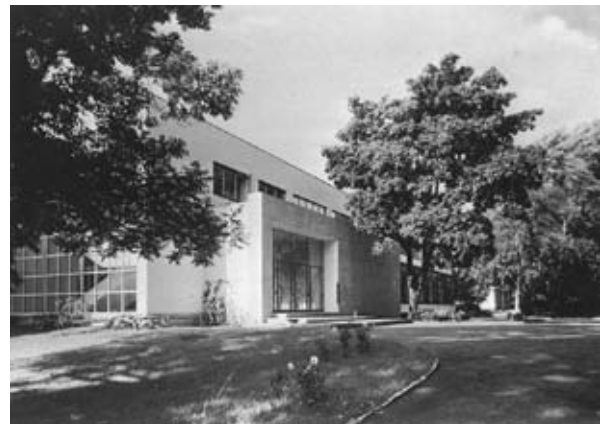
Figure 22.12 Vipuri Library

The restoration strategy is to stabilize the building and prevent further deterioration, to renew basic technical facilities, and to restore the original architecture. During this process, the building will continue to be in active use. Theoretically, the restoration of a modern building does not differ from the restoration of old architectural monuments, but in practice, there are notable differences. The original building fabric plays a significant role, and in the case of the Vipuri Library, the extensive resources of the Alvar Aalto Foundation are consulted. These include the original drawings, working descriptions and photographs from the 1930s
