CONSERVATION OF RUINS

John Ashurst

Edited by John Ashurst

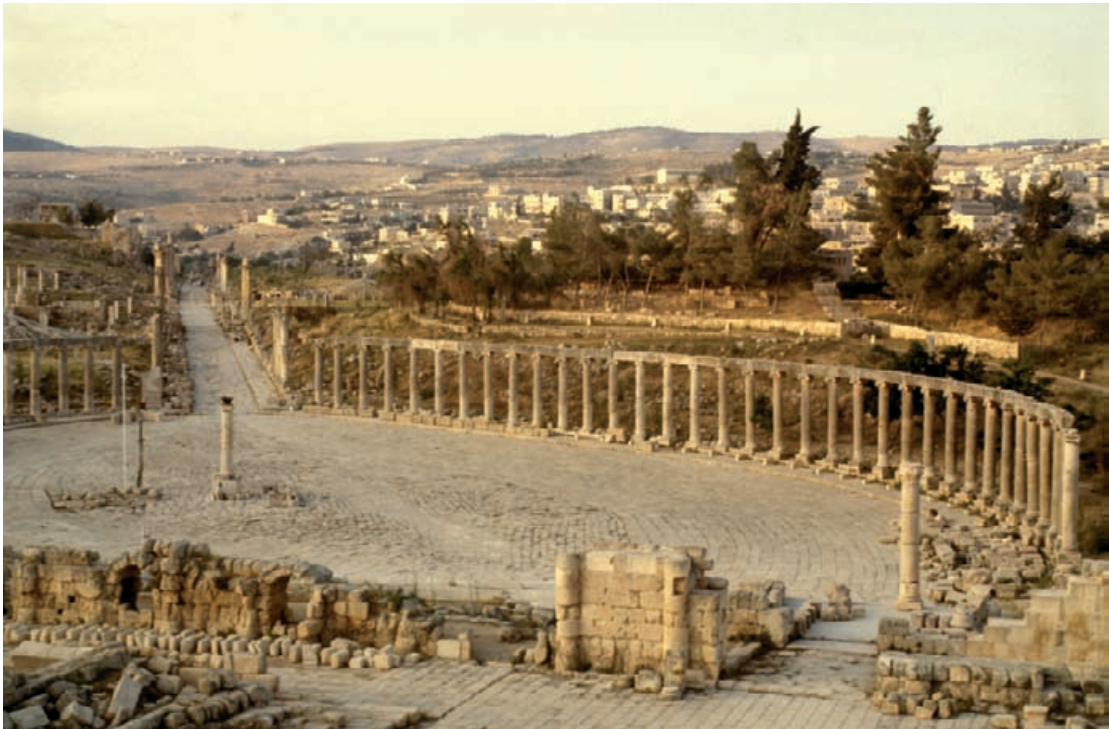
Jerash. The circular forum of Roman Jerash, substantially and mortally damaged by an earthquake.

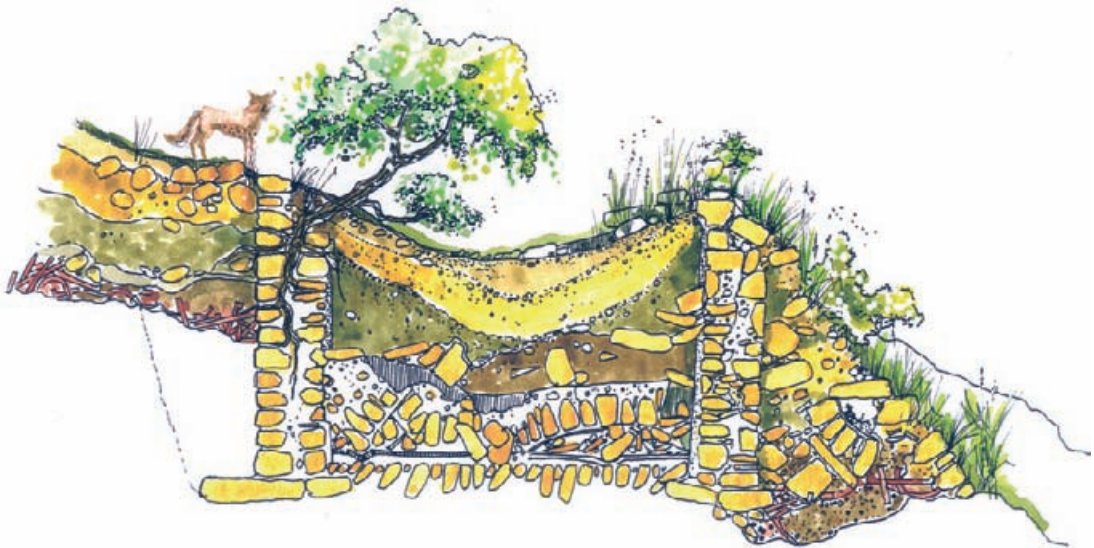
6 Archaeology as an informing force

The site is studied contextually and specifically, carefully recorded and systematically excavated. The stratification, construction, materials, artefacts and sequence of building and destruction become clear. After a period of further analysis reports are prepared and archived, perhaps suggesting a further season of excavation if funds are available. No money is left for any temporary protection, and it is confidently predicted that not much deterioration can take place in one year. The site is left in a dangerous condition and is regularly visited by souvenir hunters.

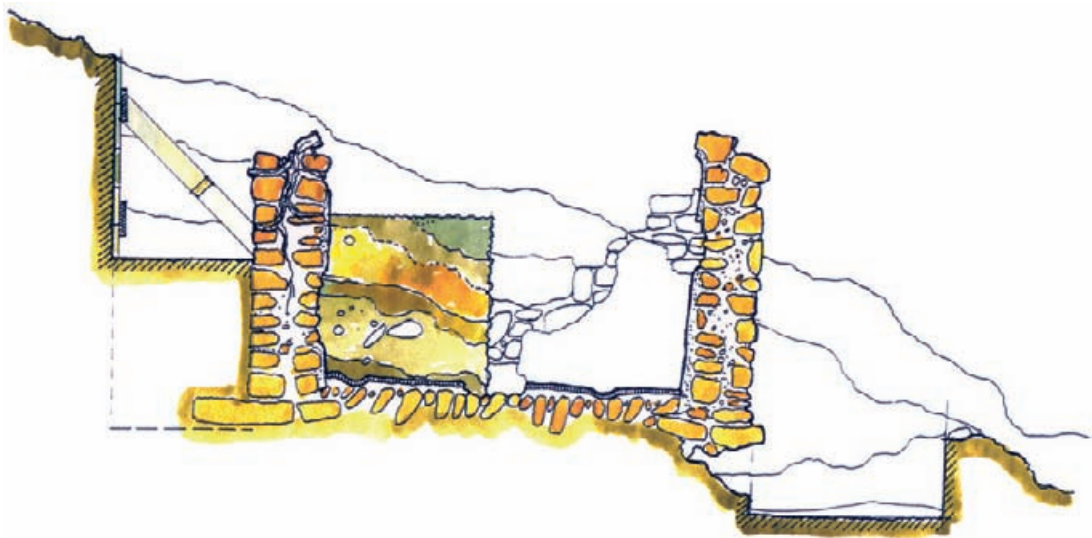
7 **Archaeology as a destructive force**

The site has provided all the information considered necessary for the historic record and is left abandoned. No money can be made available for further excavation and a period of neglect begins. Excavated material from the interior of the temple had provided a counterfort against the pressure of soil, loose rock and water moving down the hillside. Now the spoil has been removed, the rear wall collapses. Water ponds under the foot of the lower wall encouraging its subsidence. Water moving through the composite walls loosens the face work from its core. Water ponds on the mosaic floor and micro-organisms begin to colonise the painted plaster surfaces. Cut roots of vegetation growing on the wall begin to support new growth. Small mammals return to the site and begin to burrow into loose fill. The plaster is totally unprotected and detaches from the walls. Within a few years nothing significant will be left on the site for further study and re-appraisal.

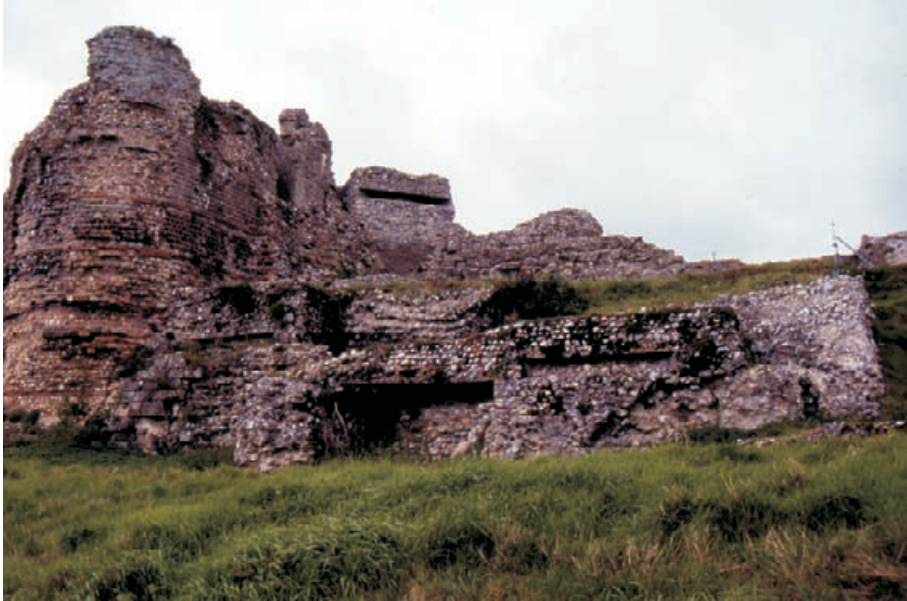
Pevensey. The Roman Fort of Anderida (late C 300) was one of a line of forts along the south and east coasts of England set up to control Saxon activity at sea and prevent incursions on land, an enterprise which failed generally but spectacularly in this particular location, with the massacre of the defending garrison. The site was adopted and modified following the Norman conquest, Pevensey Castle being formed within the Roman curtain. In 1940, the site was again adopted and modified with the installation of concrete gun emplacements in anticipation of German invasion. All periods are legible and conserved.

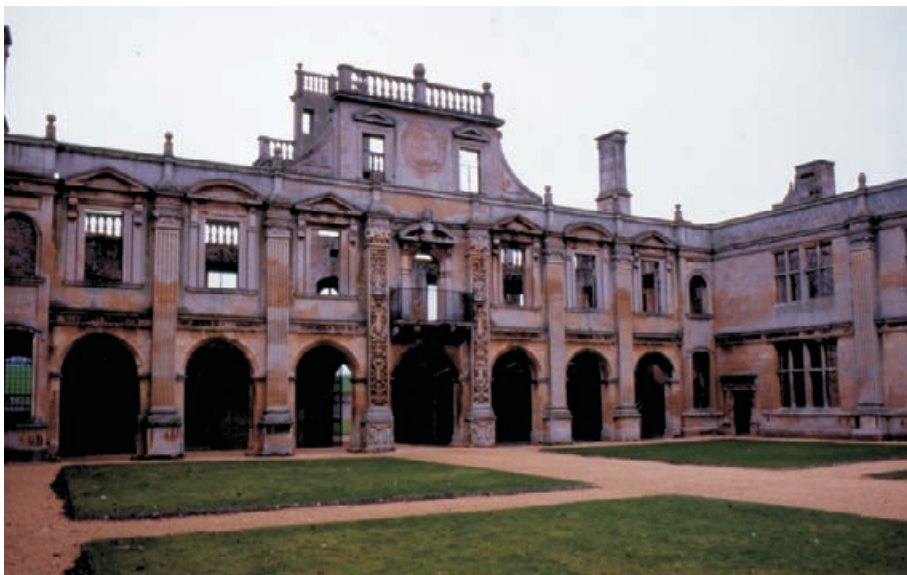
Kirby Hall. The construction of Kirby Hall began in 1570 and may have been completed by 1575. Modifications and additions to part of the house were made in the 1630s. As a partial ruin it provides useful information on construction methods and materials of the time and on the alternations, but its real significance lies in its architectural importance to the Elizabethan period and the influence it had on later domestic architecture. Plans to re-floor and re-roof the whole of the house have been made from time to time but have been abandoned.

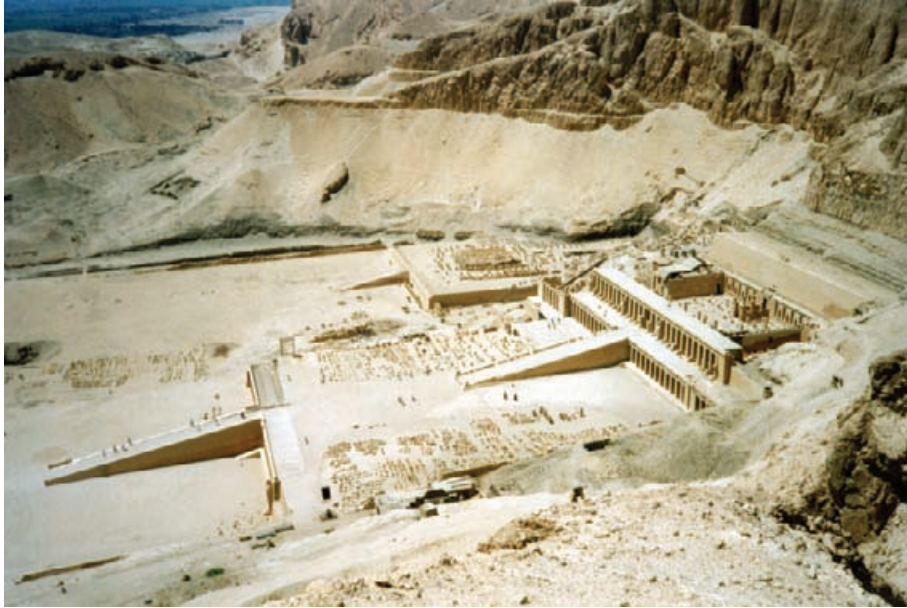
Hatshepsut. The terraced mortuary temple of Hatshepsut (Makare Hatshepsut 1503–1452 BC), located in the Theban hills, was known to Napoleon and partially explored during the 19th century. This spectacular site has been fully exposed for almost 100 years, since the work of the Egyptian Exploration Society in 1906–1909. The condition monitoring of a site of such antiquity and importance in terms of natural weathering and erosion and of visitor impact is critical to the quality of its ongoing survival and for future study.

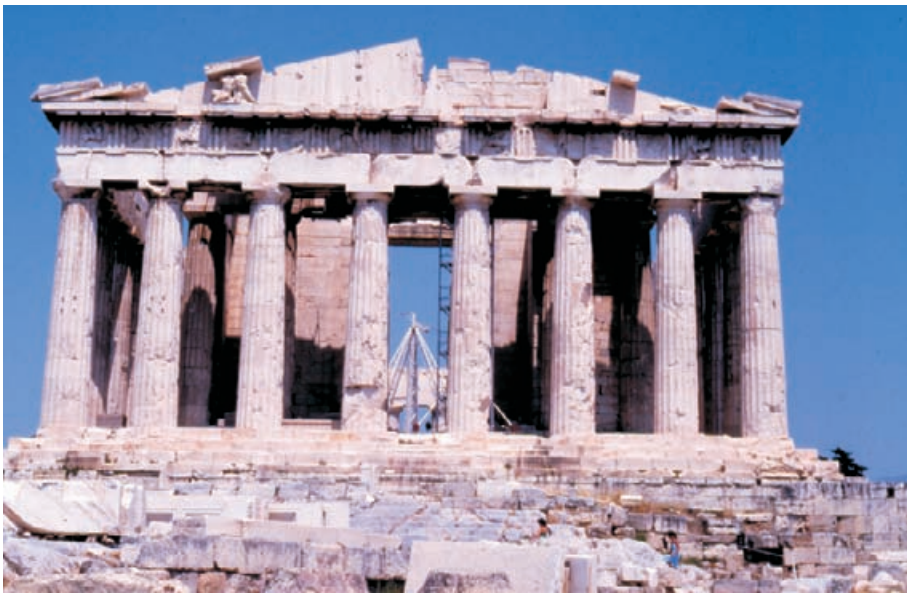
Parthenon. The Parthenon is the most famous of the 5th century BC buildings on the Athenian Acropolis and retains its spectacular beauty and sense of power in spite of multiple phases of use and alteration, from church to mosque and, disastrously, to munitions store. Although there have been periods of substantial restoration in the 19th century the Parthenon remains a testament to the ingenuity, refinement, sophistication and skill of its creators, Pheidias the sculptor and Iktinos and Kallikrates its architects. This site and its original context is of such importance that unpicking of 19th century interventions is seen as entirely justified.

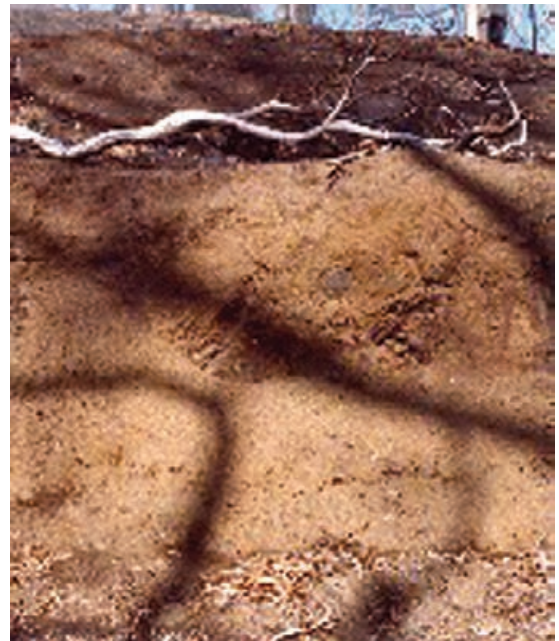
Figure 2.6 Deep *in situ* residual clay weathering showing residual basalt boulders.

It is important when investigating a new site, particularly if sited onto clays, to bear in mind the general geology of the area, the level of weathering and the location of the site within the local topography. Sites occupying hill sides or tops, apart from being closer to the underlying rock, will sit onto clays formed by *in situ* weathering (Figure 2.6), whereas those on valley floors would normally sit onto clays, which have shifted downhill under the combined influences of gravity, frost and water transport.

The tiny platelets comprising the clay particles are randomly organised within the parent rock and weathering *in situ* leaves the skeletal structure (including the microstructure) unaltered; hence the swelling and shrinking forces are randomised. Those clays shifted downhill become remoulded to some extent, and achieve a partial orientation as the platelets slide together. However, clays laid down by freshwater action are fully oriented as shown in Figure 2.7. This is the worst combination from a structural aspect, since all the platelets now lie in the horizontal plane, resulting in vertical swelling and shrinking being maximised. Ancient clays of saltwater deposit do not align as evenly as those laid down in freshwater lakes, as a result of ionic interaction.

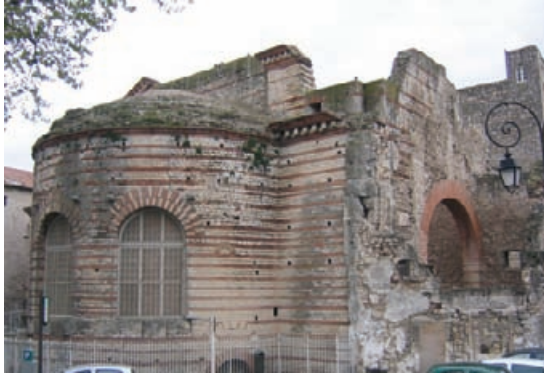
Figure 2.11 *Baths of Constantine, Arles.*

Some minor tensional capability is available from the brick layers via the mortar bonding, and the frequently repeated layers, as for example in the Baths of Constantine in Arles shown in Figure 2.11, provide

a cumulative capability for tension between the layers. The different dynamic response of fired brick, as opposed to masonry, has a dampening effect also. As can be seen, the brick courses extend the full width of the walls.

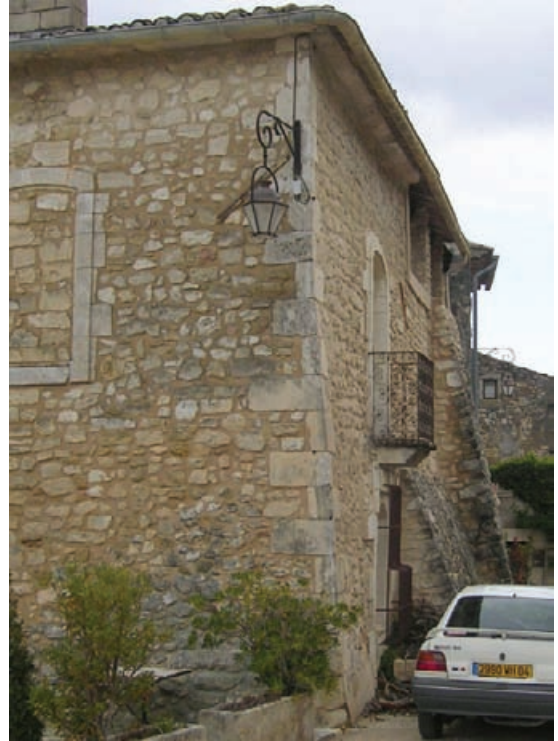
Figure 2.12 *Tapered corner designed to reduce the effects of minor earth tremors.*

In the low seismic areas of southern France, there are many examples in vernacular architecture of tapering walls or buttresses, with splayed quoins, which reduce the effects of minor tremors. These have often been added to with quite massive sloping buttresses, which taper towards their tops, and provide the same effect (Figure 2.12).

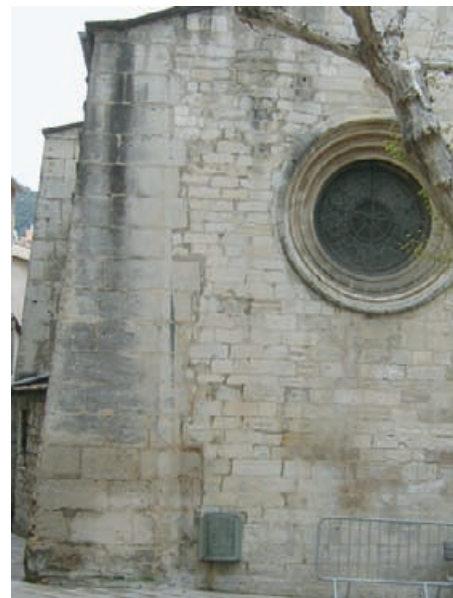
Figure 2.13 *Massive added buttress to wall fractured during seismic activity, Manosque, France.*

A similar add-on seismic buttress can be seen here provided to the seventeenth century church at Manosque, France (Figure 2.13). Notice the neat, but massive, buttress of extra large quoins which has been added to stabilise the fine limestone ashlar work of the façade, which shows signs of having been shaken and cracked by an earth tremor. The position of the crack and loose joints, just back from the corner, indicates that the shock wave passed from right to left. This is borne out by signs of light spalling to the ashlar faces of the two town gateways, which lie on the same axis of the wall shown. This is typical of light tremor damage and it shows how the masonry damage will accumulate on the lee side of the pressure wave, as the masonry rebounds, thereby realising tensional forces in the masonry. An examination of building complexes damaged by seismic activity will illustrate these principles.

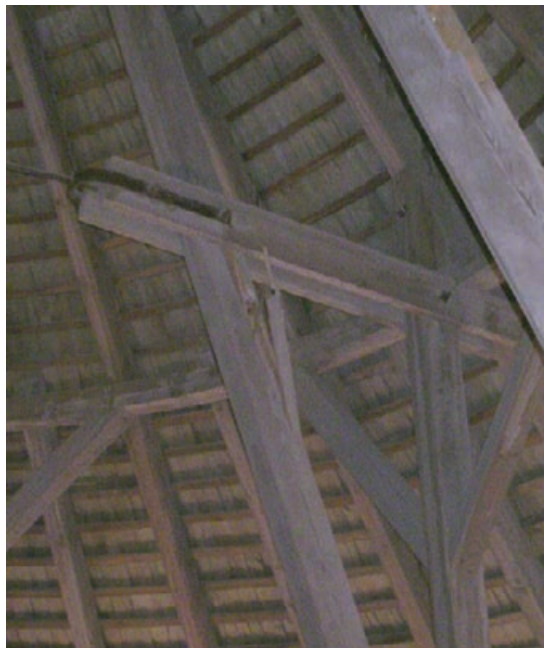
Figure 2.14 Evidence of lightning strike, Cesis Castle, Latvia.

Omission of a conductor will sooner or later lead to lightning causing some damage, as was caused by a strike in 2003 to a conical roof to Cesis Castle in Latvia (Figure 2.14), which had been replaced in the 1890s. Little damage has been caused in this case, as the vertical transmission of the electrical energy has dissipated into several of the sloping timber props. Although nominally dry, residual moisture in the timber has been vaporised from those parts of the timber retaining the most moisture, such as the central pith, and at the cross beam intersections.

Both of the props nearest the camera show the splintering effect caused by the sudden release of energy as moisture turns instantaneously to steam.

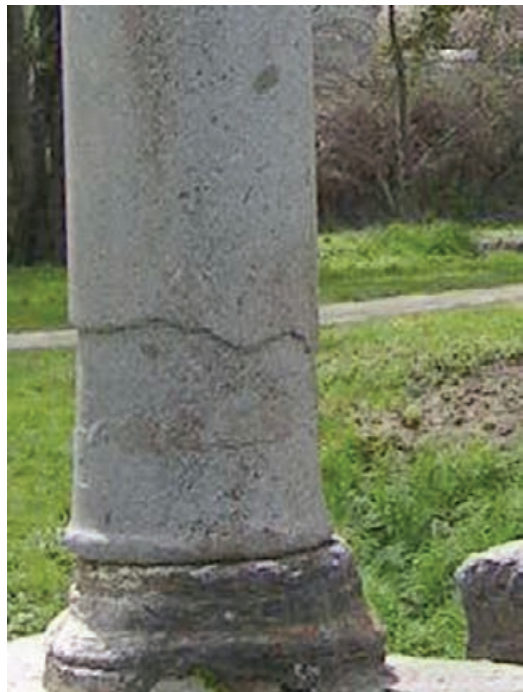
Figure 2.15 Granite column showing temperature-related ‘onion-peeling’.

The direct stresses due to temperature, which cause the typical onion-peeling of stone, occur at night when cooling causes the outside layers to shrink, whilst the interior of the stone is still hot. Thus, it is most pronounced in desert conditions, where the clear air allows rapid heat radiation loss after sundown. Granite columns sometimes found in Roman ruins

can show a variation of this effect (Figure 2.15). Hot days followed by cold nights cause microfracture of the exterior layers, and condensation or rain running down the column penetrates the very small cracks, which can then freeze as temperatures plummet. This causes localised damage mainly around the column bases. Lesser damage occurs at the top of the columns where a small reservoir of water collects between the top of the column and the capital.

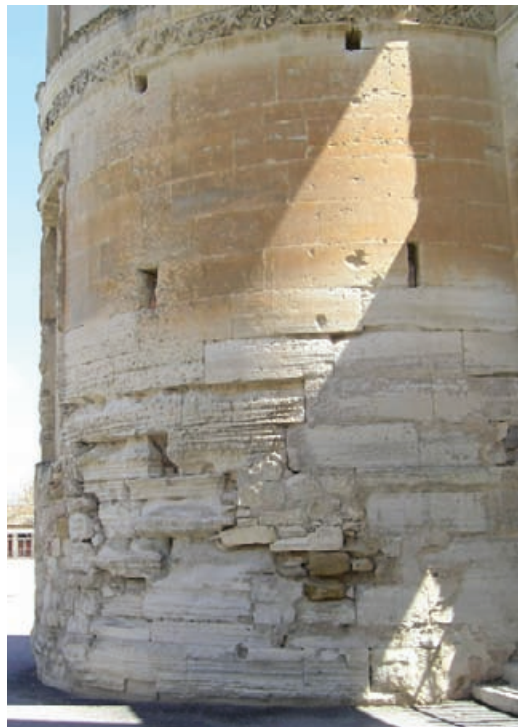
Figure 2.16 Frost damage in saturation zone created by fallen rubble.

The collection of water generally within the sedimentary stone masonry of standing ruins can lead to spalling of face stonework similar to the above, and this type of damage can be seen in Figure 2.16 of a seventeenth century chateau which was gutted during the French Revolution. Frost damage is limited

to the base of the tower walls where fallen rubble allowed the masonry to remain wet. This demonstrates the need for attention to detail to any exposed wall tops and to the removal of moisture traps.

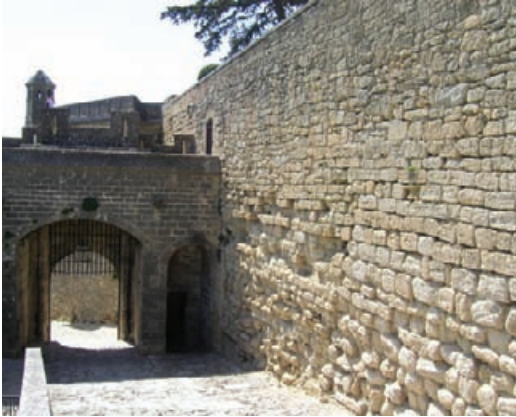
Figure 2.17 Frost damage related to the creation of an eighteenth century terrace behind an existing bastion wall.

To avoid this type of damage, filling behind retaining walls should not be done without first installing a free draining layer directly behind them. Figure 2.17 shows how the creation of a chateau terrace during the eighteenth century has left a clear outline of the step in terrace level behind the older bastion wall, shown by the resultant frost damage. Figure 2.18 shows a combination of frost and salt damage to brickwork due to mounding soil behind a brick wall.

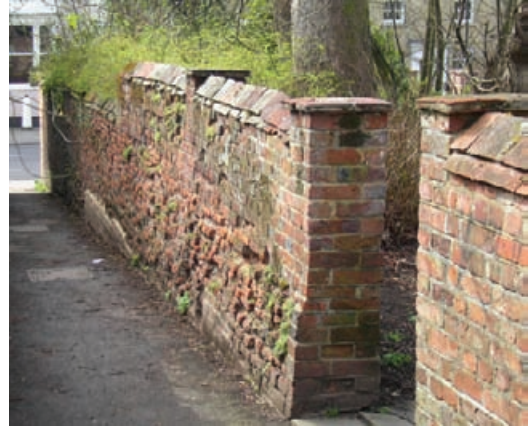
Figure 2.18 Common frost damage caused by accumulation of soil.

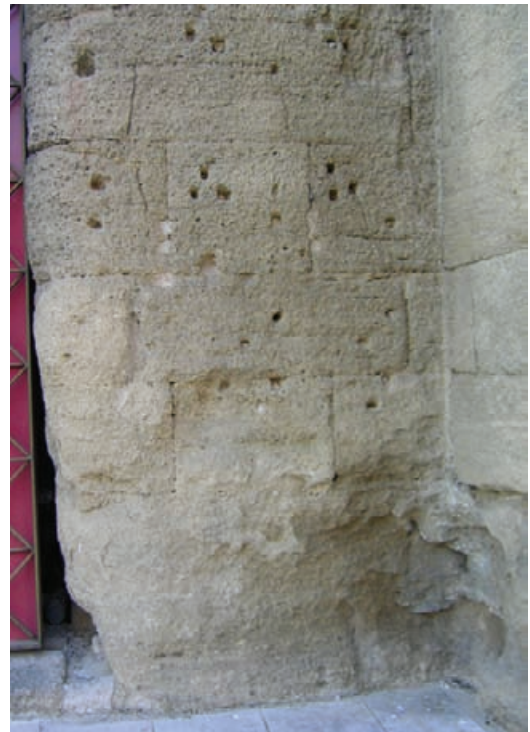
Figure 2.19 Stress cracking of the Roman Theatre at Orange (1).

This is particularly dangerous to ruins, due to the fact that loss of support is involved at ground level, and as the structure seeks to re-balance the forces acting from above, a point is reached where the applied stress is sufficient to shear the stone above. Cracks can be seen developing above the eroded levels of the Roman Theatre in Orange (Figures 2.19 and 2.20).

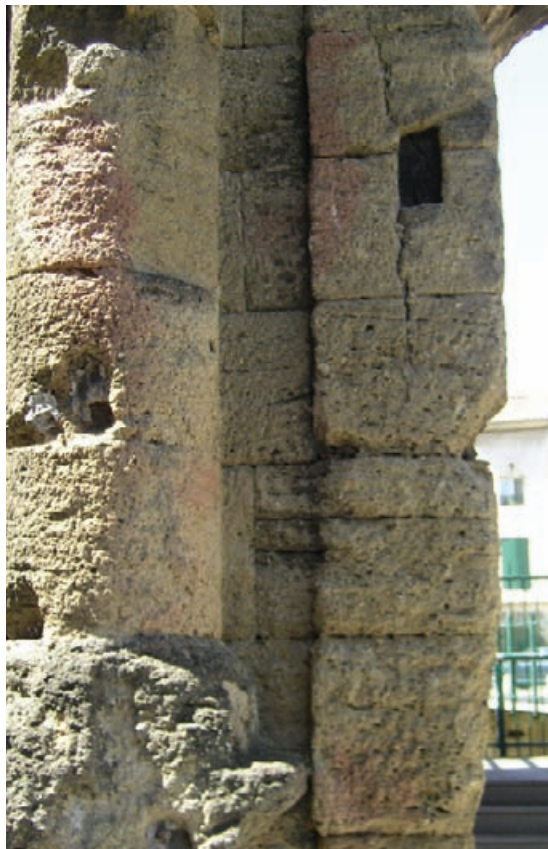
Figure 2.20 *Stress cracking of the Roman Theatre at Orange (2).*

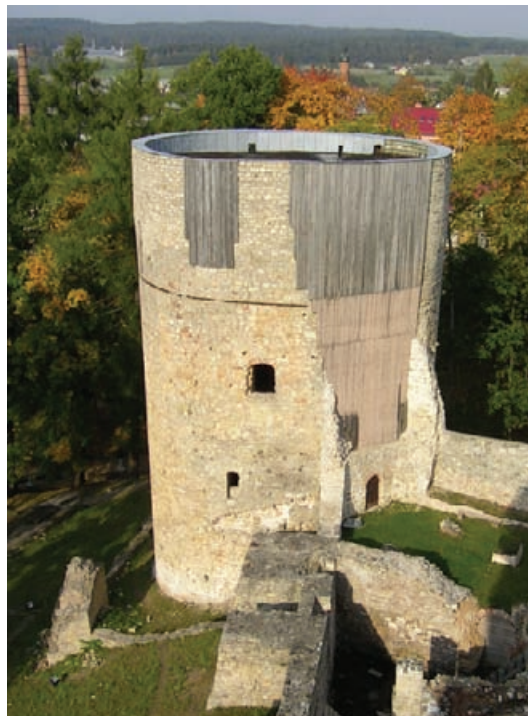
Figure 2.21 *Wall head protection of Baltic tower, Latvia.*

The Baltic tower (Figure 2.21) built by the Livonian Order has been successfully stabilised and protected from further damage, in spite of being 700 mm out of plumb, by provision of a non-intrusive roof and flashings. The openings have been kept through the flashings, retaining some of the realism of the historic apertures, and the use of boarding to close in the structure is not jarring to the sense of the ruin.

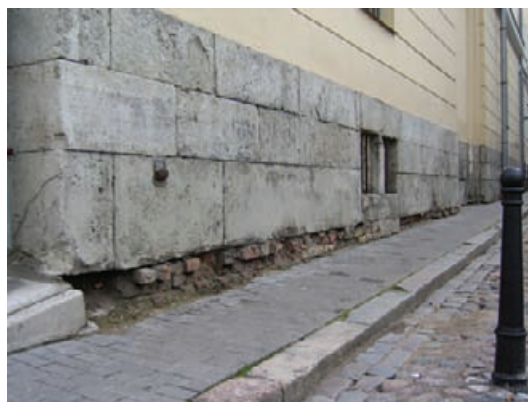
Figure 2.22 *De-icing salt damage, Old Arsenal, Riga.*

In Europe, however, especially in those countries with long cold winters, de-icing salt will cause the same effect when it is taken up as a saline solution during thaw, as seen in buildings surrounding the Old Arsenal in Riga (Figure 2.22).

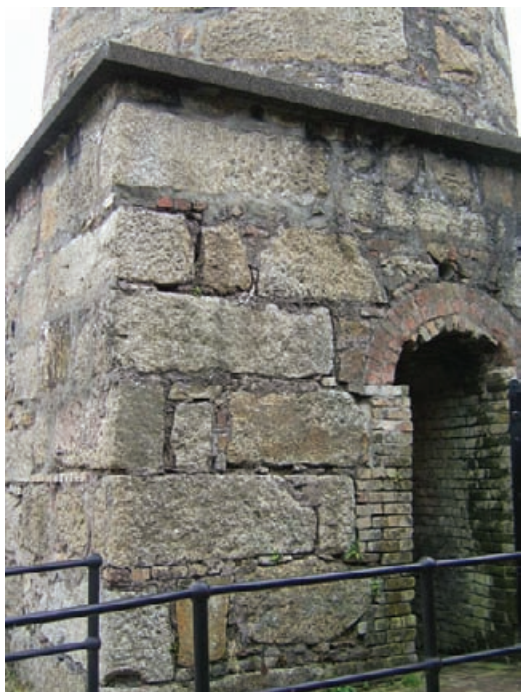
Figure 2.24 Chimney base showing effects of wind vortex erosion.

Figure 2.24 demonstrates the basic effects of wind vortex erosion in a high wind area, although little erosion occurs on the mine chimney, because the smooth profile restricts the development of vortices; the square base structure has noticeable corner erosion just where the vortices are generated.

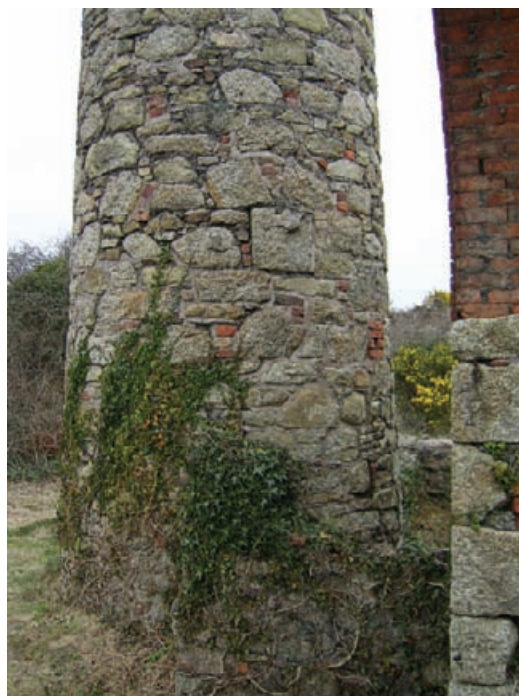
Figure 2.25 Localised erosion related to downstream vortices.

Figure 2.25 shows localised erosion to a round chimney, where downstream vortices have impinged on the surface, these being spun off the adjacent edge of the engine house ruin in the foreground.

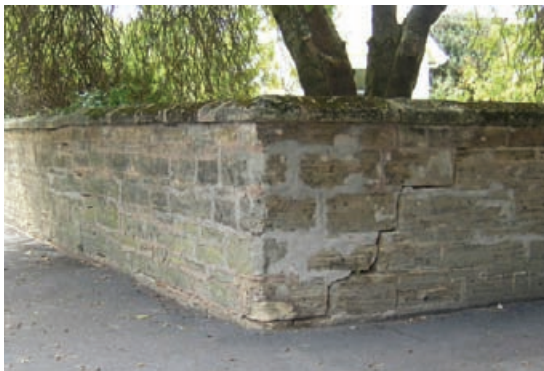
Figure 2.26 *Tree root lift.*

In spite of the beneficial advantages of selected planting given above, there is no doubt that nature is not neutral but active at all times in the general process of decay to ruins and structures alike. Plant roots, whether of climbers like ivy or ordinary tree roots, are active in lifting, breaking into masonry and increasing surface acidity (Figure 2.26). For all these reasons, the mature height rule given above for clays could be applied equally to maintaining a safe distance of trees away from masonry structures.

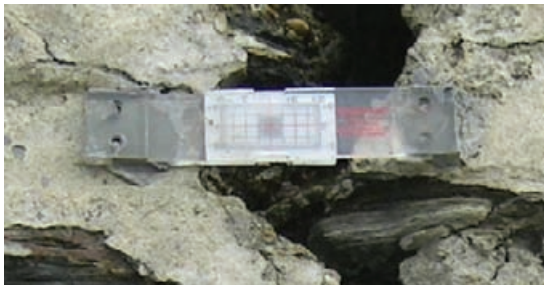
Figure 2.27 Graduated tell-tale bridging a fracture.

Should an initial visit suggest that cracks are still opening then installation of the plastic window type tell-tale is worthwhile (Figure 2.27). These come ready graduated and are made to span across cracks, and the relative movement in two planes can be plotted directly as a trace.

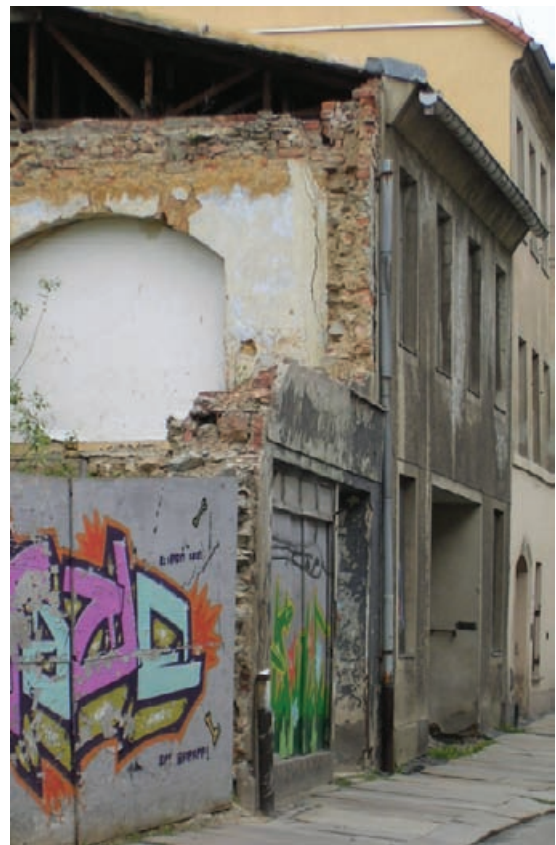
Figure 2.28 Forward lean of wall with tension cracks showing in return wall.

In Figure 2.28 it can be seen that the front wall separates as the wall leans forward, and tension cracks open in the return walls. This phenomenon increases the stress on the toe, as a consequence of which a significant vertical shear acts on the face of the structure, as demonstrated by the spectacular shear cracks on the buttress shown in Figure 2.29.

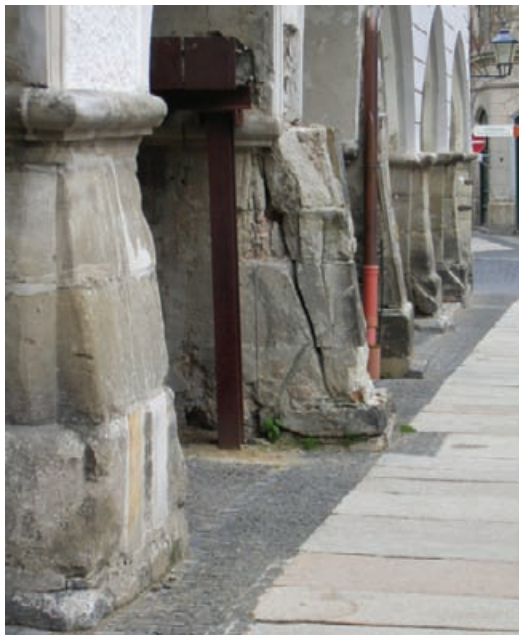
Figure 2.29 *Shear cracks in buttress of leaning wall base.*

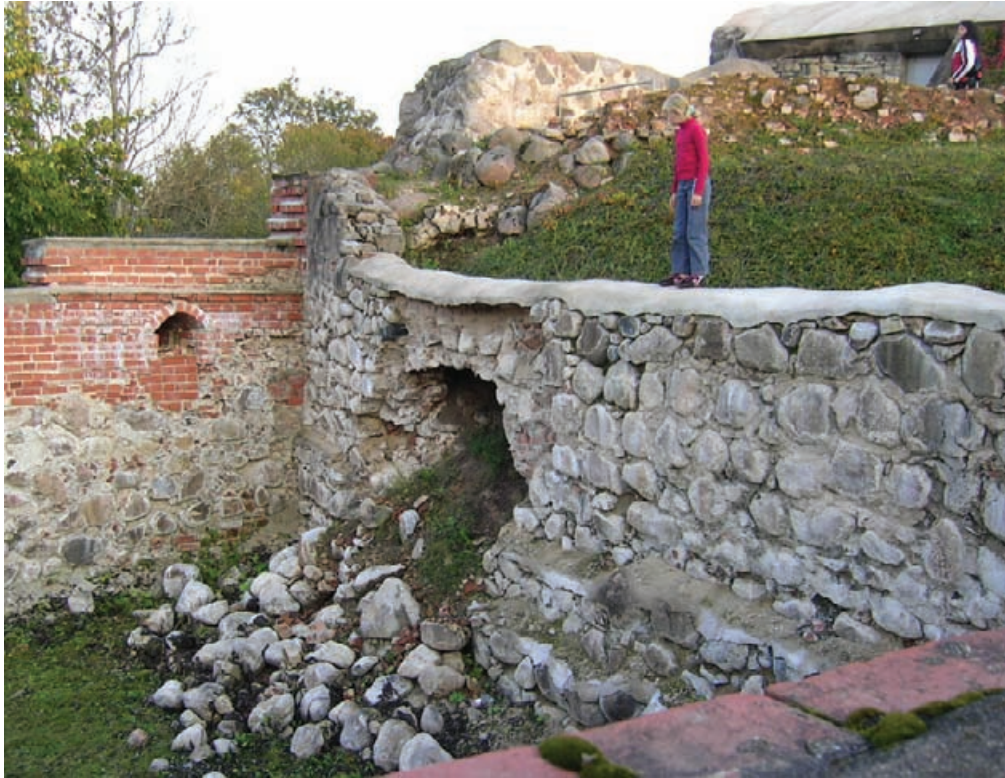
The effect of inadequate provision for drainage and discharge of water from behind a wall can be seen in the bailey of the ruined Baltic castle shown in Figure 2.31. The earth backfill collects water, which then exerts a much higher active pressure on the back of the wall, and maintains the mortar in a damp condition. The wall then fails through a combination of increased loading, weakened mortar and frost damage to mortar and masonry alike. The top of the wall is well protected by a capping, but continuous cappings in long lengths, particularly if composed of cement mortar, can experience expansion and temperature stresses large enough to lift the capping from off the masonry.

Figure 2.31 *Retaining wall failure under earth and water pressure.*

It is usually possible to insert weepholes at the base of a wall in unobtrusive positions, and to drill vertical holes from above to link with them which can be filled with drainage media. These must not be too small a diameter or they will quickly clog, or too far apart for the respective soil permeability to drain effectively.

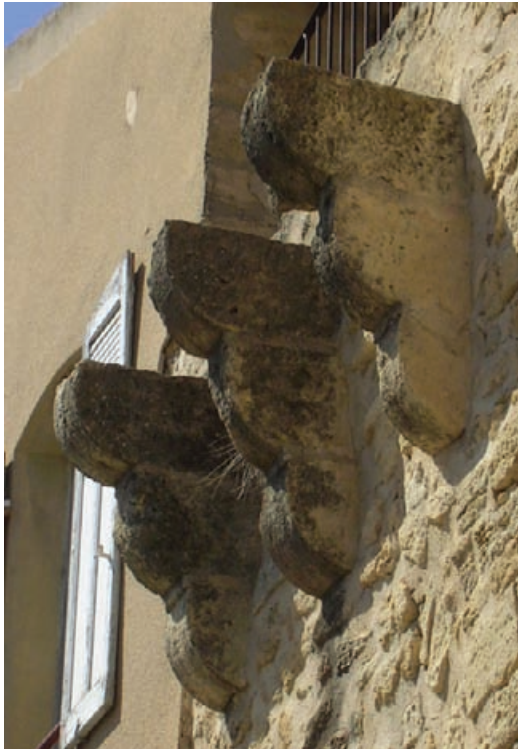
These depend on a cantilever effect and must have adequate back weight in order not to topple. In working around corbels temporary propping should be provided, until a safe amount of masonry has been laid above their back projections and has had time to cure. The corbel projection with respect to depth is always very conservative, 1:1 or less, to avoid initiating a tensional stress in the stone (Figure 2.32).

Figure 2.32 *Corbel projections.*

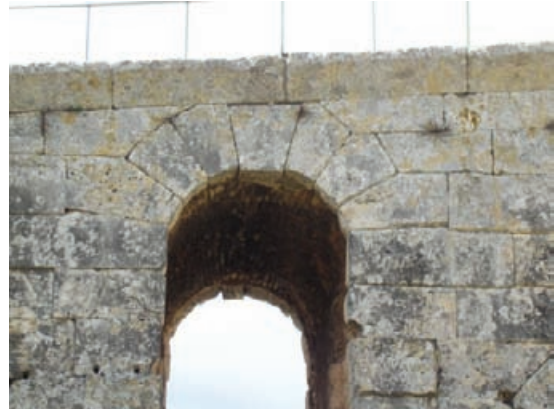
After such a long period in service, loss of mortar and wear of the stones is having an effect, and the flood spillway arch keystone can be seen dropped in Figure 2.34. The arch remains safe, and it is the approaches and spandrel filling which have suffered most from regular flooding and earth tremors, causing spreading of the spandrel walls.

Figure 2.34 *Dropped keystone at Pont Julien.*

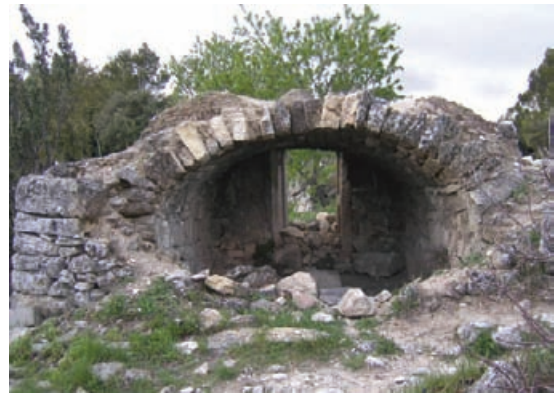
The opposite effect can be seen in Figures 2.35 and 2.36, where both arches are close to failure due to spreading at the springing points. In both cases shown the distortion is towards the springing offering the least lateral support. It can be readily seen that a flatter arch significantly increases the horizontal forces.

Figure 2.35 *Arch close to failure due to spread at springing level.*

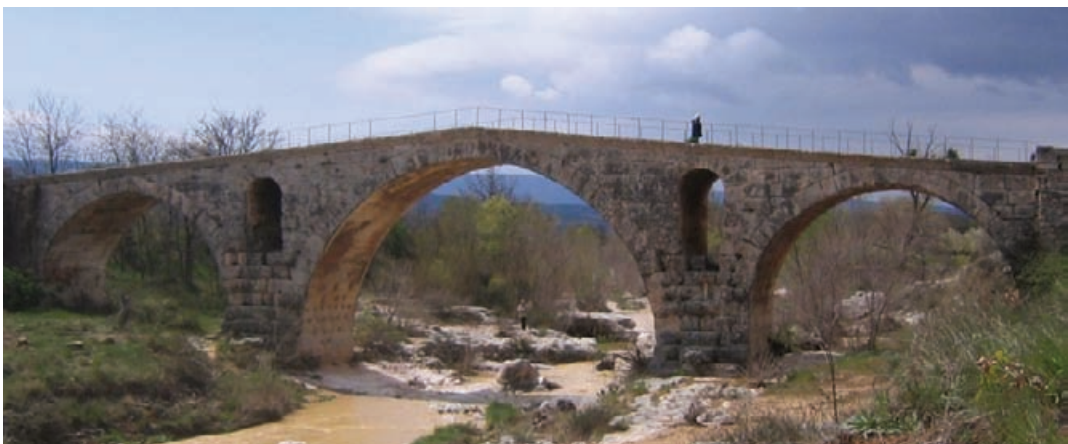
The Pont Julien, taken out of service in 2005 and built between 24 BC and 14 AD, demonstrates the enormous strength and longevity of the semi-circular arch when built of dimensioned masonry (Figure 2.33).

Figure 2.33 *Semicircular arches at Pont Julien.*

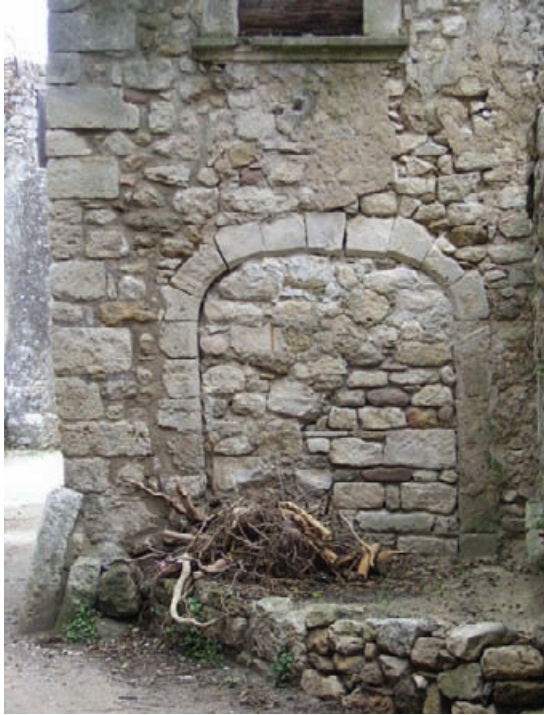
Figure 2.36 Arch close to failure moving towards the area offering least lateral support.

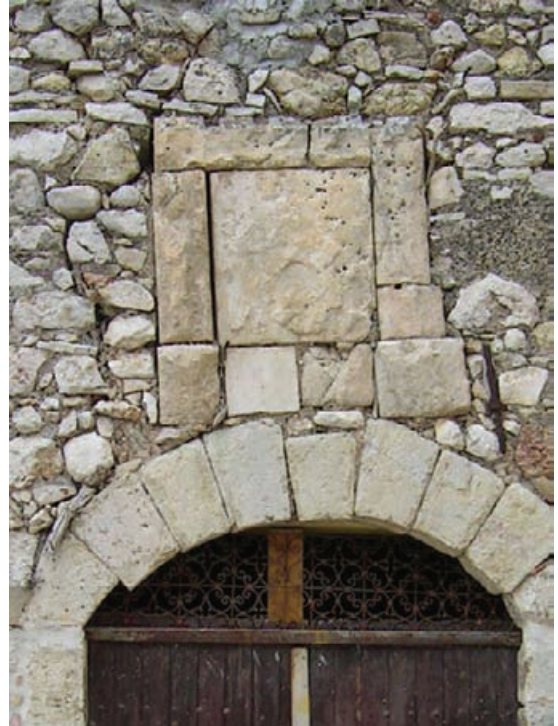
If there is adequate support from one side, but the other side is near a corner return, then a lurch to one side will result, as seen in Figure 2.37. Where the

Figure 2.37 Asymmetric movement of arch.

horizontal thrust is balanced by a second span, or by a large mass of masonry containing the arch, this loss of shape cannot occur.

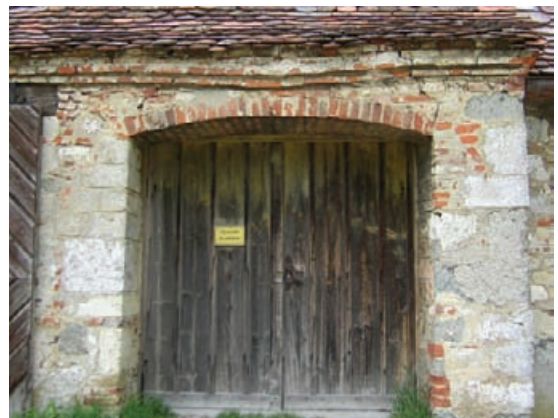
Figure 2.38 Thrust of flat arch.

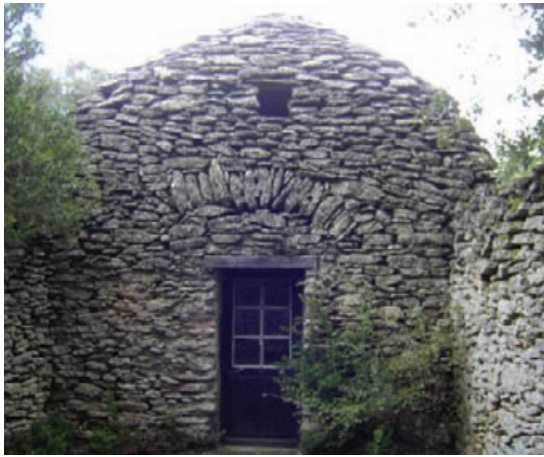
The first is a dry-stone 'borie' (Figure 2.39), which has been dated as pre-Christian era and of a type which goes back to 3500 BC. Although it has a

renewed timber lintel, the relieving arch above it is probably original.

Figure 2.39 Relieving arch in dry-stone borie.

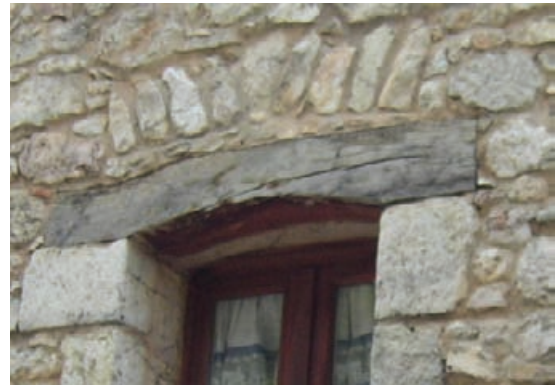
Figure 2.41 Typical relieving arch above timber lintel.

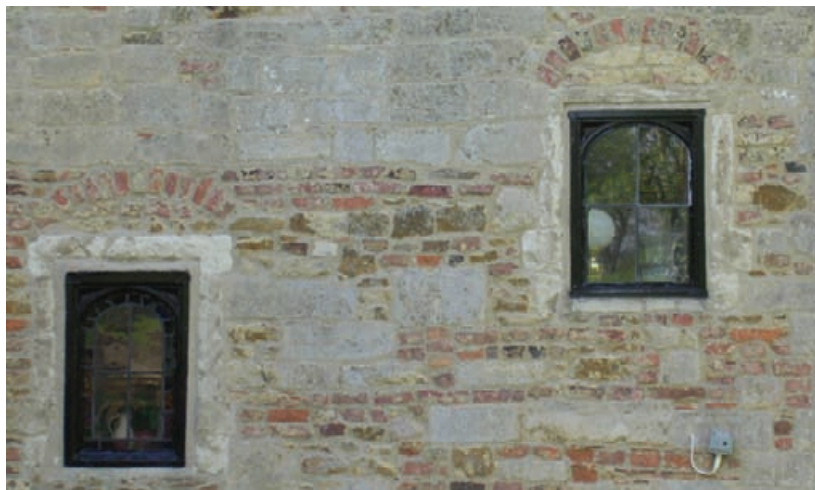
Relieving lintels are often of brick inserted into stone masonry. They do not always form so complete an arc as the ones shown in Figure 2.40, and often retain a decorative element.

Figure 2.40 Brick relieving arches in stone masonry.

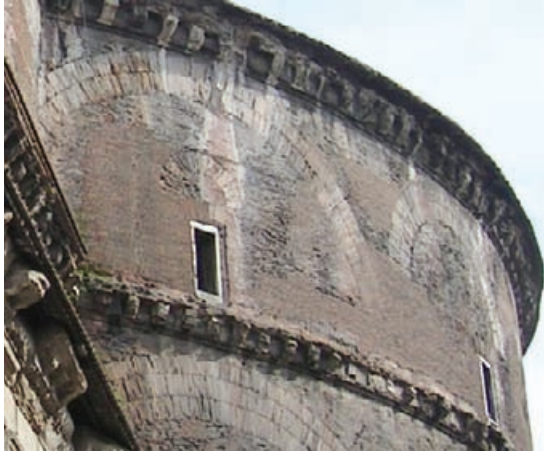
Blind arches are a variation of the same, but have a more important structural function in that they actively distribute loadings towards specific points, where other members have been provided to cater for major loadings. Perhaps the best known of these are the blind arches around the Pantheon in Rome (Figure 2.42), dating from 80 AD, and which confirm the faith that Roman builders had in semicircular

arches as a structural solution. These distribute the loads from the dome onto a series of major pilastered piers in the interior periphery, thereby enabling a series of side niches. Note also the small semicircular relieving lintel inserted above the window. One might call this a belt and braces approach, but since the building has stood since 80 AD, such criticism would be impertinent.

Figure 2.42 *Blind arches in the walls of the Pantheon.*

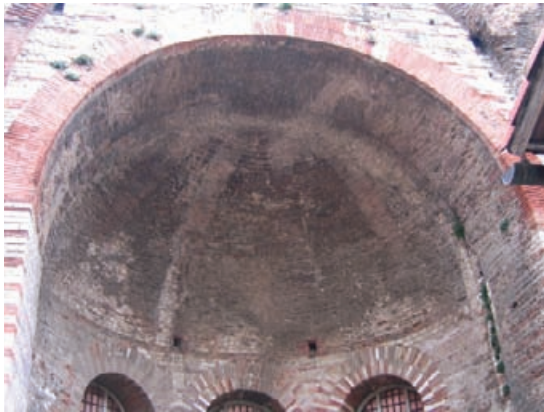
Figure 2.43 *Half cupola, Baths of Constantine.*

The half cupola in Figure 2.43 forms an apse, which exerts an appreciable horizontal force onto the adjacent structure. This is the Caldarium apse of the Baths of Constantine, which takes its support from the massive arch which separates it from the Tepidarium. The remains of a springing for a second dome, visible top right, shows how the balance of forces would originally have been achieved. Nevertheless, the apse remains intact, and the deliberate use of brickwork ribs shows how the loading from the apse roof was directed onto the pillars between the windows.

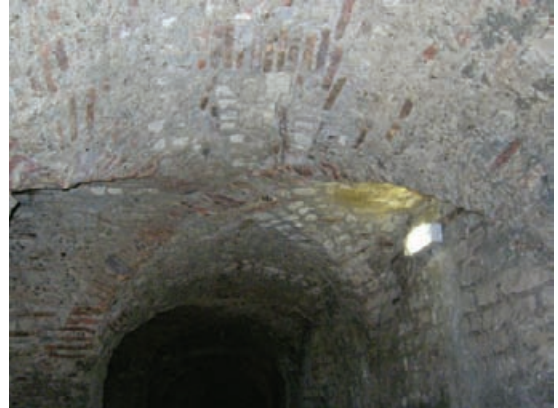
The same method is used in a diagonal form in a first century Roman vault (Figure 2.44), and the

Figure 2.44 *Diagonal brick ribs in Roman vault.*

inherent strength is achieved by a mix of brick ribs and regularly shaped limestone.

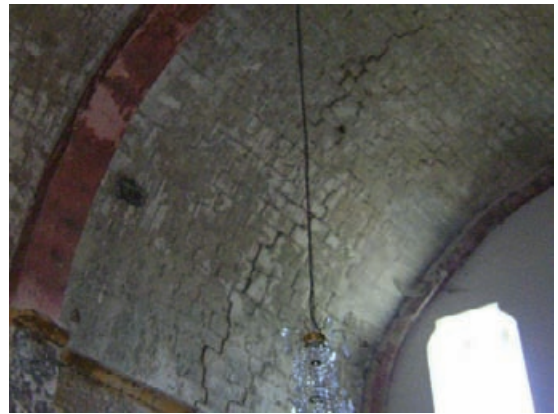
Figure 2.45 *Cracked vault related to wall movement.*

Even with dimensioned masonry strengthened by ribs at regular intervals, if the end wall moves due to weathering, then the vault will crack in its weakest plane. This is what has happened in Figure 2.45, and the second bay has similarly cracked at the midpoint between ribs as the stresses are shared by the structure into the locations providing the least resistance.

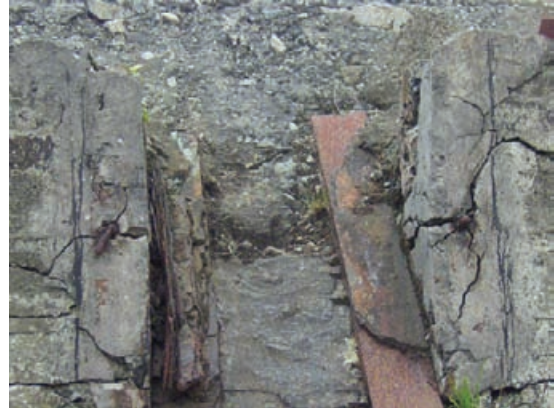
Figure 2.46 *Damage caused by rust growth.*

Rust growth occurs to steel and iron alike and exhibits as layers of rust similar to the leaves of an uncut book, as can be seen in Figure 2.46. Note how small bolts can burst open large blocks of concrete as they rust. The formation of the ferrous oxide layer increases the thickness of first one, then successive leaves. Where steel packers have been left in masonry courses they can lift many metres of building above, and it is not unusual to find a 20-mm vertical gap in the bedding joints, which when dug out reveals the presence of a strap or piece of steel plate.

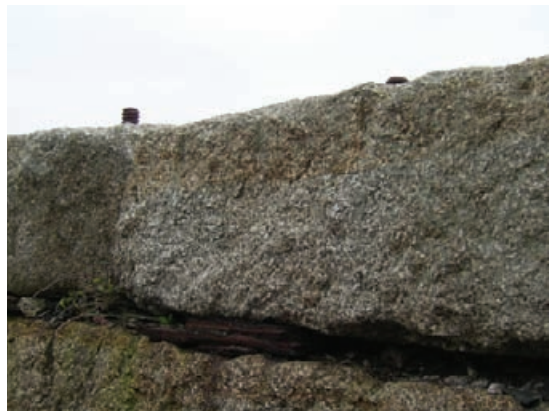
These gaps then promote the ingress of moisture, leading to further direct damage due to stresses in the masonry, accompanied by increases in dampness. Examples of the lifting effect caused by a thin packer, and direct damage to an end gable, where the stub of a steel gantry beam has been left in place, are shown in Figures 2.47 and 2.48.

Figure 2.47 *Jacking effect of thin steel packer.*

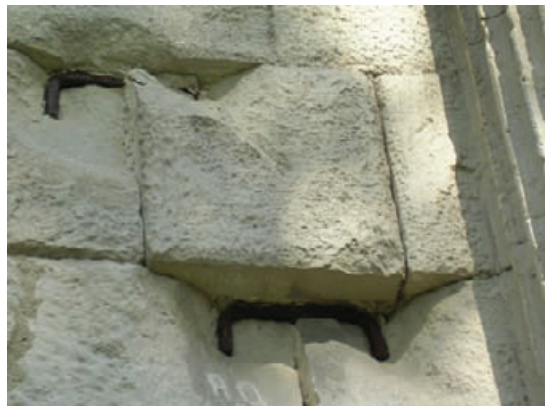
Figure 2.49 *Corrosion damage from Roman iron cramps.*

on the weather side of the Roman triumphal arch (Figure 2.49) have been exploded by rust growth of concealed wrought iron cramps (more stable bronze cramps were often used, but caused damage of another kind, as they were extensively robbed, involving breaking open of the stone/arches).

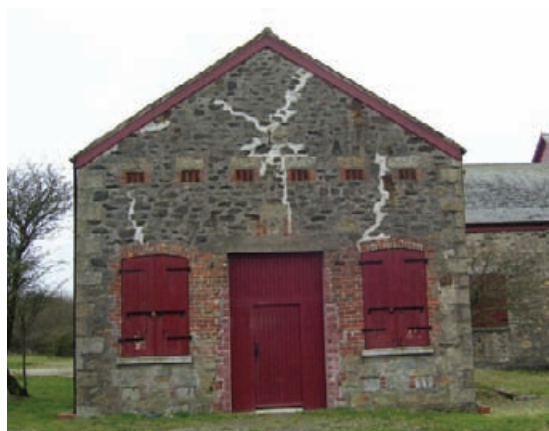
Figure 2.48 *Cracking due to corrosion of a steel gantry beam.*

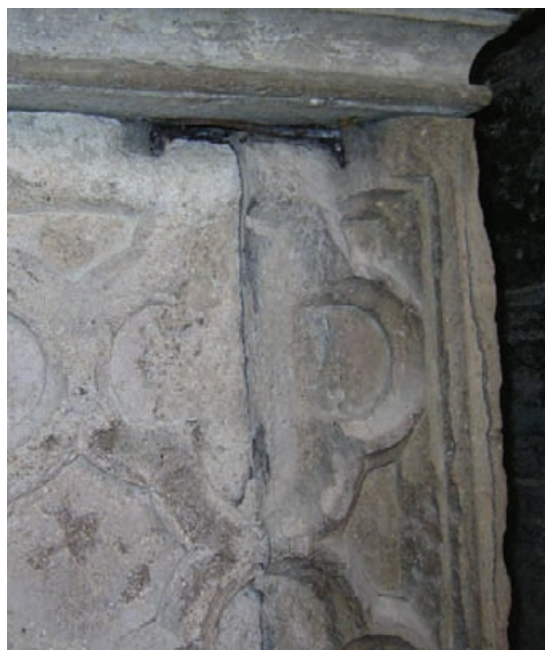
The same effect is seen in the medieval tomb in Figure 2.50 at every joint, and as an additional consequence of the rust build-up, the increased stress applied to the thin Purbeck Marble has initiated a shear crack on the outside face of the stone end panel, which is about to spall off.

Figure 2.50 *Corrosion damage from medieval iron cramps.*

The simple message is that iron or steel is not compatible with masonry, and should be removed wherever detected, and before damage becomes too severe. Where considered necessary, steel fixings in contact with masonry should be stainless steel (316L), and it should also be noted that galvanising will not survive long in a high alkaline environment such as occurs with most mortars.
