CONSERVATION OF RUINS

John Ashurst

Edited by John Ashurst

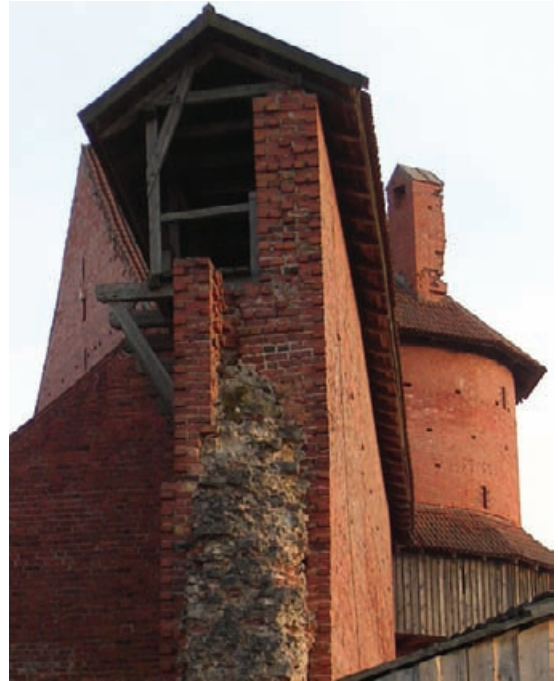
Just as it is necessary to provide expansion joints in concrete, so it is also with modern bricks in modern cement mortar, which suffer the double effect of brick growth and thermal expansion. Hence there is a danger of the cladding to the ruin core, seen in Figure 2.51, moving differentially to the core material of rubble and lime mortar.

The chimney in the background, which is part of the modern restoration, should be noted also, as a further example of frost damage.

Figure 2.51 Problems with new vitrified brick, Latvia.

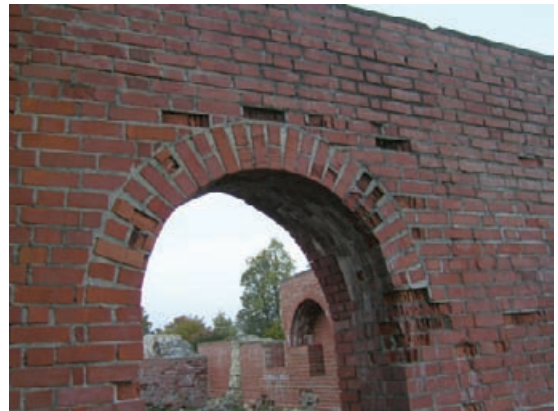
Where there are substantial anchors to each end of a brick wall or panel, such as a junction with a tower or a large mass of core, the movement in the brick face will accumulate towards the centre. This can clearly be seen in Figure 2.52 at the arch and in the wall in the background.

In its initial phases brick growth tends to be limited to the face exposed to the atmosphere, and should this also be the one subject to maximum solar effect, then significant shear forces develop on the longitudinal axis. The cellular nature of the bricks used can be clearly seen as the whole brick face has sheared off in several instances. In such a severe winter climate, the voids, which collect water due to the impermeability of the cement mortar, will spall off later with frost action, as has occurred with the chimney already noted above.

Figure 2.52 Brick growth, Latvia.

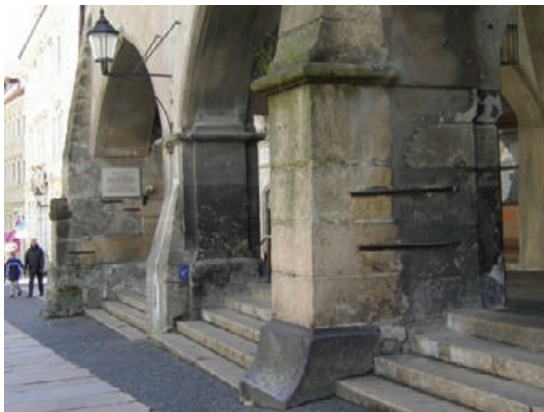
Each buttress, to this mid-1500s building in Saxony (Figure 2.53) is different, showing forward lean to the front façade over a long period of time. This has increased the toe pressures to each pier, with a concomitant horizontal component acting on the bed joints, tending to open them. The solution has been to insert long steel straps.

Figure 2.53 *Forward lean of masonry façade in Saxony.*

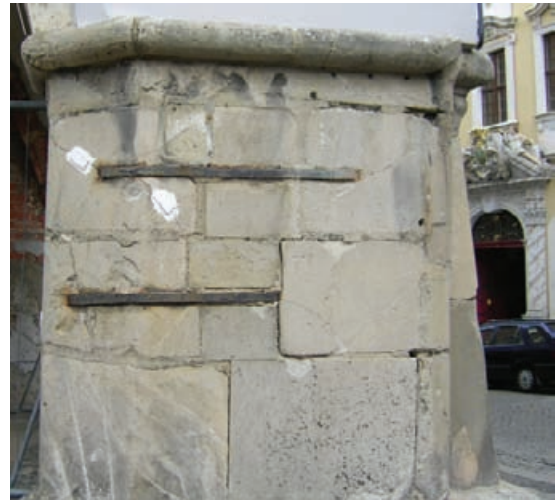
The pier at the opposite end of the same building (Figure 2.54) shows how ineffective this solution is, as all three anchor stones have cracked and spalled, and the growth at a joint has forced open the perpendicular joint, displacing the quoin.

Figure 2.54 *Long steel cramp failures showing cracked anchor stones.*

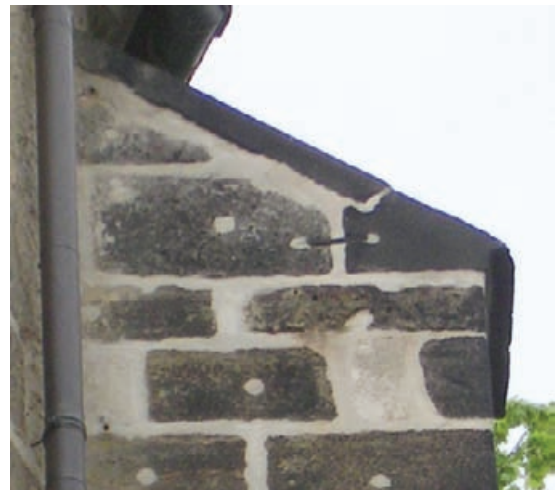
A similar scenario is about to unfurl at this medieval Kloster (Figure 2.55), also in Saxony, a recently reversed ruin. Extensive restoration work by way of pressure grouting has been undertaken, which will be evident for a long time to come. The works have left in place iron strap ties to each of the buttress padstones, which will cause cracking later.

Figure 2.55 *Cramps left in place post-grouting, Saxony.*

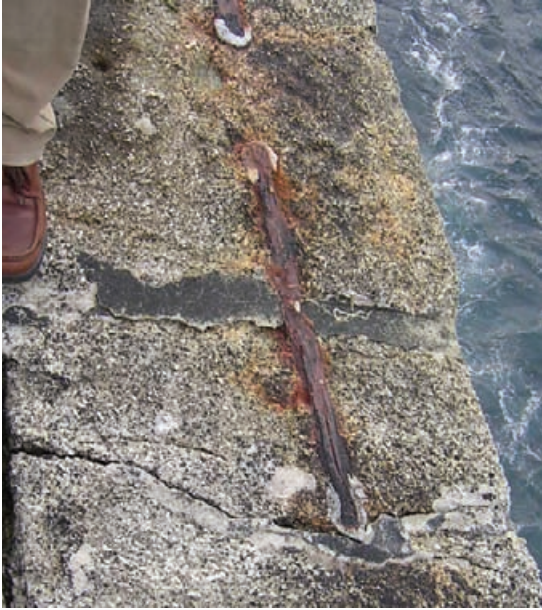
The Cornish jetty (see Figure 2.56), subject to violent storms, has been reinforced with steel straps, all of which have severely rusted and cracked the granite edge copings, in a classic counter-productive

measure. The extent of rust growth can be gauged by the size of the cracks in these major stones. They are currently being replaced with stainless steel. Note how the lead embedding has not relieved the rust growth stresses.

Figure 2.56 *Granite cracking and steel straps, Cornwall.*

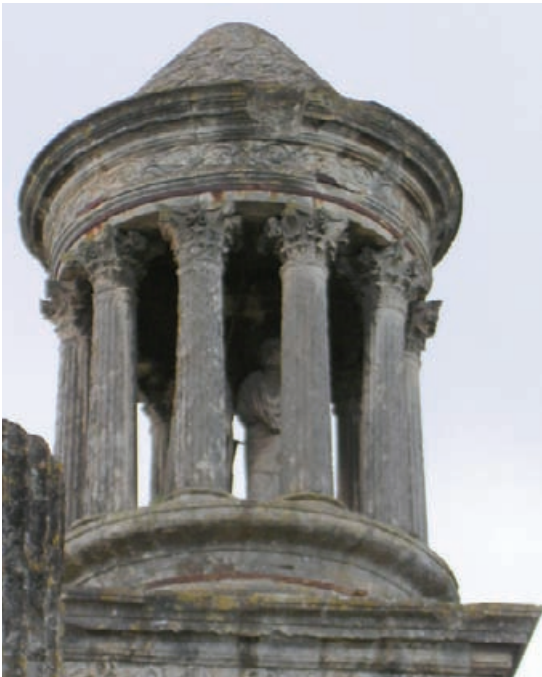
will not last long before corrosion sets in due to regular evening dew formation. It follows that exposed girding bands, such as those seen in a Gallo-Roman monument near St Remy, should be of non-corrosive metal (Figure 2.57). This is an area subject to minor earth tremors, and was possibly an expedient solution from the past. It begs the question of further expense to replace the bands when rusted through, and leaves significant local staining which is difficult to eradicate.

Figure 2.57 *Iron girding bands, St Remy.*

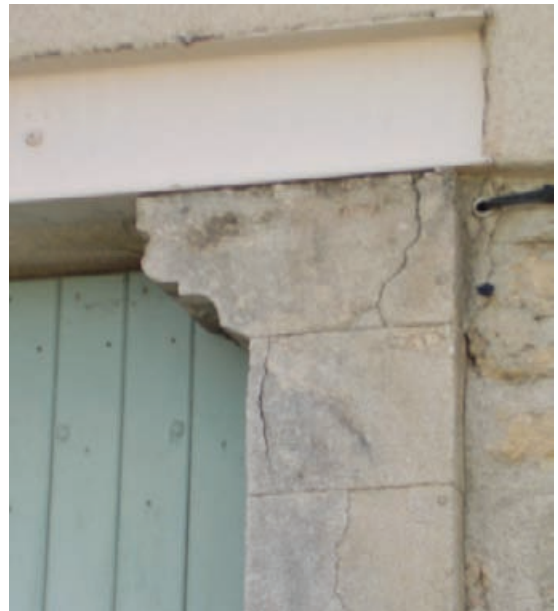
Figure 2.58, also showing a site in Provence, shows a steel beam insertion into finely crafted masonry, in which a small amount of rust growth has managed to crack three of the supporting pier stones. It is precisely because the seat cannot be painted that regular condensation will cause rust at the steel–masonry interface, and to the top surface also. The rust growth to both surfaces is increasing the direct pressure at the seat, and creating a couple forcing flexure into the beam. The two effects together are well demonstrated by the crack pattern to the pilaster cap. The leverage has then forced a shear spall to the face of the second pilaster stone, which has relieved the eccentric force, causing the increased pressure to centralise to the third stone down, which has split on the centre line.

Figure 2.58 *Cracked masonry related to corrosion of unmaintainable steel beam insertion, Provence.*

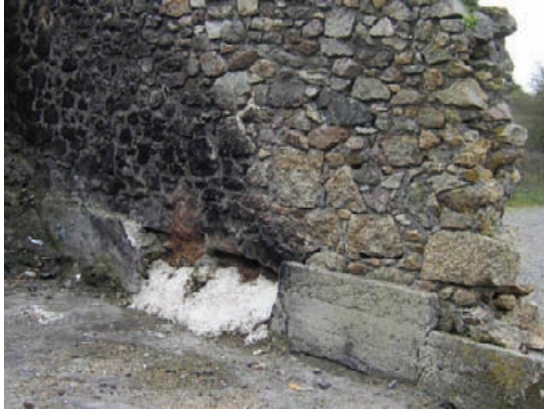
Figure 2.59 *Undermined wall and collapse.*

One of the areas of most concern to the conservation engineer is the lack of appreciation of danger with which laymen and some professionals approach excavation close to walls, and the bland assumption that because things stand for a short time, long-term stability is assured. Figure 2.59 captures that moment when the collapse of an undermined wall has already occurred, but the suspension of disbelief holds strong with the handyman. Although the wall shown in Figure 2.60 is undermined on both sides, part has collapsed and a section of concrete facing has detached, the assumption still holds that a skim of concrete 60 mm thick will hold up a granite wall of some tonnes. In neither case did further damage occur, but it could easily have been otherwise, and in the latter case irreparable damage was done to handmade bricks of high historic value. It is easy to be wise

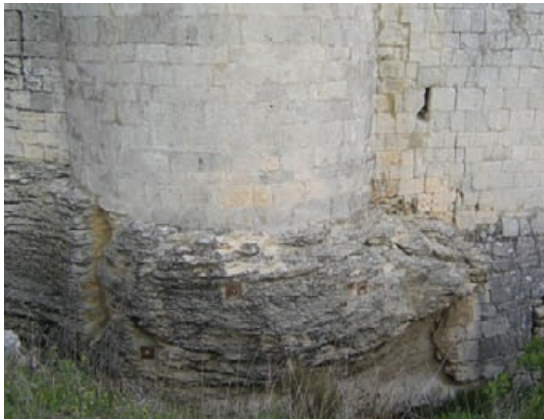
Figure 2.60 *Rock bolting at Chateau de Lacoste.*

after the event, and the magnificent work done by the French Centre des Monuments Nationaux is beyond criticism. Here, however, at the Chateau de Lacoste of the Marquis de Sade (Figure 2.60), the rock bolting seen in the picture is unlikely to work long term. There is a shear face visible in a relatively soft rock, and as work is currently in progress some direct support from firm rock at cutting level would be the best long-term solution.

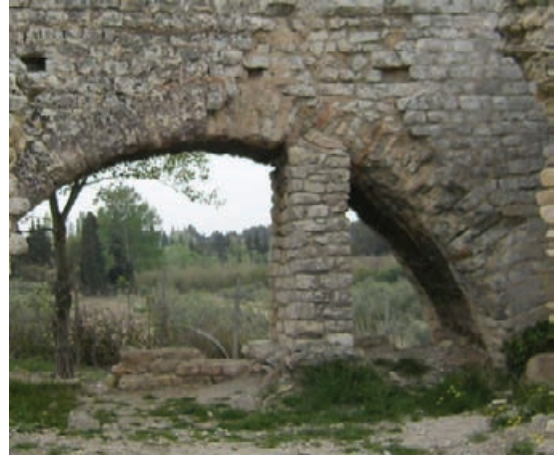
Figure 2.61 *'Temporary' masonry support.*

The pillaging of monuments in southern France has been widespread for centuries, and the sheer volume of conservation work to be undertaken is enormous. This expedient solution seen at Barbegal to the Eygalieres Aquaduct (Figure 2.61) can therefore be forgiven as public safety is still a primary consideration. The use of a masonry prop to an arch is of doubtful effect, however, and the time spent on it could have been directed to reinstatement of the missing voussoirs and minimal pressure grouting (see Chapter 4). The superior construction of this third century aquaduct has left it mainly intact, whereas the adjacent Caperon Aquaduct, which can be seen intruding into each side of the frame, has essentially collapsed.

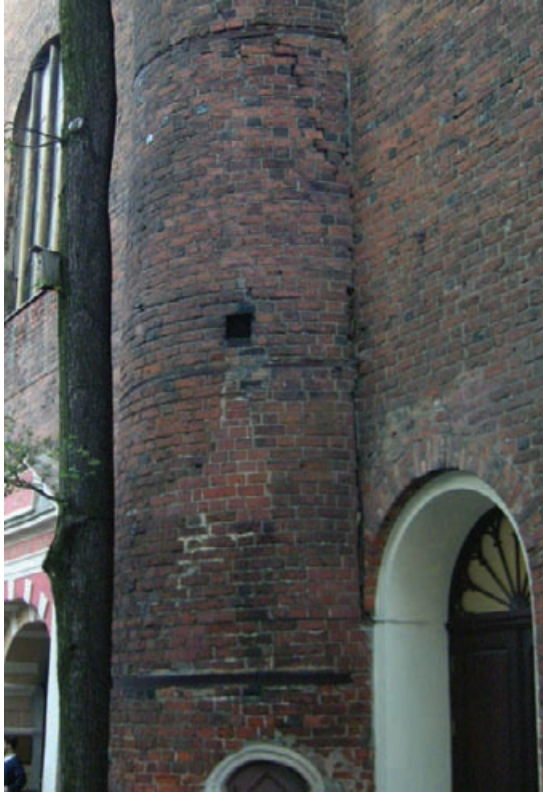
The aftermath of the Second World War has left a legacy of expedient solutions in much of eastern Europe, where occupation was continued by Soviet forces until recent times. The need to stabilise ruins until repairs or reconstruction could be effected led to many stopgap measures such as steel tie bands around a church stairwell in Riga Old Town (Figure 2.62).

Figure 2.62 *Steel tie bands, Riga Old Town.*

In each of the three bands shown in Figure 2.62, it can be seen that the tension in the bands has pulled in a course of bricks, shearing the mortar in the

process, and leaving the remaining brickwork proud of the course held. To this has now been added the problem of rust growth after so many years since the war. The rust growth has increased the steel band thickness, and hence the tension, resulting in further tangential force developing, which increases the relative distress.

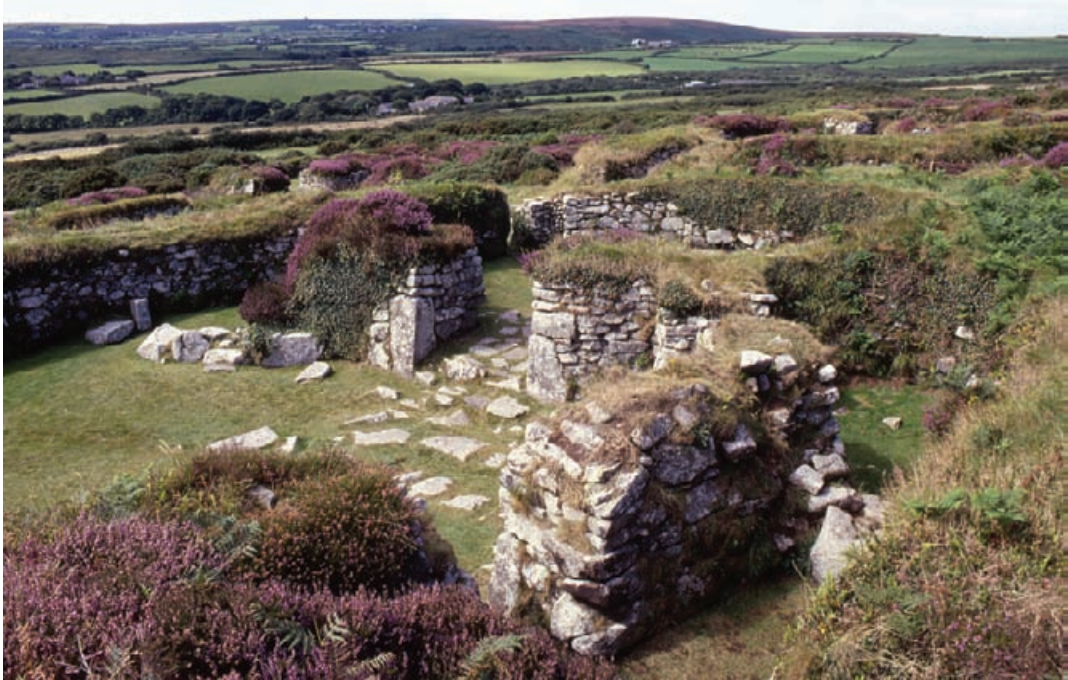
Figure 3.1 Celtic settlement of Chysauster in Cornwall: sites can become home to a wide range of flora and fauna, increasing the diversity of interest and importance.

Ruins are very special places – they are fragmentary remains of an earlier culture, civilisation or way of life that, in most cases, no longer exists. They provide a window for the visitor to look through and to visualise how things had once been. They are often romantic places which appear impermanent and unspoilt by modern times. They can be a haven for wildlife, providing homes and sources of food for a variety of flora and fauna, often rare and of special scientific interest in their own right (Figure 3.1).

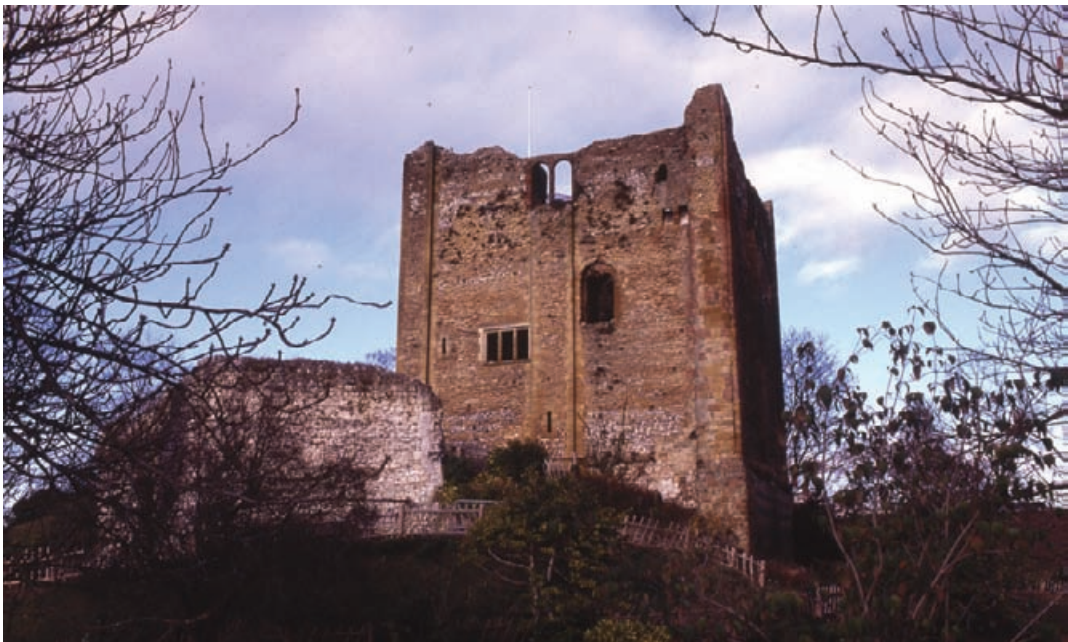
Figure 3.2 The Great Tower at Guildford Castle in Surrey: ruins are often romantic places which create special challenges for the surveyor to leave intact.

These perceptions and ideals of ruins as natural, unspoilt or romantic places within visitors' minds often create special challenges for the surveyor to leave intact (Figure 3.2). Most visitors like ruins to remain as ruins and do not wish them to appear clean and new, or obviously repaired in their appearance.

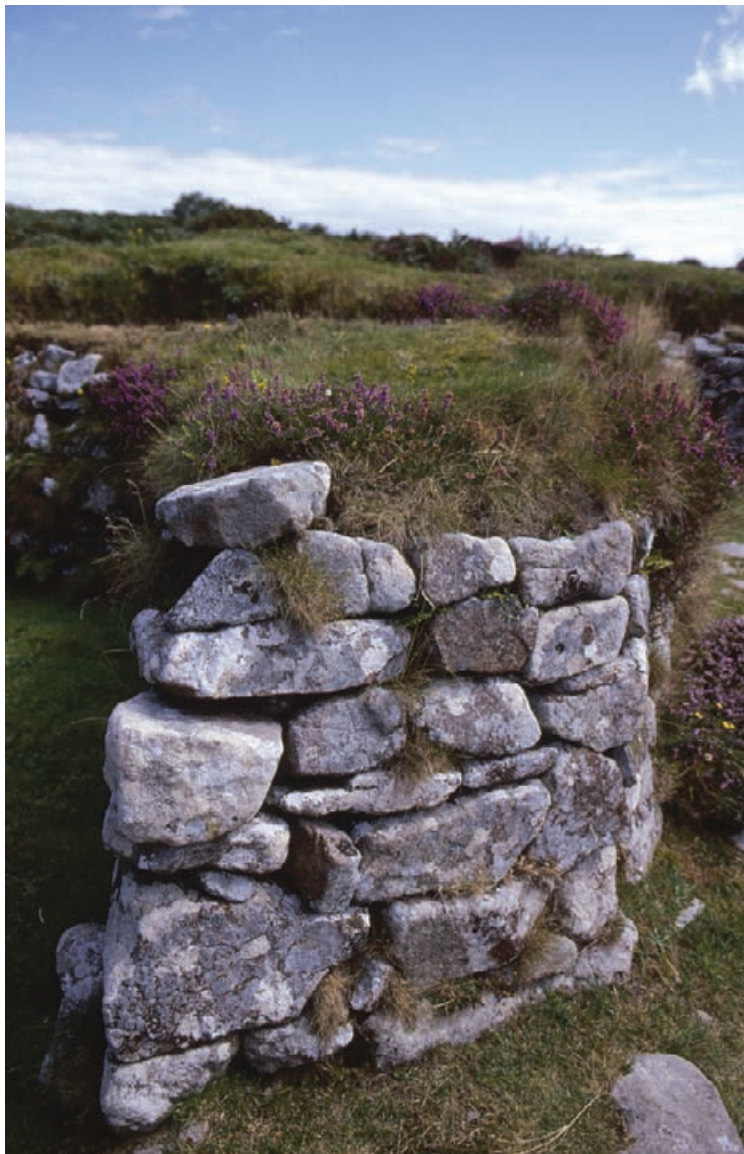
Figure 3.3 *Soft wall capping has been found to be beneficial for the protection of standing wall remains, enhancing site ecology and providing a long-term, low-maintenance conservation solution.*

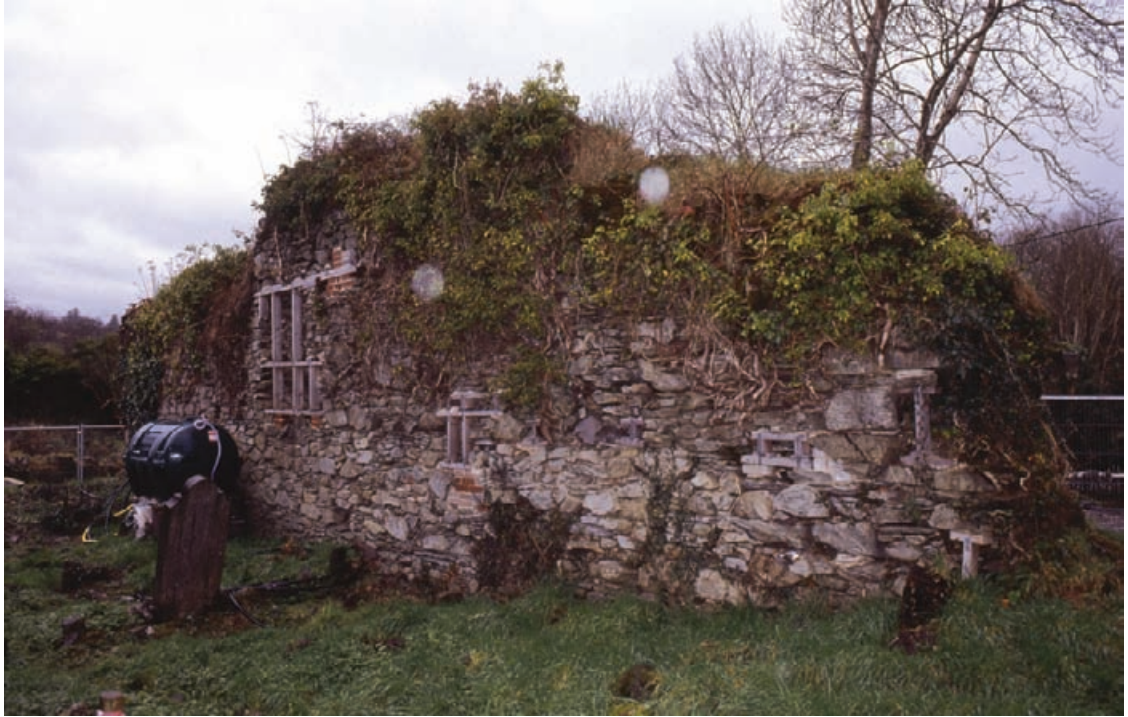
Figure 3.4 Mourneabbey, Cork, Republic of Ireland: the absence of protective roofs and wall plasters leaves ruined walls vulnerable to uncontrolled water ingress and invasive, destructive plant growth.

- Ruins usually lack protective elements such as roofs, wall plasters, harling coats, or even their original facings of stone or brick, allowing uncontrolled water ingress to the core of fabric (Figures 3.4–3.7).

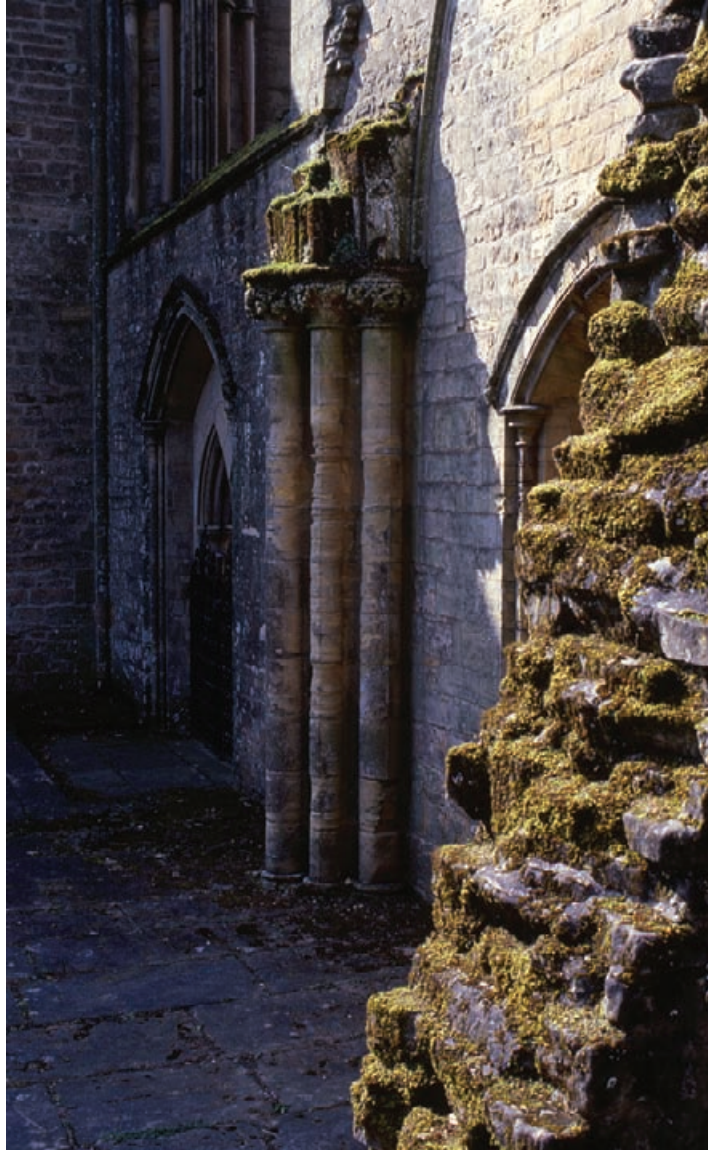
Figure 3.5 *The West Front of the Priory Church, Newstead Abbey, Nottinghamshire: where protective roof coverings have been lost and cannot be reinstated, the ruin will often require more frequent monitoring and maintenance than protected elements.*

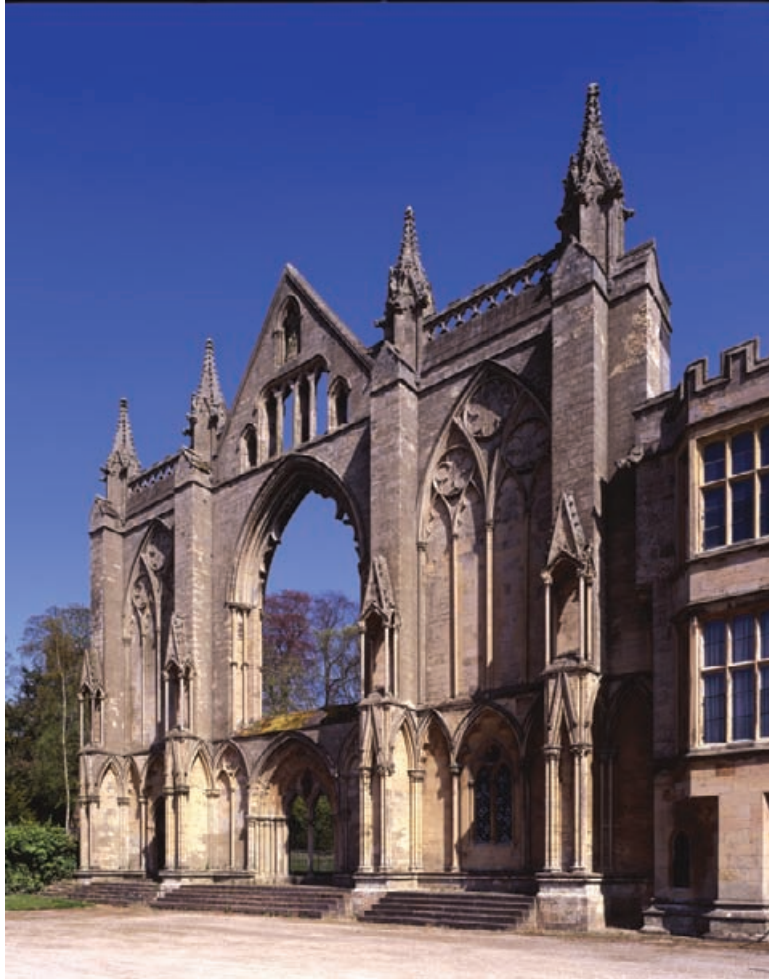
Figure 3.6 *Newstead Abbey: the standing remains of the West Front of the Priory Church. The wall is now exposed on both the external and the internal elevations, increasing the potential for rainwater ingress and decay. Carefully considered and well-executed conservation work is required to reduce the maintenance burden, but maintenance and inspection levels of the masonry will always be comparable to, or exceed, those of a building with protective elements still in place.*

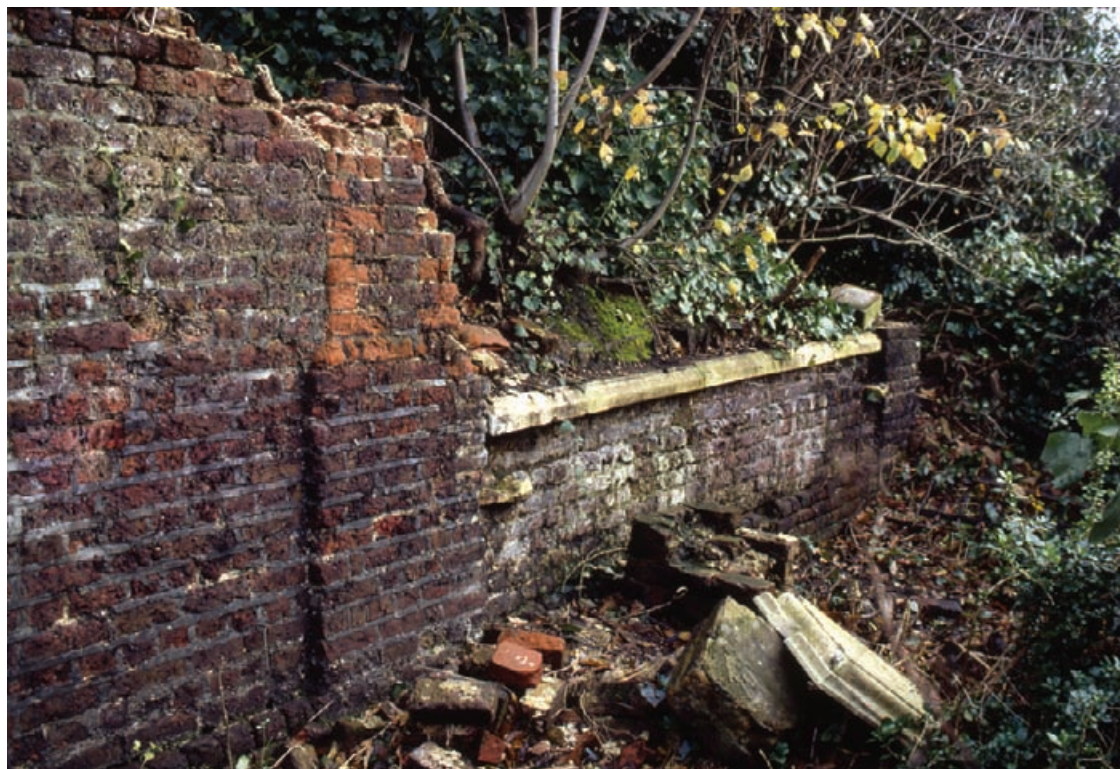
Figure 3.7 *Waterlow Park in London: ruined seventeenth century viewing platform with brick piers, part of a formal garden landscape. Lack of maintenance to the structure and surrounding garden led to the partial collapse of the wall and loss of the wrought iron screen and decorative sculpture.*

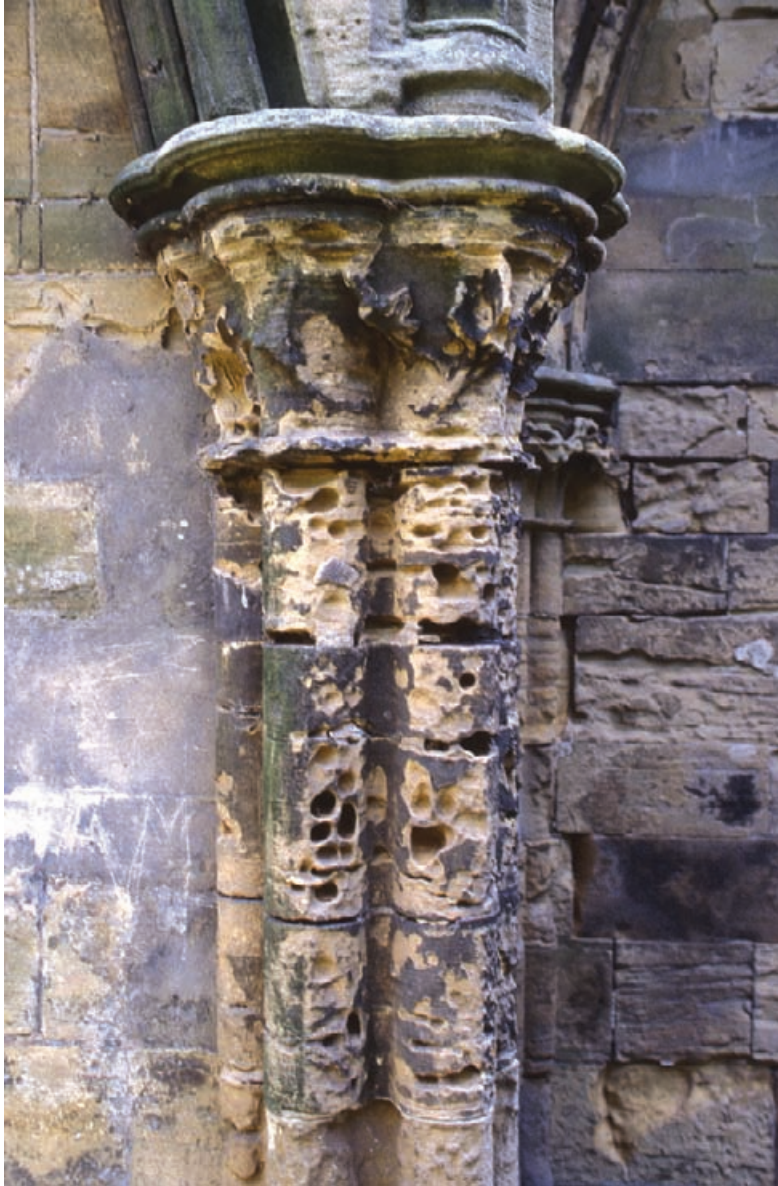
Figure 3.8 *Alveolar weathering of White Mansfield sandstone. The age, weathering, and lack of maintenance and repair over the lifetime of a ruin are often associated with advanced patterns of decay.*

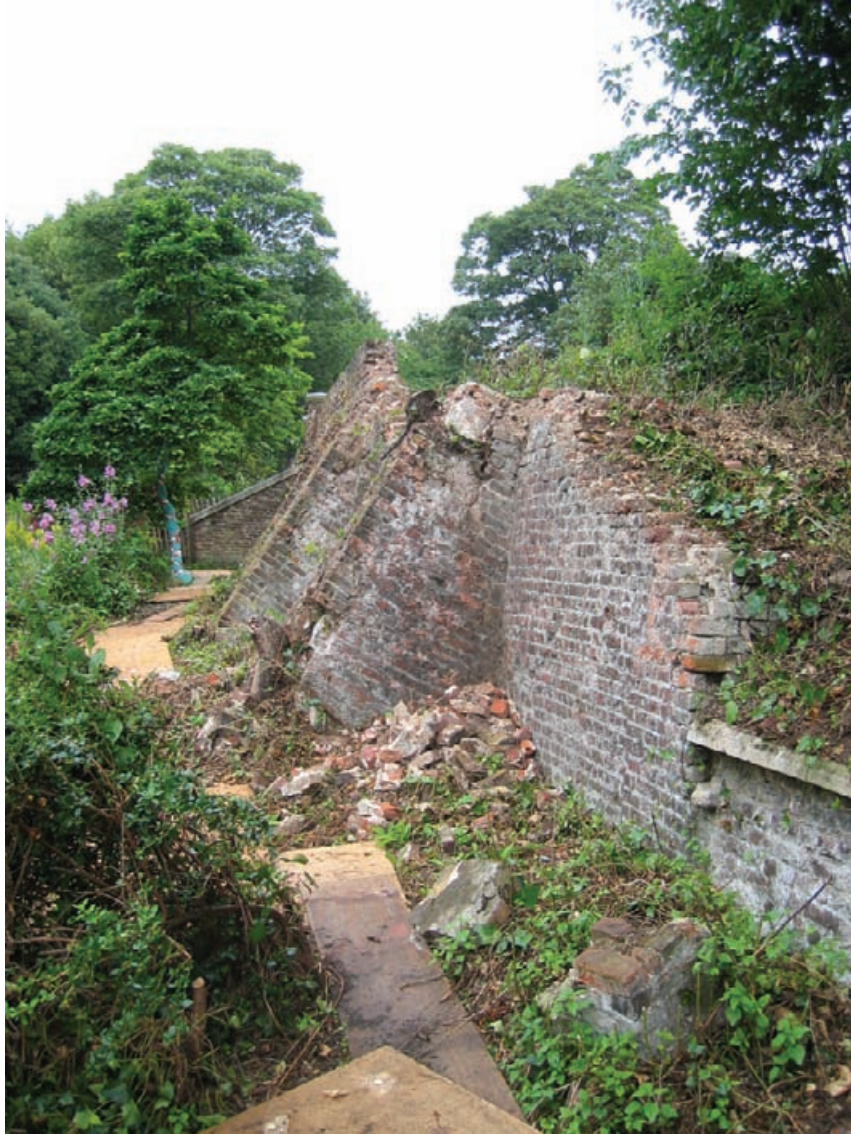
Figure 3.9 *Waterlow Park: sixteenth and seventeenth century lower terrace garden walls after removal of invasive plant growth. The upper section of the wall had collapsed.*

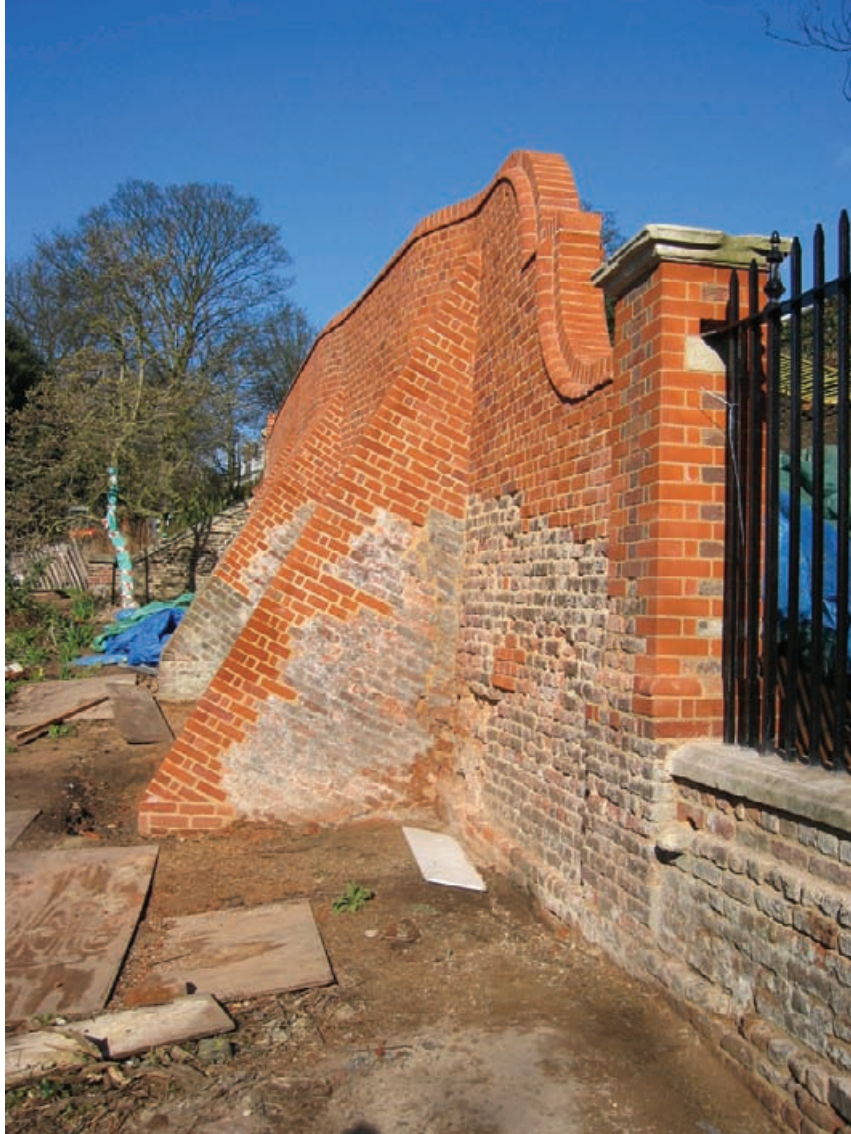
Figure 3.10 *Waterlow Park: the lower terrace wall following conservation and repair. Condition survey had determined that the long-term survival of the wall was dependent on reinstating the missing wall head to shed rainwater and protect the brickwork below, but other significant benefits included improved legibility of the structure and enjoyment by the visiting public.*

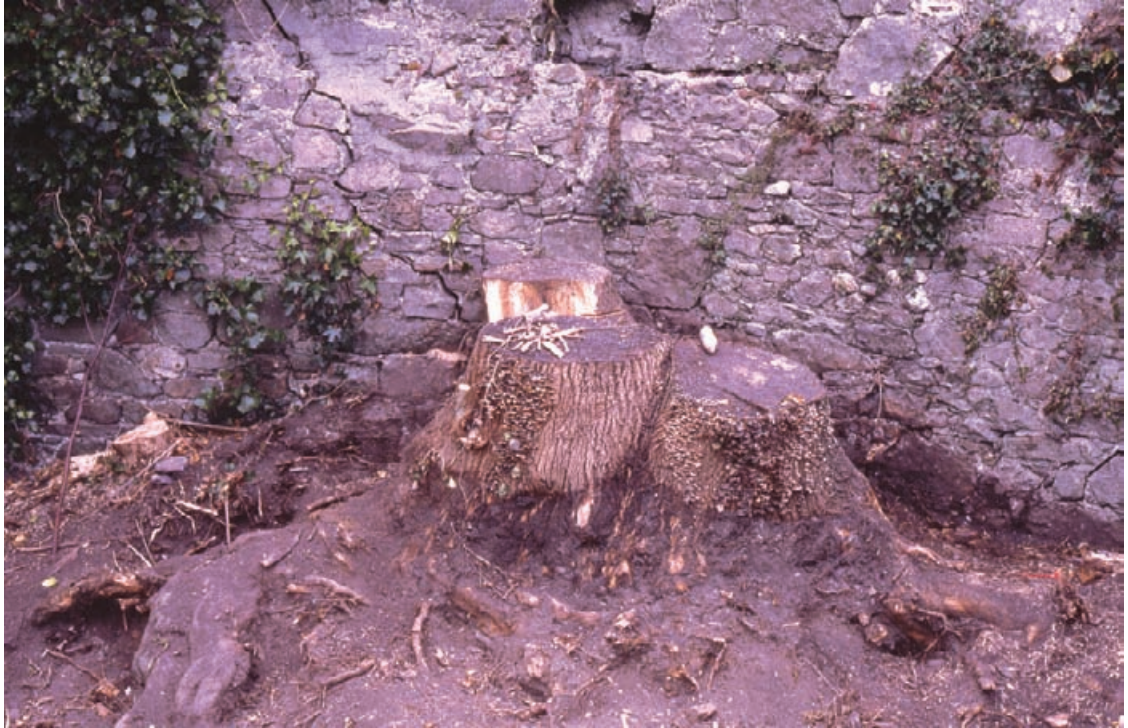
Figure 3.11 Detail of masonry wall at Rushen Abbey on the Isle of Man. Invasive plant growth should only be removed from the monument under the supervision of the conservation architect or surveyor to avoid further damage.

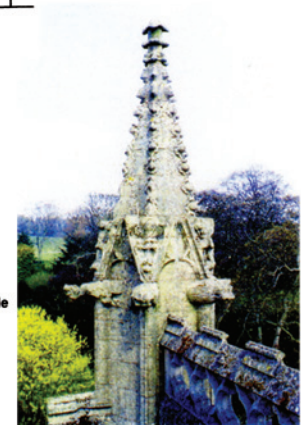
Figure 3: View of pinnacle P1 looking north

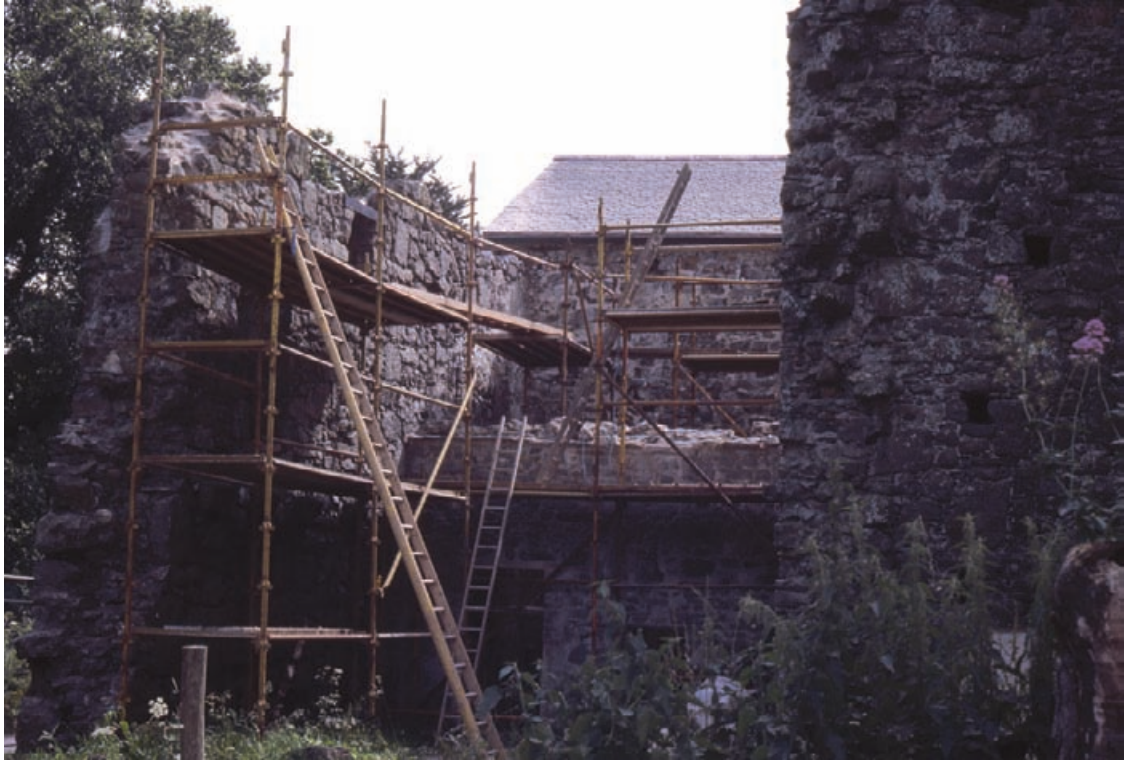
Figure 3.14 *Rushen Abbey on the Isle of Man. Access scaffolding should be considered as a means of providing close access for a condition survey. The closer the access, the greater degree of accuracy and certainty that can be achieved by condition survey.*

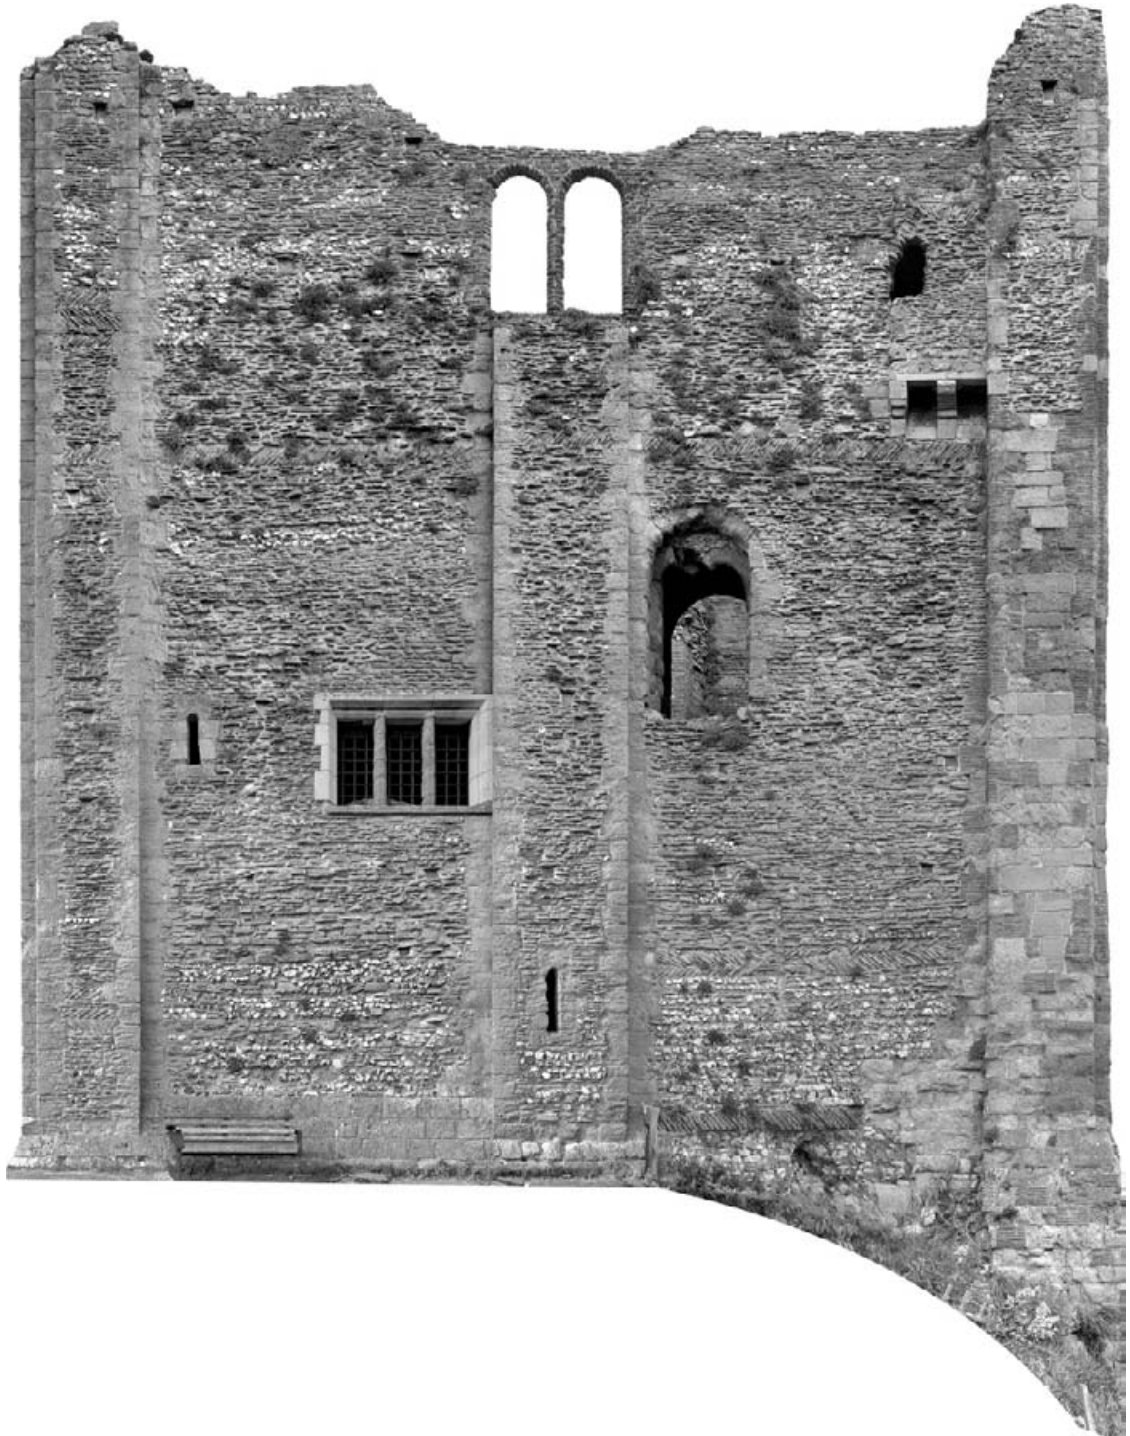
Figure 3.19 Guildford Castle. Rectified photographs can be used in the absence of elevation drawings.

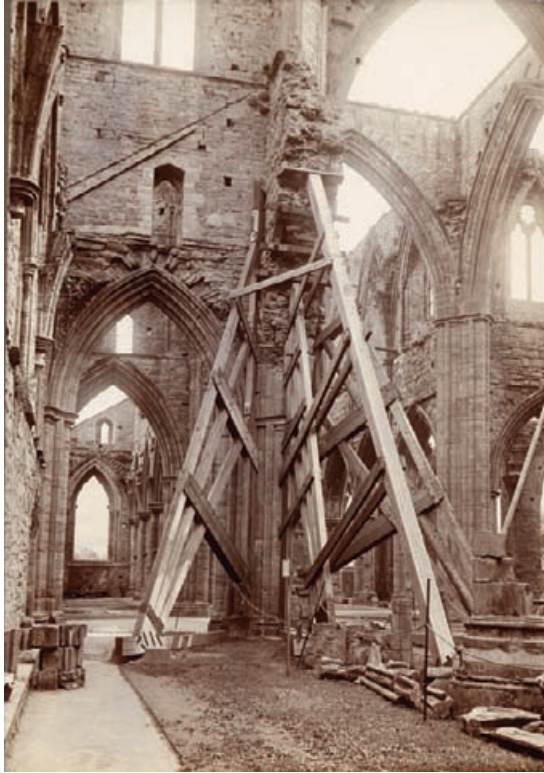
Figure 4.4a Tintern Abbey - North west pier showing timber shoring under broken nave arcade. This overhanging masonry was repaired in the manner shown in Figure 4.4b.

One of the first structural analysts of the substantial ruins of Tintern at the time of the First World War was William Harvey, whose studies of Tintern, Rievaulx, Westminster and St Paul's Cathedral were published by the Architectural Press in 1925,⁴ advocating the essential practice of knowing the whole building to understand its movements and the reason for distortion and fracturing. Two major areas of concern were identified at Tintern, once the ivy was removed. The first was a progressive westward movement of the north chancel wall, towards the great arch of the missing tower and the overhanging broken end of the north arcade of the nave (Figure 4.2). Local repairs were not able to contain this westwards movement, as the north-west pier distorted and developed a pattern of fine stress cracks. The drift of its masonry piers in the chancel to the west could only be restrained by the installation of the reinforced wall head beams shown in Figure 4.3. The corbelled masonry of the nave arcade could only be supported by the installation of the steel ledgers shown in Figure 4.4b.

conservation philosophy and which, at a major structural level, are illustrated in Figures 4.2–4.4, certain disciplines and methods have been developed in the approach to the ruin sites which can now be described.

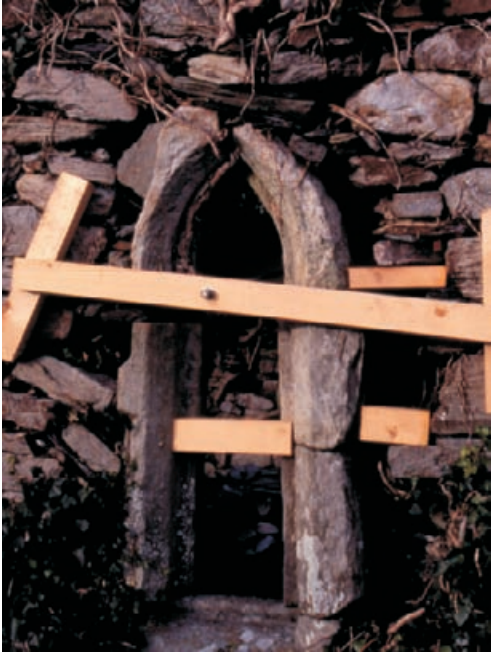
Figure 4.6 Small lancet window largely unconnected to its original masonry has been provided with corset plates bolted through the opening to provide temporary stability.

In order to design and place such support and protective temporary structures, a thorough understanding of such ruined buildings and their condition is essential. A heavy-handed and ignorant approach could cause collapse of large areas of masonry and possible loss of life of those carrying out the works. Typical temporary support and protection works are illustrated in Figures 4.5–4.9.

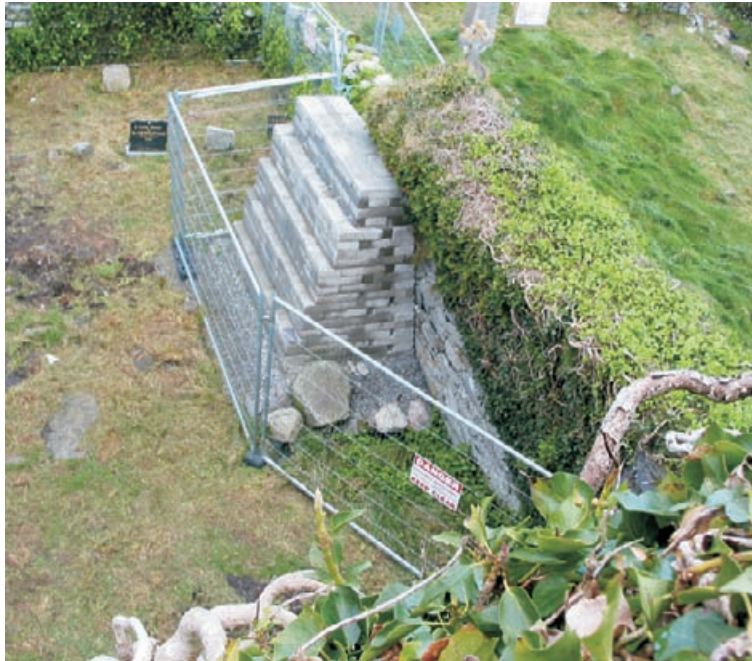
Figure 4.7 Leaning and fractured wall provided with simple temporary buttressing of concrete blocks, and ringed with security fencing. Myross Church, Ireland.

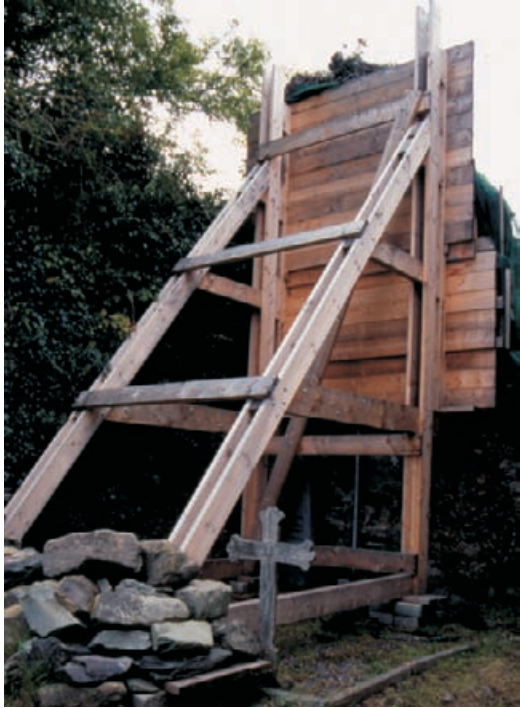
Figure 4.8 *Temporary support of high leaning wall in the form of board facings and flying shores.*

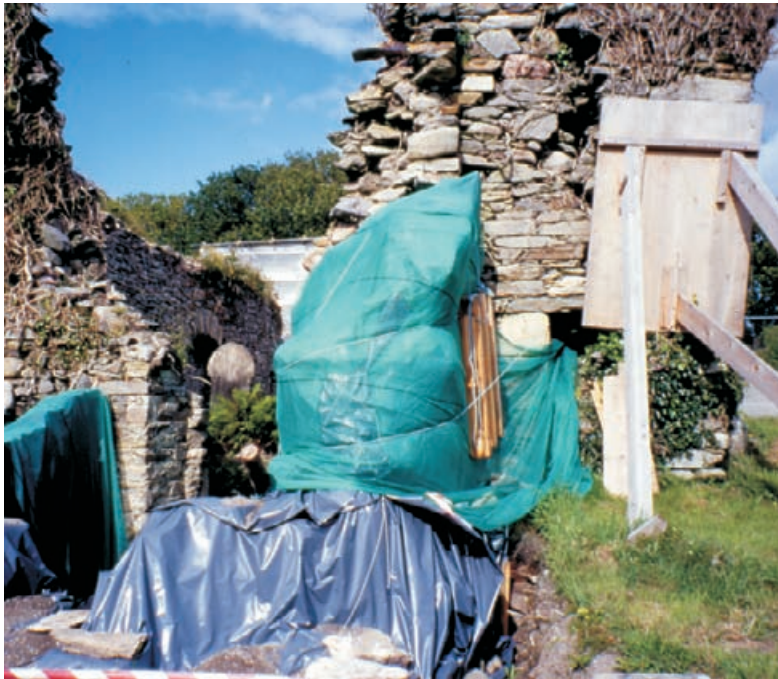
Figure 4.9 *Temporary protection and insulation of masonry against rain and frost and temporary support works, County Cork, Ireland.*

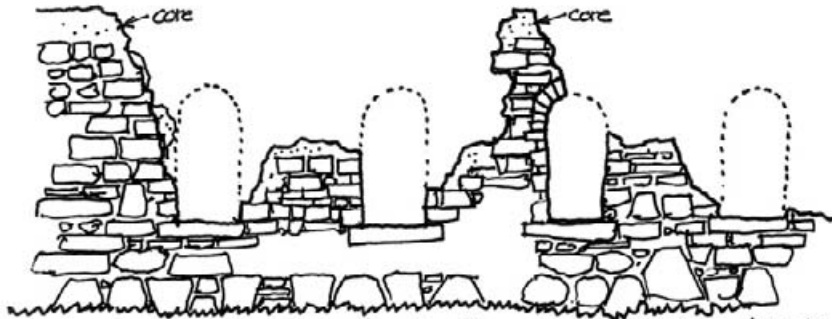
- 5 Irregular broken wall head with range of windows, leaving a wide variety of masonry heights and overhangs; original height uncertain but may be detectable in core

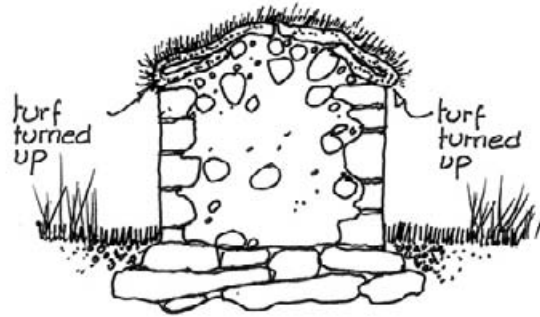
A2

INSTALLATION OF "SOFT WALL TOP AFTER CONSOLIDATION, USING A TURF CAP TO PROVIDE LONG TERM PROTECTION WITH LOW MAINTENANCE"

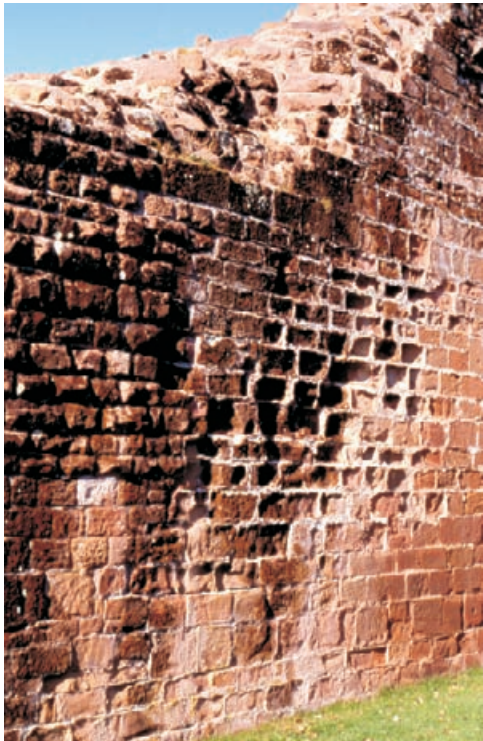
Figure 4.13 Cement-based mortar wall capping and wall profile combining to concentrate water run-off in one area with subsequent decay of wall face. Kenilworth Castle.
