CONSERVATION OF RUINS

John Ashurst

Edited by John Ashurst

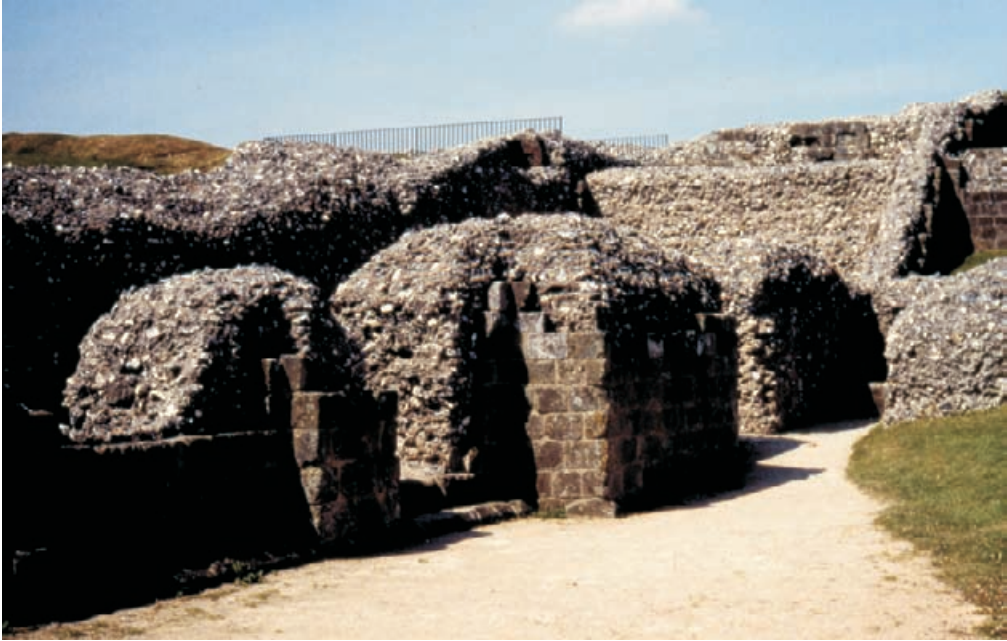
Figure 4.14 Early form of cement-based mortar and flint capping in large surface areas. These attempts to throw water off the wall head have the undesired side effect of taking water into the core through cross-cracking, where it remains trapped. Visually the core work is too far forward. Old Sarum.

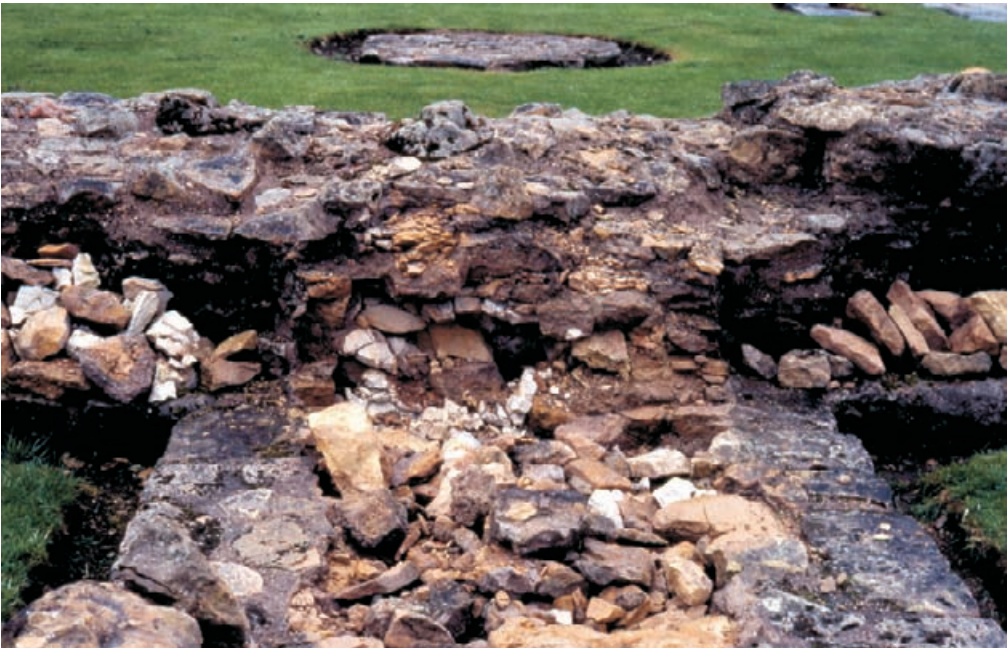
Figure 4.15 Low-lying walls such as this are very vulnerable to frost damage in cold climates and to disruption by visitors anywhere. These walls are ideal candidates for soft capping, following consolidation. Note how hard capping has been placed over unconsolidated core with disastrous results as the capped zone lifts and cracks. Thornton Abbey.

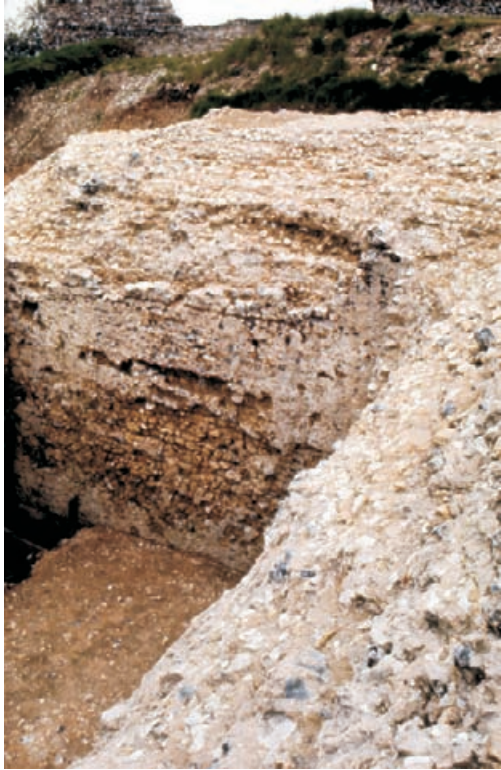
Figure 4.16 Core facework, especially that exposed at wall heads, and even buried core are particularly susceptible to binder dissolution and migration in very wet conditions, especially at low temperatures (see Appendix). The design of replacement mortar for these conditions is clearly important. Non-hydraulic or weakly hydraulic mortars are too vulnerable and may never carbonate satisfactorily in persistently wet conditions. Moderately or even eminently hydraulic lime may be needed. But if the original material is too weak for such binders a weak mortar with soil and turf capping should be used. Face core work at Castle Acre Castle.

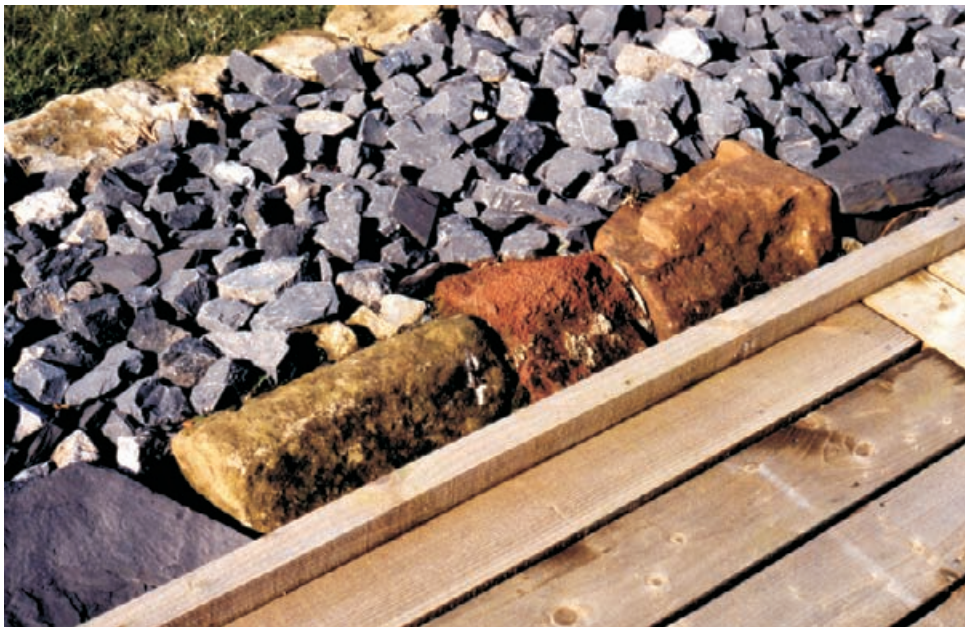
Figure 4.17 Most of this wall lies below original floor levels, with only a few stone facings showing above ground. The fragile core has been covered with geotextile membrane and sand, then set with unmortared limestone scalplings. The result is a free-draining protection which allows the wall line to be clearly read. Loose, large stones discourage visitors from walking on the walls and a more comfortable board walk is provided immediately adjacent to the wall. (see Figure 4.11, C2)

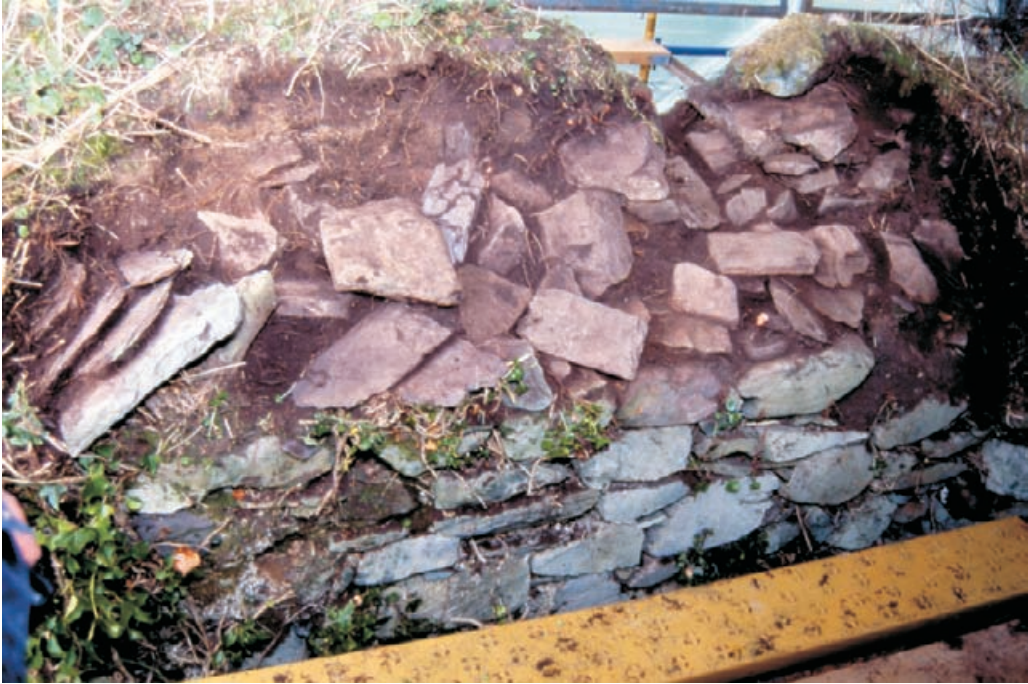
Figure 4.18 First stage clearance of ruinous wall head showing removal of vegetation and the stratification layers which confront a conservation technician.

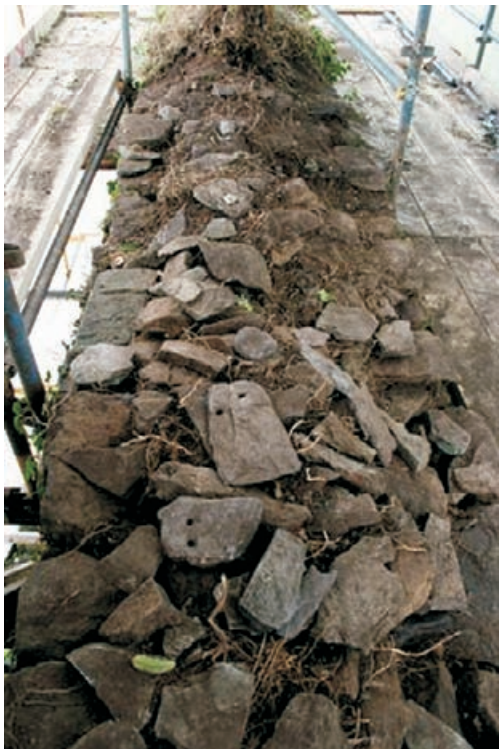
Figure 4.19 Later stage of wall head clearance clearly showing the top courses of the wall and the twice-holed tilestones lying in the loose debris; this was the first evidence seen of the original roof covering. The conservation team needed to record, lift off, consolidate and reinstate as much as possible lying in its original position.

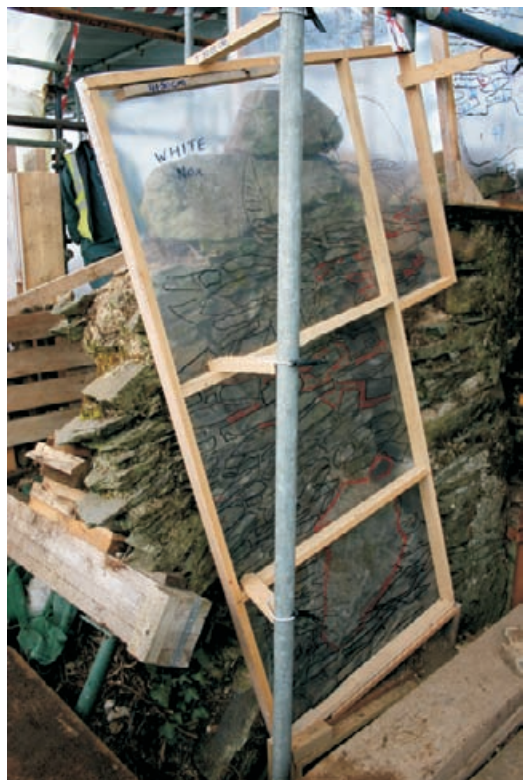
Figure 4.20 *The planning frame is shown at the battered angle of the wall top connected to the scaffold tube. Temporary supports in the form of plate and props is shown bottom left.*

Recording should consist of photographs at all stages of progress and should make use of planning frames in preparation for consolidation.

The planning frames are shown in use in Figures 4.20 and 4.21. The outline and locations of each stone are drawn with indelible markers onto the plastic film, and each one is numbered. As the loose stones are lifted from the walls they are cleaned by a bristle brushing and identified by a number corresponding to the number in the planning frame. With the exception of its uppermost course, this number is marked on the top bed of the stone. The marking system should make use of waterproof markers or paint, all of which, except the top course, will be hidden within the wall when rebuilt. The top course

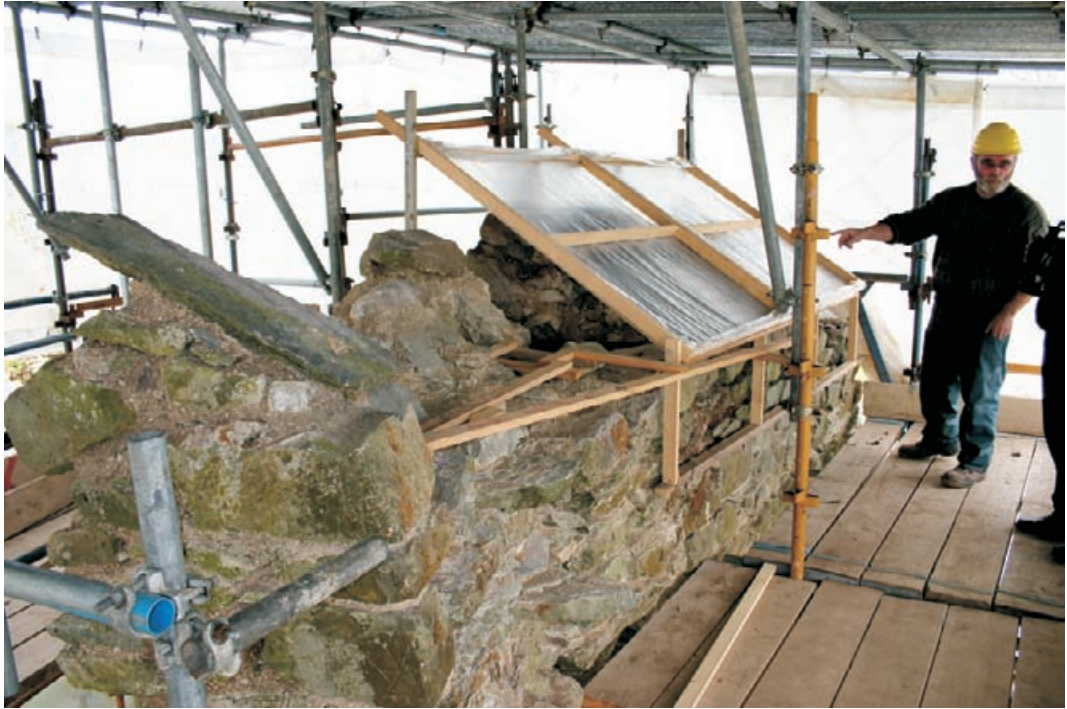
Figure 4.21 Planning frames shown in position for recording wall tops. The frames will need to be capable of repositioning in exactly the same position during the rebuilding process. Note, left, tilestone consolidated in the position found on the wall head.

can be marked on the bottom bed. The marking system enables the stones to be replaced in their original positions. When the loose, marked stones are taken down they are stacked neatly on the scaffold, ready for rebuilding. As the process of cleaning off, marking, lifting down and stacking proceeds, roots and soil within the walls are removed. Substantial roots are normally followed down into the wall by unpicking masonry until they no longer present a problem, but not all traces of root need to be removed. Fine roots can remain buried within the wall where, without light, they are unlikely to grow. The extent to which a wall head is taken down depends on a number of factors, including the size and arrangement of the masonry units, condition of the original mortars, extent of root invasion and displacement of masonry. As always, experience is essential to decision-making. The exposed wall head is prepared for resetting face stones and core by brushing down and, if available, removing small, loose material with an industrial vacuum cleaner, followed by washing with clean water. Rebuilding proceeds using a well-designed bedding mortar (see ‘Mortar’, p. 133). The position and alignment of each stone are checked with the planning frame and

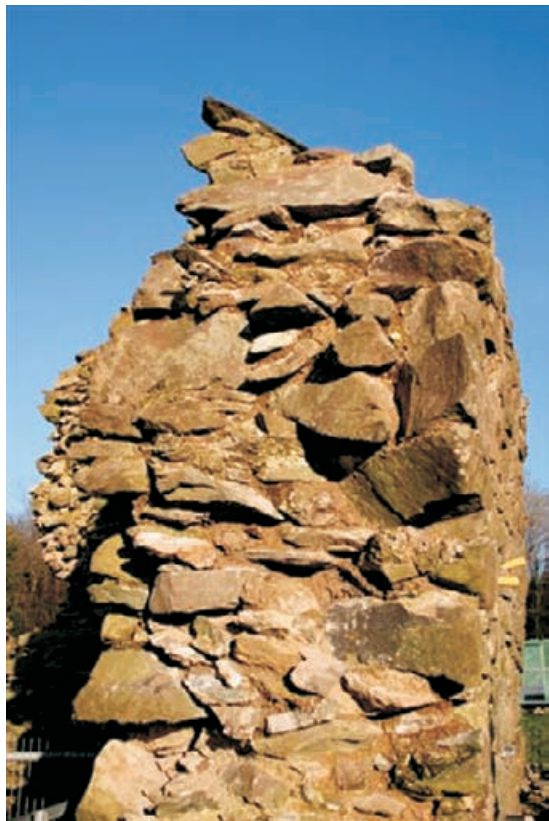
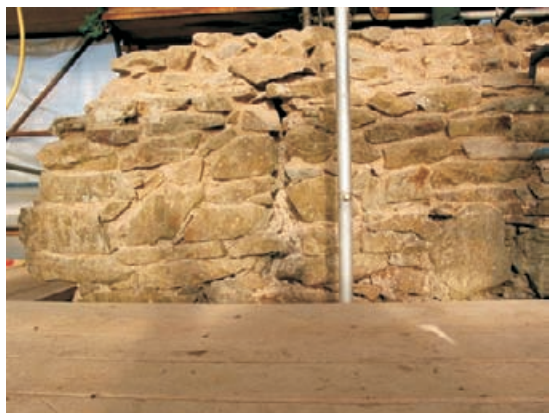
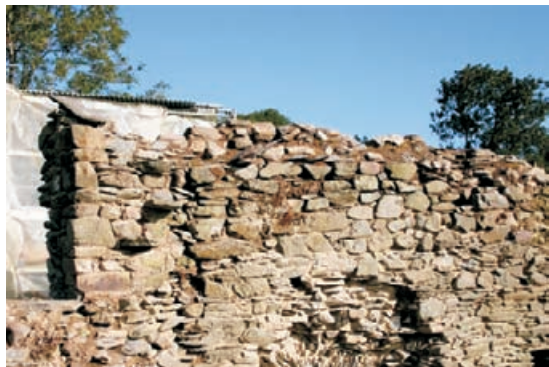
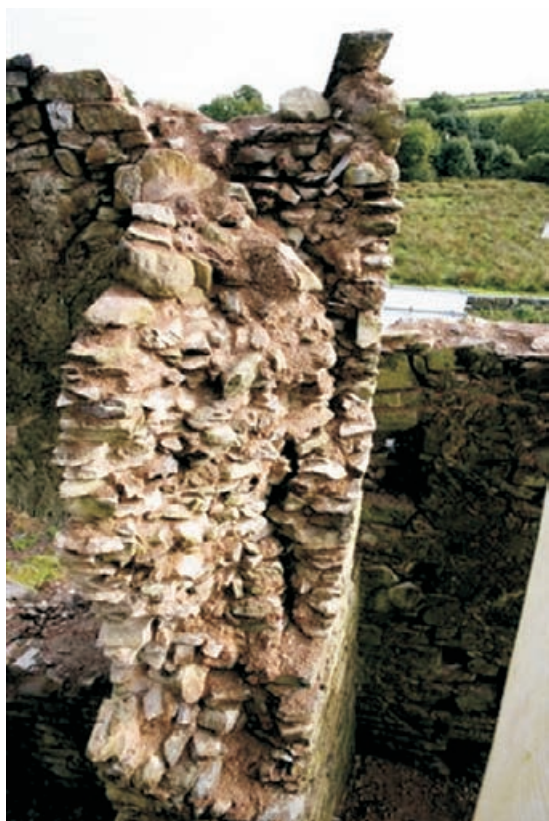
Consolidated walls showing reinstatement of all fractures, distortions and displacements as found. This work, carried out by the Cork County Council conservation technicians illustrates the highest standards of work which can be achieved in this field.

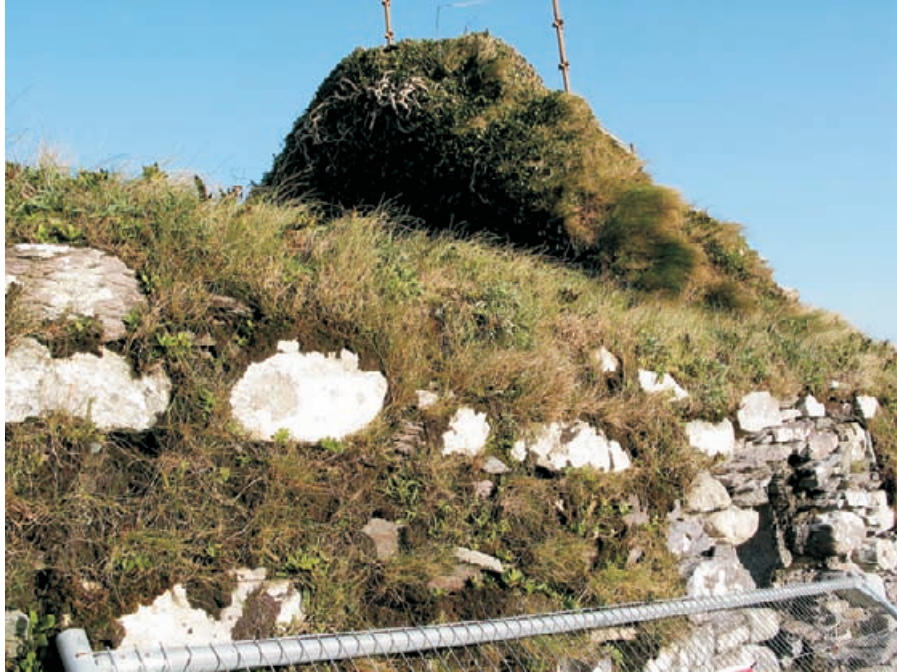
Figure 4.26 Perfect protection for this roofless ruin is provided by a mature mat of turf and wild flowers. This natural covering can hardly be improved on, and if the masonry below is stable, should be left alone.

any profiles that were made during dismantling, until the work has been raised to its original position. There is a general acceptance that the finished wall head can be modified from the original ‘as found’ position to eliminate the risk of rainwater ‘ponding’, providing that this does not affect or alter any archaeological features that exist within the masonry (Figures 4.22–4.25). If, however, it is intended to reinstate root mats, soil and plants, the ponding issue is not as relevant. On occasion, new soil and seeds representative of the site’s natural ecology are installed to provide a ‘soft top’ which acts as a benign sponge-like covering. The benefits of such a capping can be seen on many ‘natural’ sites. English Heritage found this of sufficient significance to carry out research into the beneficial effects of ‘soft tops’ as opposed to traditional hard cappings⁷ (Figures 4.26–4.32).

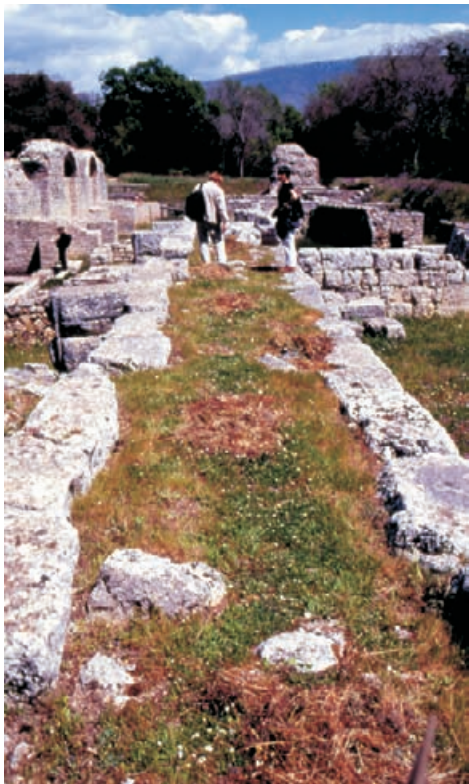
Figure 4.27 Another example of natural wall cover, this time on relatively weak, partly earthy core. The cover provides the ideal capping for any weak core which is not suitable as a weathering surface. Butrint, Albania

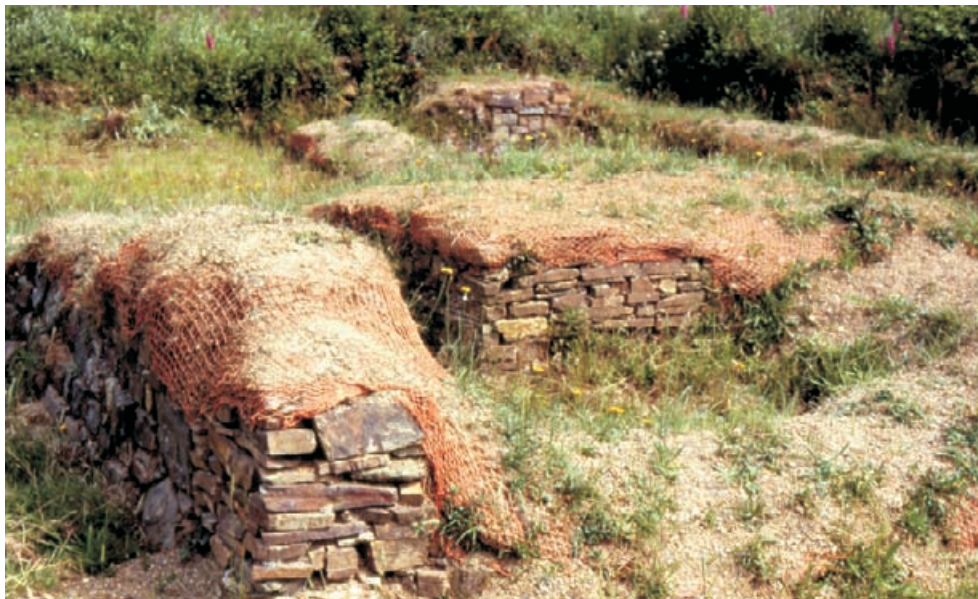
Figure 4.28 Walls built in clay mortar should not have cement or even lime-based mortar introduced as part of a consolidation process. Biodegradable net is used here to secure the loose wall heads after excavation, pegged with long plastic anchors deep into the core. In this wet area, grass and plants native to the site soon take over the wall tops again.

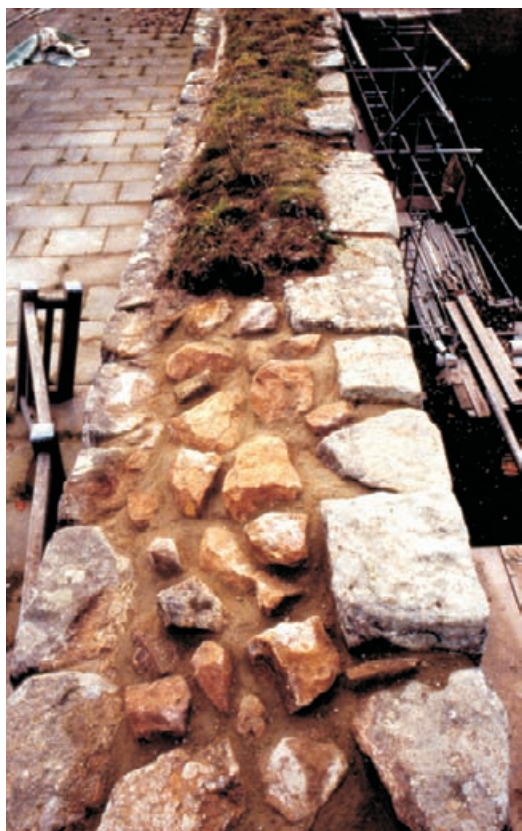
Figure 4.29 Following consolidation of this broken wall head, a layer of humus and turf is in the process of being laid to act as the new weathering surface; the variety of grass and the composition of the bedding material should follow specialist recommendations and the species should be natural to the area.

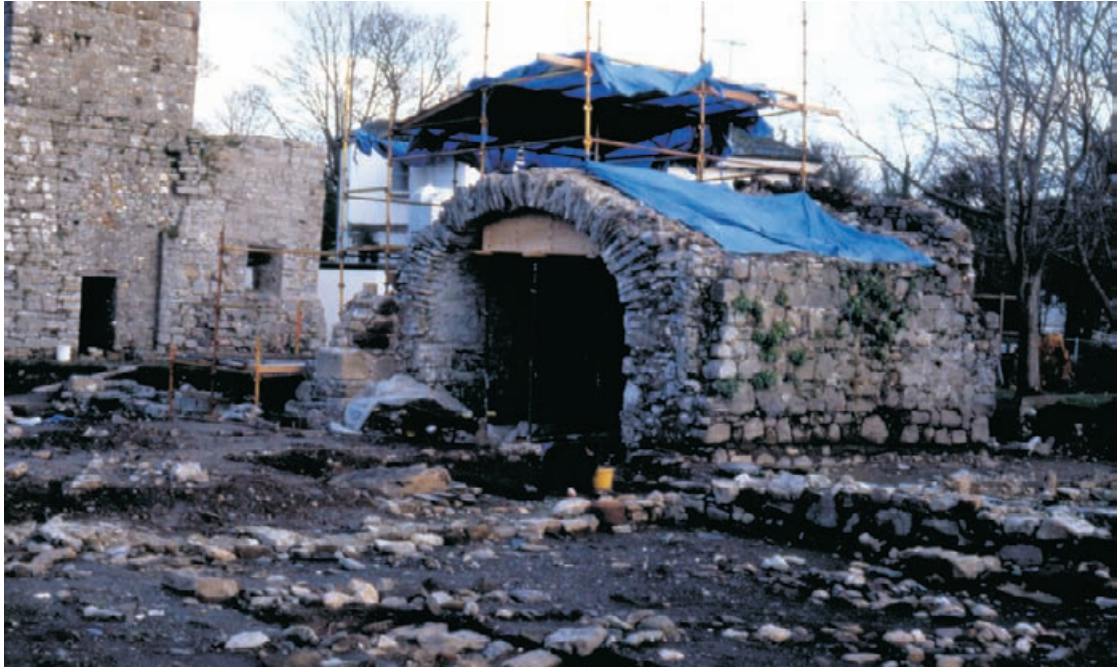
Figure 4.30 *Rushen Abbey. The Chapter House cleared of brambles and deep roots.*

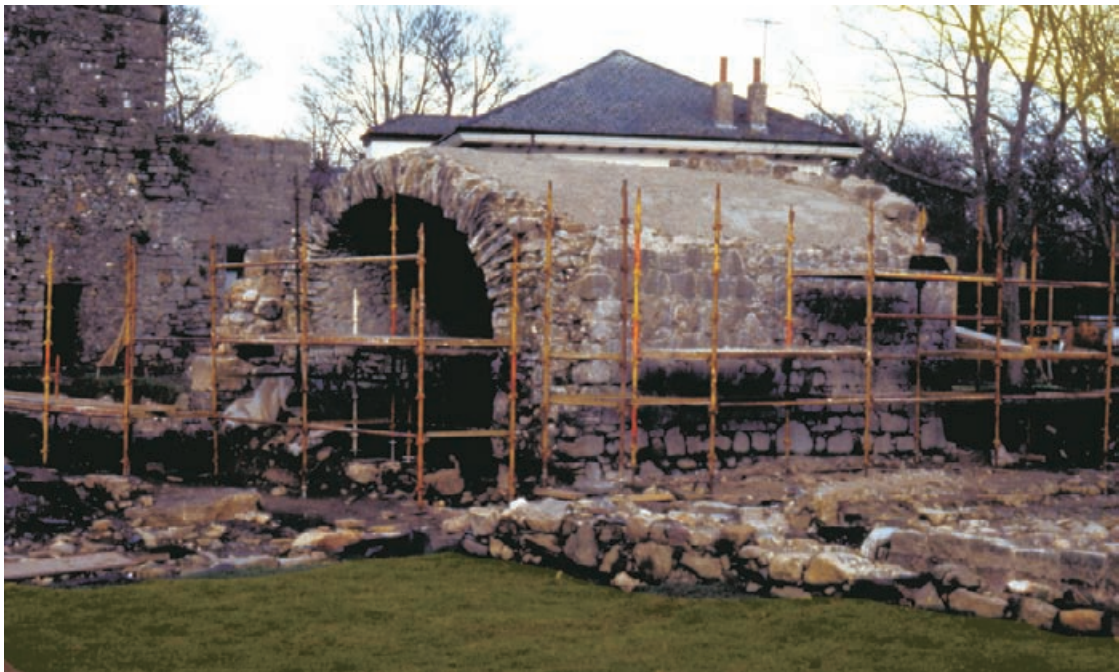
Figure 4.31 *The Chapter House vault consolidated and prepared with a hydraulic lime-based screed.*

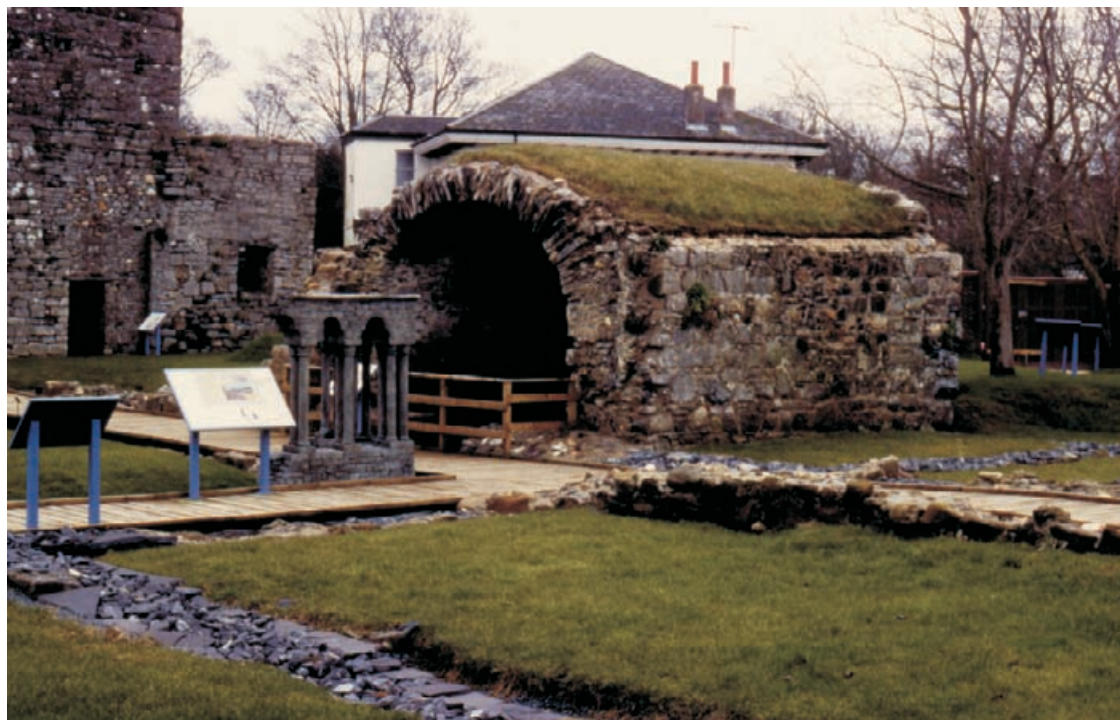
Figure 4.32 *The Chapter House vault covered with humus and turf taken from the site.*

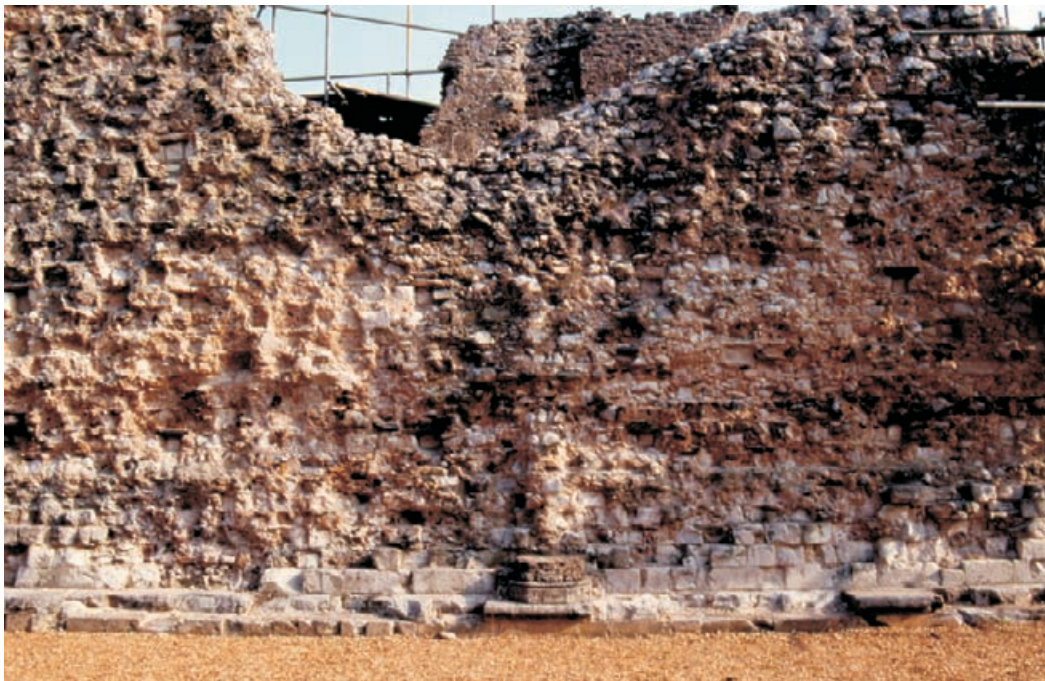
Figure 4.34 Almost all facework has been lost from his medieval composite wall. Only the core provides a record of the stone coursing and other features such as a column and vault springing line. Such core needs careful treatment; in particular, the wall heads must not be so consolidated that they become water-shedding. Either lime-mortared core or a 'soft top' of vegetation should be used. Waverley Abbey.

The term ‘core facework’ is often used to describe situations where the facing masonry has been robbed or lost and the core of the wall is now exposed as a ‘face’ (Figure 4.34). Broken composite wall ends always involve ‘core facework’, but the stone facings are often lost from large areas of wall extending back from the break, or quite independently of it. Stone robbing from the accessible lower courses and subsequent collapse of some of the upper courses is a common cause of loss. ‘Core facework’ is thus a very important element in masonry conservation.

reveal the imprint of the ‘tails’ of the facings, which were rough-backed and unworked. In this type of walling, core was raised with the stone ashlars in regular heights so that even when the ashlars have been lost it is possible to read the course heights and even the individual block sizes (Figure 4.34–4.36). Other kinds of lost facing, such as Roman reticulate construction, may similarly be recorded in core. Impressions of facings are sometimes all that remains as evidence of their existence, and the preservation of the lime core becomes a matter of great importance. Any rebuilding needs to retain the appearance of the original, even when it is distinguished from it by some identifying characteristic (see ‘Mortar’). The recreation of core of this type and its conservation are highly demanding of interpretative and practical skills.

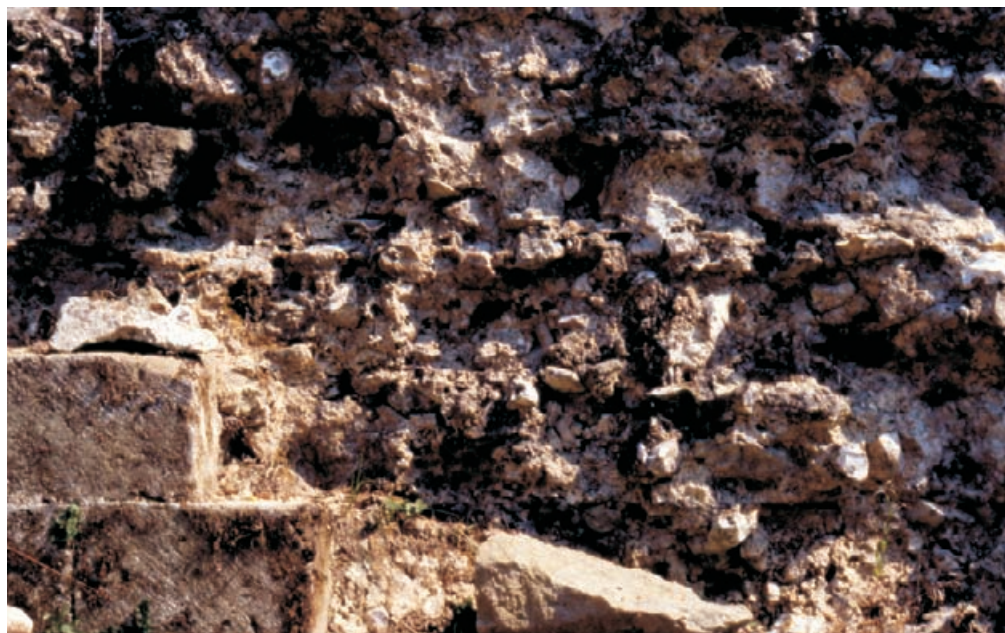
Figure 4.35 Detail of core showing the tail impressions of missing stones, with a few surviving ashlars bottom left. This evidence needs careful 'as found' consolidation to avoid losing or distorting the record. Clarendon Palace.

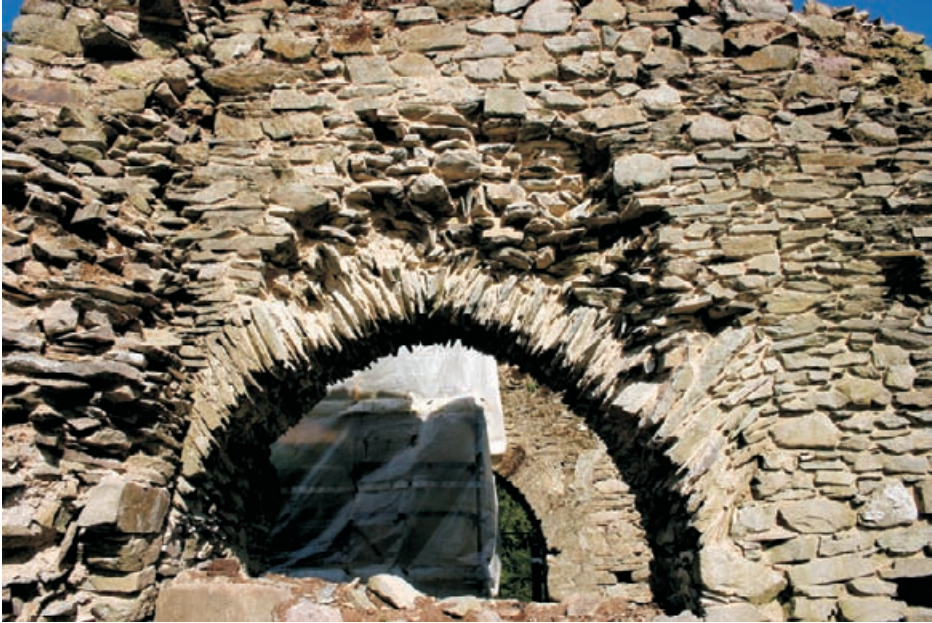
Figure 4.36 Consolidation work completed to a very high ‘as found’ standard with corbelled arch rings and corbelled out core. Complete stability has been achieved through the use of judicious masonry techniques and materials without any engineering device. Mourne Abbey.

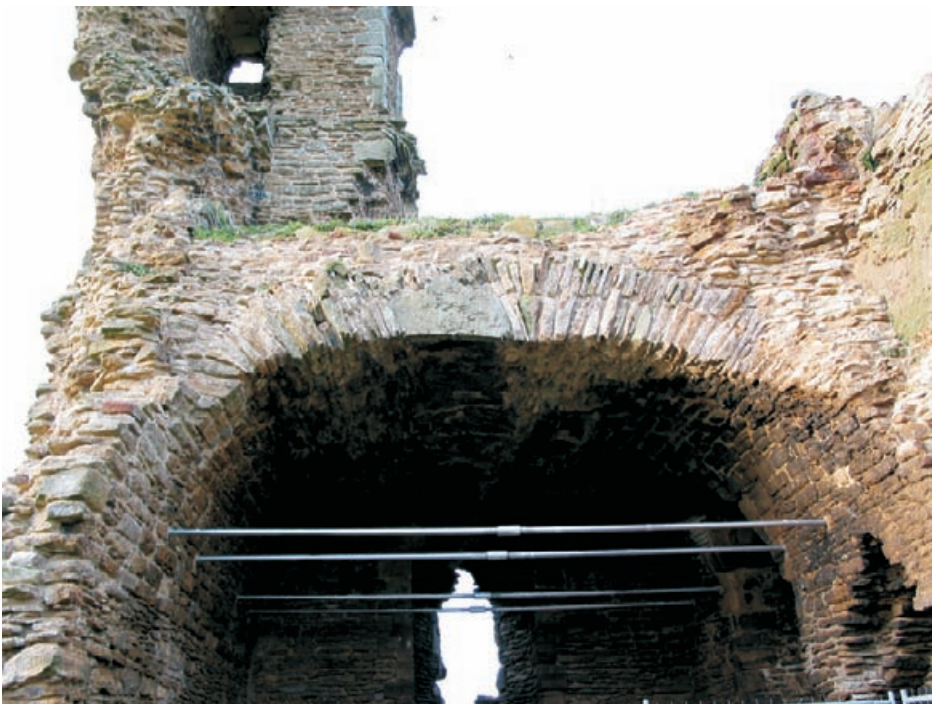
Figure 4.37 Stainless steel torsion bars introduced at the springing line of a broken vault, anchored into the core with pattress plates, to prevent the vaults spreading, fracturing and failing. Sheriff Hutton Castle.

Undertaking the consolidation work of masonry in these reduced circumstances requires a proper understanding of the way stones can be corbelled out and counterbalanced in dry masonry. Mortar should never be relied on to achieve stability as a substitute for this understanding. In situations where balance cannot be reached, structural assistance can be provided by incorporating non-ferrous metals in the form of restraining cramps, dowels, corbel bars or column and plate supports (Figures 4.37–4.41).

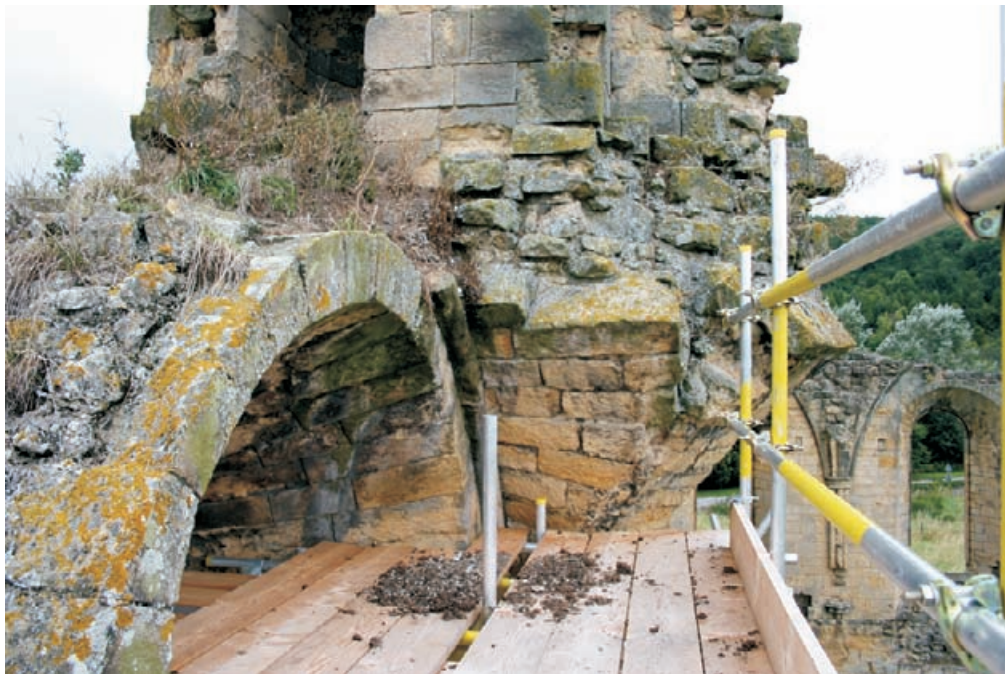
Figure 4.38 *Consolidation of overhanging masonry with long restraining cramps set into core work at Byland Abbey.*

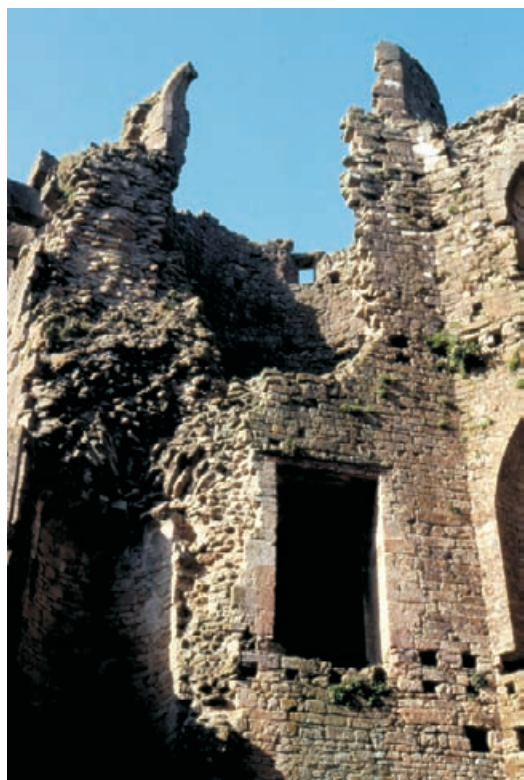
Figure 4.39 *View of overhanging high level masonry supported by restraining cramps at Nunney Castle.*

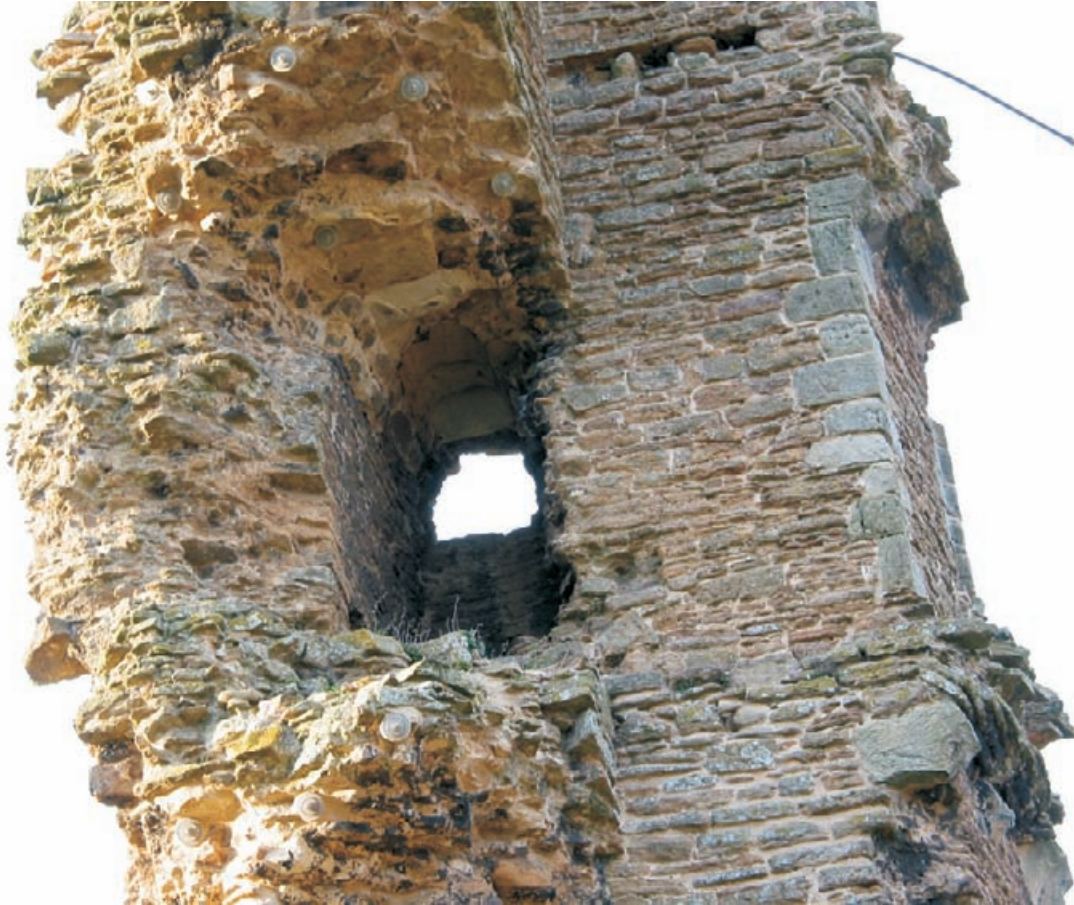
Figure 4.40 *Pattress plates and anchors used to tie back overhanging core work at Sheriff Hutton Castle.*

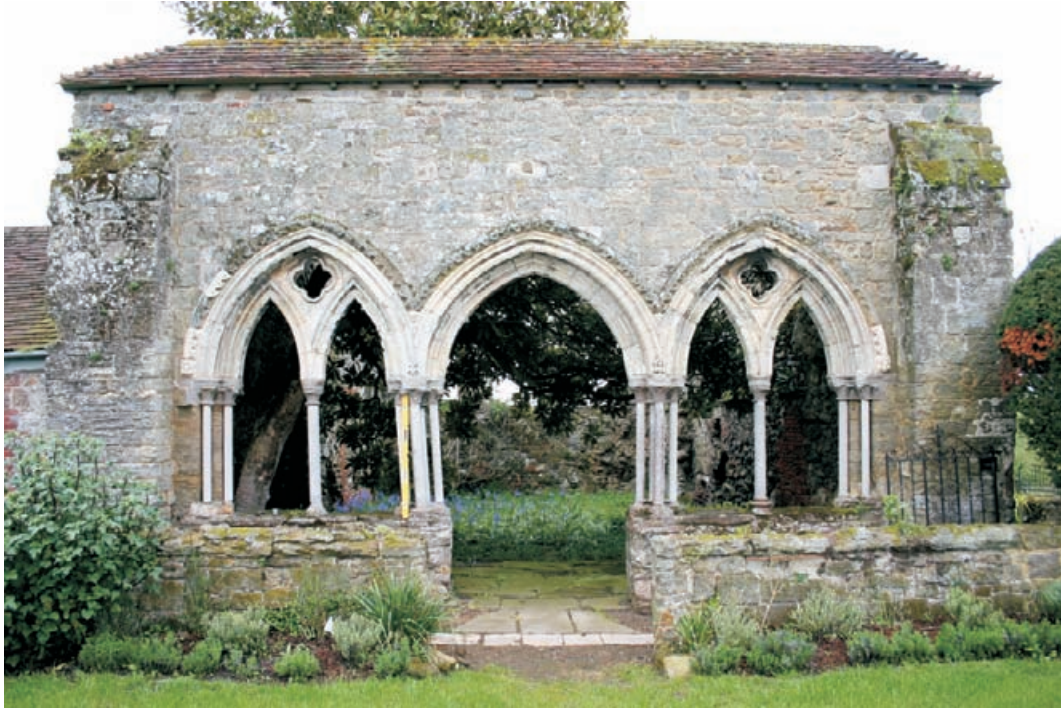
Figure 4.44 *Distortion of this medieval arcade is due to multiple causes including loss of restraints and counter-forts during ruination. Most seriously, the low wall on the left of the picture below the twisted cluster of columns is badly fractured. Only the central shaft is making contact with the wall and the arch springing.*

resin grout to form a locking profile with the wall core are an ideal solution in certain wall conditions; however, when the wall core is poorly constructed their benefit can be questionable (Figures 4.44 and 4.45).

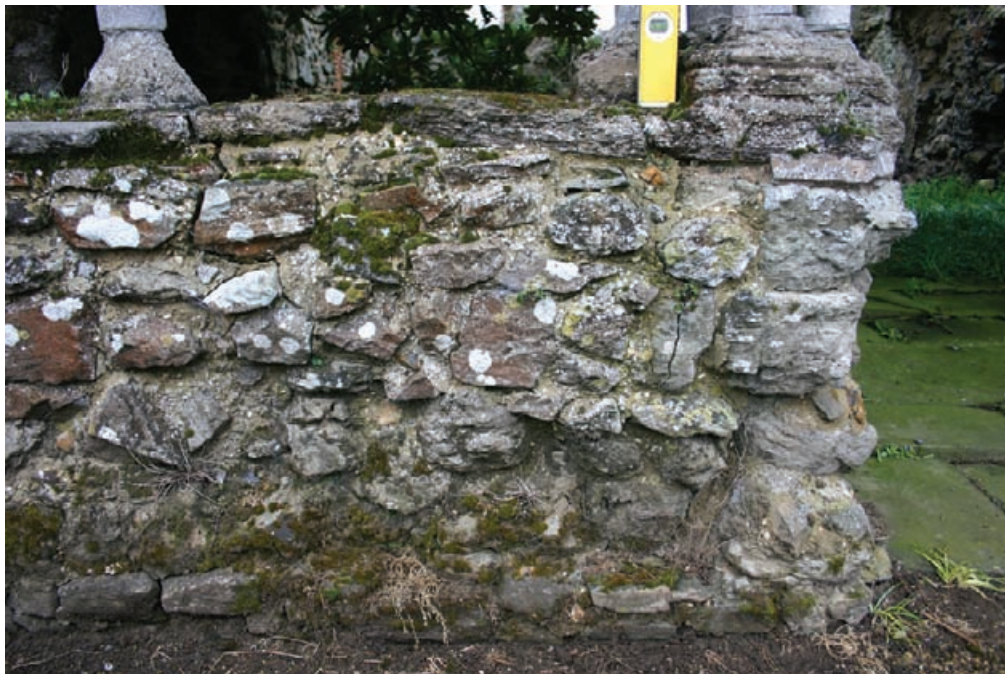
Figure 4.45 Detail of base of column cluster seen in Figure 4.44 showing the distorted and fractured support wall. Temporary supports of the arcade are required to enable the wall to be recorded, taken down and rebuilt in hydraulic lime mortar. Stitching of such poor construction is inadvisable because of lack of adequate anchorage.

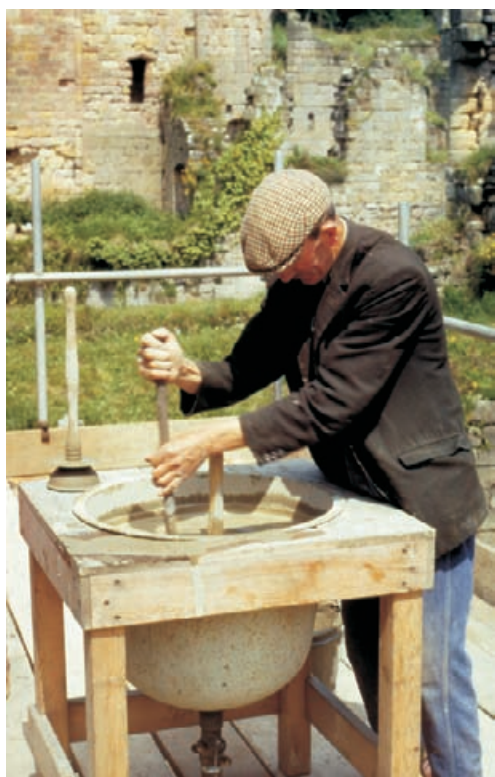
Figure 4.46 Traditional gravity grouting at Fountains Abbey showing the grout pan in its cradle on top of a scaffold. The grout solids are being stirred to keep them in suspension before releasing a plug which will allow the grout to rise from the bottom of the voided wall.

consideration before any remedial work is commenced. In the first decades of conservation work on ancient monuments in Britain, these voids were filled with cement grout (liquid mortar) introduced by a gravity feed system (Figures 4.46 and 4.47). The principles used were sound and the stability achieved in many cases undisputed, but unfortunately the choice of material sometimes contributed new problems without completely resolving the original ones. Unmodified cement grouts have poor mobility and create cold, impermeable zones within the lime-built construction where condensation can occur, encouraging frost damage in cold climates, and can deposit new soluble salts in the masonry.

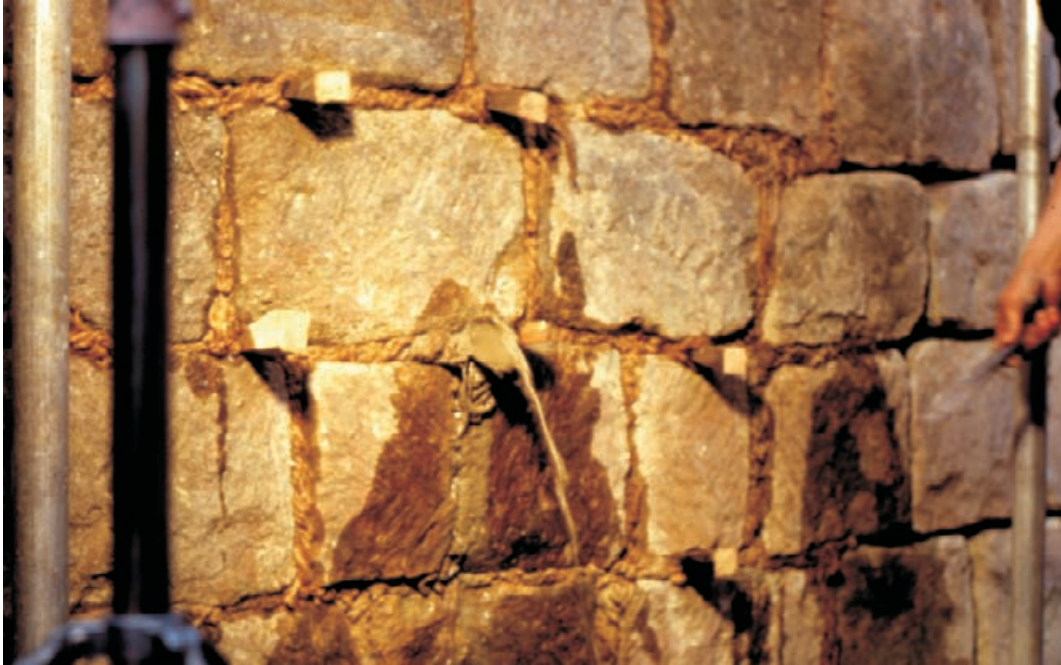
Figure 4.47 *At the base of the wall this illustration shows grout emerging from one of the escape holes provided, confirming the rise of grout behind the face stones. The blocks here are shown levelled with oak pegs and the joints plugged, in the traditional way with tarred rope.*

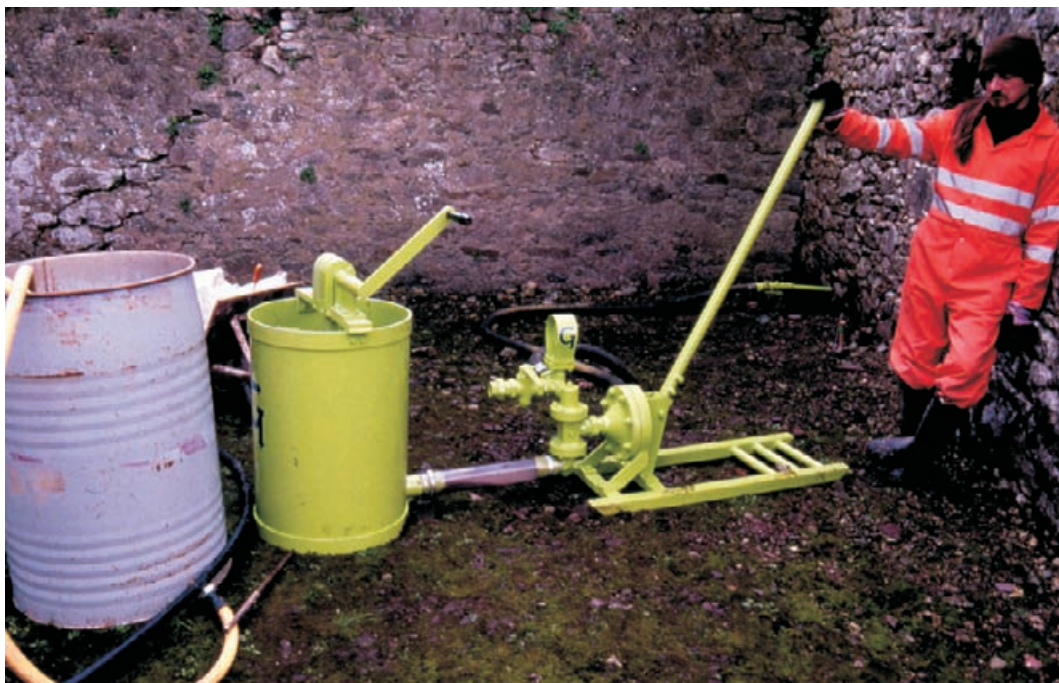
Figure 4.48 *The simple diaphragm pump which has largely replaced gravity grouting of masonry walls.*

pushing and pulling the operating lever (Figures 4.48–4.49).

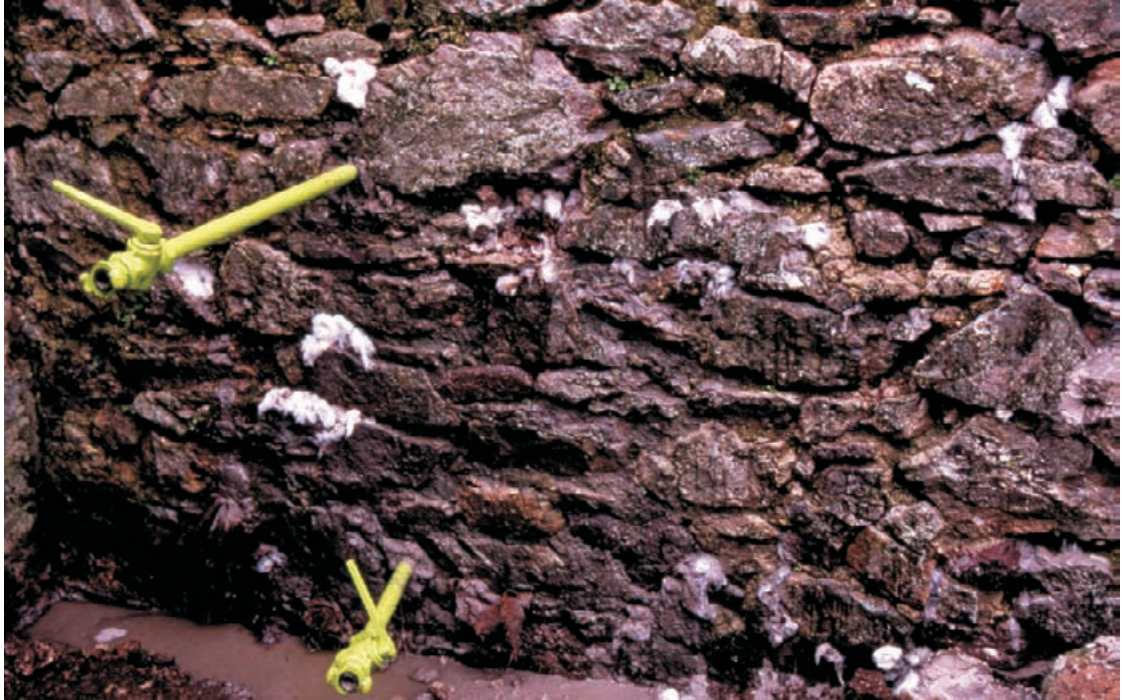
Figure 4.49 *Masonry wall showing grout nozzles installed. These can be simply coupled to the grout feed hose.*
