CONSERVATION OF RUINS

John Ashurst

Edited by John Ashurst

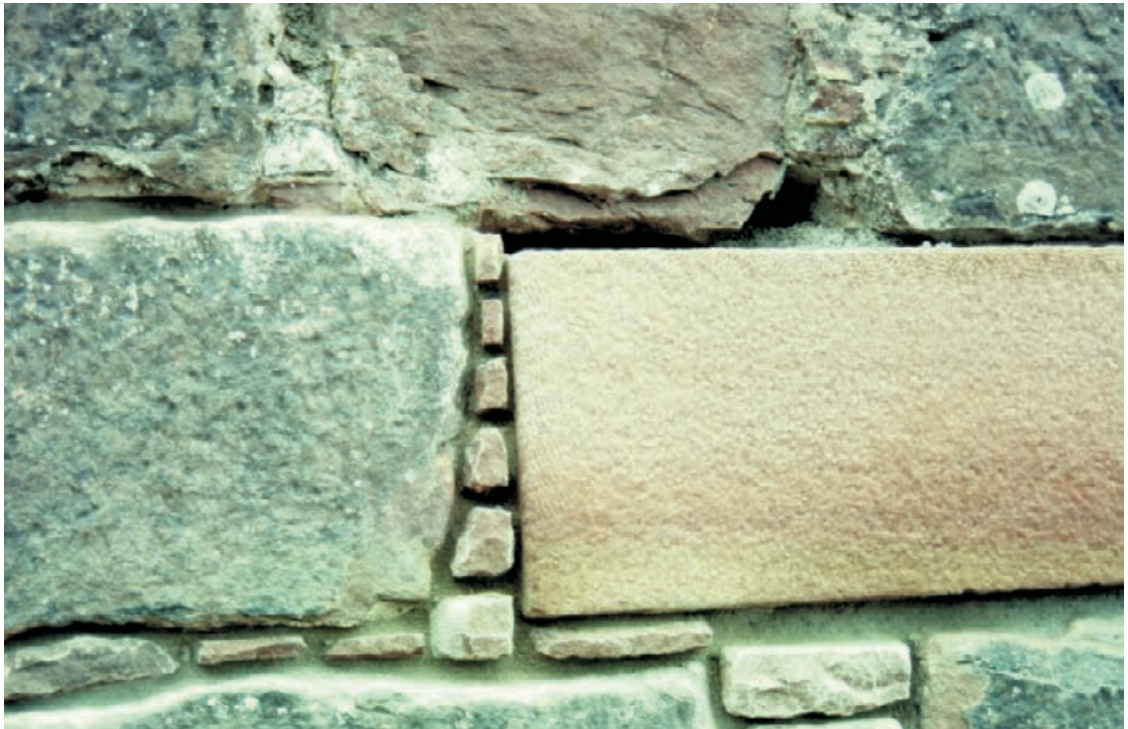
Figure 4.51 Uncomfortable machine cut replacement stone in an eighteenth century context of quarry-dressed stones.

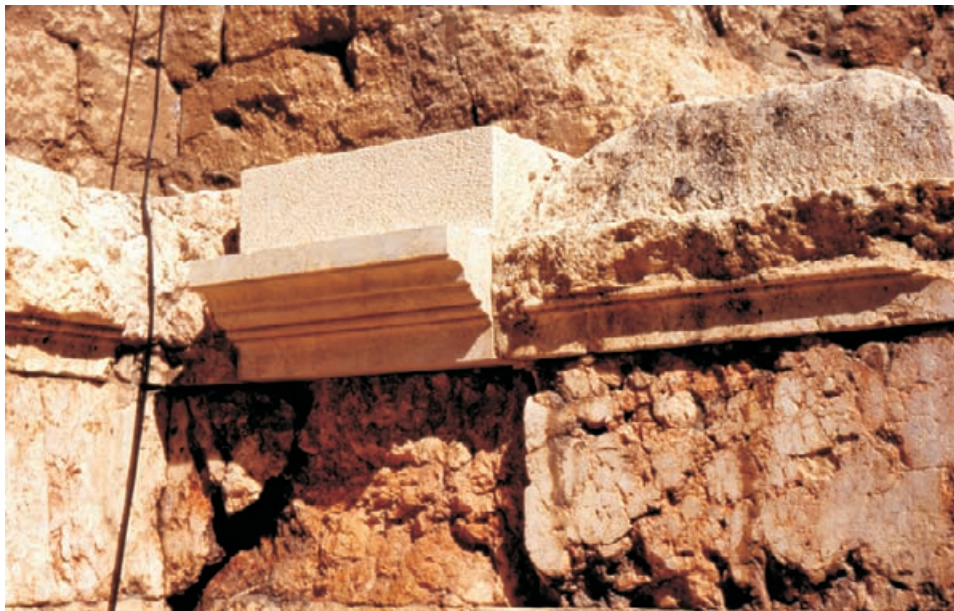
Figure 4.52 This section of Roman cornice has been prepared from templates made from a complete stone found in excavation. It is set in the wall to fill a gap and to show the original architectural line and detail. Beth Shean Israel.

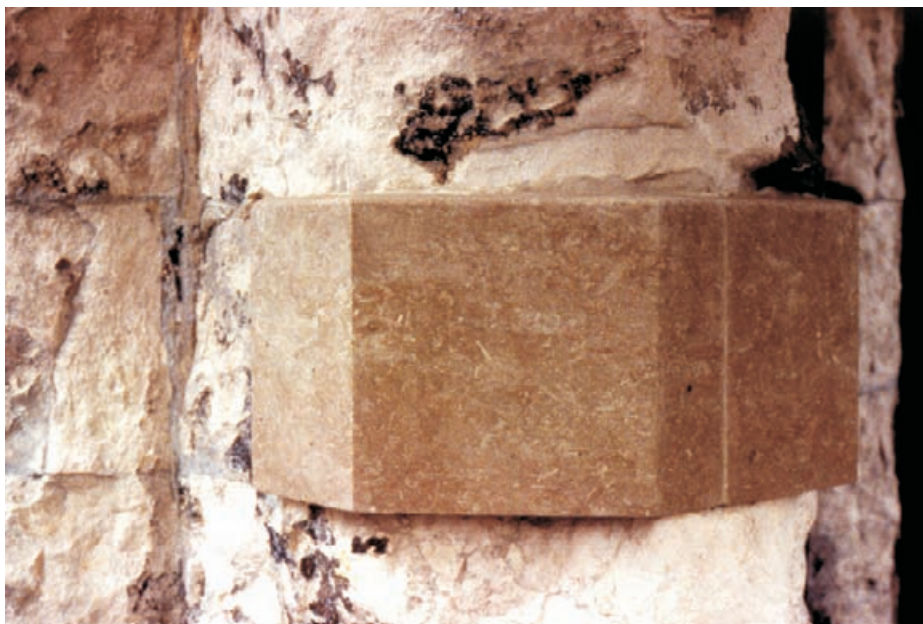
Figure 4.53 This replacement stone has been set in a damaged medieval entrance arch still used by vehicular traffic. The stone is the correct chamfered profile taken from the head of the arch and is placed in its correct line in the jamb. Although the new stone projects from the weathered masonry no mortar weatherings are used; instead the stone has a very slight fall on its top bed and a pencil-round arris. Providing the bedding mortar is deep and well packed this stone will shed water effectively. Guildford, Surrey, UK.

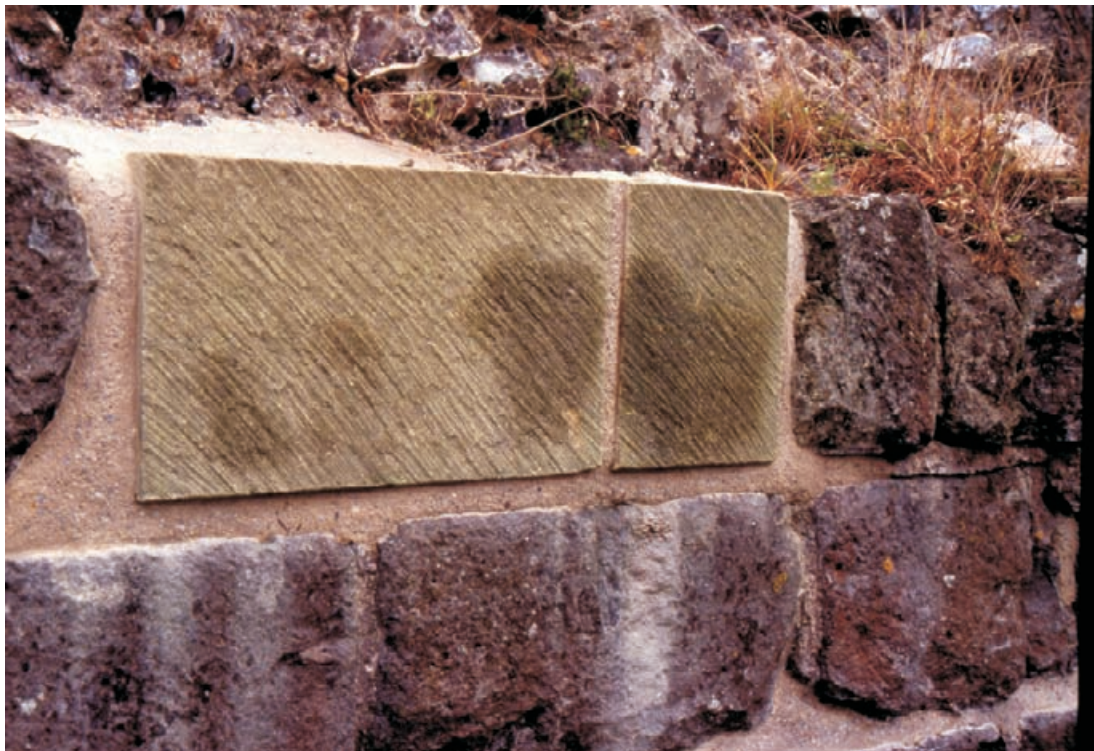
Figure 4.54 *New sawn stones are rather more comfortable in a setting of squared ashlars but suffer from arrises which are too sharp and bedding which is out of line. There is also far too much mortar on the top bed, placed in an attempt to provide a weathering. This should be compared with 4.20. New mortar has an unnatural, flat face.*

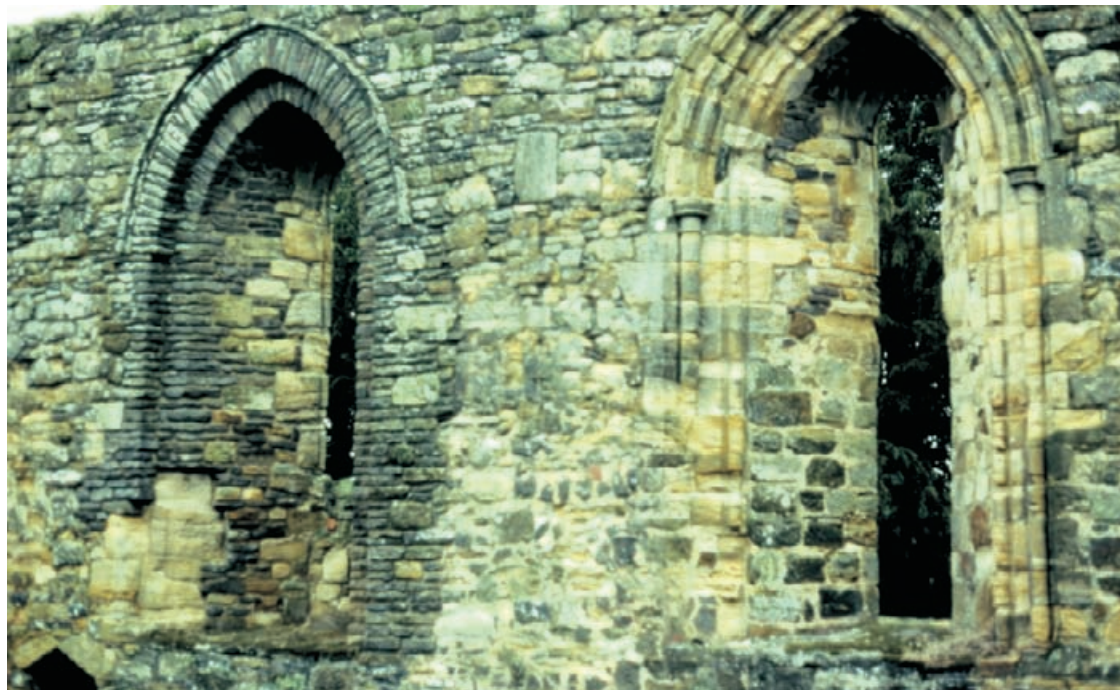
Figure 4.55 *Philosophy in place at Battle Abbey, Sussex. In the 1920s the left hand window head and masonry on each side were rebuilt. To distinguish the rebuild from the original, seen on right, the stones were roughly shaped voussoirs and jambs which recreate the scale and design of the original but remain permanently distinguishable from it. This illustrates a typical Society for the Protection of Ancient Buildings approach of the time.*

Replacement stone should always be identifiable, and there is a tradition of incising the date of placement on new stone. In some situations stone replacement within ruins may be structurally necessary and a stylistic difference may be made to differentiate new from old. Examples of this approach are shown at Battle Abbey (Figure 4.55) and Furness Abbey (Figure 4.56). In both cases a structural solution has been provided with the ‘correct’ stone, but stone which has not been moulded to imitate the original, deliberately staying short of any accusation of restoration. It can be argued, in the case of the Furness illustration, that some ghosting of the vertical roll and hollow moulding would have been an aesthetic gain; certainly, the course lines of the blocks should have been carried through.

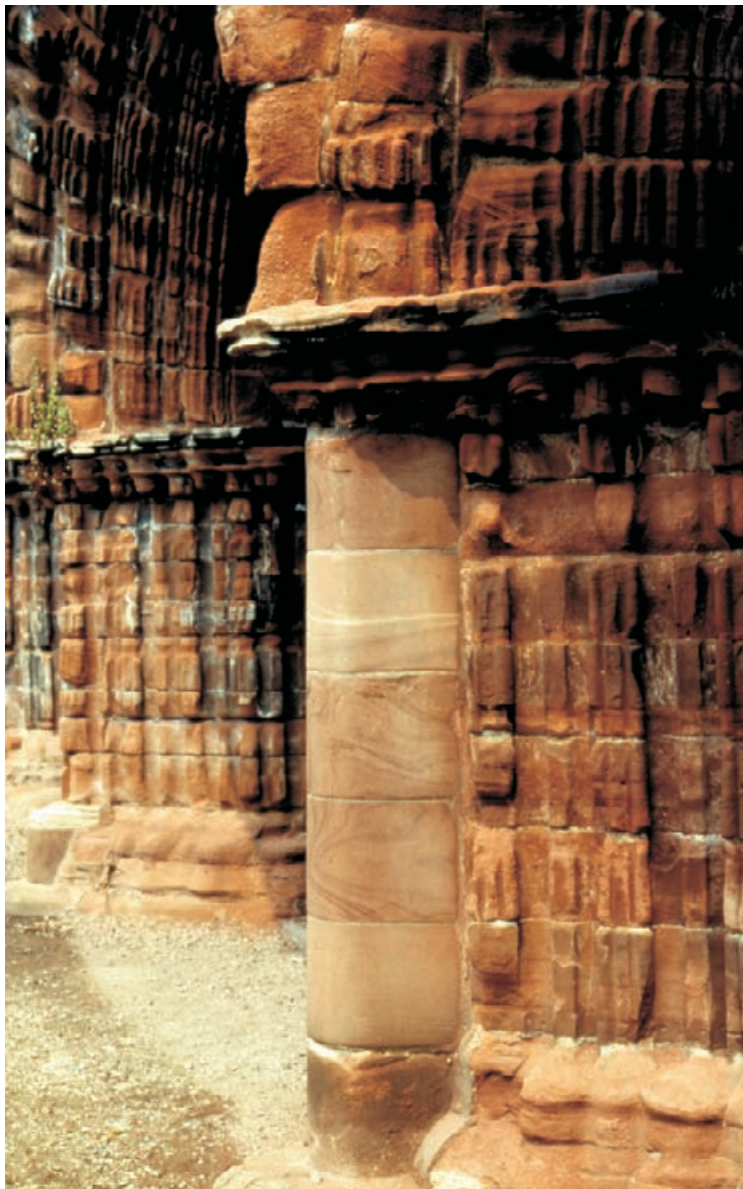
Figure 4.56 *Philosophy in place at Furness Abbey. The missing outer orders of the arcade pier have been replaced in a similar red sandstone which provides the necessary structural support for the arch but which is visually rather unsuccessful. The new line of the pier face is too far forward, and has no articulation representing the base and cap. In addition, the course lines of the new stone do not run through to match the original coursing. Some shallow vertical channelling echoing the original roll and hollow moulding would have made it a much better intervention, whilst still remaining an obvious intervention.*

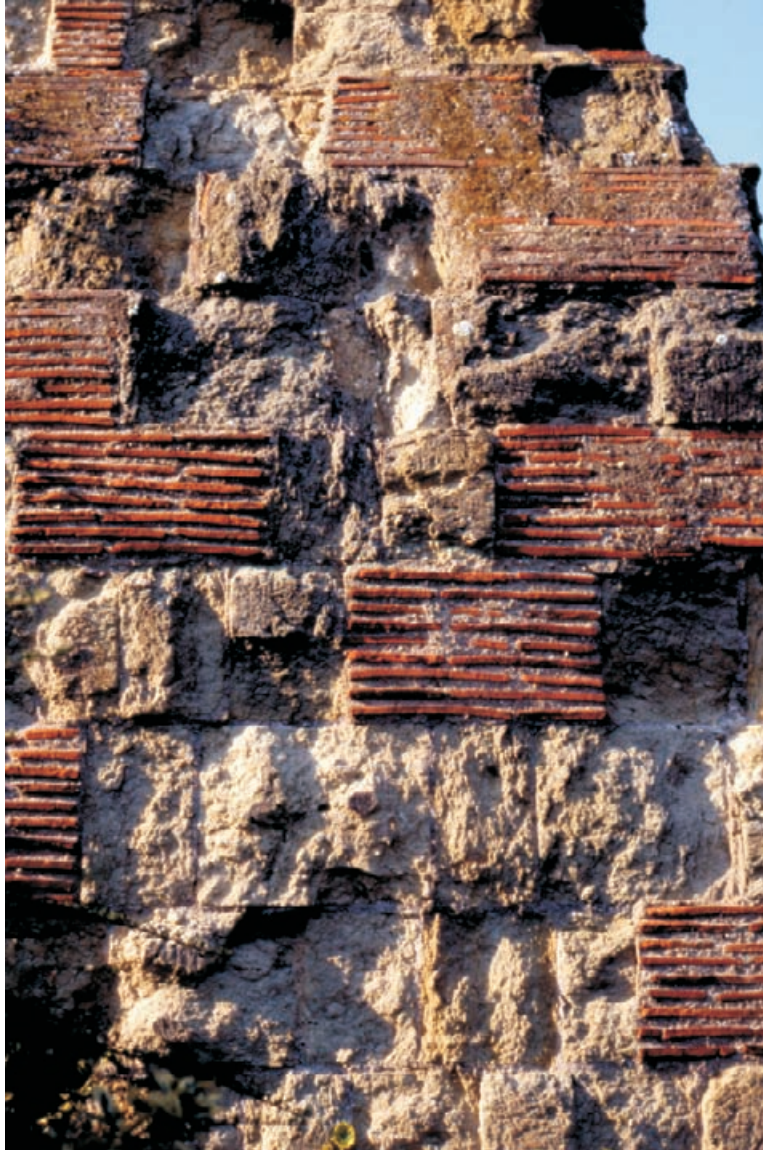
Figure 4.57 *Philosophy in place at Guildford Castle. The 1914 period clay tile replacements for decayed stones were once rendered. These repairs were and are unmistakable interventions, which is exactly what was intended.*

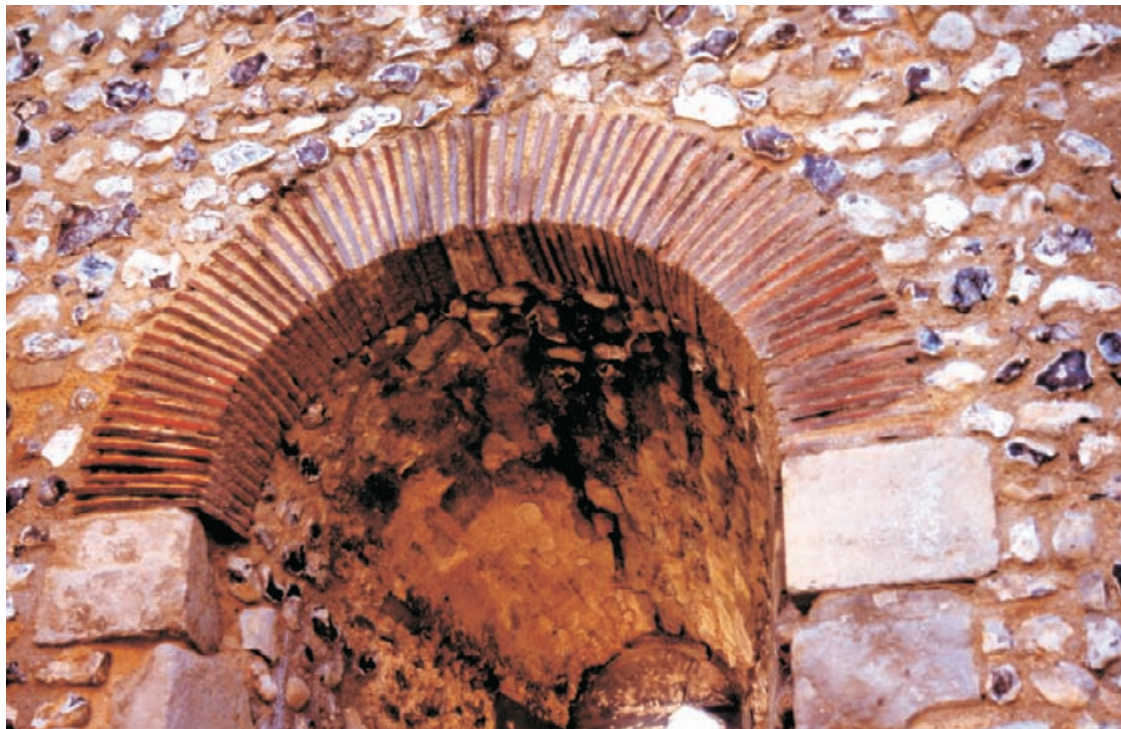
Figure 4.58 *Philosophy in place at Wolvesey Castle in Winchester. Missing stones of the arch have been replaced with clay tile rings; although an effective piece of consolidation the completeness of the tile ring could be misleading, suggesting that this might originally have been a tile arch.*

clay tiles for philosophical reasons, in both hydraulic lime and cement and lime. The argument for this approach is that structural support can be introduced in a way that does not compromise the truth, even if the tile repairs were rendered, as they often were. An example of such a repair is shown in Figure 4.57, at Guildford Castle, carried out in 1914. A more elaborate example, including full arch rings, is shown used at Wolvesey Castle, Winchester (Figure 4.58).

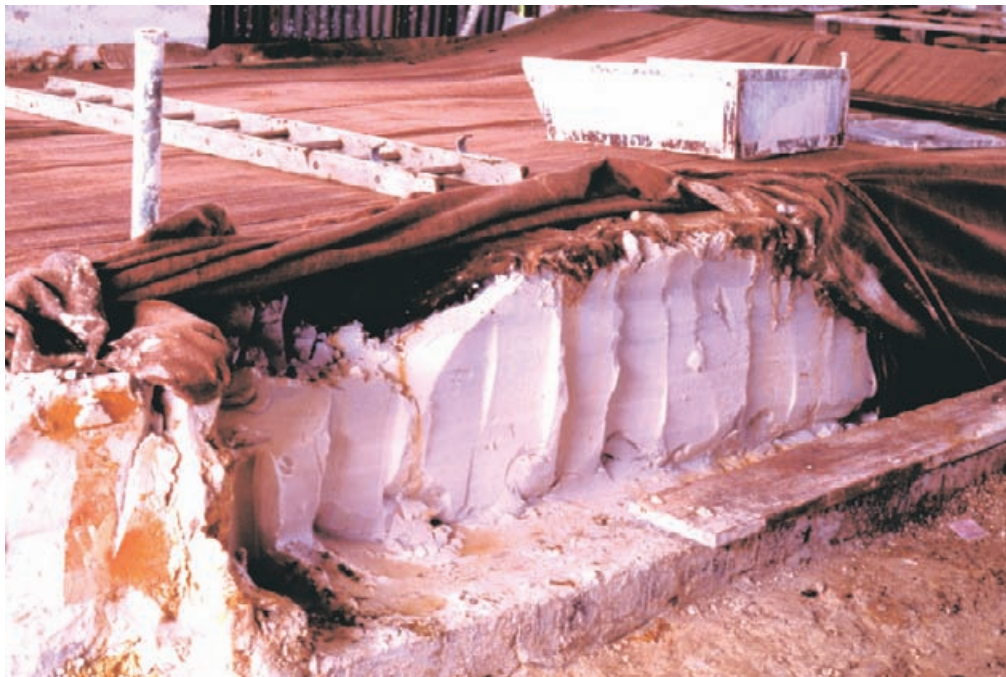
Figure 4.59 *Mature lime putty which has been aged for three years exhibiting the right consistency for use as mortar. Bryn Gilby's lime production, South Wales.*

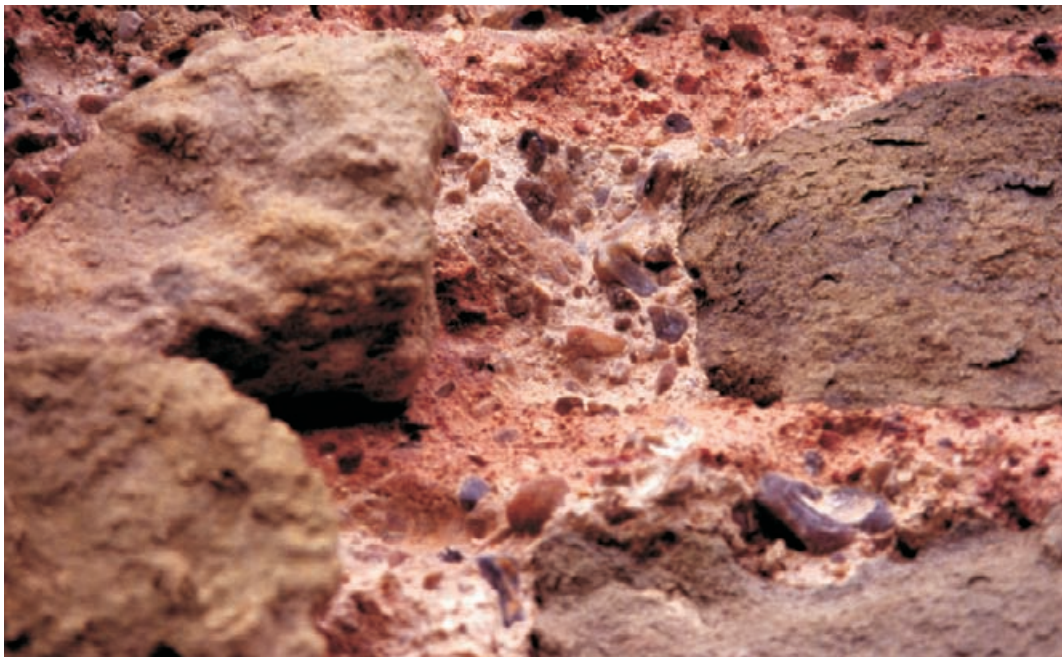
Figure 4.62 Roman mortar at Pevensey, Sussex, England showing the use of artificial pozzolan in the form of powdered brick or tile blended with large brick aggregate and lime. This mortar is extremely durable and has survived a marine environment for 2000 years.

and is equally at risk; moreover, mortar can contain important information about the technology and materials of the time of its composition and placement (Figure 4.62). A study of provenanced mortar samples is an important part of recording the history of a ruined building. The composite wall, already described, consisting of two masonry skins enclosing a core of stone and mortar, is the most common, traditional form of load-bearing wall, but variations in construction are very numerous and these variations have a profound effect on how walls behave when they are broken and exposed to the weather.

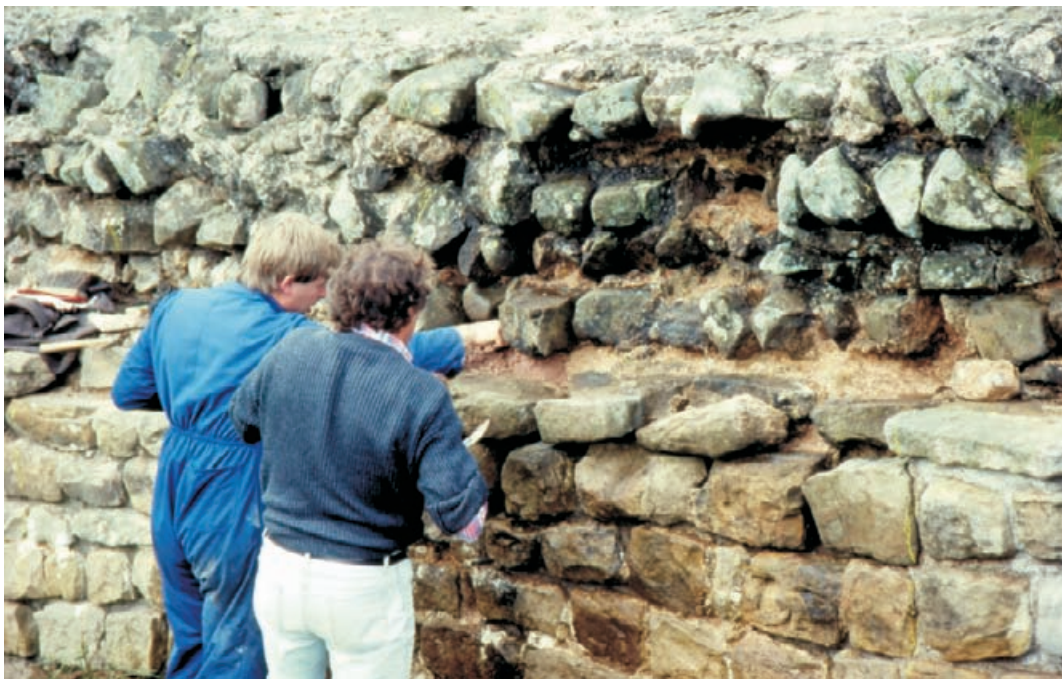
Figure 4.63 Exposed core of Hadrian's Wall with its wall head screed intact. Loss of face stones requires careful consolidation of materials not designed for weathering.

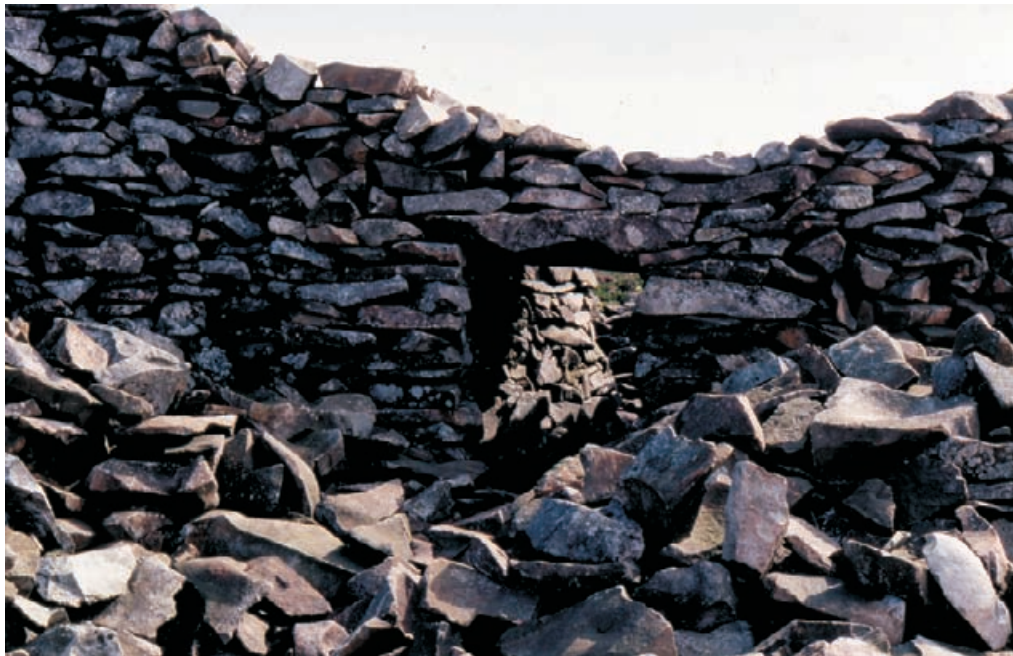
Figure 4.64 *Trei'r Ceiri.* Unmortared, roughly split slate walls of iron age date in Wales. The sophistication of this masonry lies not in the dressing of the stones but in the way in which they are assembled, each stone acting as a structural component and sitting comfortably within the wall. Such walls could be packed with earth and turf to make them water and wind proof, but should never be mortared in any consolidation work.

Unmortared walls (Figures 4.64 and 4.65)

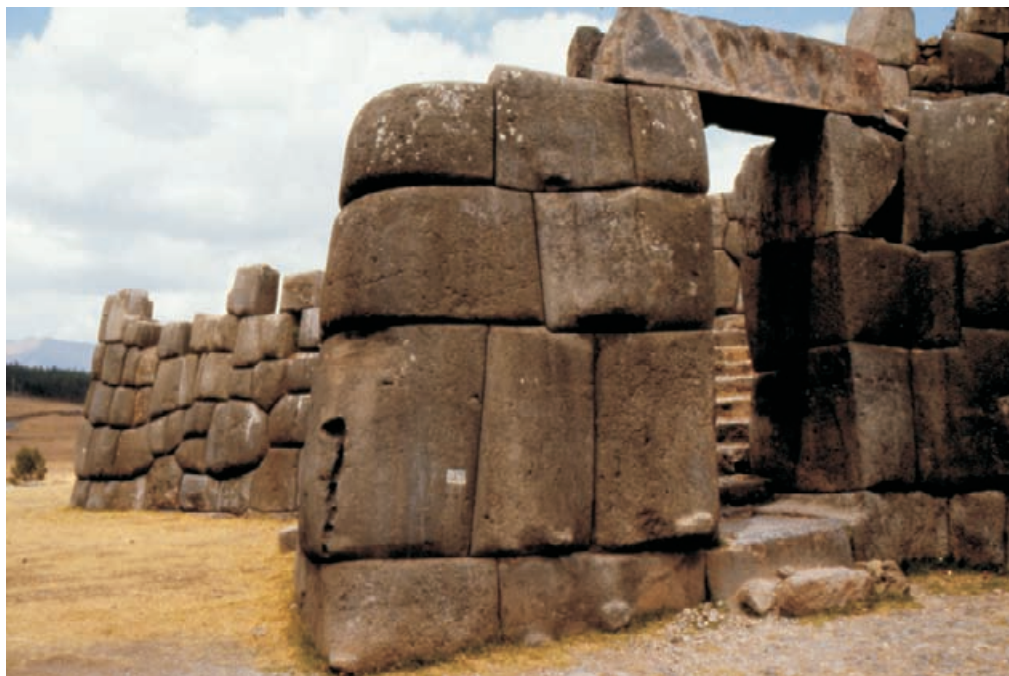
Figure 4.65 *Massive, un-mortared stones as Cuzco illustrate some of the most accurately worked masonry seen anywhere, and virtually indestructible except through severe seismic activity, deliberate demolition or artillery fire.*

to construct, whether water-washed boulders at Tel Dan, irregularly split slate slabs at Trei'r Ceiri, carefully fitted polygonal stones at Cuzco (Figure 4.66) or the seamless ashlar of classical Greece. The principal threats to such construction, depending on location, are stone robbing, seismic movement, subsidence and acts of war. Not being mortar dependent at all, they are often extremely durable and stable. The contrast between dry-built and mortared construction is particularly interesting in wet, cold climates; there is little that water movement (aside from scouring at the wall base) can do to un-mortared walls, and freezing presents few problems because of the free-draining nature of the construction. Some dry-built construction was packed with earth to keep out wind and rain, but these materials in such a context are non-structural and usually lost through time and weathering. Some were also plastered with clay, lime- or gypsum-based plasters.

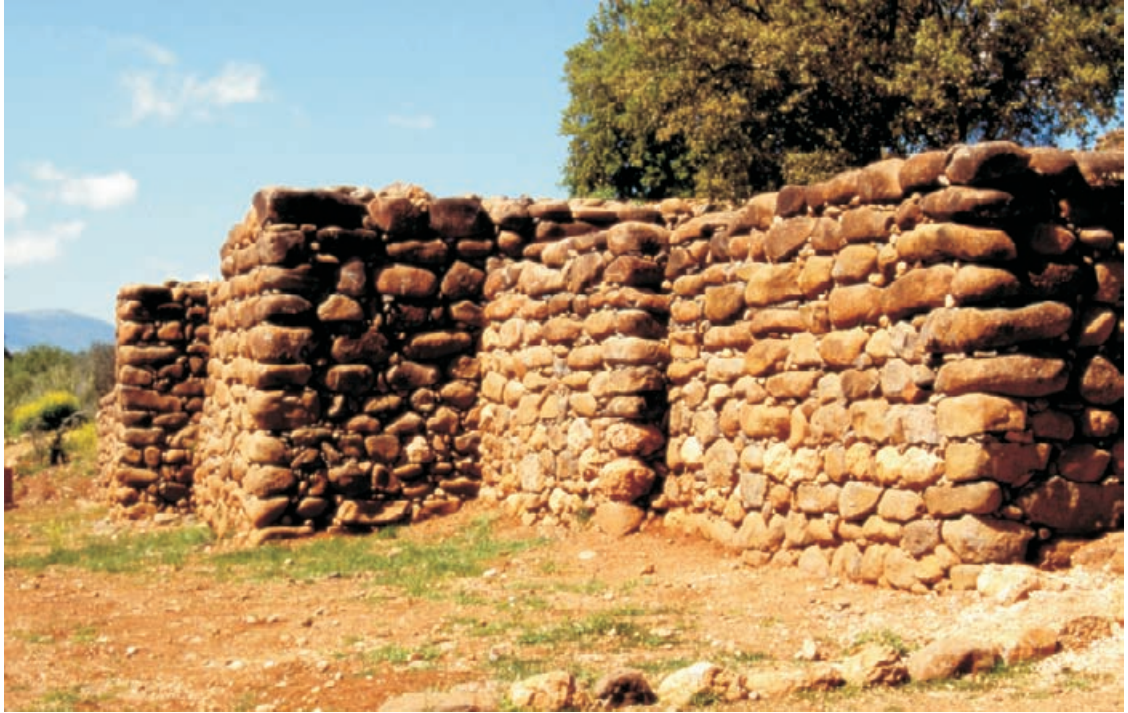
Figure 4.66 *Masonry of water-washed boulders at Tel Dan, Northern Israel. Upper courses rebuilt.*

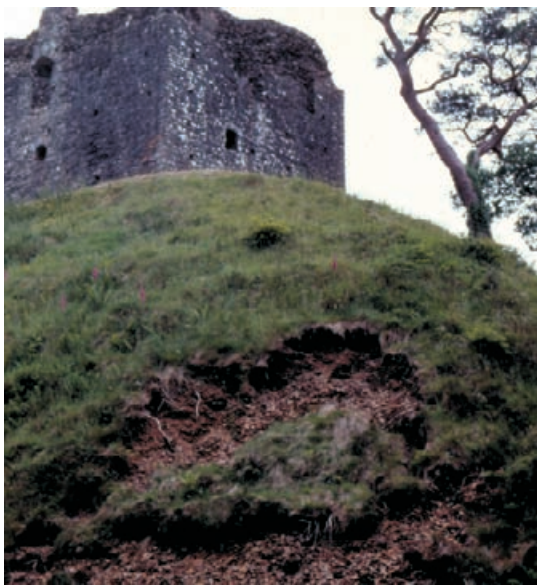
Figure 4.67 *The Medieval earth motte of Okehampton Castle, UK, showing earth slippage after heavy rain, exacerbated by burrowing rabbits. Turf repairs are appropriate, cutting into the mound and laying turfs as bonded blocks with staggered joints. Synthetic rope land mesh can be pegged across the repair until the grass is established.*

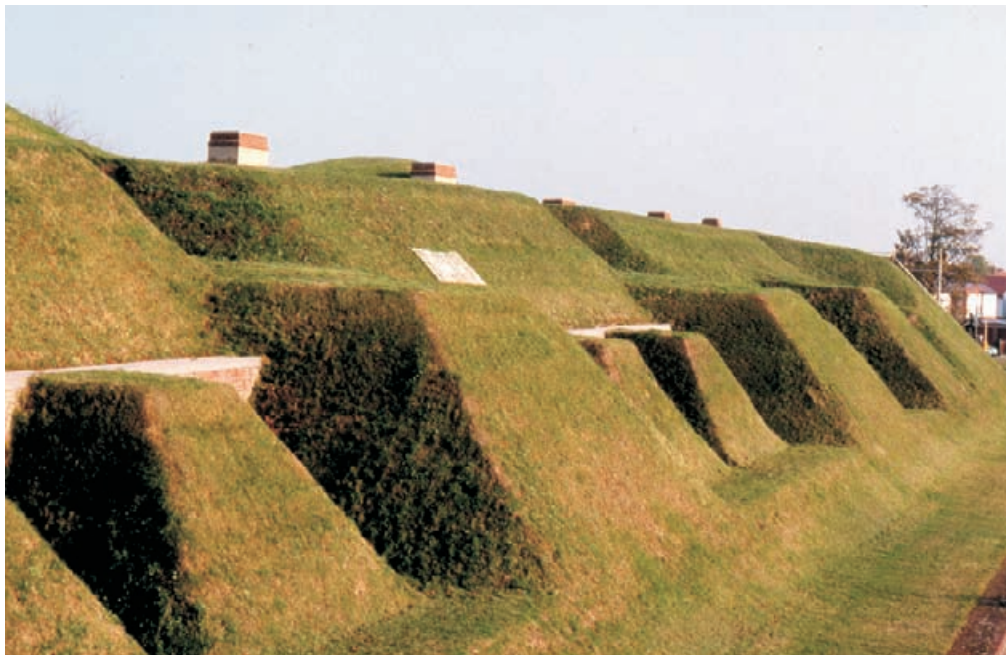
Figure 4.68 *The use of earth and turf on the late nineteenth century Fort Brockhurst, part of the Palmerston Defences of the Naval dockyards of Portsmouth. The meticulously trimmed profiles quickly become wilder in appearance as grass gains height and wild flowers become established. Repairs are made in block bonded grass sods.*

Continuity in earth building may be found in countries such as Afghanistan, Iran, Saudi Arabia, the Yemen, South America and the south-west USA, India, Africa and China, and it is from such areas that lessons on behaviour, repair and conservation of earth walls can be best learnt. Where suitable earth exists it has been used for construction, and for all building types. One of the most impressive early uses is in the form of the banks and ditches of the great Celtic oppida, although it may be argued that these are not 'walls' in the traditional sense. Nevertheless, earth has a longer history in defensive works than does any other material, absorbing impact and shock from modern artillery as effectively as it resisted missiles from Roman and medieval siege engines (Figure 4.67). Although mud-brick masonry could easily be breached by the swinging ram, earth and turf walls absorbed the shock very effectively. Earth 'ruins' include not only hill forts but a worldwide array of artillery forts from the seventeenth to the nineteenth centuries and the trench defences of two world wars (Figure 4.68).⁹

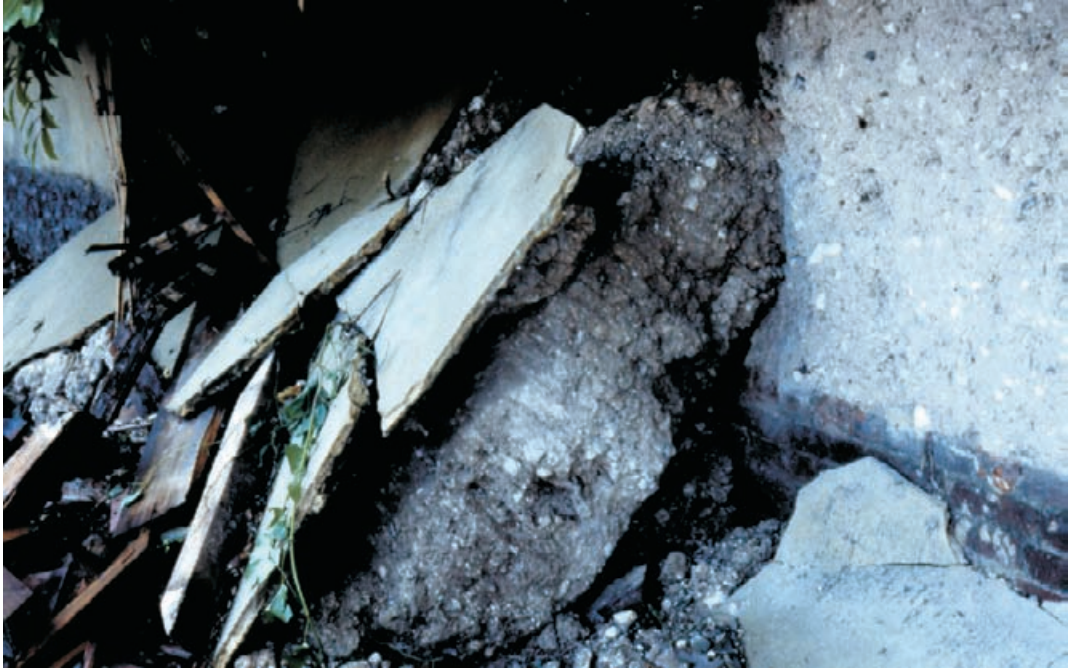
Figure 4.69 *The use of a cement rich plaster applied to earth walls is seen here in dramatic failure mode. Cracking of the plaster occurred within 6 months and failure within one year. During its lifetime it held water against the ancient earth wall causing softening and significant losses for the first time in many centuries.*

The vulnerability of earth construction is at its greatest when damage and partial ruination have occurred (Figure 4.69). In wet climates such as northern Europe, earth walls can only survive when a water-resistant plinth and a water-shedding roof with a wide overhang and a slurry or plaster wall covering are maintained in good condition. Damage and neglect, especially at the wall head, quickly lead to disintegration and collapse. In drier climates, the disintegration process takes longer but may be exacerbated by wind-blown sand, and will inevitably and eventually take place without adequate protection. Unlike fired clay, capillary rise in walls of mud brick

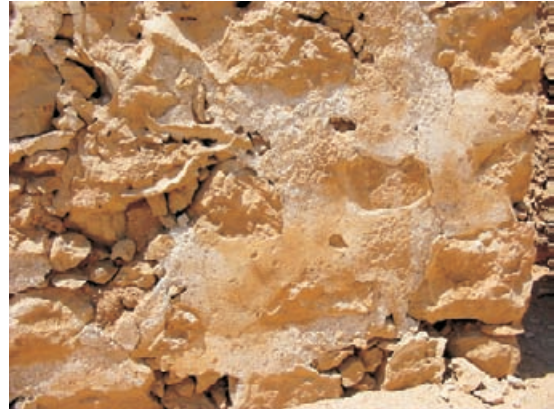
Figure 4.71 Polished Herodian plaster. Only a small percentage of plaster survives within a white cement frame which had been mistakenly used to hold the plaster in position. At the top of the picture only the cement frame survives.

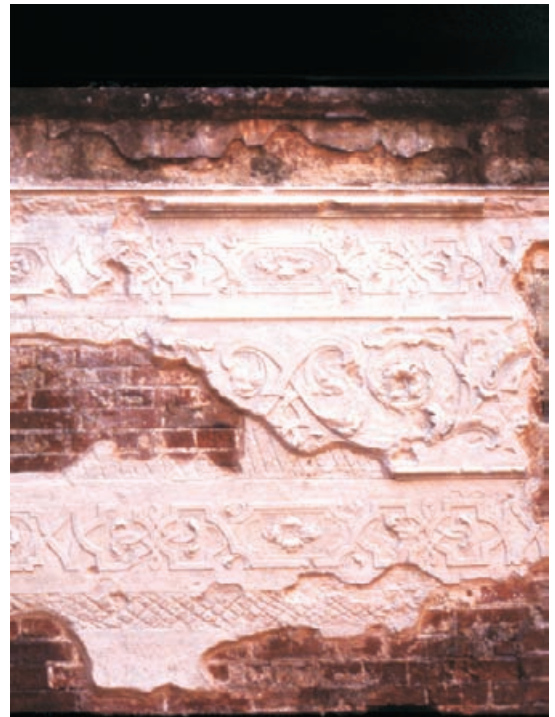
Figure 4.72 Finished consolidation work on decorative fragments of eighteenth century plaster which involved the removal of cement mortar fillets and patches and the substitution of lime putty and ceramic fills. The plaster was cleaned of organic growth using a small hand-held steam gun and was treated with a shelter coat of lime, marble dust and casein.

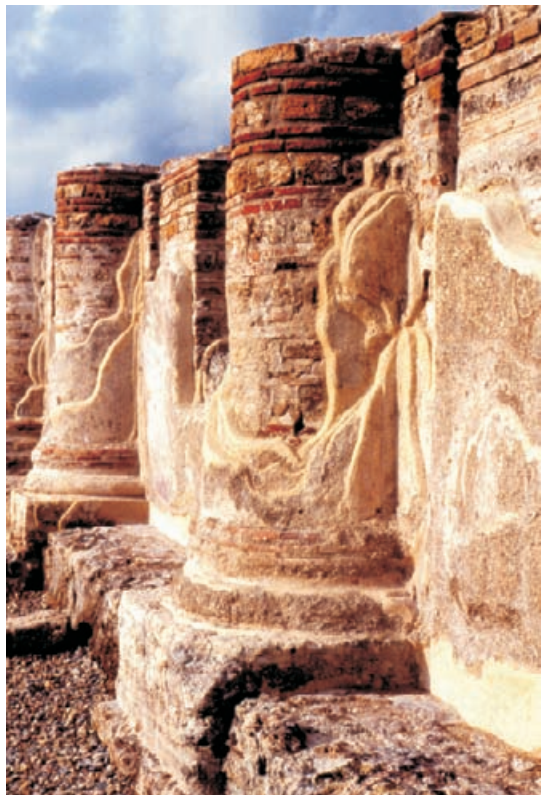
Figure 4.73 *Plaster survival in dry conditions. Multi coat plaster at Paestum. Plasters in these conditions can become detached through the activity of soluble salts migrating in the wall, especially after excavation. Detachments may need to be grouted with weak hydraulic lime and broken edges closed up with weak hydraulic lime mortar, carefully cured. Regular inspection of these important plasters is essential and replacement of protective mortar fillets may be needed from time to time.*

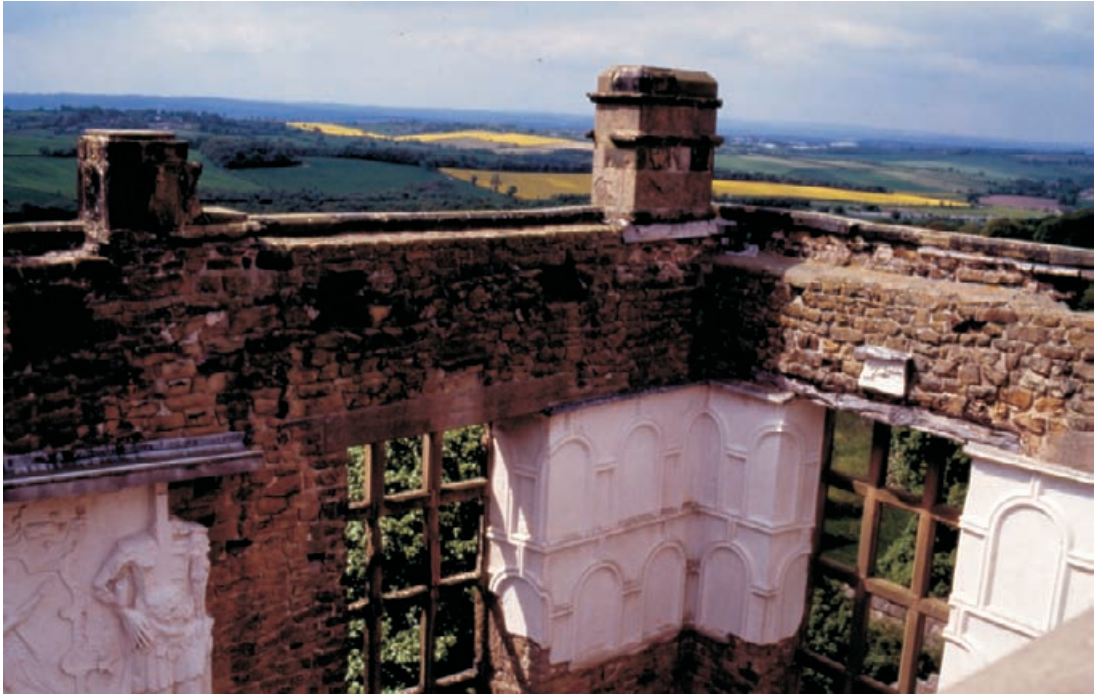
Figure 4.74 *Plaster survival in wet conditions. Decorative plaster at this level, seen at Hardwick Old Hall, is particularly susceptible to damage by water and colonisation by organic growth. In the absence of a roof, protection is provided by small, timber board projections of 300–450 mm, covered with lead. The upturn of the lead against the wall must be into a carefully formed wall chase, secured with stainless steel screws and washers. Maintenance is essential, including the use of thin lime washes.*

In the context of the ruin, conservation activity includes the installation of small roof covers attached to the wall to throw water clear of the plaster (Figure 4.74), removal of organic soil with biocide and small steam guns, removal of any impermeable cement-based mortar edge fillets or patches, flushing and grouting detachments and fractures, and installing lime mortar edge fillets and fills in lacunae (Figure 4.75). In some situations, because of the good tensile strength and flexibility of haired lime plaster, it is possible to carefully ease back a detaching plaster face onto a cleaned and lime slurried wall. Plaster grout specifications are provided in Appendix 1.3.

Walls and floors of ruined structures may themselves be fragile as in the case of earth construction, and are not infrequently associated with and intimately connected to fragile survival, such as plaster, paint, tile, mosaic, wood, metal and glass. Architectural moulding and sculpture can be added to this list. Although the *in situ* conservation of these important surfaces is properly the work of conservators specifically trained in their care, there is often a 'grey zone' in ruined buildings where fragmentary survivals are neglected or mistreated. Yet these survivals are often very important indeed to the understanding of the character and chronology of a site, and the 'conservation technicians' working on the stabilisation and conservation of the walls need to be able to recognise them and to protect them, until conservators can get to the site (see Figure 4.74).¹⁰

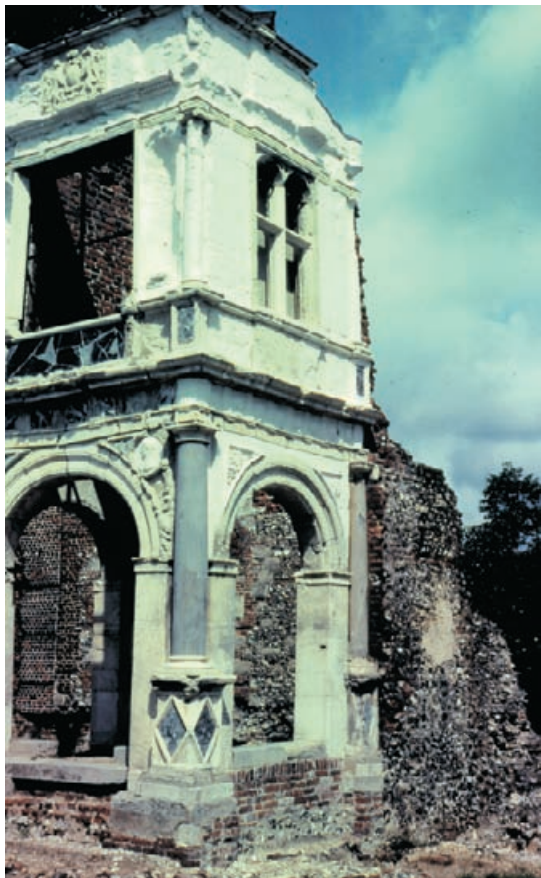
Figure 4.75 The conservation work required on Bacon's late sixteenth century entrance porch included mortar repairs, stainless steel and ceramic stitches to hold edge bedded columns together, conservation and replication of Roman marble, consolidation and surface treatment of a range of decorative stones and consolidation of heavily decayed wood sculpture.

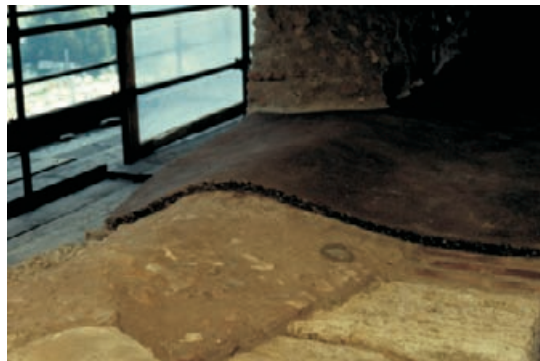
Figure 4.76 An unusual reversible wall capping system seen on the so-called 'Temple of Saturn' in the Forum of Rome, which is designed to protect the archaeology of the wall head. This is a multi-layer lime-pozzolana plaster which is designed to provide a weathering surface but which can easily be broken off in the future without damage to the original substrate.

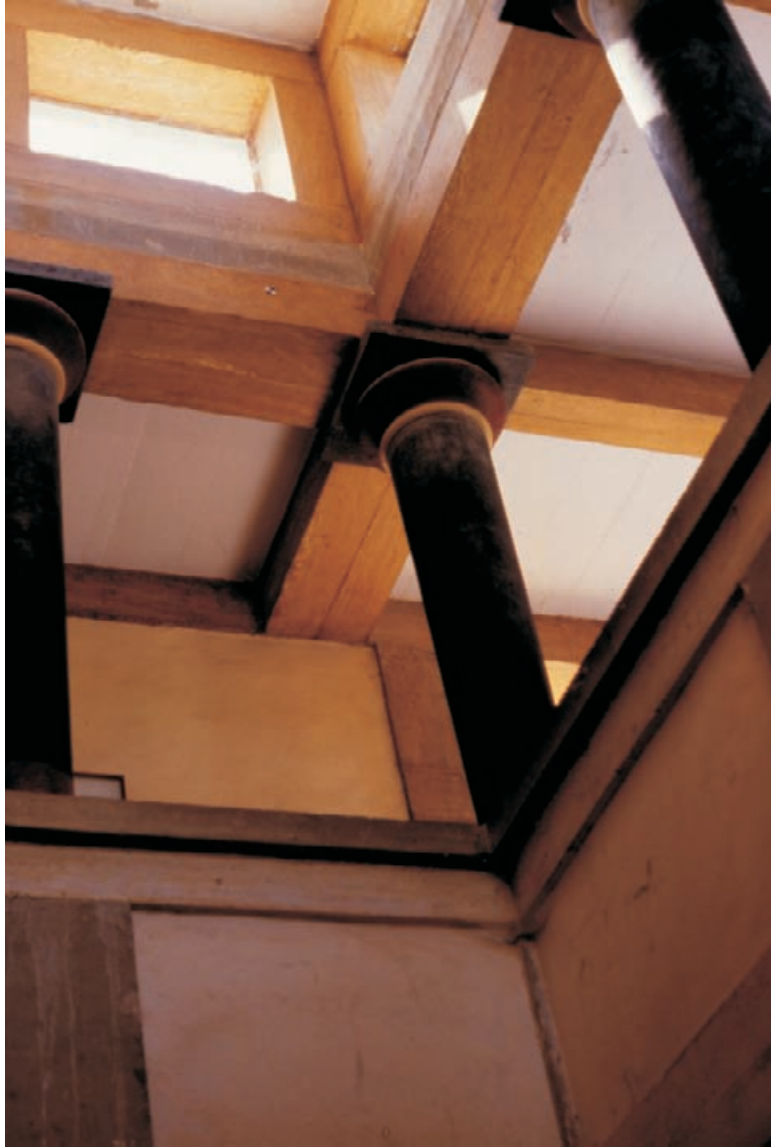
Figure 5.2 Light well in the 'Throne Room' at the Minoan Palace of Knossos on Crete, early twentieth century reconstruction by Arthur Evans (photograph: C. Woolfitt).

It is easy to find fault with early attempts at reconstruction of ancient ruins, but it must be acknowledged that much has been learned from past mistakes. The reconstruction of parts of the Bronze Age Minoan Palace of Knossos on Crete under the direction of Arthur Evans in the early twentieth century illustrates two principal issues, which have been addressed by later conservation charters: lack of authenticity and speculative work (Figure 5.2). Criticism of the Knossos reconstruction

has focused on the use of materials alien to Minoan architecture (such as reinforced concrete) and the sometimes scant evidence for quite extensive reconstruction, including wall paintings. In the 1950s the American School of Classics at Athens carried out the complete reconstruction of the second century BC Stoa of Attalos at the site of the ancient Athenian Agora, building on the surviving foundations, and incorporating sections of the original, mainly at the south end.⁴ The new stoa provides accommodation for the Agora museum and store, and for a conservation laboratory and offices for the Agora excavations (Figure 5.3). Although the new materials and design followed the original, as far as these could be determined from the archaeological remains and from nineteenth century photographs, there are some variations, for example in the modern terrazzo floor, which is quite different in character from the original, a section of which was preserved in the 1950s. Both the Knossos and Stoa of Attalos reconstructions might equally be described as recreations by the definitions of these terms set out above. The new stoa is a large structure and, inevitably, as the only complete classical building in the vicinity standing to a height of two

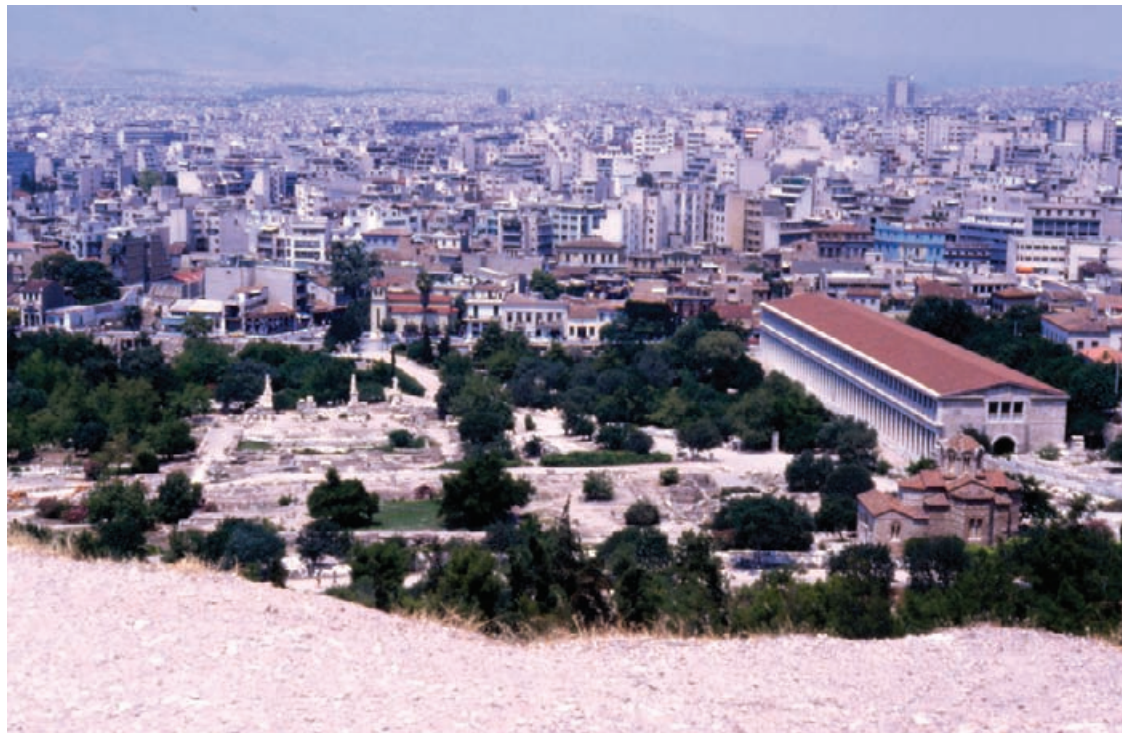
Figure 5.3 *View of the reconstructed Stoa of Attalos in the Athenian Agora, Greece (photograph: C. Woolfitt).*

storeys above ground level, it dominates the site of the Agora. It provides welcome shade in an otherwise exposed site during hot weather, but has nevertheless attracted criticism due to its impact on the original ruins and its scale and completeness in the context of the surrounding low-lying ruins.⁵

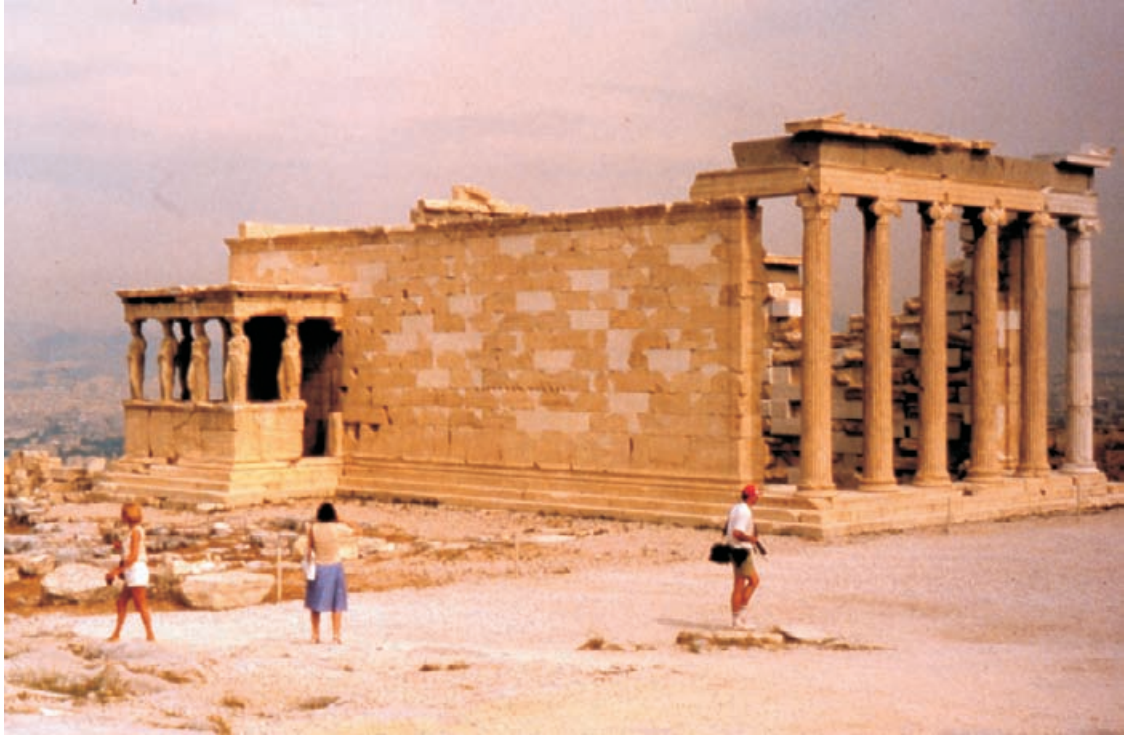
Figure 5.4 *The Erechtheion on the Acropolis, Athens, Greece, one of the monuments subject to the ongoing programme of conservation work (photograph: C. Woolfitt).*

Dismantling and reconstruction of ancient ruins is sometimes necessary to rectify the failure of past interventions. Corrosion of ferrous fixings in ashlar masonry is a common problem and one that afflicted the ruined monuments on the Acropolis in Athens (Figure 5.4). The current, extensive programme of work on the Acropolis entails localised reconstruction – dismantling of ashlar masonry, removal of the ferrous fixings and other defective repairs installed in past reconstruction work – as well as some introduction of new stone to fill lacunae and replace missing blocks. The general approach and scale of reconstruction work contrasts markedly with the treatment of the Stoa of Attalos (Figure 5.3), although, in fairness, the two schemes of work are separated by several decades, during which period the international conservation movement grew. Sculpture is removed to a museum environment and replaced with replicas; the threat posed by the corrosive
