CONSERVATION OF RUINS

John Ashurst

Edited by John Ashurst

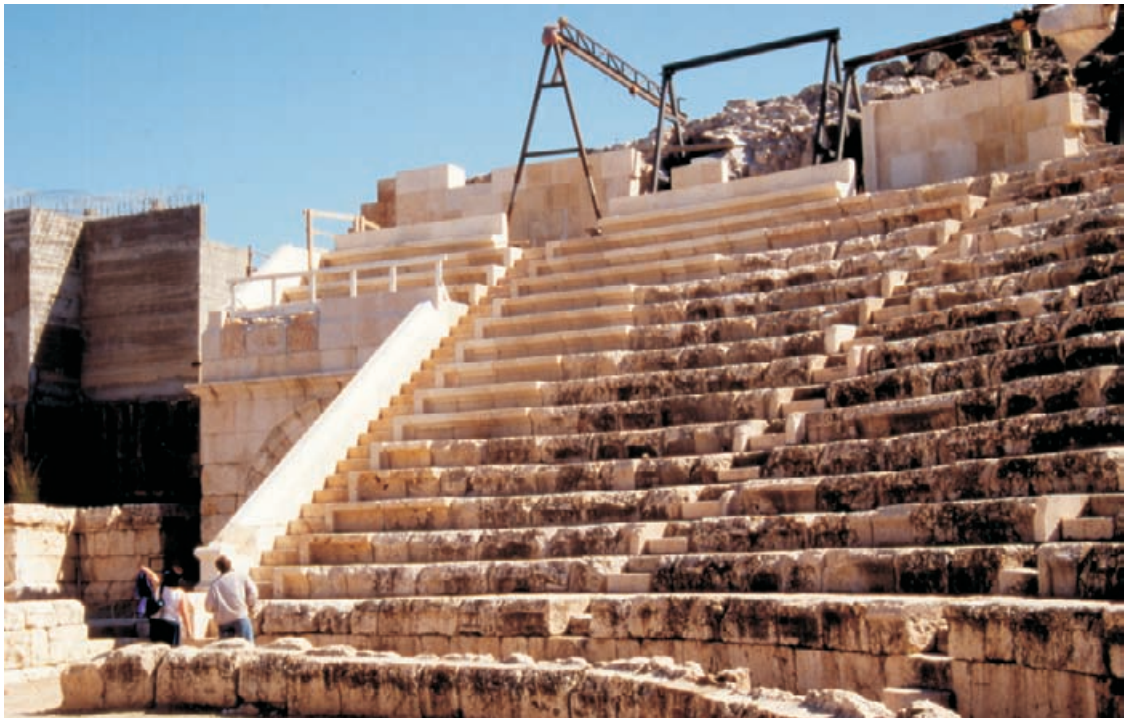
Figure 5.6 *Reconstructed section of the theatre of Beit She'an in Israel (photograph: C. Woolfitt).*

Reconstruction of part of a ruined monument is sometimes carried out to permit or facilitate its particular use. Seats and steps in ancient Greek and Roman theatres are often reinstated, either partially or completely, to provide access for modern performances. This has occurred, for example, at the theatres of Epidaurus (Sanctuary of Asklepios, mainly in the 1950s and 1960s) and Athens (Odeion of Herodes Atticus) in Greece, and more recently at Caesarea and Beit She'an in Israel (Figure 5.6). In the case of Caesarea this involved very substantial reconstruction and introduction of new concrete elements to support upper levels of seats (Figure 5.7). One principle of reconstruction on archaeological sites is that new work should be visually distinguishable from the original. The pristine condition of new ashlar stonework often contrasts strongly with the weathered original, but this initial contrast may become less obvious with weathering. Seating in a different material would be more readily obvious as a modern insertion. A section of new seats at the amphitheatre of Beit Guvrin in Israel has, for example, been erected in timber on a metal frame.

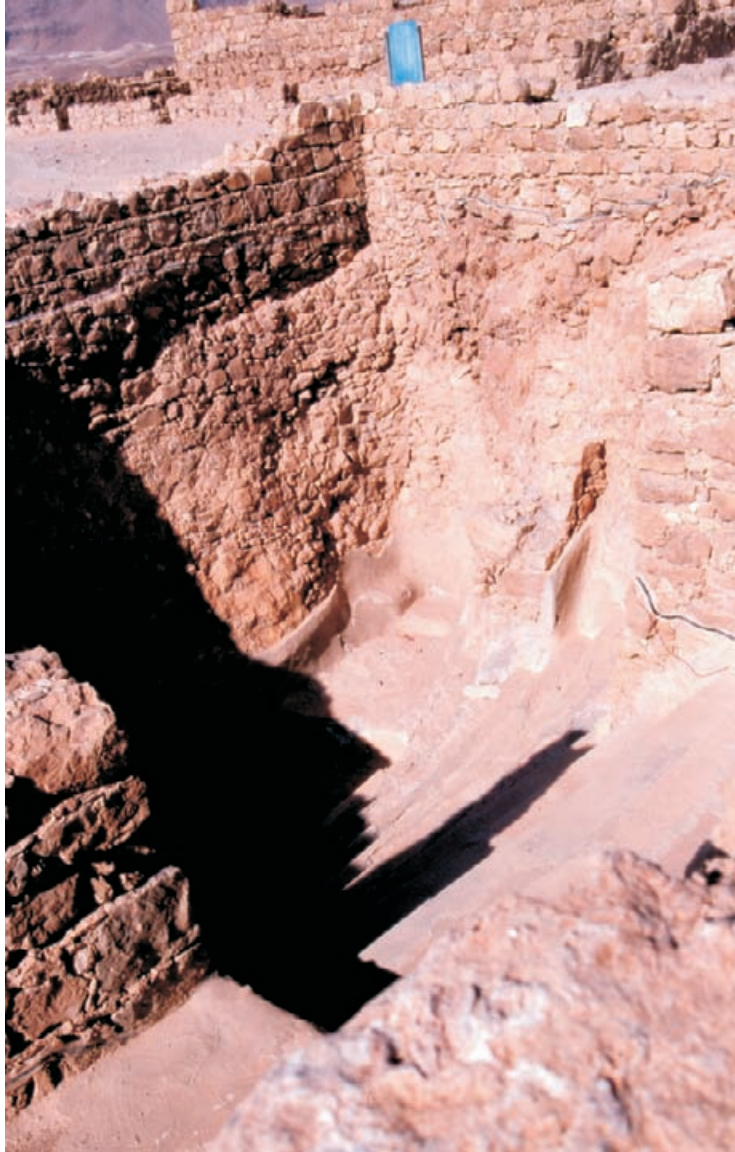
Figure 5.8 At Masada in Israel a black line through masonry joints is used to delineate rebuilt masonry from the original (photograph: J. Ashurst).

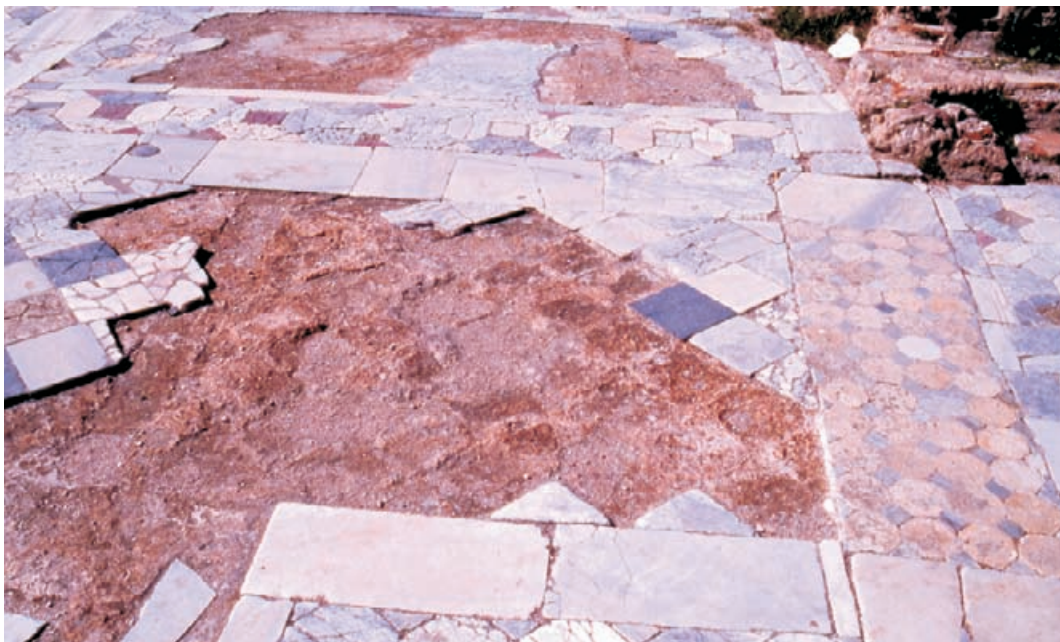
Figure 5.9 Section of ancient *opus sectile* pavement suffering gradual loss from visitor traffic and exposure; imprints of missing stones are visible (photograph: C. Woolfitt).

The consequences of leaving ruined sites exposed without any protective measures or even minimal maintenance to remove invasive plants and their damaging root systems are depressingly familiar. The vulnerability of various materials and agents of deterioration are discussed further at the end of the chapter, but several illustrations (Figures 5.9–5.12)

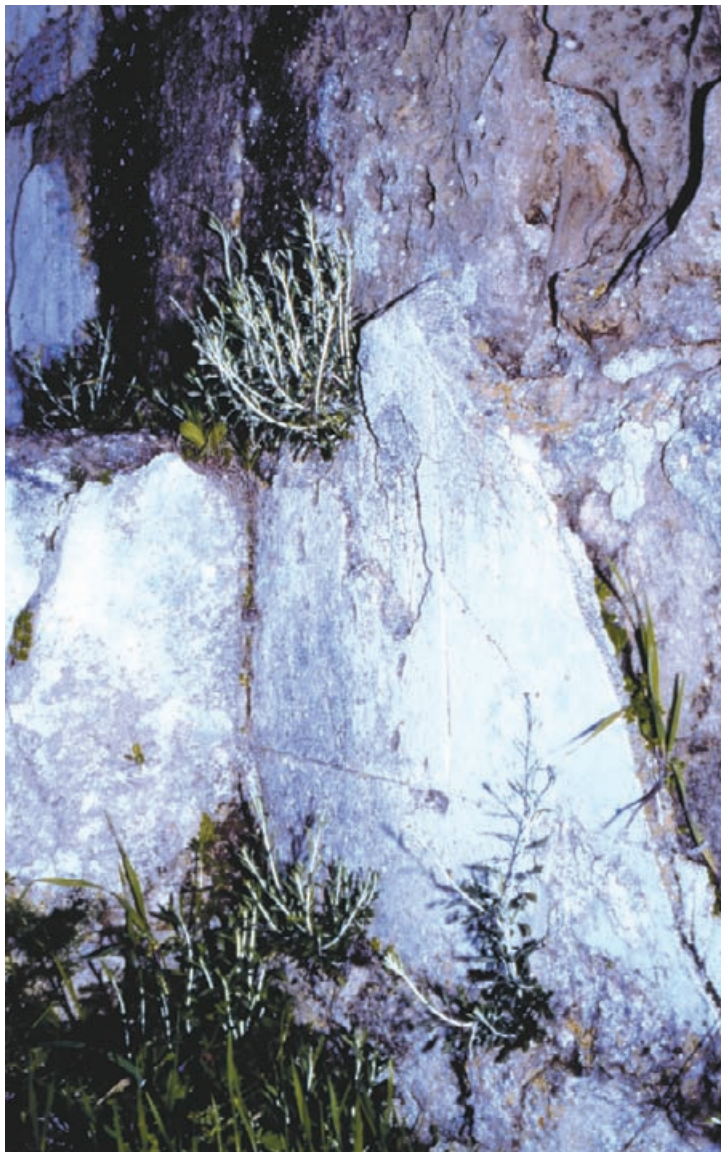
Figure 5.10 Wall plaster, lined out in imitation of ashlar, with detachment caused by the combined effects of vegetation and exposure to weather (photograph: C. Woolfitt).

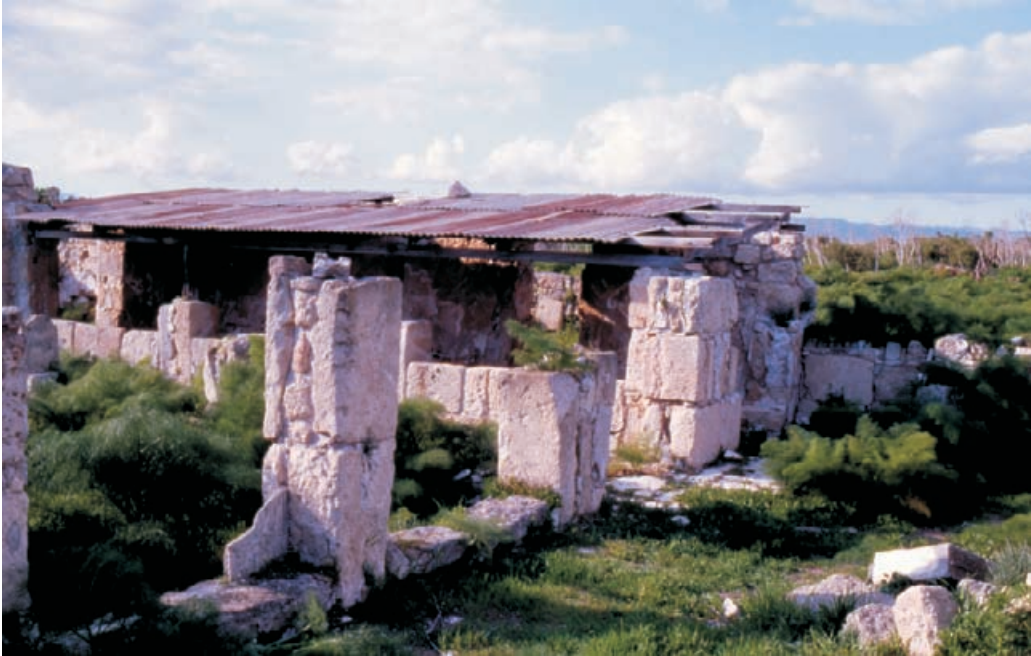
Figure 5.11 A neglected shelter and ancient site lacking maintenance, where vegetation grows uncontrolled (photograph: C. Woolfitt).

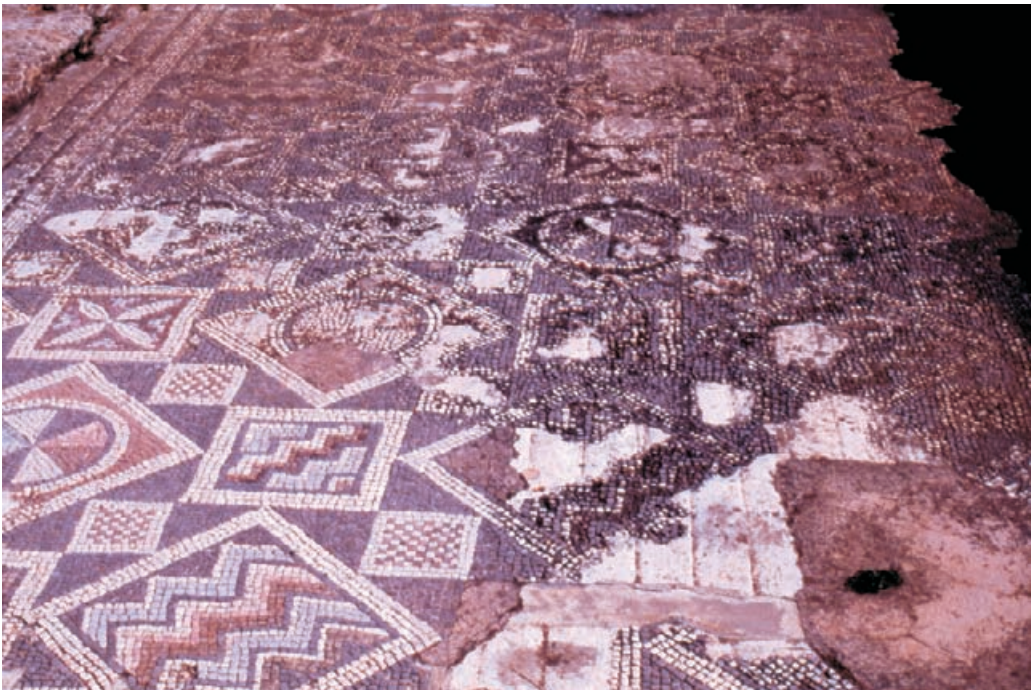
Figure 5.12 Exposed Byzantine mosaic pavement, with the pattern of water ponding and saturation reflected in the organic growth (photograph: C. Woolfitt).

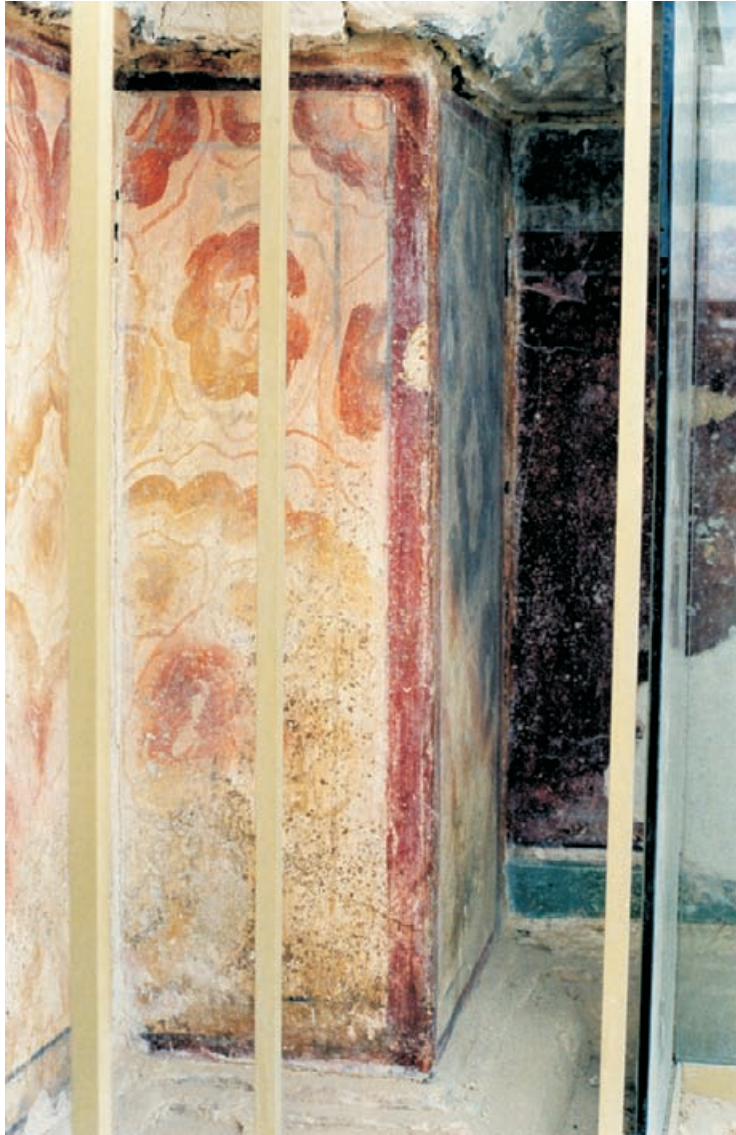
Figure 5.13 Detail of wall painting on the lower terrace at the Northern Palace, Masada in Israel, with pitting to the lower section from soluble salts (photograph: C. Woolfitt).

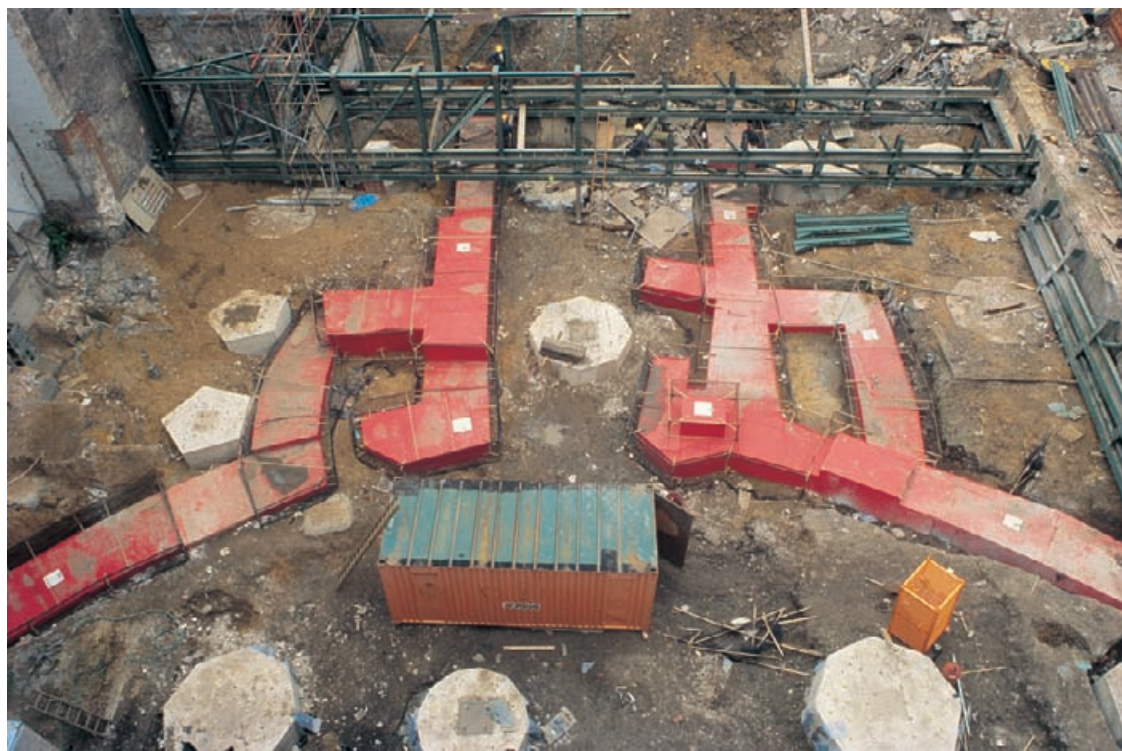
Figure 5.14 View of protected remains of the Roman amphitheatre in the course of redevelopment at the Guildhall, London (photograph courtesy of Museum of London Archaeology Service).

excavations in 1988 and designated a scheduled ancient monument (Figure 5.14). Designs for the new structure, the Guildhall Art Gallery, were consequently modified and adapted to accommodate the Roman remains and to ensure their protection whilst two new basement levels were formed below the level of the amphitheatre. Considerable engineering work was required to support the Roman remains *in situ*, by underpinning and strategically locating the piles to support the new structure around the ancient remains.

The amphitheatre walls were protected in two phases during the long construction process. First, for the piling operation carried out from a suspended steel deck above the amphitheatre, the remains were boxed in with plywood, with a layer of thick polythene protecting the masonry surfaces and the void between the masonry and plywood box filled with expanding sprayed foam. In preparation for the second construction phase, of underpinning, the remains were boxed in with concrete block. Prior to commencing the second phase, the entire area was dried out and the environment within the plywood

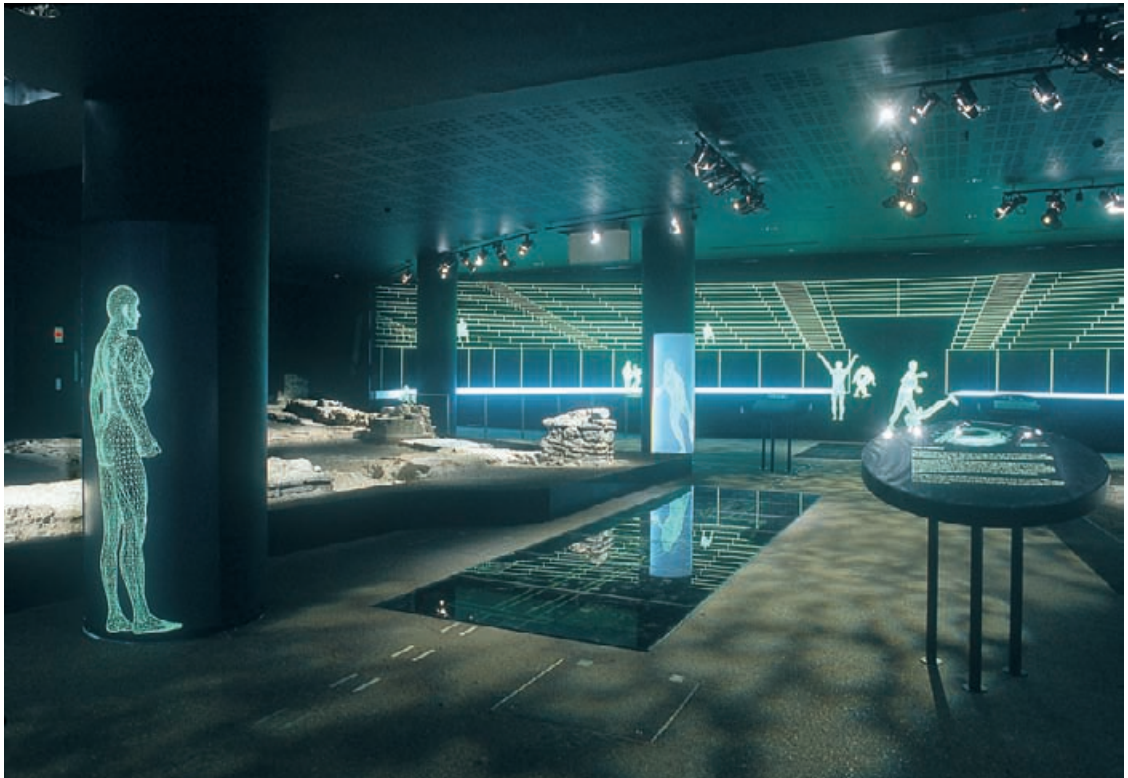
Figure 5.15 *The remains of the Roman amphitheatre in London displayed in the basement of the Guildhall (photograph courtesy of Museum of London Archaeology Service).*

The amphitheatre walls were underpinned using needles and a new concrete slab was formed beneath the remains, connected to the main floor slab. Once ambient relative humidity had stabilised to 50 per cent relative humidity, the masonry remains were uncovered gradually over a period of 15 weeks, with regular monitoring of masonry condition. No deterioration was observed and the remains are now displayed and interpreted. The display includes timber elements of the amphitheatre, which were removed from site for conservation and subsequently reinstated. Ruins displayed in such urban basement settings are often drab and uninspiring, but in this case considerable effort has been made to give an imaginative impression of the amphitheatre's original function and form, using dramatic lighting, projection and sound (Figure 5.15).

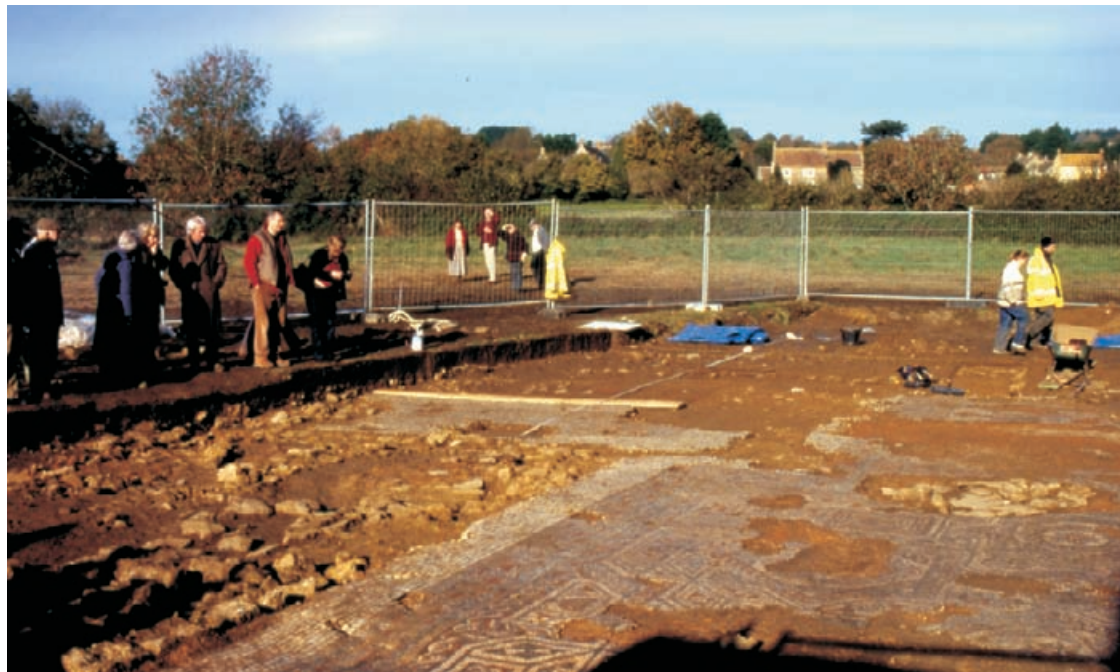
Figure 5.18 *View of the excavated Roman mosaic at Lopen in Somerset, prior to reburial (photograph: G. Abrey).*

recently excavated Roman mosaic at Lopen in Somerset (Figure 5.18). In this instance, the mosaic was reburied after recording and consolidation of fragile edges. Reburial included the following: a cover of soil directly on the mosaic surface, a layer of TerramTM geotextile, more soil, strategically placed concrete slabs and finally a cover layer of soil, formed into a slight mound.²³ The same process was used for reburial at the Roman villa site at nearby Dinnington. At Chedworth, Roman villa mosaics not protected by the existing cover buildings have also been reburied. A cover layer of gravel has been used for protection against burrowing rodents and vegetation.²⁴

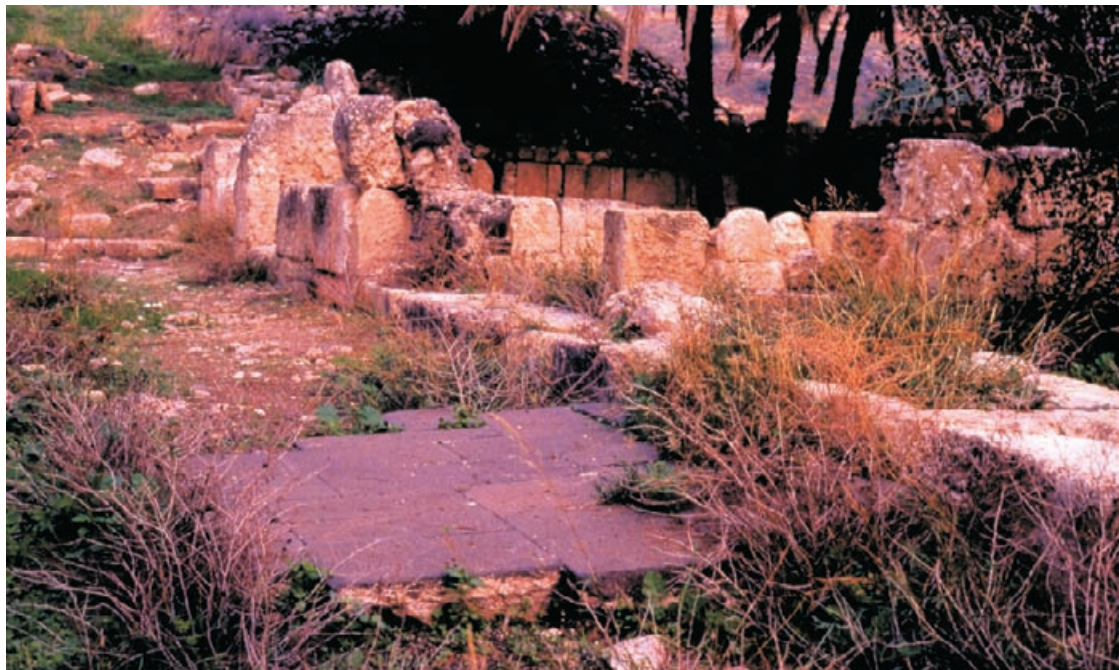
Figure 5.19 Section of mosaic pavement at Horvat Minim in Israel covered with geotextile, pozzolanic pellets and sand, which were found to be ineffective in protecting surfaces from vegetation (photograph: G. Abrey).

on mosaic surfaces. If mosaics are not covered to sufficient depth, vegetation and root systems can also cause damage, even where geotextiles are used. Sand and clay pellets have also been used directly over mosaic surfaces in the past but neither is ideal for this purpose. Experience has shown that fill should be in intimate contact with the mosaic surface, in the way that soil provided protection prior to excavation. Fill of sand or clay pellets will have large pores and voids at the interface with the mosaic. Soil is preferable as a fill material in direct contact with a mosaic. If sand is to be used it should be free of contaminants which cause staining and of soluble salts. Any cover or fill material should be chemically inert and its pH compatible with the mosaic; the lime mortars used in mosaics are alkaline, so acidic fills should be avoided.

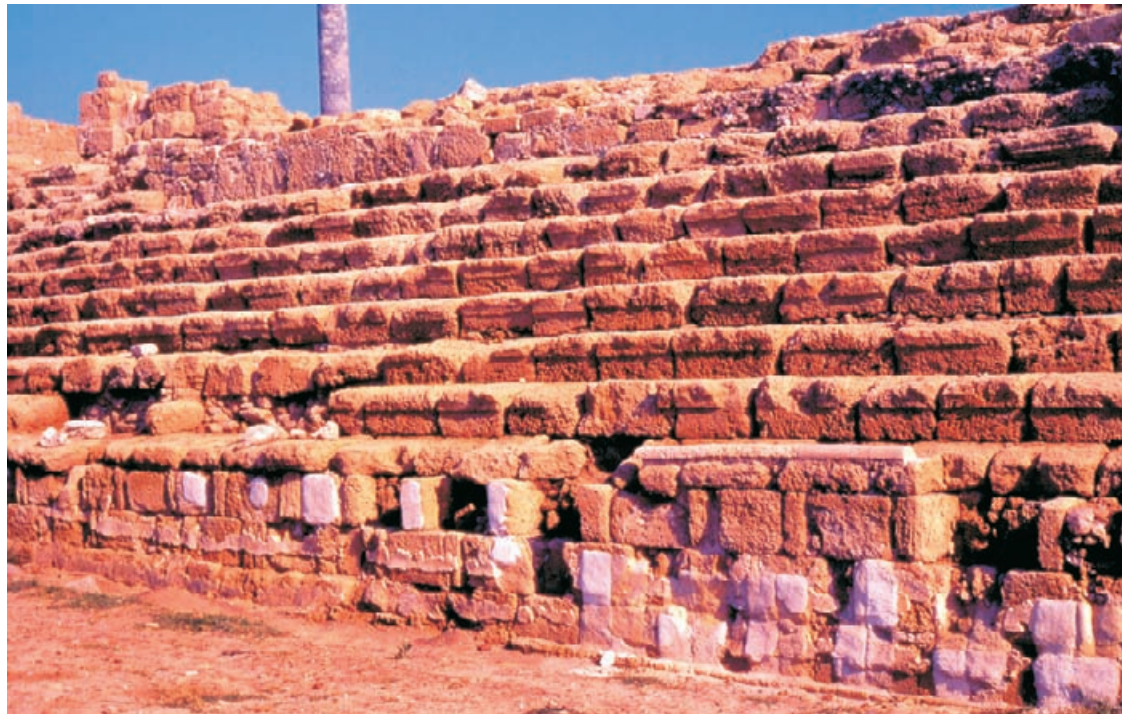
Figure 5.20 *View of the Hippodrome at Caesarea in Israel, a site of recent testing of sacrificial lime plasters for protection of original plaster surfaces in a severely exposed marine environment (photograph: C. Woolfitt).*

synthetic polyester fabrics such as Holytex™ has been considered, along with sacrificial lime-based plasters, which have been tested at the Hippodrome at Caesarea as removable protective coatings in an exposed marine environment.^{15,27} At Caesarea such plasters were found to prevent alteration of the original surfaces and to be removable without damage to the underlying plaster. This research included the use of various aggregate and fillers, including pozzolans and coloured fibres as visible markers to distinguish applied plaster layers. In the light of recent experience in the conservation of mosaics, it seems advisable to approach the use of geotextiles and other synthetic textiles in direct contact with any decorative surface very cautiously. The use of protective earth or weak lime (non-hydraulic or high calcium lime) plasters would, however, seem to be viable options as protective measures in preparation for reburial. Any system should be tested on a small area of the surface to be protected, to assess properties such as adhesion, ease of removal, any residual staining and other consequences.

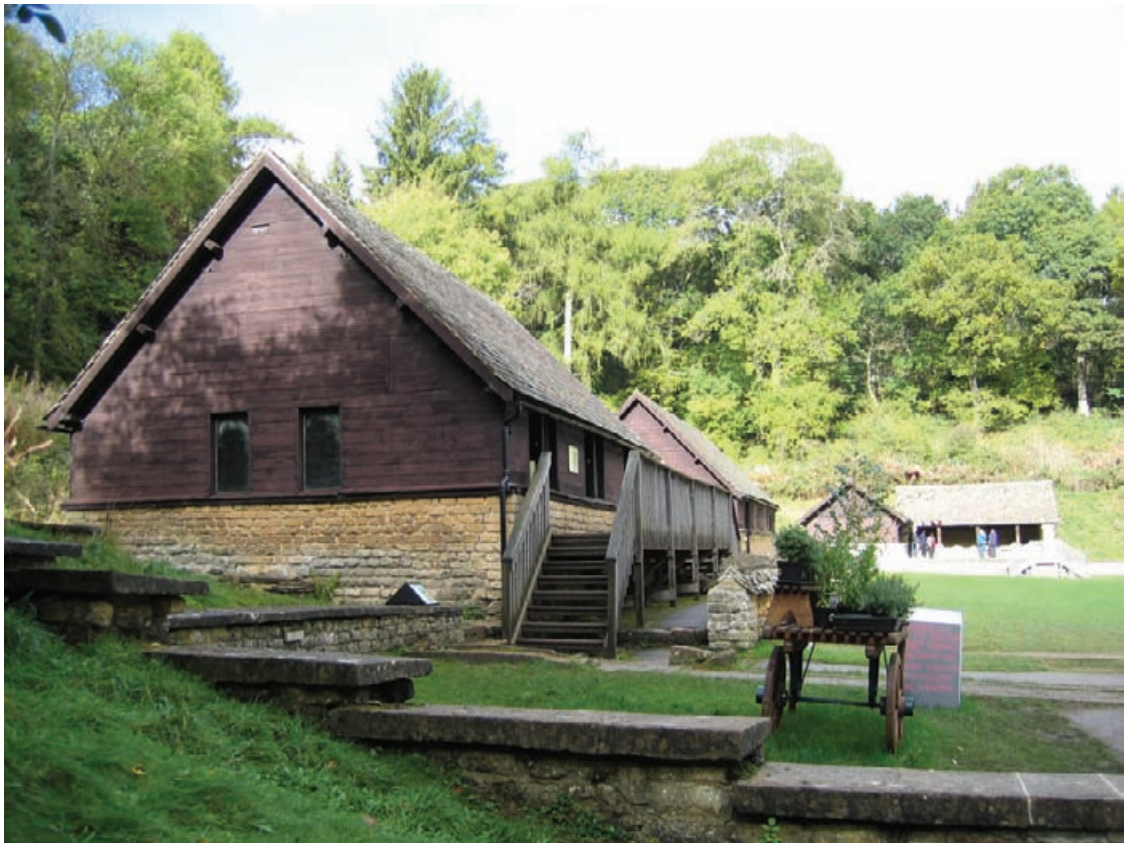
Figure 5.21 *View of nineteenth century enclosure buildings over the remains of a wing of the Roman villa at Chedworth (photograph: C. Woolfitt).*

Early enclosure buildings such as those at Chedworth and Bignor are in traditional style and materials and, in general, have the appearance of agricultural buildings. Those at Chedworth are built upon the existing Roman walls and have timber-clad walls and stone-covered roofs. At Bignor they are in the form of rubble stone buildings with thatched roofs. The Chedworth cover buildings protect mosaics and other remains of rooms, mainly in one wing of the villa, and openings in the south walls, either doors or windows, provide access for viewing the remains. The nineteenth century Bignor shelters were comparatively small in scale, designed to enclose individual rooms and mosaics. The current, more recent display building incorporates some of these

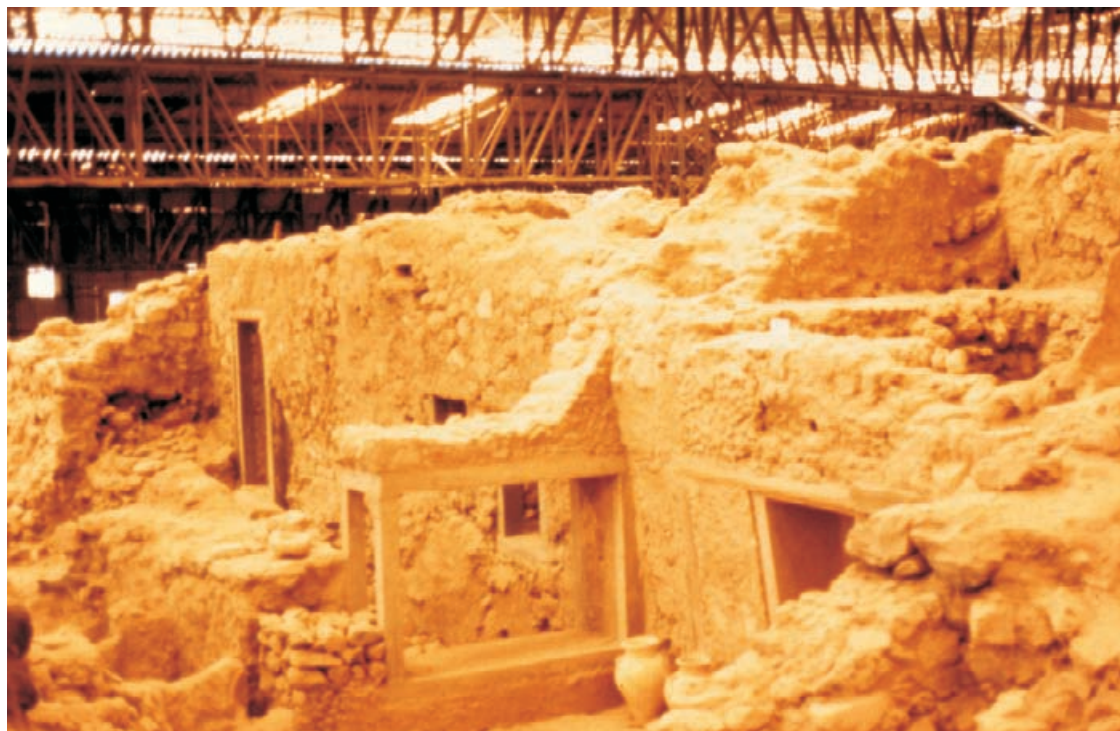
Figure 5.23 View of the Bronze Age site of Akrotiri on the Greek island of Santorini in 1987; a new protective enclosure building is under construction (photograph: C. Woolfitt).

Shelters built in the latter half of the twentieth century, particularly those over large ruined sites, have tended to be industrial in nature and appearance. The shelter at the Bronze Age site of Akrotiri, on the Greek island of Santorini, consisting of a Dexion frame, which is soon to be superseded (construction of a new enclosure is in progress at present), is an example of this. At Akrotiri the shelter extends over the entire excavated area of the site and the structural remains stand to more than one storey, so that the shelter is necessarily large. The new structure is intended to be more environmentally friendly than the one it replaces, with roofs designed to be less conspicuous in the landscape. Shelters which rely on concrete construction, such as the 1960s concrete framed shelter over the Early Bronze Age House of Tiles at Lerna in Greece, also tend to be industrial in appearance. At least the architecture of the cover buildings, in such cases, is purely functional and does not compete with the archaeological remains for attention.

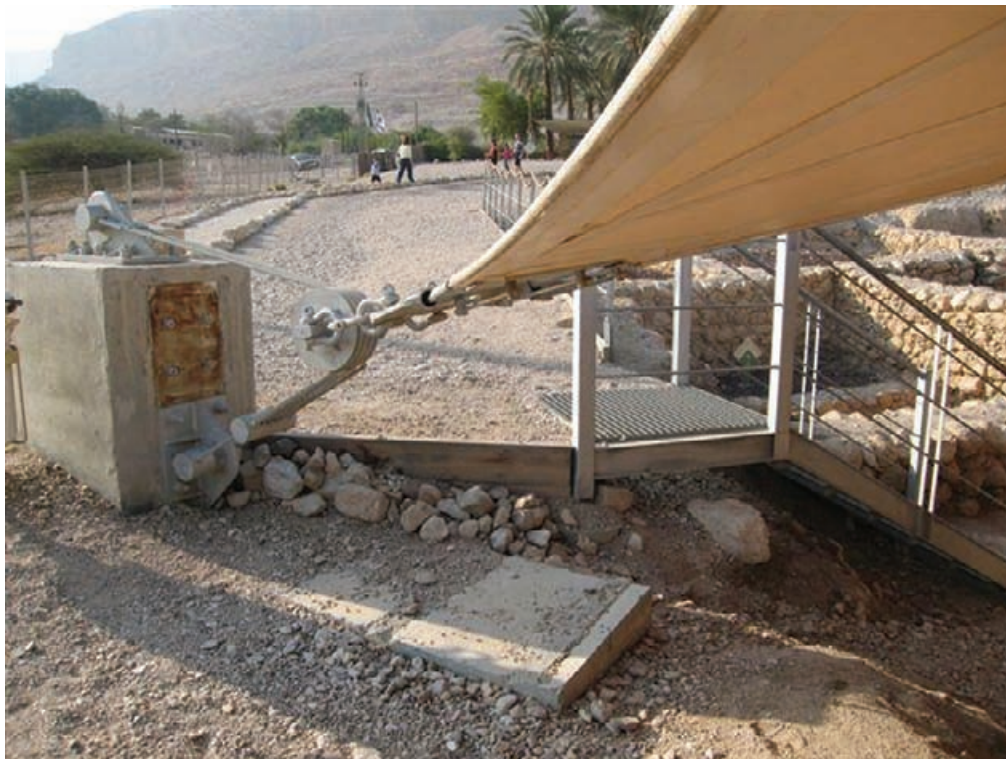
Figure 5.25 *Detail of anchor for the Ein Gedi shelter shown in Figure 5.24 (photograph: Orit Bortnik).*

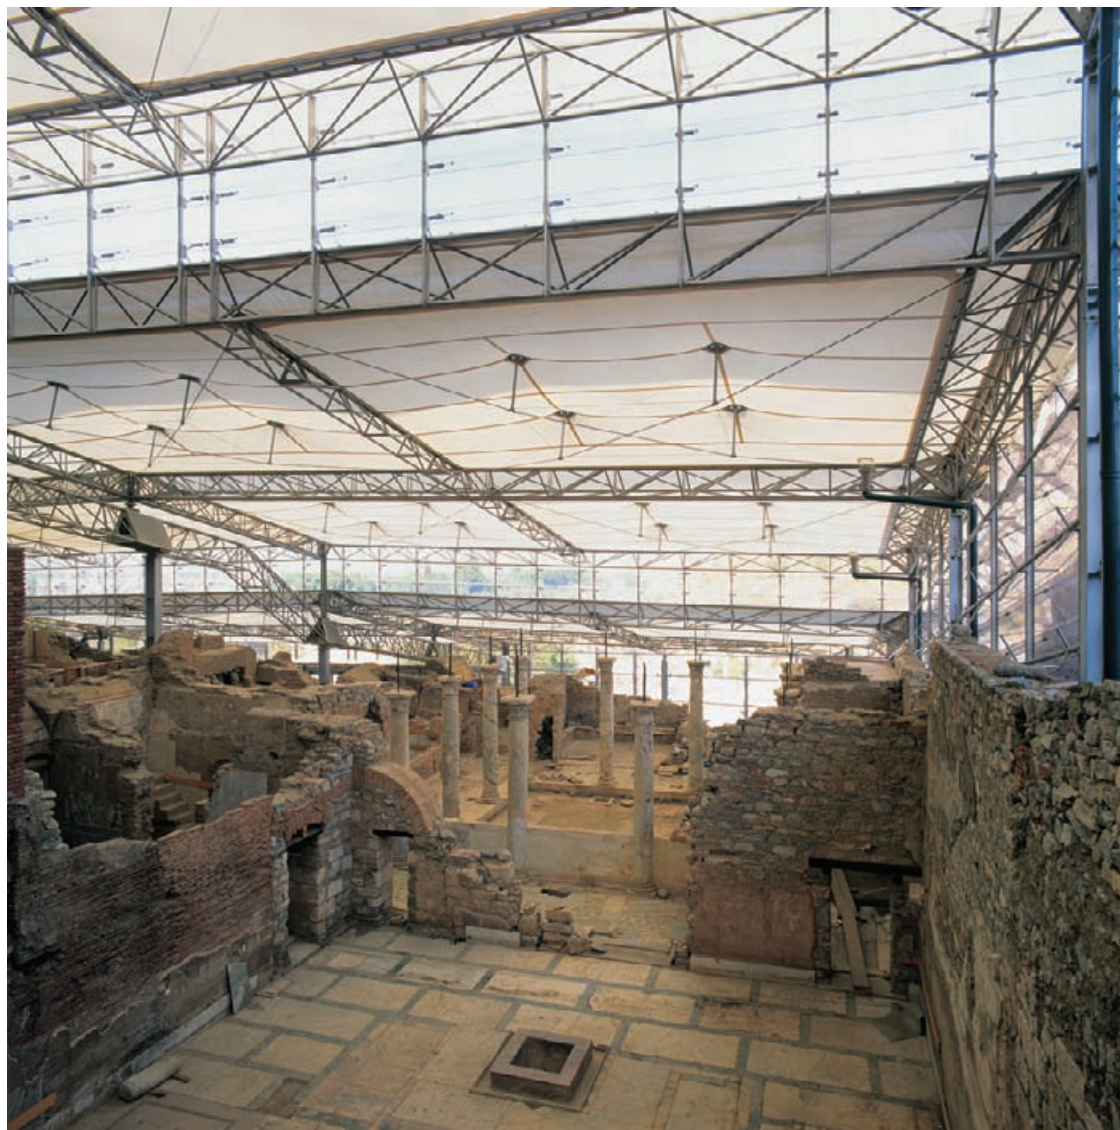
Figure 5.28 Interior of the new enclosure at Ephesus, with translucent roof and wall cover (photograph courtesy of the Austrian Archaeological Institute).

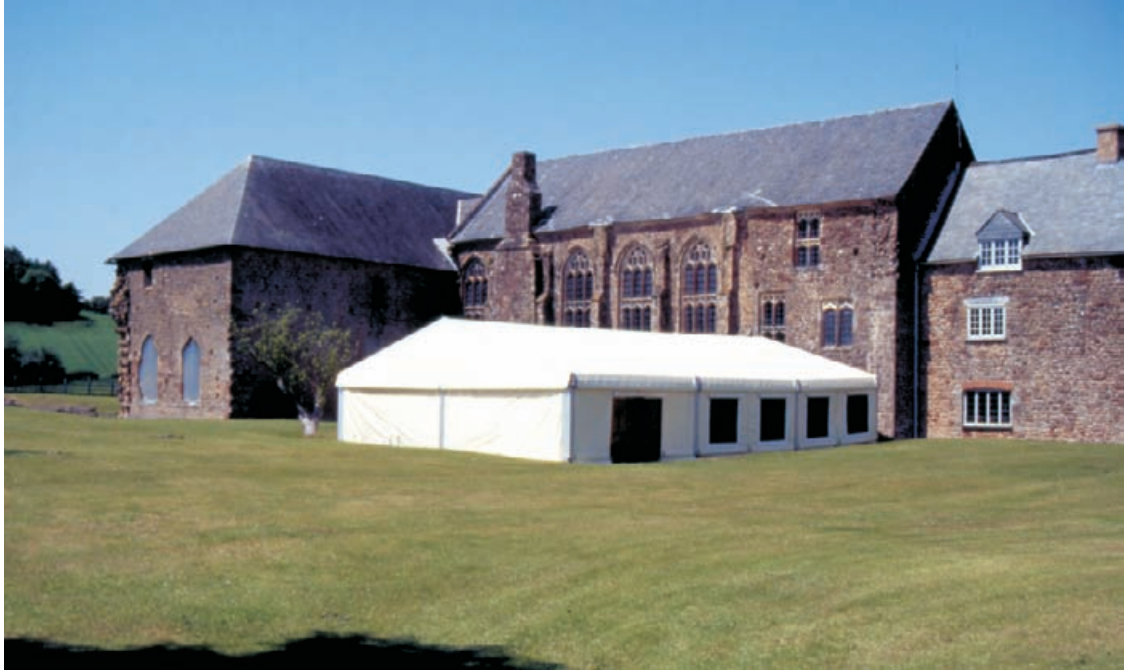
Figure 5.29 View of the tent-like shelter structure over tile pavement at Cleeve Abbey (photograph: J. Ashurst).

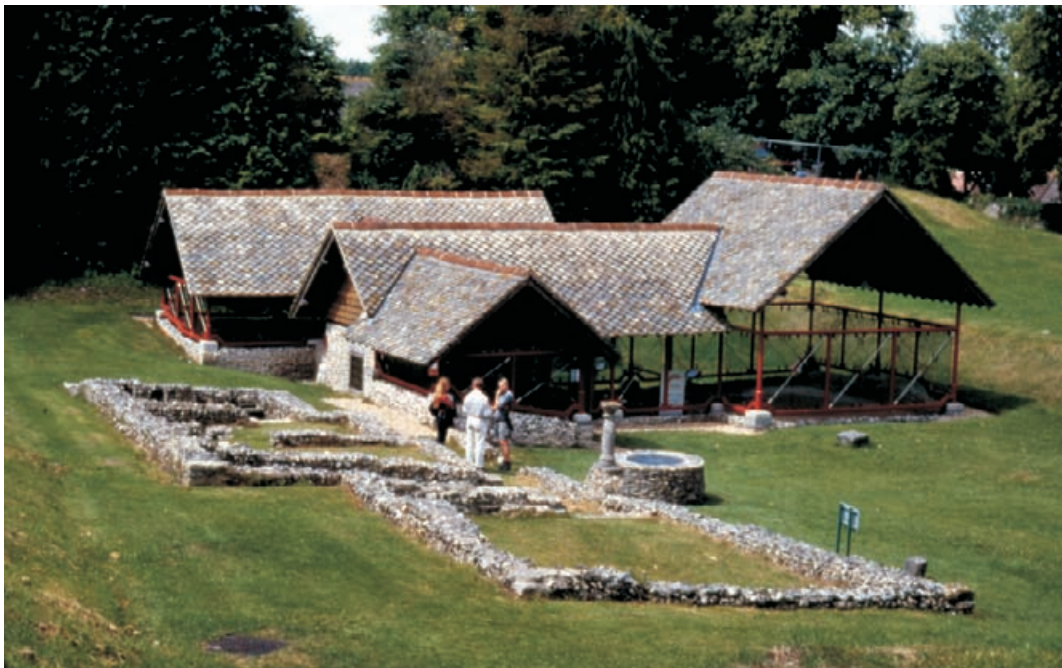
Figure 5.31 The recent protective building over the west range of the Roman Town House in Dorchester (photograph: C. Woolfitt).

Another recent and interesting example in England is the enclosure building over the west range of the Roman town house in Dorchester in Dorset, which combines contemporary and traditional elements. Here the design of the cover building, and the roof profiles, give some impression of the volume and form of the Roman building. The projecting eaves help prevent solar gain through the glass elevations. Purbeck stones used for the roof cover have been formed to replicate the Roman originals found during excavation. The plate glass that encloses the elevations is fixed to the structure’s tubular metal frame with ventilation gaps between the frame and glass, and hinging of some panels for additional ventilation when required.

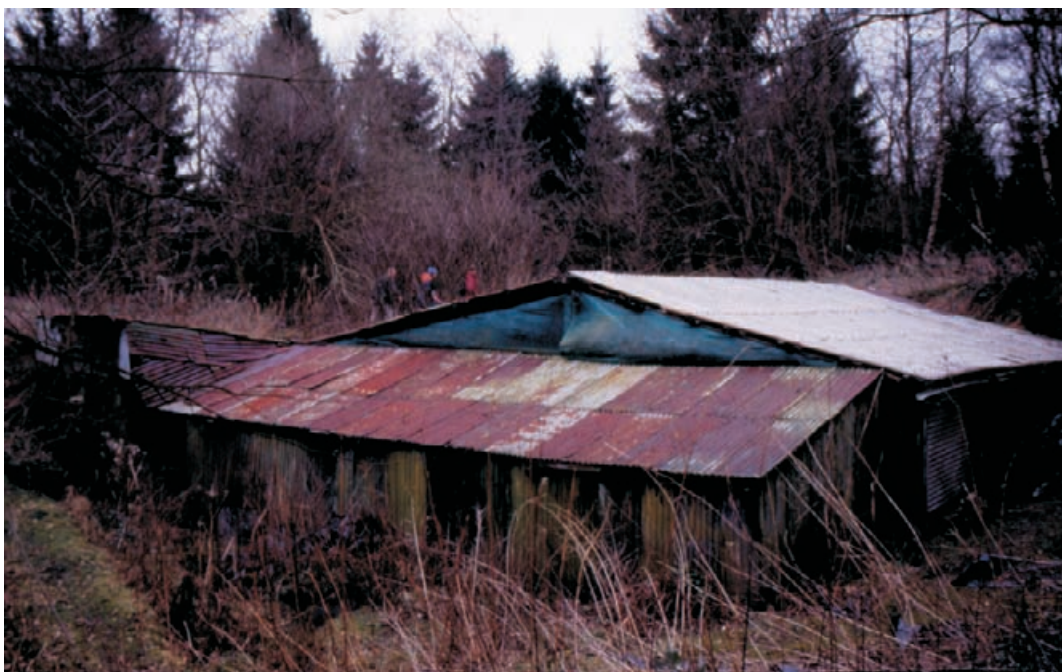
Figure 5.32 Temporary shelter over Roman remains situated in a natural depression in the landscape (photograph: C. Woolfitt).

plaster and mosaics. Surfaces typically appear green or dark (black) from organic growth, which can include fungi, commonly known as moulds. Wetting and drying and salt crystallisation can adversely affect stone, lime plaster and brick, resulting in friable and weakened surfaces. Figures 5.32 and 5.33 illustrate this situation. In this case Roman remains have been protected under an ad hoc shelter, intended to be temporary, at a site where groundwater levels and other environmental factors contribute to ongoing decay of masonry surfaces.

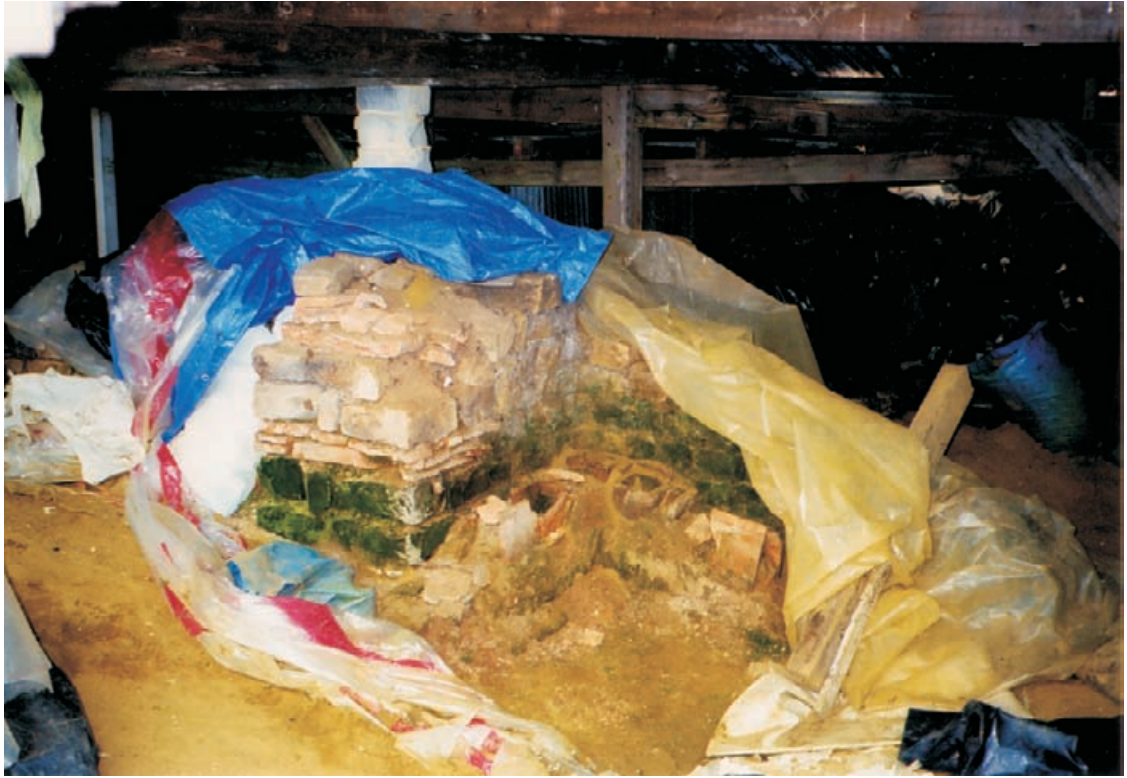
Figure 5.33 Detail of typical condition of masonry remains within the shelter shown in Figure 5.32, with damp conditions, deteriorating and friable surfaces supporting organic growth (photograph: C. Woolfitt).

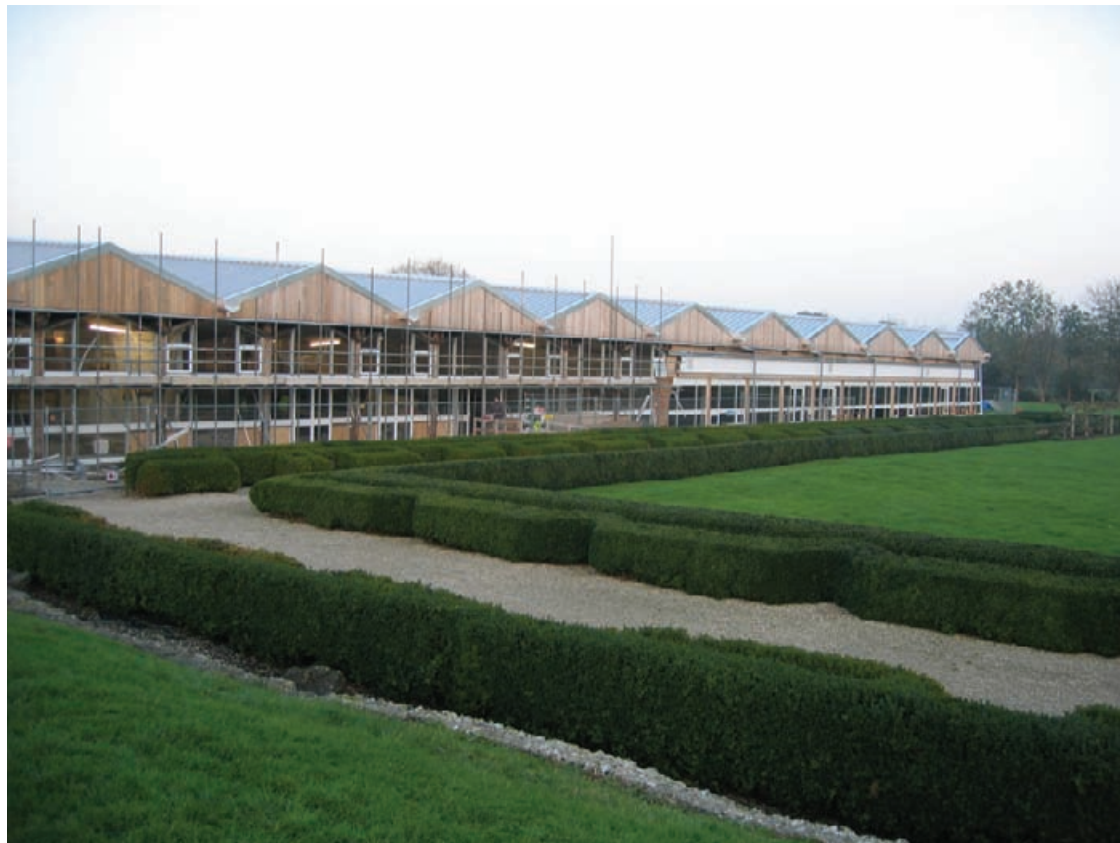
Figure 5.34 General view of the south elevation of the enclosure building at Fishbourne Roman Palace, in the process of modernisation and upgrading (photograph: C. Woolfitt).

The enclosure building over the remains of the north wing of Fishbourne Roman Palace in West Sussex was built in parallel with the later stages of excavations in the late 1960s.³⁵ Problems with groundwater and the condition of the mosaics prompted lifting and relaying of some mosaics at that early stage; others were lifted and relaid subsequently on impervious membranes in the 1980s. Current modernisation of the 1960s structure, of timber, aluminium and glass, is being carried out as part of a wider programme of upgrading of interpretation facilities at the site, supported by the Heritage Lottery Fund. Work to the enclosure building includes improvements to lighting and internal

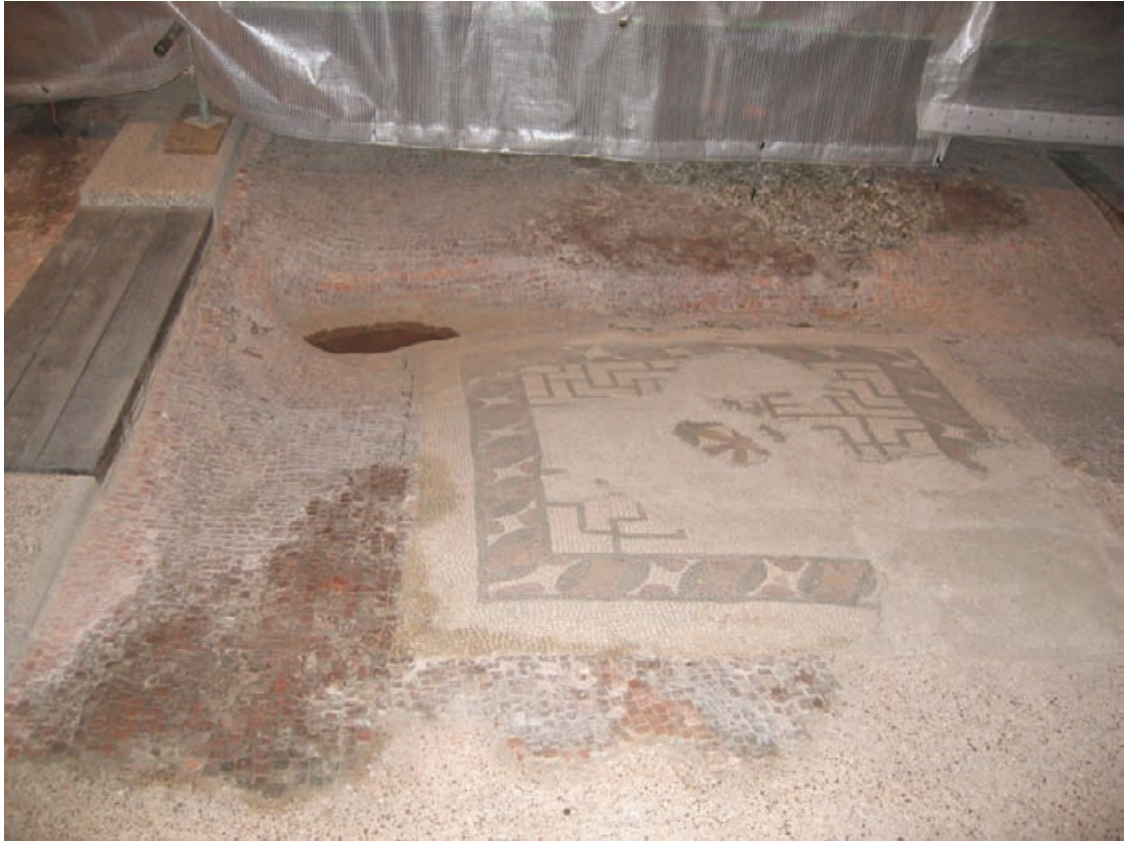
Figure 5.35 Detail within the enclosure building at Fishbourne, with groundwater ponding on the mosaic surface and causing staining (photograph: C. Woolfitt).

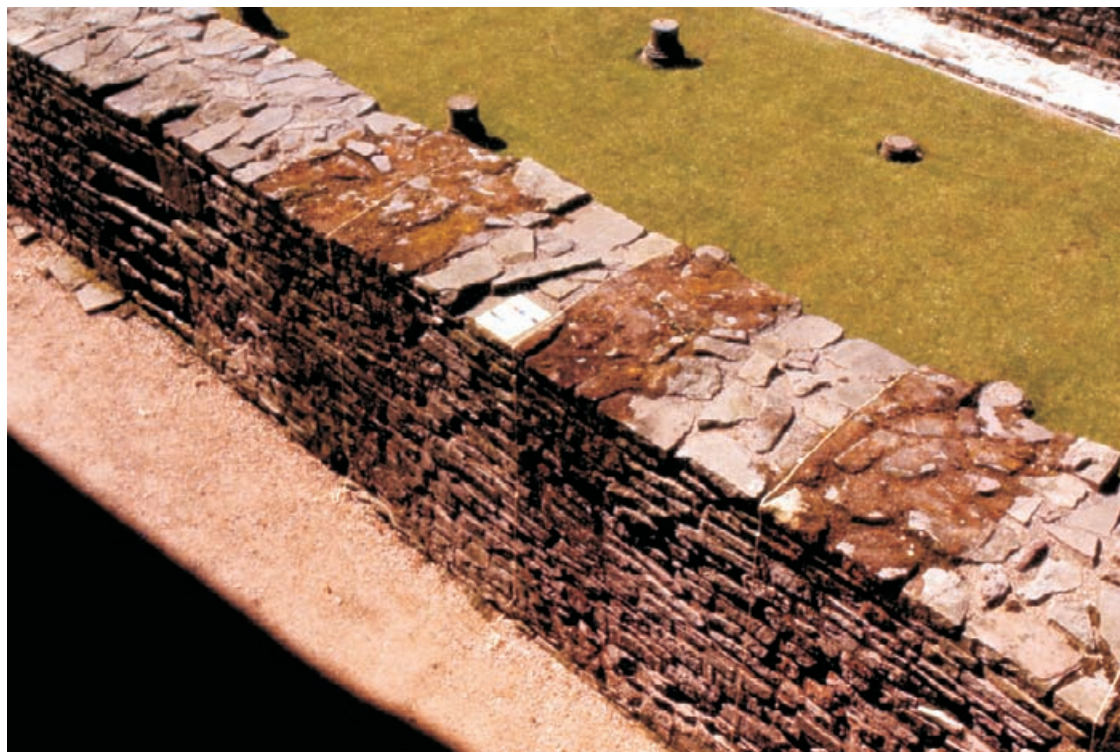
Figure 6.1 *Biocide trials at Tintern Abbey in 1972, carried out by the Ancient Monuments Division and the Building Research Station. The objective was to compare different treatments against untreated controls, to identify the most effective and persistent materials to keep wall tops free of organic growth.*
