CONSERVATION OF RUINS

John Ashurst

Edited by John Ashurst

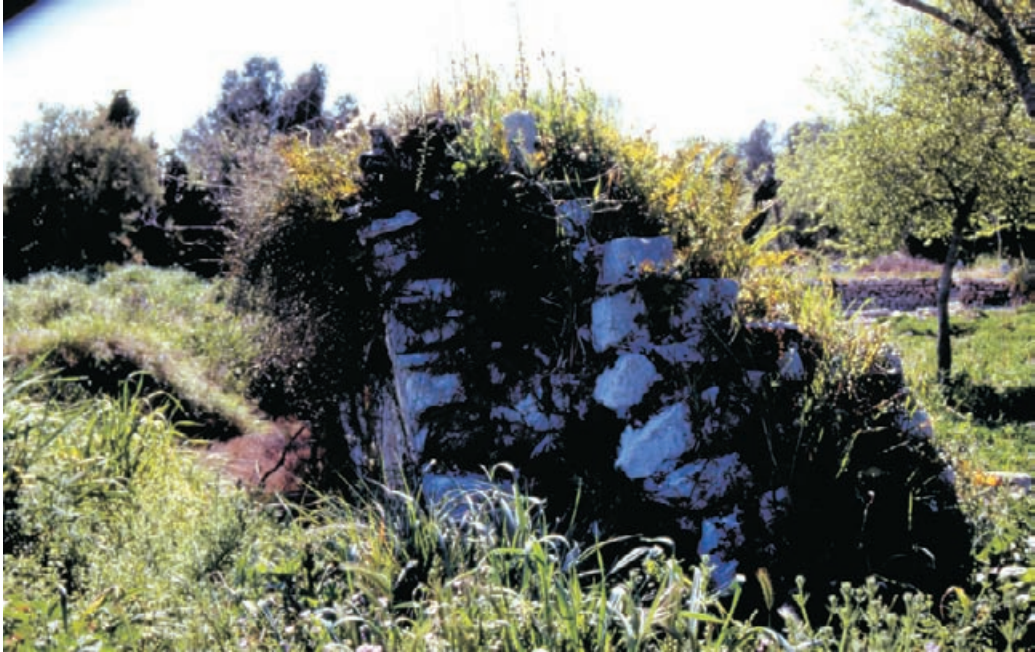
Figure 6.5 *Plants thriving on the lime core and sloping surfaces of collapsed walls at Butrint, Albania. On such an extensive site, zones such as these may be left in their 'natural' condition without loss or detriment to the monument.*

environments for a wide variety of plants (Figures 6.5 and 6.6). The archaeology of the stones may have an unusual bearing on plant colonies when, for instance, siliceous stones are transported to sites in limestone regions and become host to lichens and other plants not native to the region. Similarly, sandstone copings on brick or limestone walls may support species distinctly different from each other. Walls, generally, are not hospitable to many plants because of the lack of soil and water, sometimes coupled with extreme

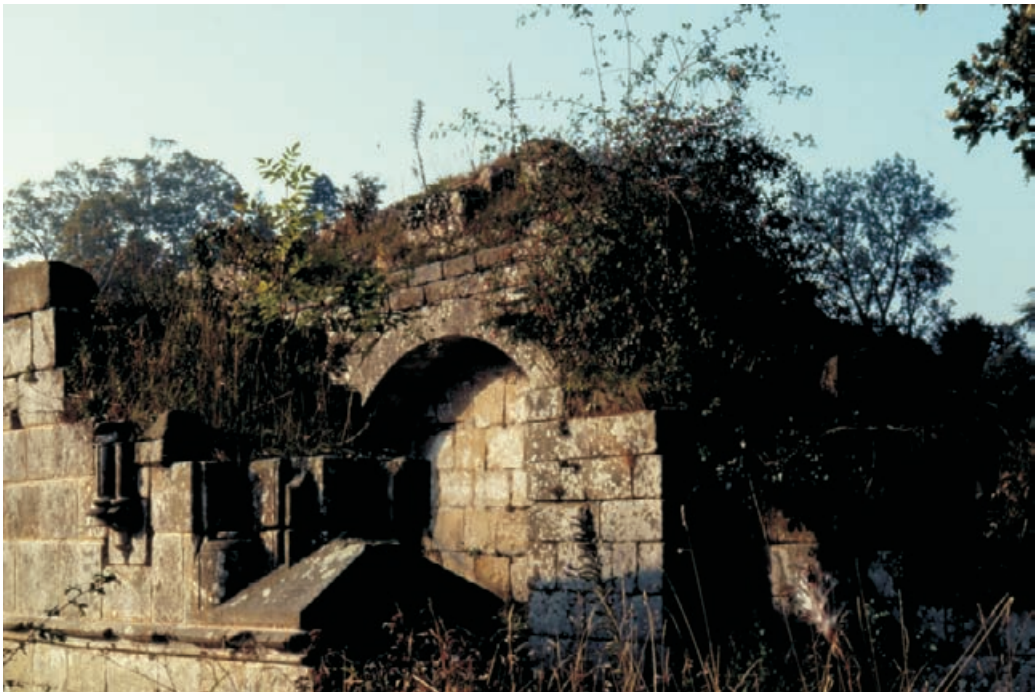
Figure 6.6 *Wall cover at Jervaulx Abbey, UK, including wild roses, is an undeniable asset to the site, but needs to be controlled to allow adequate stabilisation and masonry maintenance to be carried out.*

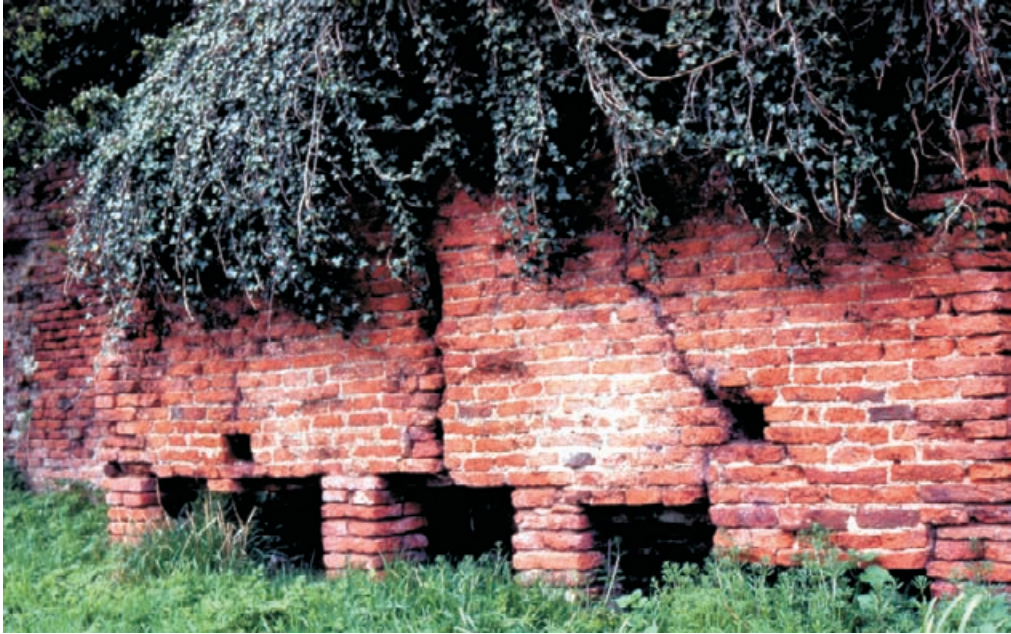
Figure 6.7 The late fifteenth/early sixteenth century brick precinct wall of a monastery, with its moat, now generally dry but seasonally wet, showing settlement fractures with brick underpins, mortar deterioration and luxuriant ivy growth. The wall is host to bats and masonry bees, sometimes to owls, and frogs, slow worms and newts are sometime inhabitants of the moat. The Conservation Management Plan includes recommendations for the management and maintenance of the site which must embrace and balance the preservation needs of the historic fabric and the needs of the natural inhabitants and their environment.

roost sites, and works must be halted as soon as they are identified; works should also be avoided during the roosting and breeding season, which generally occurs during May to September. Once bats are identified it is necessary to halt any works and to consult a specialist organisation or SNCO such as English Nature (EN), so that their presence can be recorded by an officer of EN and they can be temporarily removed from the site during the works if necessary. Once works are complete, they can be reintroduced onto the site as long as the conditions are maintained for their inhabitation (Figure 6.7).

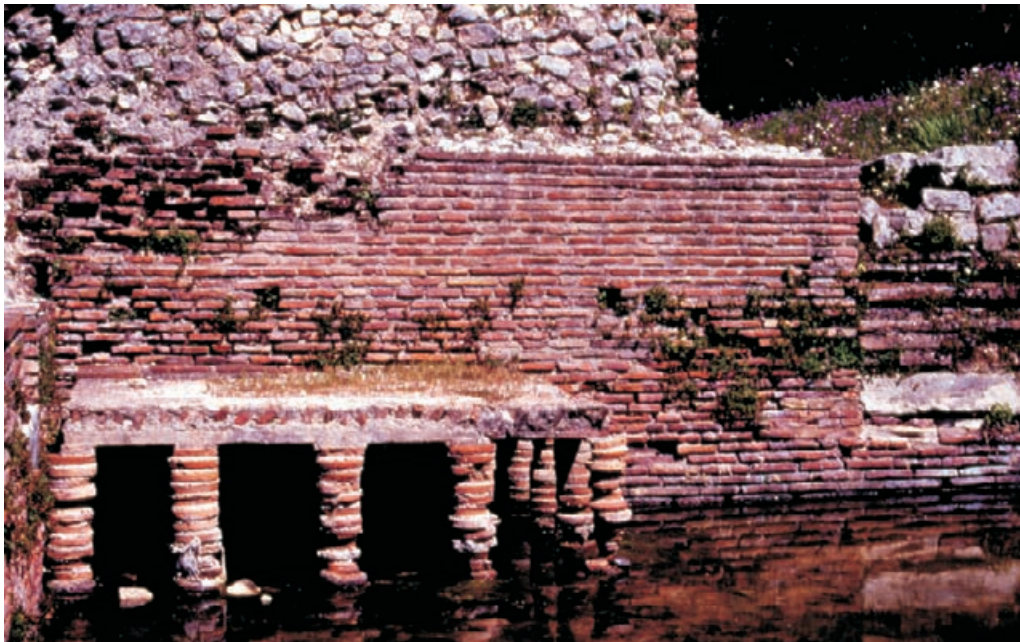
Figure 6.8 Flooded area of hypocaust, Butrint, now home to terrapins, requires draining if soluble salt damage to pilae is to be addressed. Alternative flooded zones with less sensitive fabric can be used for relocation.

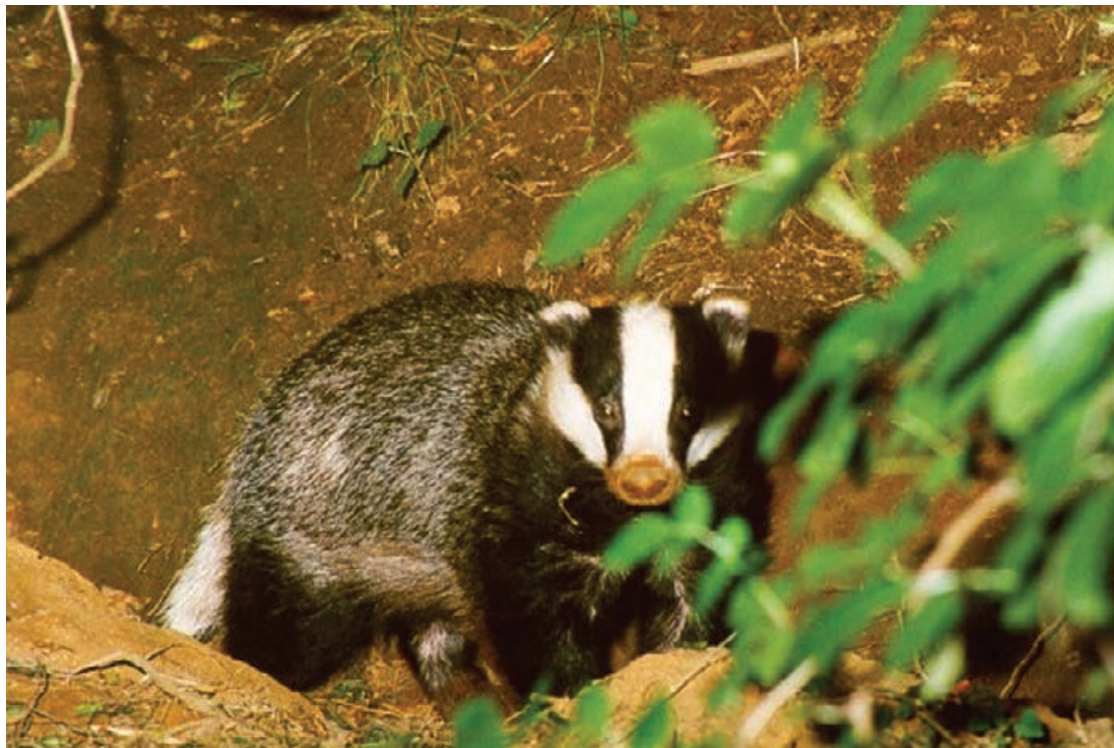
Figure 6.9 Underground engineering works by one of the UK's protected species, the badger, can become a problem for buildings and earthworks.

Another situation which sometimes needs to be addressed and resolved is the presence on site of burrowing animals such as moles, rabbits and badgers (Figure 6.9). These creatures create voids underground in the development of their habitats, and these indiscriminately excavated voids can cause the undermining, settlement and partial collapse of masonry walls and destruction of earthworks. Selective soil grouting of rabbit warrens in earthworks, once the population has moved out, is a stabilising conservation technique which is sometimes useful and appropriate. Badgers are a protected species under the provisions of the Wildlife Act 1981 and the Protection of Badgers Act, but these burrowing animals can be humanely controlled under the guidance of the SNCO. Their existence should be encouraged as they are rare and beautiful creatures which are now under the added threat of culling due to a disputed risk of their transmitting tuberculosis to cattle. Conditions can generally be improved via the works for the animals and fauna, and built into the ongoing management policy for the site.

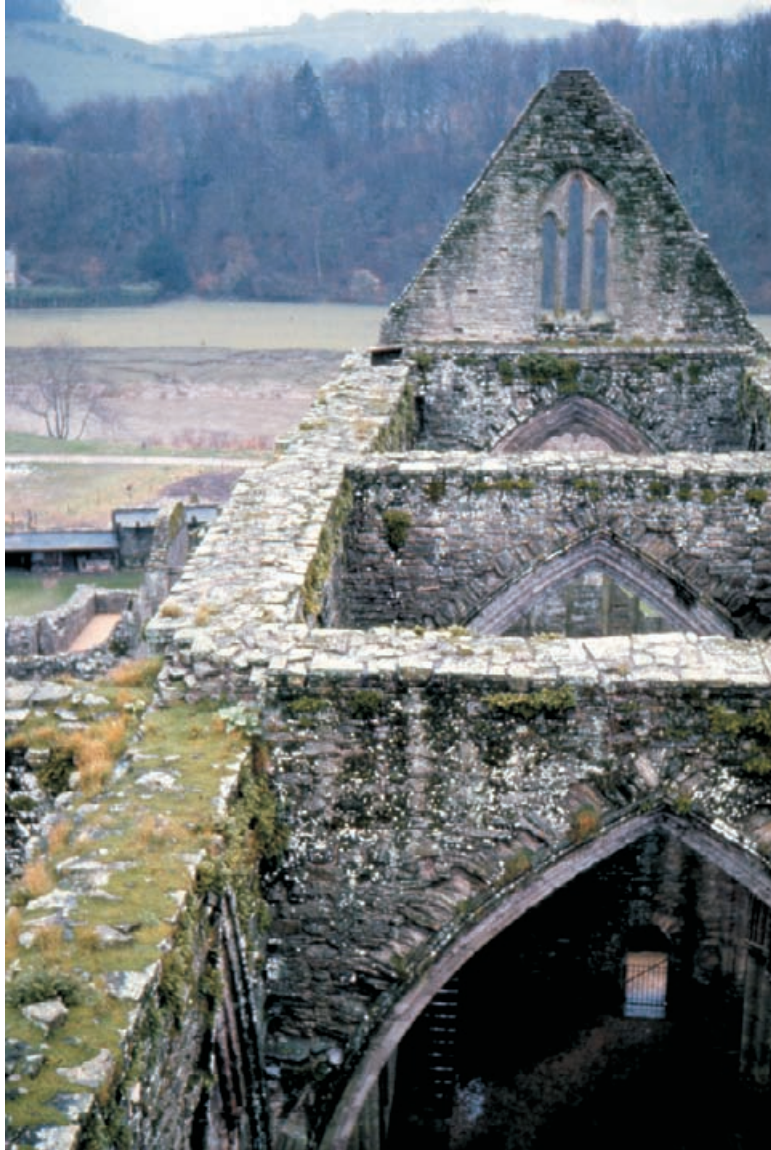
Figure 6.10 *Wall tops at Tintern Abbey showing formation of grass and bryophytes in the foreground and biocide-treated surfaces beyond.*

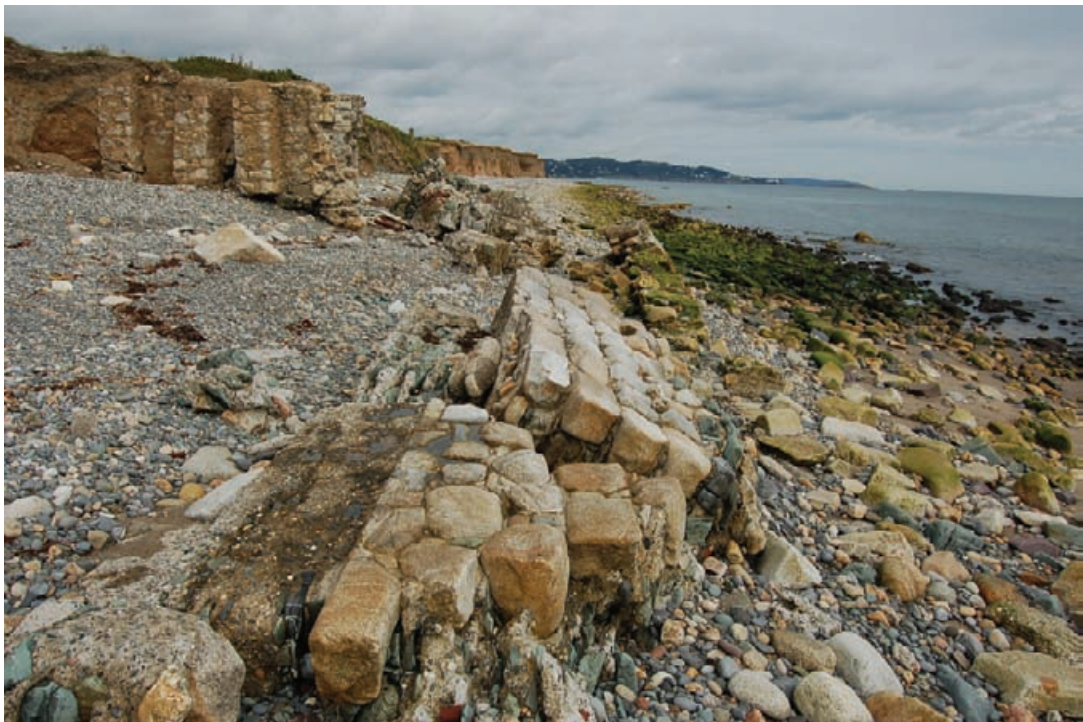
Figure 7.2 This railway at Bray, Co. Wicklow on the eroding east coast of Ireland, was abandoned c. 1917, but stretches underwater for more than 2 km, with submerged traces of two martello towers, a gate lodge, fishermen's cottages and a submerged forest over 6000 years old.

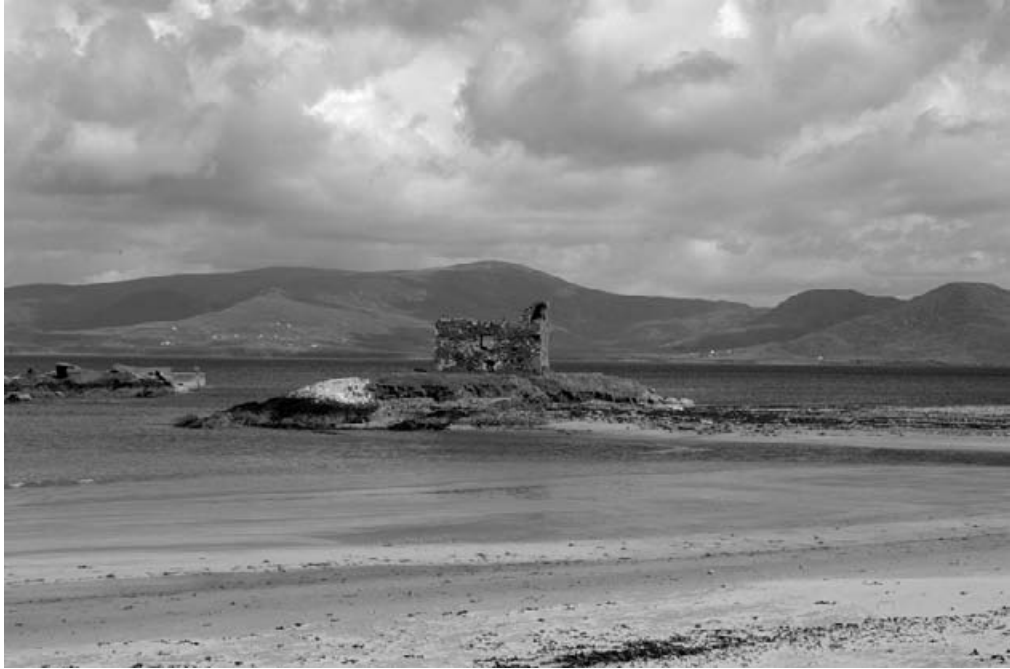
Figure 7.3 *Ballinaskelligs Castle, a medieval tower house now situated on a very vulnerable narrow sandy isthmus on the south-east coast of Ireland.*

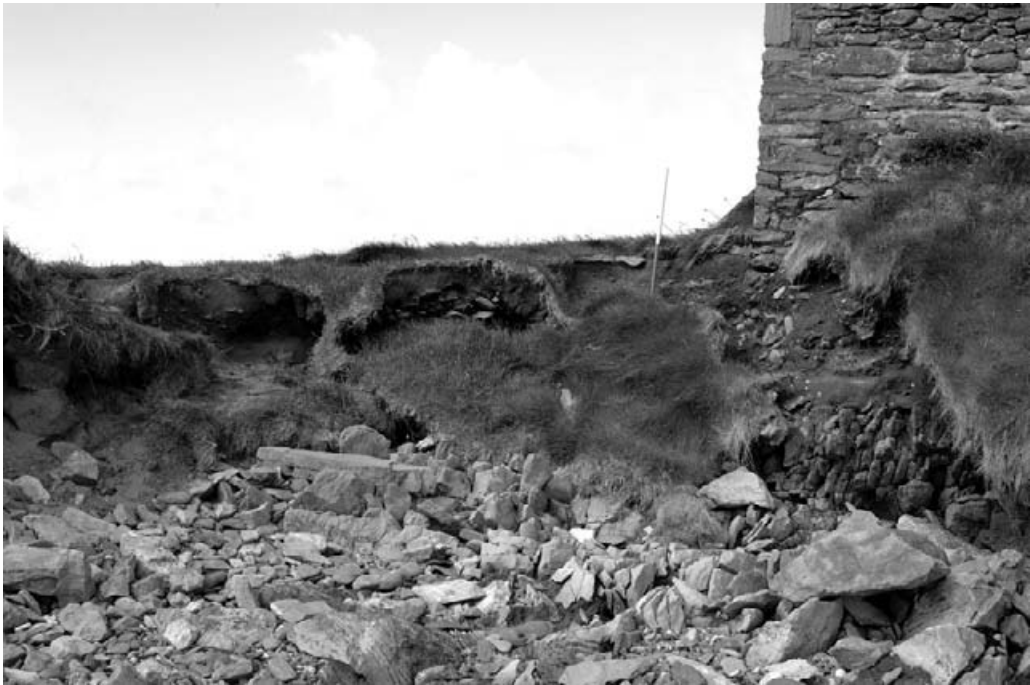
Figure 7.4 *Erosion is now beginning to undermine the corners of the tower, with the cobble beach corrodng the cills of the principal historic stone entranceway.*

including undermining, abrasion and corrosion, and the exposure of previously buried areas to daily wet–dry cycling through tidal movements. The process of undermining commonly leads to the exposure of the shallow foundations typical of historic buildings and the formation of structural cracks, which tend to develop rapidly and lead to the partial collapse of sections of the monument.

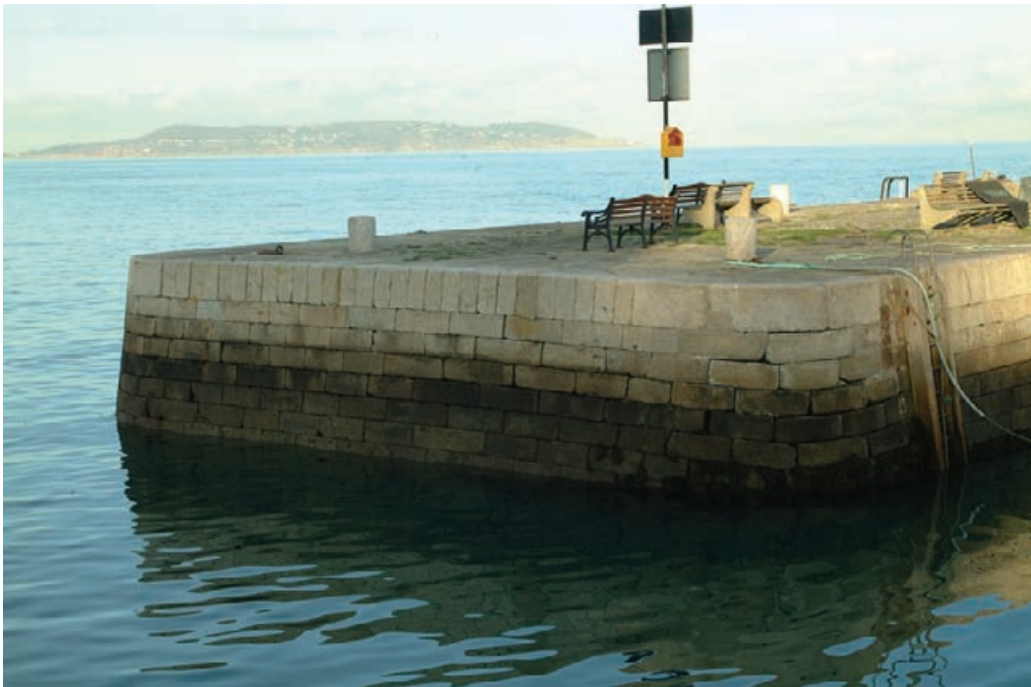
Figure 7.5 Subsidence of the corner of this 19th century granite harbour due to extensive dry jointing and undermining.

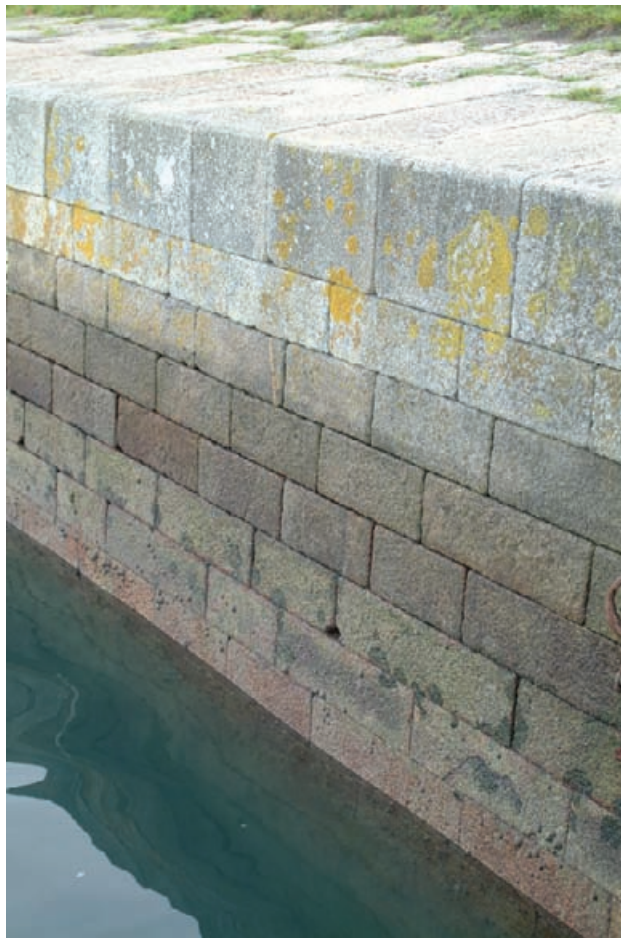
Figure 7.6 *Vertical zonation showing transition from marine to terrestrial species.*

Submerged sites may feature a complex environment of floral and faunal species, and the banding and distribution of marine organisms in the vicinity of a submerged ruin provides valuable information about the level and severity of exposure. Exposed littoral building surfaces are typically dominated by communities of common mussel (*Mytilus edulis*) and barnacles (*Semibalanus balanoides*, *Chthamalus* spp.) with limpets (*Patella* spp.) throughout. On exposed submerged building surfaces, kelp normally dominates, with an understorey of foliose red or brown seaweeds forming a dense bed below the main kelp zone. Fucoids also occur in distinct horizontal bands, and a wide stretch of fucoids and seaweeds exposed during low tide indicates potential for

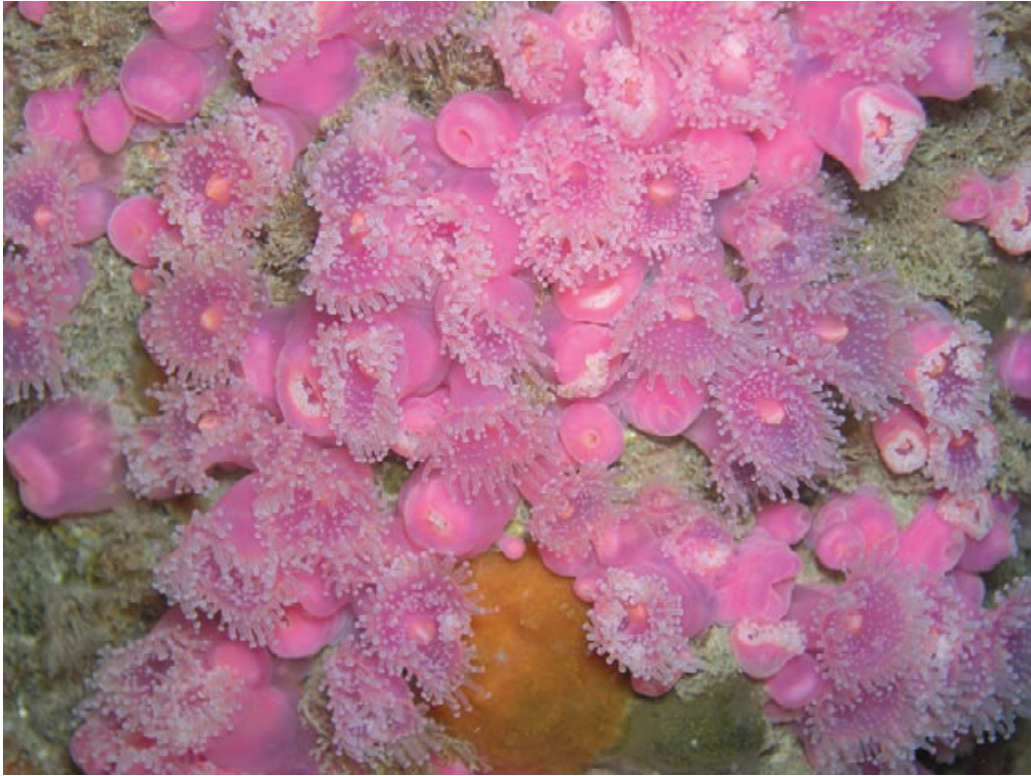
Figure 7.7 Submerged masonry surfaces can be obscured by extensive marine growth (e.g. the jewel anemone (*Corynactis viridis*) which may have other heritage values. Courtesy of Rebecca Morris.

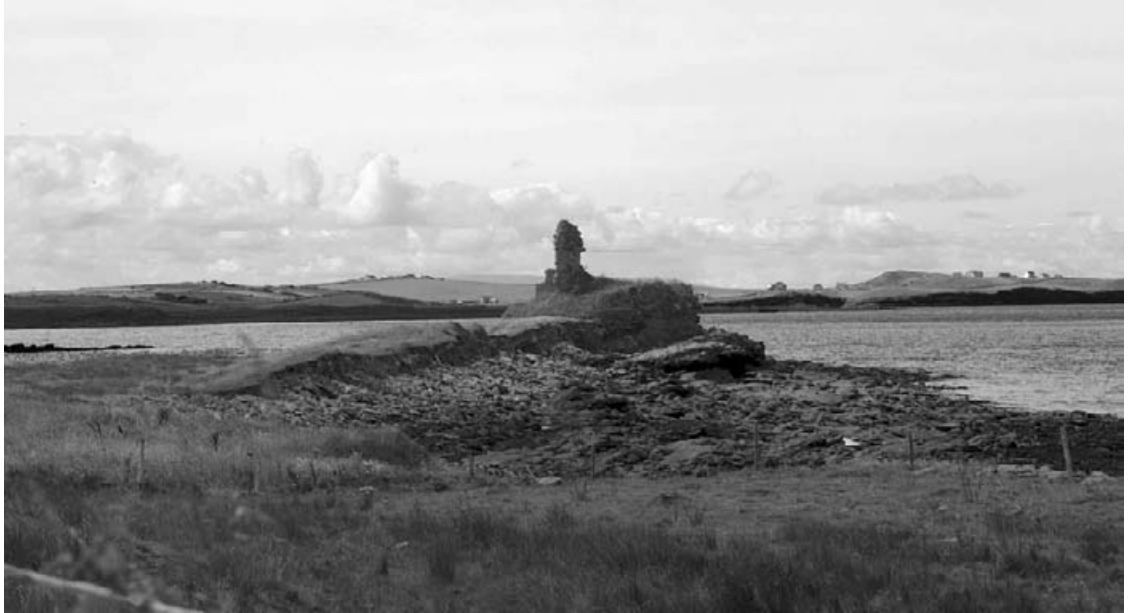
Figure 7.8 *The remains of McSwyne's Castle, Donegal, located on a narrow eroding isthmus on the Atlantic north-west coast of Ireland.*

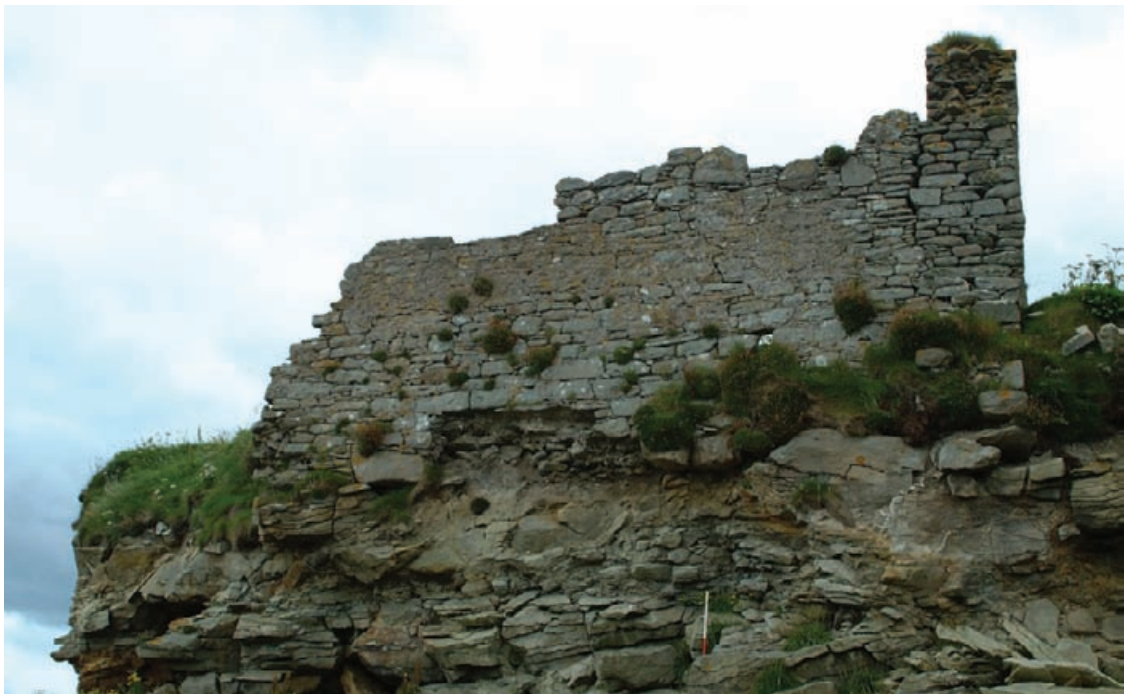
Figure 7.9 *Erosion of the sandstone bedrock beneath McSwynes Castle by wave action and corrasion by the boulder/cobble beach element leading to partial collapse of the outer face of masonry.*

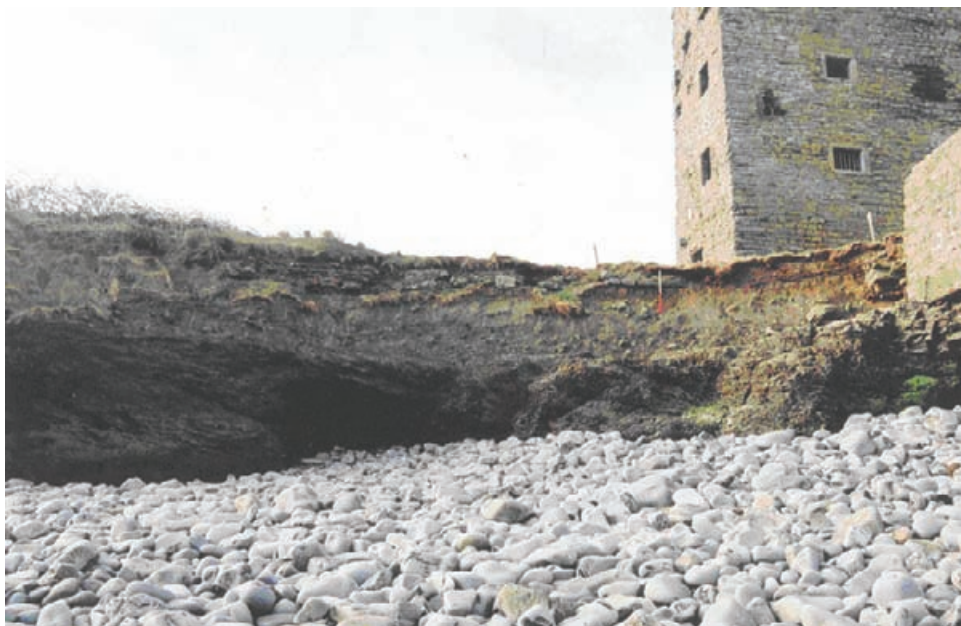
Figure 7.10 The inter-tidal area below Carrigaholt Castle, Clare on the west coast of Ireland showing a highly mobile erasive cobble beach. The sub-surface remains of a now-lost gabled house can be seen in the cliff edge, now within 3 metres of the tower.

The shoreline consists of a 5 m cliff face (3.5 m high siltstone bedrock below 1.5 m soft glacial till). The rocky cliff is friable and deteriorating rapidly, worsened by drainage run-off from the surrounding agricultural pastureland. Corrasion is caused by water-rolled limestone cobbles, substantially more durable than the siltstone cliffs. Cliff recession is funnelled into the formation of shallow caves leading to collapses of sections of the cliff. The foundations of a four-storey gabled building and associated archaeological deposits are exposed in the eroding cliff face, now standing <3 m from the base of the castle. The tower itself is in good condition, showing only minor decay forms such as biological colonisation, graffiti and some stone decay.

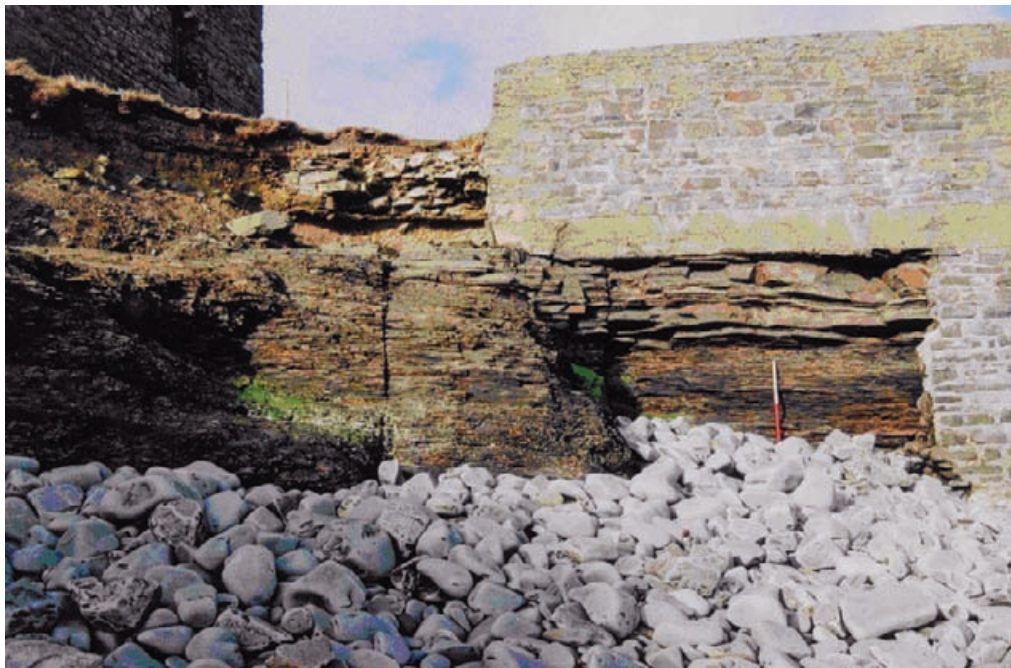
Figure 7.11 Erosion tends to become focused at the edges of coastal protection works and other masonry surfaces. Here the protective bawn wall of Carrigaholt Castle, recently repaired, is again under threat as erosion tunnels around behind the wall.

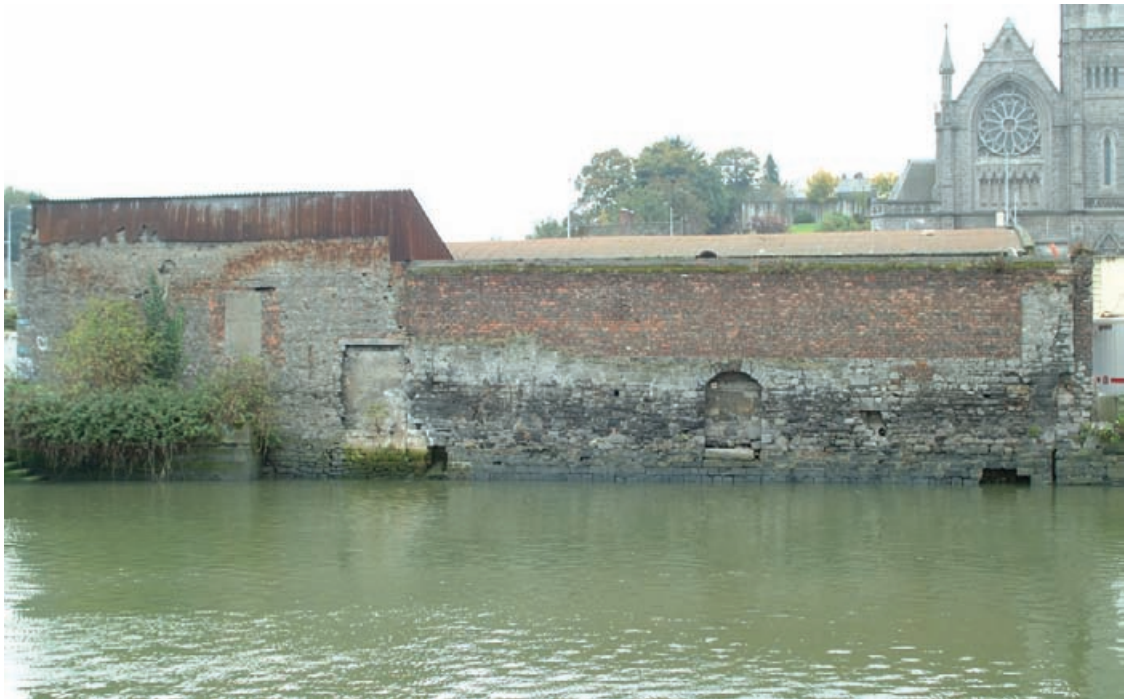
Figure 7.12 Medieval waterfront merchant's house at Drogheda on the east coast of Ireland, showing a range of conservation issues, including modern overburden, later repairs, missing and dislodged masonry, and difficulties in interpreting the character of the archaeological monument.

The original sections of the building showed relatively few decay forms. Biological colonisation was limited by poor water quality and confined to a few furoid and crustacean species in the littoral and sublittoral areas. The base of the wall was disrupted and the waterside of the building showed a few missing masonry units, dry jointing and a few dislodged stones. The doorway and garderobes were largely intact. The interior face of the monument was in poor condition and required stabilisation. The site had been archaeologically excavated and the below-ground structures were to be preserved *in situ*.

The conservation strategy for the building was to consolidate the ruin as a standing archaeological monument for display and appreciation as a public feature within a new development. Repairs were planned on

a ‘minimum intervention’ basis to stabilise vulnerable sections of masonry, and to allow the still functioning tidally flushed garderobe chutes and the water-door to be visible to the public. The original mortar was analysed, and a new series of mortars were designed using local sands and different binders to cope with submerged areas, inter-tidal areas, general pointing and wall capping. The work encompassed:

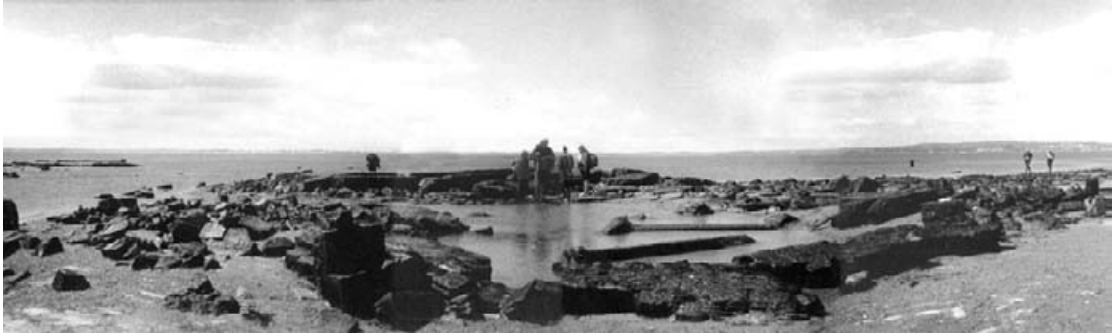
Figure 7.14 Rosslare Fort at the mouth of Wexford Harbour submerged c. 1927, containing the remains of a quadrangle of brick and timber houses, a lifeboat station, a martello tower and an earthen star-shaped fort.

leave some of these monuments relatively intact. Others such as Rosslare Fort will see entire settlements disrupted in situations where conservation is not a feasible option, and in some cases it may be necessary to do nothing, and simply to preserve the monument by record and commemorate it in some way. The challenge for the future is to preserve what we can, as best we can, with the resources currently available.

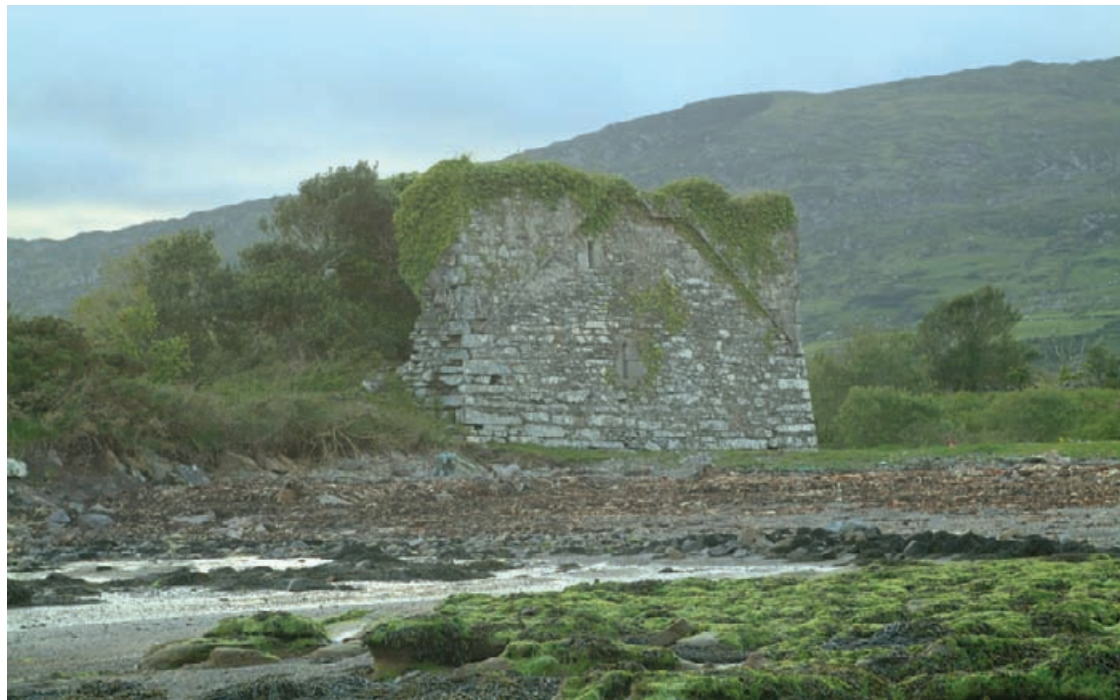
Figure 7.15 Castlecove Castle on the shores of the Ring of Kerry in south-west Ireland. Though protected from the brunt of Atlantic storms, high tides reach the base of the castle. Increased storminess and rising sea levels may have profound implications for similar coastal ruins.

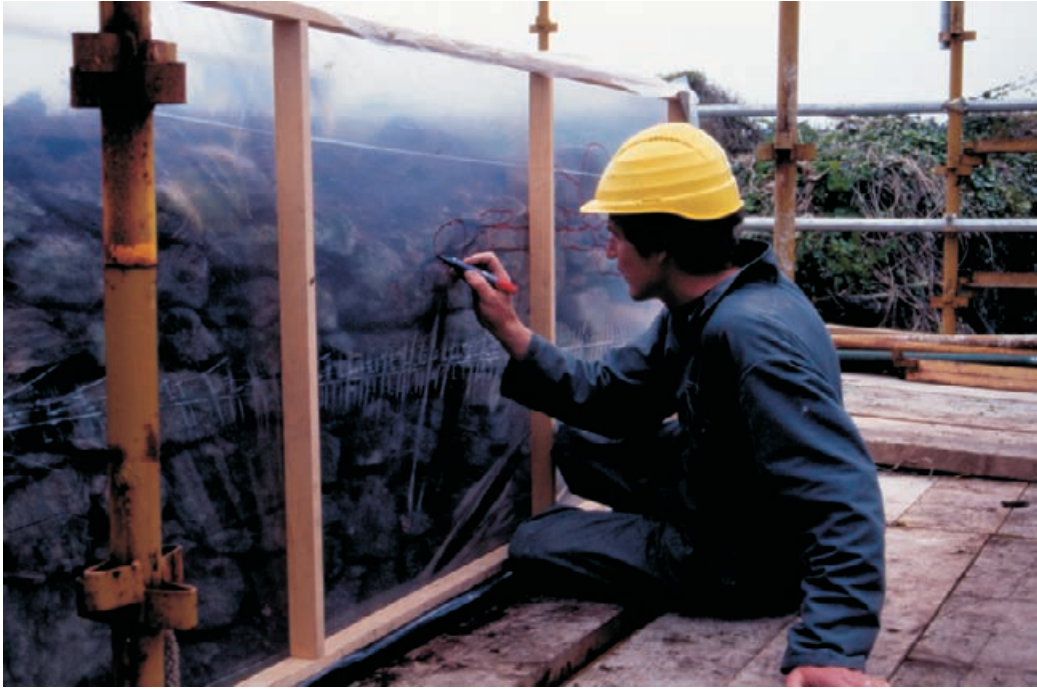
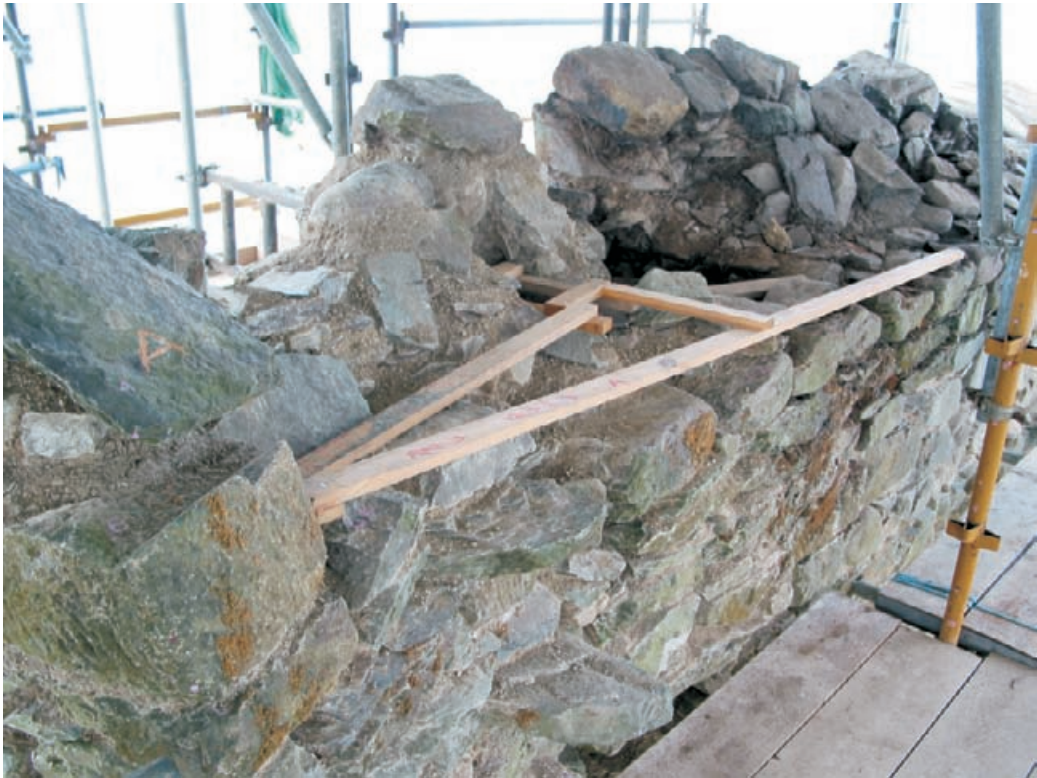
Training. Training exercises with John Ludlow's conservation technician team in County Cork, Ireland show, top, the use of the planning frame in marking out stone sizes and positions before taking down and rebuilding and, bottom, the use of profile frames in recording twists and distortions in the wall to enable the consolidated work to be built back in exactly the same positions.

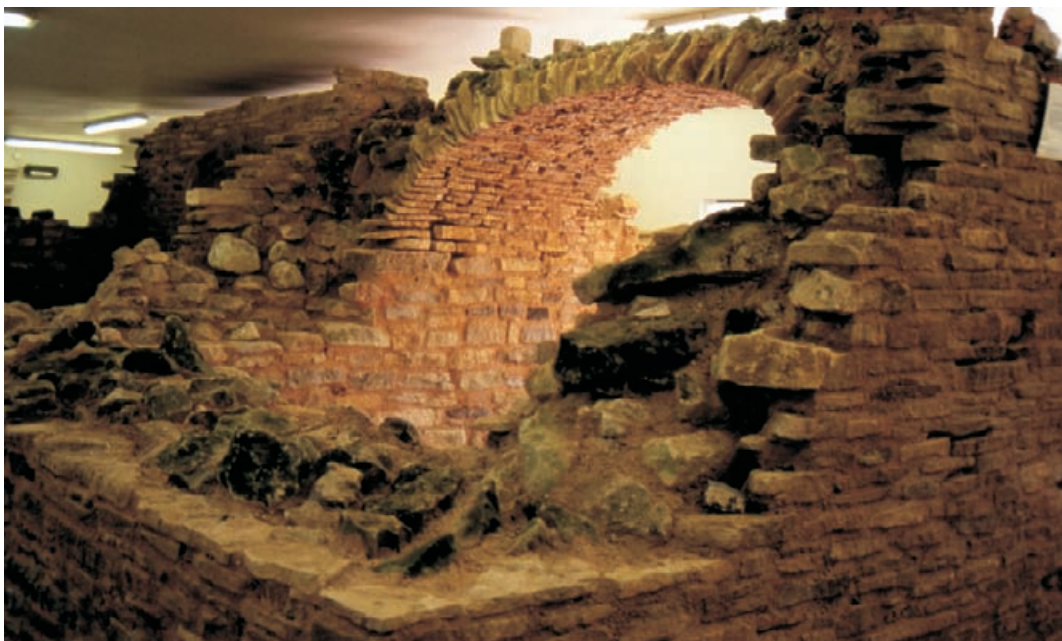
Figure 8.3 'Ruinette' at West Dean College, Sussex, England, designed by John Ashurst and Colin Burns and built by Gerry Williams and his team. The ruinette incorporates many of the conditions found in the field, such as unstable and voided core work, detaching faces, cracked vaults and overhangs. Practitioners can gain experience in consolidation work without risk to historic fabric.

for training by agreement with Dr David Leigh and the Trustees of the Edward James Foundation at West Dean College. This is some 50 miles east of Fort Brockhurst, where an old dairy building was converted into a training centre and new facilities including new 'ruinettes' were constructed (Figure 8.3).

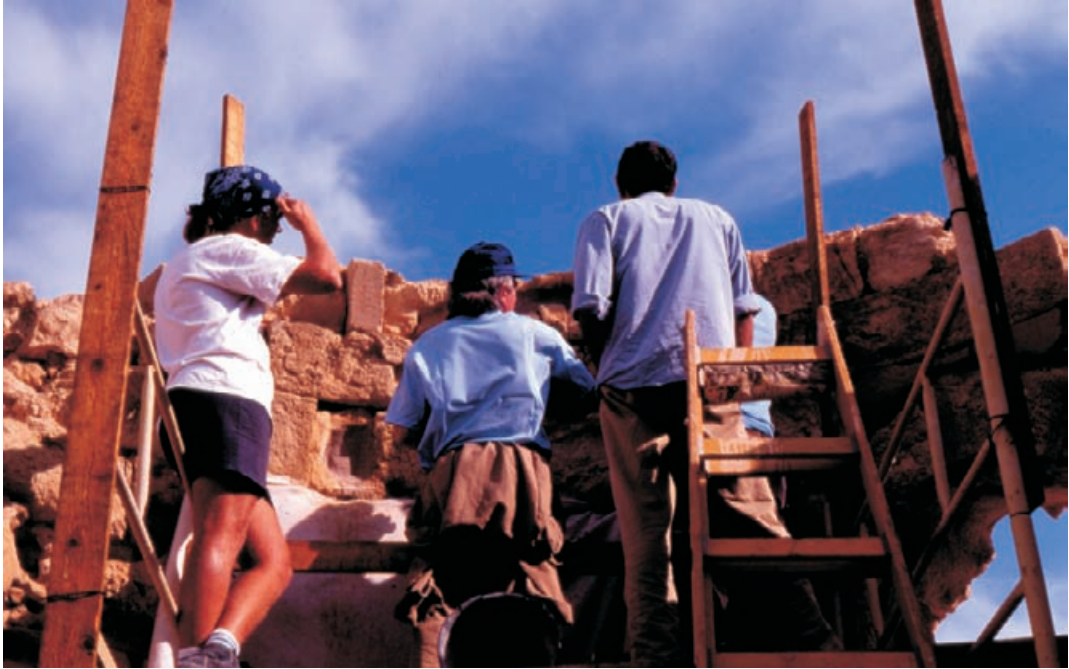
Figure 8.4 Site training with Asi Shalom's conservator team on the Byzantine Church at Masada. Stabilisation of weak surfaces and consolidation of wall heads.

The tutors developed programmes in ruin consolidation with specialists in other countries, including the training of a directly employed labour force to work on the largely untouched ruin sites in different locations. Notable amongst these are Cork in Ireland, under the direction of John Ludlow; the pioneer training of a similar group in Butrint in Albania, funded by the Getty Conservation Institute, working with Reshat Gega; and in Israel, the development of a team of conservators based at Masada with Asi Shalom (Figures 8.4–8.7).

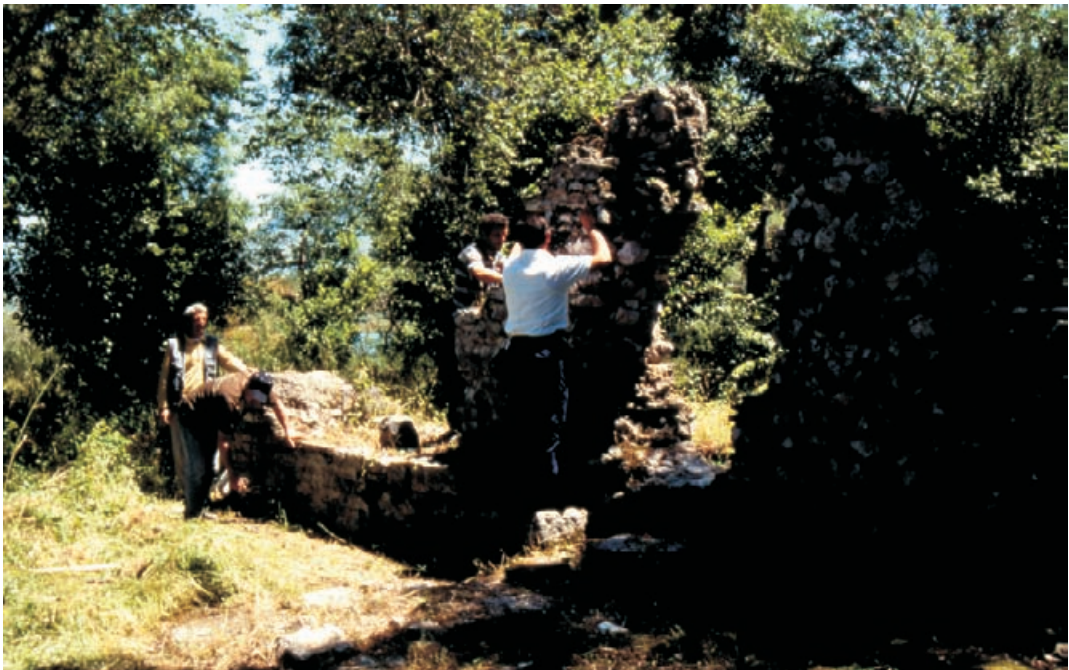
Figure 8.5 Site training on the 'Venetian' House, Butrint, Albania. First-stage site recording and assessment.

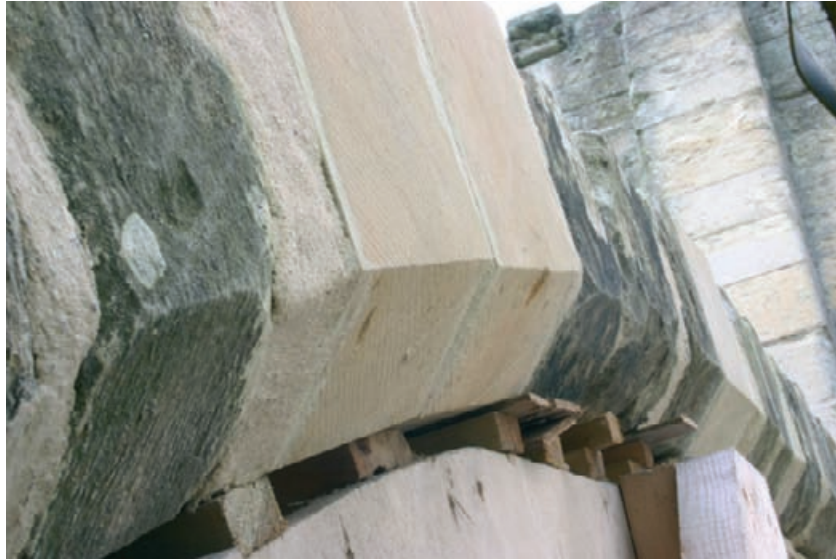
Figure 8.6 *The distorted and failing arch of a medieval flying buttress has been temporarily shuttered to its distorted profile. For it to perform satisfactorily the curvature of the arch needs to be restored but instead a muddled hybrid, partly distorted, partly 'corrected' has been created resulting in a confused assembly of new and old stones.*

Lack of experience, confidence, team organisation, masonry skills, supervision and the absence of any trials or exemplars have damaging, long term impacts on historic sites; ideally, it should not be possible for work of this quality to be carried out on a national historic monument. This situation is never the fault of one individual but of a system which permits it to happen and which may not even recognise the damage it has done.

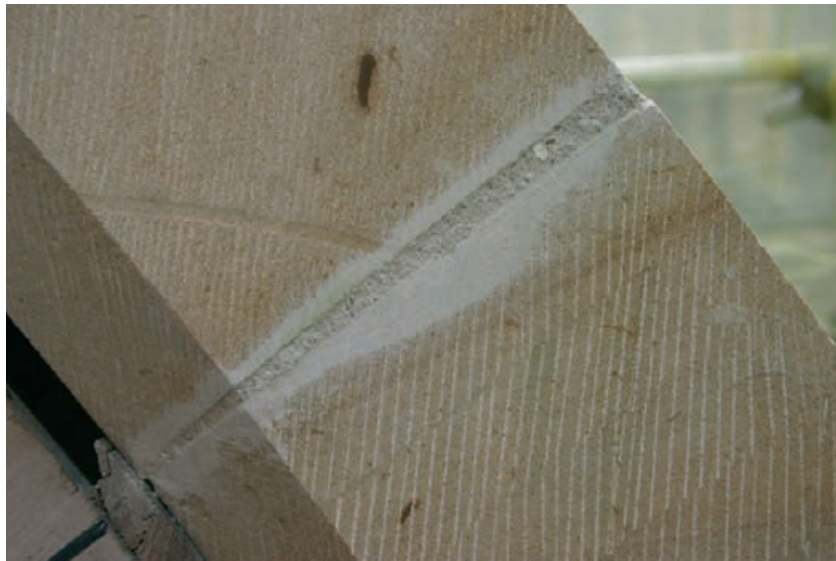
Figure 8.7 *New stones are simply square blocks sawn six sides with a straight chamfer cut on two faces. Because there is no masonry involved the blocks still exhibit lash marks from the saw and a parody of tooling has been applied to the faces, even though there is no evidence of tooling on the original stones; the blocks form wedge-shaped joints and the blocks do not even line up. Some joints are imperfectly filled, and lime stains the surface of the stones.*
