CONSERVATION OF RUINS

John Ashurst

Edited by John Ashurst

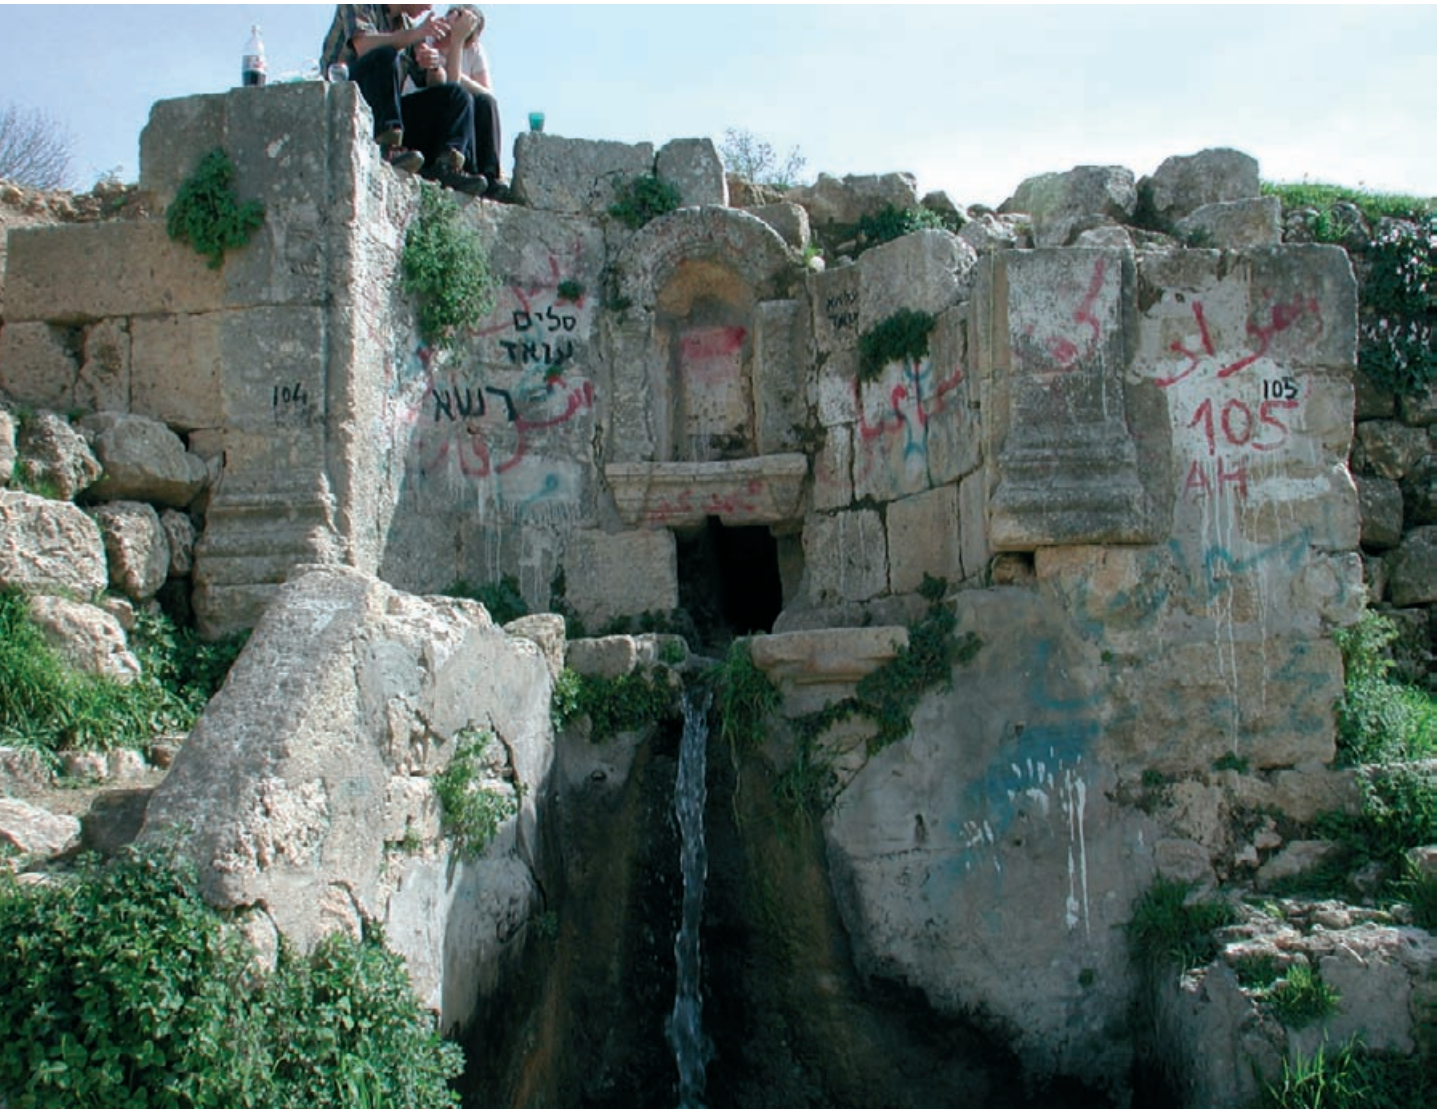
Unwelcome Visitors. Abandoned and neglected sites are always at risk from unwelcome visitors who, in ignorance, show no respect or enjoyment of the ruins. Vandalism in the form of graffiti, dislodging of stones and removal of material from the site is a common experience. Photograph Asi Shalom.

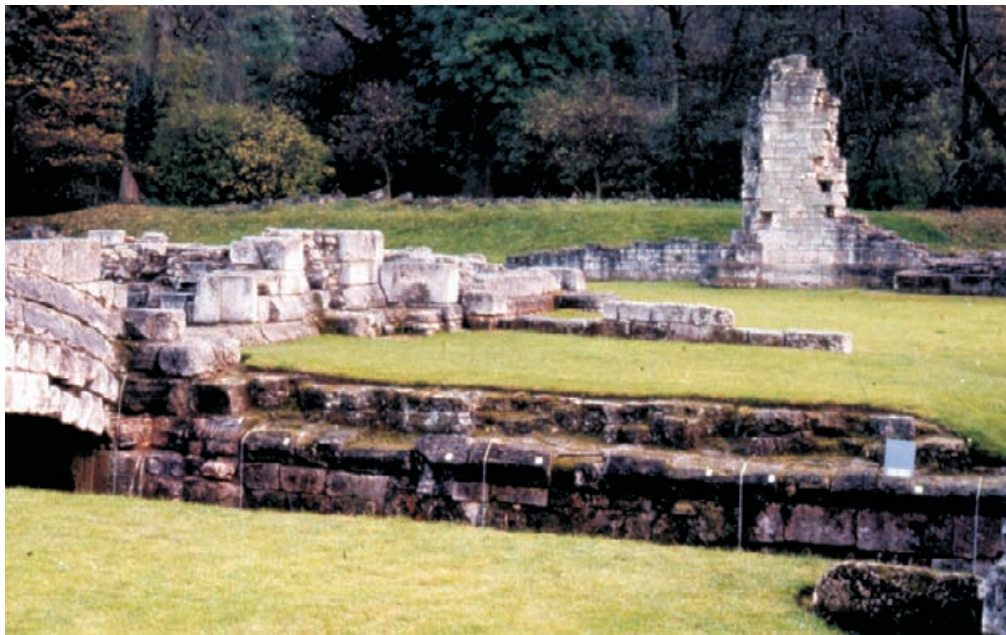
Figure 9.1 Roche Abbey, Yorkshire in the 1970s showing the use of closely mown grass as a context for the ruins, ‘conserved as found’. This became the presentation house style of the Office of Works and its successors for many decades (photograph: J. Ashurst).

The 'conserve as found' approach was common in the UK from the early twentieth century and was championed by the Office of Works and its successors for a period of approximately 70 years. During this time many hundreds of very large and complex virgin sites were conserved using what were then largely experimental conservation techniques. The approach was principally concerned with structural matters and archaeology, and sought to 'freeze' masonry at a point in time in its 'as found' condition by revealing as much original fabric as possible (see Chapter 4). Ruined fabric was 'retrieved' by the removal of later additions, fallen masonry and 'damaging' vegetation, and a standard range of consolidation techniques was used to arrest decay. Monuments were set off by closely mown grass and formal paths so that their primary 'evidence' might be displayed to maximum effect. Though the approach resulted in a high degree of similarity between sites and an attendant sad air of civic, almost clinical, austerity, it has been highly influential elsewhere in the world and continues to shape contemporary attitudes (Figure 9.1).

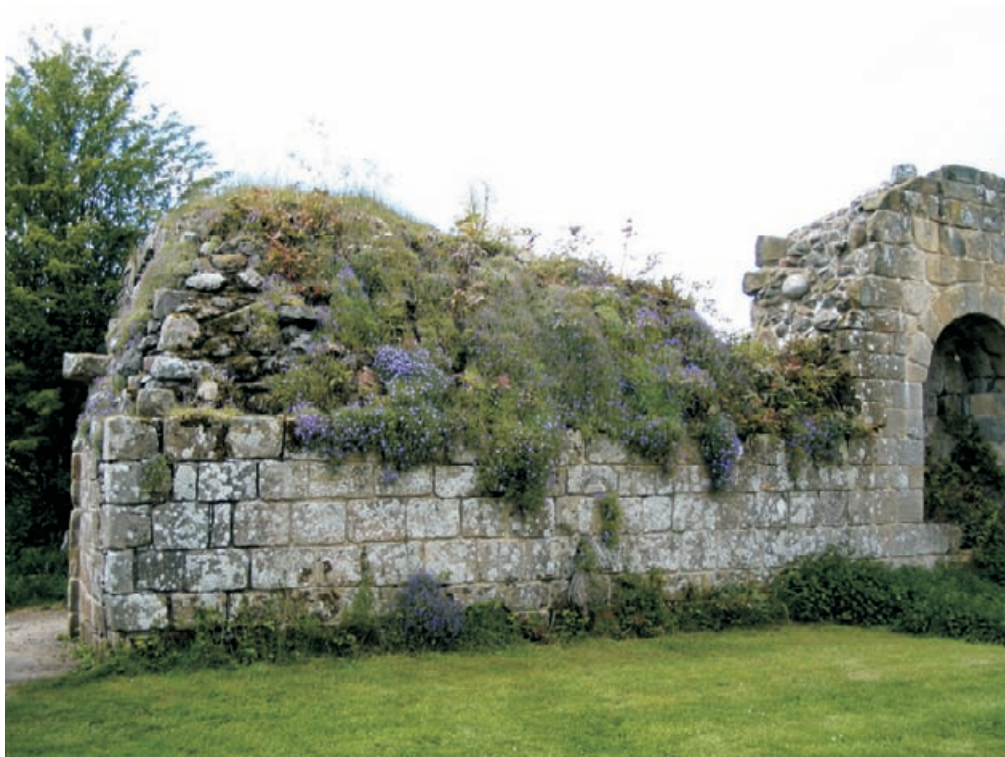
Figure 9.2 *A thick carpet of wild flowers and grasses cap the ruined walls of Jervaulx Abbey (Yorkshire) in a striking picturesque display.*

Whilst the picturesque landscaped gardens of Stowe, Buckinghamshire and Stourhead, Wiltshire typify the fashion of the day, the ruins of Fountains Abbey in Yorkshire dominate what is arguably the most important eighteenth century water garden to survive in England. Though the garden is still much as it was conceived, it is today presented in a tidied up fashion. Jervaulx Abbey, Fountains’ close neighbour, is one of only a handful of ruins to retain the picturesque qualities for which it was admired. A thick natural grass thatch and an abundance of wildflowers cover its ruined walls, and seemingly untamed trees, plants and grasses soften its setting and give the impression of walls rising from the land as if they were one (Figure 9.2).

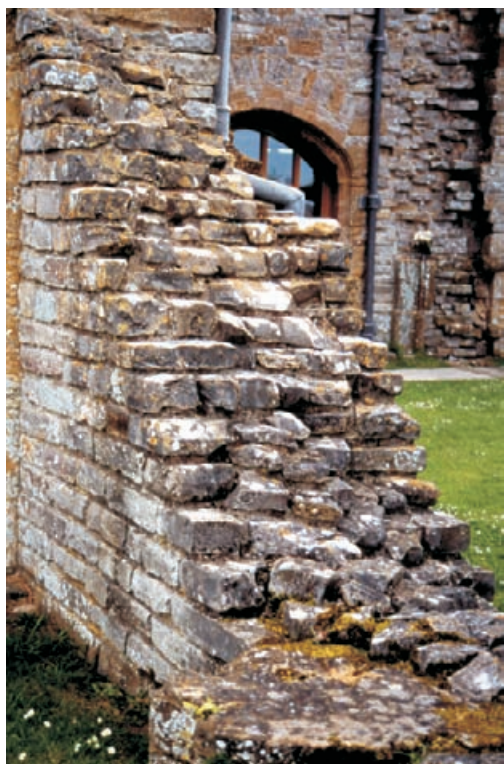
Figure 9.3 (a) An example of 'rough racking', a favoured treatment by the Ministry of Works (UK) in the first half of the twentieth century for broken wall ends and heads, used selectively at Muchelney Abbey to denote post twelfth century work.

stone walls were typically constructed on original stone footings and finished using different techniques to distinguish between different building phases. Muchelney Abbey in Somerset was one of many ruined guardianship sites to be treated in this way; low walls containing some original material were constructed on medieval remains, twelfth century remains were finished with level tops and later material was rough-racked (Figure 9.3).

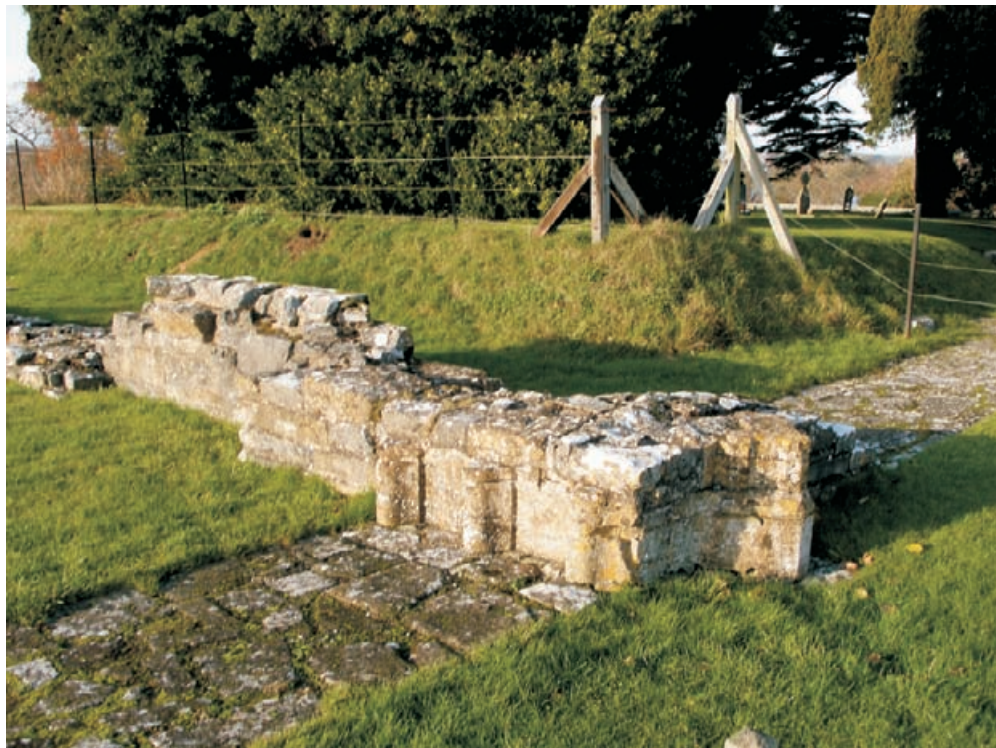
Figure 9.3 (b) The use of different forms of masonry consolidation and capping at Muchelney Abbey to distinguish between building phases of construction illustrating another early house style of presentation (see page 251).

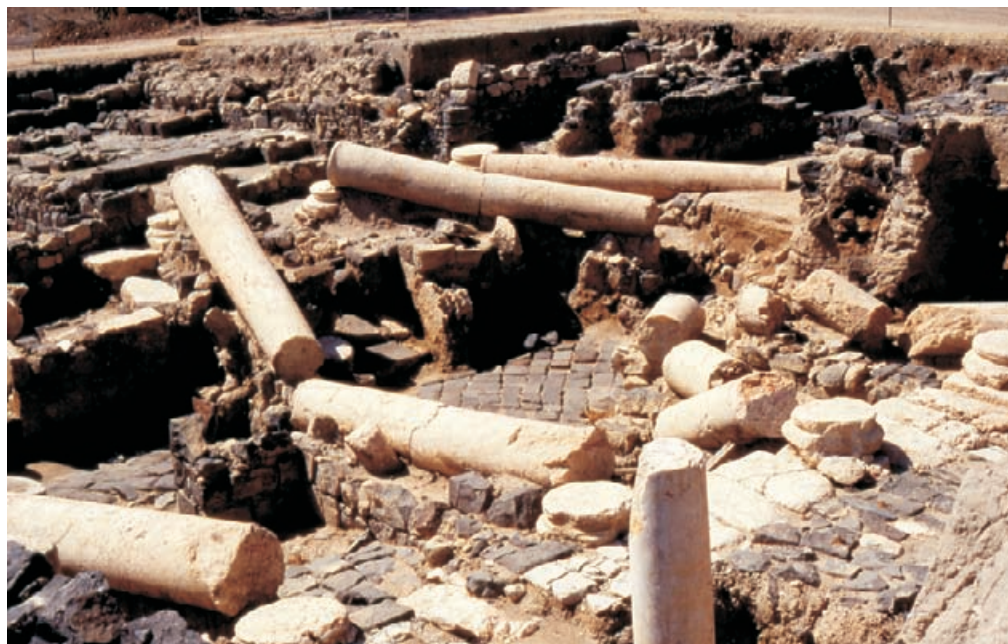
Figure 9.4 The excavated site at Beth Shean, Israel showing limestone columns lying on the basalt-paved shopping street, as they have been since the town was largely destroyed by earthquake (photograph: J. Ashurst).

Anastylosis is the name given to the process of rebuilding the remains of collapsed structures in their original positions and it is common practice in parts of the world prone to devastating earthquakes or having suffered conflict (Figures 9.4 and 9.5). Elsewhere, anastylosis is always difficult to justify, but a strong case can sometimes be made for partial rebuilding at sites catering for a broad, often international, audience of mixed visitor type. Here the re-erection of minimal fabric, a few well chosen significant features, should normally

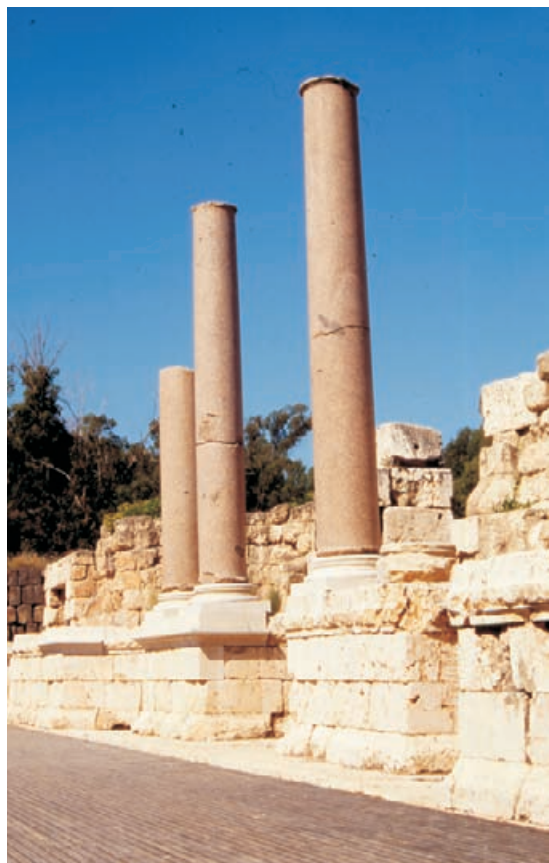
Figure 9.5 *Anastylosis at Beth Shean, with re-erected columns recovered from their fallen positions in the street below (but see comments in Chapter 1, page 23, on Tall elements repaired with reinforcing rods set in resin).*

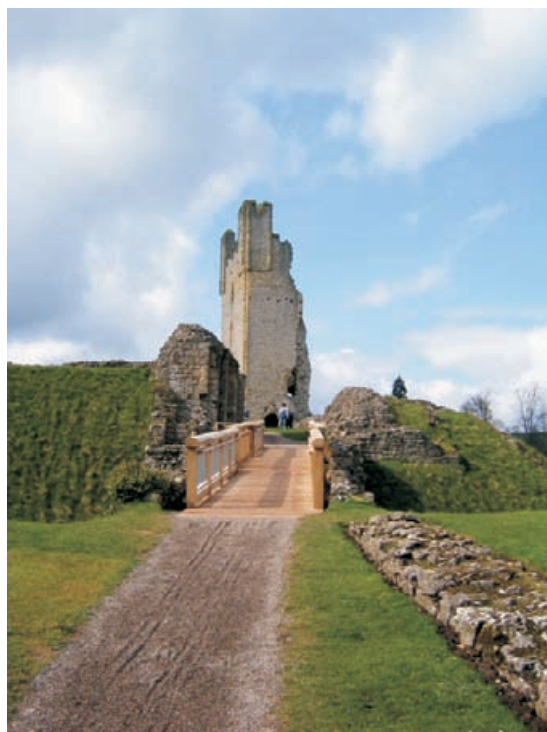
Figure 9.6 *One of two sympathetic, though distinctly modern, oak bridges constructed at Helmsley Castle in Yorkshire. With much timber fabric having long since perished, the use of oak goes some way to redress the masonry: timber balance.*

The disappearance of perishable elements, such as wooden bridges, floors and stairs, can cause both practical and intellectual problems. The provision of such items, particularly bridges over moats and ditches, is often essential for access and to aid intelligibility. Where restored, construction should ideally be unmistakably modern in design, but of materials sympathetic with what may originally have been used (Figure 9.6).

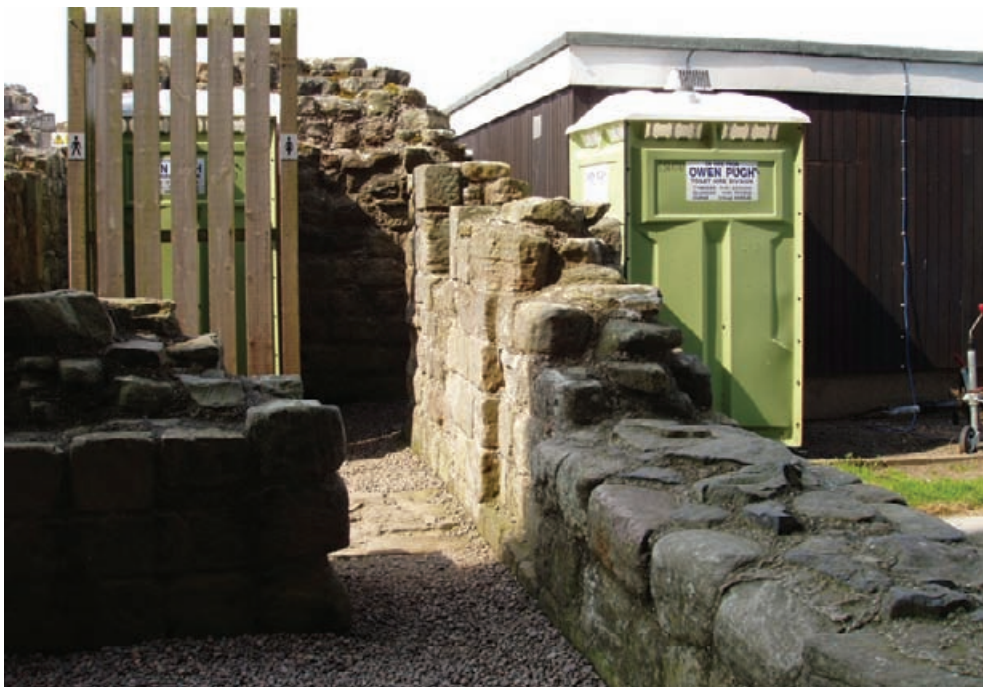
Figure 9.8 *The proximity of services, such as portable toilets, to historic fabric can have a seriously adverse effect on enjoyment of a site.*

detract from monuments and should age well and weather comfortably in their settings. The proximity of facilities to historic fabric can be offensive and excessive; poorly planned, badly designed or insensitively located facilities have a seriously adverse impact on the significance of features, ecological characteristics and an enjoyment of the site (Figure 9.8).

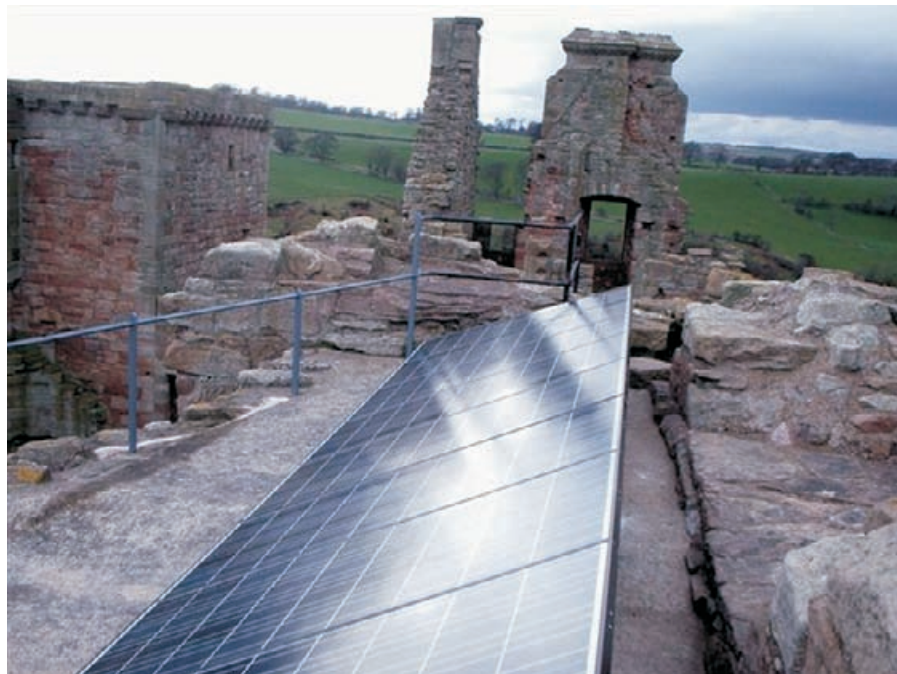
Figure 9.9 Eight photovoltaic panels are sensitively and reversibly sited on top of the remains of the fourteenth century tower and provide general power to a small shop and ticket office. The panels replaced a noisy generator, are fully reversible, and meet government initiatives and green tourism initiatives.

whatsoever. Where mains servicing is required but is prohibitive for reasons of archaeological sensitivity or cost, imaginative responses are needed if today's mandatory standards for human comfort (minimum temperatures, etc.) and energy efficiency levels are to be met (Figures 9.9 and 9.10).

Figure 9.10 Crichton Castle (Midlothian, Scotland) is the first Historic Scotland site to be powered by the sustainable technology shown above (Figure 9.9).

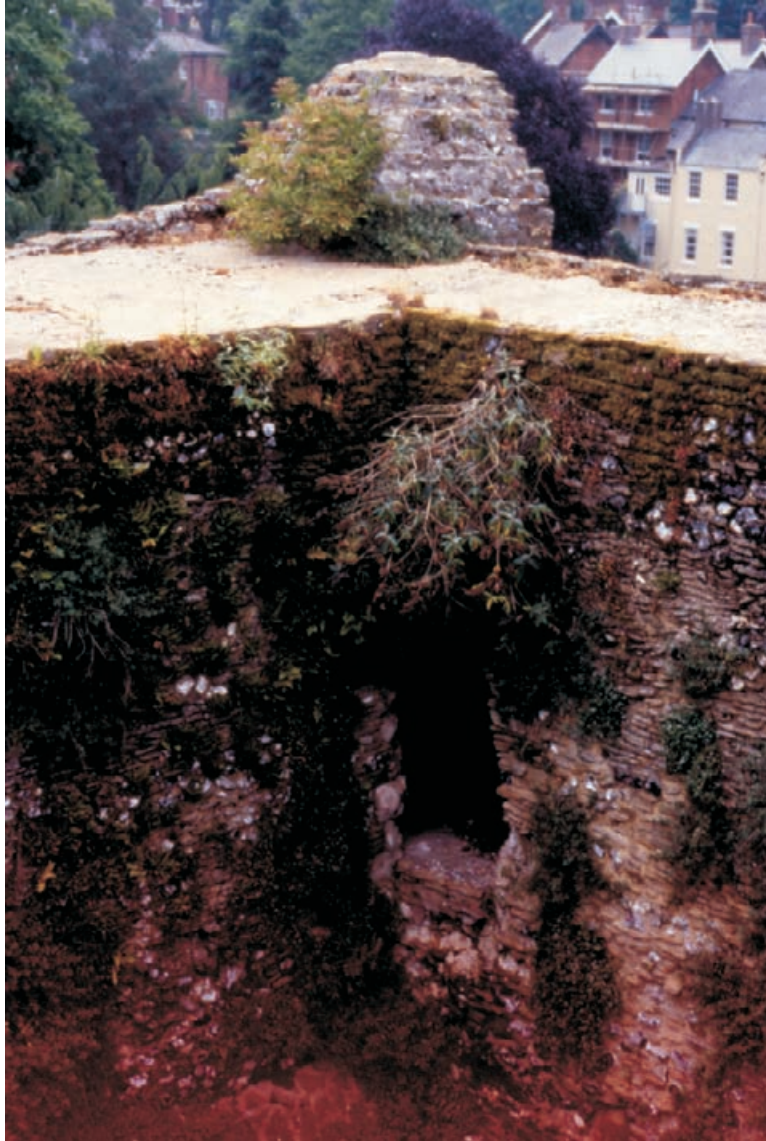
Figure 10.2 *The internal south-east corner of the tower at wall-head level, illustrating the extent of plant colonisation and screeds sloping into the tower.*

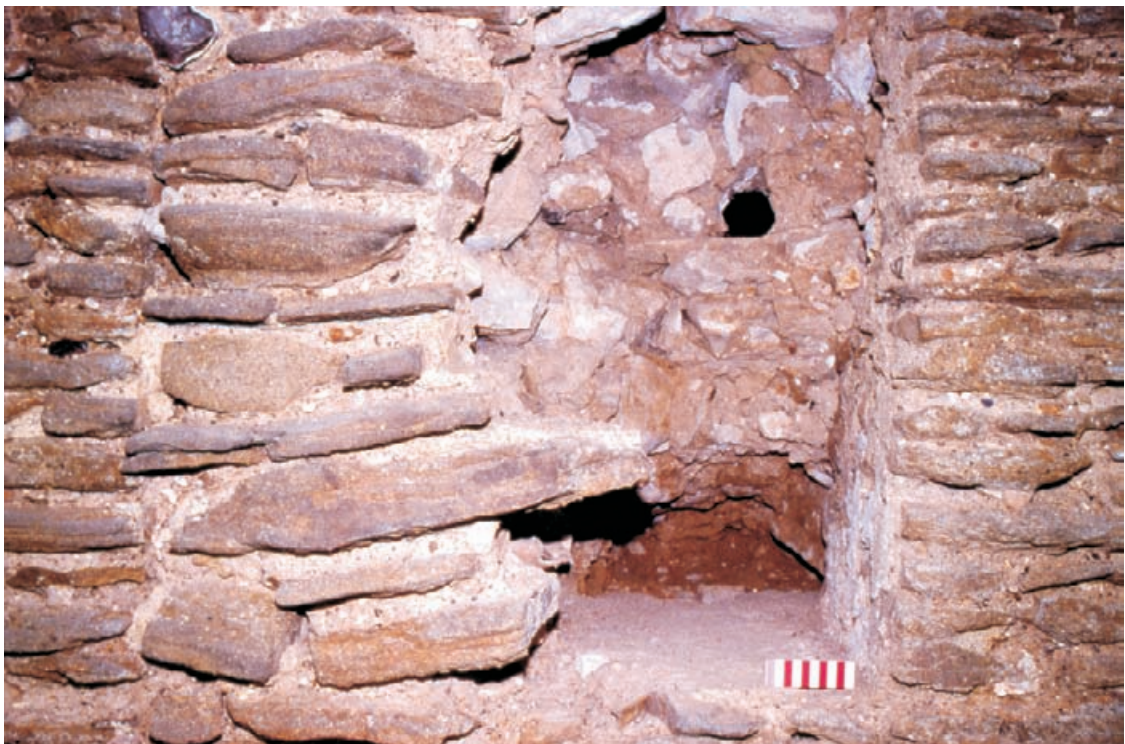
**Figure 10.4** Blocked embrasure on the west elevation in the course of excavating fill to expose the plastered vertical face of the merlon.

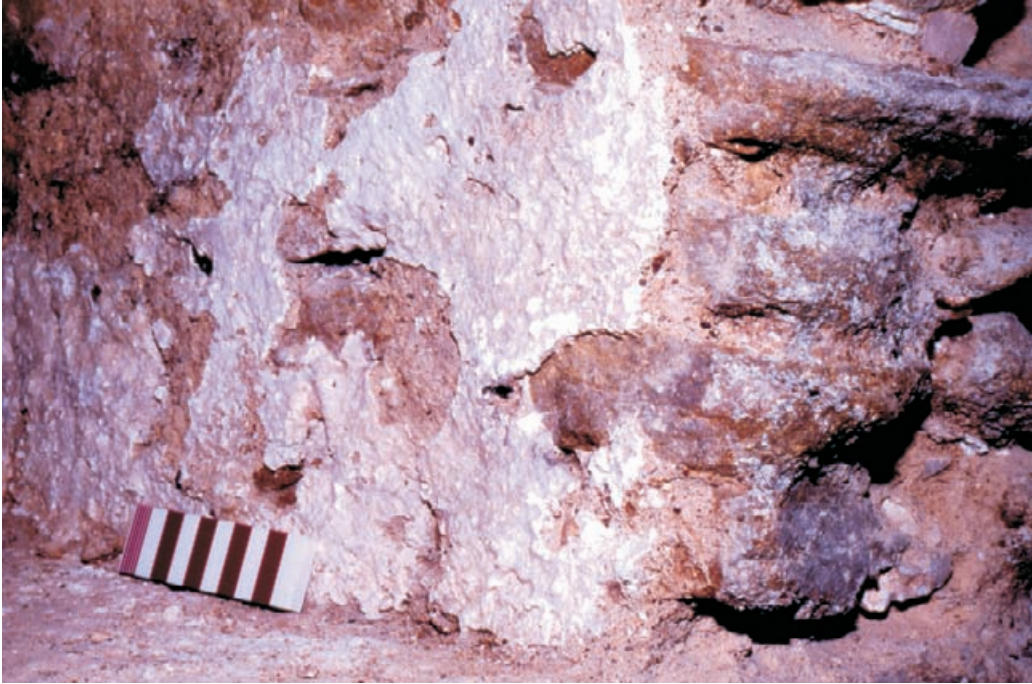
Figure 10.5 Detail of Norman plaster (in Figure 10.5) applied to the merlon in the tower's first phase of construction.

Rubble construction of this period was typically plastered and although no plastered medieval surfaces were visible on the exterior of the keep, it was presumed (and later confirmed in the course of conservation and archaeological study – see Figures 10.4 and 10.5) that the external walls had been finished with lime-based plaster.² The internal masonry surfaces were certainly plastered. Remnants of plaster and paint survived internally, most notably in the

An essential part of the site work was archaeological recording, which was a condition of scheduled monument consent.⁴ Before erection of scaffolding, all masonry elevations were subject to rectified photography and photomosaics of the elevations produced (Figure 10.3). Measured survey was carried out to permit production of plans at each level. Scaffolding was designed to be completely independent of the monument and was secured by ground anchors rather than the usual masonry anchors. Once scaffold access was available the elevations were resurveyed at close range. At the same time, cleaning and cutting out of defective pointing began. Removal of later pointing soon revealed significant archaeological features, which would substantially alter the scope of work to the tower. Vertical features had been noted during recording of the west elevation and close range inspection confirmed that these were the lines of a crenellated parapet (Figure 10.9). The line of the parapet survived best on the west and south elevations, where it was clearly defined by a thin white layer of limewashed plaster applied over the horizontal and vertical faces of the embrasures. The line was legible on the north and east, but was less intact. The discovery of the limewashed plaster was particularly

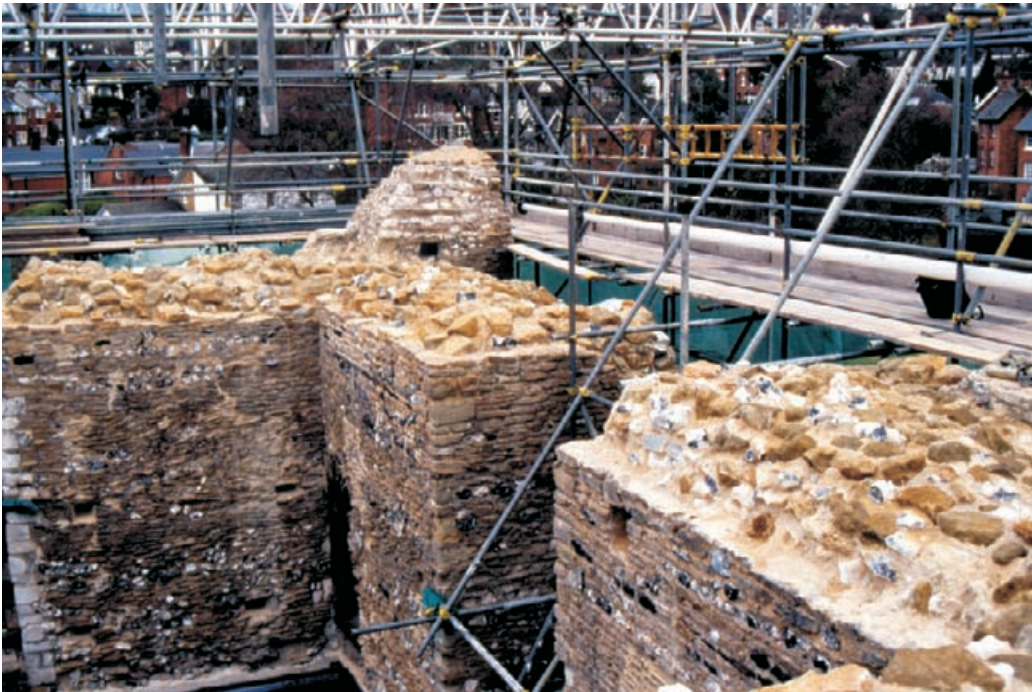
Figure 10.6 Existing flat screeds were removed and core work constructed to shed water off the wall heads and indicate their broken form prior to 'rationalisation' in the nineteenth and twentieth centuries.

- *Consolidation of the wall tops.* To eliminate water penetration to wall cores and shed water to the outside faces, in the traditional ‘ancient monuments’ way. This involved resetting core work in hydraulic lime-based mortar to profiles which clearly indicate the broken nature of the wall tops (before these were ‘rationalised’ in nineteenth and twentieth century repair programmes) channelling all water away from the internal space (see Figure 10.6).

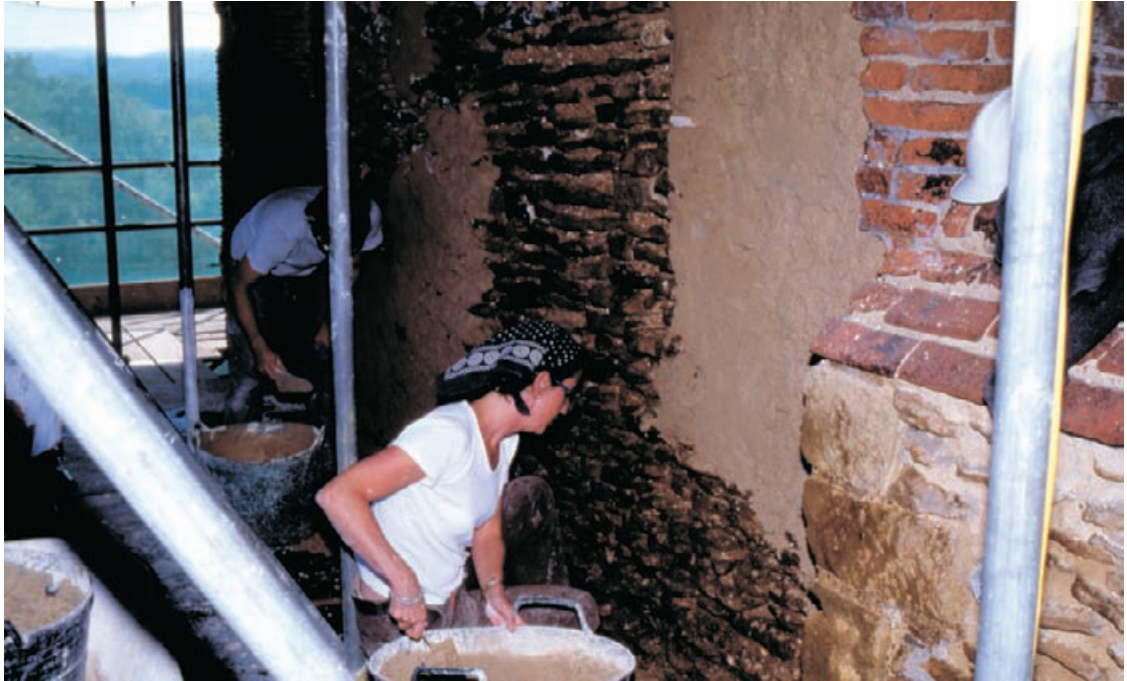
Figure 10.7 *Plastering trials were carried out to establish the mortar mix and final appearance and finish.*

- Limited rebuilding was carried out where masonry was displaced by roots of woody plant species.
- *Repair of medieval stonework.* Pinning and grouting of ashlar masonry forming openings which exhibited spalls and fractures.
- *Construction of new internal perimeter gallery and ticket/custodian's office* at ground level inside the tower.
- *Site trials.* All aspects of the work were subject to trials to ensure satisfactory methods and materials. For example, replastering trials included preparation of mortar samples for approval of mortar composition, as well as application of panels of plaster to confirm colour, texture and finish.

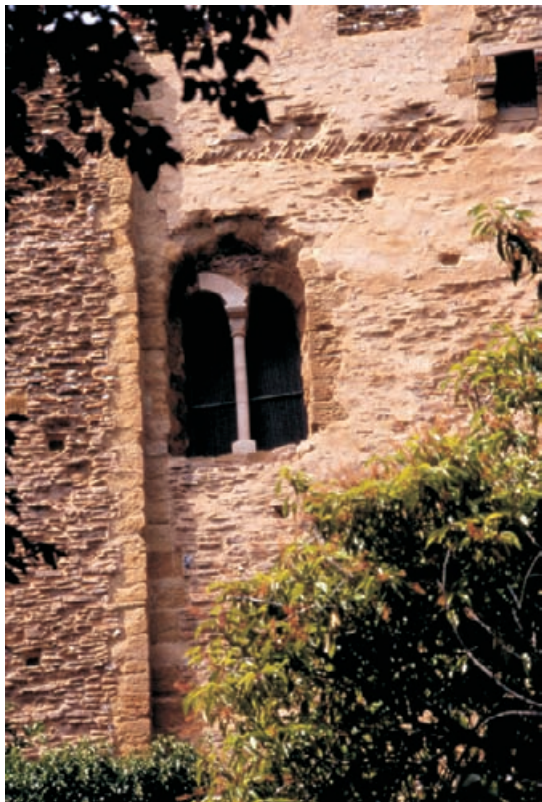
Figure 10.8 *None of the Norman window mullions survived and one was reinstated in the south window to support the remaining voussoirs and interpret the early window detail.*

The proposal was contested on the grounds of uncertainty about the integrity of the corework above. If the core could not provide the necessary anchorage the masonry at the face could be significantly weakened close to the south face to no beneficial effect. An alternative proposal was to reinstate a load-bearing column and abacus to return to the original structural arrangement. This solution was finally adopted, although not with unanimous support, because of the perceived 'restoration' involved. In spite of this, the structural problem has been simply resolved and the opening made visually intelligible to visitors. No attempt to detail the column, its capital or its abacus was made beyond cutting the basic profiles and it could not be mistaken at any time for original work. Architecturally, the work has been generally acknowledged as a substantial gain (Figure 10.8).

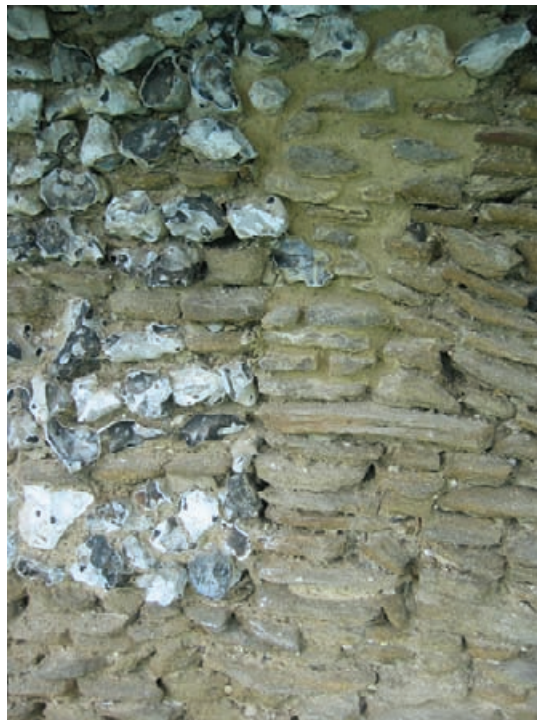
Figure 10.9 *Detail of line of crenellated parapet on south elevation, with Bargate rubble construction of merlon on the right and infill of embrasure in flint on the left.*

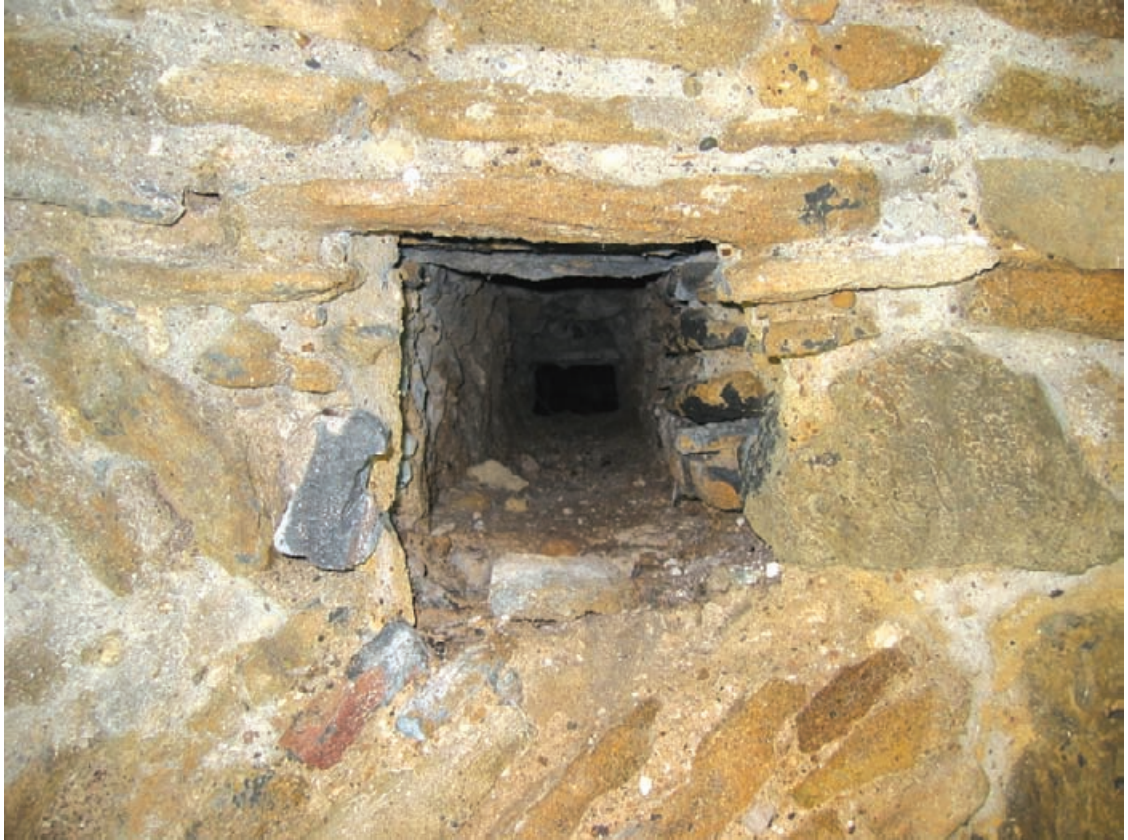
Figure 10.10 Detail of channel for drainage of original roof through east elevation. View of external face which has been unblocked.

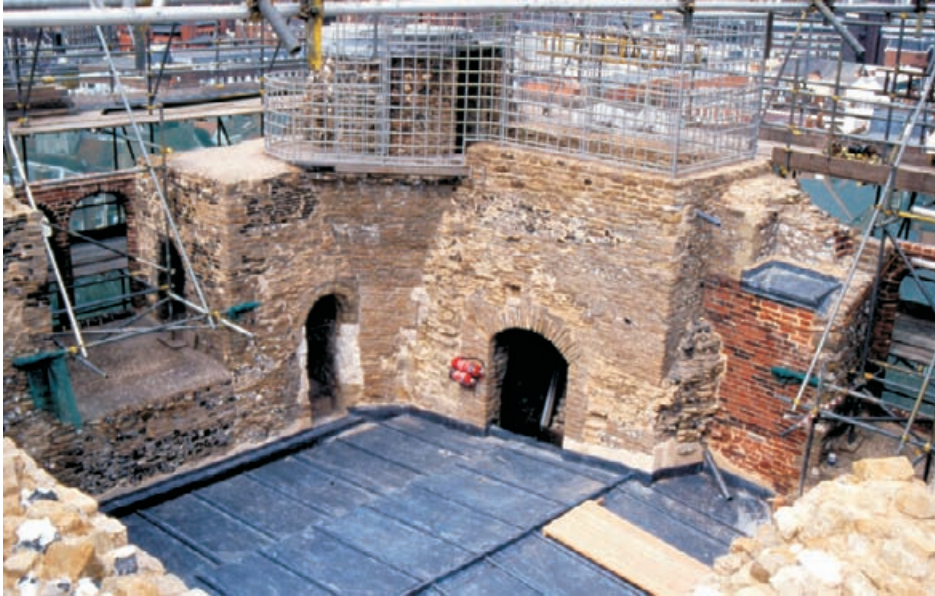
Figure 10.12 *View of new lead covered roof, looking north-west.*

were supported by archaeological evidence, not speculative assumptions about the original construction. The construction of a new roof would bring substantial benefits for the condition and sustainability of the tower in the long term. Principal among these was the protection the roof would provide for the castle interior, by excluding rainwater and preventing organic growth from recurring. The internal environment would be considerably improved for visitors as well. Pigeons could be excluded by metal mesh applied over openings. Acceptance of the proposal to re-roof the tower led to rethinking of the provision for access at first floor level. In lieu of the gallery previously envisioned, a design was developed for a complete floor (at first floor level) to stand independently of the tower masonry, on a concrete raft in the base of the tower. Introduction of a new roof and floor would define the original spaces and assist with interpretation of the tower, in particular of the principal chamber, which is thought to have functioned as an audience or presence chamber for the new Norman rulers to receive and impress vassals.

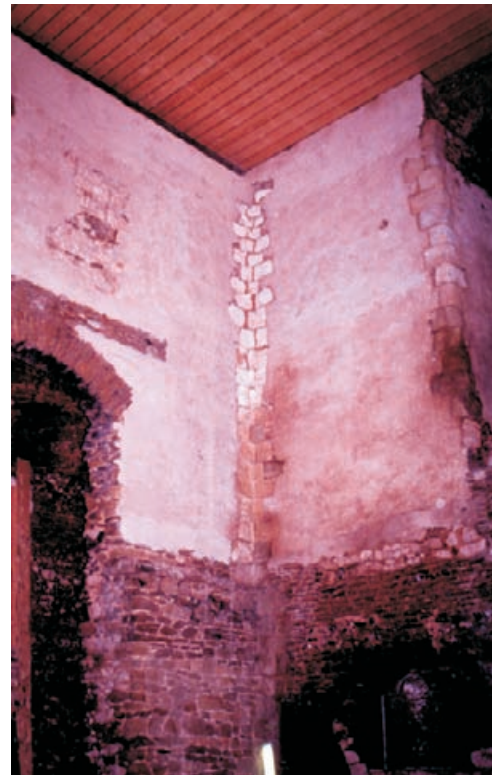
Figure 10.13 *Internal view of plastered principal floor level with boarded soffit of new roof, prior to construction of new floor at level of base of new plaster.*

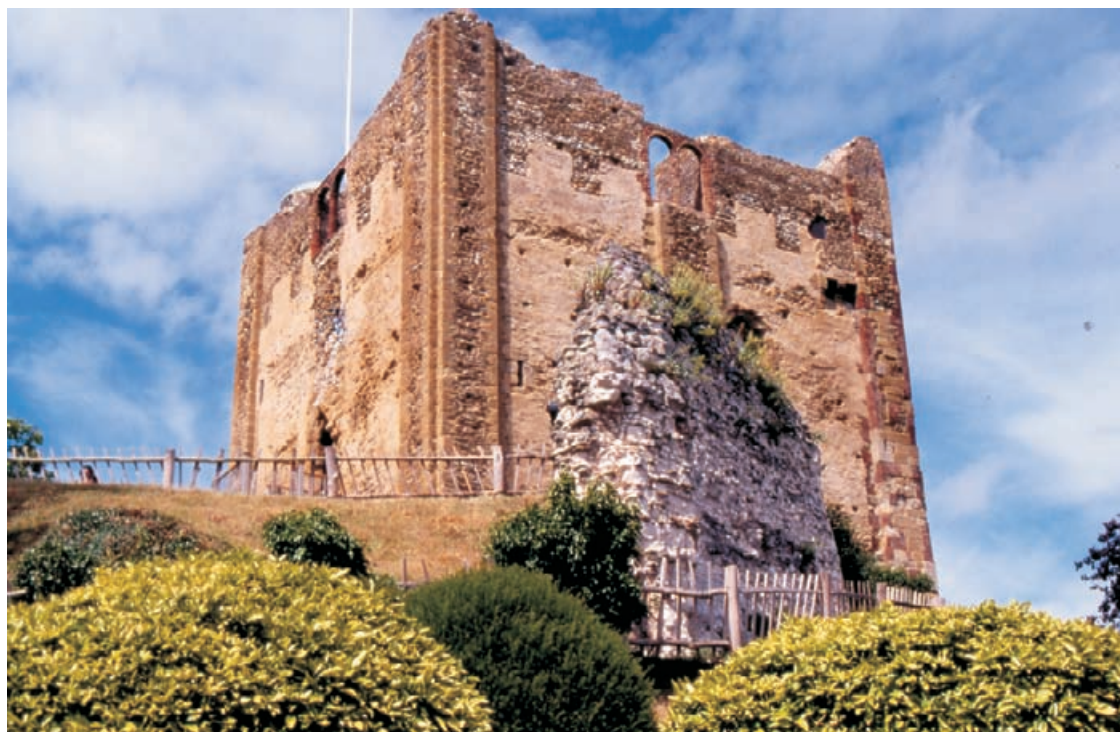
Figure 10.14 View of tower from south-west after completion of conservation work. (Compare with the same view in Figure 10.1.)

significant since so little evidence of the original treatment of external surfaces of Norman buildings has survived. The decision was taken to interpret the line of the crenellated parapet in plaster on the external elevations (Figure 10.14).

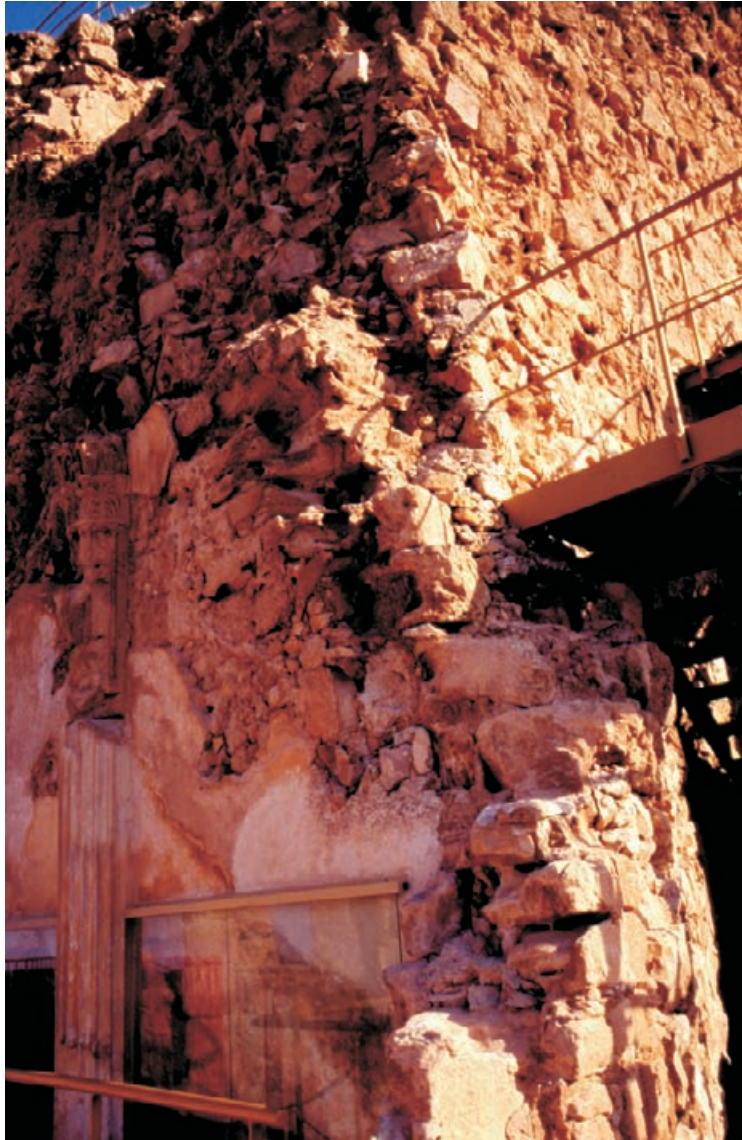
Figure 10.17 *The middle terrace northern wall, showing at its base the coloured plasters of the tridinium on the lower terrace. The fragile condition of both rock and stones can be seen.*

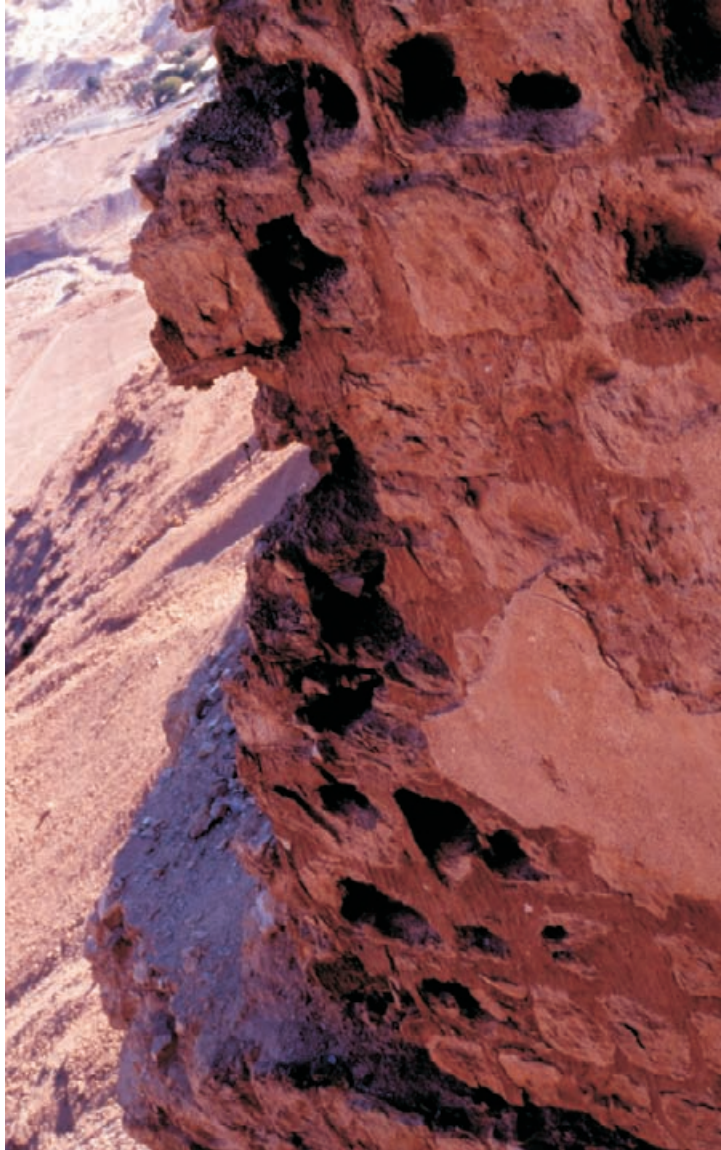
Figure 10.18 *The northern wall of the caldarium showing the fragile, egg crate-like form of the weathered stones (top centre) where they are not protected by plaster (bottom right).*

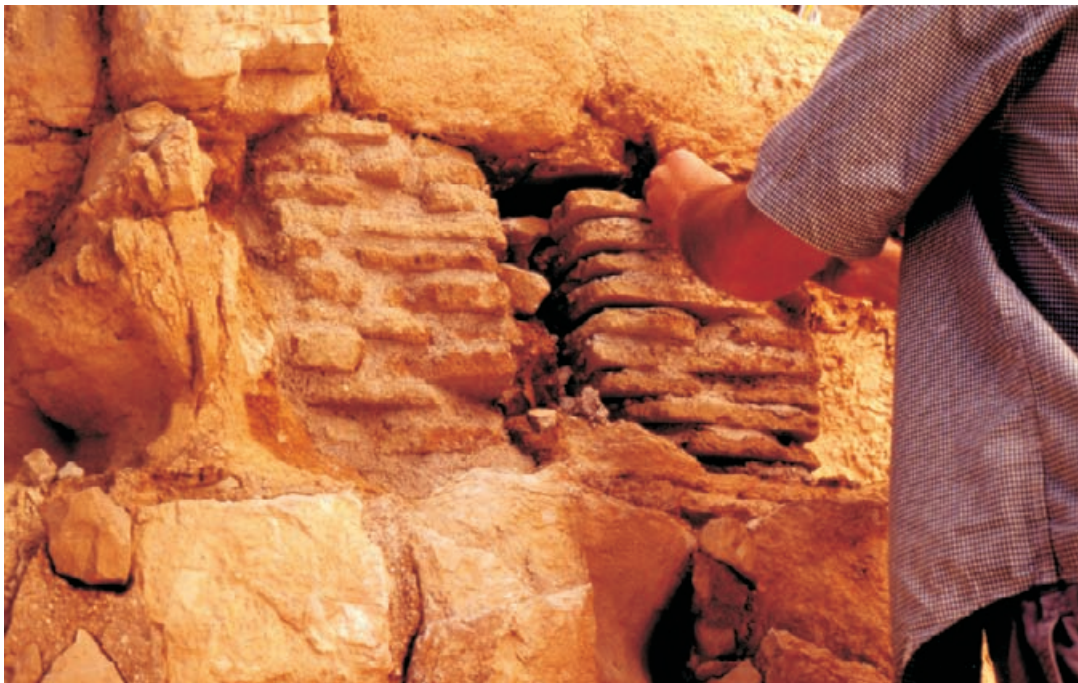
Figure 10.19 *Repair of the cavernously decayed stones of the Northern Palace was carried out using “tiles” cut from salvage, weathered stone bedded in pozzolanic lime mortar. Each stone was repaired individually. Joints were packed with mortar and stone in the final stages. The split faces of the tiles blend comfortably with the rough, weathered texture of the surviving masonry and are quickly coloured by the mud washing over the mountain during rainfall. Repaired stones are always easily identifiable at a 2 metre range.*

The usual procedure of cutting out and replacing badly decayed stones with new stones was clearly impracticable in large walls which had become something like a fragile egg crate. The rigid grid of the 'crate' was formed by the joints and the stone adjacent to the joints; the voids were the centres of the stone blocks. Mortar filling alone was also impracticable because of the large volume of material each fill would require and the problems of curing such a volume without the development of shrinkage. A solution was therefore devised based on the use of stone tiles, bedded in lime mortar. The principle consisted of cutting a level base at the bottom of each cavity and raising a stack of tiles with mortared joints within the cavity until its roof was supported. This process provided, within each stone, a structural support system which left the Herodian coursing in place (Figure 10.19).

importance, since fillings which were of superior strength and durability would place additional stresses on the historic work and accelerate its decay. The material for the tiles was therefore selected from salvaged stones of the same age and condition which had fallen from the mountain and lay at various levels below, many of them damaged and all of uncertain exact provenance. These stones were sawn into tiles of 40–50 mm thicknesses. Mortar was based on a

mature lime putty with sand and limestone aggregate and a ceramic pozzolan. Water ratios were kept as low as practicable and the repairs placed into well-wetted cavities before commencing the curing process of feeding them with mist sprays of water behind protective sun screens over periods of 10–14 days. Wet drapes of geotextile fabric were kept in place overnight when the mountain began to give back the heat of the day.

The visual impact of considerable numbers of tile stacks within the walls was another potentially controversial issue. Sawn faces were tried but were too intrusively regular, so the tiles were split instead and even worked with masonry chisels when in place to provide more natural-looking faces. Washes of mud from the mountain were applied to soften the initial appearance of the tile stacks, a task which the mountain subsequently took over itself as the few heavy annual rainstorms flooded off the plateau top. Textures and colours were very quickly in complete harmony with the appearance of the weathered Herodian walls (Figure 10.19).

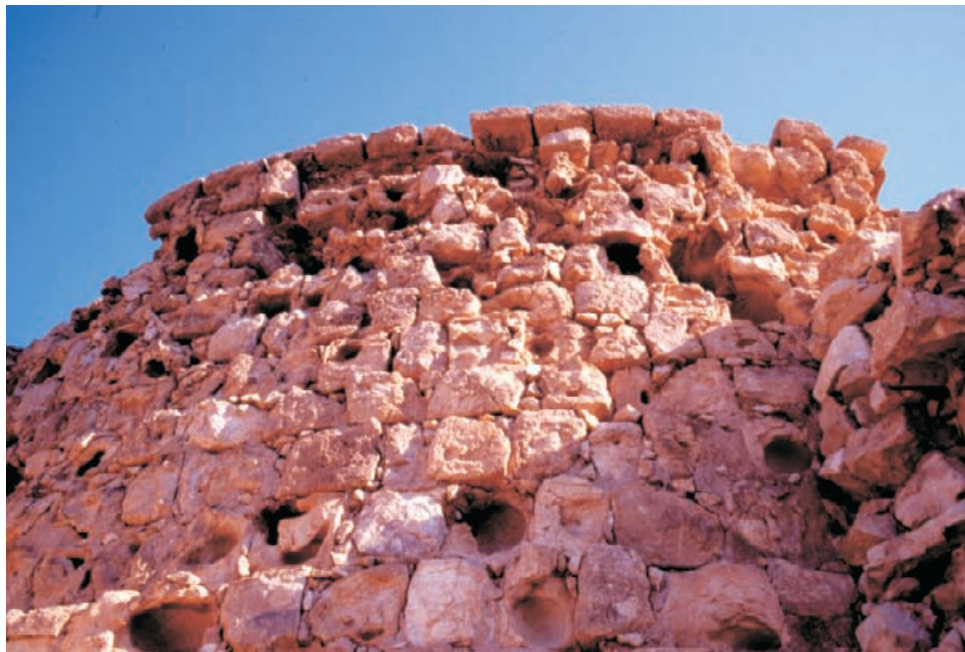
Figure 10.20 Early prototype of stone tile in lime mortar with a close texture to match stones in better condition. Thin mud washes are already blending the repair into the background.
