CONSERVATION OF RUINS

John Ashurst

Edited by John Ashurst

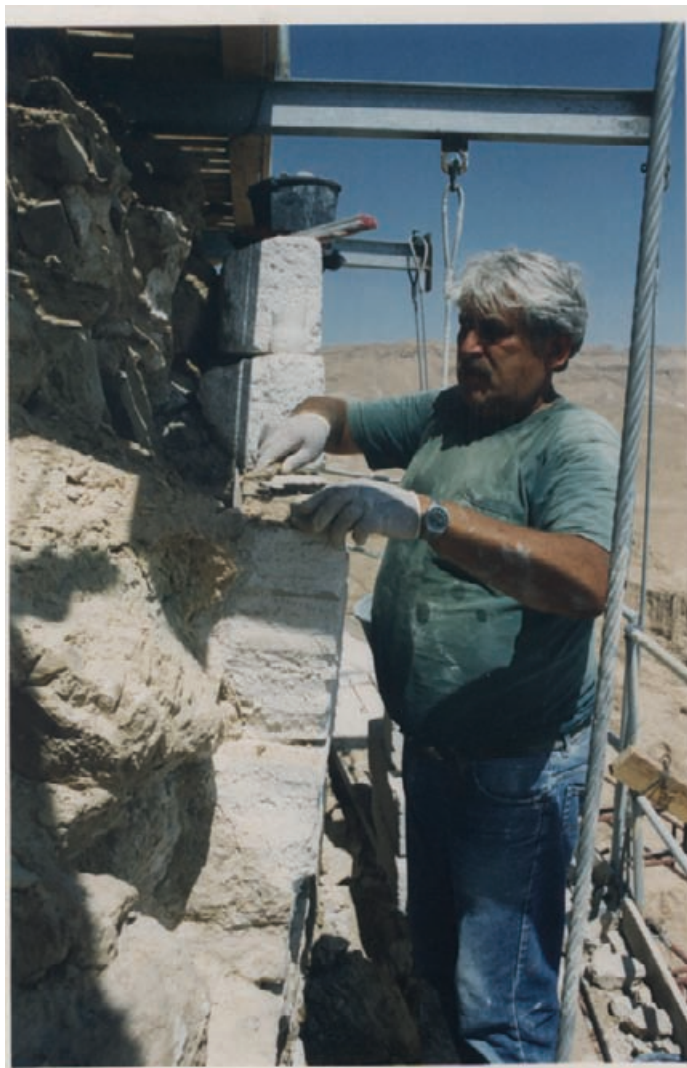
Figure 10.21 *Work proceeding from a suspended scaffold placing cast blocks back on the line of missing stones.*

A decision was finally made to replace the missing stones with cast stones. There were three reasons for this decision: new limestone was considered to be too aggressive visually and in terms of comparative durability; the use of new limestone was considered to be too close to condoning a policy of restoration; and the use of new limestone ashlar would require too exact a geometry to work in with the irregularities of the surviving Tholos plan. ‘Stones’ were cast in wood moulds based on a moderately hydraulic natural lime (NHL3.5), sand and porous aggregate to provide a block of adequate compressive and flexural strengths with good water vapour permeability. Stone sizes were taken from the tail impressions of the missing stones, and the bedding mortar was lime putty-based with ceramic pozzolan. To provide the essential stability for a high wall in such a precarious location, stainless steel dog cramps and restraint

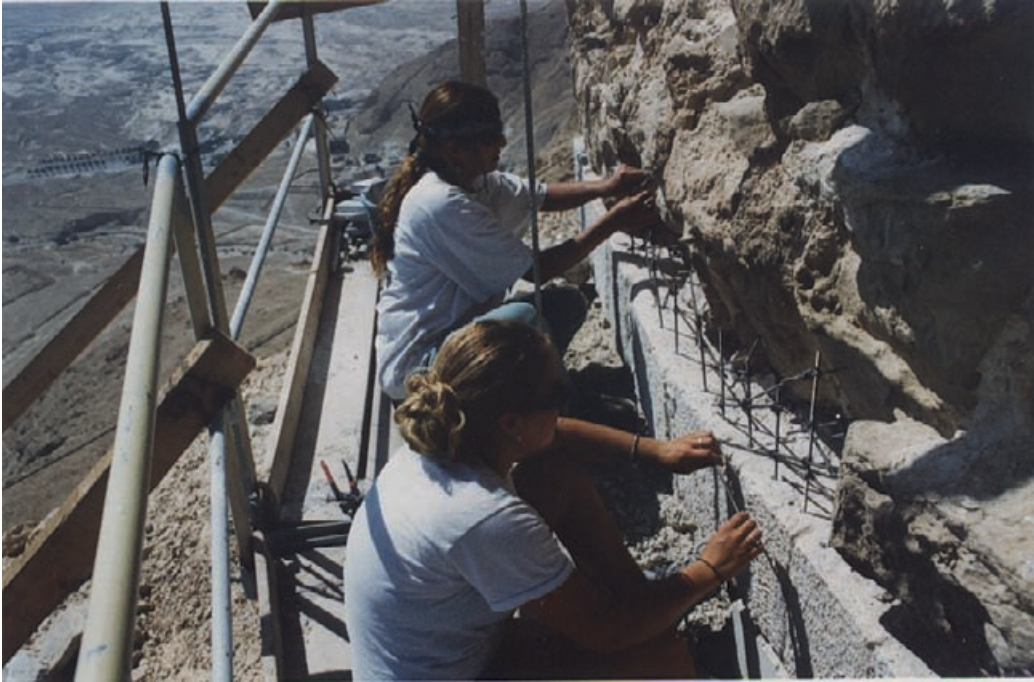
Figure 10.22 *Assemblage of cast stones with stainless steel dowels and restraint fixings. The conservators are checking the final position of the face line.*

fixings of butterfly pattern were introduced (Figure 10.22). All cast block surfaces were finally plastered in a mud-coloured lime putty plaster to match the ubiquitous undercoat plasters of Masada.

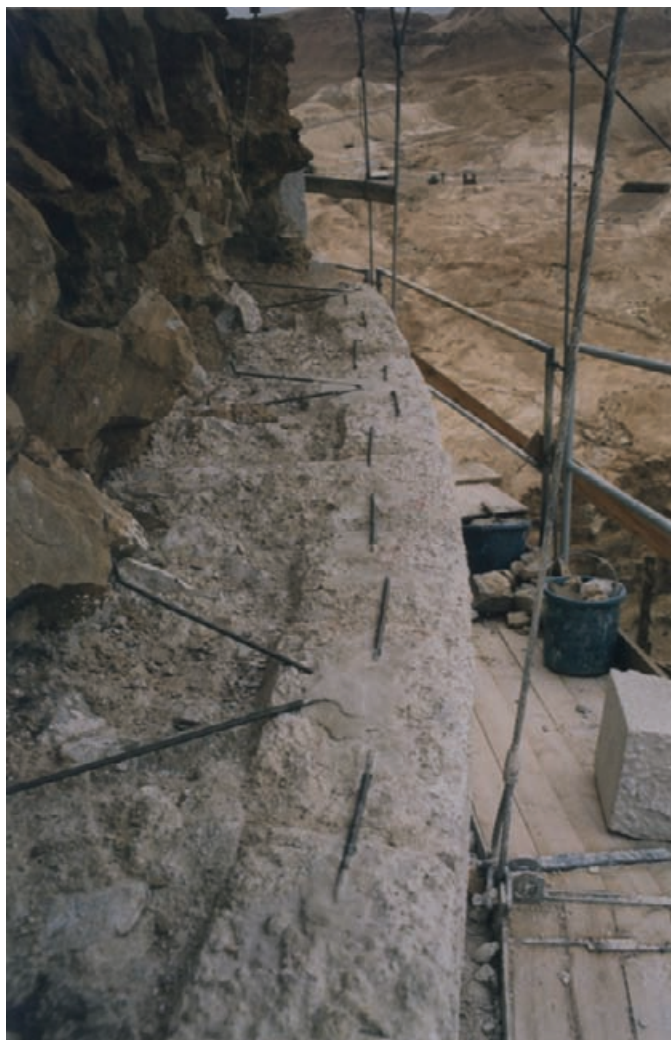
Figure 10.23 *Detail of cast block fixing showing stainless steel dog cramps grouted in hydraulic lime and the dovetail fixing method back into the core of the rock. The fill between rock and cast rocks is a weak hydraulic lime and stone aggregate.*

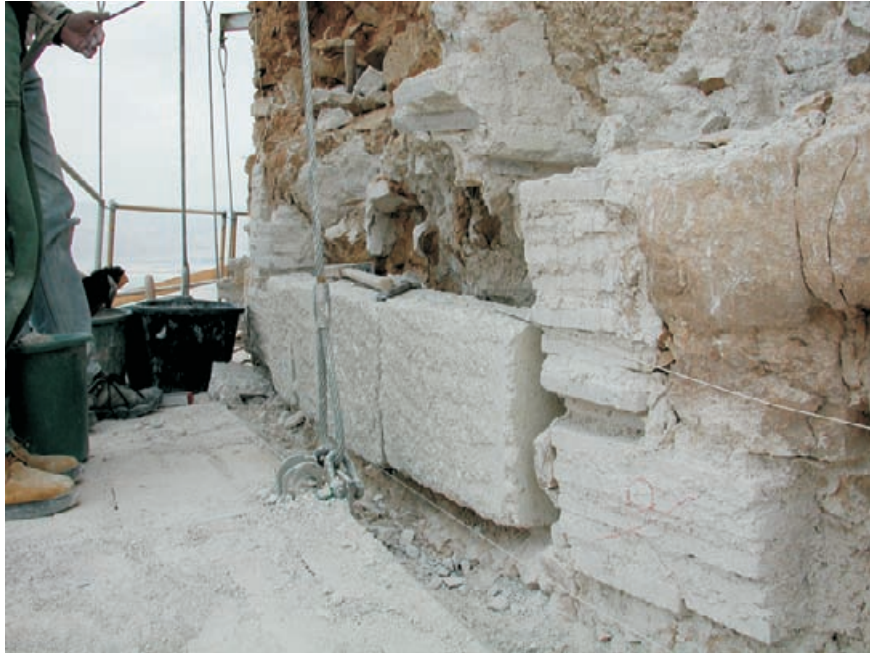
Figure 10.24 During the progress of the facing work the surviving original stones can be seen in the foreground. Adjacent to them are two stones which have been repaired with split tile and lime mortar. Beyond the repairs can be seen three of the cast lime blocks with a roughened texture. The consolidated Tholos wall is now a mixture of original stone faces, repaired original stones and new cast stones where the facing was missing. Every part of the original face was secured and saved.

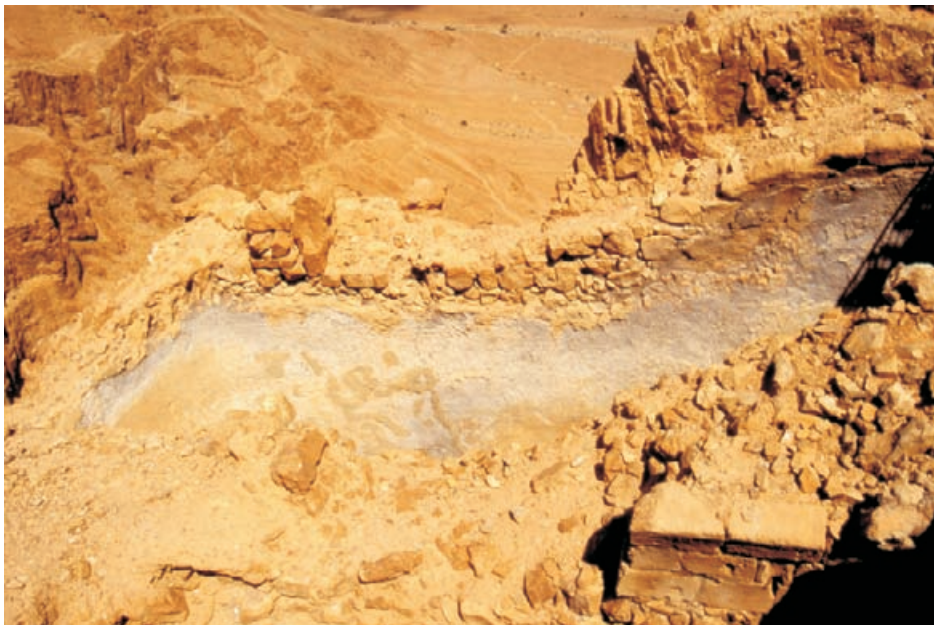
Figure 10.25 Herodian plaster lining to the artificial gutters running around the mountain to collect water and deliver it into rock-cut cisterns.

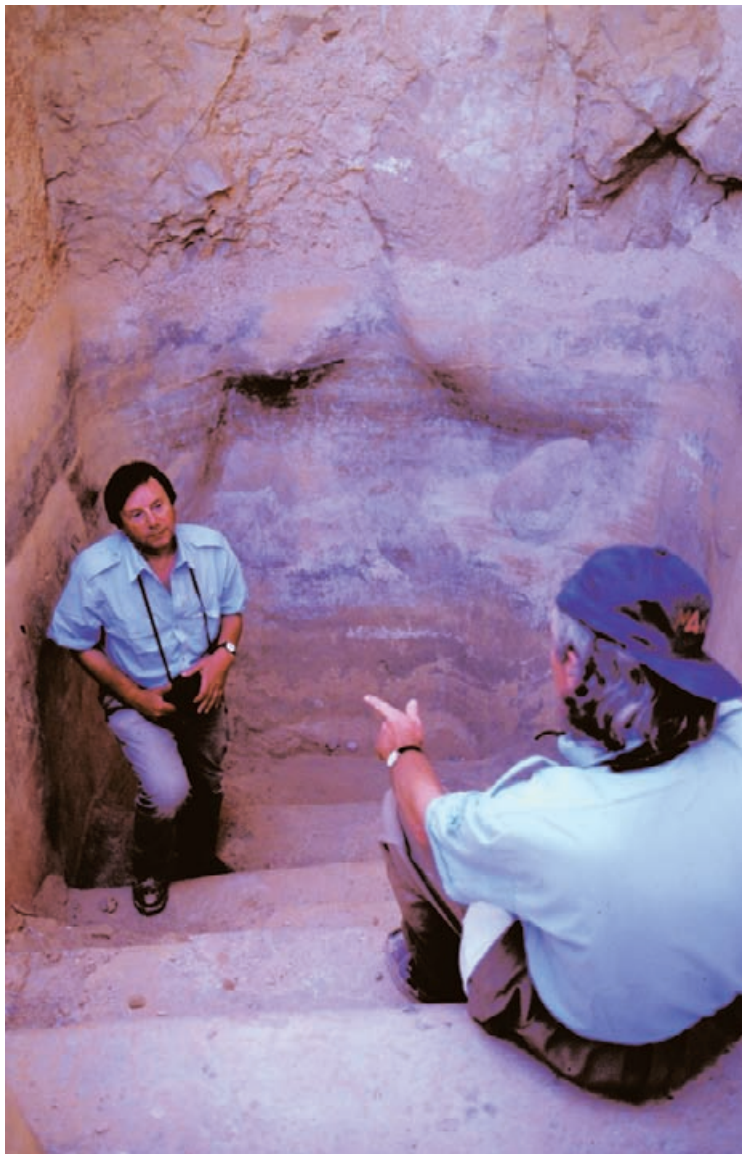
Figure 10.26 *The authors seen in the plastered frigidarium. The steps and the walls still retain much of the original polished plaster in excellent condition, still capable of holding water.*

The frigidarium was the most complete of the rooms, consisting of a deep, rock-cut pool reached by seven plastered steps and approximately half of its vaulted roof (Figure 10.26). The water-holding plaster was still impressive, showing the same ingenuity that was used in the collection gutters, cistern and pool linings elsewhere on the mountain, and on which the impregnability of Masada depended (Figure 10.25). Such plasters, typically, have a base of clay packing with small stones to close up fissures and irregularities in the rock face, undercoats of lime plaster very rich in wood ash and charcoal, and a finish of fine, white lime plaster with a very close, almost polished surface. The water-holding capacity of these plasters is remarkable and was recently (2004) applied to the repaired and

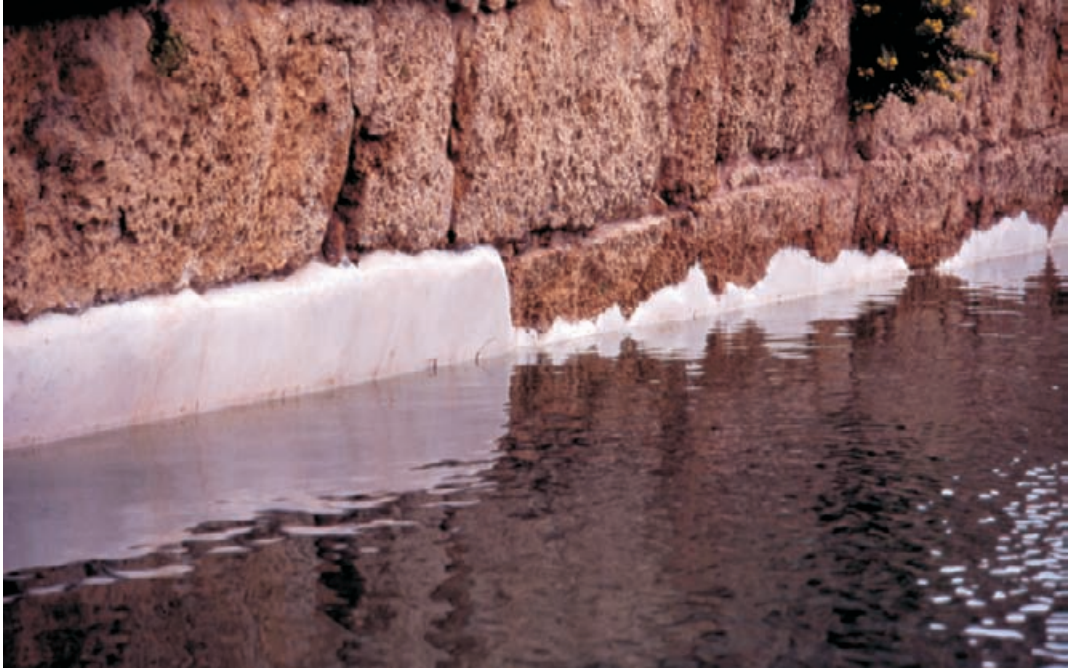
Figure 10.27 *Detail of new water-holding plaster applied by Kimi Maman to the restored Herodian dam above Caesarea. The plaster copies that of the Roman period.*

part-reconstructed Herodian dam above Caesarea with great success (Figure 10.27). In the frigidarium, water marks at various levels were still much in evidence, testimony to the efficiency of the plaster over many decades. There survived at least two repairs neatly applied over areas where the rock profile presumably came too close to the surface and likely to be contemporary with the original construction. Above the broken vault was a small ash-plaster lined water system with floor channels and a square outlet which must originally have been fitted with a wooden plug; through this outlet water

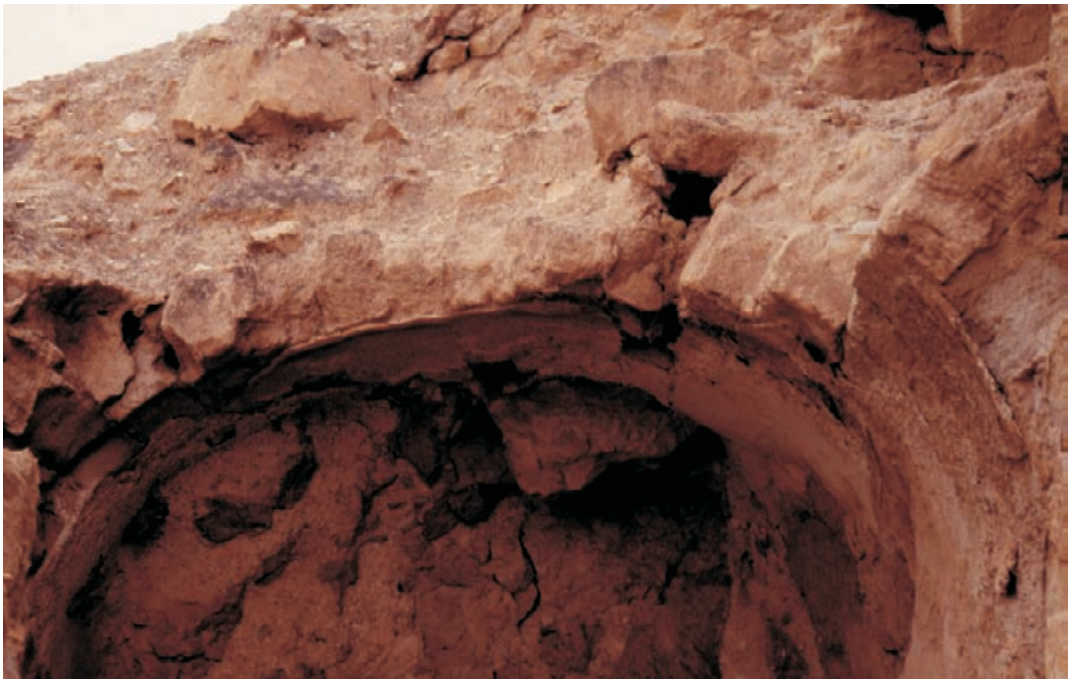
Figure 10.28 *Detail of the broken and freshly damaged edge of the frigidarium vault, showing its extreme fragility.*

In the 1990s, fresh rock falls from the mountain, perhaps exacerbated by unauthorised visitors climbing above the bath house, were beginning to damage the plaster threshold and steps; even more seriously, the broken edge of the frigidarium vault was becoming increasingly fragile and further losses were imminent (Figure 10.28). Once again, the message of the need for continuing monitoring, maintenance and protection following archaeological examination was clear to read.

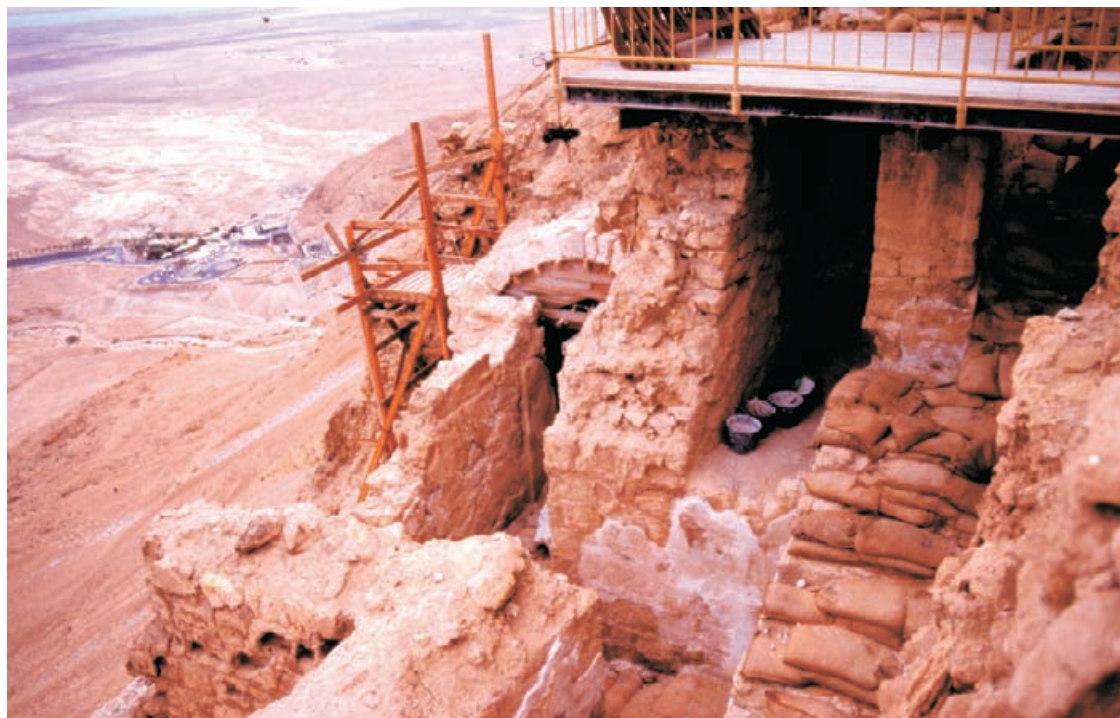
Figure 10.29 *View from the lower terrace of the small bathhouse complex during reinstatement of the vault.*

of access, which encourages trespass, but this may be overcome if plans to recreate the full floor area of the lower terrace are implemented; from an extended floor it would be possible to look down into the bath house and see its layout without needing to go down into its vulnerable plaster spaces (Figure 10.29).

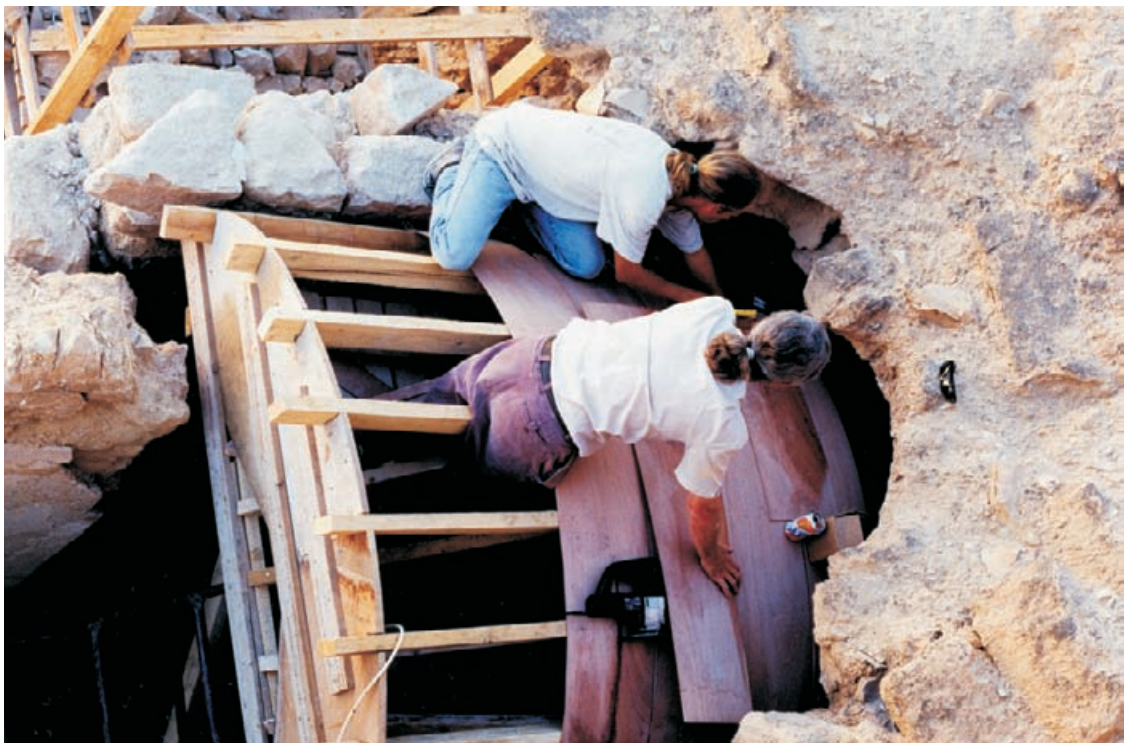
Figure 10.31 Completed form work seen against the raised eastern wall of the frigidarium.

were taken from the springing base line to establish the slightly distorted intrados line of the vault. The profiles obtained in this way were then translated onto 18-mm plywood formers, joined horizontally by 75 mm × 50 mm softwood framing, braced and screwed together to make a strong rigid base on which to construct the new vault. The last stage (Figure 10.32) was to screw-fix three sheets of 6-mm ply over the formers to create a rigid shell on which the stones would be set. The third sheet of plywood was introduced to allow for a plaster thickness on the surface of the vault.

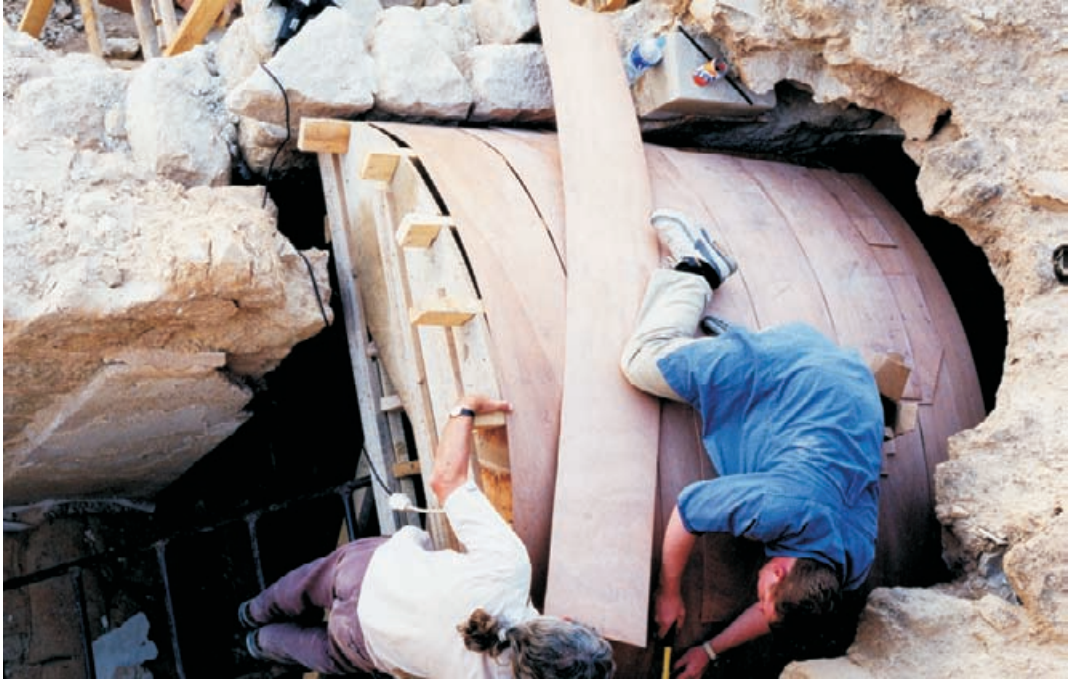
Figure 10.32 Fixing the plywood sheathing to the vault former.

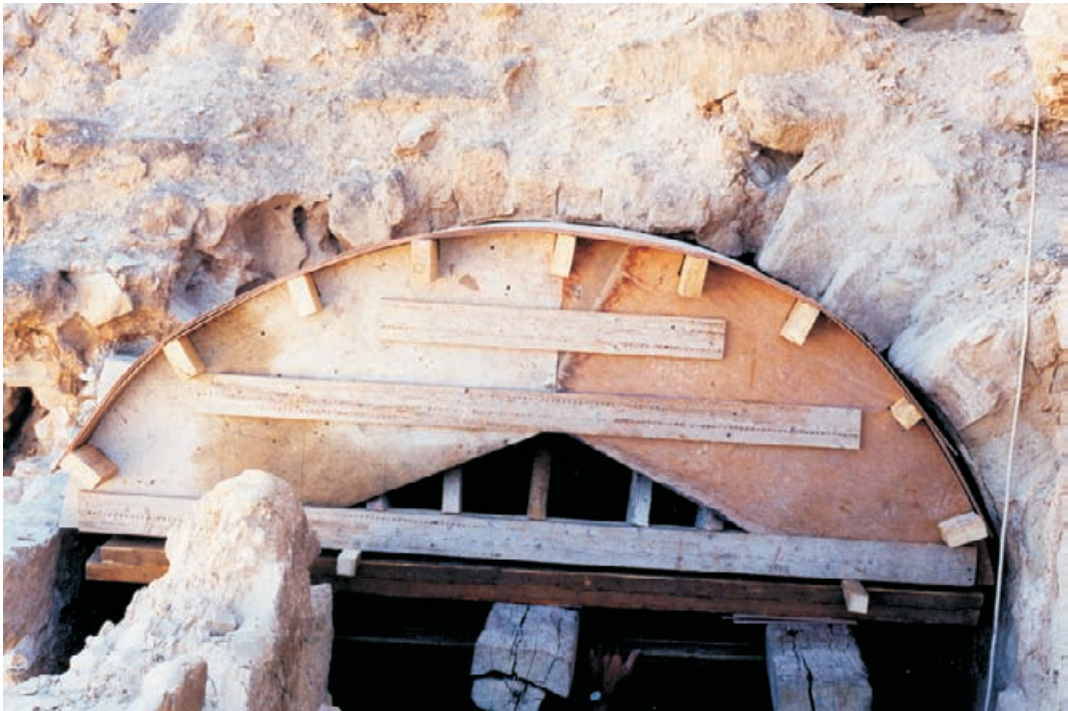
Figure 10.33 Completed formwork raised up into position under the old work.

The falsework was too heavy and unwieldy to slide into position and was obstructed anyway by the layout of the vault entrance, and thus was finally assembled and raised within the vault space, the last positioning being achieved with the use of wedges (Figure 10.33).

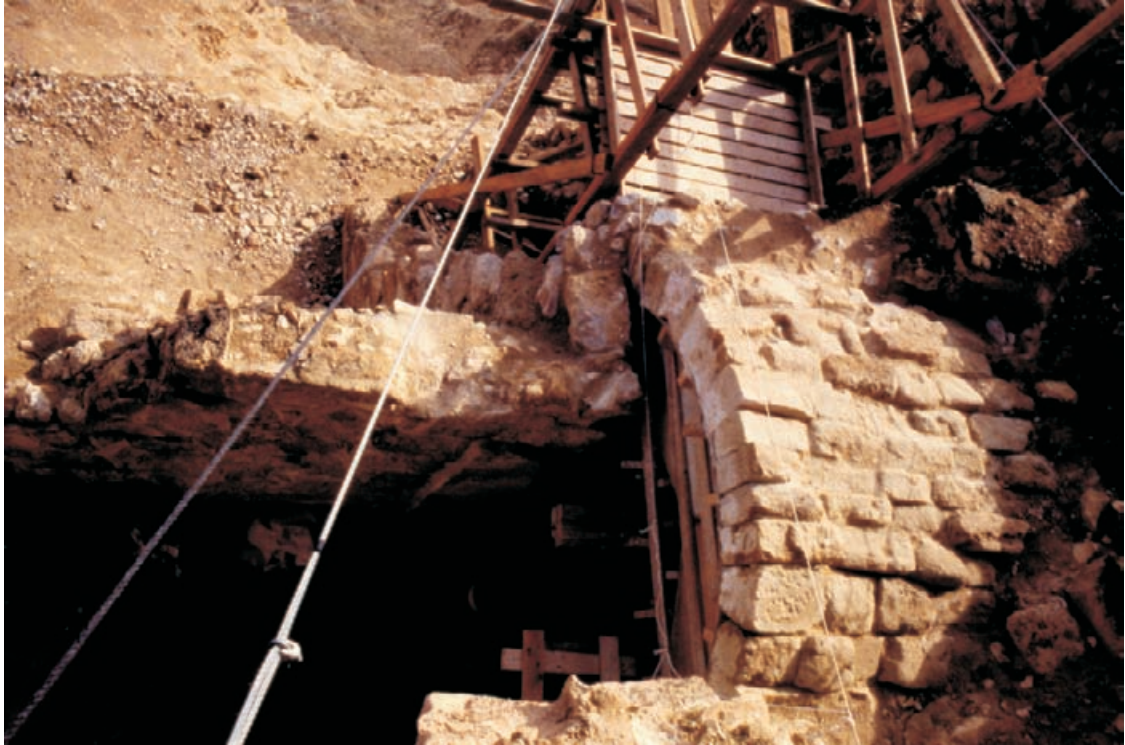
Figure 10.34 Completed vault showing the caldarium and the edge of a precipice beyond.

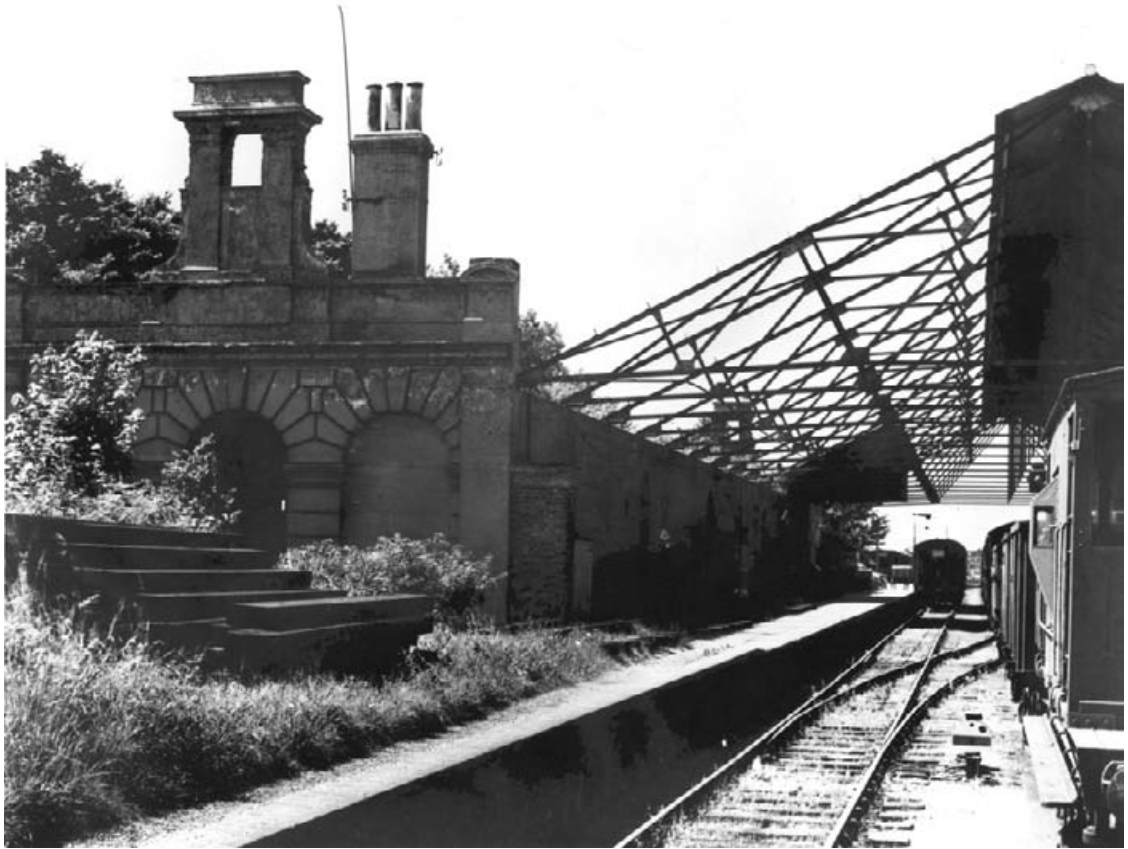
Figure 10.36 Hillspan roof installed after the original timber roof was destroyed by enemy action in 1941.

destroyed the offices and booking hall in the terminal, and business had to be conducted from buildings constructed at the west end of the passenger platform. A metal Hillspan roof was erected, leaving the passenger platform exposed to the weather (Figure 10.36).

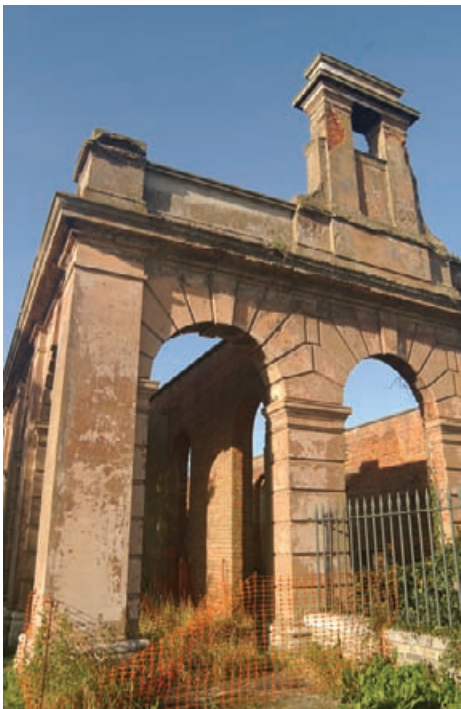
Figure 10.39 *Cement stucco used to replicate rusticated masonry is particularly vulnerable to the ruined condition of the building and needs careful maintenance.*

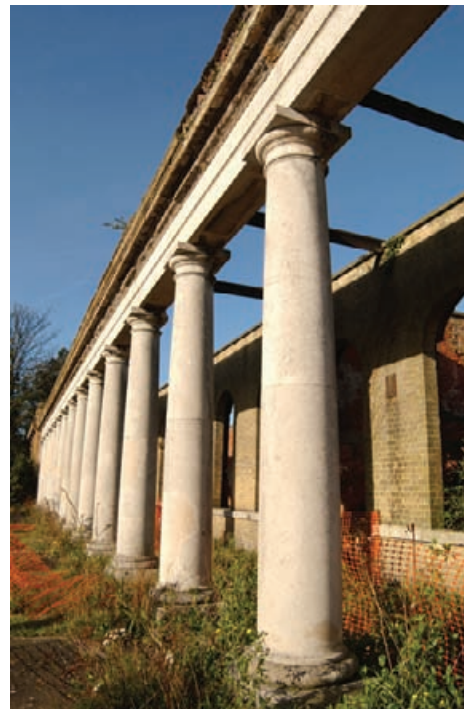
Figure 10.40 *The tuscan order was used by Sir William Tite for the entrance colonnade, worked in portland stone, with scholarly detailing.*

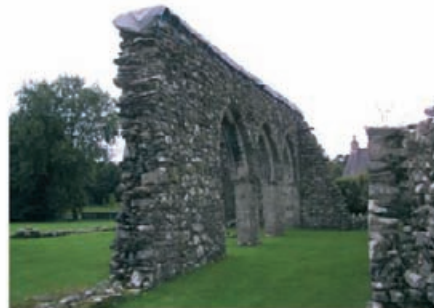
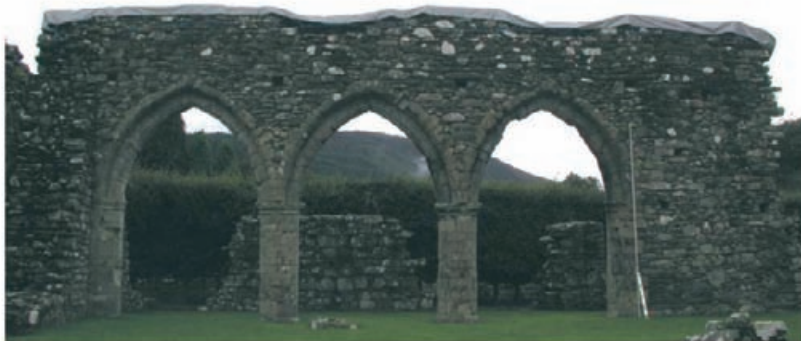
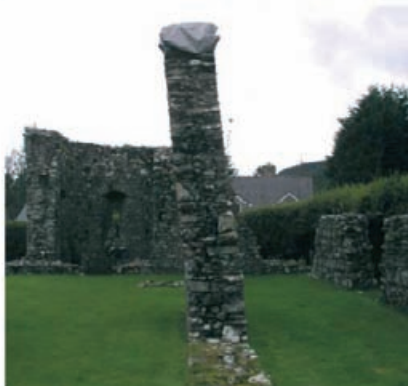
The end elevation of the wall is shown in the photograph opposite and illustrates the significant movement present at the east end of the arcade wall.

On the north side of the arcade the movement is encouraging the mortar joints to open. Vegetation is also becoming established as illustrated in the photograph. Movement of voussoirs is also present, and voids were noted. These are all issues which will contribute to ongoing deterioration of the wall.

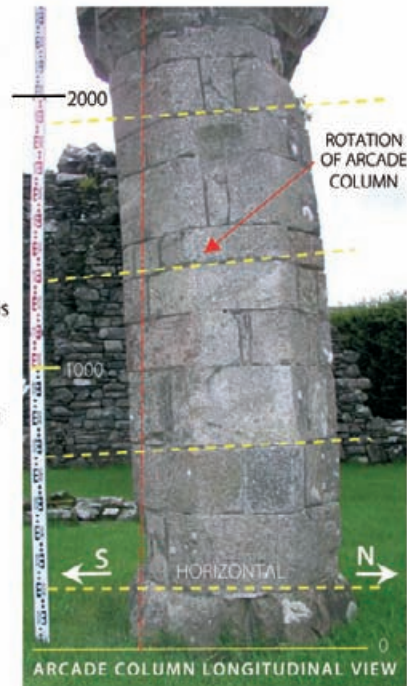
At the base of the arcade column the bedjoint remains reasonably level suggesting a stable foundation.

Rotation occurs at subsequent bedjoints above this level, indicating movement is related to superstructure failures or weaknesses.

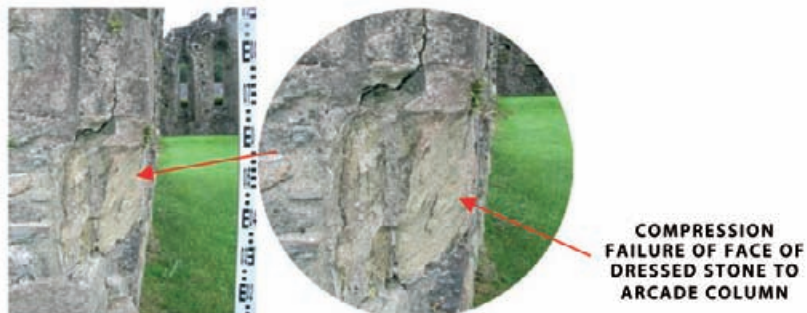
The combination of rotation of the arcade column and the rigidity of the base plinth at ground level is causing elevated compression stresses, which have resulted in local failure. The photograph below illustrates the compression failures, which are occurring on the south side of the columns at low level.

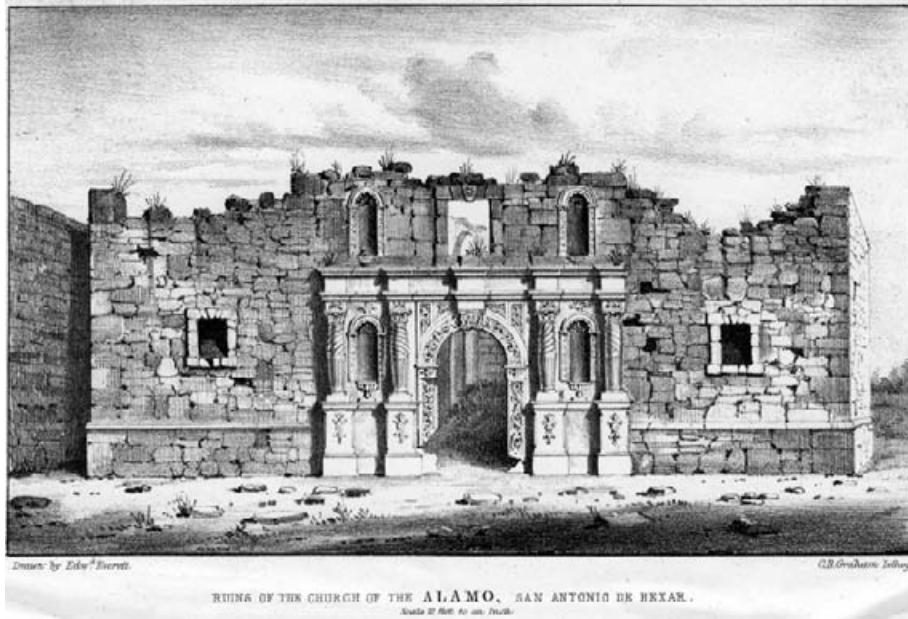
Figure A4.3 'Ruins of the Alamo in 1845 from a sketch upon a map of the country in the vicinity of San Antonio de Bexar made by J. Edmund Blake, 1st Lieut. Topographical Engineers USA' (DRT) (Reproduced by kind permission of the Daughters of the Republic of Texas).

From the Alamo archives, one image is particularly striking. Less than ten years after Santa Anna’s troops took back the Alamo from Travis’ garrison of volunteers, 1st Lieutenant Edmund Blake of the USA Topographical Engineers made a detailed drawing of the west front of the church (Figure A4.4 – Ruins of the Alamo in 1845 from a sketch upon a map of the country in the vicinity of San Antonio de Bexar).

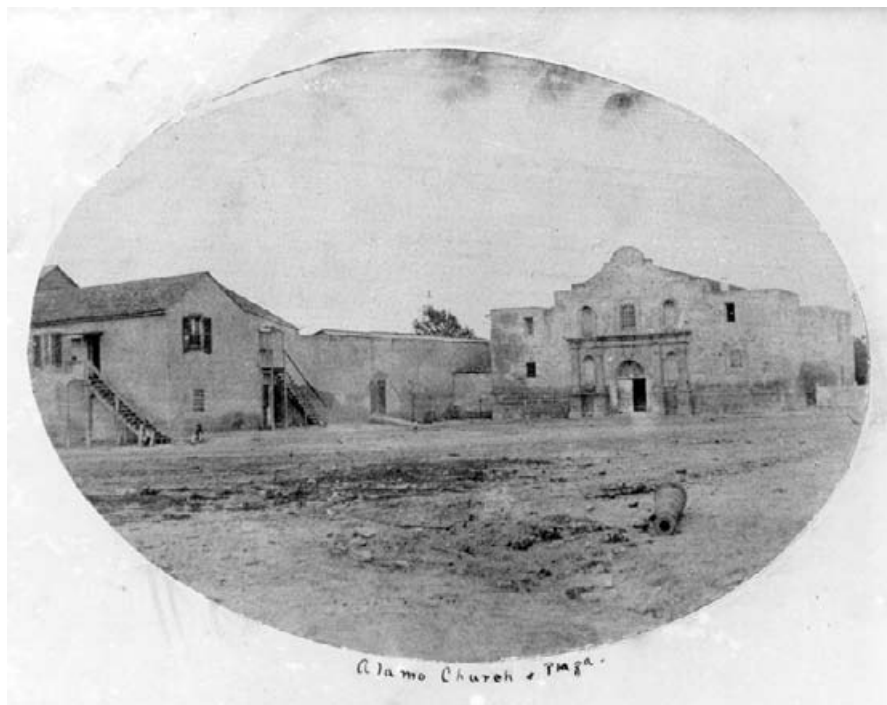
Figure A4.4 The 'Alamo Church and Plaza'. Post 1860 rebuild of the west façade of the Church building and of its roof (DRT) (Reproduced by kind permission of the Daughters of the Republic of Texas).
