**GEOMORPHOLOGICAL
HAZARDS OF EUROPE**

C. & C. EMBLETON

GEOMORPHOLOGICAL HAZARDS OF EUROPE

1997

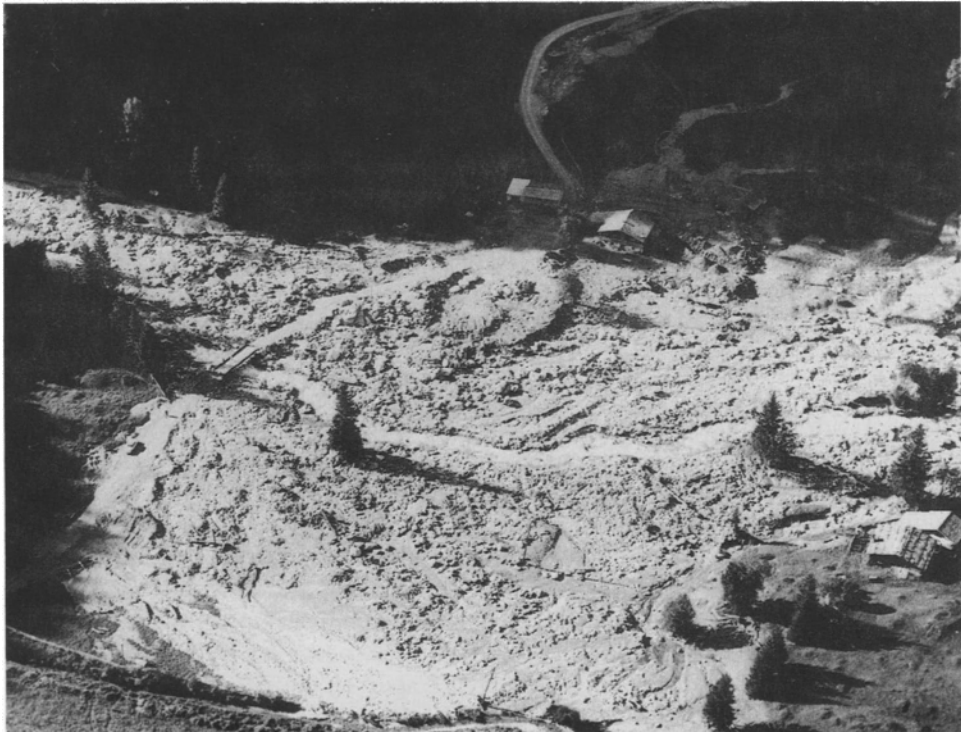
Fig.1.2. View of the devastation caused by the debris flow of 7 September 1970 in the Rauris valley, Hohe Tauern. Several houses were damaged, as well as the road which had been partly repaired when the photograph was taken (*Copyright, Forstliche Bundesversuchsanstalt*)

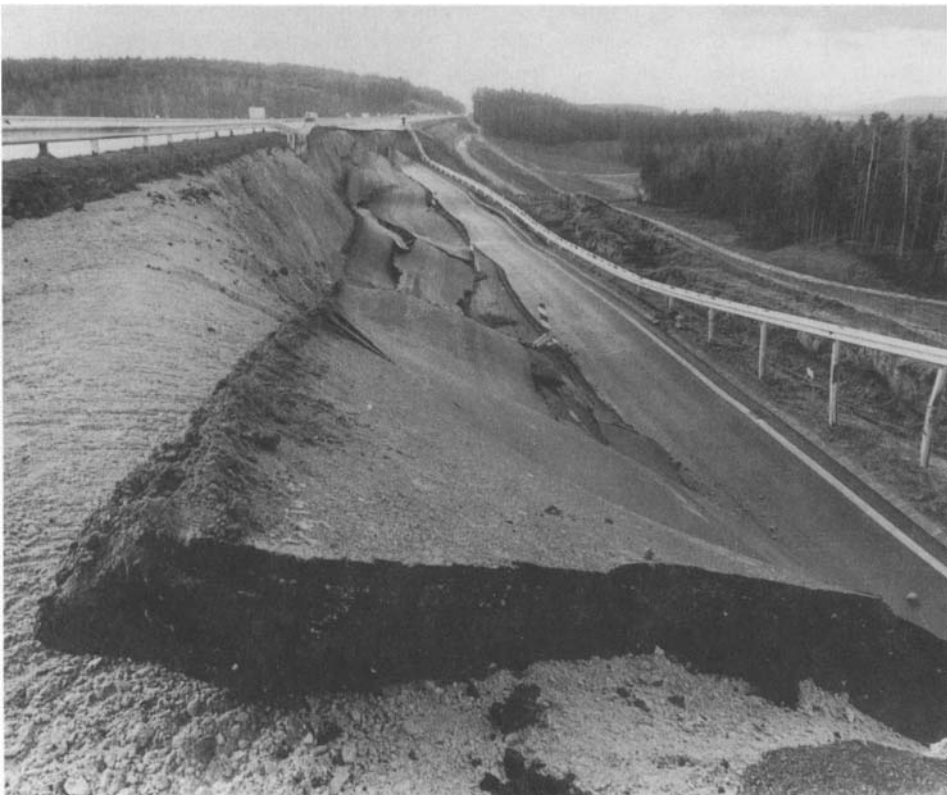
Fig.1.7. A section of the newly-built Süd-Autobahn which collapsed in December 1985, a few days after the road was opened (Copyright, Franz Pauritsch)

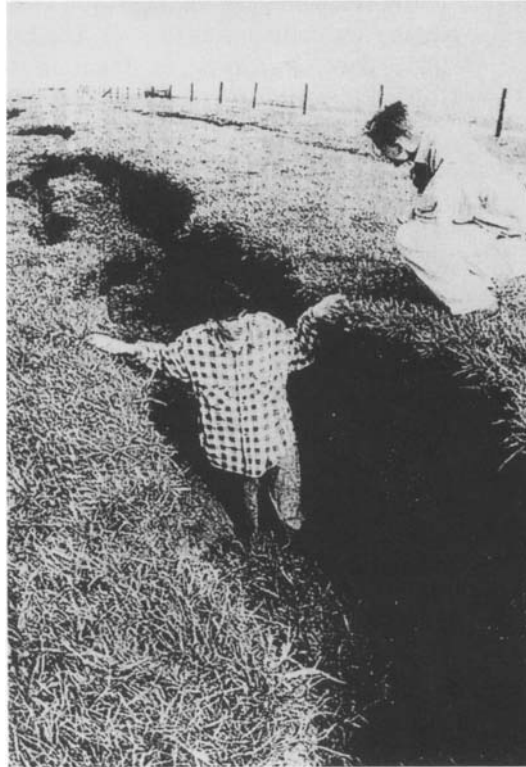
Fig.2.2. Damage to dykes along the Meuse caused by the Roermond earthquake of 13 April 1992 centred in the Campine area of the Netherlands

The Roermond earthquake of 13 April 1992 was also noteworthy ($M = 5.5$). Its epicentre lay about 10km outside Belgium in the Campine region of the Netherlands. Its focus at a depth of 16km is related to the Peel fault of the Roer (Rur) graben. About 200 aftershocks were recorded. Earthquakes of this intensity occur 1900 times a year worldwide, but for the Benelux countries the return period is 130 years. Damage totalled 7×10^9 Guilders (about 3.7×10^9 U.S.dollars), and the event was considered a national disaster in the Netherlands, though not in Belgium despite the mass movements that were triggered and the damage to some of the Meuse dykes (Fig.2.2). Sand fountains (sediment liquefaction under pressure) were also reported.

River banks, scarps, dykes, artificial road cuts are regularly destabilised by slumping and local collapse. Internal cohesion is reduced following heavy rain, but periods of drought and lowered river levels can also result in subsidence. The 1992 Roermond earthquake, already described, similarly caused slumping of dykes (Fig.2.2).

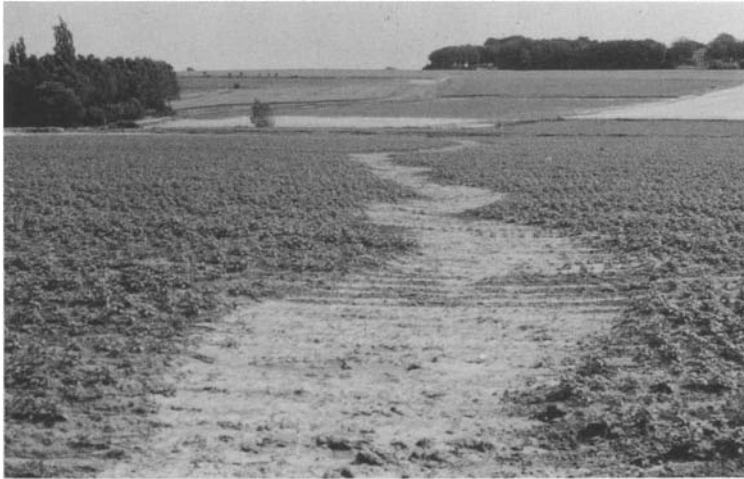
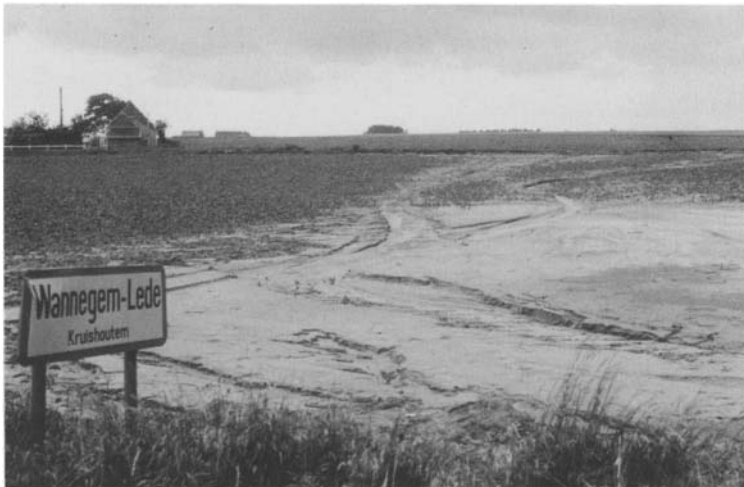
Fig.2.3. A (*upper*): Erosion of the humic topsoil by rilling in an area of sandy loam; potato crop; B (*lower*): Sandy loam colluvium burying the humic topsoil at the foot of slopes (Photos: I.Heyse, 1985)

Ephemeral gullies can form and re-form up to seven times a year. The rates of incision can be 1-10mm/year, and a single intense cloud burst of 10 minutes' duration and several centimetres of rainfall has been observed to erode 30t of loam per hectare. Sometimes the entire Ap humus horizon is destroyed or buried (Fig.2.3). Deep, steep-sided, permanent gullies (Fig.2.4) change the morphology completely and may in turn induce mass movements.

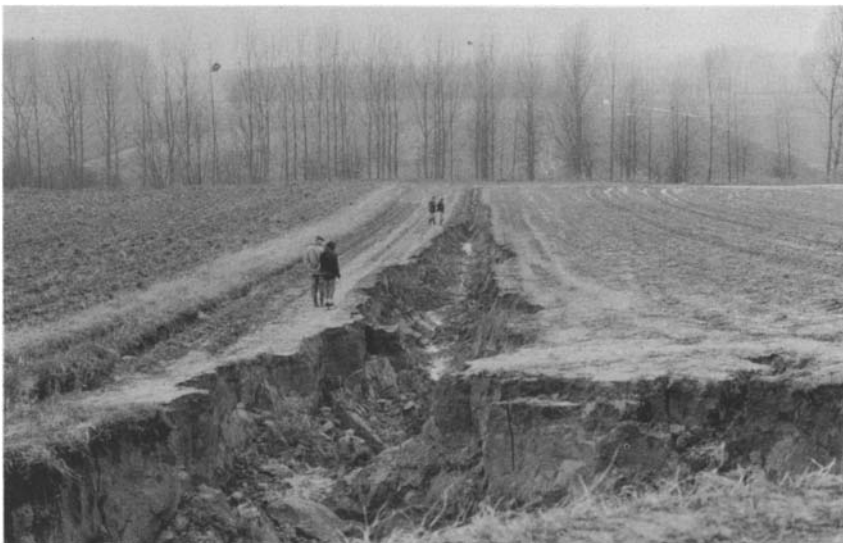
Fig.2.4. Formation of deep vertical-sided gully, showing side slumping, owing to improper cultivation techniques in a hilly area of sandy loam (Photo: I.Heyse, 1993)

Financial losses owing to soil erosion have been estimated in the range between 1 and 2×10^9 Belgian francs (about 15-30 million U.S.dollars) in a year by de Ploey. The news value of this type of hazard is very low because it seldom shows clearly visible signs or affects infrastructure; the danger is long-term and insidious. Figure 2.4 shows the irreversible loss of soil by improper cultivation techniques.

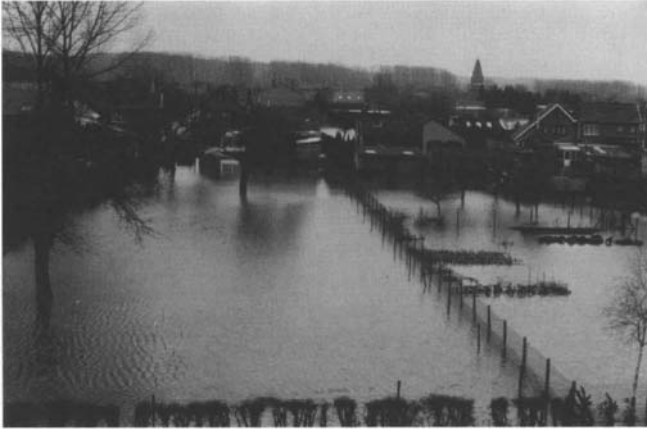
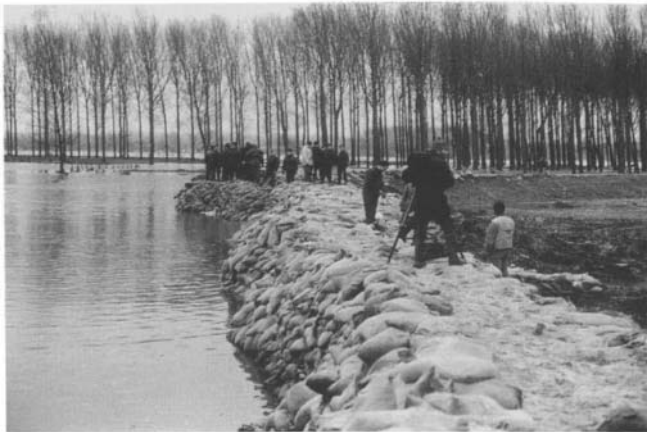
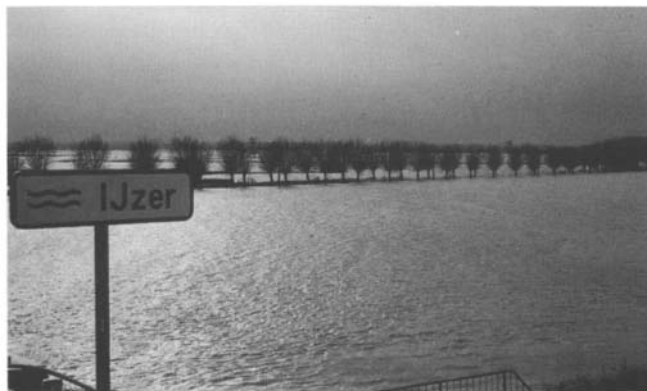
Fig.2.6 (facing page). A (upper): Flooding in the Campine area of the Meuse valley, near Maastricht; B (middle): Dyke burst, Meuse valley, Stokkem, Molenveld: note the lateral shifting of about 2m in the rebuilt dyke caused by water pressure; C (lower): The Yzer-Ieperlee confluence where a lake covering 7000ha was formed. All three photos by I.Heyse in December 1993.

(Figs.2.5 and 2.6). In the Meuse basin, the whole river system from the French to the Dutch border was affected. In Dinant, water rose to more than 2m in the streets, the brand new Walloon Parliament building in Namur was flooded, and in Seraing near Liège, the water level reached 4.72m above normal, which corresponds to a discharge of 3650m³/s. In the Campine area, the maximum flood level occurred in the night of 22/23

December 1993, 5m above normal, with a discharge ten times the average winter flow and 100 times the average summer flow. The dyke-building programme begun in 1980 was only 20 per cent completed, and the water-soaked loamy dykes were not able to withstand the water pressure. About 2500 people had to be evacuated.

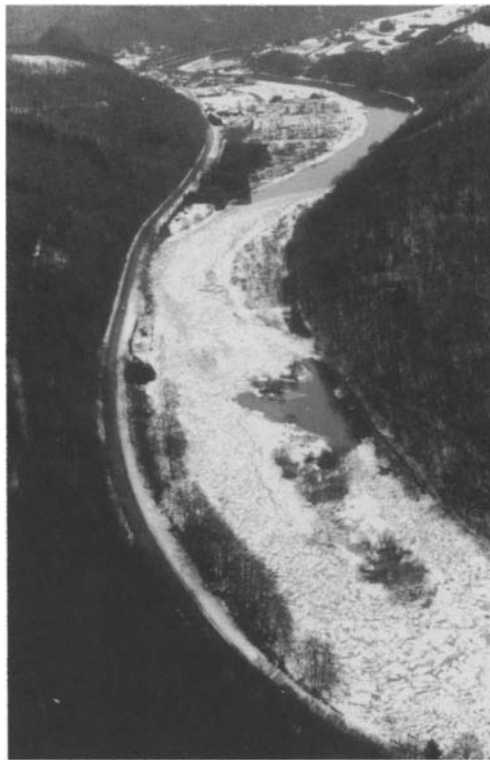
Fig.2.8. Ice-jam formation, Semois valley, Ardennes, in 1985 (Photo: I. Heyse)

lead to very rapid rises in water level; subsequent freezing can further consolidate the ice jam. Weather conditions in January 1985 favoured such events in the Meuse valley near Namur and on some tributaries such as the Semois near Vresse (Figs.2.8 and 2.9). Ice jams developed on the 5th, 6th and 9th of January, with water levels rising quickly to 3m above normal winter level, dropping back to normal levels between each episode of freezing. In the Scheldt basin at this time, similar phenomena were observed on the Durme and Dender valleys (between Geraadsbergen and Ninove).

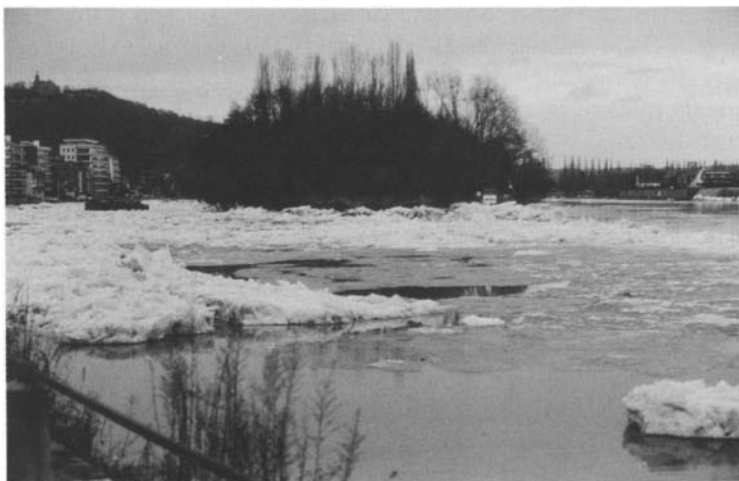
Fig.2.9. Ice-jam formation in the Meuse valley near Namur in 1985 (Photo: I. Heyse)

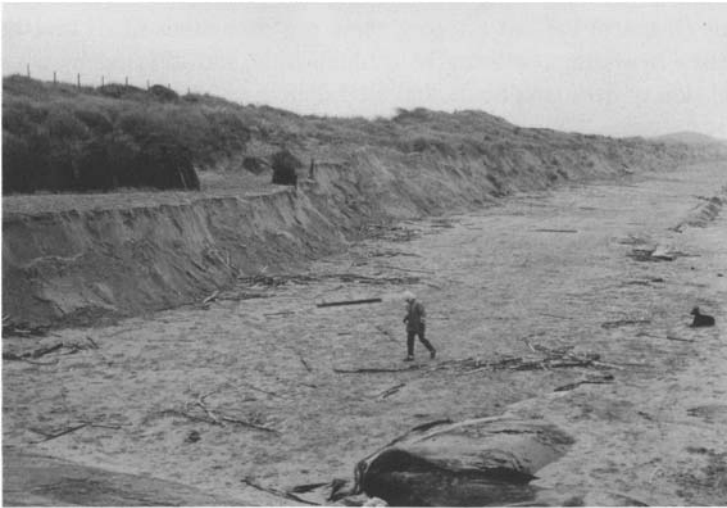
Fig.2.11. Formation of a beach cliff and erosion of the coastal dune belt by a storm surge in the autumn of 1993 (Photo: I.Heyse)

From 1947 to 1993, air photos show that the dune front has receded by 15-30m, an average of 0.33-0.65m per year. The winter storms of 1993 can be seen to have formed a

well-developed cliff at the dune base (Fig.2.11). Photogrammetric surveys are made after each severe storm surge. The present dune belt is so narrow that even one storm surge may be sufficient to initiate a break-through.

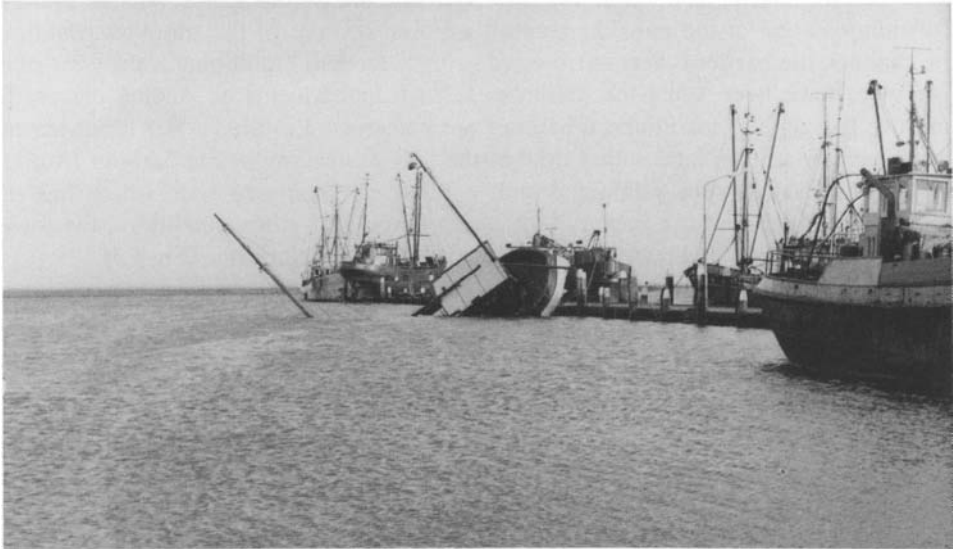
Fig.4.2. The fishing port of Rømø devastated after a storm in January 1976. In the far background, a fishing vessel can be seen dumped on the pier owing to the high water level which overtopped the white bollards. The fishing vessel in the centre foreground has its stern resting on the pier and its bows on a sunken ship. The water level is still high: normally, the decks of the ships lie below the level of the pier.

up during average storms. Land outside the dykes and land protected by only low dykes can suffer severely. In 1976 (Fig.4.2) and again in 1981, the fishing port on Rømø was completely inundated when the sea surface rose to about 5m above mean sea level (Møller, 1988).

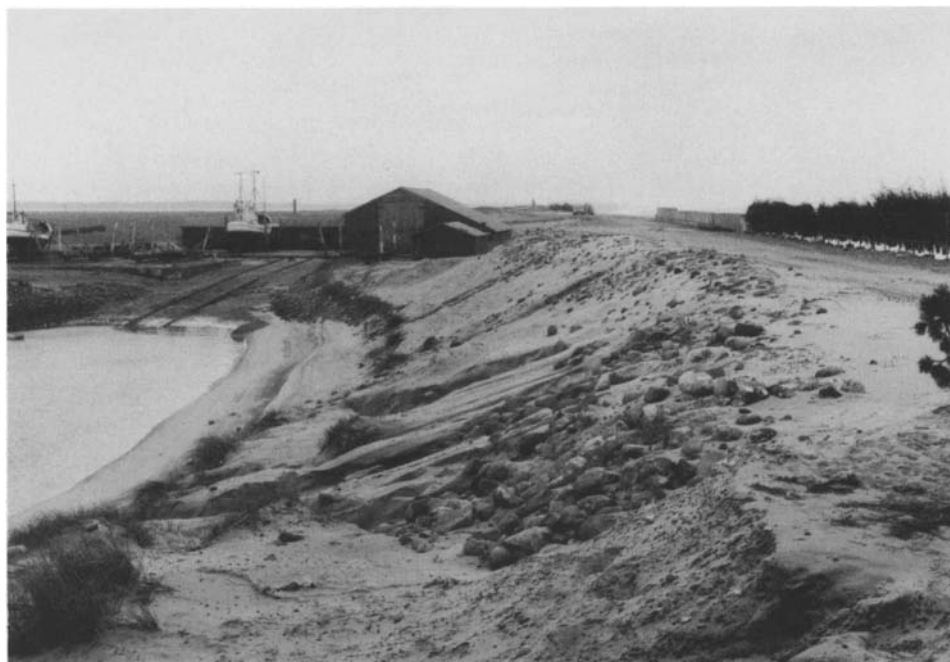
Fig.4.3. A dyke overtopped by waves, west of the fishing port of Torsminde (March 1990). The seaward side of the dyke is to the right (south); north of the small shipyard is a basin partly filled with sand transported across the dyke. Facing the North Sea, branches have been planted in a fence to prevent transport of blown sand, but most of the sand has been carried over the dyke by waves.

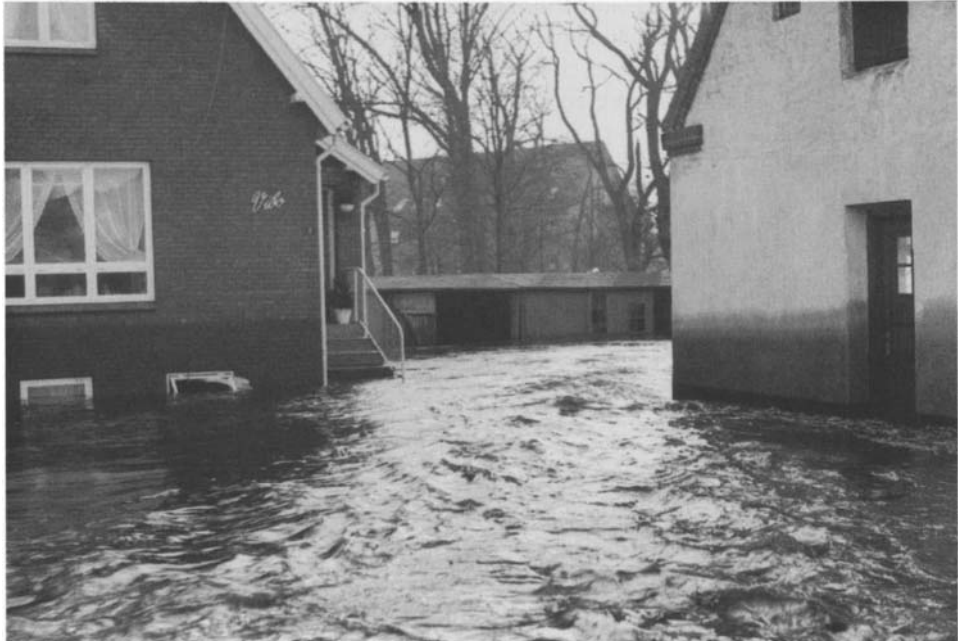
Fig.4.5. Flooding in Holstebro in March 1970. The high-water mark can be clearly seen on the wall of the house to the right. The basement of the house was filled with water-transported sand. Large parts of this town, which had never suffered from flooding before, were badly damaged and the people had to be evacuated.

overflow of water courses, most of which have very low gradients. In 1970, for example, the stream through Holstebro was flooded (Fig.4.5). In this case the level of damage was high because the road embankments normally retaining the water here, collapsed because of faulty construction.

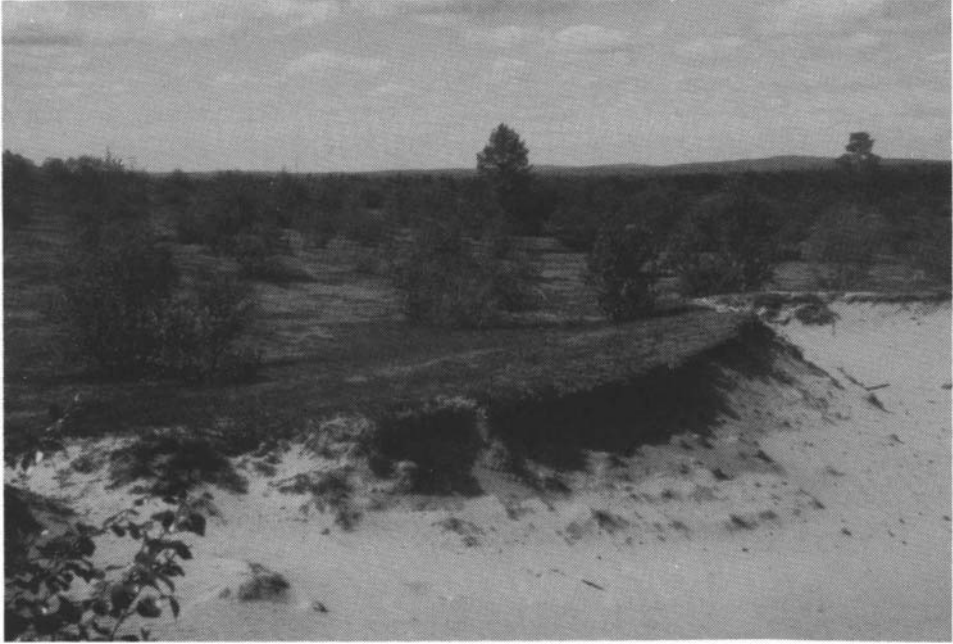
Fig.5.7. Reactivated aeolian activity in the Hietatievat inland dune field, Lapland (photo: L.Koutaniemi, 1974)

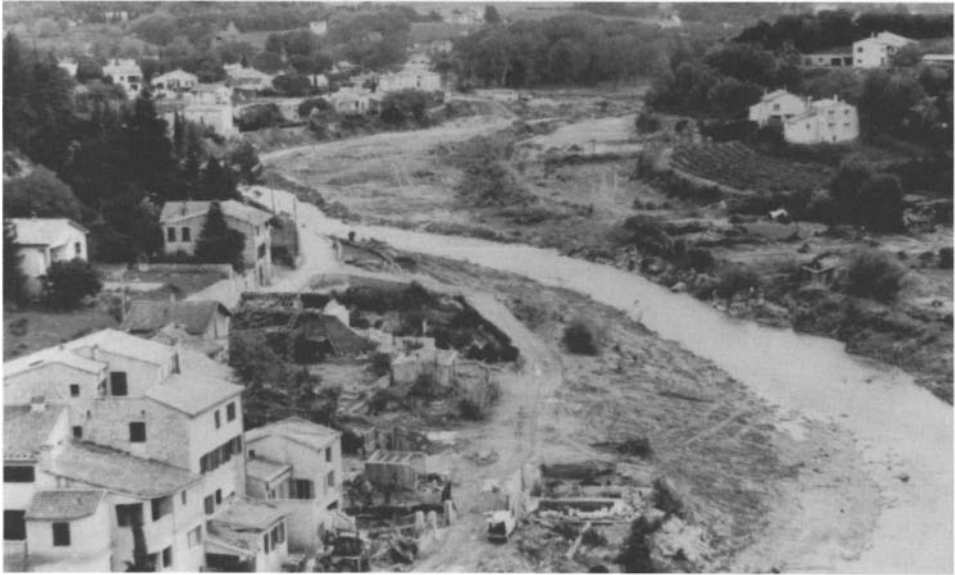
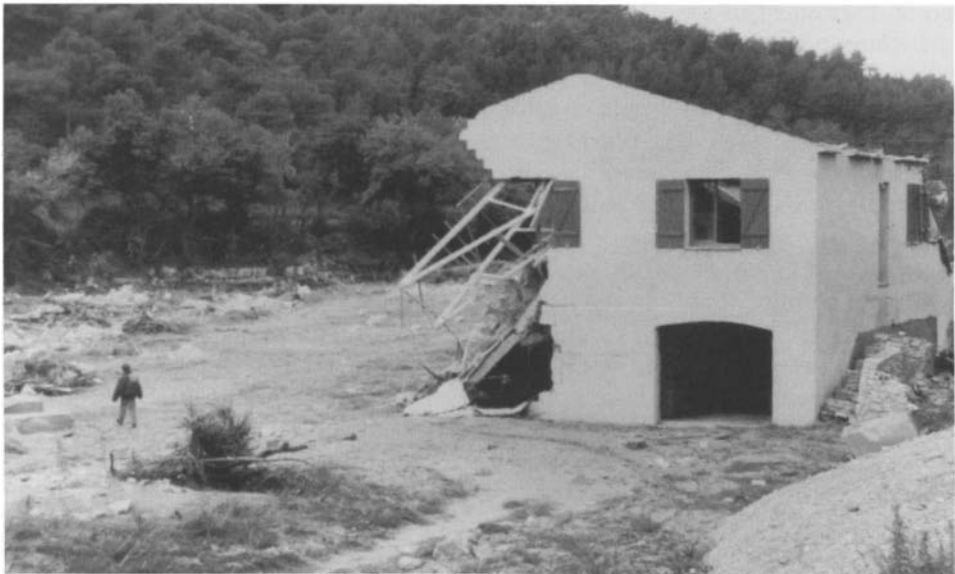
Fig.6.3 A (*upper*): The floodplain of the Ouvèze, looking upstream from Vaison, after the flood of 22 September 1992 (most debris has been removed); B (*lower*): Destruction of a house by the same flood (J-P.Bravard)

3) The most recent destructive flood at the time of writing was that of 22 September 1992, which killed 42 people in the Department of Vaucluse, including 32 in the small town of Vaison-la-Romaine, drained by the river Ouvèze, a tributary of the Rhône (Fig.6.3). More than 200mm fell in 4 hours over 200km^2 on the slopes of Mt Ventoux which towers above the town, generating a peak discharge of about $650\text{-}800\text{m}^3/\text{s}$ at Vaison.

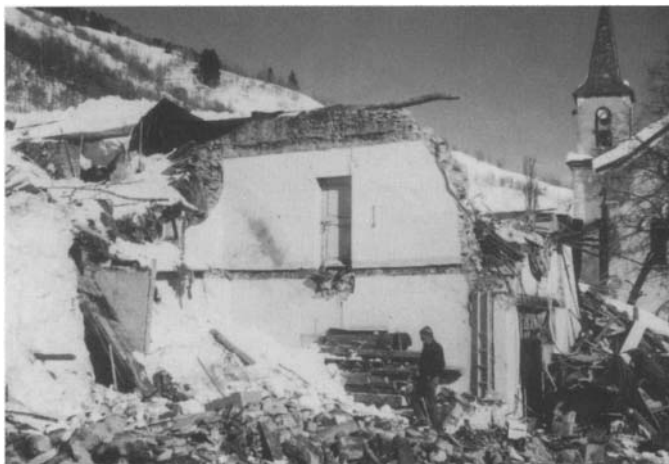
Fig.6.8. Buildings destroyed by snow avalanches, 20 January 1981, in Saint Colombanles-Villards, Savoy (photo: F.Valla)

Although avalanches have destroyed many alpine holiday chalets, the consequences are more serious when permanent residences are involved (Fig.6.8). On a single day in 1981, Tuesday 20 January, several avalanches in Isère and Savoy engulfed altogether 14 people, two of whom died. Numerous buildings as well as agricultural and touristic equipment were destroyed, including 10 secondary homes in the village of La Morte; 16 houses and the church were damaged in the parish of Clavans. The total damage was estimated at several tens of millions of francs. The death toll can be far more serious if avalanches occur during the high season in a ski resort. In February 1970, 39 people died in a chalet at Val d'Isère, and in the 1988-89 ski season, when there was relatively little snow, 33 accidents were reported involving 105 people, of whom 17 died.

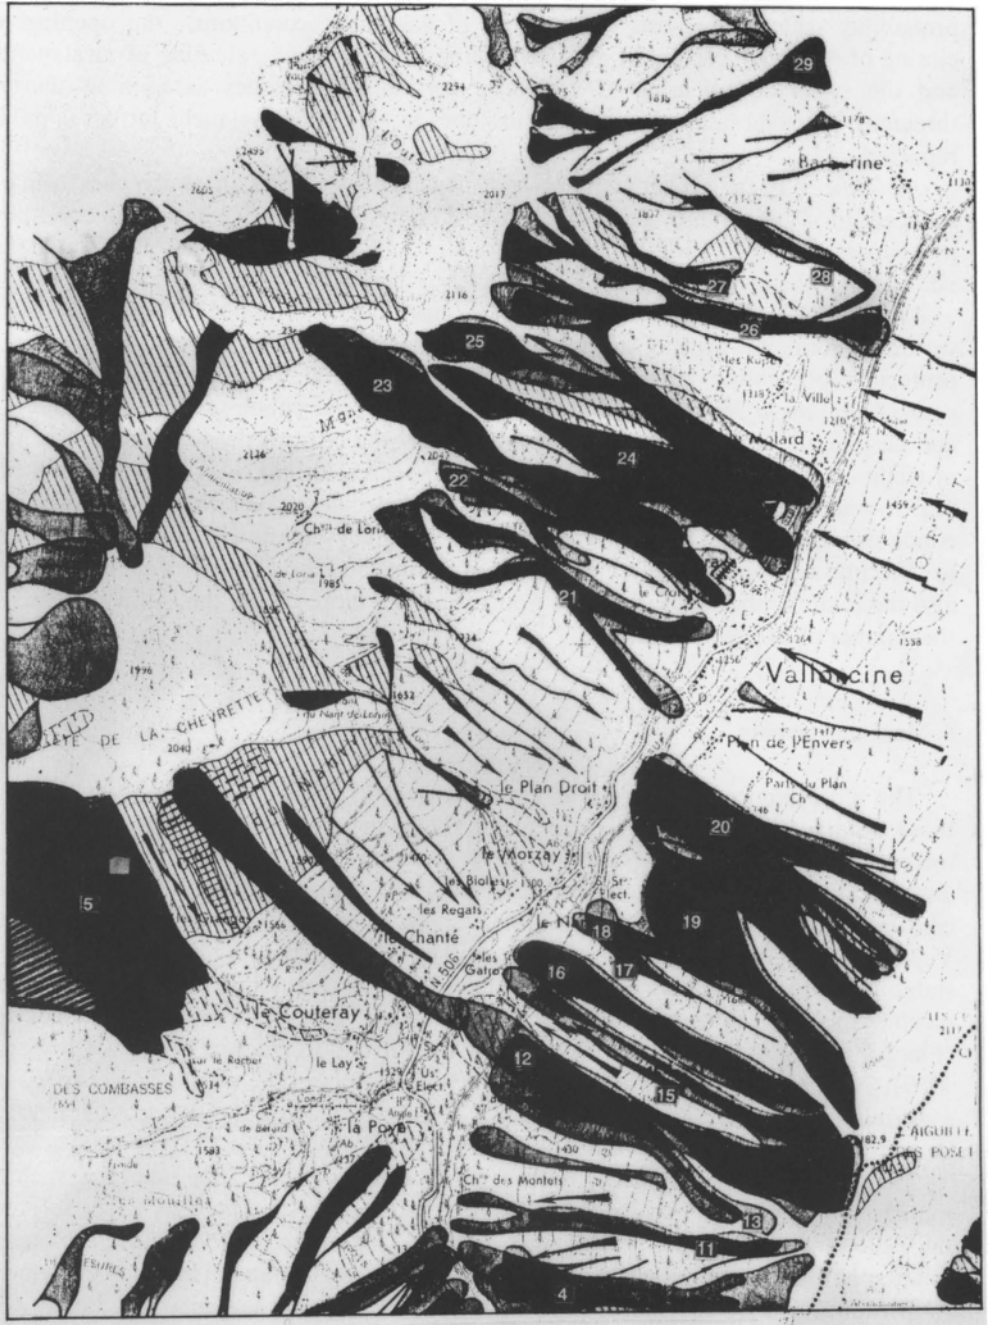
Fig.6.9 Example of the 1:20 000 / 1:25 000 map of high-risk avalanche sites (*Carte de localisation probable des avalanches*)

In the past, people's knowledge of danger zones was very fragmentary and often restricted to the immediate vicinity of their traditional village. It was not until the catastrophic avalanches of 1970, and more particularly the Val d'Isère avalanche, that a decision was taken to produce a map of high-risk avalanche sites covering all the mountain systems in France, entitled *La Carte de Localisation Probable des Avalanches* (for example, Fig.6.9). Initially the map, with a restricted circulation, was drawn to a scale of 1:20 000; it will, however, be updated at a scale of 1:25 000.

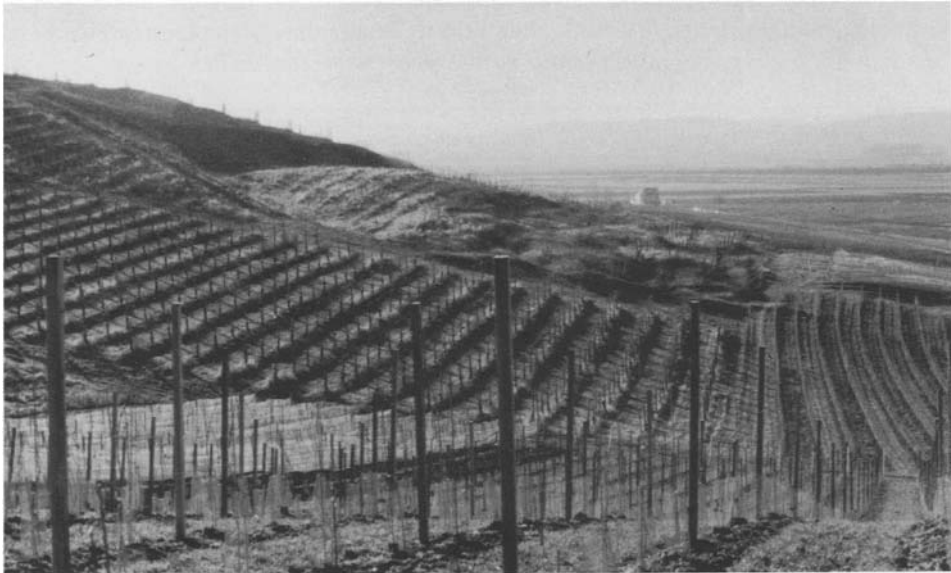
Fig.7.1. The landslide of Im Laberstall in the Tertiary basin of Mainz, dating from January 1989. Its volume is about $125\,000\text{m}^3$, the height of the scarp about 6-7m (R.Dikau, 1990).

In Germany, mass movements (Fig.7.1) and their related hazards are investigated not only by geomorphologists but also by geologists, forestry and construction engineers. Some of the Federal State Geological Surveys, for instance, are working on the

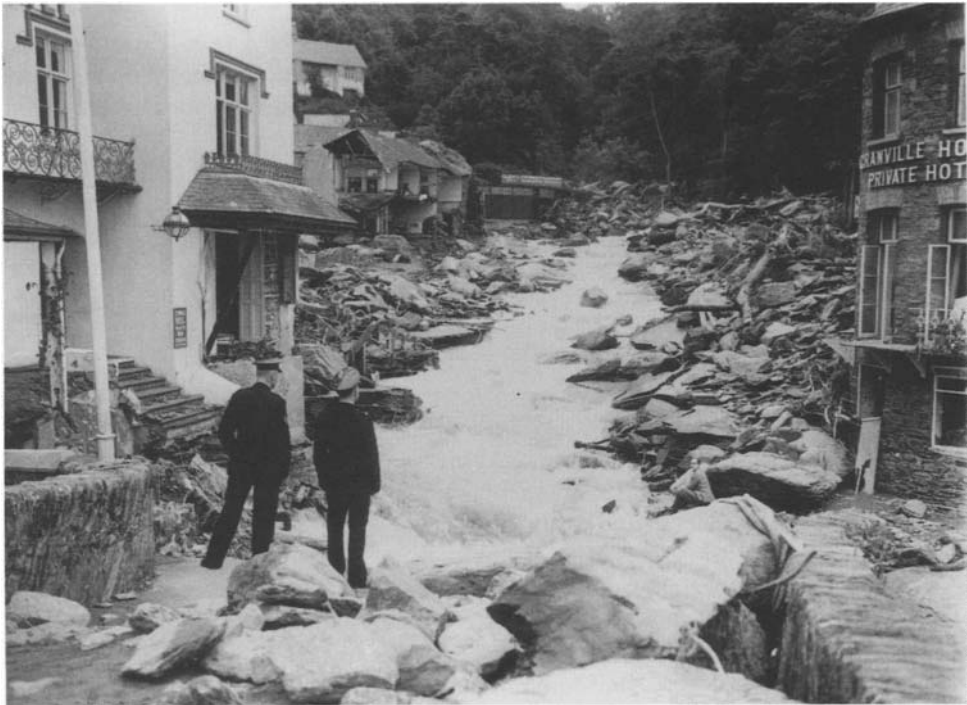
Fig.8.3. The aftermath of the Lynmouth flood, August 1952. (Photo: *Press Association*)

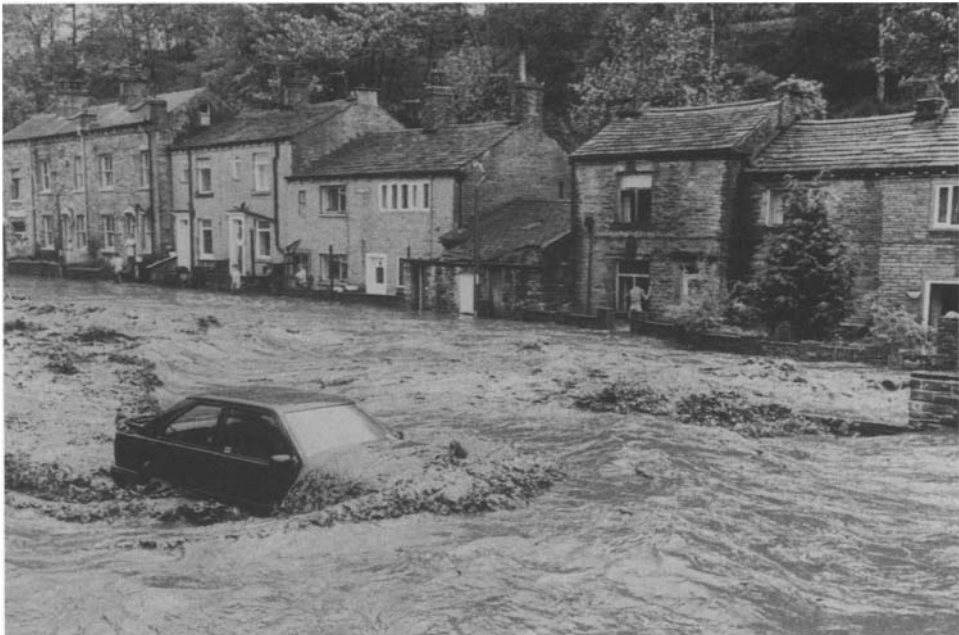
Fig.8.5. River flooding at Luddenden, Yorkshire in 1989. (Photo by kind permission of the *Halifax Evening Courier*)

upland parts of catchments, where few observers are available, and the arrival of the flood wave in the populated lowlands with their urban centres (Fig.8.5). Pressure for housing, especially in the south-east, has meant that many more properties are now at risk. The problem is particularly acute in the Thames NRA where the population is over 8 million. Despite the relatively dense cover of river and rainfall gauges, there is still a need for more automatic recording stations.

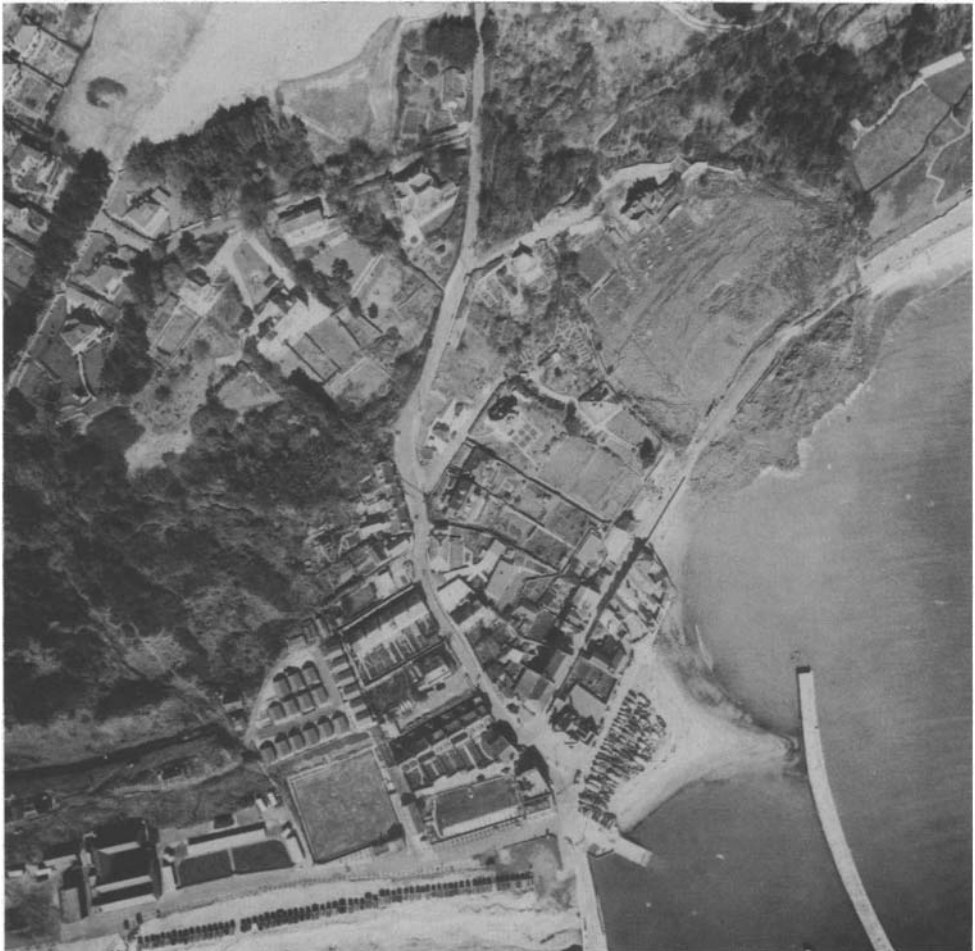
Fig.8.7. The Cliff House landslide at Lyme Regis, 1962. Vegetated and degraded cliffs in Liassic clay can be traced across the photo, which over time have been developed for housing, especially where the Cobb Road descends the cliff. During the slide, Cliff House was destroyed, but the shear surface did not displace the esplanade.

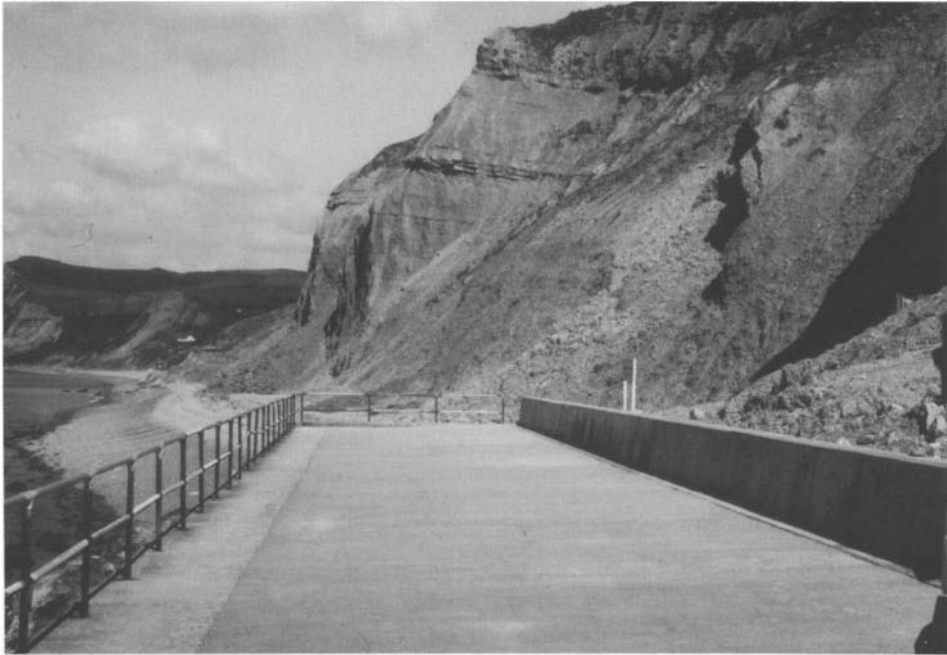
Fig.8.8. The western end of the sea wall at West Bay, Dorset, built to protect the cliffs (Jurassic) from wave attack. Large boulders (not visible) have been placed beyond the end of the wall, but the sea is already beginning to attack the exposed end and the sediments behind. The cliffs beyond are unprotected and may be expected to retreat, thus further increasing the vulnerability of the wall. (Photo: C.Embleton)

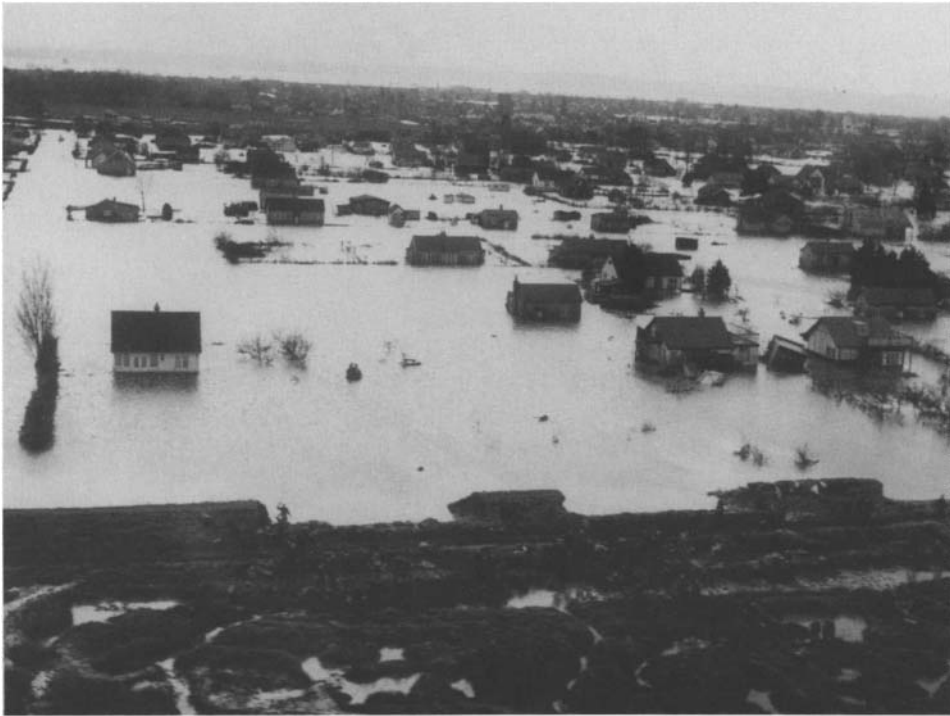
Fig.8.10. Flooding of Canvey Island in the Thames estuary on the 2nd of February 1953, two days after the disastrous East Coast Floods. The breached sea wall in the foreground is being repaired. The whole population of the island, about 12 000, was evacuated; the death toll here alone was over 100. (Photo: *Press Association*)

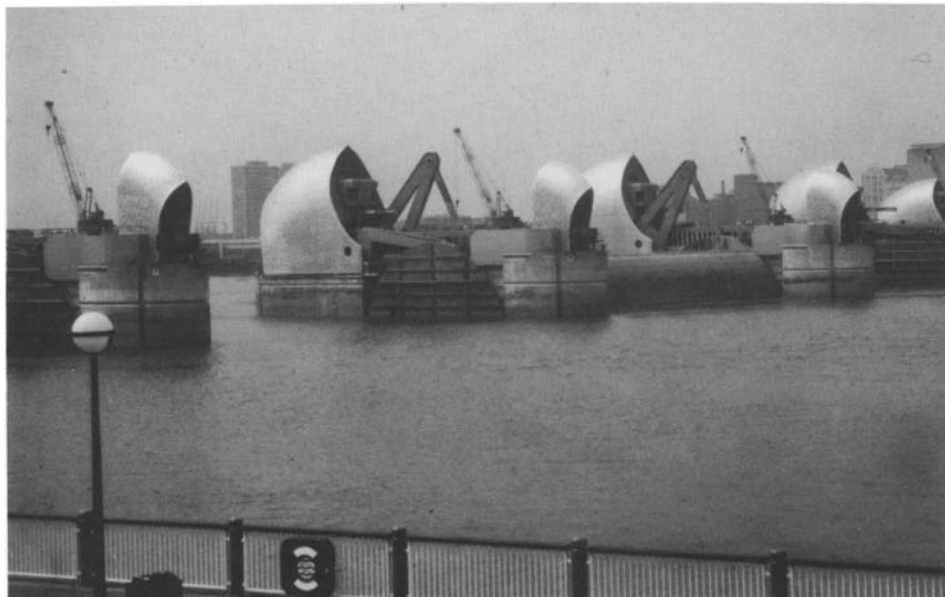
Fig.8.11. The Thames Flood Barrier, Woolwich. One of the gates (to the right of centre) is partially closed. (Photo: C.Embleton)

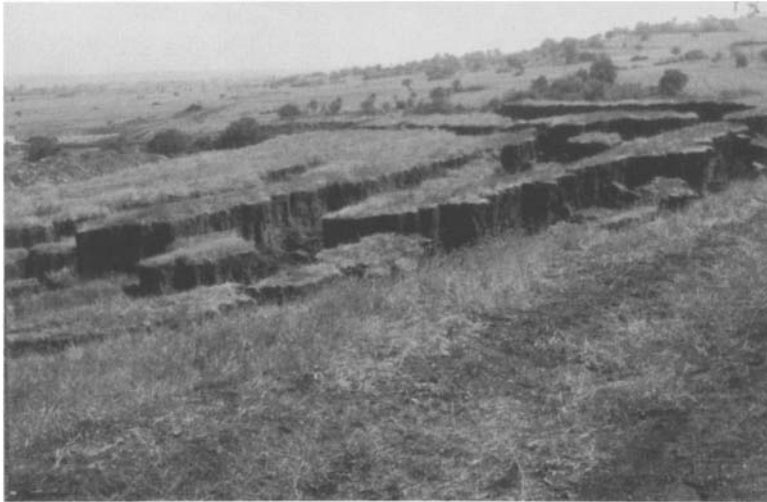
Fig.9.6. Progressive rotational slides in alluvial deposits, Evros river area, north-eastern Greece

5.1.1. Quaternary deposits These comprise basin infills, slope deposits and alluvial tracts. Since a large part of the population lives in the alluvial basins and lowlands, these materials also form the foundations for many engineering structures and are therefore very significant in terms of potential hazard (Fig.9.6). Their properties are extremely variable, both horizontally and vertically, and some formations contain swelling clay minerals.

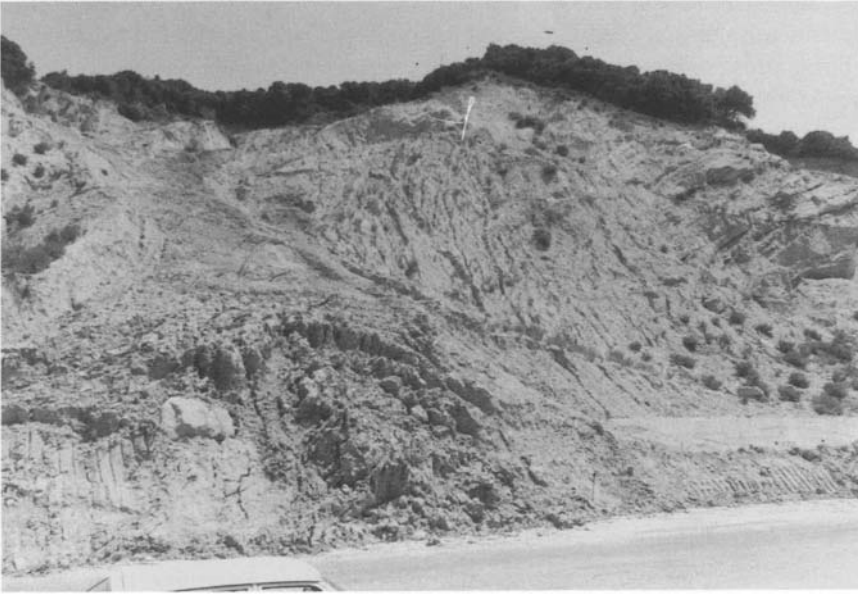
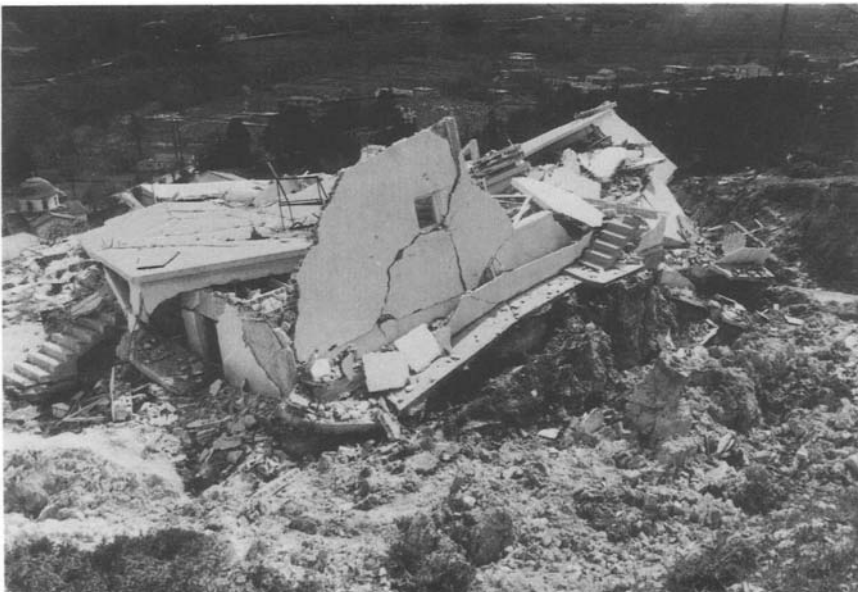
Fig.9.7.A (*upper*): Rotational slides in marly Neogene sediments, transformed into earthflows near the foot which abut on the Preveza-Igoumenitsa road, western Greece. B (*lower*): Collapsed house built on clayey-marly Neogene sediments

5.1.2. Neogene sediments and molasse. Three types are differentiated from an engineering viewpoint - fine, coarse and mixed - which determine their mechanical behaviour. Generally, they have low density and strength, and may show both swelling and shrinkage phenomena. Rock falls and slides prevail in the coarse sediments, earth flows, creep and rotational failures in the fine sediments (Fig.9.7).

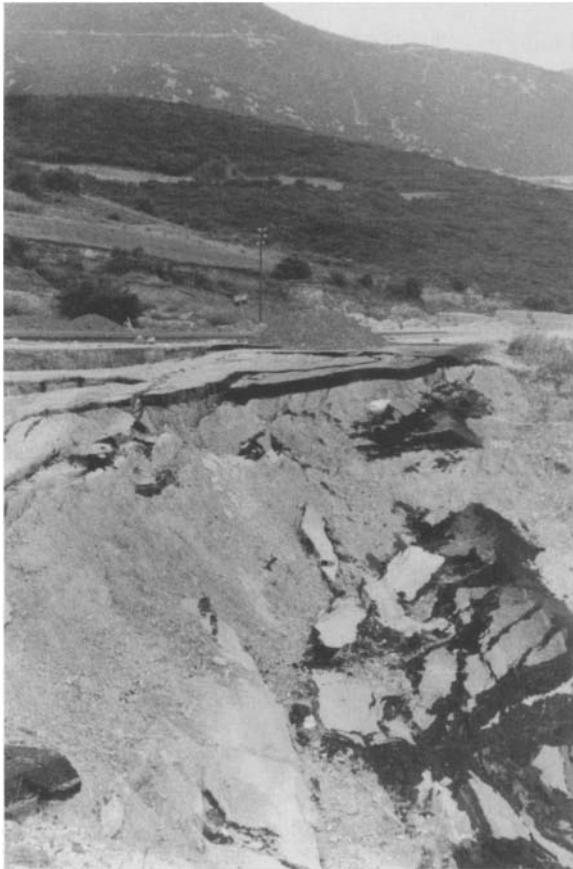
Fig.9.8. Failure of road embankment with poor foundations on weathered flysch and lacking drainage

5.1.3. *Flysch* covers extensive areas in western Greece and exhibits a high frequency of landslides. It consists of argillaceous shales, siltstones, sandstones and conglomerates. Much of its outcrop corresponds to areas of strong relief and relatively high rainfall. Mass movements, especially translational and rotational slides (Fig.9.9), earth flows, creep and, to a lesser extent, rock falls are frequent. Most of the failures occur where the flysch is highly fractured or weathered (Fig.9.8); elsewhere it can be relatively stable.

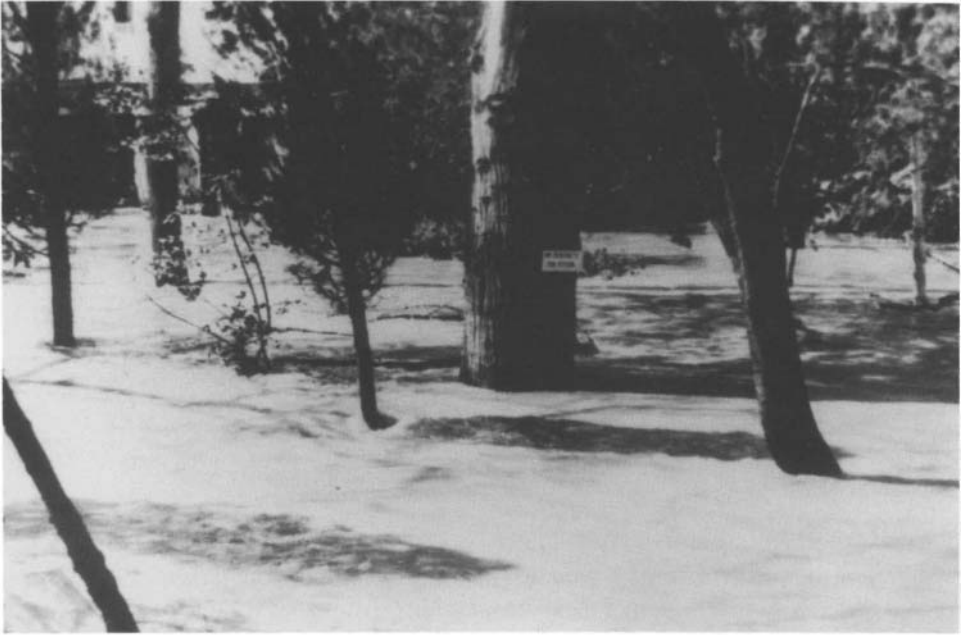
Fig.9.13. (*facing page, upper photo*) The overflow of the Pinios river at Aghia Paraskevi, Tempi ravine, during the flood of 27 March 1987. The actual river bed lies to the left of the photo. (S.Beloukas, Ministry of Agriculture)

Among such extreme events, the major flood of 24-27 March 1987 on the Thessalia plain may be mentioned, caused by both intense rainfall and snowmelt. The water in the Pinios river rose to over 6.3m in the narrow pass of Amygdalea (normal water level less than 1.0m), 15km above the town of Larissa (with 6401km² of basin area upstream) and to 8.0m at the Tempi ravine (normal water level also less than 1.0m), located 18km above the basin outlet (9512km² of basin area upstream). The measured discharge exceeded 1000m³/s at both points. Owing to the narrowness of the channel at these places, significant parts of the Thessalia plain upstream from each were inundated (Fig.9.13).

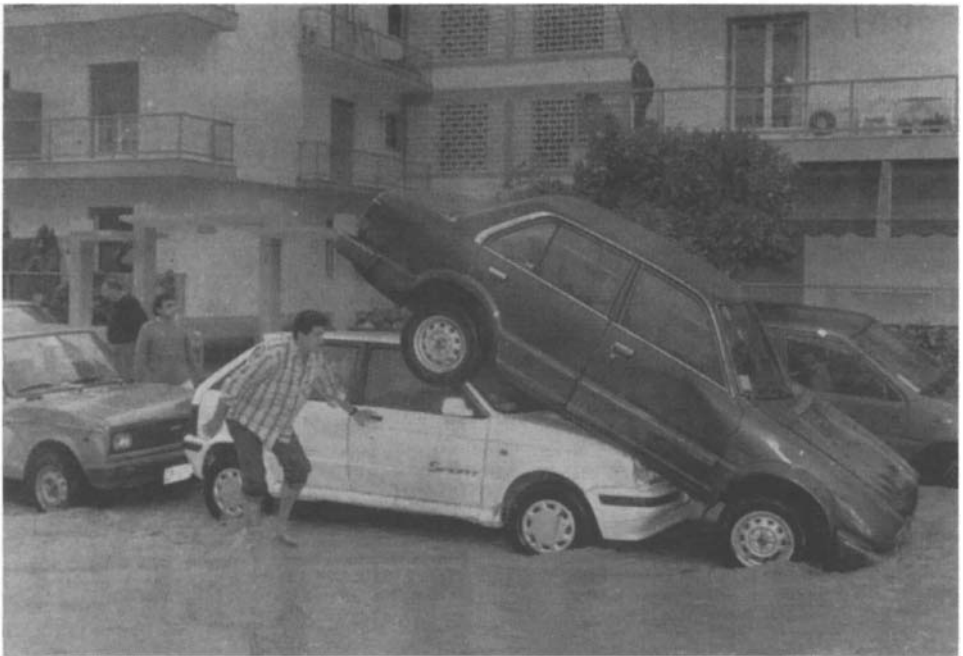
Fig.9.14. (*facing page, lower photo*) Cars moved and damaged in a street which was turned into a stream by the flood of 20-22 November 1993, Glyfada, south-east Athens. (Photo from *Eleftherotipia*)

This has become a serious problem in Athens, the capital, with its population of about 4 million. Recently (20-22 November 1993), a severe flood in the south-eastern part of Greater Athens resulted in inundation of houses and streets (which turned into streams), carrying off cars and causing other damage to property (Fig.9.14). The storm causing the flood was intense and prolonged but not exceptional. A plot of its severity is shown in Figure 9.15. The data used in this plot were taken from the meteorological station of the National Technical University of Athens, 20km to the north of the flood

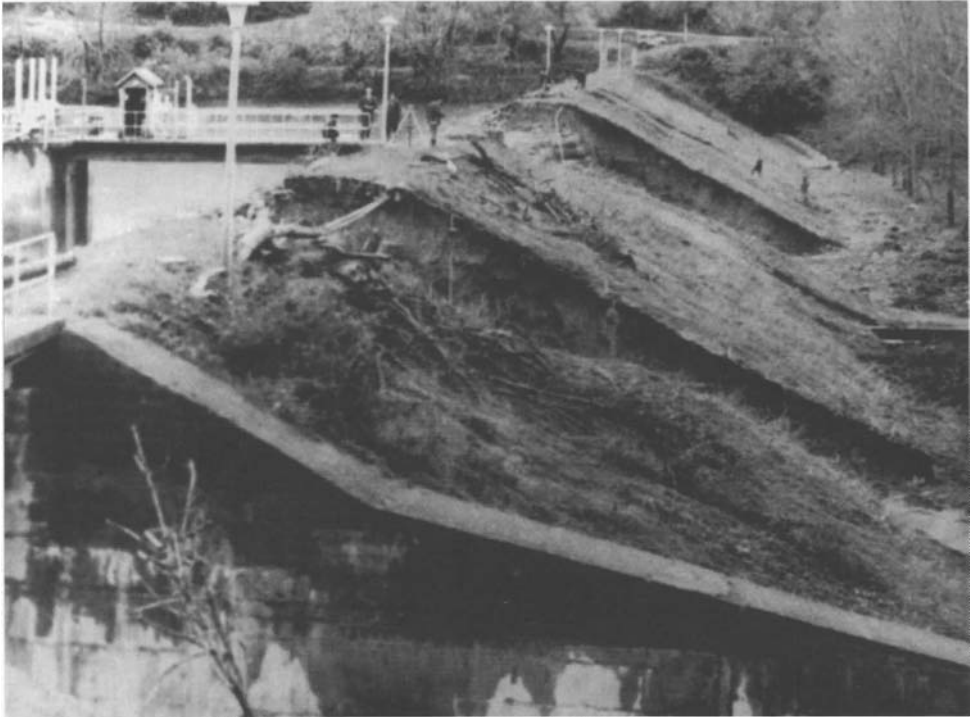
Fig.9.16. A view of the breaches in the Atras dam caused by the flood of 18-19 November 1979
