**GEOMORPHOLOGICAL
HAZARDS OF EUROPE**

C. & C. EMBLETON

GEOMORPHOLOGICAL HAZARDS OF EUROPE

1997

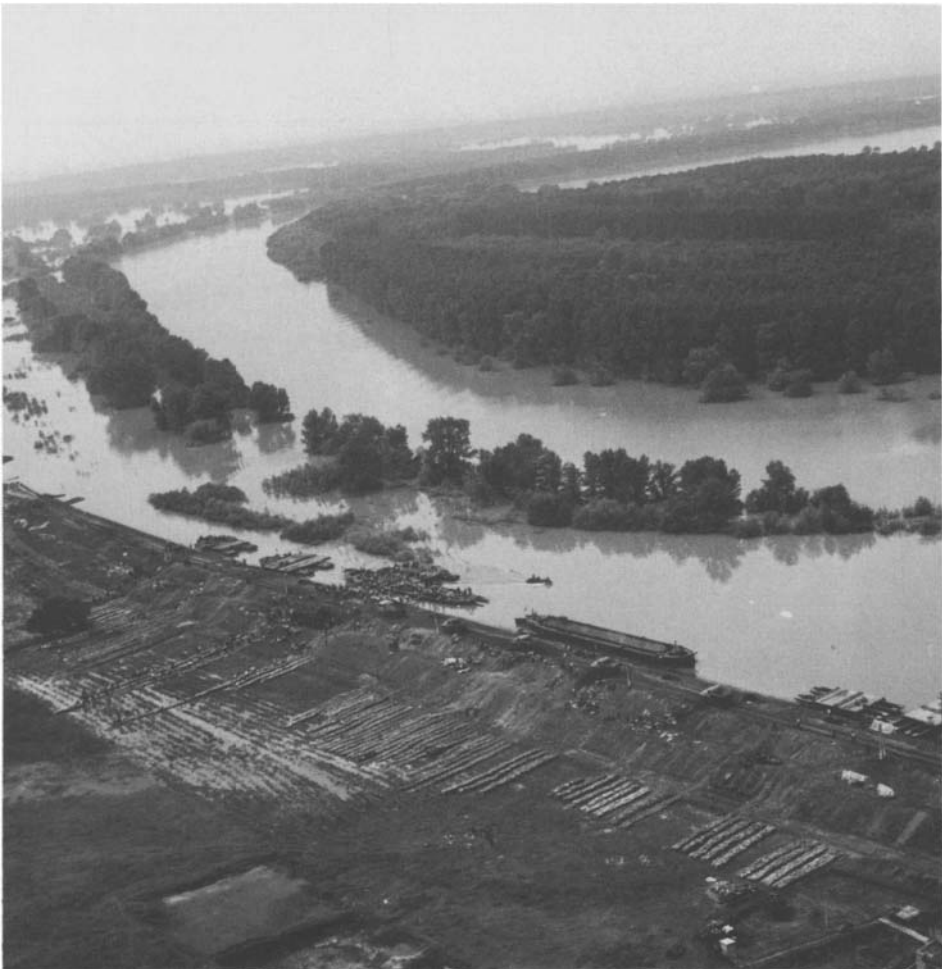
Fig.10.2. Bankfull discharge on the Tisza river in May 1970, caused by the damming effect of tributaries (photo: Water Management Documentation Aerial Photography Service)

- e) Floods caused by other forms of damming include the effect of a tributary joining a low-gradient trunk stream. For example, the Körös rivers and the Maros may dam back the Tisza during major floods (Ambrus, 1967; Fig.10.2)

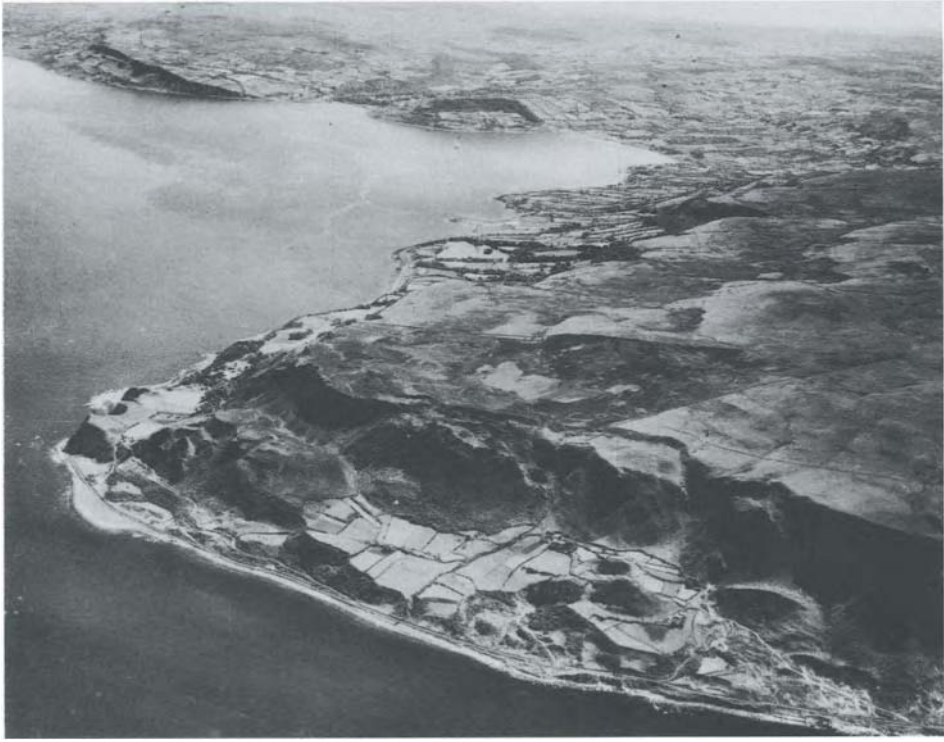
Fig.11.5. Aerial view of Garron Point, Co.Antrim, showing multiple rotational landslips, with vertical displacements of up to 125m, below the plateau surface at about 300m O.D. Some of the blocks have prominent steep seaward faces and back-tilted upper surfaces, while others have been degraded by weathering and their outlines obscured by aprons of block scree (Photo: *Aerofilms Ltd*)

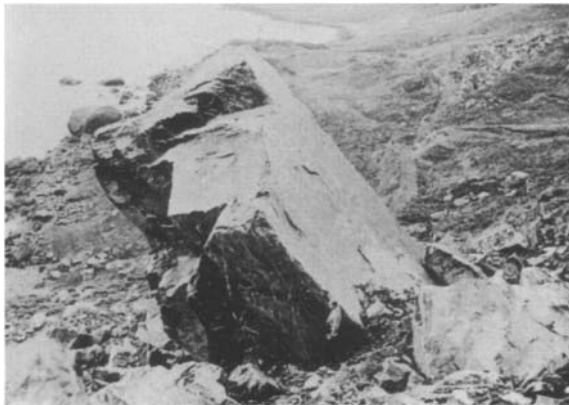
Fig.11.11. (*upper*) Diagrammatic cross-section at Fair Head, Co.Antrim (for location, see Fig.11.6). The twin dolerite sills are intruded into Carboniferous shales. The upper of the two dolerite outcrops shows fresh scars where huge prisms of rock have been dislodged to form a large part of the block scree extending to below sea level; one large prism fell in 1970 and there is a constant stream of falling shale fragments (after Davies and Stephens, 1978).

(*lower*) View showing the fallen dolerite prism in 1970, embedded in the block scree; the scale is provided by Dr Francis M. Syngé. (Photo: N.Stephens)

1971). At Fair Head, occasional falls of massive prisms of dolerite (Fig.11.11) and a constant accumulation of shale fragments indicate the degree of cliff instability. Disintegra-

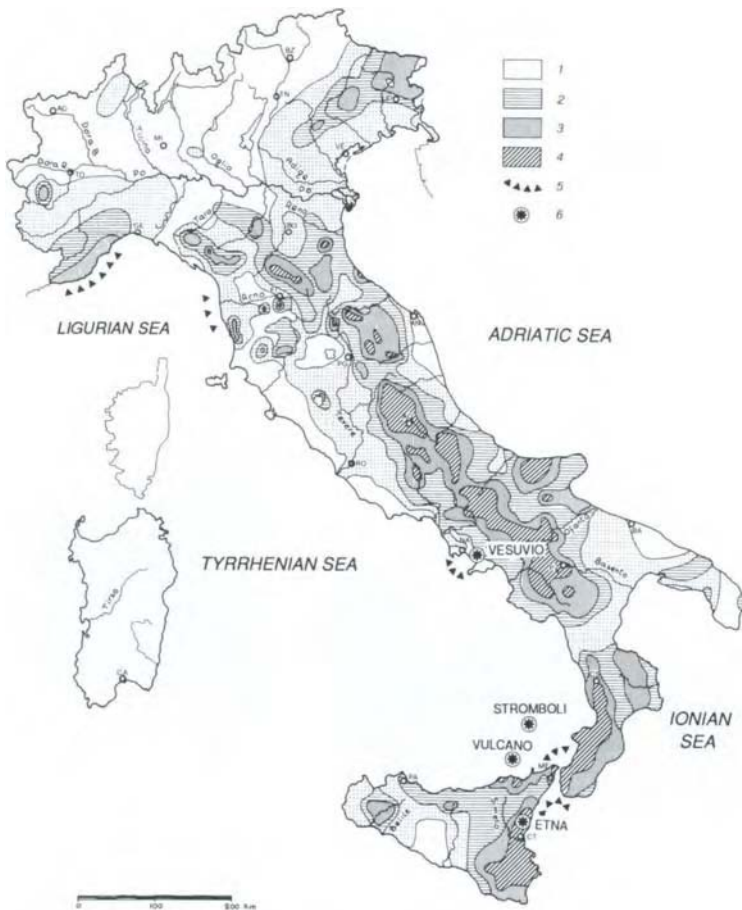
Fig.12.3. Seismic and volcanic activity in Italy, showing areas of maximum earthquake intensity on the Mercalli scale: 1: \leq VII; 2: VIII; 3: IX; 4: \geq X; 5: coastlines most likely to be affected by tsunamis; 6: active volcanoes

Lastly, some coastal seismic areas are also at risk from tsunamis, which can cause disasters such as the one in Reggio Calabria in 1908. Among the areas at risk (Fig.12.3) are western Sicily, many parts of the Calabrian coast, the Gulf of Naples, the Conero (Marche) headland and western Liguria.

Two volcanoes, Stromboli and Vulcano (Fig.12.3) are islands in the Eolian arc off northern Sicily; they arose in the mid- to late-Pleistocene period following calc-alkaline and then shoshonitic activity.

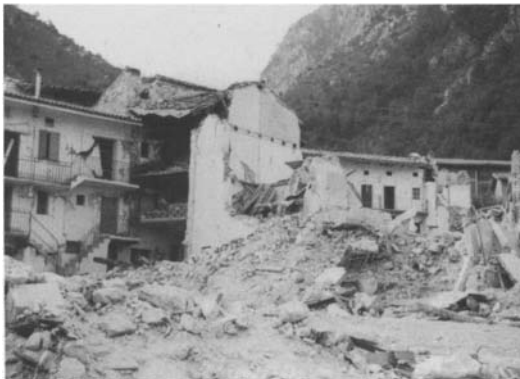
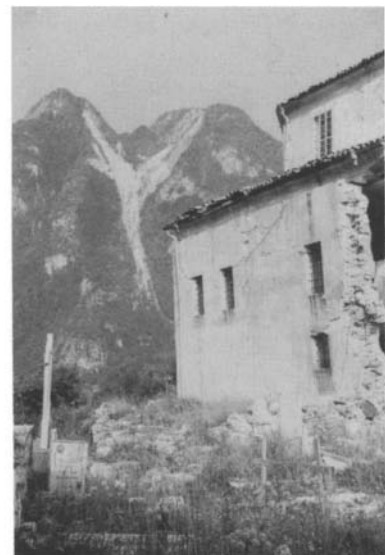
Fig.12.4. a) (left) Buildings damaged by the Friuli earthquake of 1976; b) (right) Effects of the Friuli earthquake, 1976: in the foreground, a damaged church and cemetery; in the background, rockfalls from the limestone mountains (photos: G.Rodolfi)

In this century there have been twelve disasters. Apart from the considerable damage to buildings and monuments, the Reggio Calabria-Messina earthquake of 1908 resulted in 85 000 to 100 000 deaths, the earthquake in Marsica (Abruzzi) in 1915 saw the loss of 30 000 lives, in Friuli in 1976 (Fig.12.4) the victims numbered 1000, and in Campania-Irpinia in 1980 there were 4000 deaths.

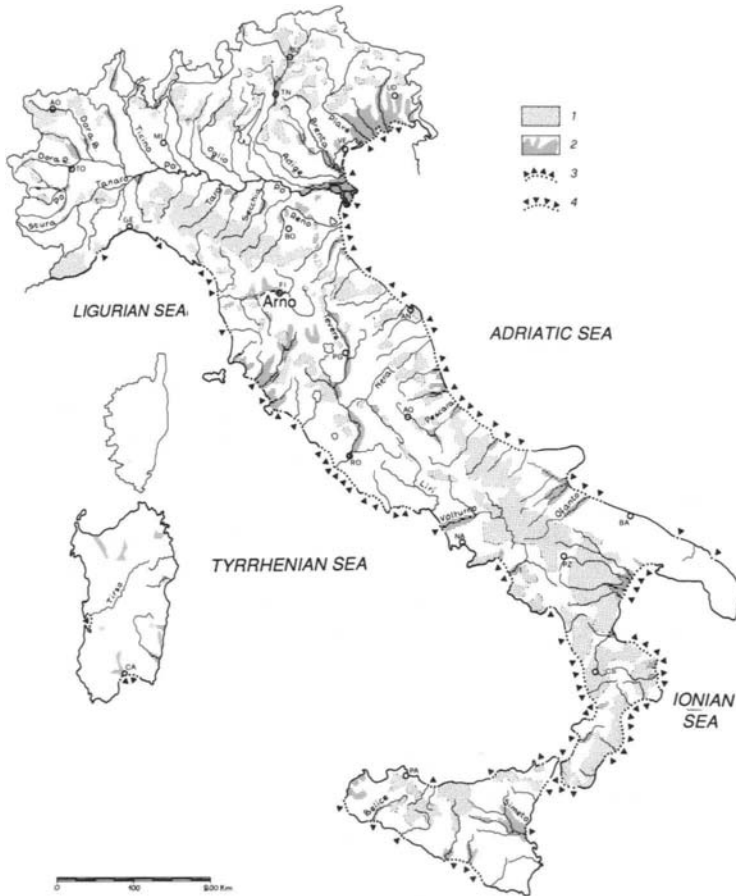
Fig.12.8 Map showing the distribution of the principal exogenic hazards in Italy. 1: areas liable to severe soil erosion and mass movement; 2: areas liable to flooding; 3: coastal aggradation and silting of coastal valleys; 4: coastal erosion

3. Exogenic processes (Fig.12.8)

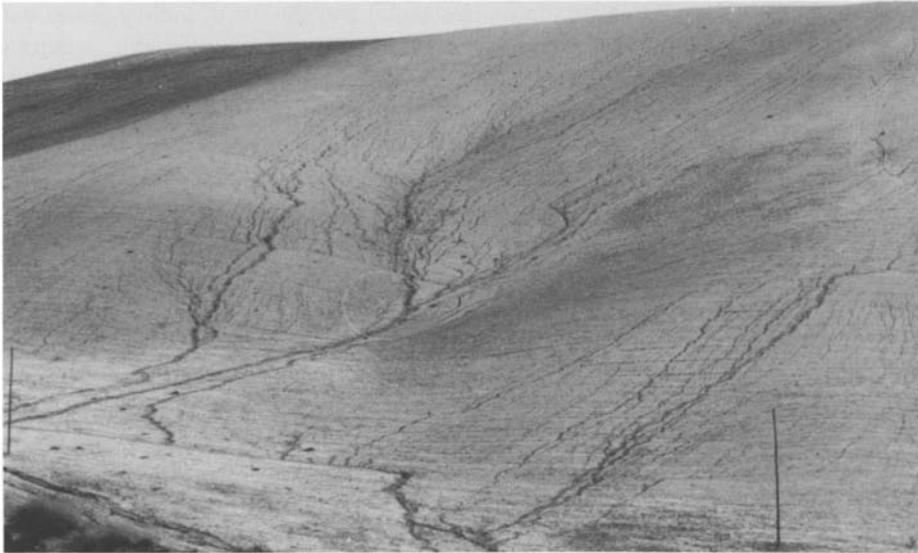
Fig.12.9. Intensive cultivation needs large and level fields: a view of severe soil erosion after heavy rains which followed ploughing (photo: G.Rodolfi).

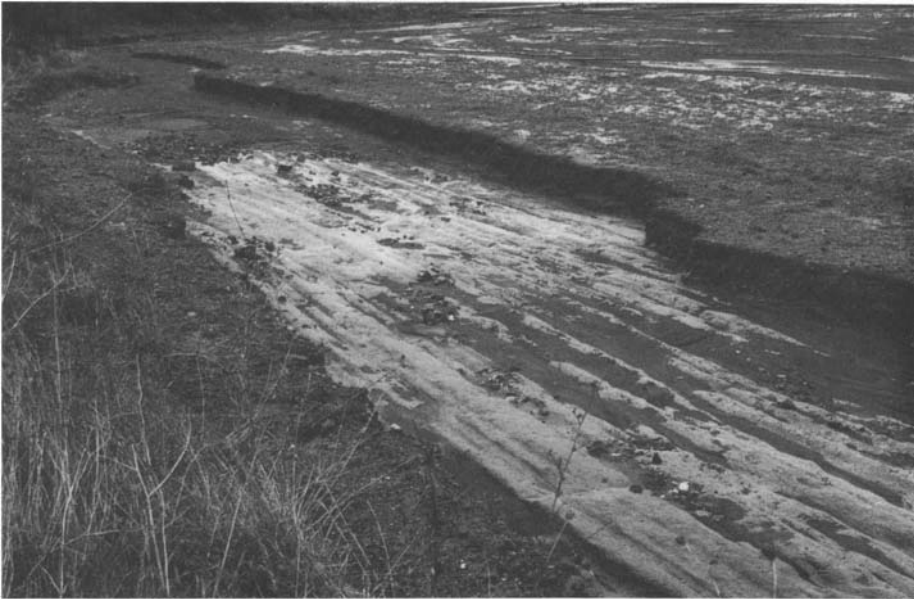
Fig.12.10. Rill developed during a single storm on southern Tuscany. The plough layer, 30cm thick, has been totally removed. Width at mid-distance is approximately 200cm (photo: D.Torri)

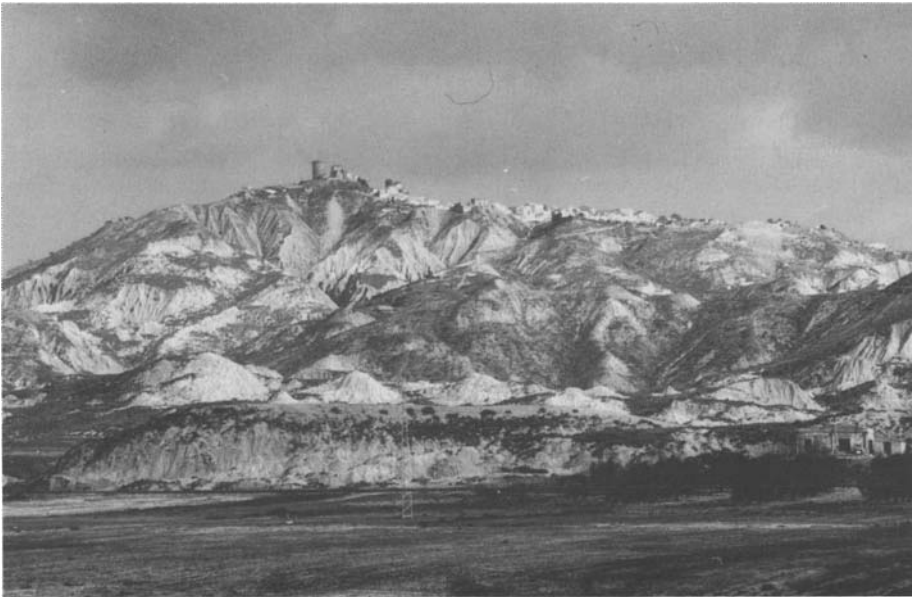
Fig.12.11. The town of Pisticci in Basilicata. The town is intermittently being undermined by mass wasting, in an area of generally eroded, "clayey" landscape. The substrata consist of poorly cohesive silty, clayey and sandy deposits of the marine Neogene cycle, subjected to the typical Mediterranean climate (photo: G.Rodolfi).

degrees of erosion, depending on the lithology of the clays, their structural conditions and, to a lesser extent, on the climatic conditions and presence, if any, of a vegetation cover, there are few regions of Italy that are not characterised by *calanchi*, a form of gully erosion also involving some types of superficial landslide, from the Emilian Sub-Apennines down to those in Abruzzo, in Tuscany, Lazio, Basilicata, Calabria and Sicily, and even in Piedmont (Alexander, 1980; Vittorini, 1977). Wherever well-developed examples of these and other similar forms of erosion (such as *biancane* and *crete* in the Siena area) are found, the landscape appears desolate and uninhabitable. In some cases, there are larger, populated districts (the most famous examples are in the neighbourhood of Siena in Tuscany and Pisticci in Basilicata) that are at serious risk because of erosion which has already destroyed some parts of these centres (Fig.12.11).

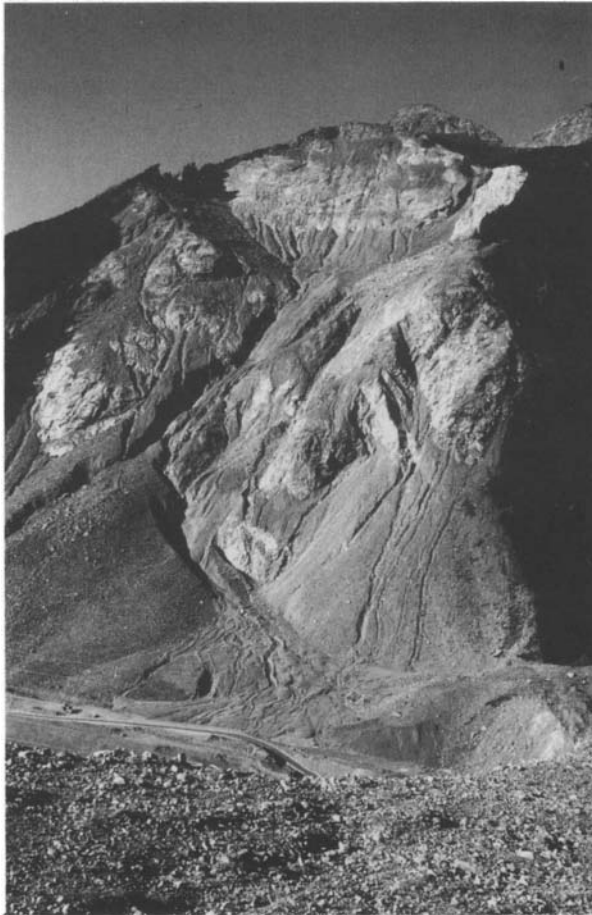
Fig.12.12. The scar of the huge landslide that dammed the River Adda in 1987. Some secondary falls are still active in the upper part (photo: G.Rodolfi).

In July 1987, after an abrupt rise in temperature above zero, accompanied by intense rainfall, rapid thawing of mountain snow in Valtellina, besides causing flooding of the River Adda and its tributaries, also brought about an enormous landslide which blocked the valley at a point not far from the site of the prehistoric landslide near Bormio mentioned above (Laffi and Fossati, 1988). The slide, which buried the town of S. Antonio, caused 20 deaths and created a lake which, since it was extremely dangerous for the densely populated valley below, was gradually drained artificially, with considerable risk for those involved in the work (Fig.12.12).

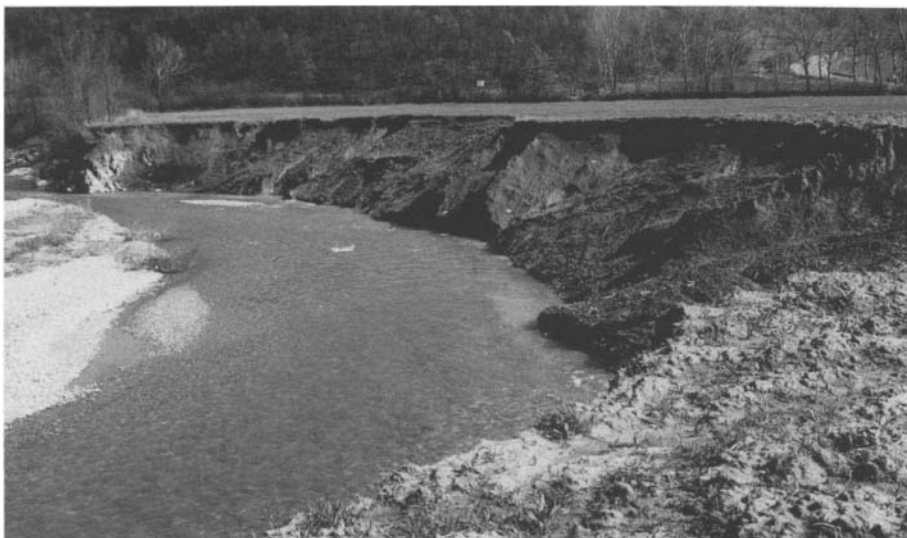
Fig.12.13. (*upper*): Riverbanks cut in alluvial materials of intermontane basins are rapidly undermined if not protected (photo: G.Rodolfi)

Another factor which has encouraged rapid change in the river system is that, in most cases, rivers in the Apennines flowing across coherent rock types, such as arenaceous flysch, meet less resistant lithologies at the foothills where valleys can be rapidly incised. This tendency has been reinforced by human activity, especially gravel extraction from the river beds. For example, renewed erosion has begun in the Apenninic foothills around the right-bank tributaries of the Po and among the Adriatic rivers. The consequent lowering of the river beds by a few metres has led to the undermining of the piers of several bridges. Table 12.4 gives some examples of this (Tazioli, 1982). In the lower stretches of rivers that flow across alluvial plains, or in intermontane basins, especially in meandering reaches without bank protection, lateral erosion is a problem linked to this lowering of river beds (Fig.12.13).

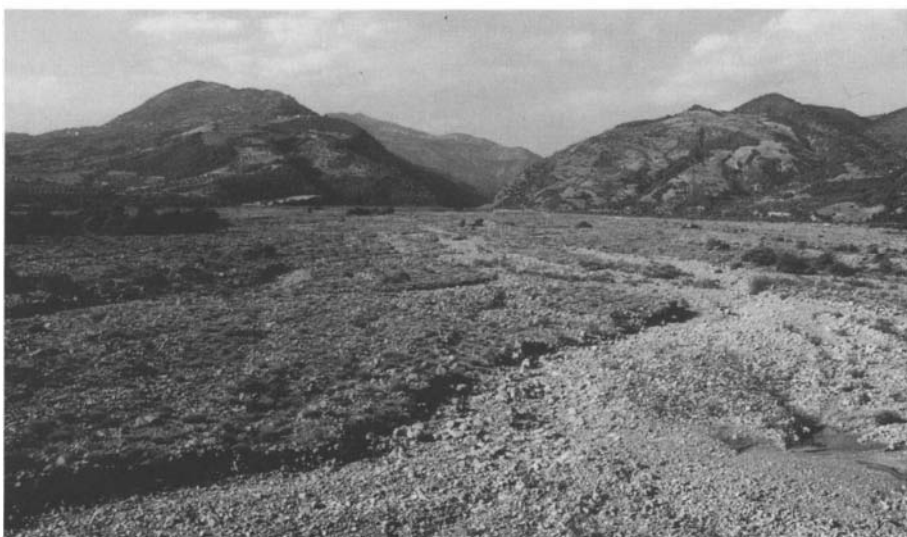
Fig.12.14. (*lower*): A typical *fiumara* along the Calabrian coast. This intermittent river, coming from the Sila massif, deposits its bedload to form an extensive alluvial fan. Settlements along the Ionian coast, 300m farther downvalley, are at a high risk from floods (photo: G.Rodolfi)

the south - known as *fiumare* (Fig.12.14) - which are characterised by episodic discharge, periods of flooding when there are strong currents and heavy loads alternating with periods when the channel becomes virtually dry and the debris is deposited. In the case of channels which are artificially embanked, along the Po for example, sediment deposition is restricted to the channel.

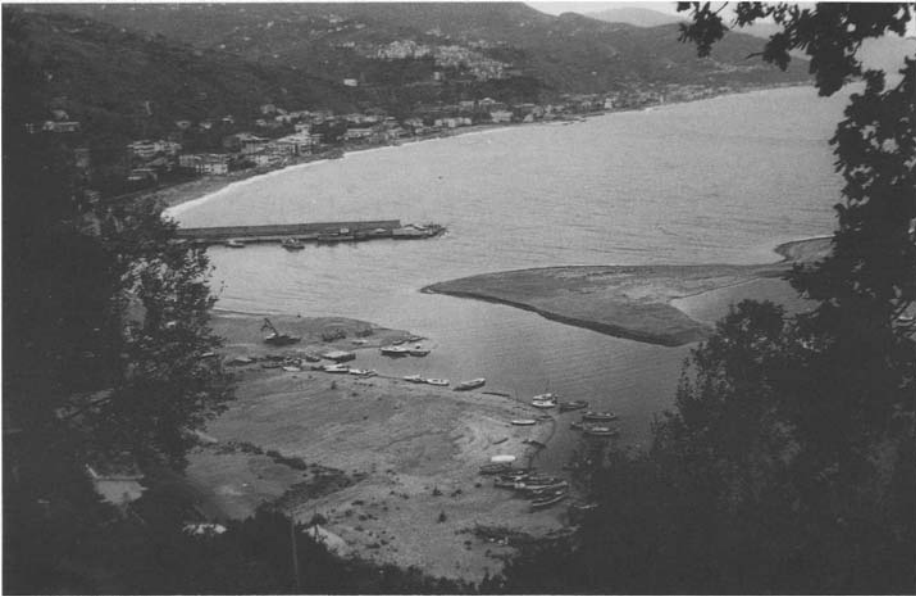
Fig.12.15. The touristic harbour of Cetraro on the Tyrrhenian coast of Calabria (1982). The small harbour is becoming silted, as a consequence of the poorly-advised construction of the jetty, in disregard of the local coastal dynamics (photo: G.Rodolfi)

Elsewhere, indications are given by the disappearance of deltas, for example of the Arno, the Ombrone and the Tiber, which for centuries used to project into the sea. It has also become necessary to defend many built-up areas, such as Ostia, Fiumicino and others. Work on the coasts has been massive and has often altered the original appearance (Fig.12.15), though many natural beauty spots remain.

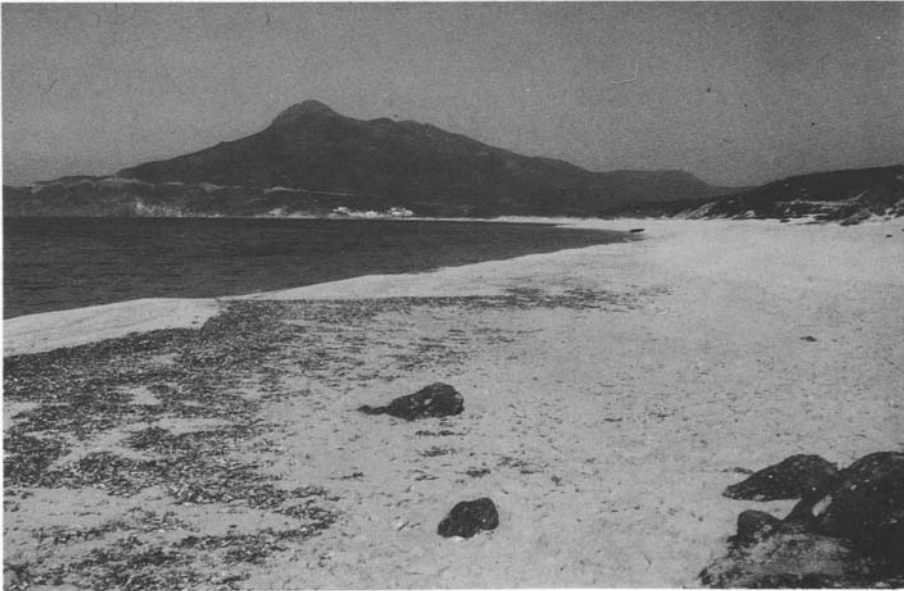
Fig.12.16. Sandy deposits along the Sardinian coast; aeolian activity is restricted to the beaches (photo: G.Rodolfi).

sandy deposits on beaches, but only for a short distance inland (Fig.12.16). The presence of old vegetated dunes parallel to the coast indicates that aeolian processes were much more active in the past than now, particularly during eustatic falls of sea level in the Quaternary.

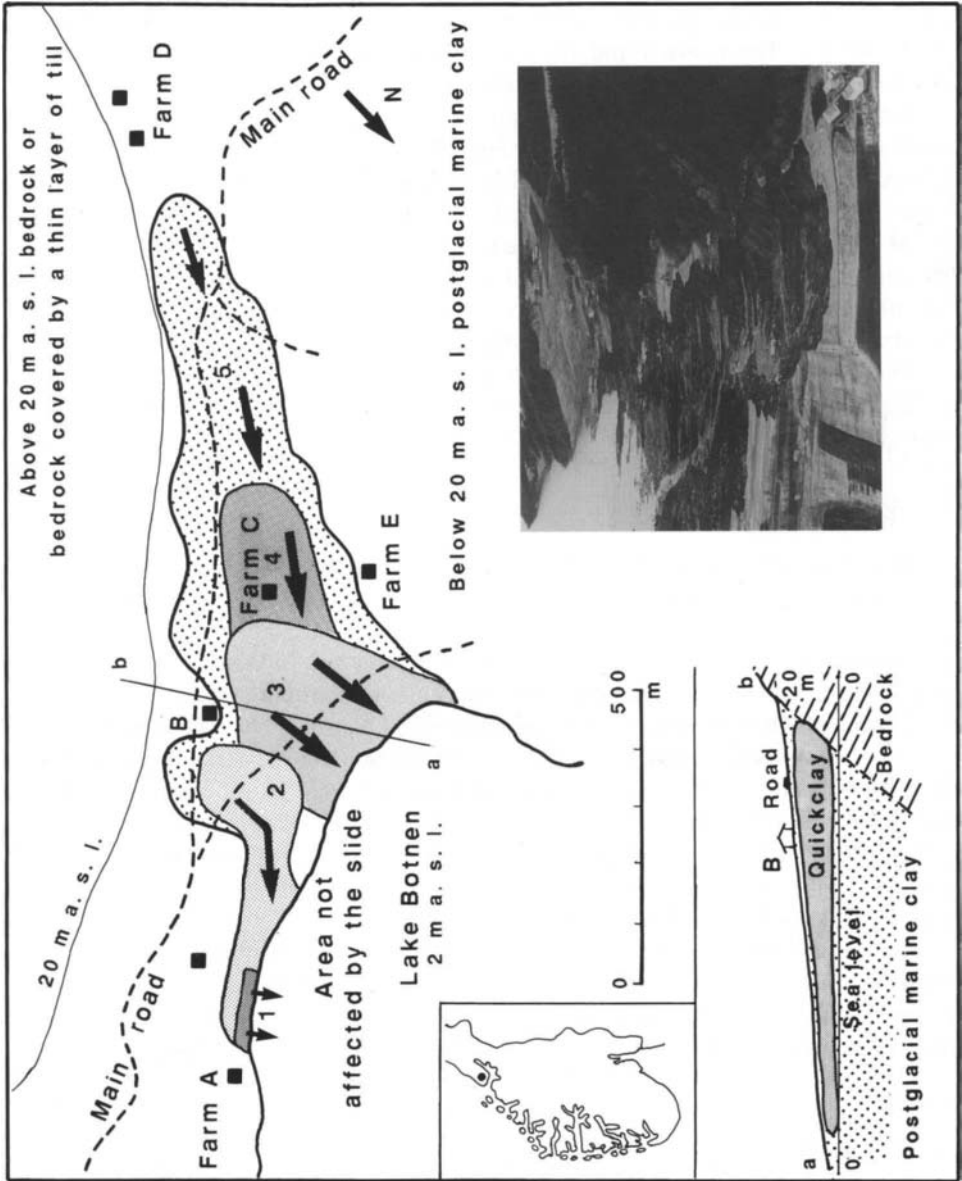
Fig.14.3. The Rissa clay slide of 29 April 1978. Photo: Aftenposten

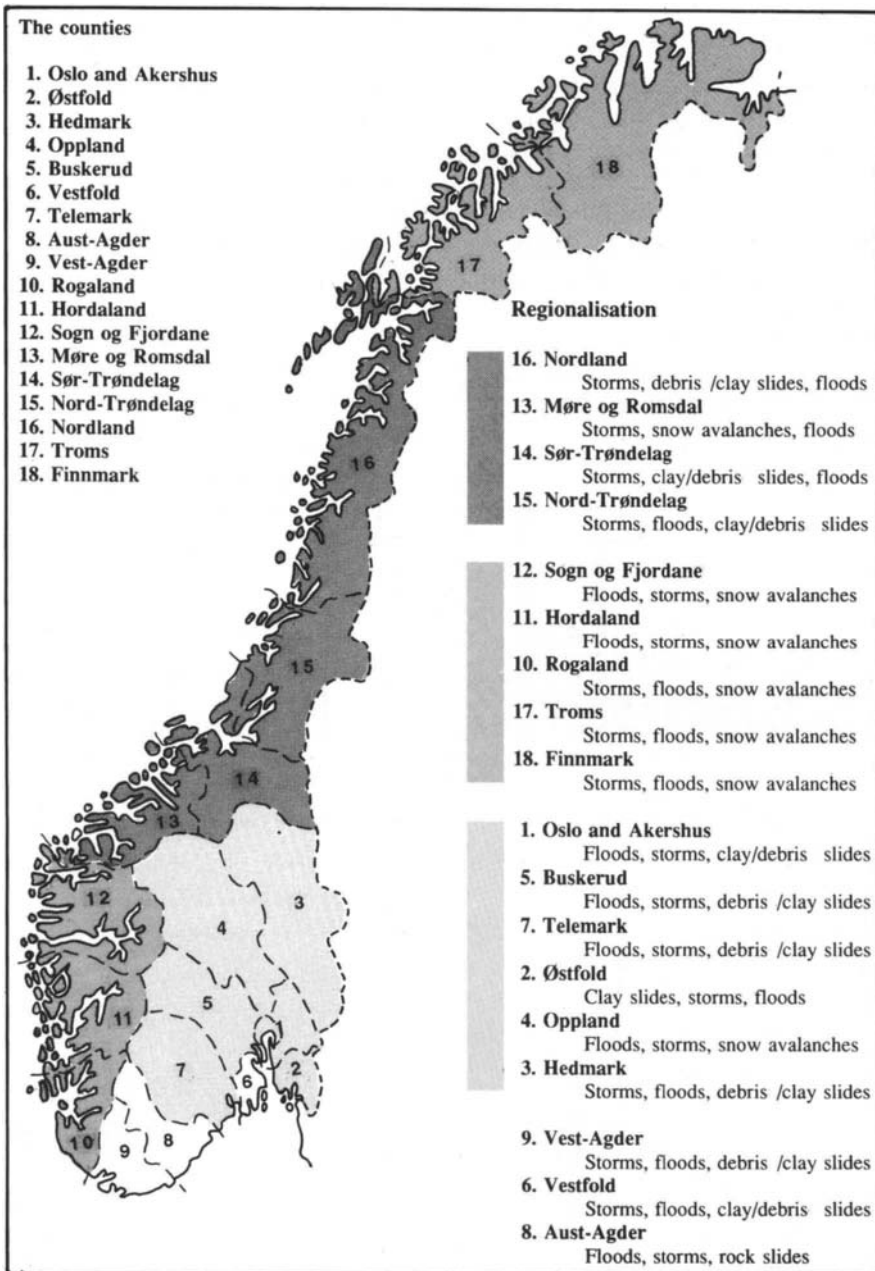
Fig.14.7. Regional distribution, by county, of geomorphological hazards in Norway

Figure 14.6 shows the regional distribution of hazards by county (1-18: see Fig.14.7; note that Oslo and Akershus counties are combined as no.1). Total disbursements are given in Fig.14.6a; Fig.14.6b,c,d show a breakdown according to type of hazard. In respect of the counties 1 (Oslo/Akershus) and 7 (Telemark), the year 1987 was exceptional, as noted above, for severe rain storms, wind damage and storm surge. The cost for Oslo and Akershus was 195 million NOK, and for Telemark 92 million NOK. All other values for total disbursements per year are below 5 million NOK. If the high 1987 values for Oslo/Akershus and Telemark for 1987 are omitted, a regional breakdown

into two groups of nine counties each is significant. The first group is in the south-east (1-9: see Fig.14.7) where the total disbursement for the NDAF and NPP together was 874 million NOK; the second covers western and northern Norway (10-18) with 1474 million NOK.

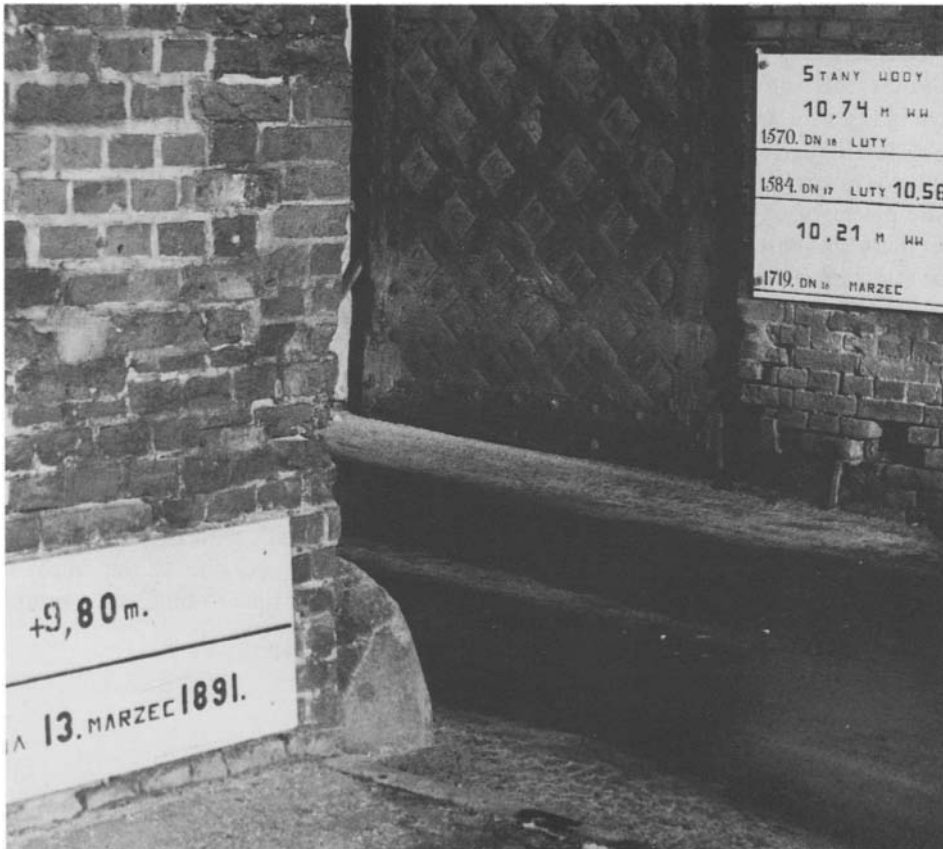
Fig.15.1 High-water marks on the walls of the old city in Toruń (photo M. Grześ)

of local embankments for flood protection in Poland date from the 13th century, though doubtless some earlier attempts at protection had been made. Fig.15.1 shows the recording of the high floods of 1570, 1584, 1719 and 1891 on the walls of the old city in Toruń, on the lower Vistula. It is in the later part of the 19th century, however, that there began a period of intense activity to regulate the rivers. By 1985, 370 rivers in Poland had been completely or partly embanked along a total length of 9208km. Of these, only about 40 - 50 per cent are designed to protect against the 100-year flood, and at least 1500km are in need of modernisation. According to hydrological engineers, another 5400km of embankment are needed, which could protect 4500km² and some 400 000 people.

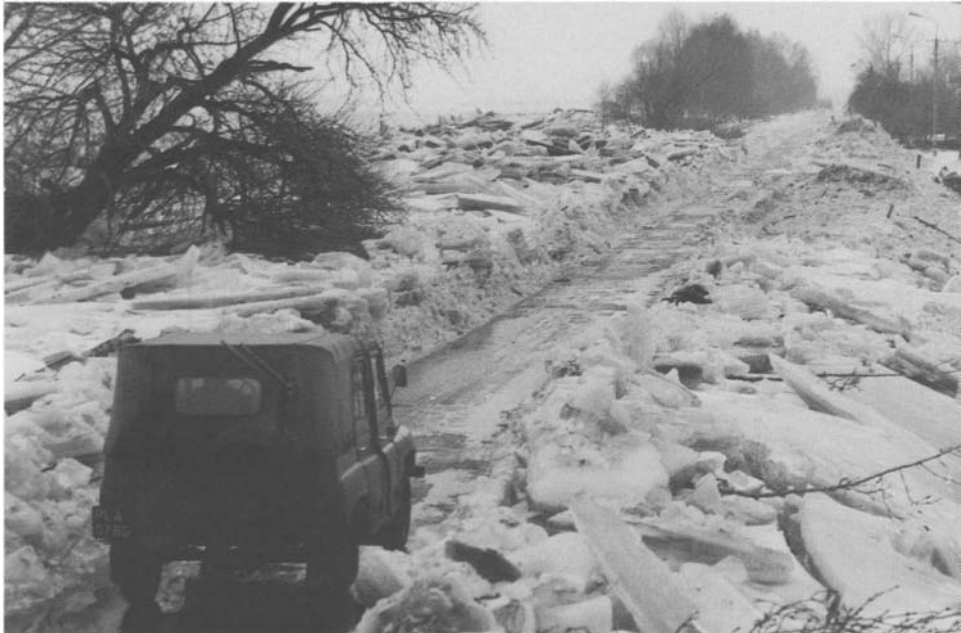
Fig.15.3 Masses of piled-up ice floes from the Vistula river at Wola Brwileńska on the road from Włocławek to Płock. Photo taken after the elimination of the ice jam of January 1982 (photo M.Grześ).

Floods owing to ice jams may occur during the formation and break-up of the ice cover on rivers. They are extremely difficult to predict and can cause great damage to river regulation and other construction works (Grześ, 1991). The biggest recent flood of this type took place on the Vistula river in January 1982 (Fig.15.3 and 15.4), on the

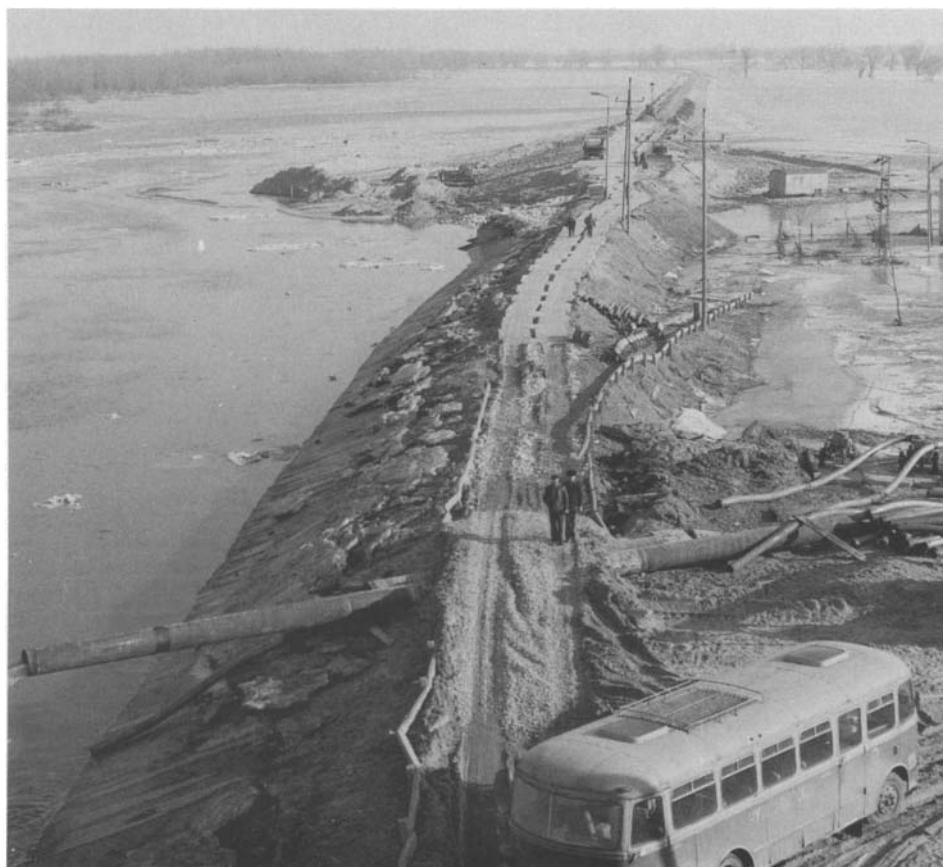
Fig.15.4. Destruction of Vistula dyke by the catastrophic ice-jam flood of January 1982. The photo was taken in March showing repairs under way (photo M.Grześ).

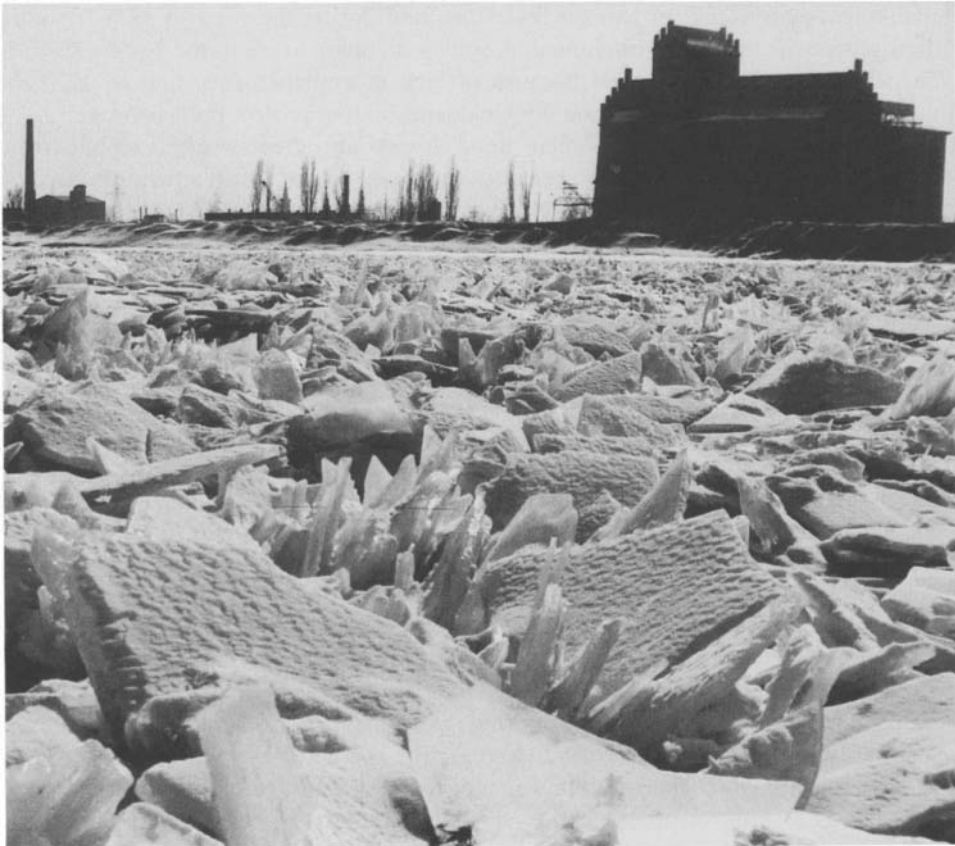
Fig.15.5. Surface of the ice jam on the Vistula at Plock, February 1987 (photo M.Grześ)

The exact mechanism by which the river becomes blocked or partially blocked is complex; essentially it involves reduction of the wetted perimeter of the channel, and certain channel morphologies are more favourable than others to ice-jam formation. The main locations predisposed to ice jamming are marked on Fig.15.2. Part of the complexity of the situation results from the position of Poland on the boundary between maritime and continental climates, so that individual winters may have two or more cycles of complete river freezing. On the big rivers such as the Vistula, which flow from south to north across the country, the break-up of the ice cover starts earlier in the south and is linked to the snowmelt flood. The flood travels downstream to encounter a barrier of river ice, which begins to break, but the ice floes then pile up over each other to create a blockage (Fig 15.5).

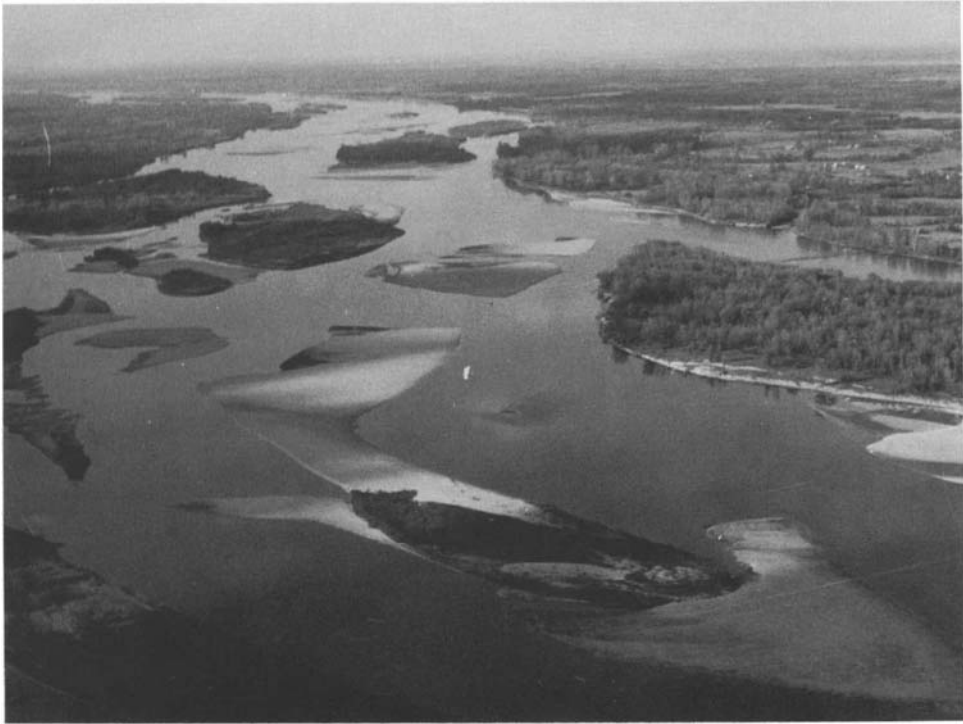
Fig.15.6. The Vistula upstream from Plock, summer low water (photo M.Grześ)

The River Vistula (Fig.15.6), with a length of over 1000km, drains a catchment of nearly 200 000km² of which 87 per cent lies in Poland. The average basin rainfall is about 600mm/year. Two flood periods can be distinguished: in March-April owing to snowmelt, characterised by high and prolonged discharge peaks, and summer rainfall-induced floods from late June to late July. Ice cover on the river lasts roughly 6-8 weeks. Transport of solid material is estimated at 800 000t/year (Manthey, 1981). On the upper Vistula, flood levels can be 5-6m above low-water level; on the middle and lower Vistula 7-9m, and at Tczew over 10m.

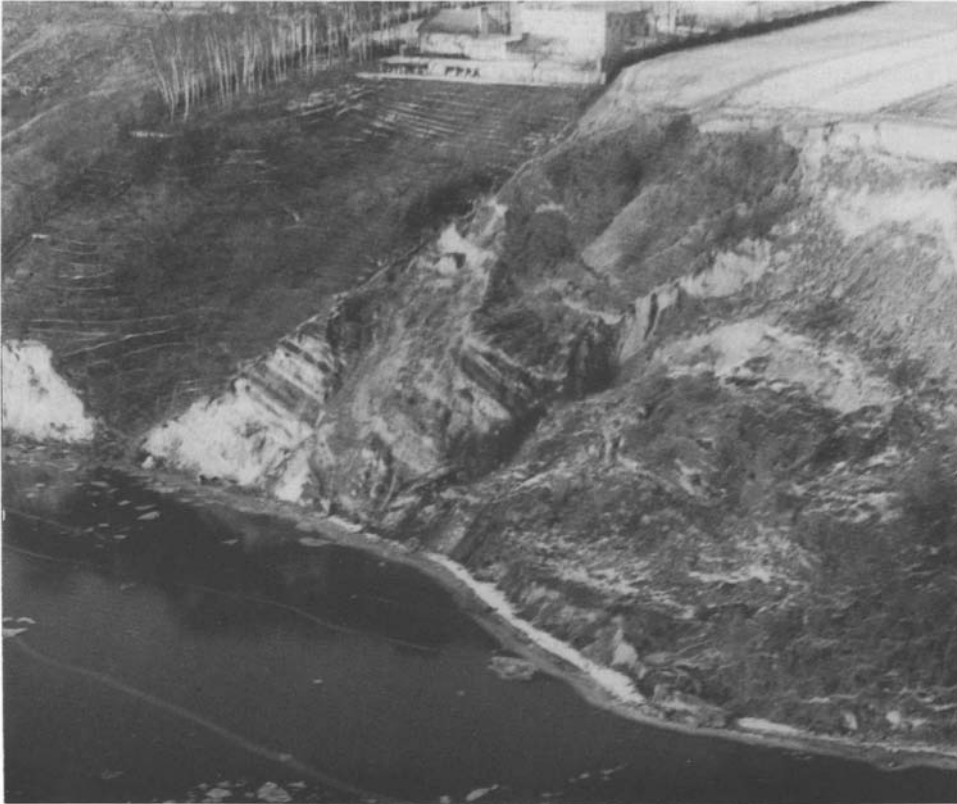
Fig.15.10. Mass movements on the bank of the Włocławek reservoir at Dobrzyn, triggered by the raised water level (photo M.Grześ)

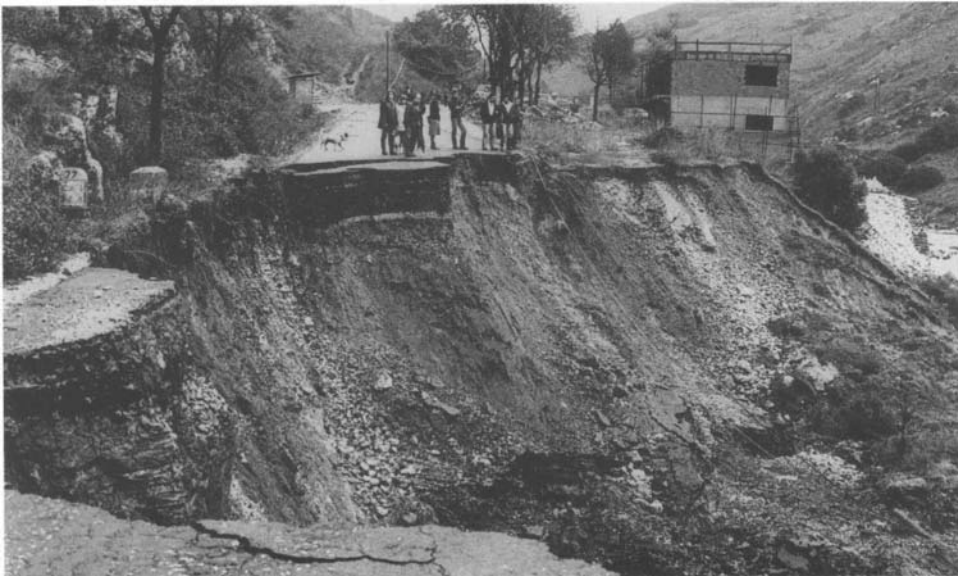
Fig.16.7. The Calhandriz landslide that occurred north of Lisbon, in February 1979, destroyed several houses, some of them newly built (photo: A.de Brum Ferreira)

In addition to the structural and geomorphological conditions just mentioned, certain climatic characteristics also contribute to slope instability. The most significant of these are the irregularity, intensity and concentration of the rainfall. Very heavy rainfall may lead to flash floods in small watercourses, causing rapid bank erosion and many small landslides and earthfalls. Major landslides, however, are related to longer periods of continuous rain. Such was the case at Calhandriz (Fig.16.6) in February 1979, where an event of this type destroyed about ten houses, some of them newly built (Fig.16.7).

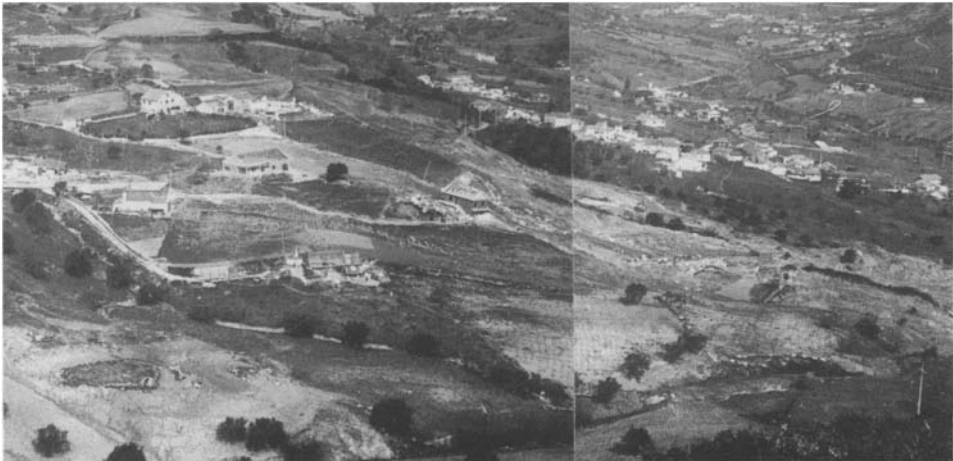
Fig.16.8. The road along the Trancão valley was washed out during the 1983 flash flood in the Lisbon region (photo: A.de Brum Ferreira).

Rainfall of similar intensity again occurred in the Lisbon area on the night of 18 November and the early hours of 19 November 1983 (Fig.16.8). The meteorological station at Lisbon airport recorded 14mm in 5 minutes, 17mm in 10 minutes, 18.5mm in 15 minutes and 24mm in 30 minutes. Damage to property caused by the ensuing floods was then estimated at 12 000 million Esc (about 140 million US dollars); 1800 families lost their homes and 610 houses were destroyed. Nevertheless, the death toll on that occasion was no more than 10, which can perhaps be explained by better preparedness and a more speedy reaction by both the people and the authorities, prompted by the memory of the 1967 tragedy. In hydrological terms, however, the 1967 episode appears

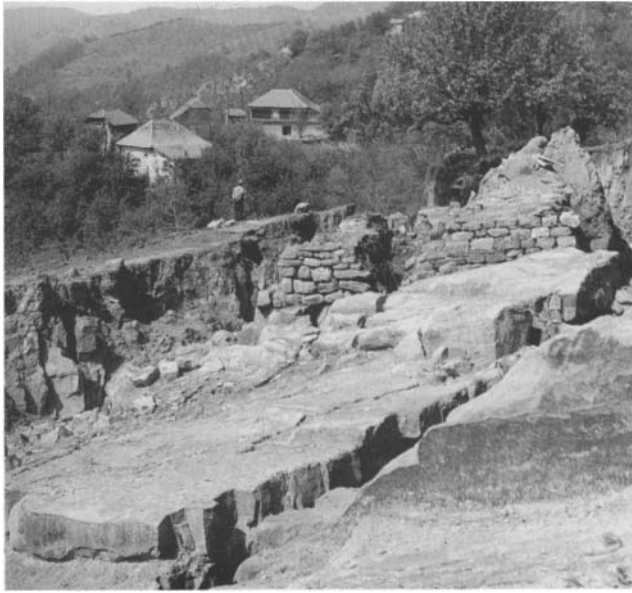
Fig.17.2. Deep-seated landslide triggered by the earthquake of 4 March 1977 in the village of Colți, Curvature Subcarpathians (Photo: D.Bălțeanu)

Two of the most powerful earthquakes to strike Romania occurred on 10 November 1940, magnitude $M = 7.4$ on the Richter scale, and on 4 March 1977, $M = 7.2$. Detailed research has been carried out on each. The seismic shocks had marked effects on the relief, particularly evident in the Curvature Subcarpathians (the segment where the Subcarpathians sharply change direction: Fig.17.1) and in the Flysch Carpathians, where large rockfalls, debris flows and landslides were recorded (Rădulescu, 1941; Radu and Spânoche, 1977; Bălteanu, 1979; Mândrescu, 1981). The 1977 earthquake caused the deaths of 1570 people, destroyed no less than 33 000 buildings and caused damage to 765 industrial units (Bălan, Cristescu and Cornea, 1982) (Fig.17.2).

snow-melt and heavy summer rainfall. Some remain active for 2-3 years, while others are covered with vegetation after a few months. Deep-seated slides are triggered by many different causes - heavy rainfall, strong earthquakes (Fig.17.2), and overloading of the slopes either naturally or due to human activity, are the commonest. Mudflows are frequent after heavy rain on deforested slopes (Fig.17.5) and can exceed 1km or more in length. Rockfalls and debris flows are most often triggered by earthquakes: during the earthquake of 4 March 1977, debris flows with volumes up to 360m³ occurred on the south- and east-facing slopes. Slope instability varies according to drainage basin and to patterns of neotectonic activity. The worst affected area is that of the Curvature Subcarpathians, included in the seismogenic region of Vrancea, where rates of denudation

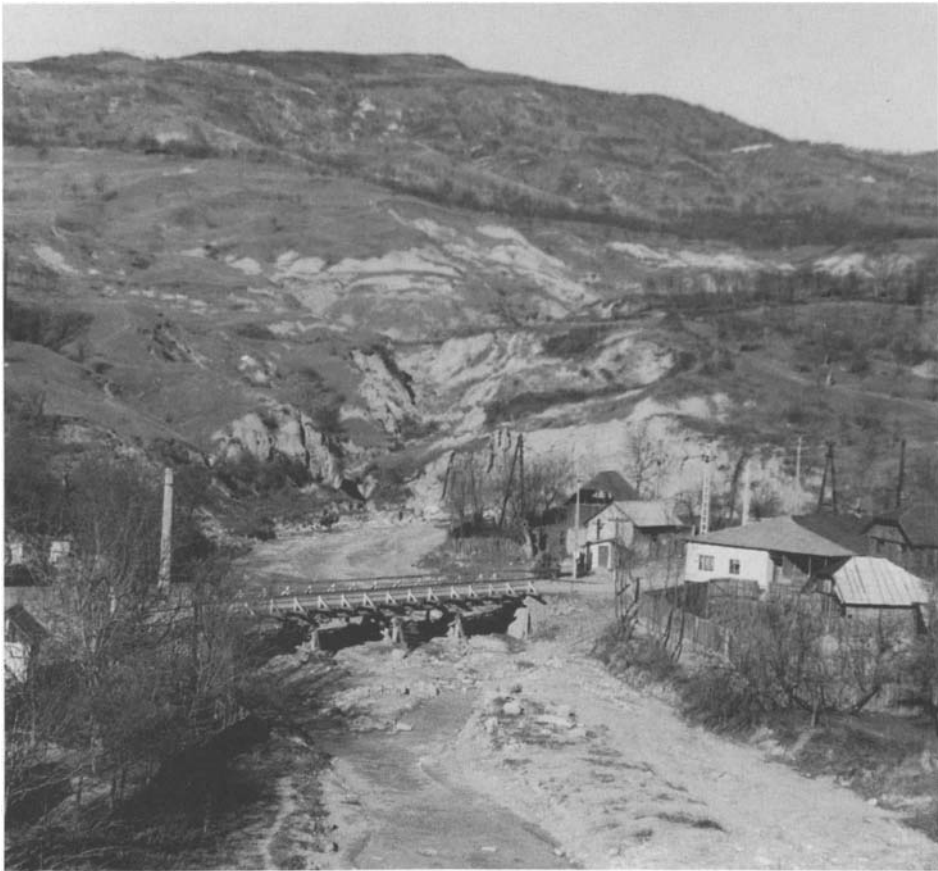
Fig.17.3. Complex mass movements on the southern slope of Blidisel Hill (Buzău Subcarpathians), built of Neogene molasse (Photo: D.Bălteanu)

In the Subcarpathians, formed predominantly of folded and faulted Neogene molasse, the slopes are highly unstable (Figs.17.3 and 17.4). The distribution and variety of mass movements are strongly related to the lithology and to land use and land management. The most frequent types are translational slides, medium- to deep-seated rotational slides and mudflows. Shallow translational slides affecting the top 1-1.5m of the slope materials have the widest distribution and are especially active during spring

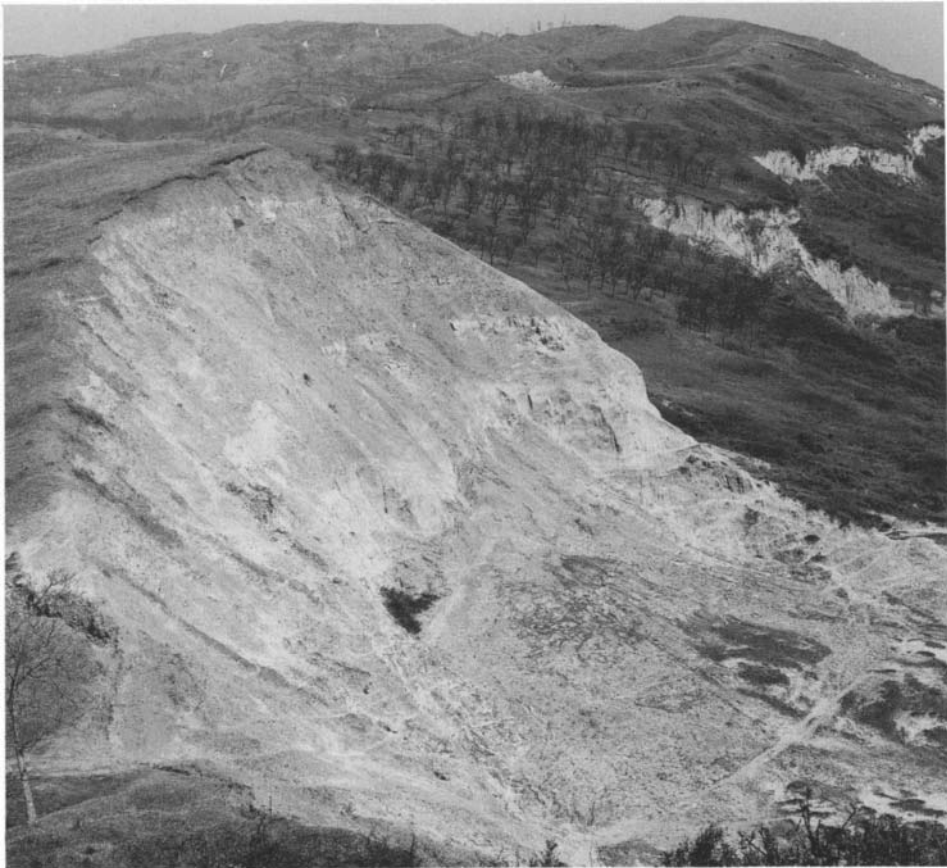
Fig.17.4. Slope affected by deep-seated landslides in the Buzău Subcarpathians (Photo: D.Bălțeanu)

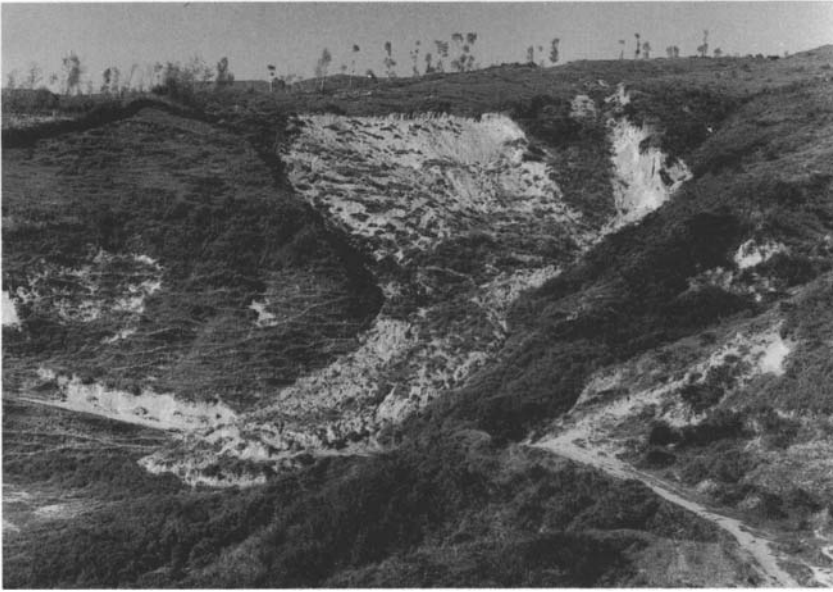
Fig.17.5. Earthflow in the upper basin of the Bălăneasa river, Buzău Subcarpathians (Photo: D.Bălțeanu)
