**GEOMORPHOLOGICAL
HAZARDS OF EUROPE**

C. & C. EMBLETON

GEOMORPHOLOGICAL HAZARDS OF EUROPE

1997

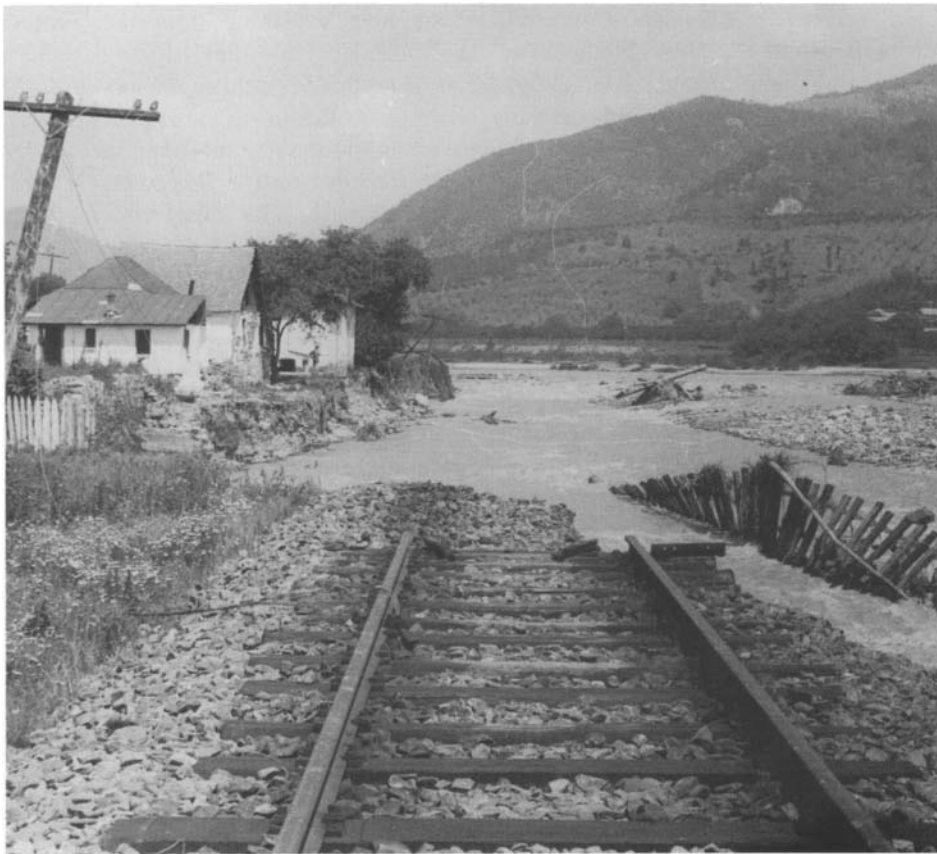
Fig.17.6. Destruction of the Buzău-Nehoiș railway in June 1969 by flooding on the Buzău river at Păltineni (Photo: D.Bălțeanu)

The most recent catastrophic floods were recorded in 1969 (Fig.17.6), 1970, 1975 and 1991. Less disastrous events took place in 1932, 1938 and 1948, affecting smaller areas.

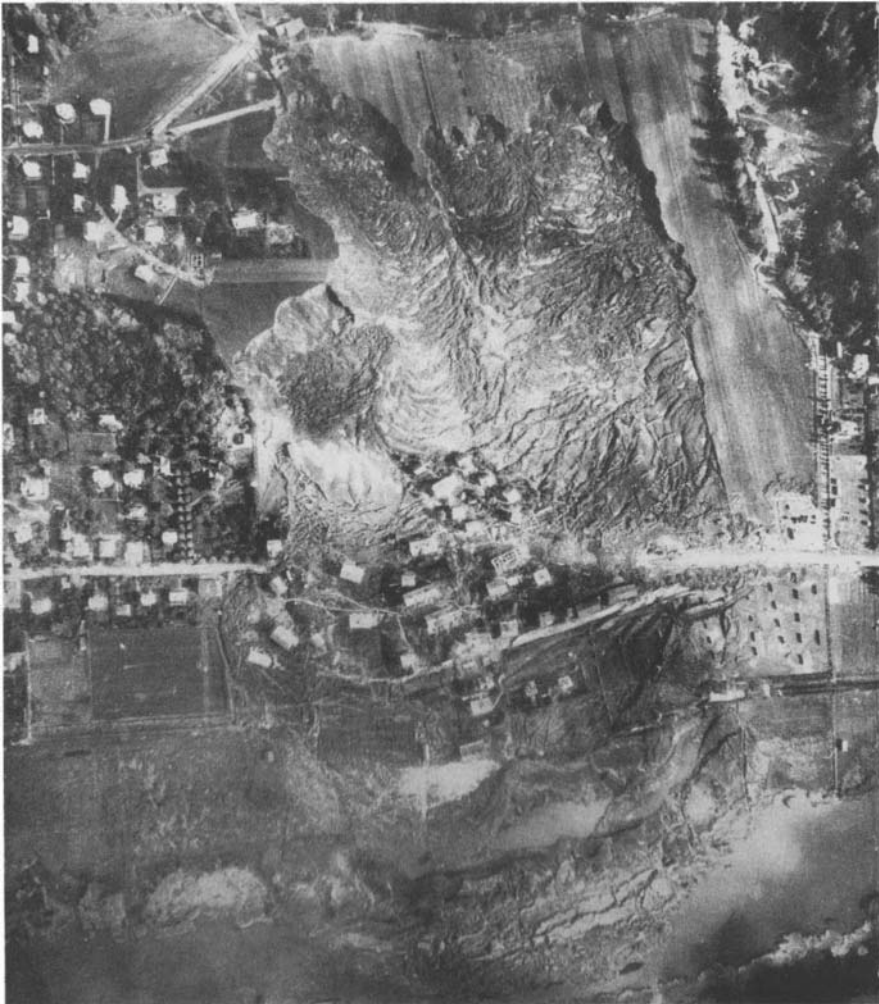
Fig.19.4. The Surte slide. Note the bulge into the river (lower) and the disturbed road and railway. The clay crust has been broken into separate narrow blocks, indicating the movement in the soft clay below (photo from Caldenius and Lundström, 1956).
