Transport and Road Research Lab.  
Crowthorne (England)

**TRRL LABORATORY REPORT 970**

**THE KENYAN LOW COST MODULAR TIMBER BRIDGE**

**J D Parry**

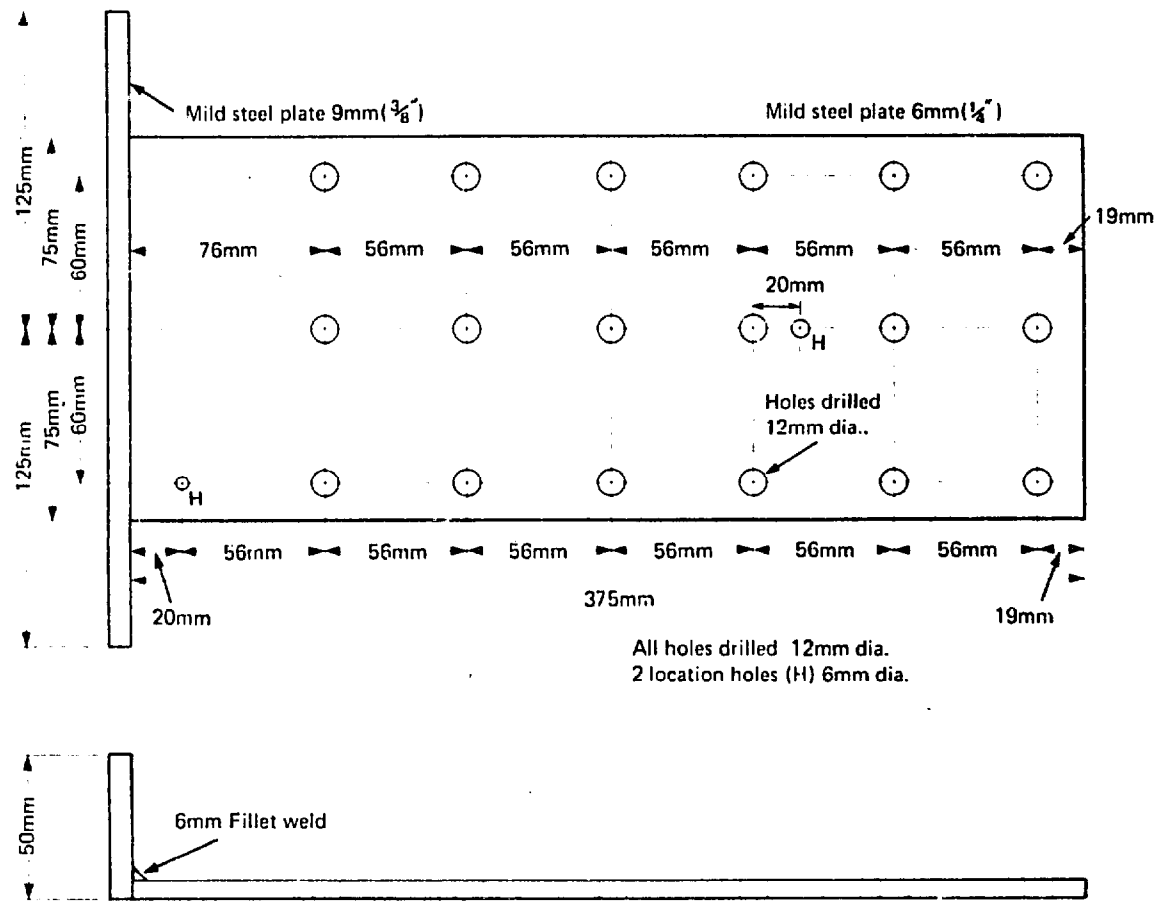
Fig. 6 TOP PLATE

Steel dowels are used to join the timber members at each corner of the frame. The two top joints are identical, each consisting of two steel plates (Figure 6) one on each side, through which the dowels pass, penetrating through the horizontal timber member and then into the diagonal. There is no connection through the joint but the two top steel plates are joined when the end plate (Figure 7) is welded across them; a male end plate at one end of the frame and a female at the other.

Although the location of the dowel holes in the drilled plates (Figures 6 and 8) is not very critical, a template for the pilot drilling saves time marking out and gives a consistent result. The 40 mm holes in the bottom chords (Figure 3) should be drilled accurately using a template.

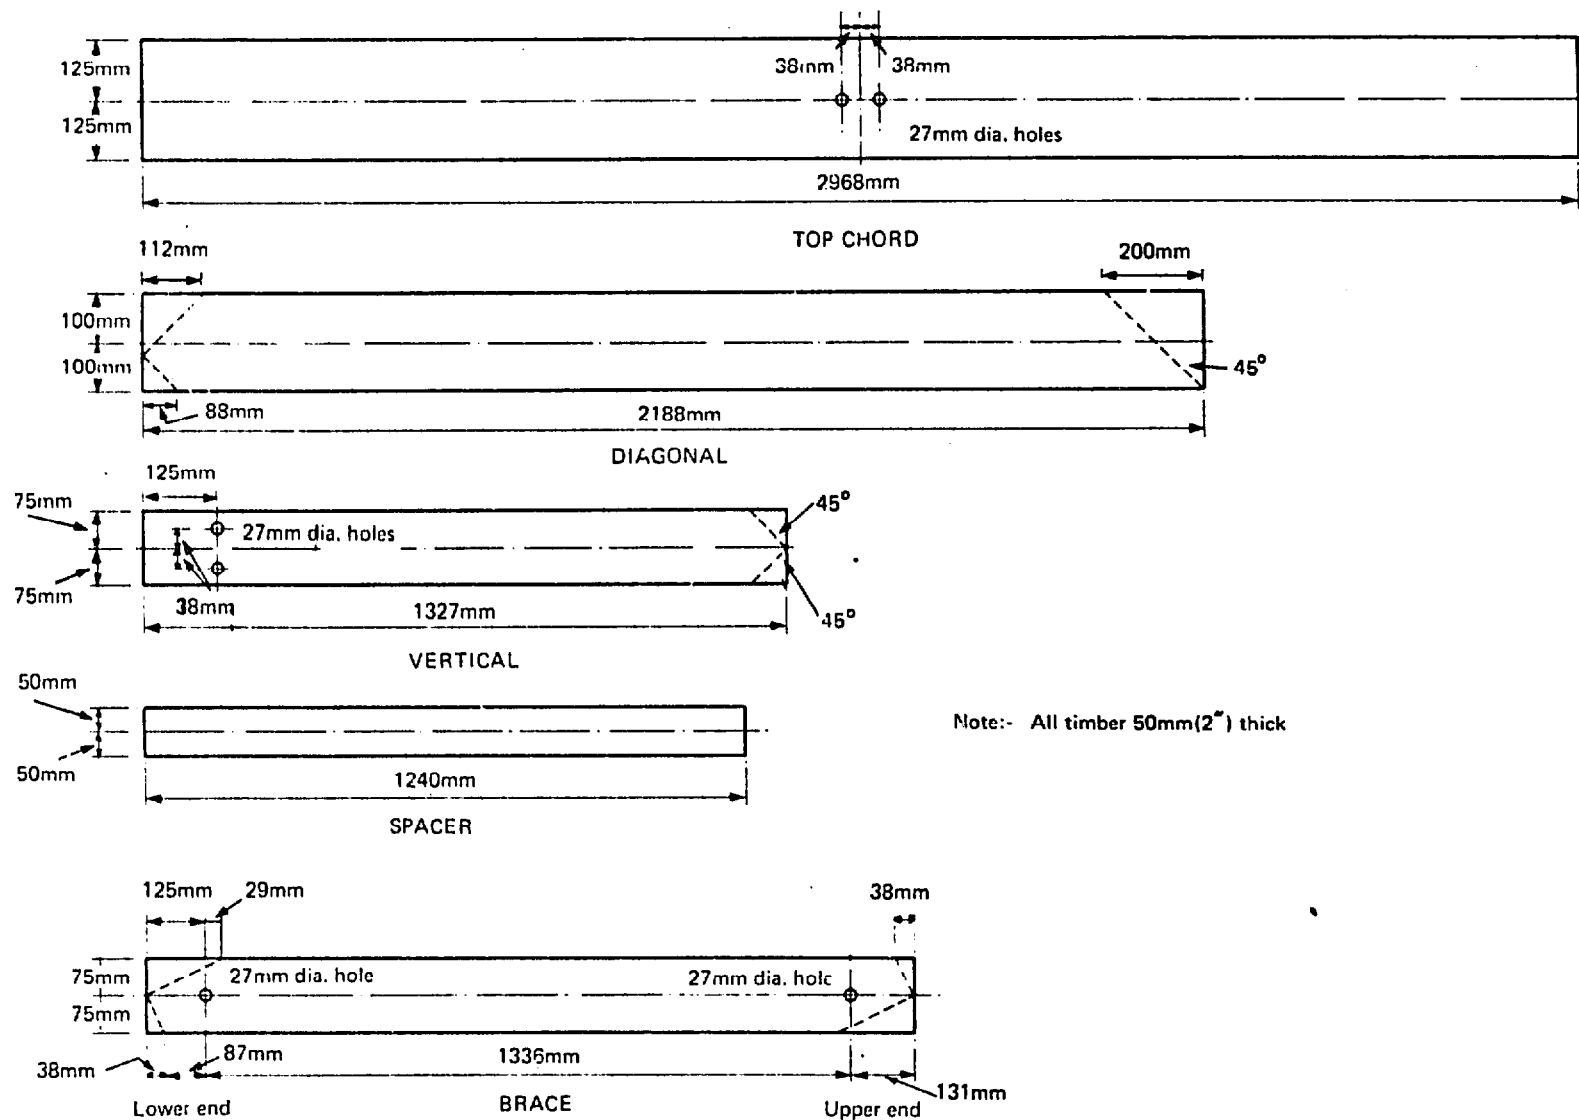
Fig. 5 TIMBER MEMBERS

All the timber is of 50 mm nominal thickness and the depths of the frame members vary from 100 to 250 mm according to their duty (Figure 5). Each timber member comprises two identical pieces of timber which are nailed together back-to-back, except the top chords which are separated by 100 mm spacers. The advantages of this double section design are:-

The timber members of the frame are cut to the dimensions shown in Figure 5. It is important that lengths and angles are cut accurately, and for this reason it is recommended that simple jigs are used at this stage. Of equal importance is an assembly jig to ensure that all the frames are assembled to give constant length, depth between centres of the locating pins (1343 mm), and squareness of the end plates. The vertical struts should not project above the top surface of the top chords.

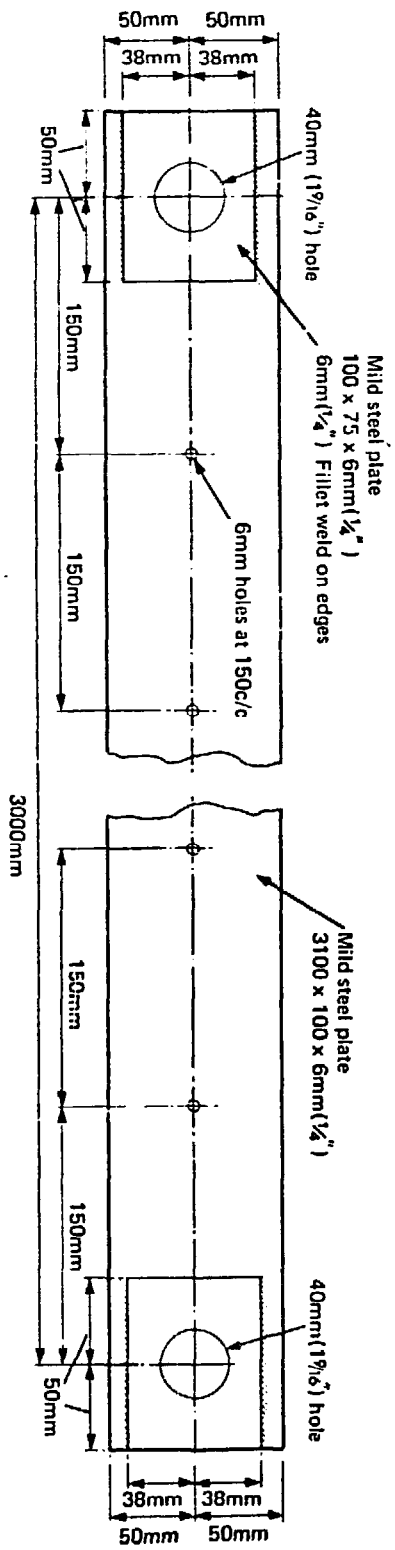
Fig. 3 BOTTOM CHORD

Each truss is assembled from a number of identical frames (Figure 2), prefabricated and transported to the site together with the steel bottom chords (Figure 3). The frames are made of rough sawn softwood boards 50 mm thick, dowelled and nailed together to form an inverted triangle 3 metres long with a vertical brace. They weigh about 140 kg each and are all made in the same manner. Practical considerations limit the number of frames in a truss from 3 or 4 to about 8 or 10, according to the properties of the timber employed.

- (ii) the distance between hole centres in the bottom chords (Figure 3) and
- (iii) the squareness of the end plates (Figure 7) that butt together when the frames are assembled end to end.

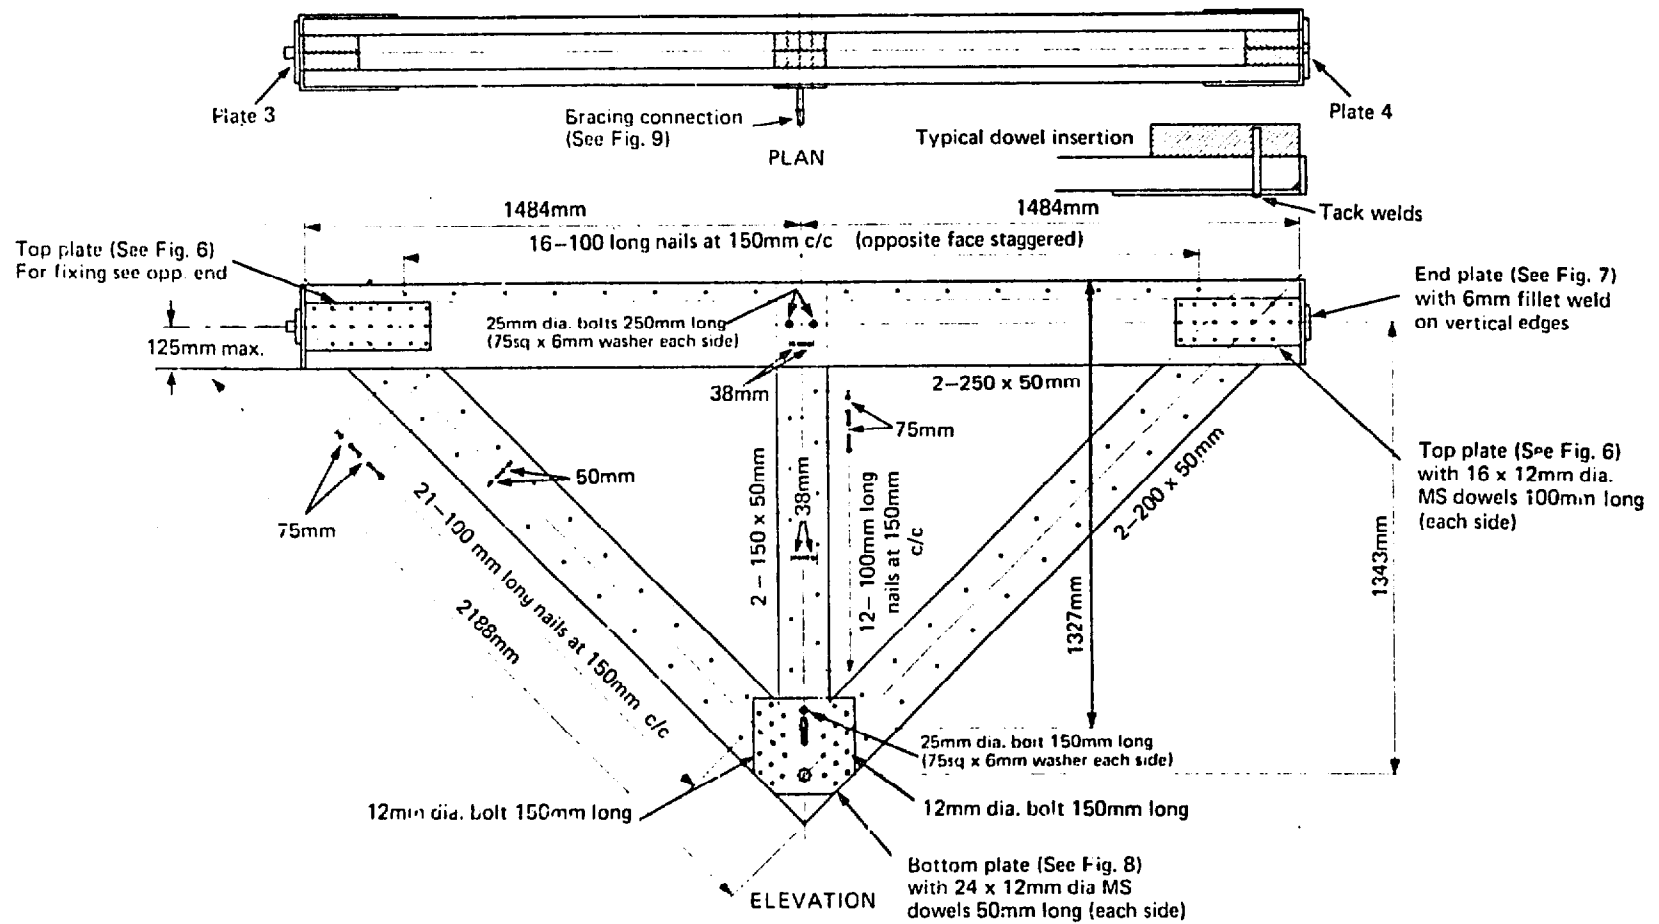
Fig. 2 FRAME ASSEMBLY

Figure 2 details the frame on which this bridge design is based. The top horizontal chords are always in compression whereas most diagonal members take both compressive and tensile loads. On the end frames of each truss however, one diagonal member will be permanently in tension and the other in compression. The vertical members are under load only when the frame to which they belong is underneath a superimposed load. The pin locating the end frame to the bridge bearing carries the largest shear force on the truss into the end joint of the frame.

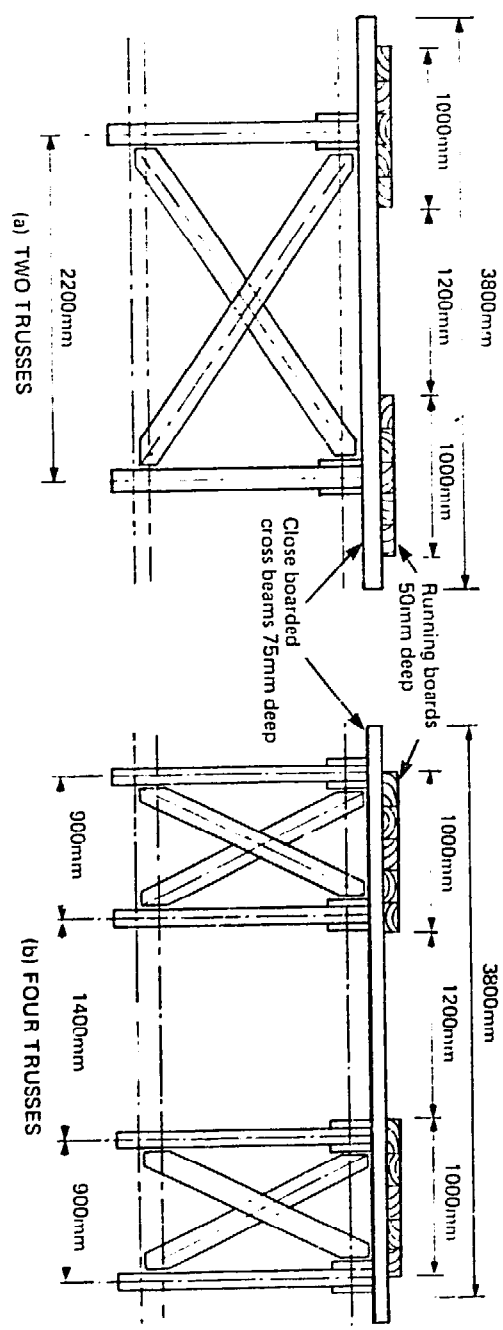
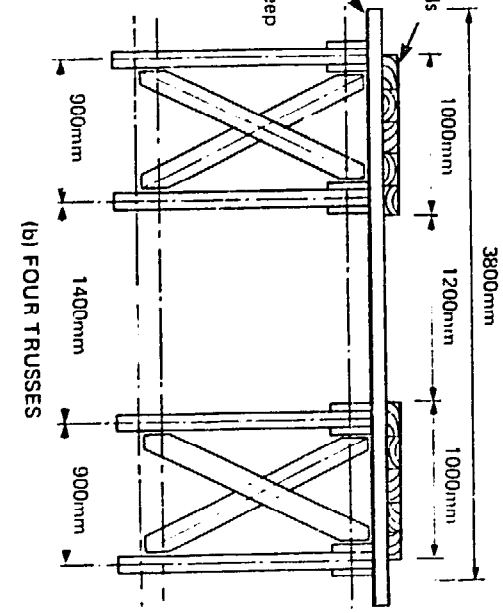
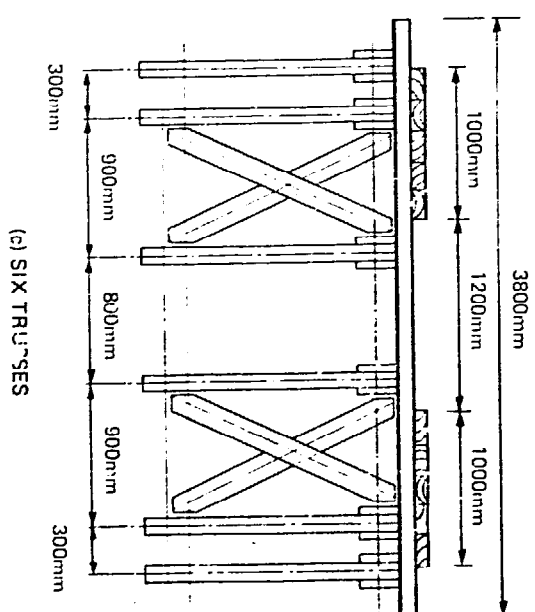
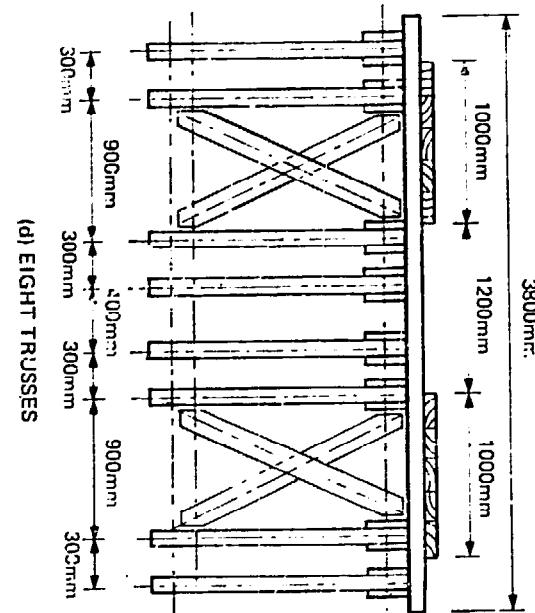
In a typical bridge, four trusses are positioned side-by-side, but the number of trusses can range from two to eight depending on the loading requirements (see Figure 1).

Fig. 1 TYPICAL CROSS-SECTIONS USING (a) TWO TRUSSES (b) FOUR TRUSSES (c) SIX TRUSSES (d) EIGHT TRUSSES

The vertical cross-bracing shown in Figure 1, and the close boarded cross beams provide a large measure of lateral stability. In addition sway bracing is achieved by attaching long wooden members diagonally in a horizontal plane to the underside of the top chords and at bottom chord level. The vertical braces are attached to the top chord using a bracket (Figure 9) and are bolted to the lug on the bottom plate (Figure 8). The lower sway braces may be bolted to the bottom plates with the lug turned through 90° or may be nailed to the wooden spacers between the bottom chords.

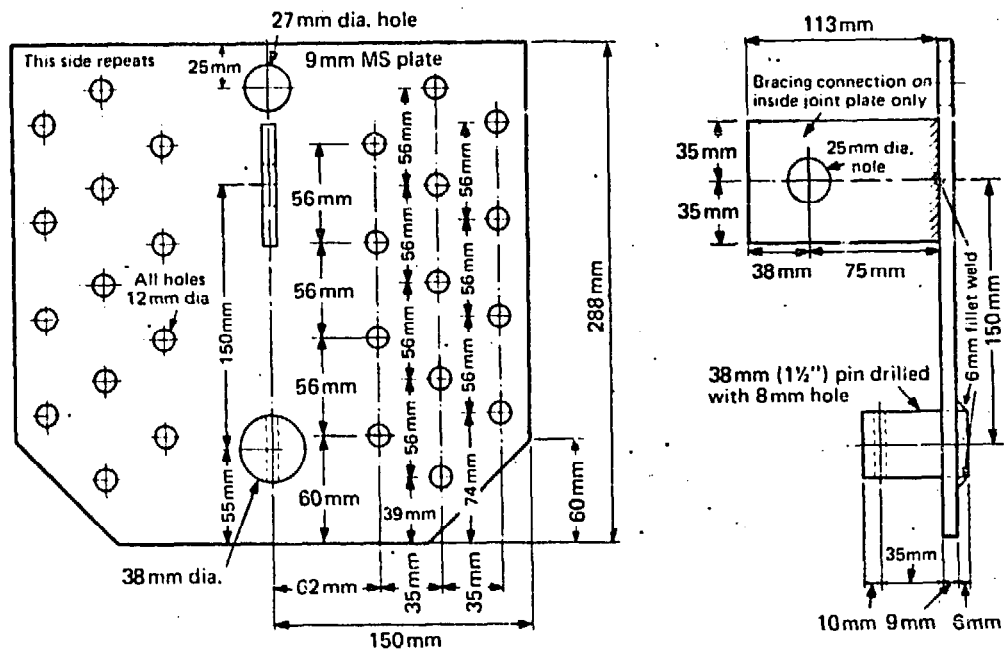
Fig. 8 BOTTOM PLATE

In the bottom joint, the two diagonal members are not joined by the dowels but each is dowelled to the bottom plates (Figure 8). Again similar plates are used each side of the joint and dowels are driven through them and into the timber from each side. In addition two through-bolts hold the plates in place. The vertical member is restrained by one bolt which also passes through both plates. The top of this member is held between the horizontal chords by two through-bolts. These bolts convey the load from the horizontal chord to the vertical member and so down to the bottom joint of the frame.

- (i) the location of the pins in the bottom plate (Figure 8) or the positioning of the plate on assembly of the frame,

Two important aspects of this design are its simplicity and cheapness of manufacture. To this end, all the frames are virtually identical; the only variation being different versions of the bottom plate (Figure 8) according to bracing requirements.

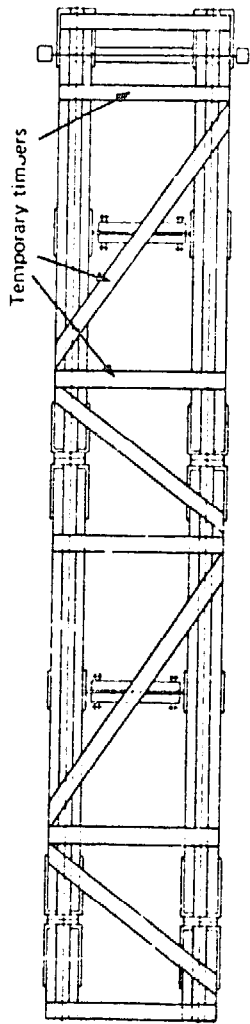
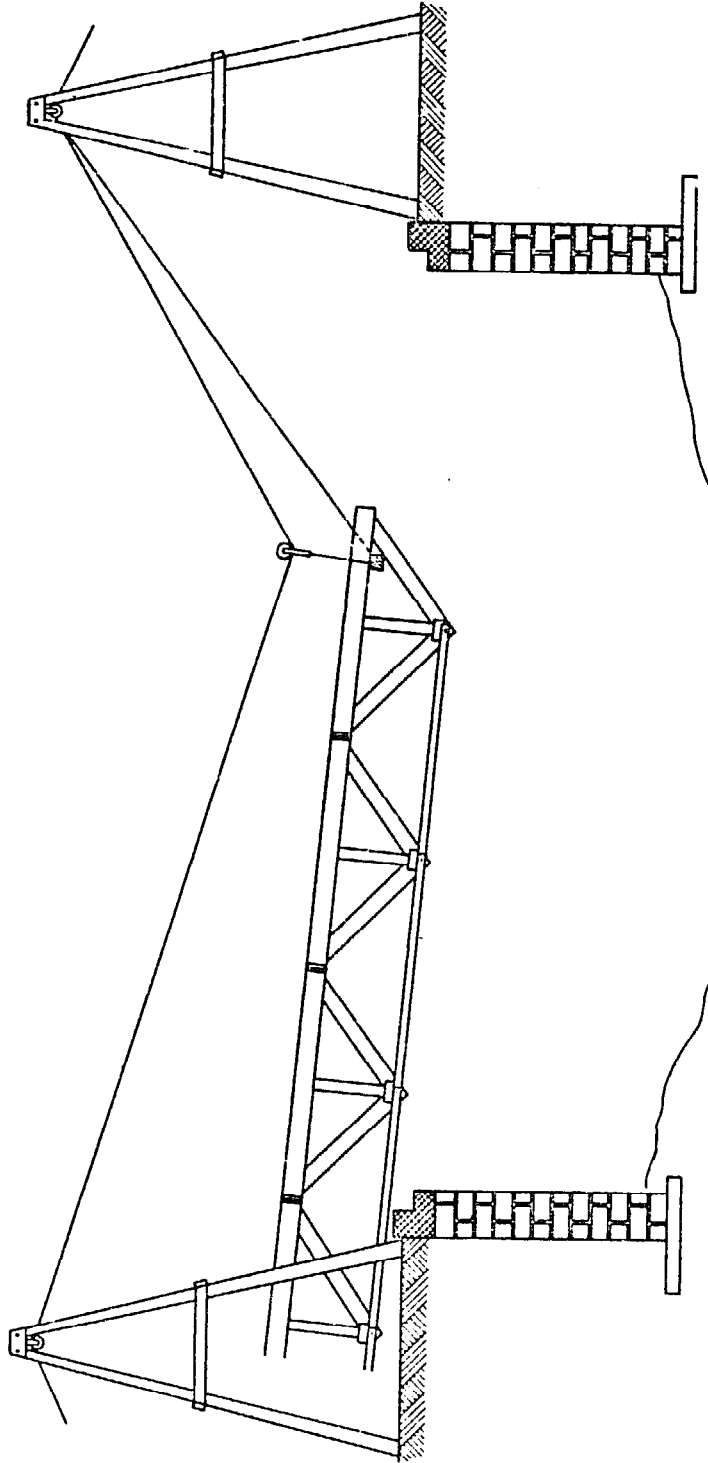
Fig. 11 LAUNCHING A PAIR OF TRUSSES

The first bridge constructed at Isiolo was built by hand, with each frame being bolted into position in its final place. This was done in the dry season and the method would not be practical for a crossing with deep water or across a ravine. Subsequent bridges were built without support from below using a timber derrick on each abutment with a wire rope stretched between them. The truss was then built up at one abutment and launched across the river; this was done in stages adding further frames until the full truss length was reached (Figure 11).

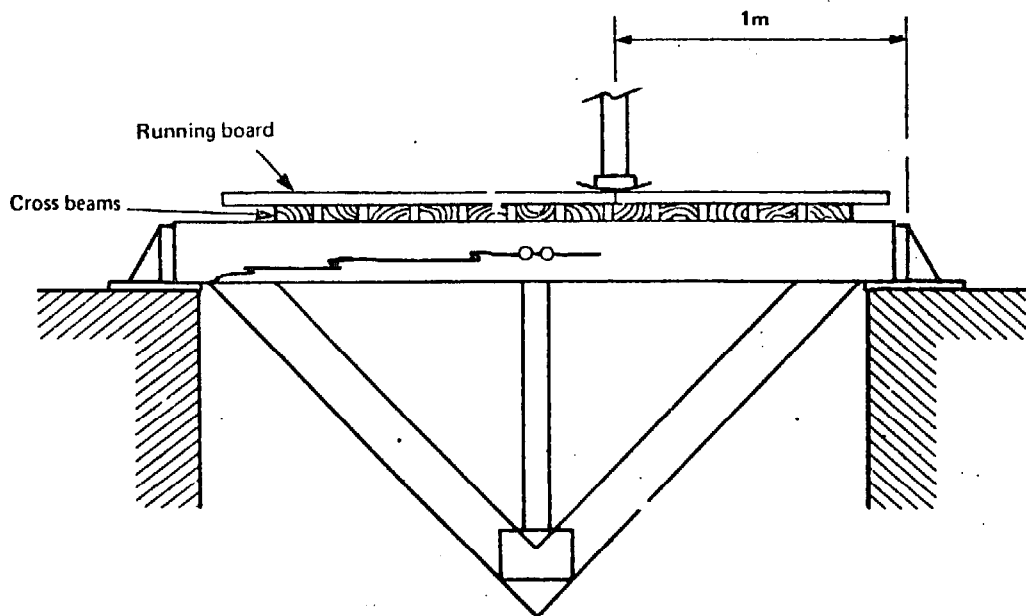
Fig. 12 TEST LOADING A SINGLE FRAME

In all four cases the frames failed when a split was opened in one of the horizontal members across the bolt holes at its centre. This split progressed away from the load point under further loading until it broke out near the end of the member, either into the dowel holes or into the lower surface. The failure occurred gradually and in all cases the frame continued to sustain the load that caused the horizontal member to split. A greater load, or several applications of the same load, were required to cause the second horizontal member to fail. The moisture content of the timbers measured with a resistance meter ranged from 15 per cent to 17 per cent. The results are summarised in Table 1.

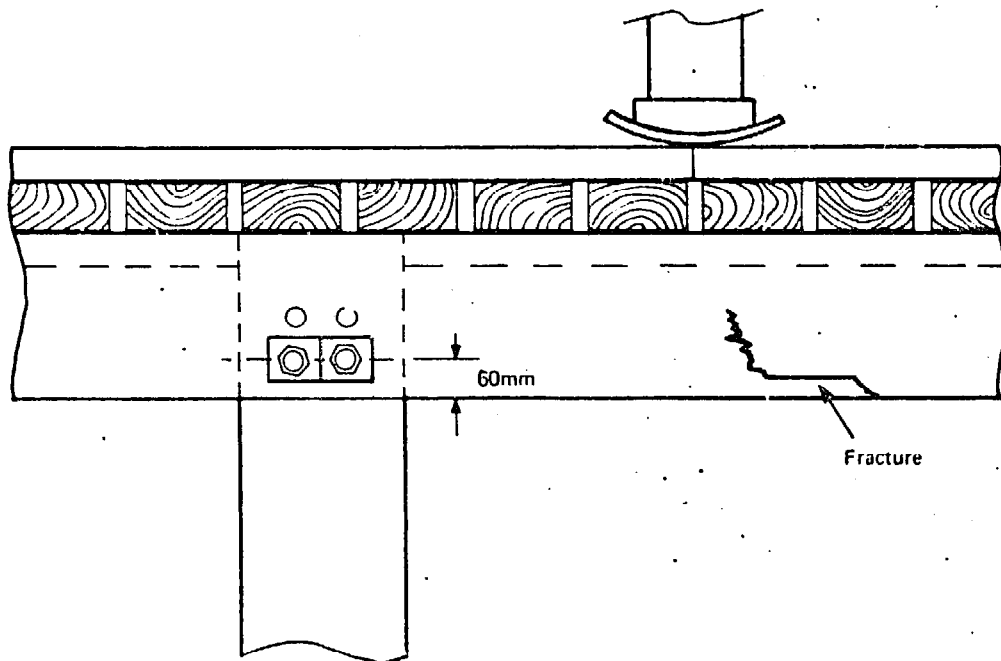
Fig. 13 FRAME MODIFICATIONS

In order to obtain better use of the strength of the horizontal members of the frame, the four failed units were repaired using new timber for the horizontals. The two bolts that caused the splitting were removed from the holes on the centre line of the horizontal members and placed 60 mm from the lower edge as shown in Figure 13.

- (iii) Placing the two bolts on the centreline of the horizontal members causes unnecessary weakening. This may be avoided by positioning these bolts 60 mm from the lower edge of these members.

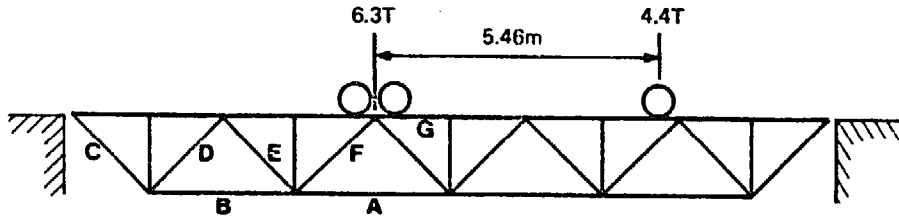
Fig.14 BRIDGE TEST AT ISILO

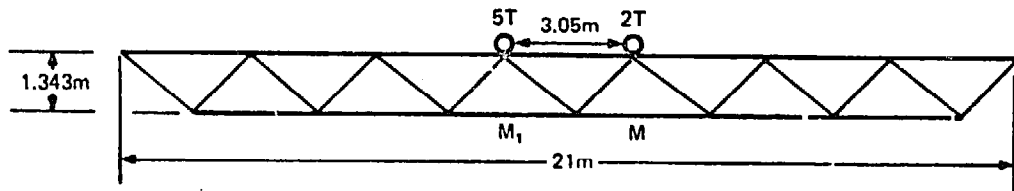
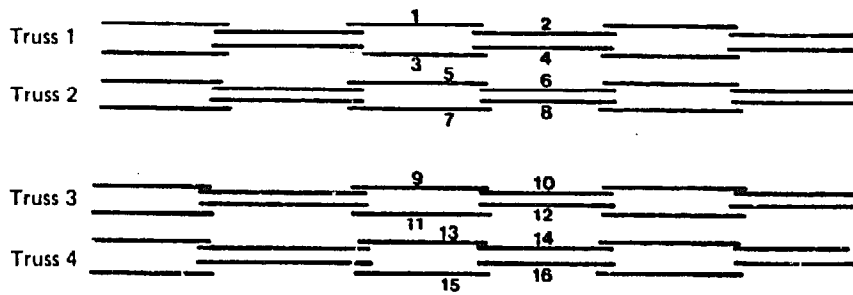
(a) ELEVATION

(b) PLAN OF STEEL CHORDS

Fig.15 BRIDGE TESTS AT NYERI - BOTTOM CHORDS

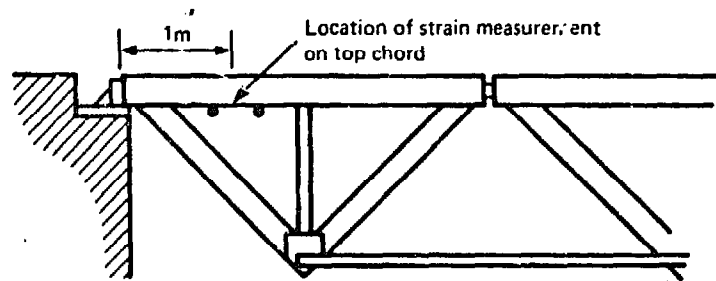
It is thought that the first bridge built at Isiolo failed when the horizontal top chords of the end frames broke, due to being repeatedly overloaded. Consequently strain measurements were taken with a demec gauge on the lower faces of four of the top chords of the bridge at Nyeri in 1979 (Figure 16). The results are shown in Table 7.

Fig.16 BRIDGE TESTS AT NYERI - TOP CHORDS

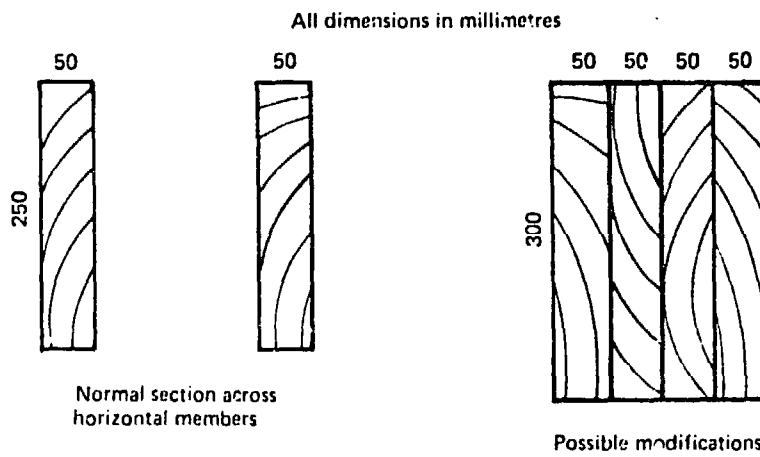
Fig. 17 ILLUSTRATION OF THEORETICAL OVERLOAD CONDITION
