WORLD BANK TECHNICAL PAPER NUMBER 29

# Rural Water Supply Handpumps Project

## Handpumps Testing and Development: Progress Report on Field and Laboratory Testing

**UNDP Project Management Report Number 4**

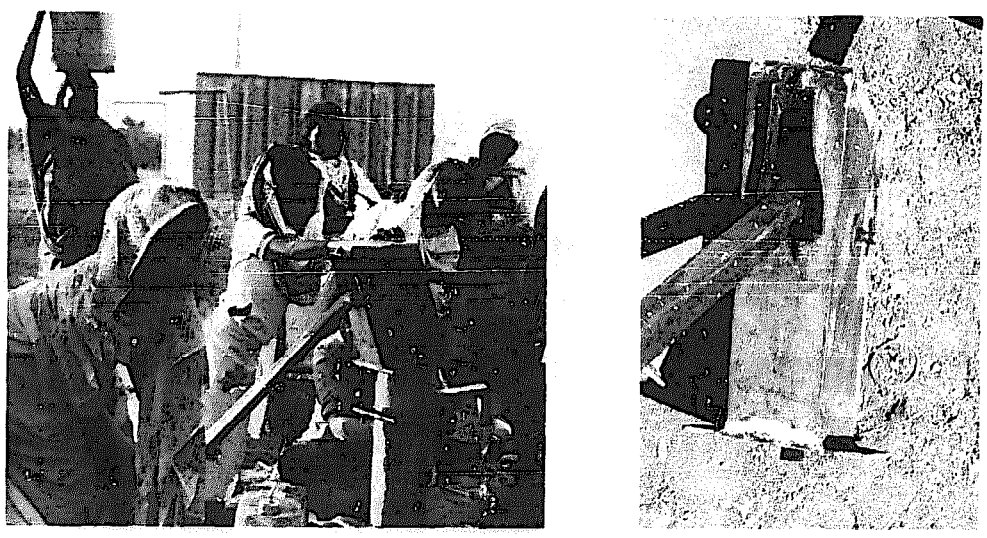
FIGURE 2-3 DAMAGED INDIA MARK II PUMPHEADS IN THE SUDAN

The damaged pump on the left is still working, and the pumphead on the right is awaiting reconditioning at a workshop. The pumps shown here have "peeled back" pumphead cases due to lateral handle movement resulting from worn bearings. It is likely that the cause of this bearing wear is the regular removal of the axle pin and its replacement (by hammering) through the bearings every time the pump is dismantaled. This proceedure is based on instructions in the India Mark II O & M manuals, although in fact it is not necessary to remove the axle pin except when the handle, bearings or the pin itself need replacement. The manuals are being modified to take account of this.

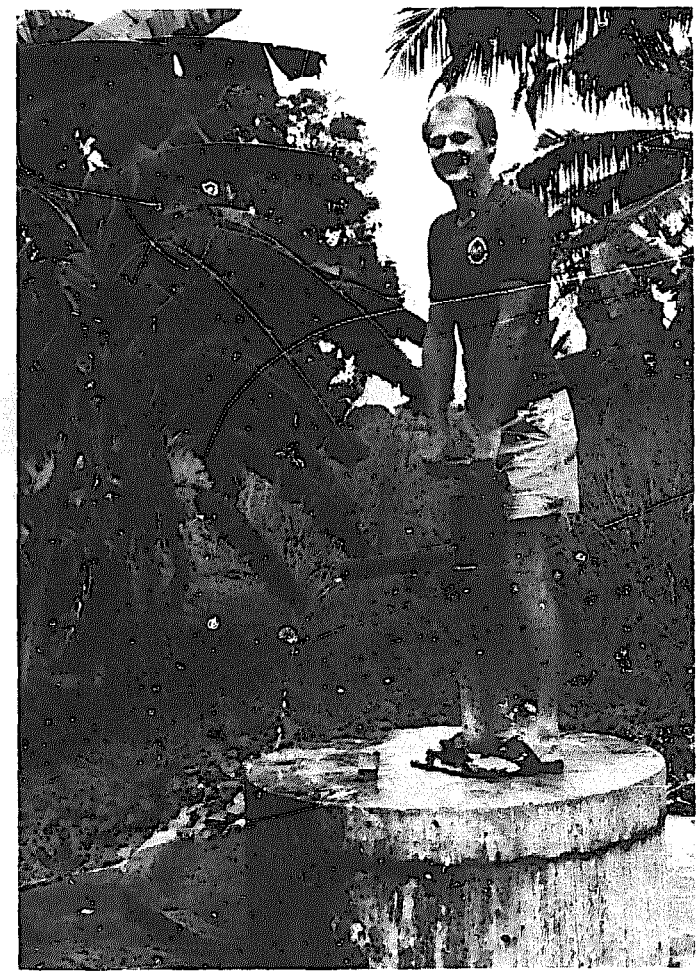
FIGURE 2-4 LOCAL DIRECT ACTION HANDPUMP IN TANZANIA

**In an attempt to avoid frequent bearing and lever arm replacement in low-lift pumps installed by Finnwater in Tanzania, the pump head was removed and a T-handle fixed onto the pump rod to produce a direct action pump for trial. Users immeadiatly accepted this modification and considered it to be an improvement. The pump shown here is being operated by a member of the Finnwater staff.**

Discussions with the CME and Finnwater staff on the benefits of direct action pumps (see Annex A) resulted in the fabrication of a small number of units in their project workshops (Figure 2-4). There has been a good response from the users and careful monitoring of these units is planned.

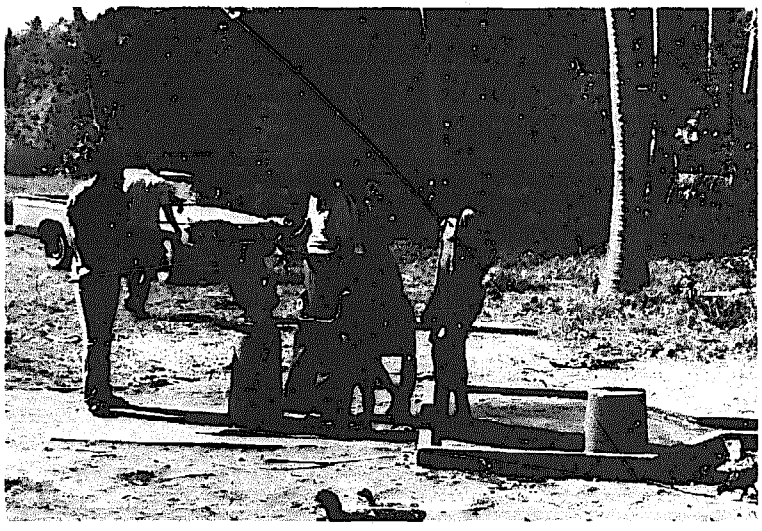
FIGURE 2-7 KENYAN-MADE MODIFIED INDIA MARK II PUMP

This Kenyan-made pump has two notable modifications from the standard India Mark II design. First, the pedestal is made of concrete instead of steel, in order to reduce the cost. Second, the discharge spout has been elongated in order to move water away from the pump. This helps keep the pump operating area dry and to minimize the possibility of sullage water entering the well.

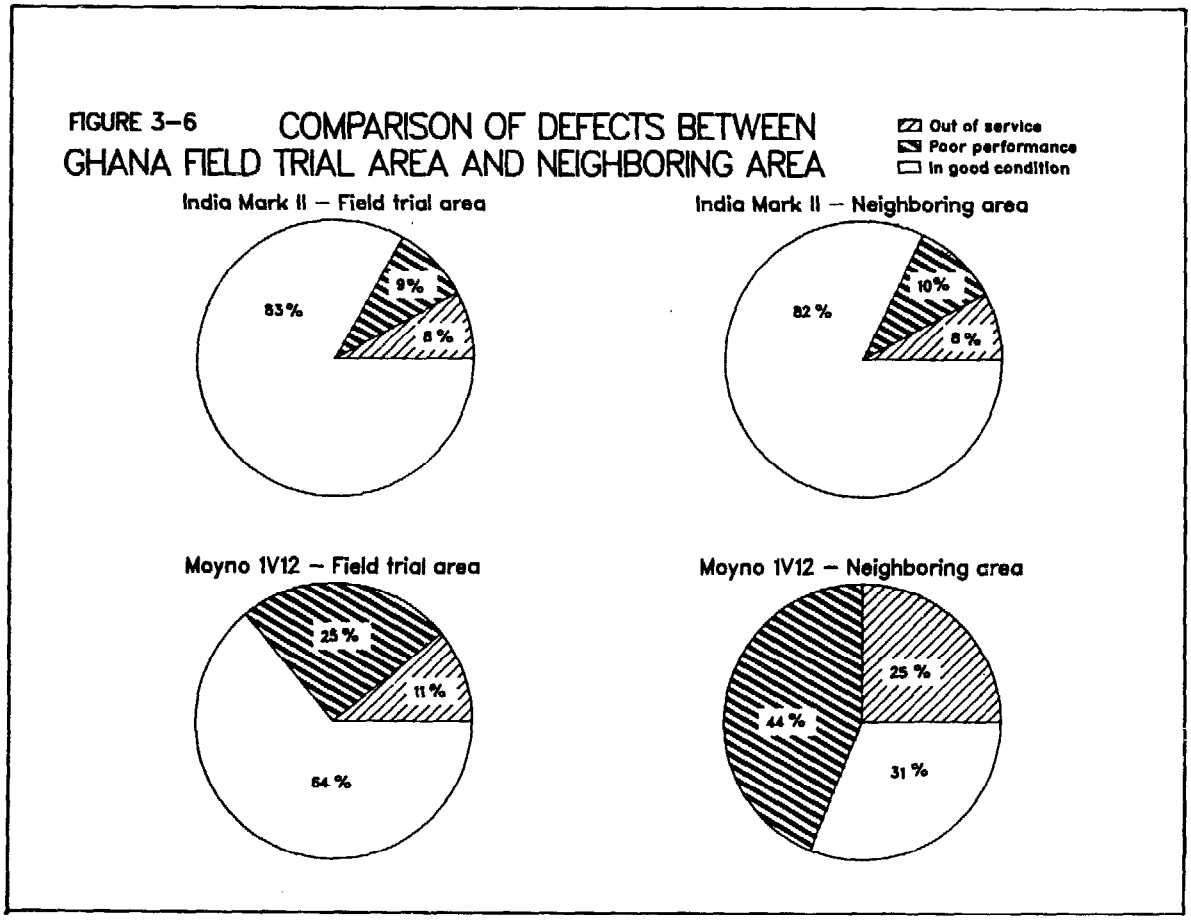
Defects of Handpumps Outside the Field Trial Area: In Figure 3-6 and Table 3-2 results of defects of the handpumps of the field trial area are compared with defects of handpumps of a neighboring area. There are 72 India Mark II and 16 Moyno pumps in the neighboring area. Comments:

- o There are no significant differences with respect to the India Mark II pumps; however, the Moyno pumps show significant differences. In the neighboring area out of service defects are more than double and the percentage of pumps in good condition is only half, in comparison to the field trial area.
- o Preventive maintenance has not yet been started on a regular basis in the neighboring area.

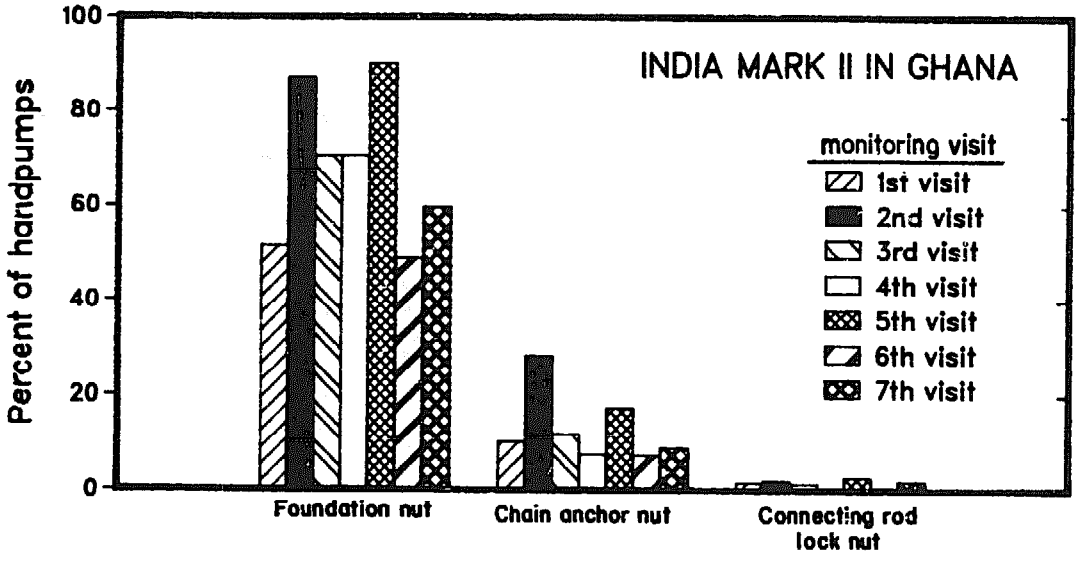
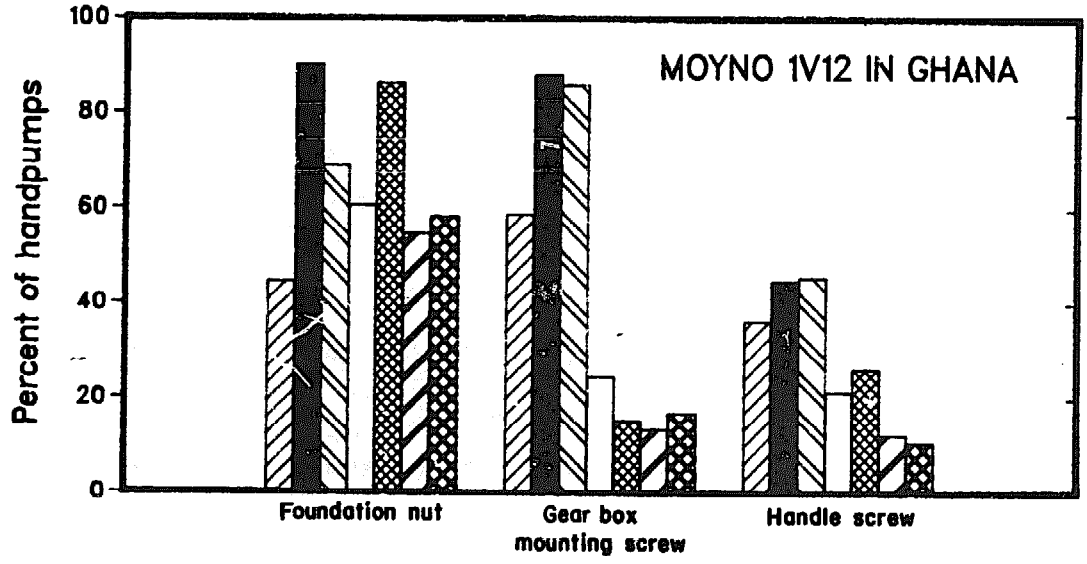
FIGURE 3-7 LOOSE NUTS AND BOLTS VS. PUMP AGE

Slackened Nuts and Bolts: Figure 3-7 shows that a high percentage of screws, nuts and bolts slacken on both the India Mark II and Moyno. In the case of the India Mark II a loose connecting rod lock nut can result in the chain becoming disconnected from the pump rod, and for the Moyno a loose handle screw can cause free play which damages the keyway where the handle connects to the gearbox. Handle free play as well as loosened gearbox mounting screws can allow the Moyno pump head to shake during use which in turn can severely damage the drive mechanism. The reason for this situation is that, in general, neither lock nuts nor spring washers are used.

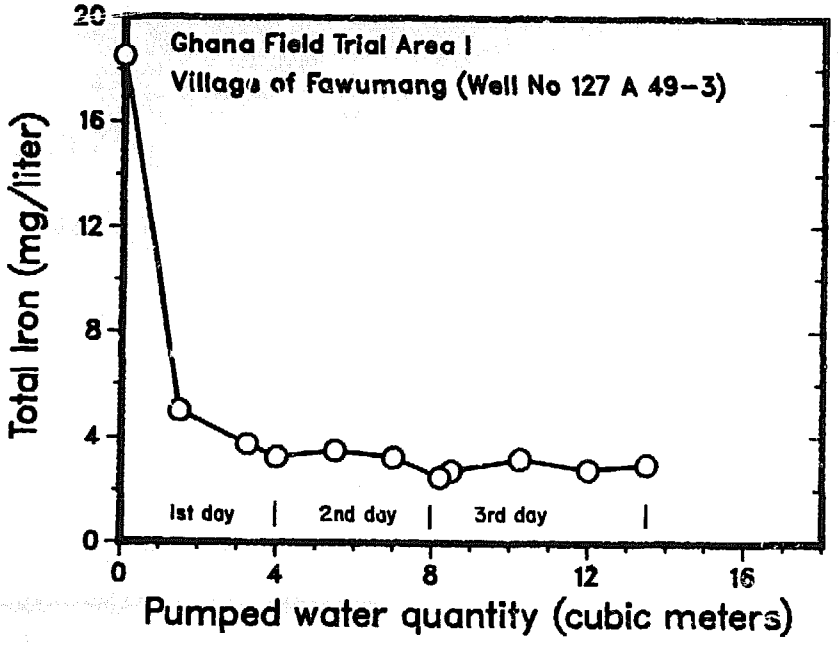
FIGURE 3-15 IRON CONCENTRATION VS. TIME WELL IN USE

- o The amount of iron contributed by corrosion varies and is particularly high in wells that are little used in which corroded material has had time to accumulate. This is clearly demonstrated in the example given in Figure 3-15, where the total iron concentration in well water dropped from about 18 mg/l down to 2.5 mg/l after several hours of pumping.

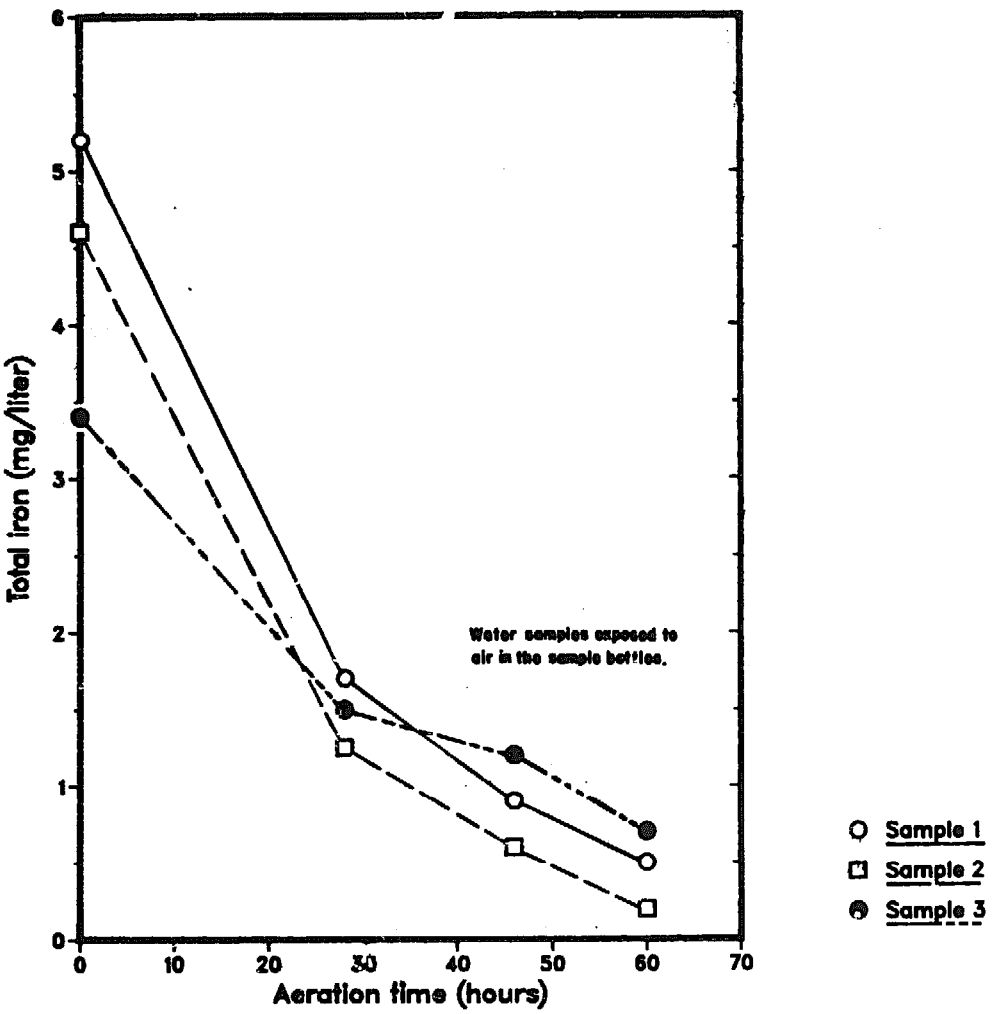
FIGURE 3-16 IRON CONCENTRATION VS. AERATION TIME
Ghana Field Trial Area I

o The exposure of groundwater with a high iron content to air (in open receptacles or even stoppered sample bottles) reduces the iron concentration significantly, even within hours (see Figure 3-16).

Conclusion: Measurements of iron content in both drilled and dug wells and the results of aeration tests indicate that storage of groundwater for one to two days may be both an effective and simple solution to the iron problem. As a general rule, handpumps that have corrosive below-ground components should not be used where the groundwater is aggressive. Iron can be removed from water by means of simple techniques such as aeration and filtration. However, as long as the users of handpumps fail to maintain the pumps adequately, iron removal plants, even simple ones, are not recommended because they too, would require proper maintenance.

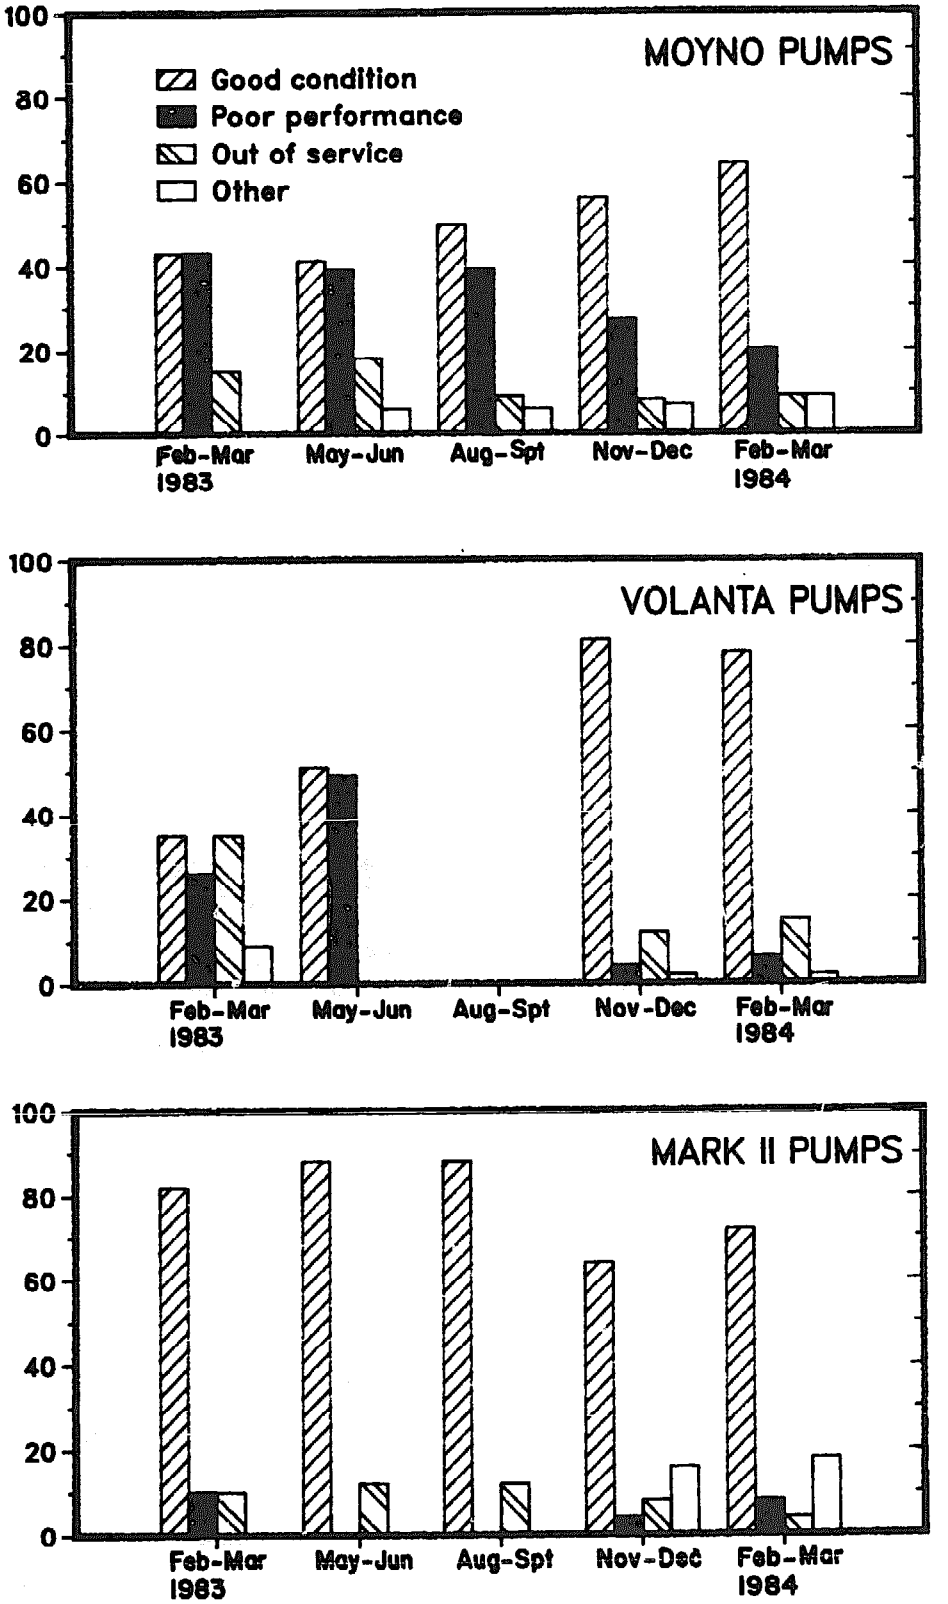
FIGURE 3-20 CONDITION OF PUMPS IN BURKINA
(FEBRUARY 1983 TO MARCH 1984)

The condition of Moyno, Volanta, and India Mark II pumps monitored between February 1983 and March 1984 in the Burkina test area is depicted in Figure 3-20. The average well depth, static water level, and installation depth of the pump in the three pump areas differ as follows:

The out-of-order defects found on Moyno pumps in this field trial are comparable to those reported from the Ghana Field Trial I.

Volanta pumps: There are two reasons for the relatively poor performance of the Volanta pumps during the first two monitoring visits:

- o The pumps were still equipped with cables and most of the rising mains had threaded joints.
- o The maintenance system for these pumps had not been adequately set up.

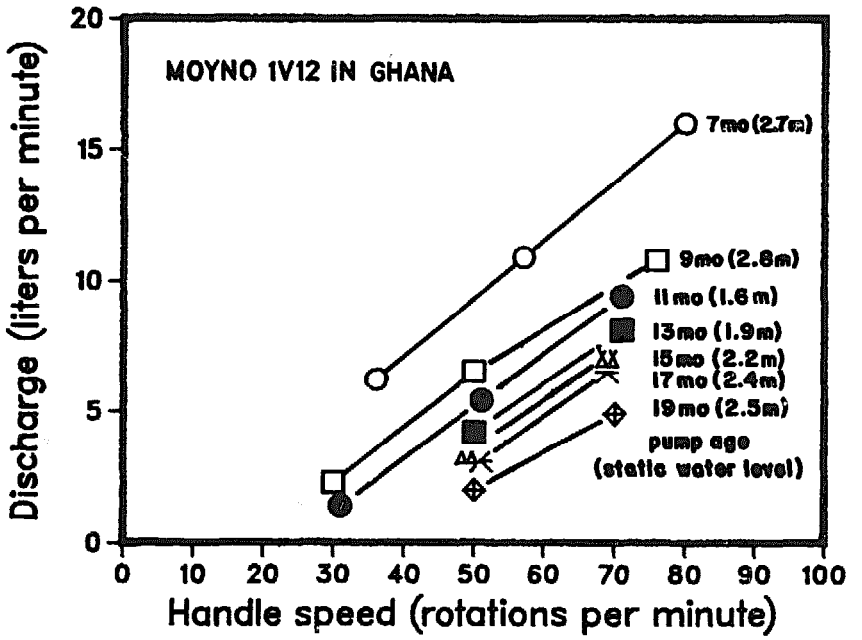
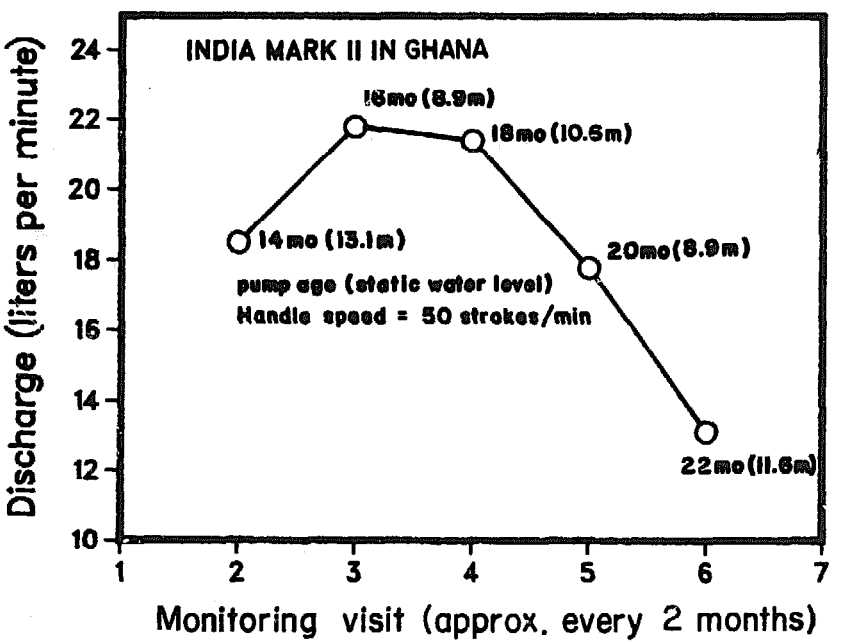
FIGURE 3-22 DISCHARGE RATE VS. HANDLE SPEED AND AGE

Wear of Cup Seals and Scaling of Rotors: Figure 3-22 shows examples of how the wearing of cup seals (India Mark II) and scaling of rotors (Moyno) develop under unfavourable conditions.

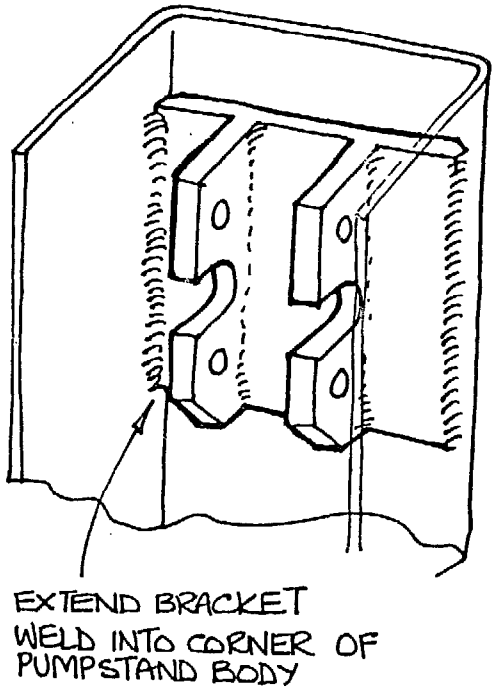
The pipe clamp slotted into recesses in the pumpstand body, retained by very small socket setscrews. These were difficult to remove and might easily be dropped down the well, and they should therefore be eliminated. We understand that the clamp is now welded into the pumpstand body.

The handle bracket should be enlarged so that the points of attachment are in the stiffest regions of the pumpstand body: see sketch, right.

It may be necessary to chamfer the edge of the bracket as shown below:

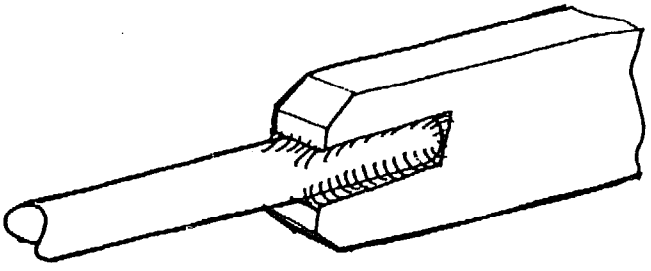
The handle shock load test results have shown the importance of adequate strength here. The handle might be modified as shown, right, to enable the condition of the weld to be monitored more readily and be stronger than the existing design. The manufacturer has recently improved the welding and added a securing bolt. The pivot pin need not be headed.
