Final Report on the Investigation of the Macondo Well Blowout

**Deepwater Horizon Study Group
March 1, 2011**

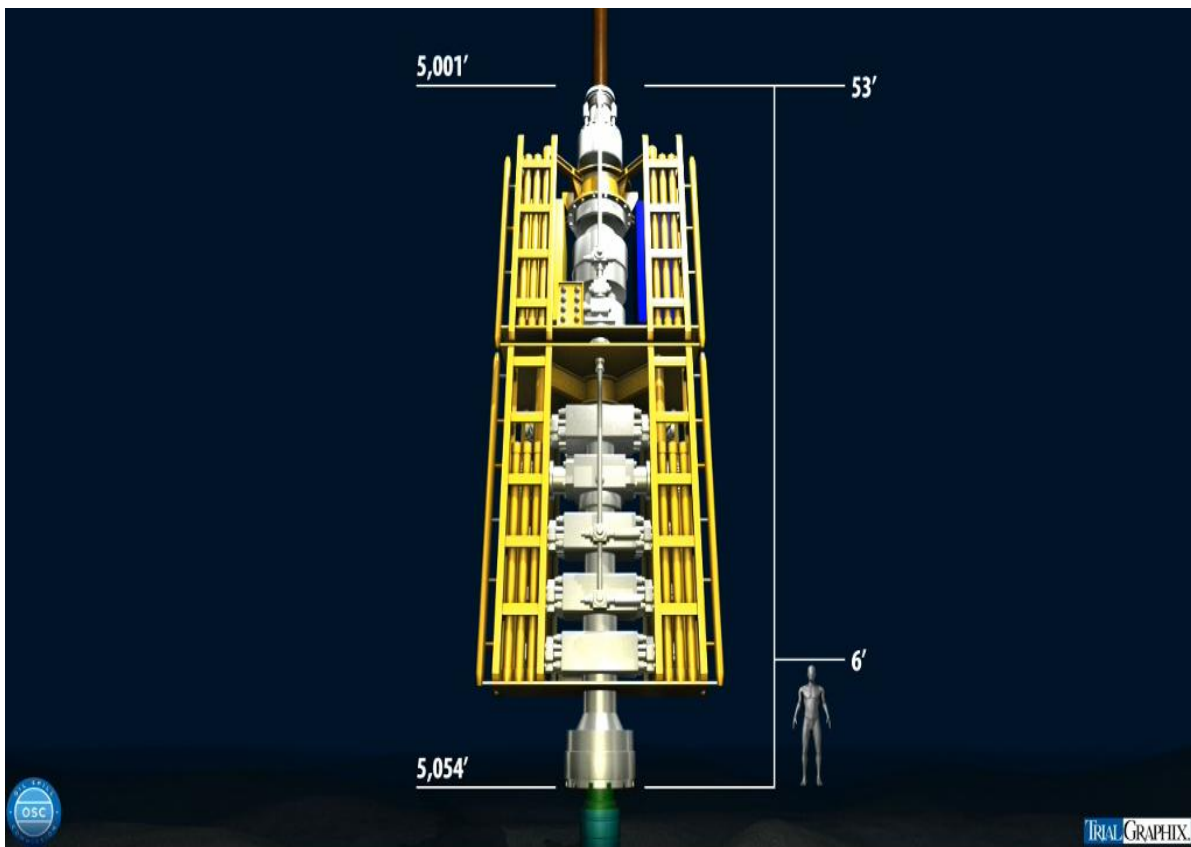
Figure 1.7 – Blowout Preventer (BOP).²⁶

At the depth and pressures encountered by the *Deepwater Horizon* well, MMS regulations require at least four remote-controlled, hydraulically operated valves, or rams during offshore operations.²⁵ All of the rams on the BOP failed to close properly during the blowout event that occurred on the *Deepwater Horizon*.

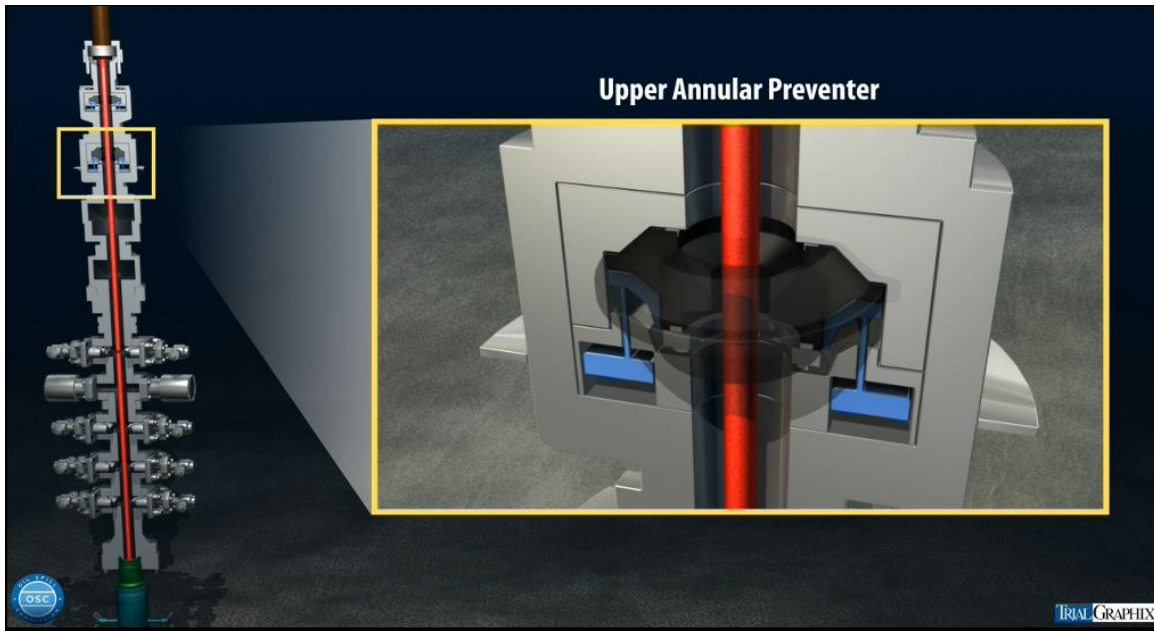
Figure 1.9 – Upper Annular Preventer.²⁷

Annular Preventers (Figure 1.9) are rubber donut shaped seals that close around the pipe sealing the well. They can also seal the well with an absence of pipe in the hole. Stripping occurs if an annular is closed around the pipe, and the pipe is moved upward or downward during this time. Witness accounts stated that stripping had occurred on the *Deepwater Horizon* and pieces of rubber were observed. The stripping could have weakened the annular preventers.

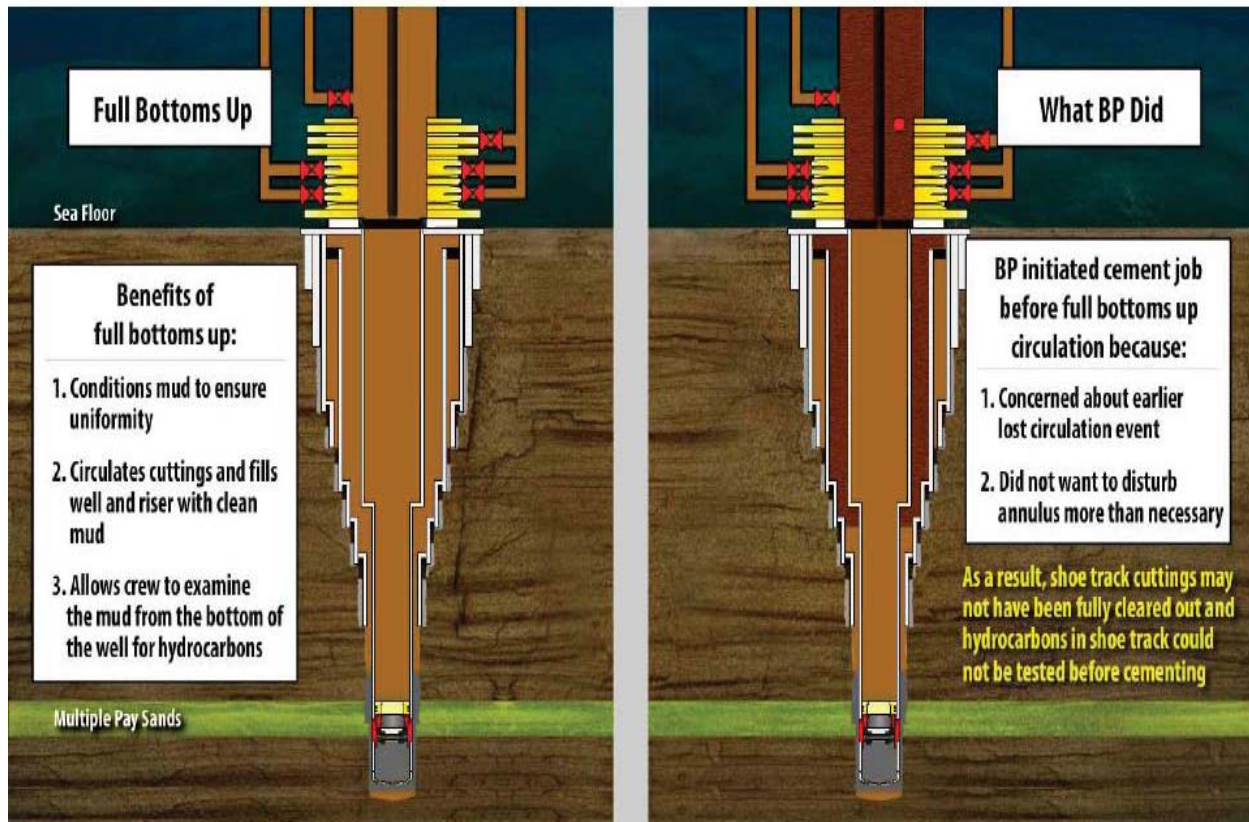
Figure 1.18 – Illustration of *bottoms up*.⁷⁰

BP made the decision not to do a complete *bottoms-up* circulation of the well before cementing that would remove hydrocarbons and debris in the bottom of the well (Figure 1.18). Due to BP engineer concerns for *wash out* in the weak formation at the bottom of the hole accompanied by disturbance of the lost circulation material that had been placed in this part of the well, only about half of the well-casing volume was circulated out.⁶⁵ The incomplete bottoms-up circulation did not meet Halliburton’s *best practices*.⁶⁶ This incomplete circulation would have left any hydrocarbons that remained in the well lingering in the upper part of the well.

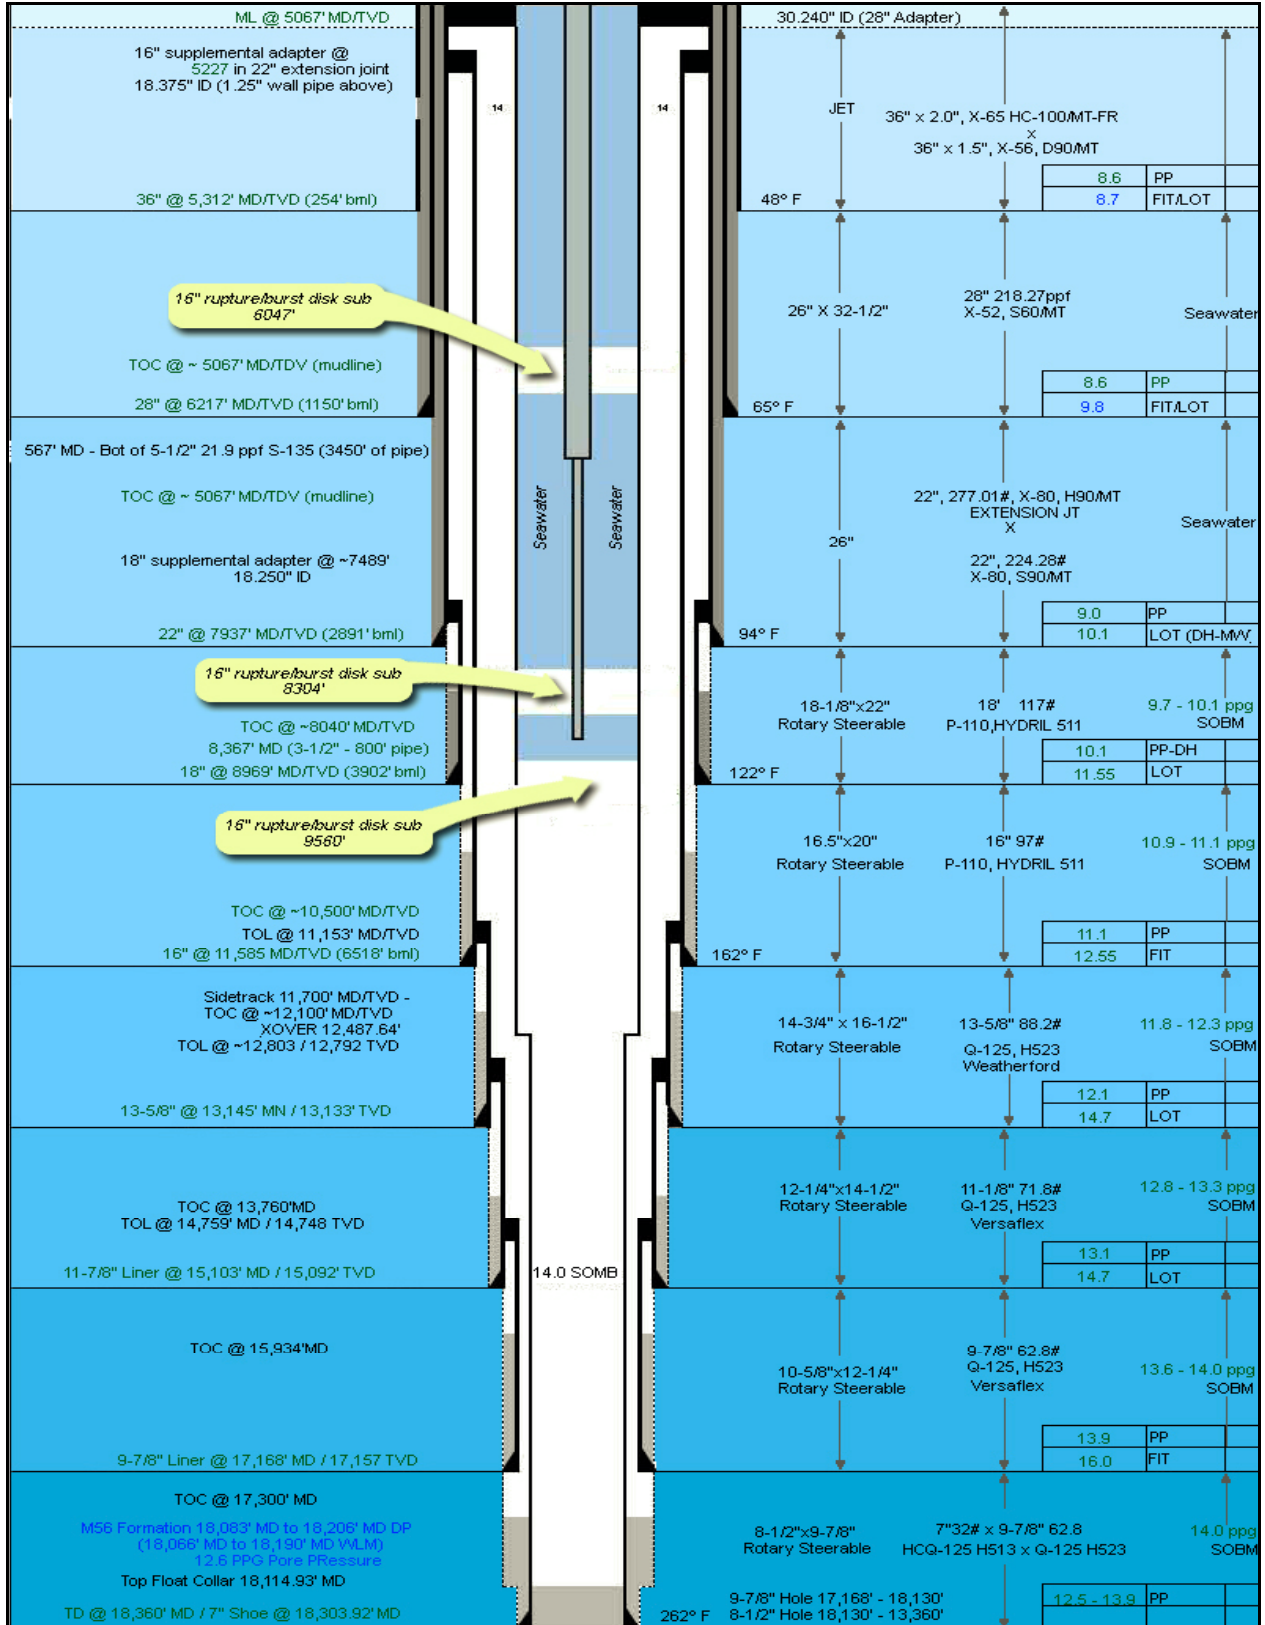
Figure 2.1 – Well schematic.

The well had been drilled to total measured depth 18,380 ft below the rig floor’s Kelly Bushing (KB),² which equated to 13,293 ft below the sea floor, a.k.a., mud-line (Figure 2.1).³ The well had penetrated a hydrocarbon production zone (pay zone) of about 124 ft in thickness.¹ A tapered string of production-type casing was run and cemented using nitrogen-foam cement slurry containing various additives⁴ with the bottom of the 7 in casing shoe sitting at 18,303 ft KB.^{1,5} The crossover from 7 in to 9⁷/₈ in production casing was at 12,487 ft KB.¹

BP determined that even though burst and collapse (rupture) disks had been placed earlier at strategic locations in the well, the best way to prevent annular pressure build-up was to leave an open annulus at the bottom of the last string of casing (Figure 2.1). While this design would not provide BP the specified 1,000 ft of cement above the uppermost hydrocarbon zone, it would allow placement of the top-of-cement 500 ft above the uppermost hydrocarbon zone, as per MMS regulations. BP's technical requirements specify if less than 1,000 ft of cement is used above a distinct permeable zone, then the top of the cement must be determined by a "proven cement evaluation technique" such as a cement evaluation log, and the plan must include 100 ft of centralized pipe above the permeable zone.

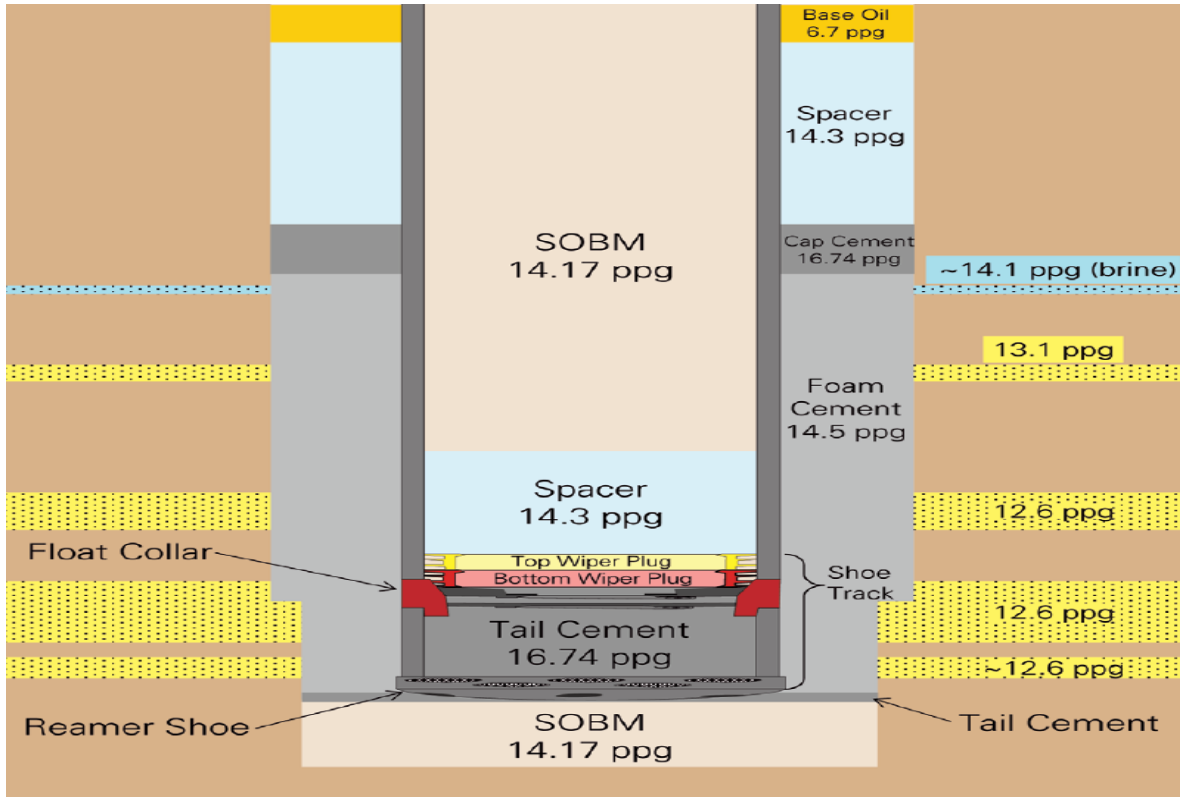
Figure 2.5 – Planned cement placement.²⁵

Figure 2.5 shows the planned cement and other well fluids placement under *ideal* conditions at the bottom of the well. Realization of this placement depends on the materials in the well at the bottom of the well after the long-string production casing was run, the performance of the double valve float collar, and the relatively weak formations under and around the float collar. Given the concerns for the weak formations in the bottom of the well, only partial circulation of the well fluids was performed after placement of the production string. This could have left cuttings in the bottom of the well—in and above the *rat hole* below the shoe track and reamer shoe. In addition, the relatively short distance between the bottom of the shoe track and the bottom of the rat hole combined with the lower density of the Synthetic Oil Based Mud (SOBM) relative to the density of the cement (16.7 ppg cap-and-tail cement and 14.5 ppg foamed cement) could have encouraged intermixing of the cement with the well materials and mud in the rat hole.

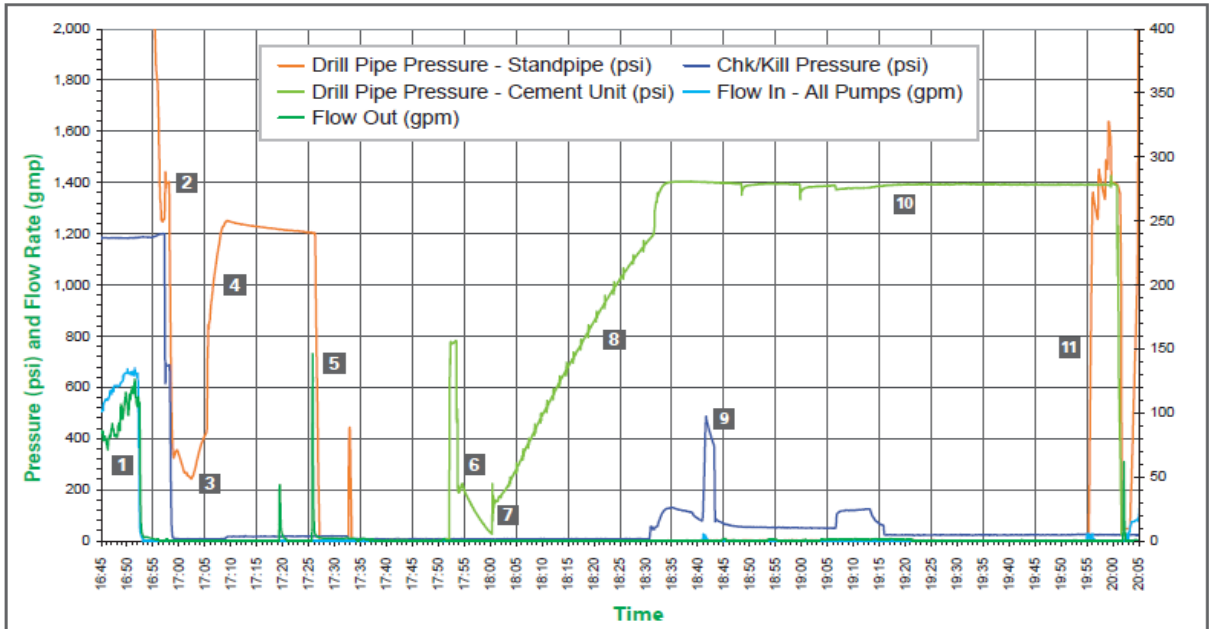
| <p>1 Spacer displacement complete; mud pumps stopped.</p> <p>2 Annular preventer closed; attempt to bleed drill pipe pressure to zero.</p> <p>3 Drill pipe pressure decreases to only 273 psi; annular preventer leaking.</p> <p>4 Drill pipe pressure increases as annular preventer leaks; hydraulic closing pressure increased to seal annulus.</p> <p>5 Drill pipe pressure bled to zero for negative-pressure test.</p> <p>6 Decision made to conduct negative-pressure test via kill line; kill line opened; 3 bbls to 15 bbls bled to cement unit.</p> | <p>7 Shut in kill line at cement unit, drill pipe pressure starts to increase.</p> <p>8 Drill pipe pressure slowly increases to 1,400 psi.</p> <p>9 Fluid pumped into kill line to confirm full; kill line opened to mini trip tank for monitoring.</p> <p>10 Discussion ongoing about 'annular compression' and 'bladder effect' while monitoring kill line; drill pipe pressure static at 1,400 psi.</p> <p>11 Negative-pressure test concluded, declared a success; preparation made to continue displacement.</p> |

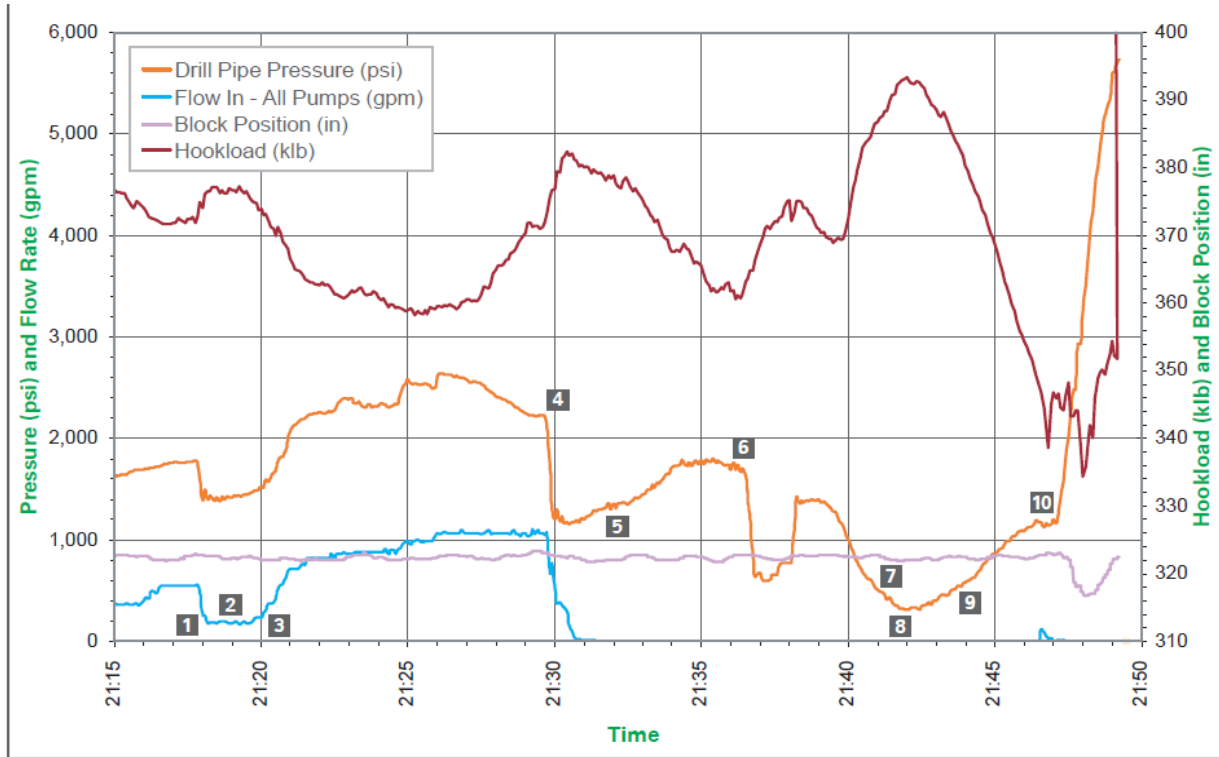
| <p>1 Pressure relief valve on pump #2 opens; toolpusher called to rig floor.</p> <p>2 All pumps shut down except boost pump.</p> <p>3 Assistant driller called to pump room.</p> <p>4 Pumps shut off.</p> <p>5 Toolpusher and driller discuss 'differential pressure.'</p> <p>6 Opening of 4" surface line to bleed pressure.</p> | <p>7 Mud/water flows onto rig floor and then unloads through the derrick.</p> <p>8 Diverter and annular preventer activated; diverted to mud gas separator.</p> <p>9 Well site leader and senior toolpusher receive calls from rig floor; annular preventer attempting to close.</p> <p>10 BOP sealing.</p> |

Figure 2.10 – Real-Time data (April 20, 2010) after mud pump shutdown.³⁸

Testimony indicates that about 9:47 p.m., the well site leader was notified that the well was being shut in, the senior toolpusher was notified of uncontrolled flow from the well, and that seawater and drill mud had started to flow out of the riser onto the rig floor. Note that the well site leader said his alarm clock showed 9:50 p.m. when he received the news, but his clock or the real time clock could easily have been different by a few minutes. The real time data,⁸ as partially duplicated in Figure 2.10 above, shows a sharp increase in drill pipe pressure starting at 9:47 p.m.

After about 9:40 p.m., the drill pipe pressure increased from about 340 psi and reached 1,200 psi about 9:47 p.m. (Figure 2.10). Testimony indicates that by about 9:47 p.m. seawater and mud were shooting up through the derrick, and shortly thereafter the diverter was closed and flow from the riser was routed to the mud gas separator (MGS) (Figure 2.11 and Figure 2.12).

Analysis of the available information indicates the BOP lower annular was closed at 9:50 p.m. and the pressure in the drill pipe began to increase. As the BOP annular pressure increased there was a very rapid increase in drill pipe pressure to approximately 5,700 psi at 9:49 p.m. (Figure 2.10). The increase in drill pipe pressure is thought to be due to pressurization and sealing of the lower annular.

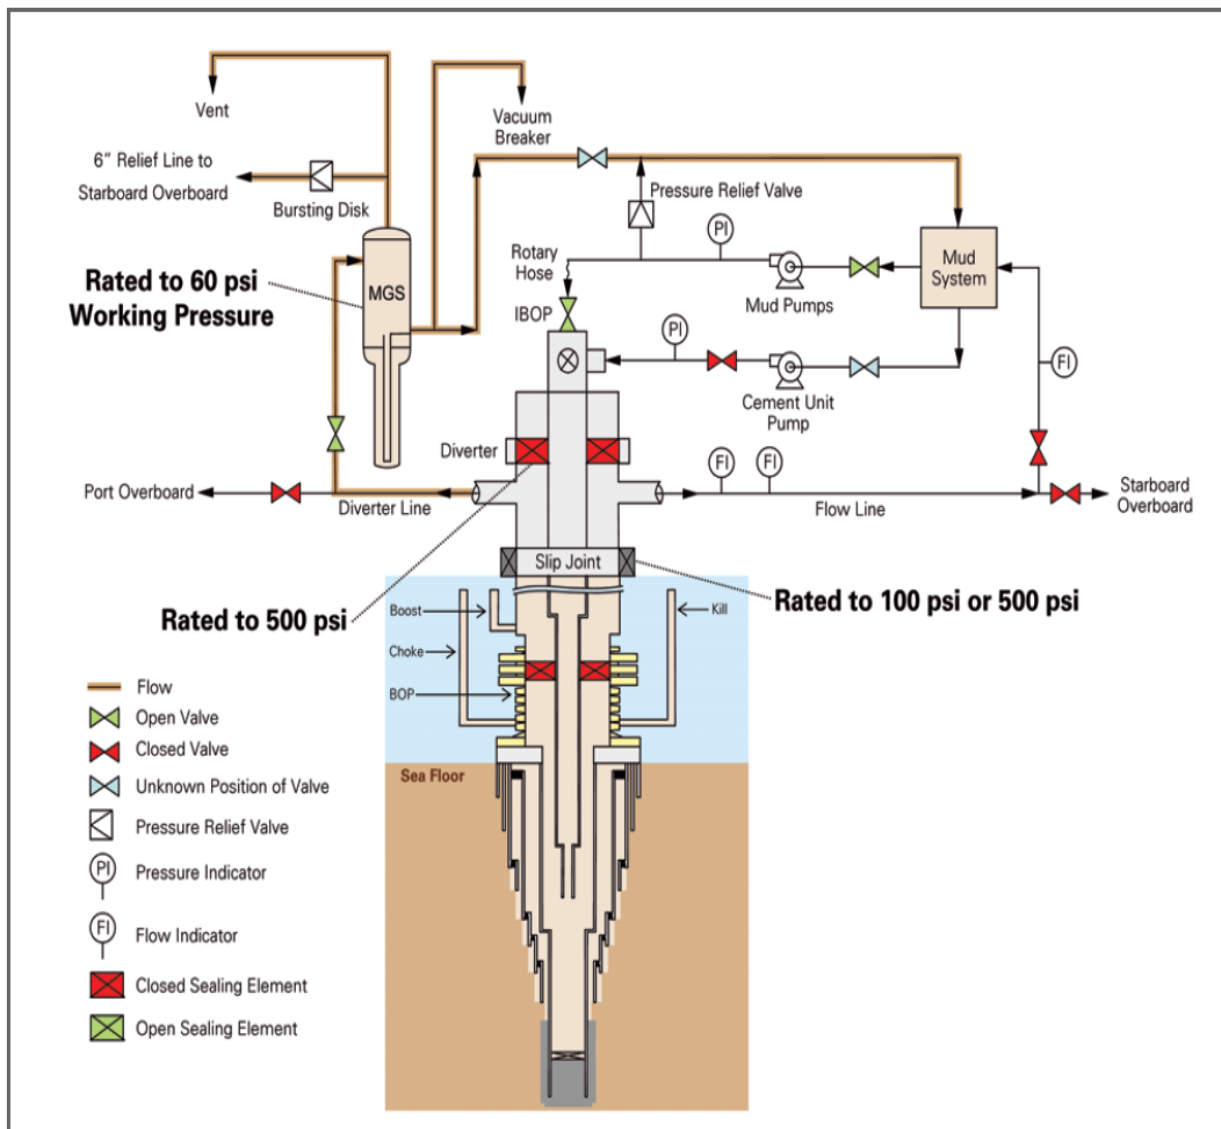
Figure 2.11 – Schematic of *Deepwater Horizon* surface equipment.³⁹

Subsequent hydrocarbon flow could have developed through the drill pipe inside the riser. There are a number of pieces of equipment that could have failed and allowed hydrocarbons to flow to the surface through the drill pipe (Figure 2.11) thereafter. Also, flow could have developed outside of the drill pipe (Figure 2.13). Following loss of power, the rig dynamic positioning system was inoperable. Rig drift-off following the loss of power could have caused the drill pipe to be pulled through the BOP destroying the annular seal and allowing resumption of flow up the riser. Analysis

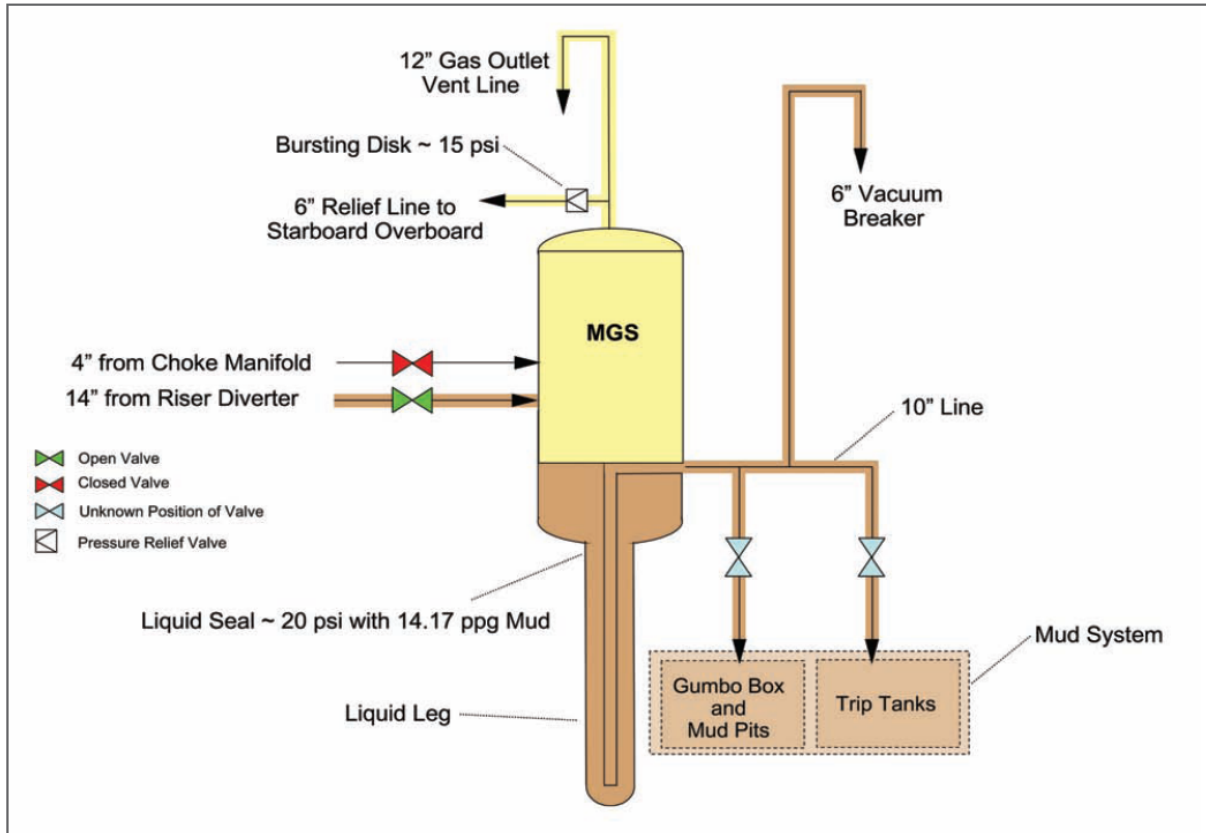
Figure 2.12 – Schematic of *Deepwater Horizon* Mud Gas Separator.⁴⁰

Returns blowing strongly from the riser were routed to the MGS unit rather than directly overboard through one of the 14 in diverter lines.⁴¹ As a consequence, MGS unit was quickly over-pressured and its capacity overwhelmed. That resulted in dispersion of gas and liquids over a large area of the vessel, including into electrically unclassified spaces where ignition sources may be present, i.e., spaces not classified as “explosion-proof” such as engine rooms. Although there is no record or testimony to prove it, it appears that the sealing packer on the riser slip joint leaked massively under the impetus of back pressure applied. First, there was active fire under the rig floor after the explosions according to testimony, and second, there was testimony of hearing a high pressure gas release from that direction preceding the first explosion.³²

Testimony indicates that about 9:45 p.m. water, mud, and gas exited the MGS vents—indicating failure of the low pressure, low capacity MGS unit. Once the MGS failed, high pressure flammable hydrocarbon gas and condensate vapor/mist (aerosol) was released to the rig decks. Gas-hissing noises were reported coming from different parts of the rig. The first gas alarm sounded about 9:47 p.m. accompanied by roaring noises and vibrations. About 9:50 p.m., the main power generation engines started over speeding followed by the loss of rig power and the first and second explosions. Testimony indicates the first explosion happened very close to the MGS—ignition caused by vapor ingestion in one or more of the power generation engines is deemed to be very likely based on the record and the historical database.⁴²

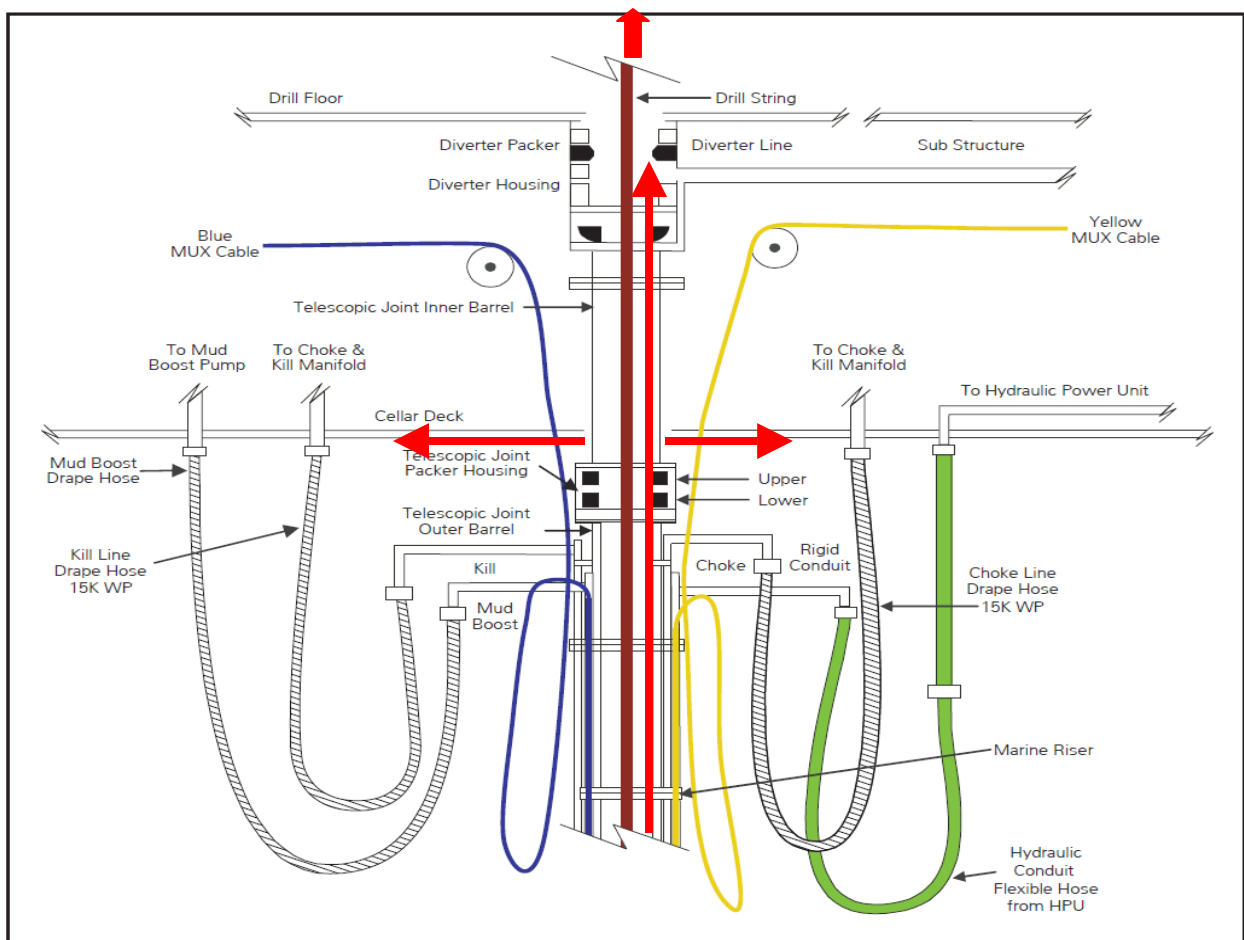
Figure 2.13 – Configuration of drilling riser, drill pipe, and other equipment in Moonpool area.⁴⁴
