Macondo Well
Deepwater Horizon
Blowout

LESSONS FOR IMPROVING
OFFSHORE DRILLING SAFETY

Committee on the Analysis of Causes of the
Deepwater Horizon Explosion, Fire, and Oil Spill to
Identify Measures to Prevent Similar Accidents in the Future

NATIONAL ACADEMY OF ENGINEERING AND
NATIONAL RESEARCH COUNCIL
OF THE NATIONAL ACADEMIES

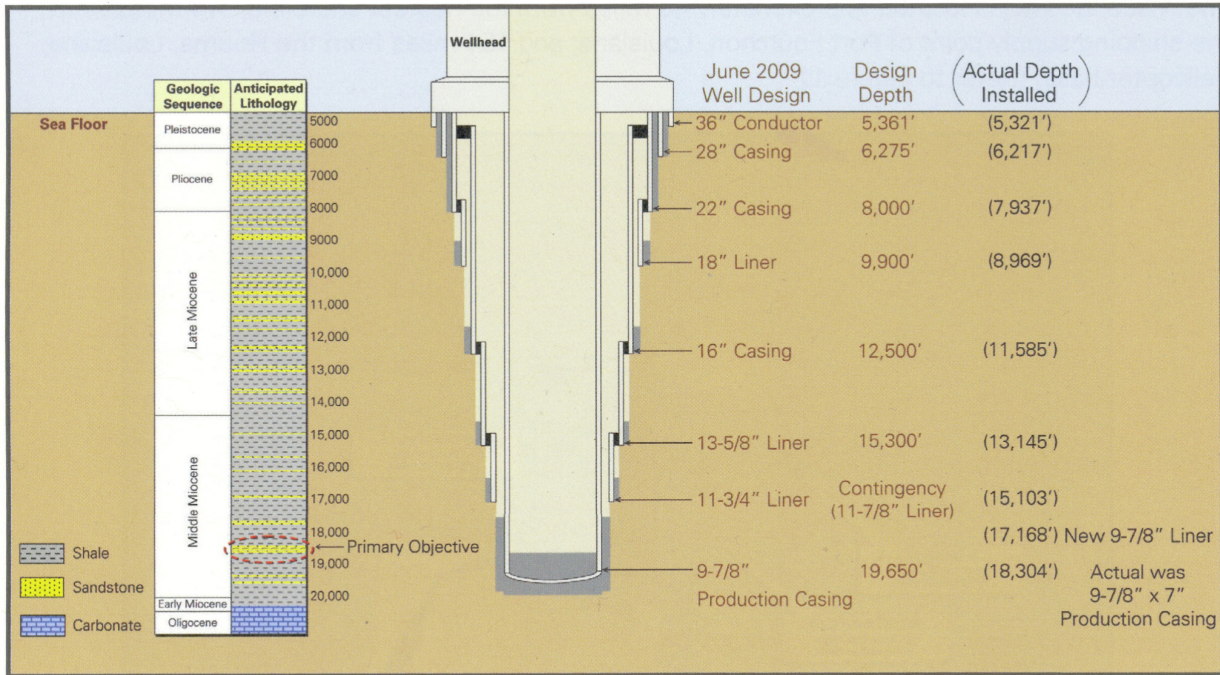
The original plan, shown in Figure 2-1, called for eight casing strings and liners (each consisting of steel casing segments that were screwed together), but the plan was modified to react to conditions that were encountered during drilling. Drilling ceased at 18,360 feet (a shallower depth than planned) and involved the use of a total of nine casing strings and liners, rather than the planned eight, including the final $9\frac{7}{8}$ - \times 7-inch tapered production casing (sometimes referred to as a “long string”) as shown in Figure 2-2. The well was to be temporarily plugged and abandoned after the production casing was set and then completed for production at a later date.

FIGURE 2-1 Original wellbore architecture planned for Macondo well. Source: BP 2010, p. 16. Reprinted with permission; copyright 2010, BP.

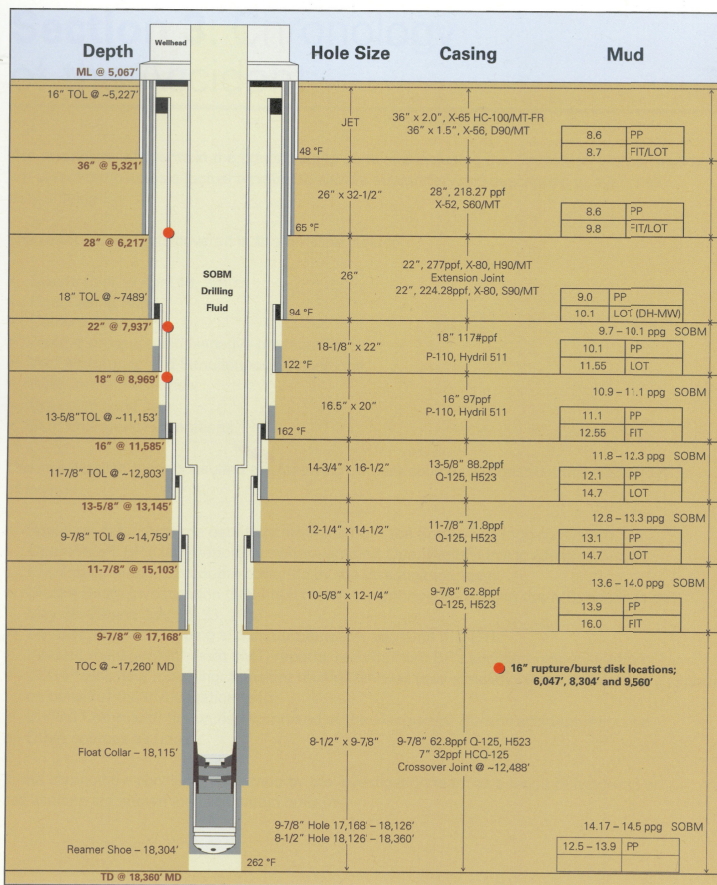
FIGURE 2-2 Final wellbore architecture for Macondo well. Source: BP 2010, p. 19. Reprinted with permission; copyright 2010, BP.

occurred. The shallowest possible escape point would have been 7,937 feet had a rupture disc and the top of the 18-inch liner failed (see Figure 2-2). This is about 2,937 feet below the ocean floor. Depending on the flow rate, pressure, and formation type, flow at this point might find a pathway to the ocean floor and cause a breach outside of the well. Therefore, a more robust design from a downhole blowout point of view would be to lower the possible point of escape from the wellbore to a deeper point where eventual breaching at the seafloor is impossible or at least very unlikely. This could be done by running a deeper casing string as a long string rather than as a liner and sealing it in the wellhead.

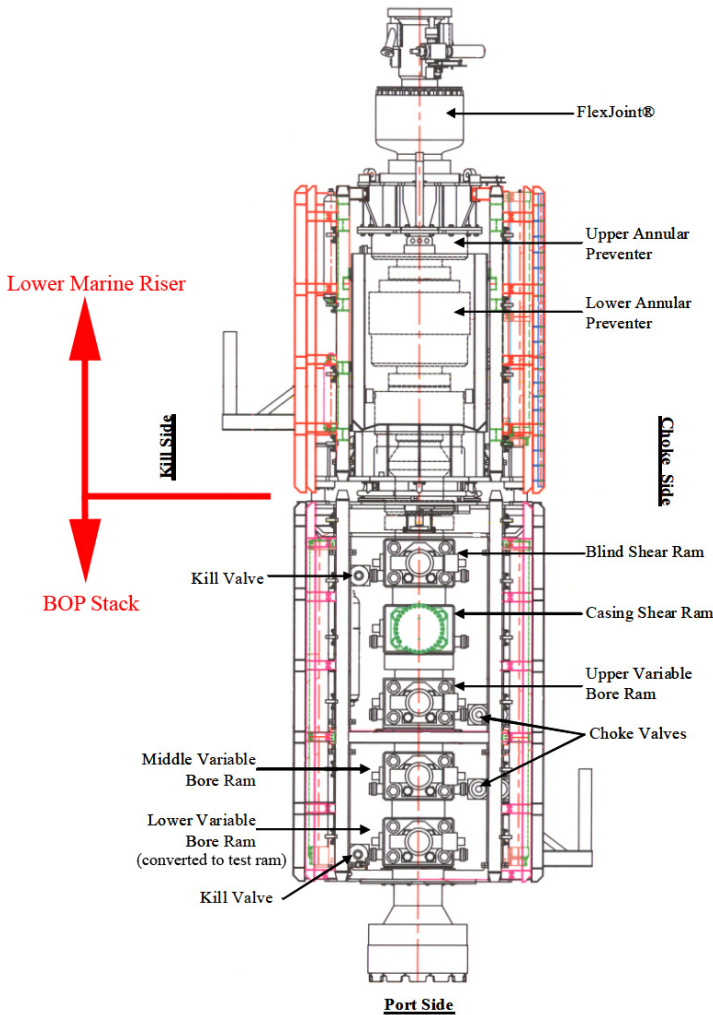
Deepwater Horizon BOP Port Side

FIGURE 3-1 Deepwater Horizon BOP port side. Source: DNV 2011a, I, p. 14. Reprinted with permission; copyright 2011, DNV.

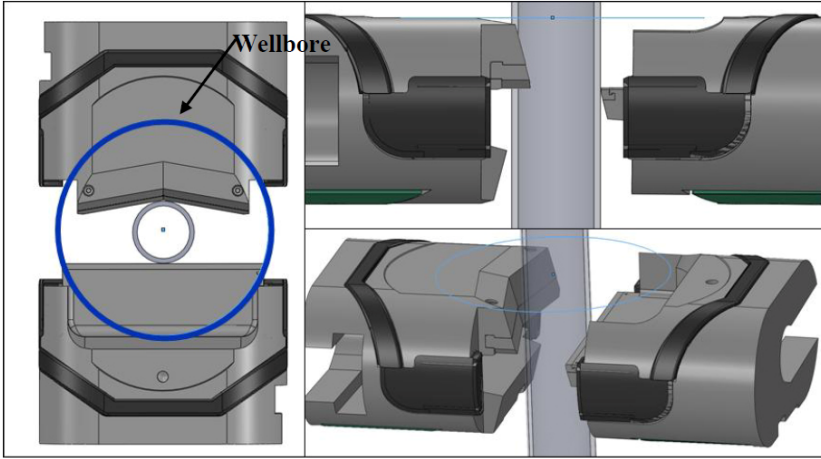
The BSR was the uppermost of the five rams of the BOP stack and is shown for nominal operation in Figure 3-2. A BSR is like a massive metal scissors with two opposing blades that are designed to slice through the drill pipe as the blades pass by each other, as shown in Figure 3-3, and seal the well. The design intent was that, when the two blades of the “scissors” passed by each other and fully penetrated into the “side packers” on the other side, the seal

FIGURE 3-2 Sketch of intended nominal operation of BSR in the Macondo well. Source: DNV 2011a, I, p. 155. Reprinted with permission; copyright 2011, DNV.

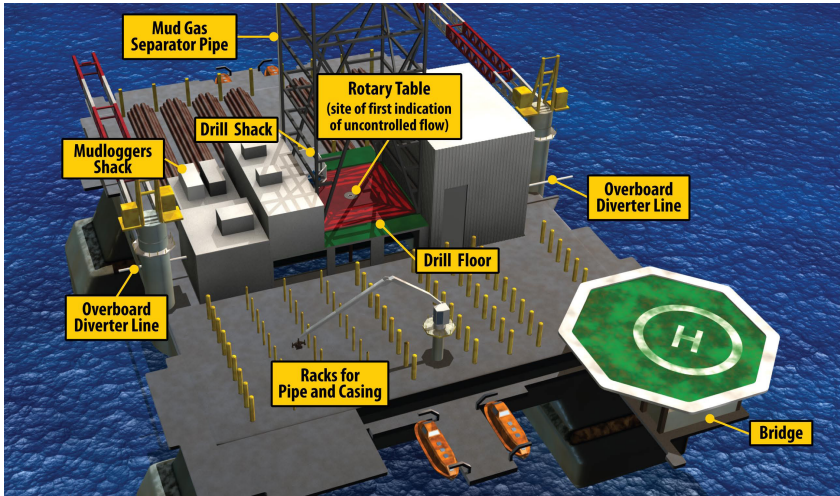
The only path, other than straight up through the derrick or through the MGS system vents, through which uncontrolled hydrocarbon flow could have been directed is through 14-inch diverter lines, which were positioned to send the flow overboard at about derrick floor level (see Figure 4-2). Testimony cited above indicates that this did not occur, and why there was no hydrocarbon flow along that path remains an unresolved question.¹⁰ According to BP's analysis, the overboard diverter flow of hydrocarbons might have delayed the formation of the explosive cloud that surrounded the rig (BP 2010, 128).

FIGURE 4-2 Illustration of the main deck of the *Deepwater Horizon*. The rig crew could send fluids from the well overboard through the overboard diverter lines. Alternatively, the crew could route flow from the well to an MGS pipe and vent hydrocarbon gas before sending the mud to the mud pits (not shown). Source: Chief Counsel 2011, p. 27.
