DEFECTS AND DETERIORATION IN BUILDINGS

2nd Edition Barry A. Richardson

Defects and Deterioration in Buildings
2nd edition

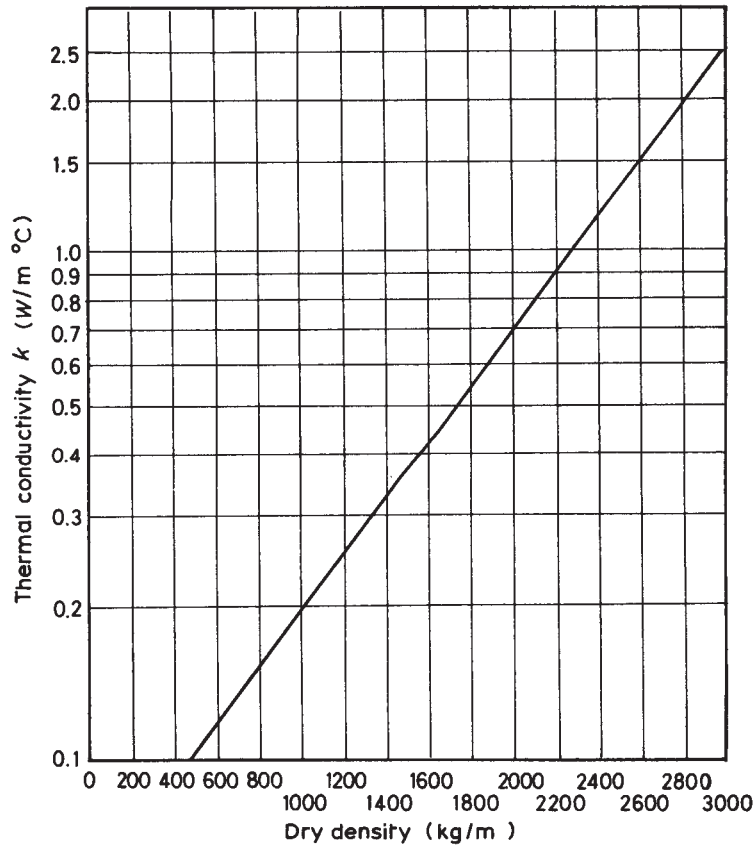
Fig. 3.1 Variation of thermal conductivity k with density. The graph shows the thermal conductivity for typical dry brickwork, masonry, concrete and plaster, but thermal conductivity increases with moisture content and a correction must be applied by multiplying by the appropriate factor.

<i>Material</i>	<i>Moisture content</i>	<i>Bulk density</i>	<i>Thermal conductivity</i>
Asbestos	Cement sheet	5	1600	0.4
	Insulation board	5	750	0.12
Asphalt	Roofing		1920	0.58
Brick	(See Fig. 3.1)			
	Common, dry	0	1760	0.81
	Conditioned at 17.8°C and 65% RH	6	1870	1.21
	Wet	16	2034	1.67
Building board	Asbestos insulator	2	720–900	0.11–0.21
	Fibre board		280–420	0.05–0.08
	Hardboard, medium		560	0.08
	Plasterboard, gypsum		1120	0.16
	Woodchip board		350–1360	0.07–0.21
	Woodwool slab	5	400–800	0.08–0.13
Carpeting	Wilton type			0.058
	Wool felt underlay		160	0.045
	Cellular rubber underlay		270	0.065
			400	0.10
Concrete	(see Fig. 3.1)			
	Gravel 1:2:4		2240–2480	1.4
	No fines, gravel 1:10		1840	0.94
	Clinker aggregate	4	1680	0.40
	Expanded clay aggregate	5	800–1280	0.29–0.48
	Pumice aggregate	4.6	770	0.19
	Vermiculite aggregate		400–880	0.11–0.26
	Cellular		320–1600	0.08–0.65
Cork	Granulated, raw	7	115	0.046
	Slab, raw	7	160	0.050

<i>Material</i>	<i>Moisture content</i>	<i>Bulk density</i>	<i>Thermal conductivity</i>
	Steel, high alloy		8000	15
	Zinc 99.9%		7130	113
Plaster	(see Fig. 3.1)			
	Gypsum		1120–1280	0.38–0.46
	Perlite aggregate		400–610	0.079–0.19
	Vermiculite aggregate		480–960	0.14–0.30
	Sand cement		1570	0.53
Plastics, cellular	Polystyrene, expanded board		15	0.037
	Polyurethane foam		30	0.026
	Polyvinyl chloride, rigid foam		25–80	0.035–0.041
	Urea formaldehyde foam		8–30	0.032–0.038
	PVC floor covering		0.40	2.5
Plastics, solid sheet	Acrylic resin		1440	0.20
	Nylon		1100	0.30
	Polycarbonate		1150	0.23
	Polyethylene, low density		920	0.35
	Polyethylene, high density		960	0.50
	Polypropylene		915	0.24
	Polystyrene		10.50	0.17
	PTFE		2200	0.24
	PVC rigid		1350	0.16
Roofing felt				
Stone	(see Fig. 3.1)			
	Granite		2650	2.9
	Limestone		2180	1.5
	Marble		2700	2.5
	Sandstone		2000	1.3
	Slate		2700	1.9
Tiles	Burnt clay		1900	0.85
	Concrete		2100	1.10

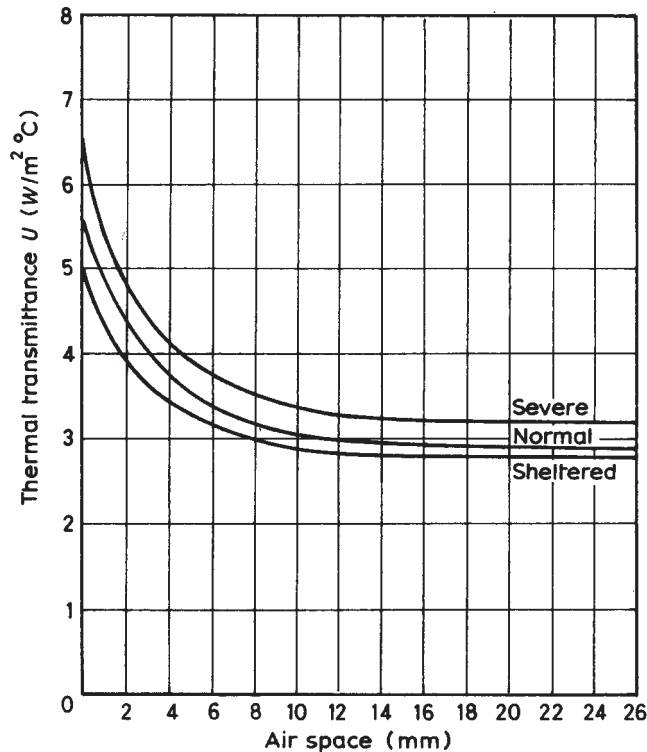
Fig. 3.2 Thermal transmittance U values for double glazing.

U value, which is 5.53 in this case for single glazing alone. In fact, windows are multi-component elements consisting of frames as well as glazing. The U value for the frame, which usually occupies 20 to 30% of the window area, depends upon its construction; the U value for a normal uninsulated aluminium or painted steel frame is about 5.5, the same as for the glass. Examples of U values for complete frames are given in Table 3.4. An interesting point is the relatively high U values for proprietary metal frames with factory-sealed double glazing with a relatively small air gap, but U values are greatly reduced, indicating improved thermal insulation, with wider air gaps and more efficient wood, uPVC or thermal break aluminium frames. The importance of a sufficient air gap is illustrated in Figure 3.2.

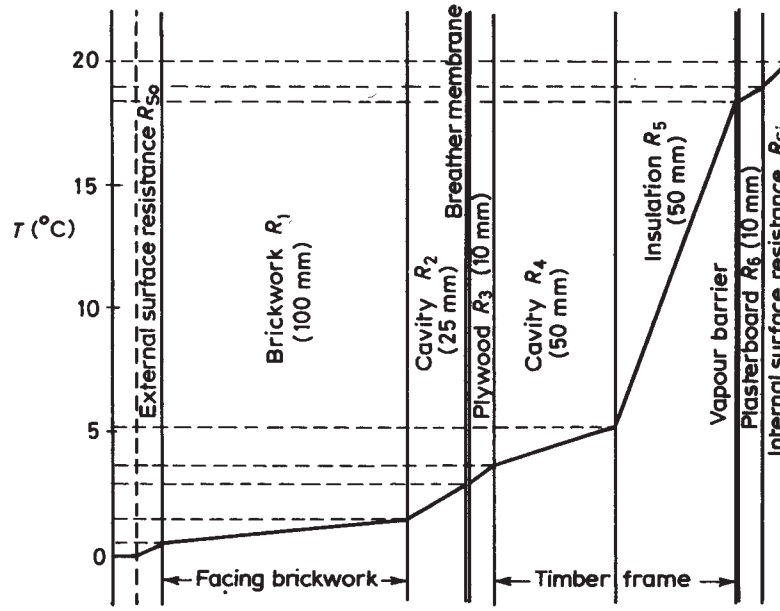
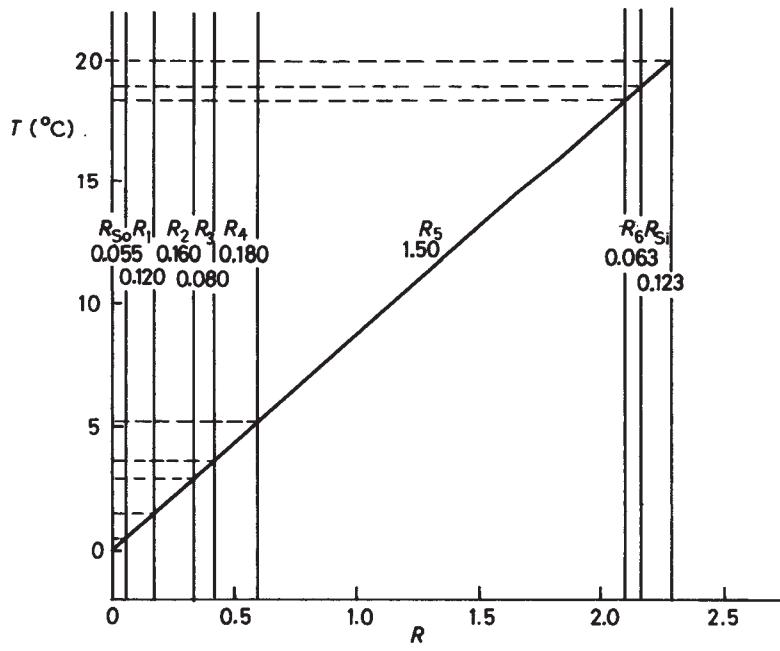
(a)

(b)

Fig. 3.3 (a) Section through brickwork-clad timber frame wall showing temperature gradients through each component, (b) Temperature plotted against thermal resistance to determine temperatures at component interfaces.

The exceptionally high thermal resistance of the glass fibre insulation quilt is very apparent from these calculations, but it is most apparent if the thermal resistances of the various layers of the wall are plotted graphically, as in Figure 3.3. The temperature gradient is in proportion to the thermal resistance so that the temperature loss across the building element can be plotted on this graph as a straight line, thus indicating the temperatures at the interfaces between various layers of the structural element. If these temperatures are then transferred to the interfaces on a diagram of a section through the wall and the points joined up to show the temperatures through the wall, the steep slopes indicate the best insulation which is, in this case, across the glass fibre insulation quilt. Diagrams of temperature drop across a building element are thus useful as an indication of the thermal significance of the various components, but they are also useful in assessing the dangers of interstitial condensation, as discussed in greater detail in section 4.7.

In this particular example, illustrated in Figure 3.3, in which the internal temperature is 20°C and the external temperature is 0°C, it is clear that if the internal air has a humidity equivalent to a dew point of 11°C, interstitial condensation will occur where the structure is at lower temperatures, that is from within the insulation to the exterior of the element. Precautions are therefore necessary to prevent this condensation from accumulating and causing fungal decay in the sheathing plywood and stud frames. The usual precautions are to provide an impermeable vapour barrier on the warm side of

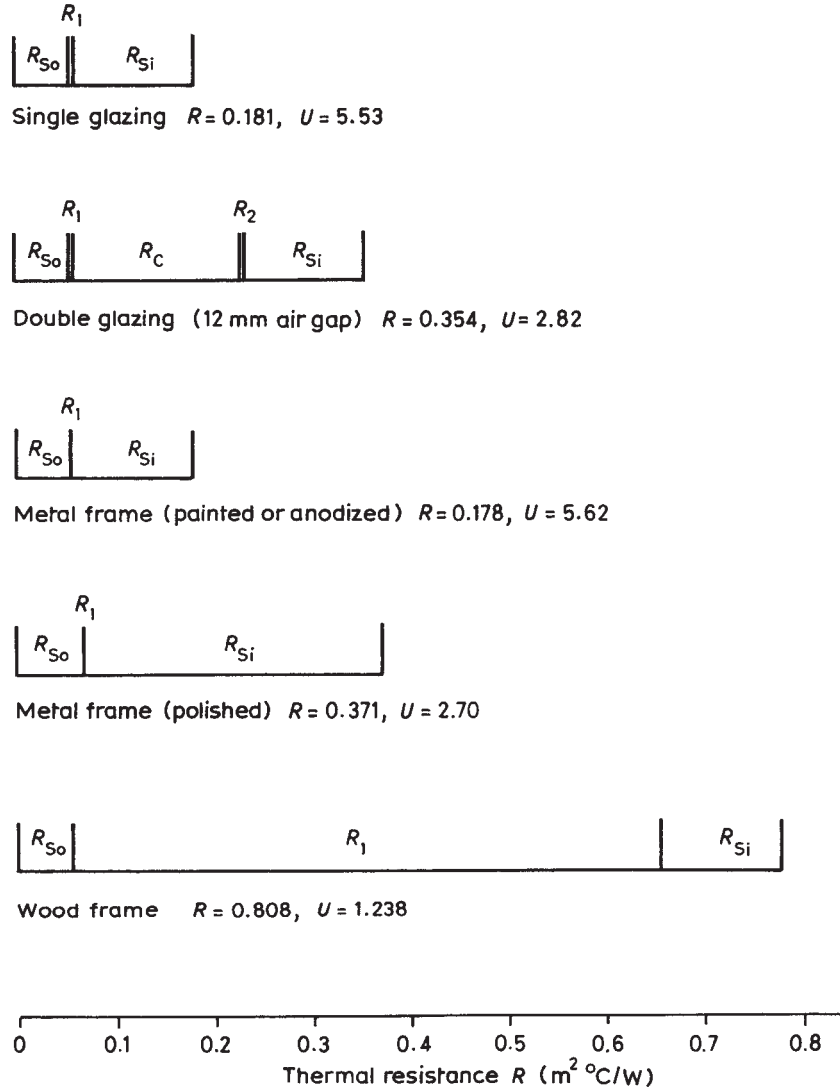
Fig. 3.4 Thermal resistance R for typical window-frame components.

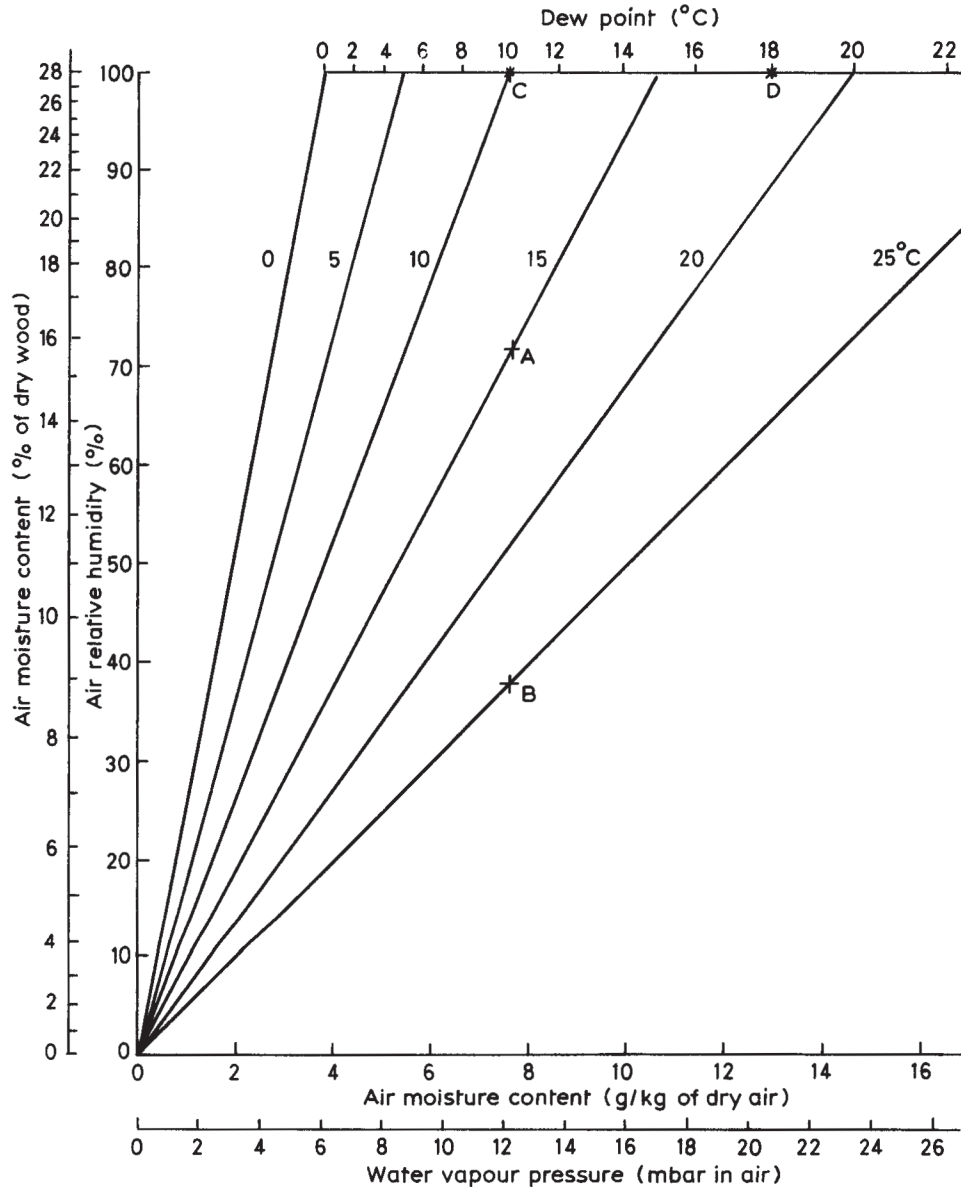
Fig. 4.1 Properties of air in relation to moisture content and temperature. This diagram enables the dew point of air to be determined by measuring the temperature and relative humidity. The average relative humidity is indicated best by the moisture content (MC) of wood in contact with the air, and wood moisture content can be used with an estimate of average air temperature to give a more accurate assessment of dew point and condensation risk. The following estimates can be used to assess risks:

The properties of air in relation to moisture content are illustrated in the psychrometric diagram Figure 4.1. The 'dampness' of air is indicated by its relative humidity, that is the humidity or moisture content of the air as a percentage of the moisture content of saturated air at the same temperature. The water absorbing capacity of air increases with temperature, so that if air at constant moisture content is heated, it will appear to become drier because the relative humidity is reduced. For example, air with a moisture content of 7.5g/kg will have a relative humidity of about 70% at 15°C (point A), but if it is heated to 25°C the relative humidity is reduced to about 37.5% (point B), indicating that it 'feels' drier although the moisture content is actually unchanged. Conversely, if the same sample of air is cooled to about 10°C, its relative humidity will increase to about 100% or saturation (point C); any further cooling will result in condensation, and the temperature at which the air reaches saturation is therefore known as the dew point. An increase in moisture content will also increase the dew point, so that if the moisture content of the same air sample is increased to 13g/kg, the dew point is increased to about 18°C (point D). Vapour pressure is directly proportional to moisture content and does not vary significantly with temperature; the significance of vapour pressure will be discussed later in relation to interstitial condensation in section 4.7.

Air moisture content, vapour pressure and dew point cannot be measured conveniently on site, but they can be easily determined from temperature and relative humidity measurements using Figure 4.1. For example, if the air in a building has a relative humidity of about 70% at a temperature of 15°C (point A), it can be seen that it has a moisture content of about 7.5g/kg with a vapour pressure of about 12mbar and a dew point of about 10°C. Dew point is usually the most important factor, at least in winter conditions, and this information indicates that, if the air

Wood moisture contents are in equilibrium with atmospheric relative humidity, as explained previously. A wood moisture content of about 28% is equivalent to air saturation or a relative humidity of 100%, as shown in Figure 4.1. Higher wood moisture contents are evidence of absorption of liquid water and a clear indication of excessive dampness. Generally high moisture contents develop in this way in wood components affected by roof or plumbing leaks, or by penetrating or rising dampness,

Air and moisture content relationships are discussed in detail in section 4.2 and presented in the psychometric diagram Figure 4.1. The risk of condensation depends simply on the moisture content of air and the temperatures that it will encounter; condensation occurs when air encounters temperatures below its dew point, and the dew point depends only on the moisture content of the air. The determination of the dew point for accommodation air is described in section 4.2, in which it is recommended that the ambient relative humidity of the accommodation air should be determined by measuring the moisture content of painted wood components isolated from any obvious source of penetrating, rising or condensing dampness, such as an architrave over an opening in an internal partition wall. The wood moisture content or ambient relative humidity determined in this way enables the dew point to be determined through an estimate of the average temperature of the accommodation air; it is suggested that 15°C is appropriate for living rooms in winter and 17°C in summer, with 12.5°C in winter and 15°C in summer for bedrooms. Dew points determined in this way must then be related to the temperatures that may be encountered. The most common form of condensation is dew on the cold internal surfaces of glazing, window frames or even walls, but Figure 4.3 enables the internal surface temperatures to be deduced from the thermal resistance R or thermal transmittance U values for a structural component in conjunction with internal and external temperatures.

It can be seen from Figure 4.1 in Chapter 4 that, at a night temperature of 5°C, air has a maximum moisture content of 5.4g/kg (100% relative humidity), but at 20°C in a building this represents a relative humidity of only about 37%, rather lower than the normal comfort level of 45–60%. However, many large buildings have mechanical ventilation which is excessive; a fresh air ventilation rate of 11/s per person is sufficient to ensure adequate oxygen supply and carbon dioxide clearance, but a

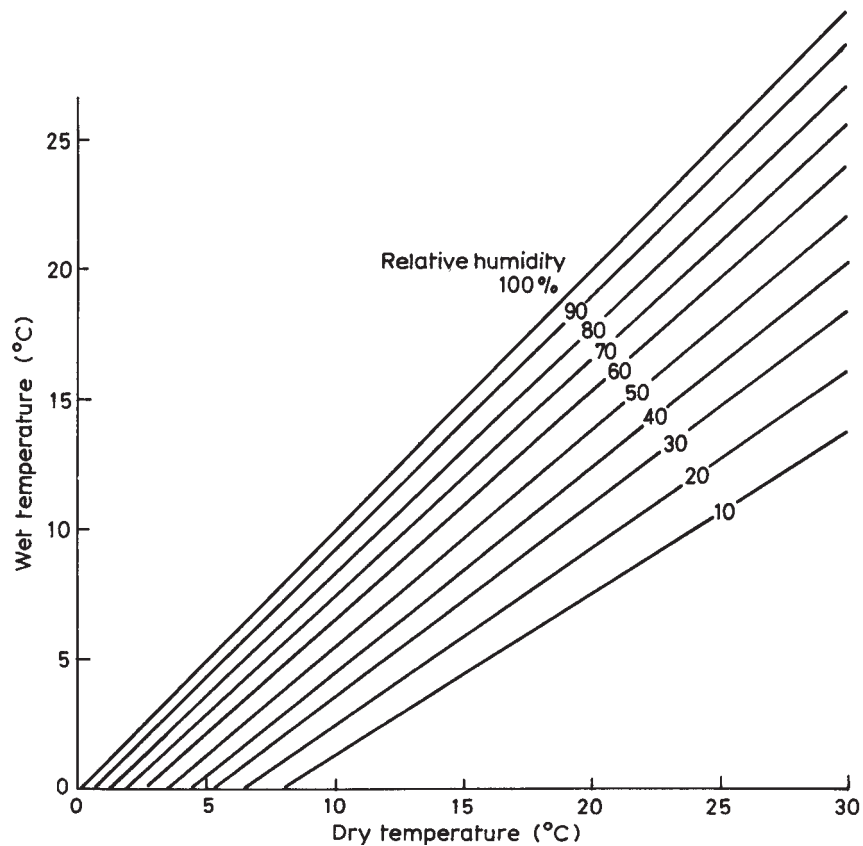
Fig. 4.2 Determination of relative humidity of air using wet and dry temperatures.

Various instruments can be used to determine the temperature and relative humidity of air with varying degrees of accuracy. Hygrometers measure relative humidity directly, usually using the change in length of hair or a strip of paper, but generally the best technique is to use the 'wet' and 'dry' temperature method. This involves using a thermometer or other temperature measuring instrument in the normal way to determine the 'dry' air temperature and then fitting a porous material wetted with distilled or de-ionised water to the thermometer bulb or sensing element to determine the 'wet' temperature. Water evaporation from the wet material causes cooling, so that the 'wet' temperature is lower than the 'dry' temperature, except when the air is already saturated or the relative humidity is 100%; the 'dry' and 'wet' temperatures are then the same. The 'dry' and 'wet' temperatures can therefore be used, in conjunction with Figure 4.2, to determine the relative humidity. The main advantage of this method is that the same temperature measuring system is used to determine both temperatures so that any errors in the measurement virtually cancel out in normal relative humidity measurements; in conventional 'wet-and-dry bulb' thermometer instruments the two thermometers can be compared with a 'dry' air measurement and a temperature correction applied if one is reading higher or lower than the other. The method can be very accurate if there is a reasonable flow of air around the sensing element.

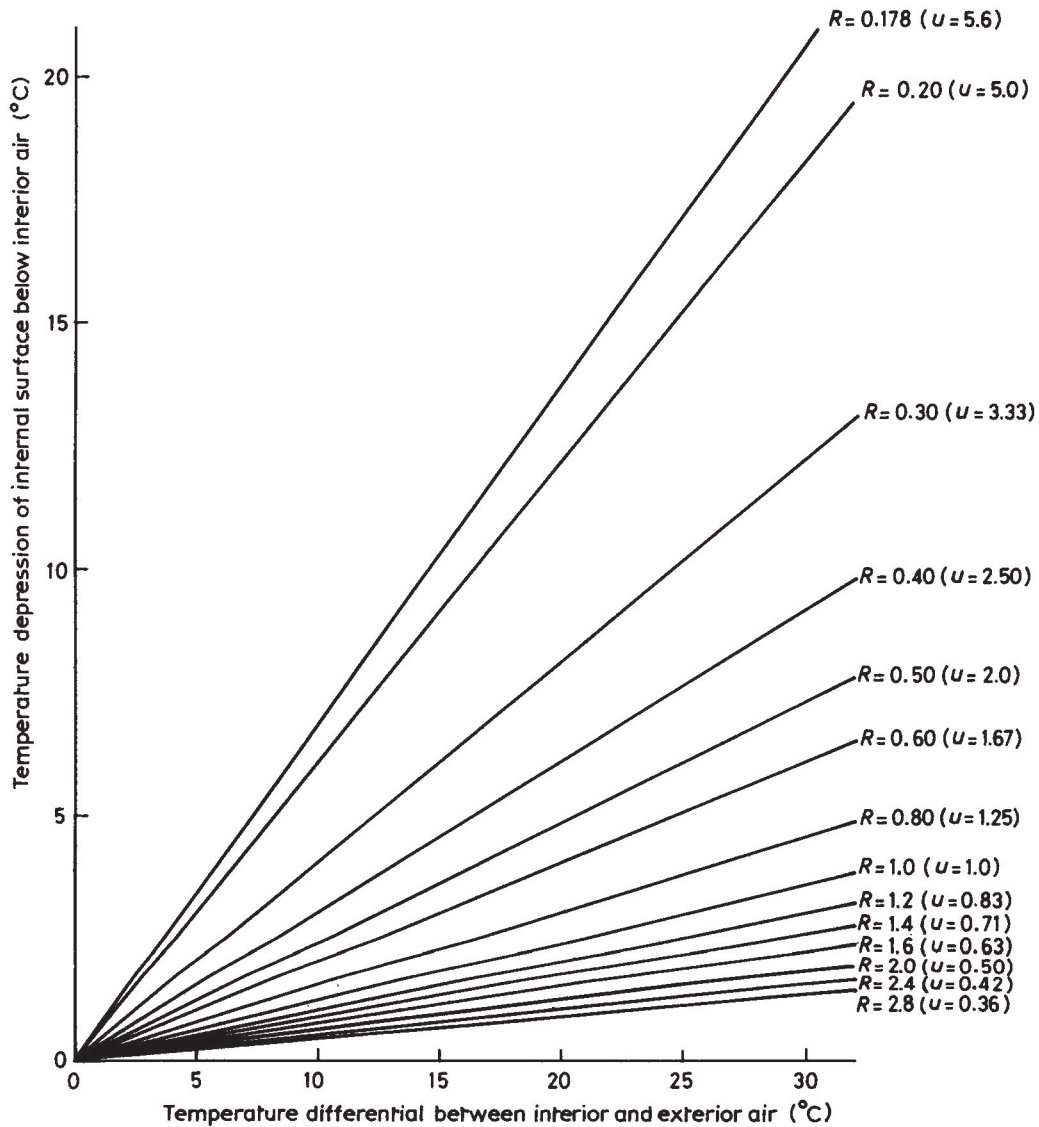
Fig. 4.3 Internal surface temperatures in relation to temperature differences between interior and exterior air. This diagram can be used to estimate internal surface temperatures for various interior and exterior air temperatures. Alternatively temperature measurements can be used to determine the R (for U) value of an external wall, door or window component. It is assumed that the internal surface has high emissivity (it is not polished or reflective) with a surface resistance of 0.123, and the external surface resistance is 0.055 (high emissivity, normal exposure). $R=0.178$ ($U=5.6$) therefore represents minimum thermal resistance, appropriate to single glazing and painted or anodised metal window frames.

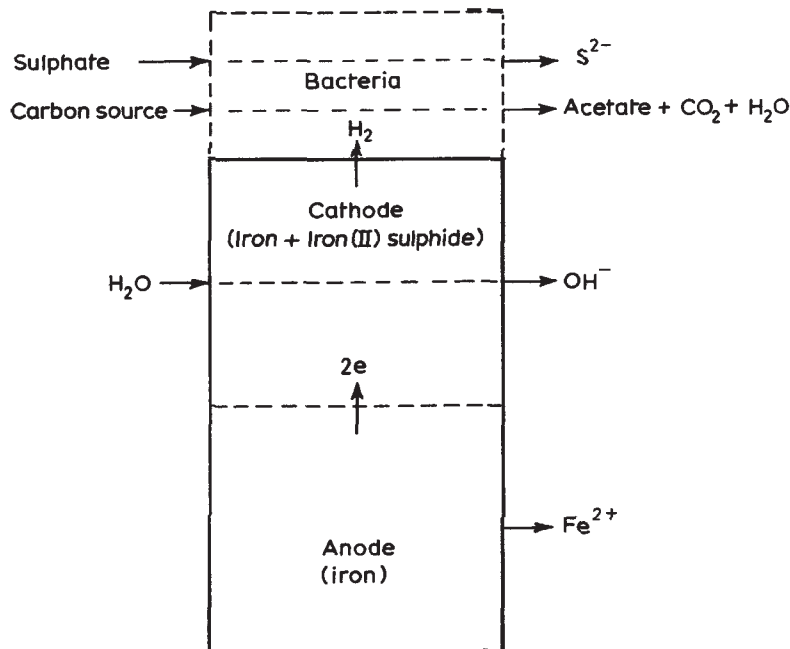
Fig. 4.4 Diagrammatic representation of the anaerobic corrosion of iron.

The ratio of ferrous sulphide to hydroxide is a useful diagnostic feature which can be used to confirm the involvement of sulphate-reducing bacteria in corrosion. The process is illustrated diagrammatically in Figure 4.4.

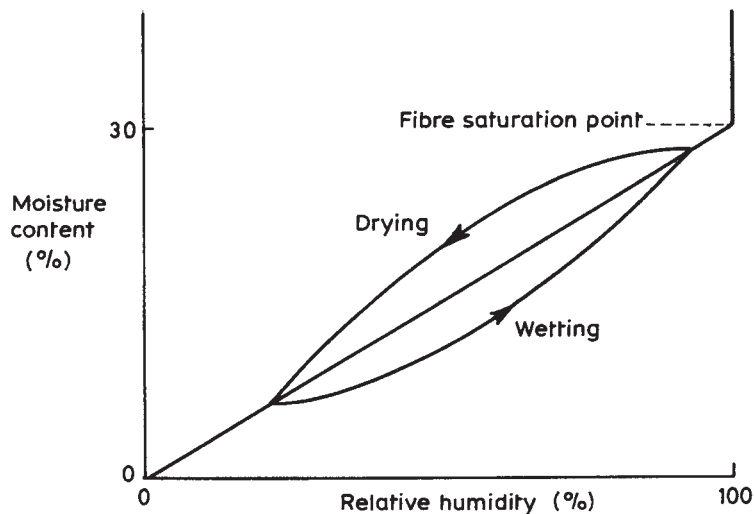
Fig. 6.1 Variation in the moisture content of wood with changes in atmospheric relative humidity.

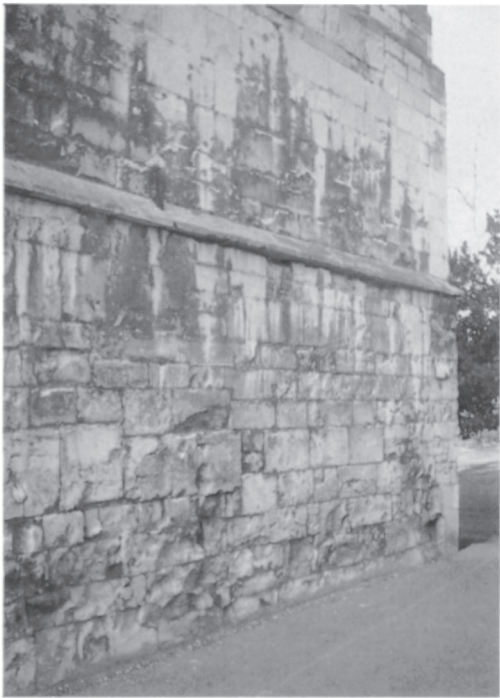
Plate 1. Frost damage affecting stone masonry at Lincoln Cathedral. The stone was normally durable but suffered frost damage where it was affected by rising dampness and therefore had a high moisture content in freezing conditions.

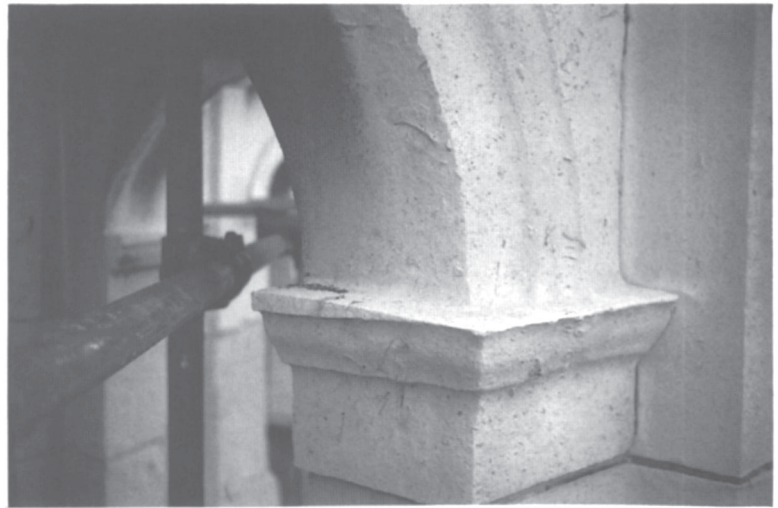
Plate 2. Stone erosion at St Paul's Cathedral, London. The Portland limestone was protected within the arch, but horizontal surfaces were slowly eroded where they were exposed to rainfall containing dissolved pollutant gases.

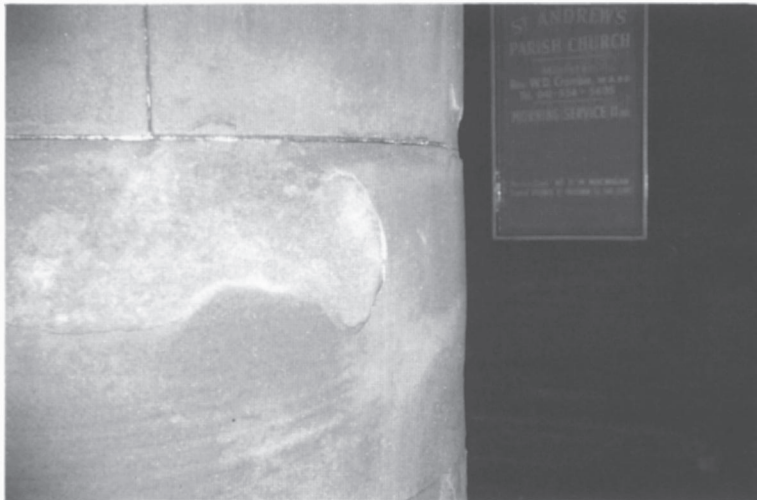
Plate 3. Stone erosion at St Andrew's Church, Glasgow. The carbonaceous sandstone columns absorbed acid rainwater which dissolved the carbonate binder and deposited calcium sulphate within the surface, stresses in the outer surface than causing it to separate from the weakened stone beneath.

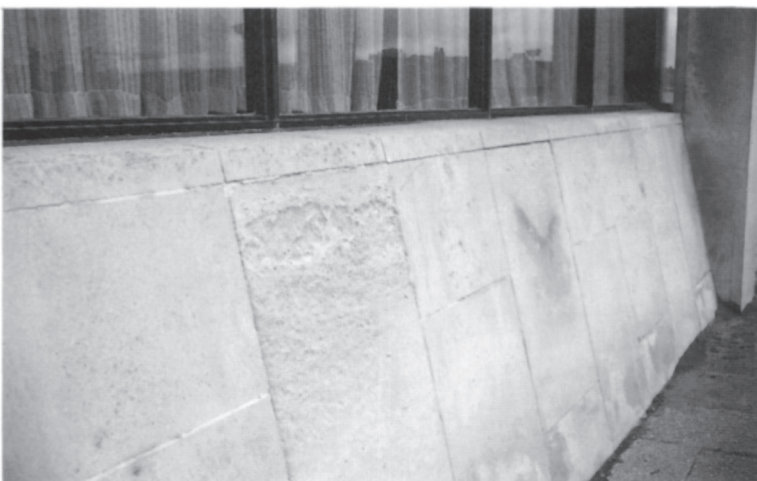
Plate 4. Portland limestone erosion in Blackpool. Erosion of isolated cladding panels was due to pore size variation; the durable panels were predominantly macroporous but the eroded panels were microporous.

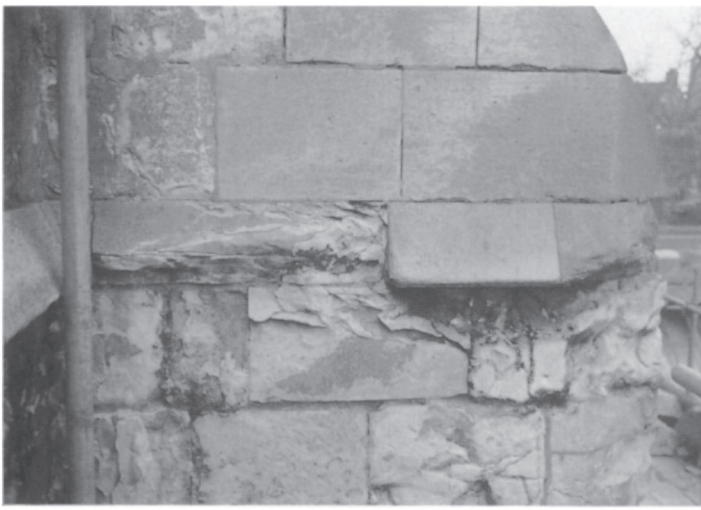
Plate 5. Stone incompatibility at Lincoln Cathedral. The stone repair was very durable but also very porous, allowing rainwater to accumulate on the original stone beneath and cause frost spalling during freezing conditions. Similar fracture and erosion damage can be caused by absorption of limestone washings by a sandstone, or even magnesian limestone washings by a calcareous limestone.

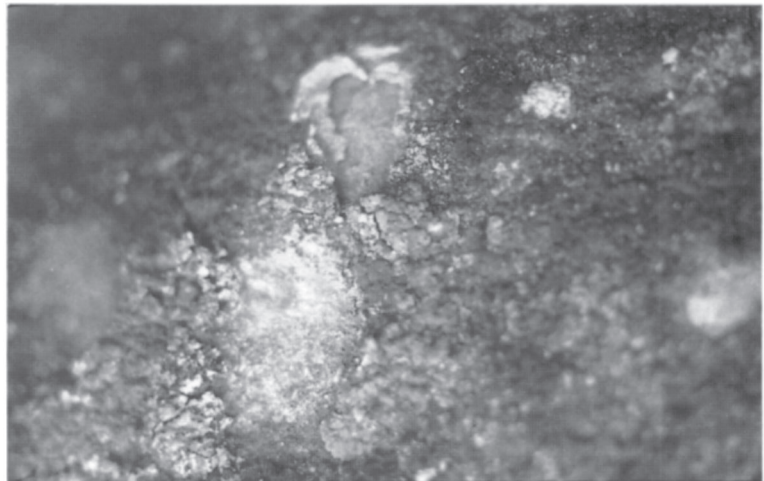
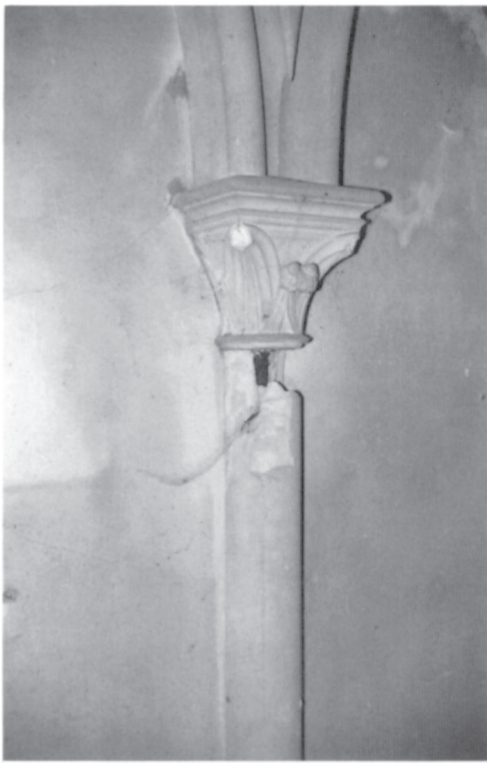
Plate 9. Metal corrosion damage to stone and concrete. Corrosion of ferrous dowels and cramps in masonry and steel reinforcement in concrete causes expansion and spalling damage.

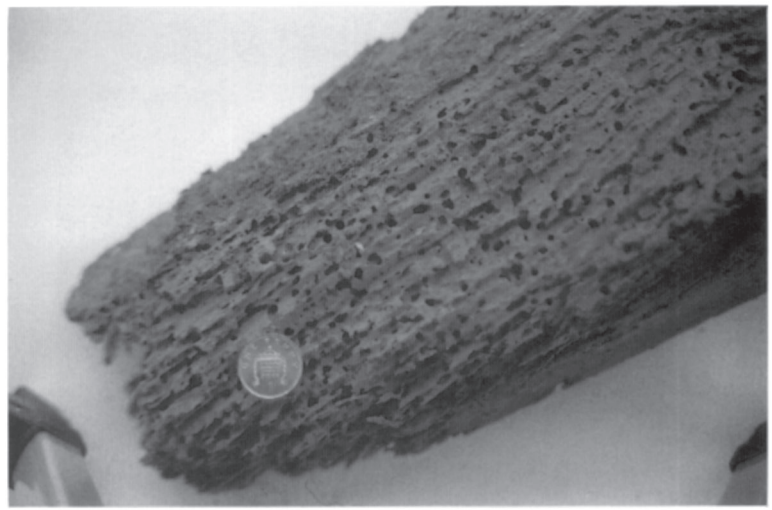
Plate 10. Death Watch beetle damage. Death Watch beetle normally attacks only damp and slightly decayed hardwoods and it is therefore particularly associated with old buildings; a variety has developed in the Channel Islands which also attacks damp softwoods in modern buildings.

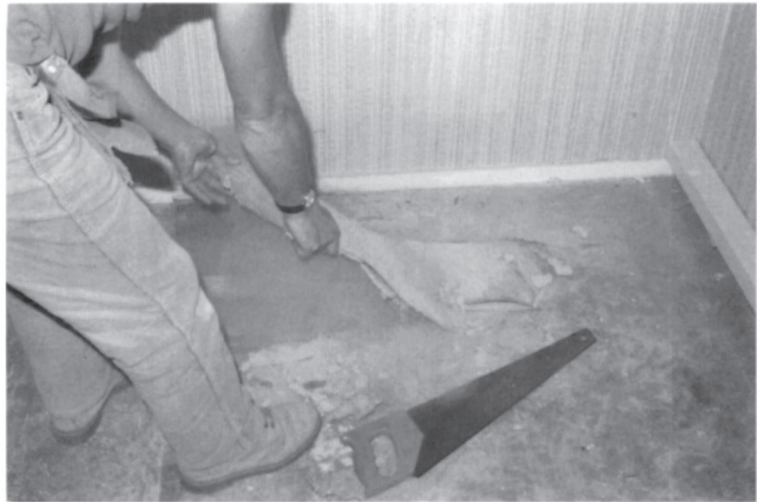
Plate 11. Powder Post beetle damage to a plywood floor. Powder Post *Lyctus* beetle attacks only fresh sapwood of certain hardwoods but it can cause complete destruction.

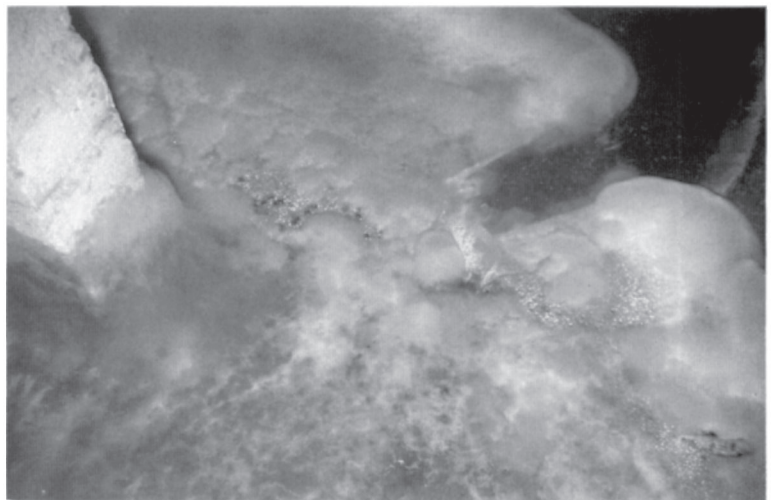
Plate 13. The Dry rot fungus. The Latin name *Serpula lacrymans* or weeping fungus refers to the 'tears' of water that develop on active growth, maintaining the humidity of the atmosphere.

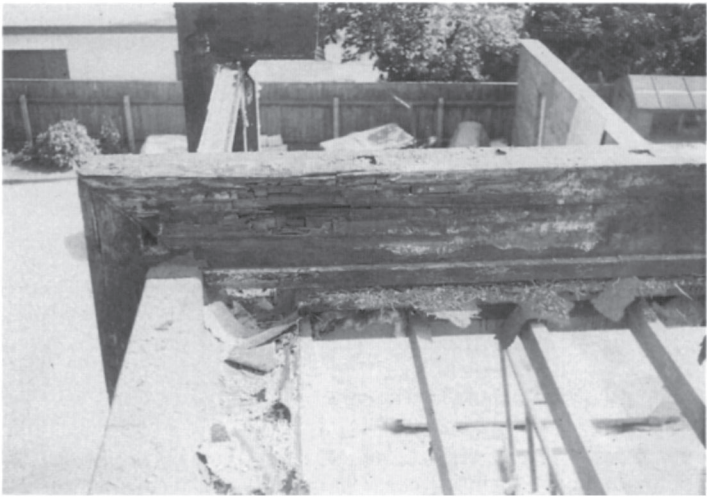
Plate 14. Fungal decay in modern buildings. This external structural frame first suffered Wet rot damage and it was covered with felt to prevent rain penetration, but Dry rot, stimulated by acidity from the original Wet rot attack, developed as the moisture content slowly decreased.

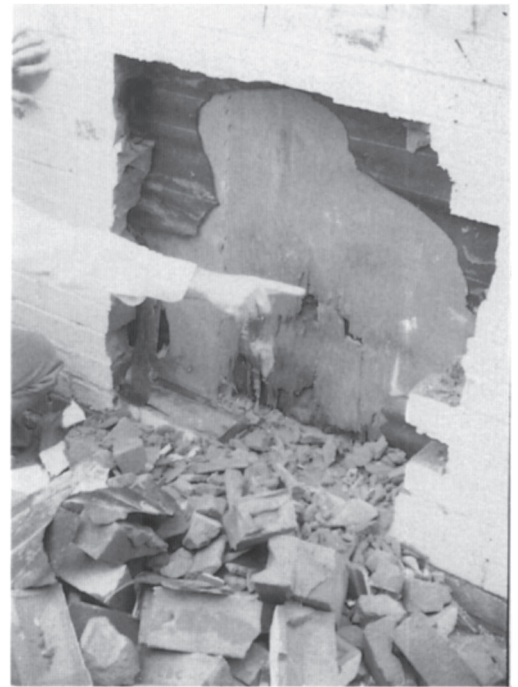
Plate 15. Fungal decay in modern buildings. Decay caused by interstitial condensation in the sheathing plywood on a timber frame house; condensation accumulated because the inner vapour barrier was damaged and the cavity between the sheathing plywood and the external brickwork cladding was unventilated. Decay due to condensation can also develop in floors laid on battens on concrete slabs if the floor space is not ventilated to the exterior; condensation is encouraged if the space is ventilated to the interior.

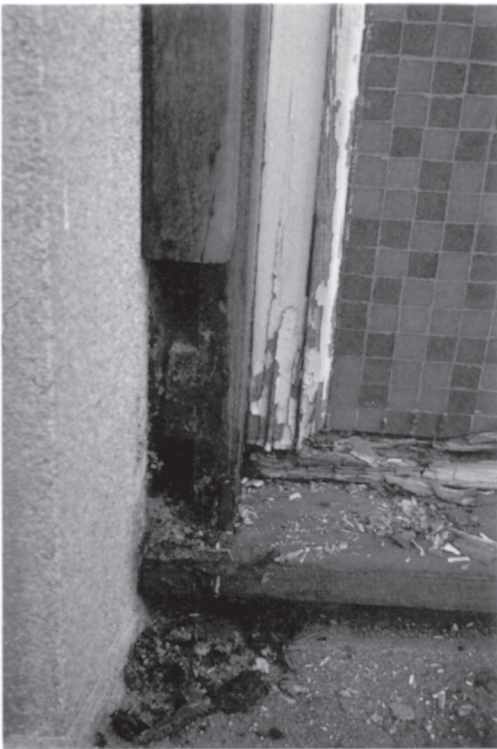
Plate 16. Fungal decay in joinery (millwork). Water absorption through end-grain surfaces can cause decay in untreated wood joinery, decay in susceptible wood often spreading to resistant wood.

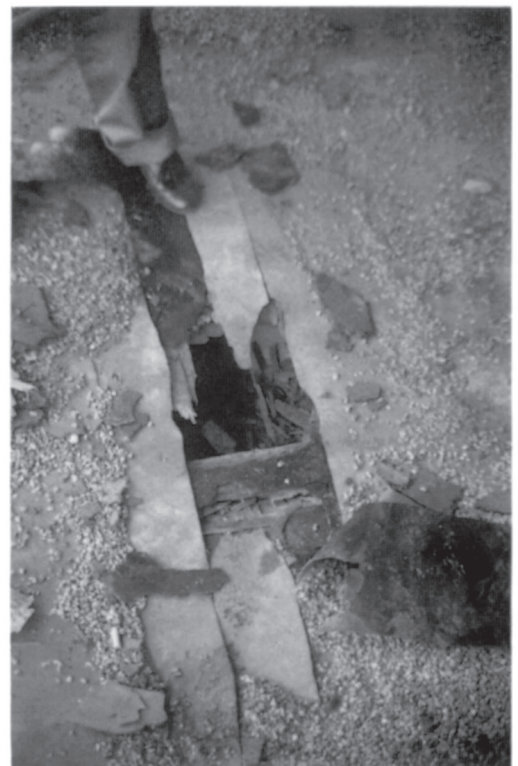
Plate 17. Fungal decay in flat roofs. Interstitial condensation in roof decking often causes fungal decay damage; condensation can be avoided by ventilating the space between the decking and the ceiling insulation in order to disperse moisture diffusing from the accommodation.

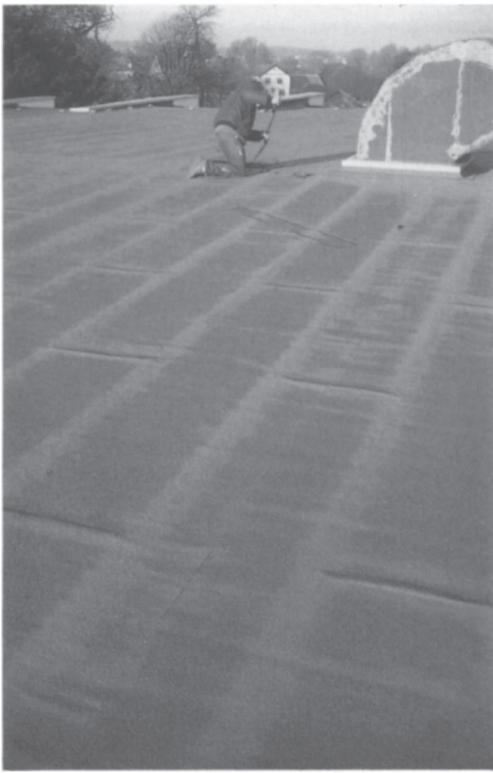
Plate 18. Heat loss through a flat roof. On this felted roof photographed after rainfall the light lines have been dried by heat loss through the metal framework supporting the cement-bonded wood wool insulating slabs.

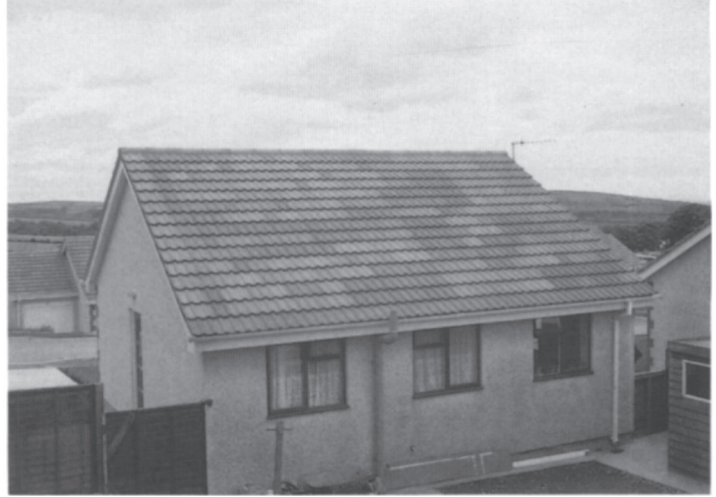
Plate 19. Concrete texture. The colour variation in these concrete tiles was caused by poor control of water content during manufacture, the lighter colour being due to excessive water and cement laitance on the surface.

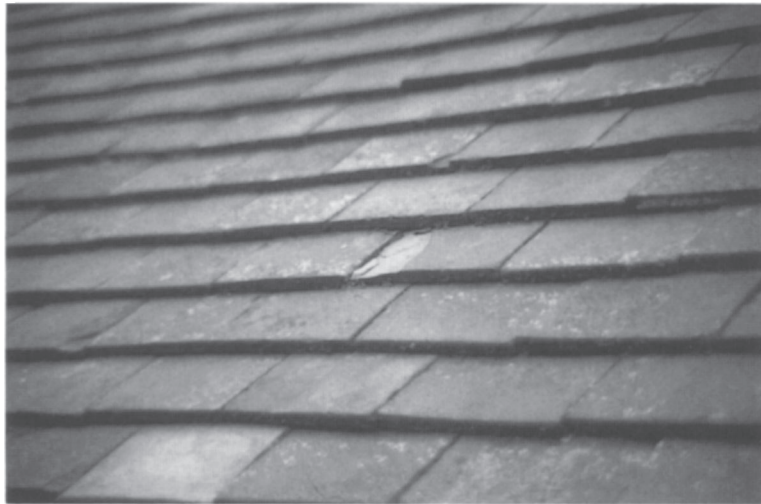
Plate 20. Frost spalling in clay roof tiles. Frost spalling is caused by prolonged retention of water by microporous tiles which are more likely to be saturated in freezing conditions. Microporosity is often associated with light coloured underfired tiles; similar failures occur in clay bricks.

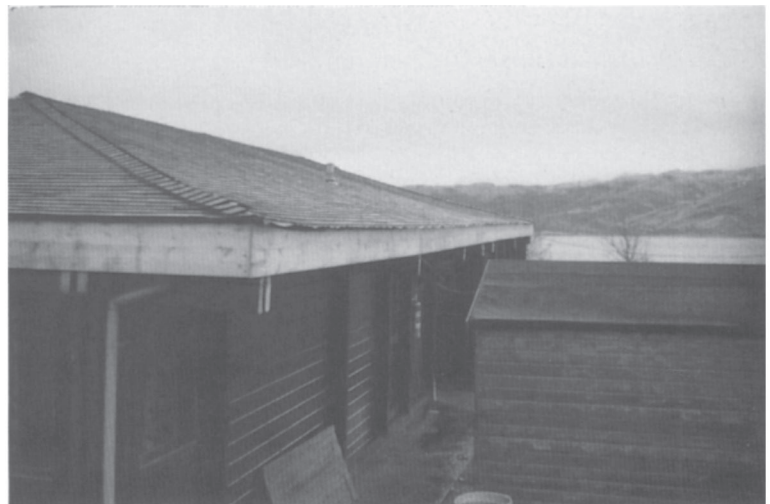
Plate 21. Water penetration in low pitch roofs. Low pitch roofs have poor resistance to rain penetration in windy conditions, even if closely bedded coverings are used such as the western red cedar shingles in this photograph; the sarking felt beneath the covering often gives temporary protection and problems may not develop for several years, usually at the eaves where the sarking felt deteriorates most rapidly.

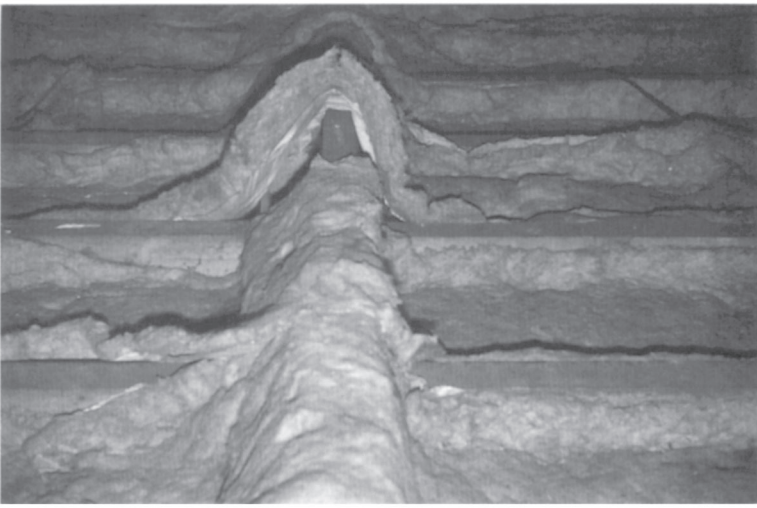
Plate 22. Remedial wood preservation problems. Ceiling insulation must be removed to allow treatment of ceiling joists; if organic solvent preservatives are applied to glass or mineral fibre insulation there is a danger of fire through auto-ignition.

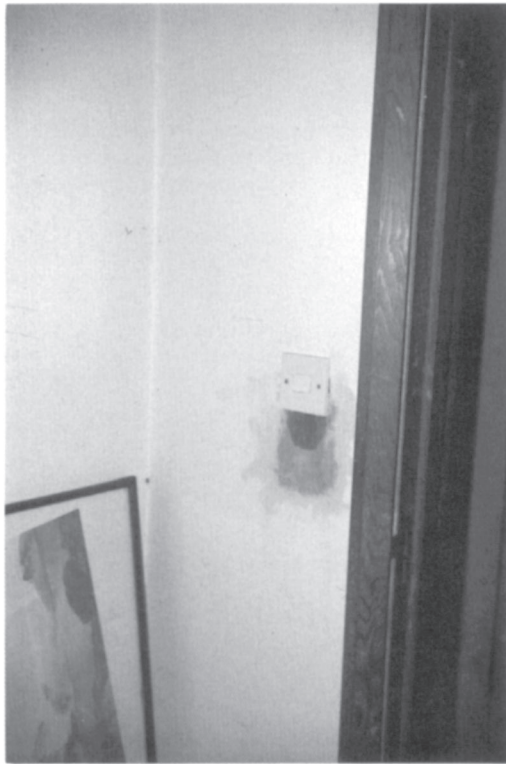
Plate 23. Remedial wood preservation problems. If some organic solvent formulations are applied too generously, solvent vapours are absorbed by PVC cables, causing bleeding of the plasticizer which can stain ceilings and walls but also cause arcing and short circuits.

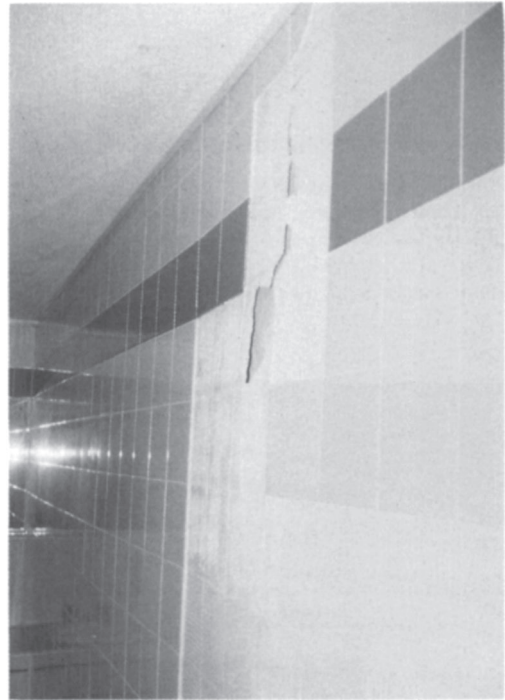
Plate 24. Damaged wall tiling. Wall tiles can be dislodged by differential movement, usually through shrinkage of cast concrete or concrete block backgrounds; normal good practice requires movement joints through the tiling to relieve these stresses.

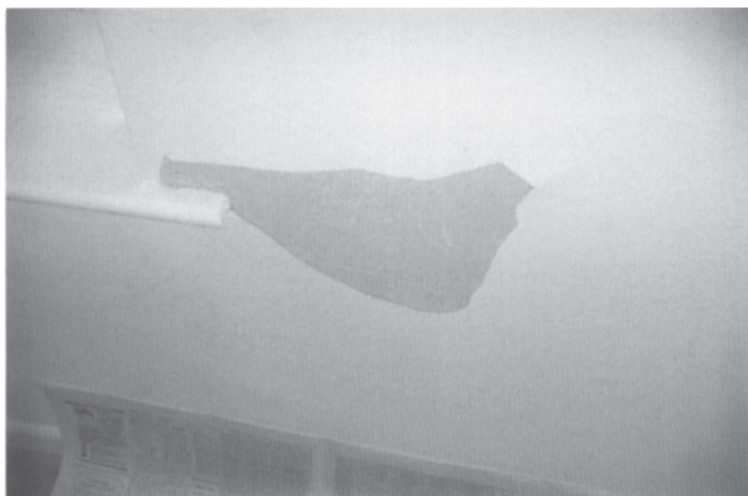
Plate 25. Plaster detachment. Gypsum plaster separation from a cement/sand undercoat in dry conditions is caused by a failure to wet the surface thoroughly before plastering.

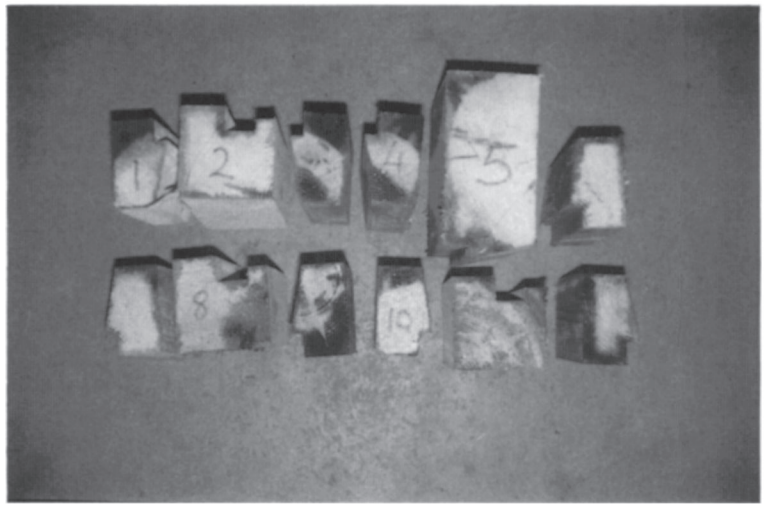
Plate 26. Penetration of wood preservative. Penetration depends on the properties of the preservative and the wood, as well as the moisture content of the wood; in sample 1 the sapwood is completely penetrated, but in sample 11 sapstain deterioration has increased porosity and allowed some penetration into the heartwood, whilst only limited penetration has been achieved in sample 2 because it had a high moisture content and no space for the preservative.

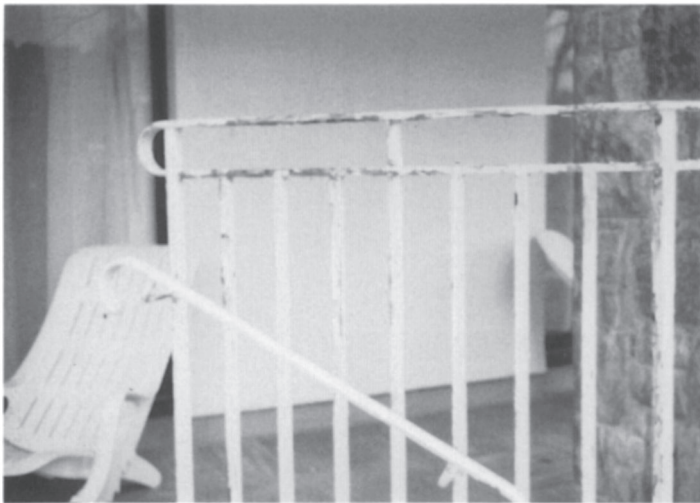
Plate 27. Corrosion of steel railings. Corrosion developed on these steel railings shortly after erection and decoration; a zinc-rich primer had been used to inhibit corrosion but it is only effective if applied to clean steel, and in this case it was applied over mill scale, old red oxide primer and rust.

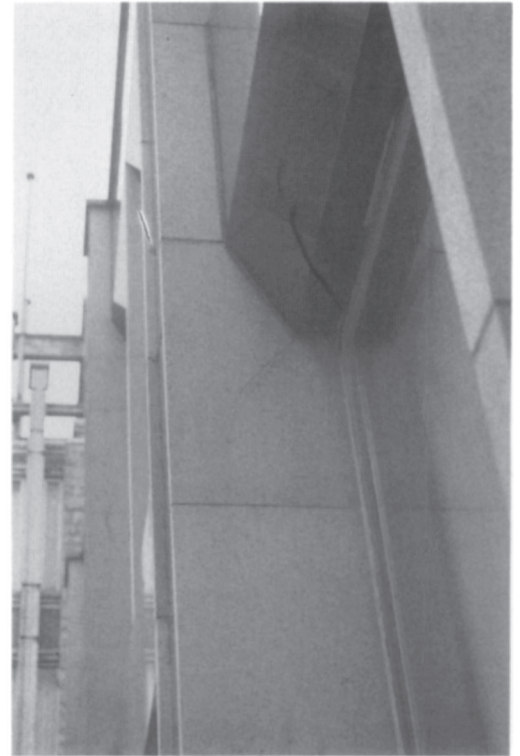
Plate 28. Stone cladding fractures. Fracturing of this granite cladding panel was caused by failure to continue the horizontal movement joint around the adjoining transom feature; the transom granite cladding also fractured.

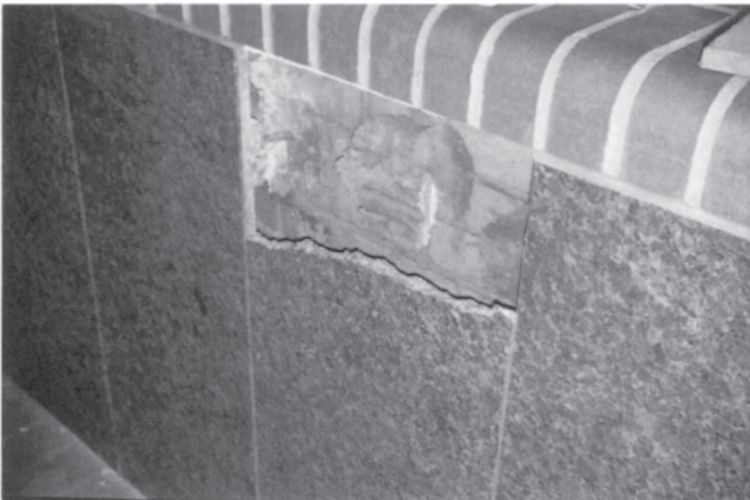
Plate 29. Stone cladding fractures. Fracturing of this granite cladding panel was due to expansion of positioning dabs; gypsum plaster was used to thicken the cement mix, water vapour absorption subsequently causing sulphate attack of the cement, expansion of the dabs and fractures of the cladding.

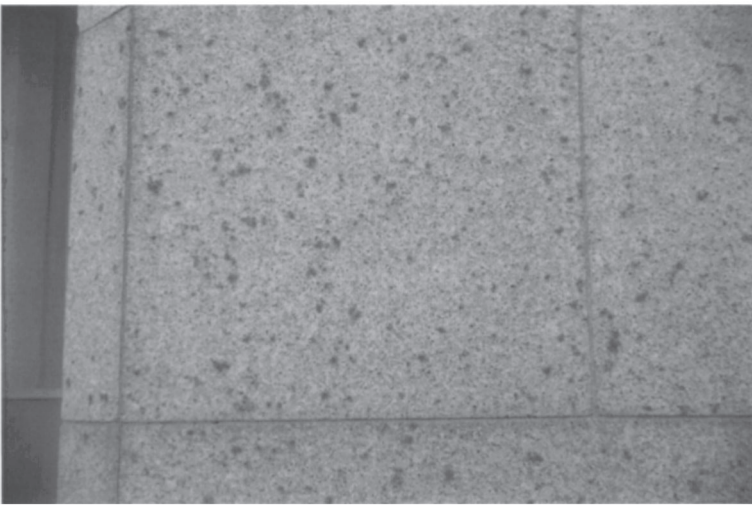
Plate 30. Iron stain on granite cladding. These patches of brown stain on light grey granite were caused by 'rust' formation following decomposition of iron pyrites inclusions during flaming to give a rough finish.
