DEFECTS AND DETERIORATION IN BUILDINGS

2nd Edition Barry A. Richardson

Defects and Deterioration in Buildings
2nd edition

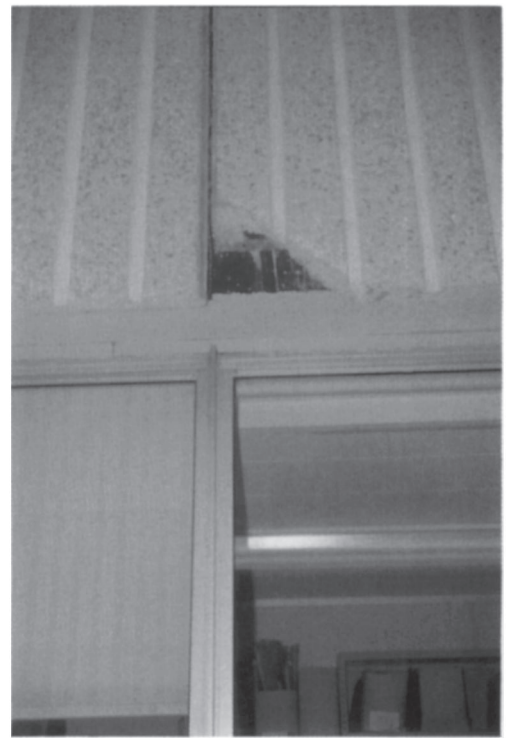
Plate 31. Fractures in concrete cladding. Fractures in concrete cladding are usually caused by reinforcement corrosion through inadequate cover, but in this case the panel was damaged during erection, partly because it was being handled too soon after casting and was rather weak.

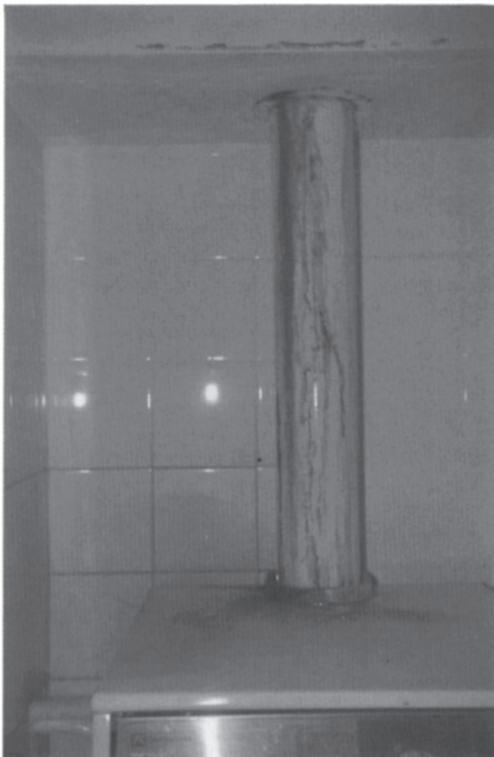
Plate 32. Condensation in a boiler flue. (a) Condensation, due to inadequate air flow in the flue, dripping from the flue pipe above the boiler; (b) Condensation and flue acids causing damage to decorations in the room above the boiler.

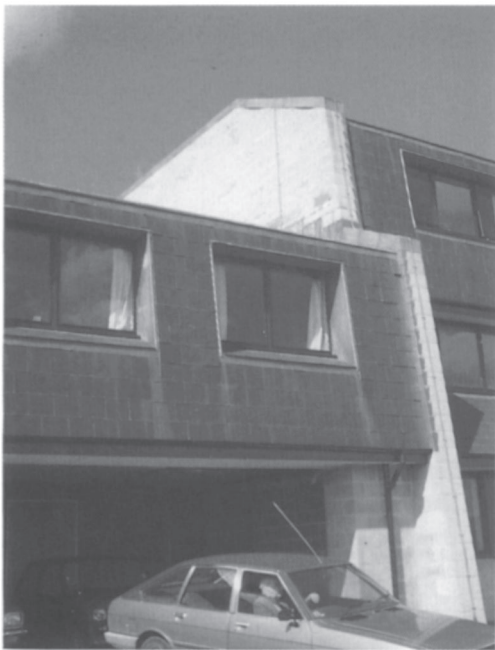
Plate 33. Water penetration in a new cast stone building. Cast stone is usually manufactured using a semi-dry mix to give an interesting surface texture but it is difficult to compact and is often very porous; water penetration into porous cast stone in this case caused flooding of the trays over windows and lower roof extensions with severe dampness internally.

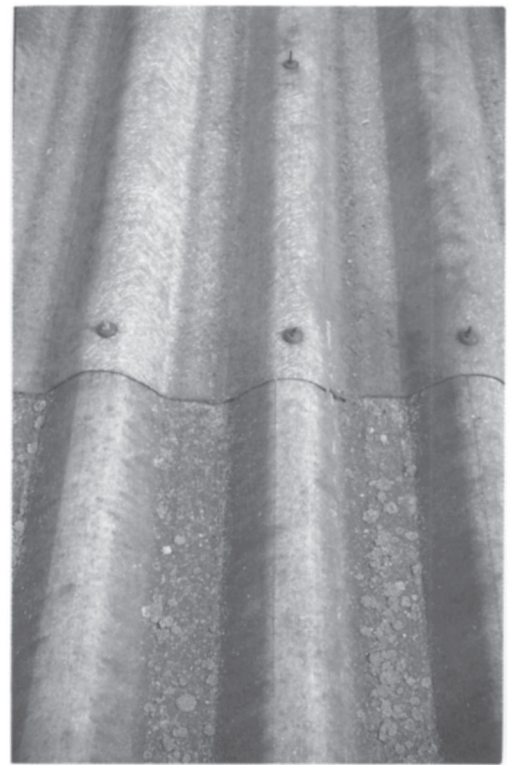
Plate 34. Deterioration of GRP roof panels. Glass-reinforced polyester roof panels usually deteriorate steadily, exposing the glass reinforcement, but fire retardent panels deteriorate more rapidly with loss of the more soluble phosphate fire retardent which often encourages lichen growth if washing contaminates adjacent cement roofing panels.

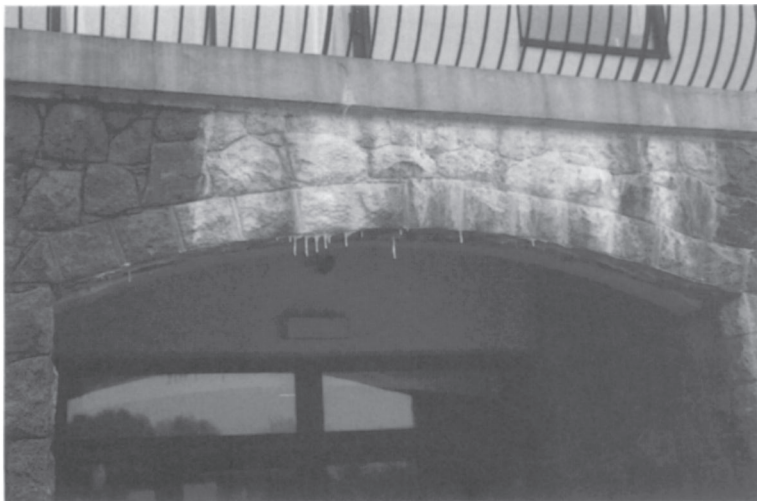
Plate 35. Lime deposits on masonry. These heavy lime deposits were caused by water saturating a semi-dry bed under paving on the flat roof above, the lime solution then emerging from the masonry through failure to provide an edge upturn to the roof damp-proof membrane beneath the paving.

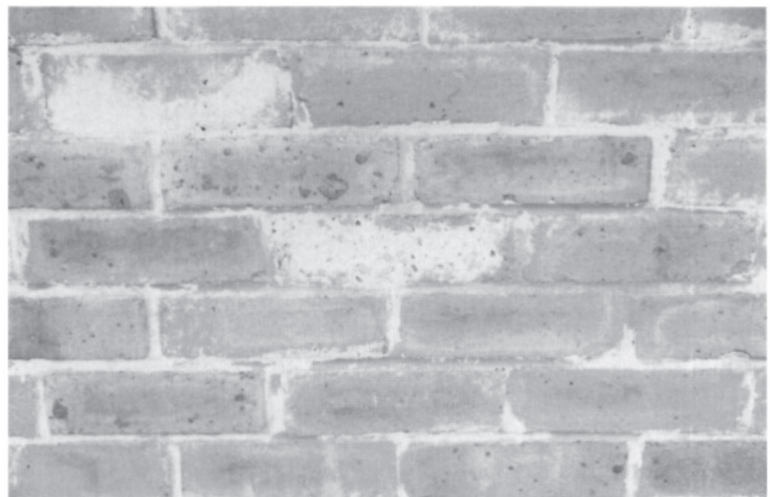
Plate 36. Sulphate efflorescence on bricks. Bricks containing excessive soluble sulphate often suffer from unsightly white efflorescence or crystallization, but the sulphate may react with the cement in the mortar joints to cause expansion and perhaps severe structural damage; sulphate resisting cement should always be used with bricks containing excessive sulphate.

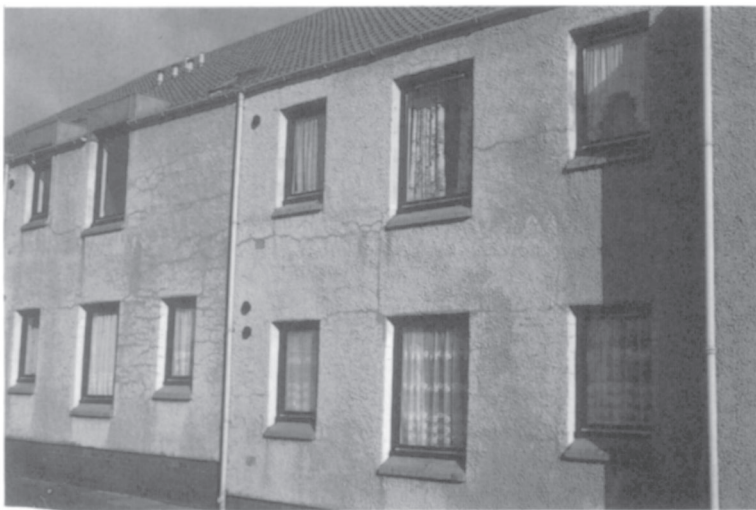
Plate 37. Render fractures. The fractures in this render are caused by sulphate attack expansion of the cement in the mortar of the supporting brickwork; the bricks were known to contain excessive sulphate and sulphate resisting cement was specified but not used.

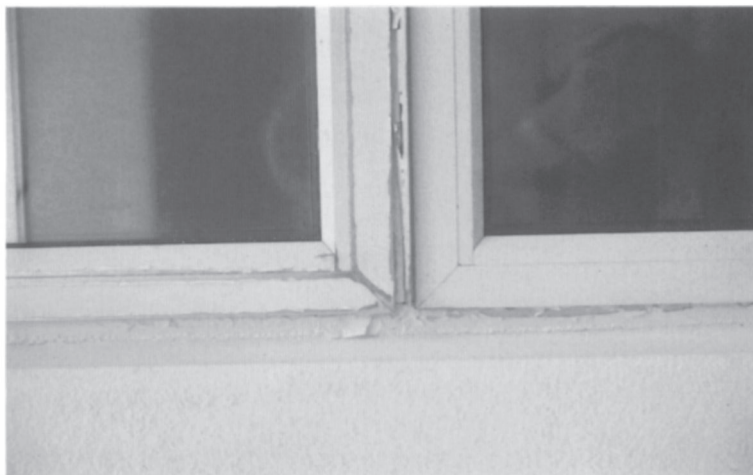
Plate 38. Paint deterioration in a marine environment. The electrophoretic acrylic coating on these new aluminium window frames was damaged by alkali attack; sea spray reacted with the lime in the adjacent new rendering to form sodium hydroxide.

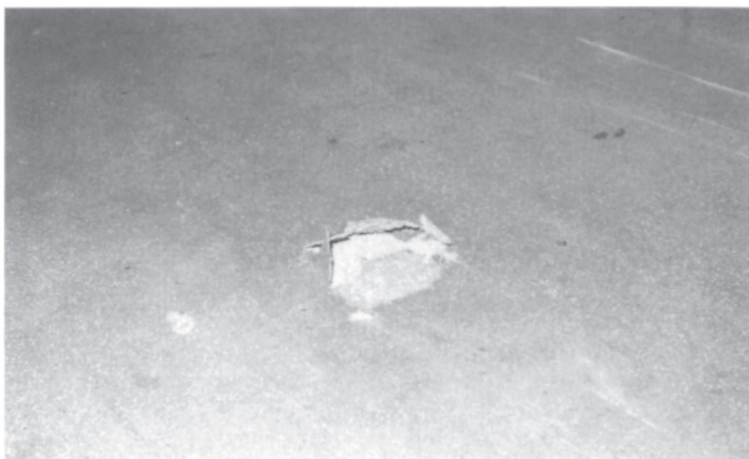
Plate 39. Failure of epoxy resin flooring. This industrial floor was laid as a resin and aggregate base coat or screed followed by a resin finish, but the basecoat resin did not cure because it was not properly mixed or the temperature was too low; inadequate cure was indicated by a strong phenolic odour.

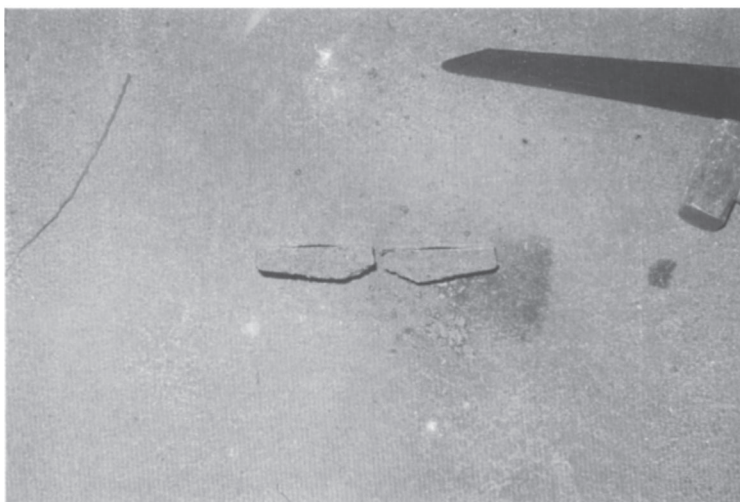
Plate 40. Blister formation in a swimming pool floor. The pool floor comprised a reinforced concrete slab and cement/sand screed, topped with an epoxy resin screed and finish, but the finish was not completely impermeable and the screed resin did not cure, producing concentrations of phenolic compounds which caused water flow by osmosis through the semi-permeable finish and development of the blisters.

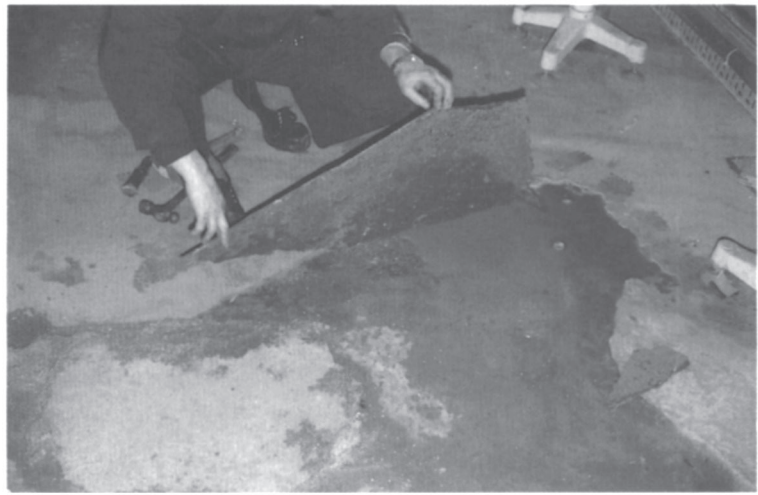
Plate 41. Failure of polymer-modified cement flooring. This polymer-modified cement and aggregate floor topping was laid in a bottling hall without movement joints, stresses causing fracturing and separation from the concrete base, but the floor topping also 'domed' beneath the syrup machines through expansion caused by sugar reaction with cement; cement-based flooring must never be used if sugar contamination is possible.

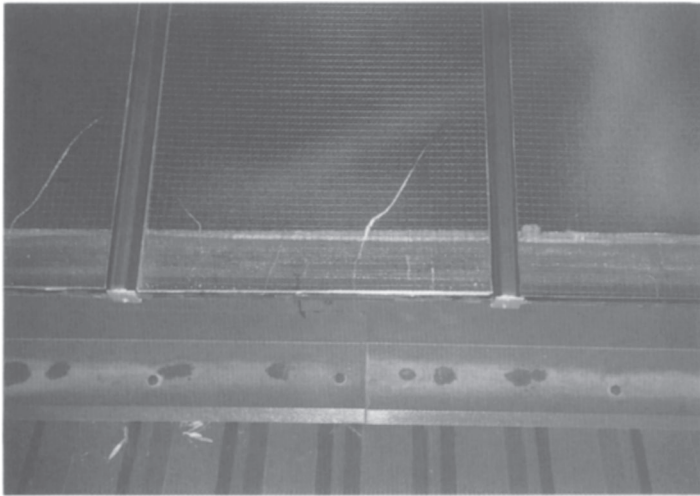
Plate 42. Fractures in patent double glazing. These industrial patent glazed roof lights were fitted with sealed double glazing units with inner wired glass and outer plain glass, the units projecting well beyond the seal so that, when the inner wired glass was expanded by the accommodation heat, the projecting cool glass was stressed, causing the observed fractures.

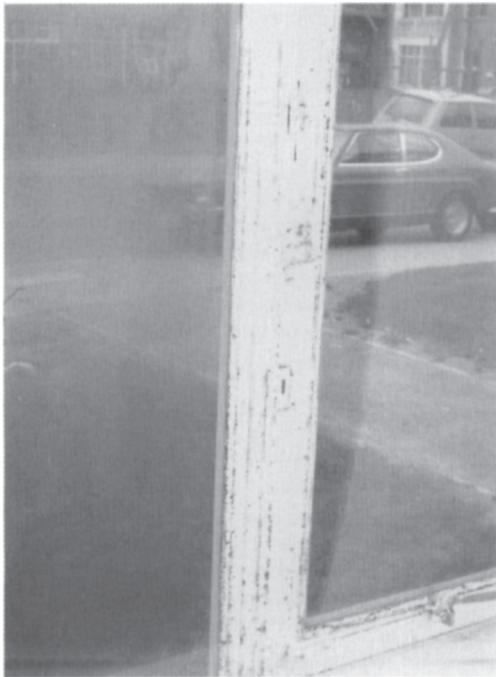
Plate 43. Condensation in sealed doubleglazing. Condensation within these double glazing units was due to defective seals; stepped units were involved and the defective seals allowed warm humid air from the accommodation to enter the units, causing condensation on the inner surface of the outer glass.

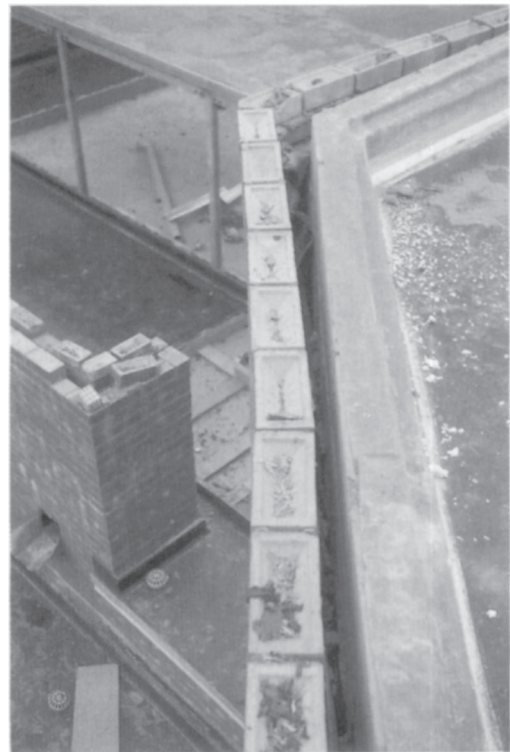
Plate 44. Sulphate attack in clay brickwork. This new brickwork to an octagonal building was exposed to heavy rainfall which caused sulphate in the bricks to migrate and react with cement in the mortar to cause expansion, increasing the height of the brickwork but also causing the observed distortion.

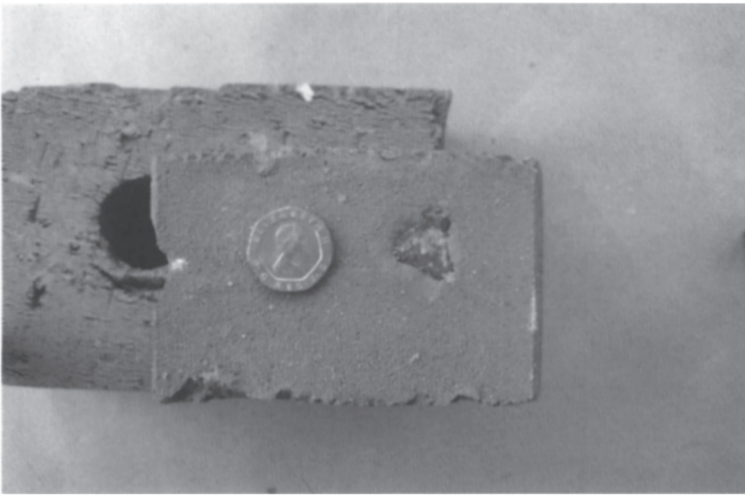
Plate 45. Limeblowing in clay bricks. Shells embedded in the brick clay were reduced to quicklime during firing, but slow absorption of moisture from the air caused expansion and rupture of the brick surface.

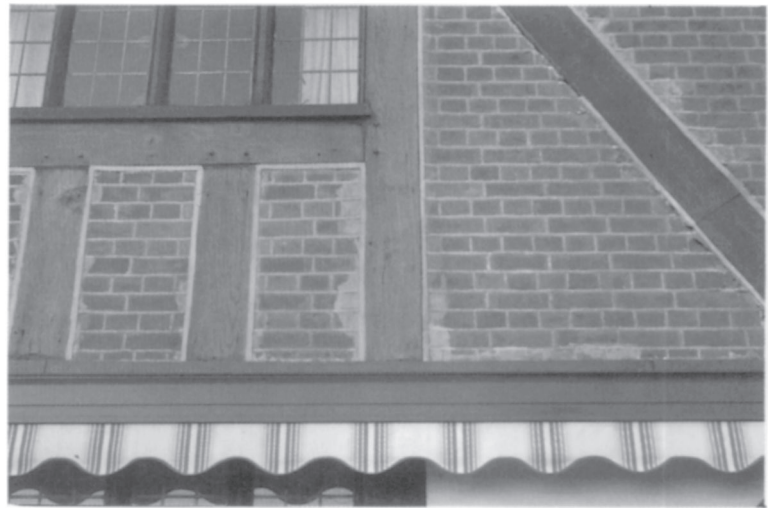
Plate 46. Differential movement between brickwork and wood. In dry weather shrinkage of the wood frame formed a gap which was then pointed with mortar, but subsequent expansion of the wood caused spalling of the adjacent brickwork.

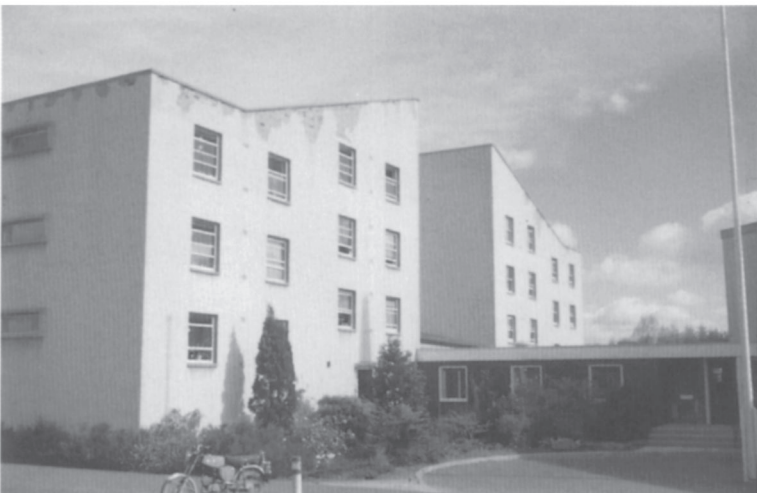
Plate 47. Render failure due to water penetration. The damp-proof course beneath the concrete wall copings was trimmed against the edge of the brickwork before rendering so that it did not protect the top edge of the render; water penetrating through the coping joints accumulated behind the render which became detached during frost.
